In-bore Detonation of Non-standard Ammunition,
Testing a Russian T-55 Tank

Steven J. Reeves and Ralph Scutti

In-bore Detonation of Non-standard Ammunition

Testing a Russian T-55 Tank

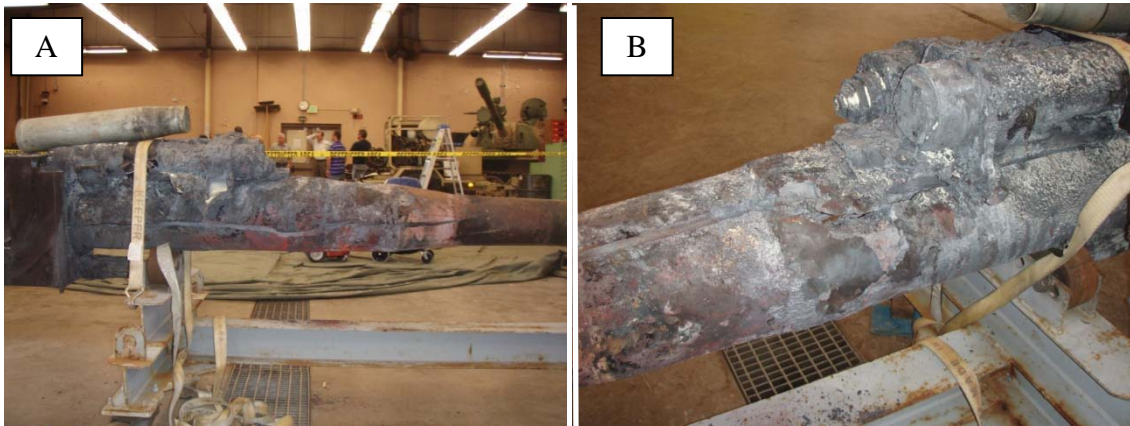
Figure 1 Failed 100-mm gun tube after incident, 65” and 60” long cracks in images A and B respectively

The final report titled; Evaluation of Failed 100-mm T55 Soviet Tank Cannon, August 2009 concluded ‘Through Benet Laboratories failure analysis and interior ballistics simulations the gun tube could safely fire the BK5M HEAT round. The accident was caused by the BK5M HEAT round detonating in the tube. A reason for the premature detonation is unknown and part of an ongoing investigation. The projectile was at or near maximum acceleration when the event took place.’ The report also stated in the summary; ‘Failure mode of the tube is fast fracture due to an overpressure situation, Projectile travelled approximately 16 inches prior to the event, Tube material had adequate strength to support firing of the HEAT round under normal conditions, The chamber pressure at the time of the accident was 3000 Bars, The residues examined from the bore surface were determined to be rust, brass and elements found in the primer, and The projectile was fired and began to move’.

5) The failure analysis performed by Benet Laboratory concluded that the projectile moved approximately 16 inches down the tube before detonating. Additionally Benet concluded that the gun tube did not fail due to fatigue or wear but rather due to an event (force) that it was not designed to contain.

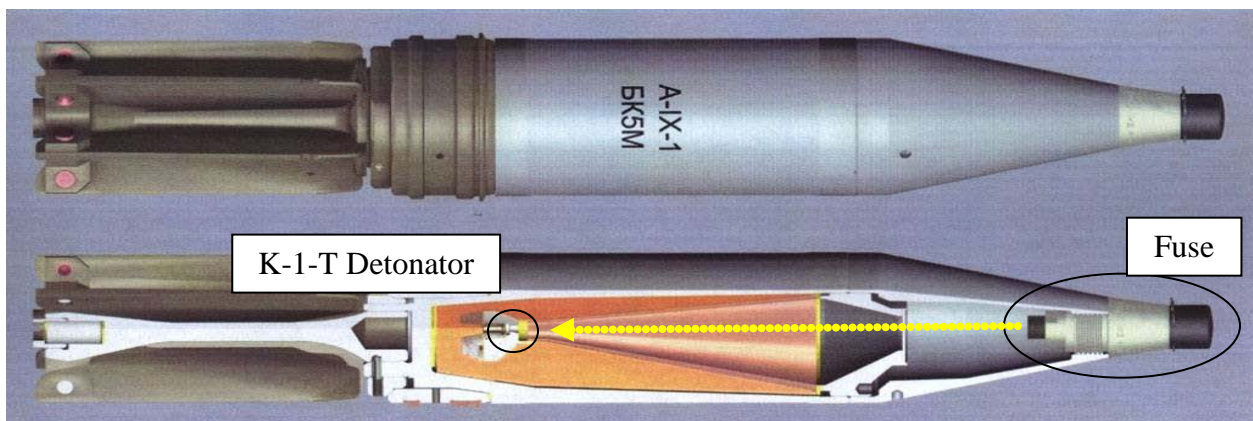
Two of the BK5M warheads were examined in October 2008 to determine if the high explosive could be removed. Removal of the projectile’s high explosive main charge was determined to not be feasible due to the design of the projectile and equipment limitations. The HEAT round uses a ‘spit-back’ explosive detonating train to initiate the high explosive main charge. When armed, the GPV-2 fuse at the tip of the round (fig 2) is crushed upon impact with the target. This causes the pezio-generator (fig 3) to generate an electrical pulse sufficient to initiate the electric detonator (fig 3), initiating the fuse explosive train. The fuse detonator (fig 3) fires down the center of the copper cone (fig 2) and ignites the K-1-T base detonator (fig 2) in the body of the projectile. The K-1-T detonator is integral to the high explosive, preventing safe removal of the high explosive main charge.

Figure 2 Projectile, Russian BK5M 100-mm HEAT

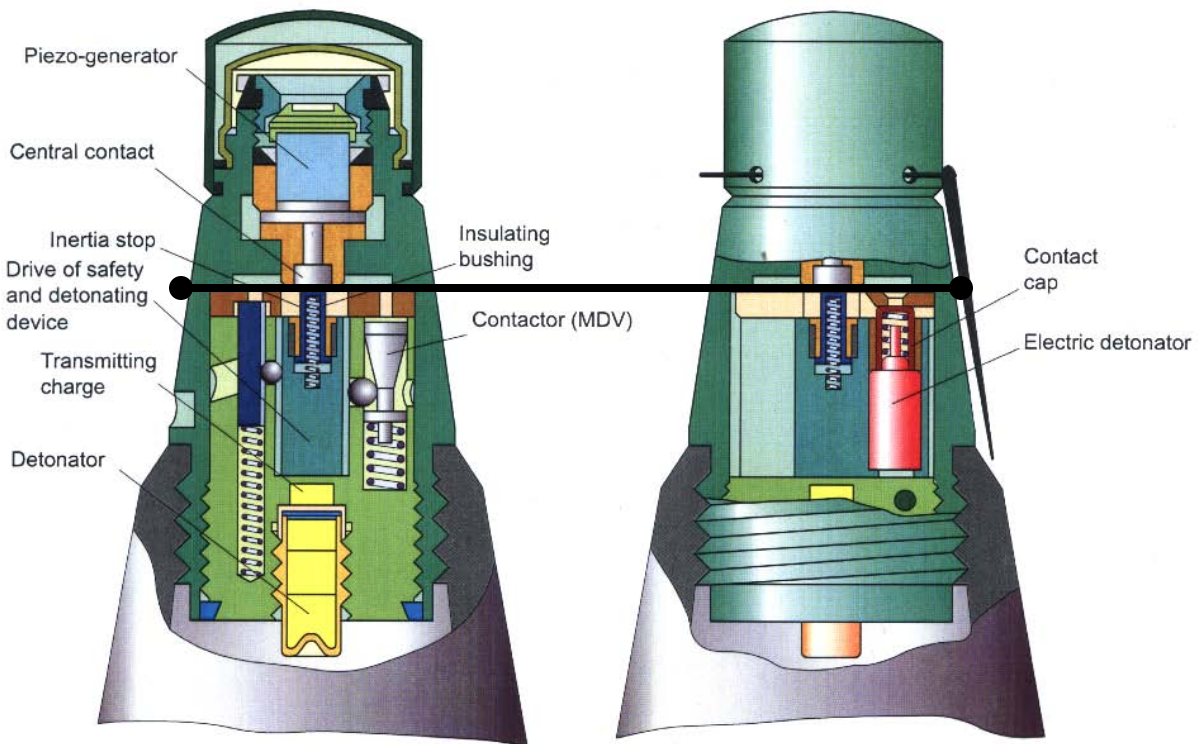
Figure 3 Fuse, GPV-2 for the Russian BK-5M 100-mm HEAT projectile (shown as received).
Modification, all internal components below black line were removed

Since the high explosive could not be removed to totally inert the round the GPV-2 fuse was modified in an attempt to make the projectile less likely to detonate prematurely. The safe and arming mechanism was removed from the GPV-2 fuse, leaving only the pezio-generator and central contact in the fuse. All energetic materials were removed from the GPV-2 fuse. All of the components under the black line (fig 3), the safe and arming mechanism, were removed. The group that performed the modification had documentation indicating that all fuses were modified and all material removed from the fuses was destroyed.

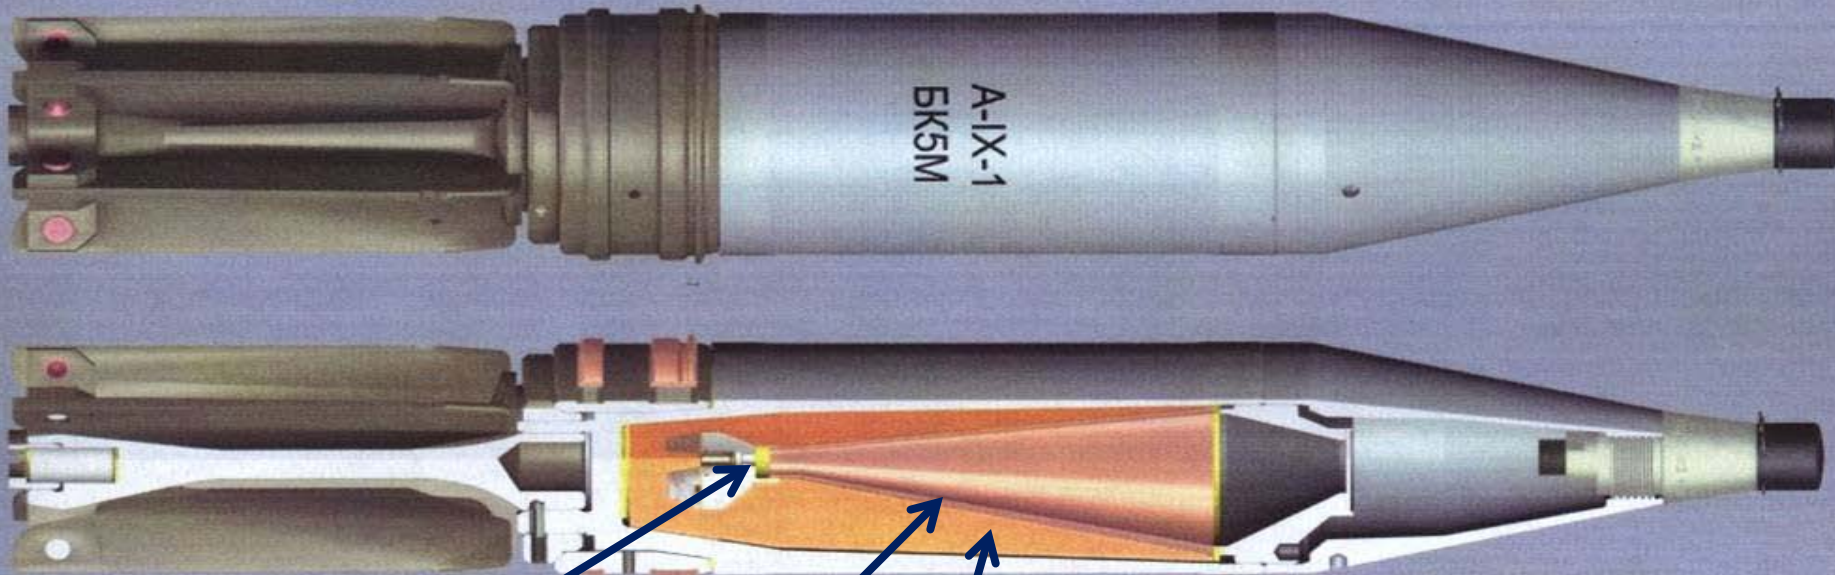
100mm HEAT BK5M Warhead

K-1-T detonator Cap

Copper Lining

RDX

638mm/25.11" Long, 12.2kg/26.90 lbs

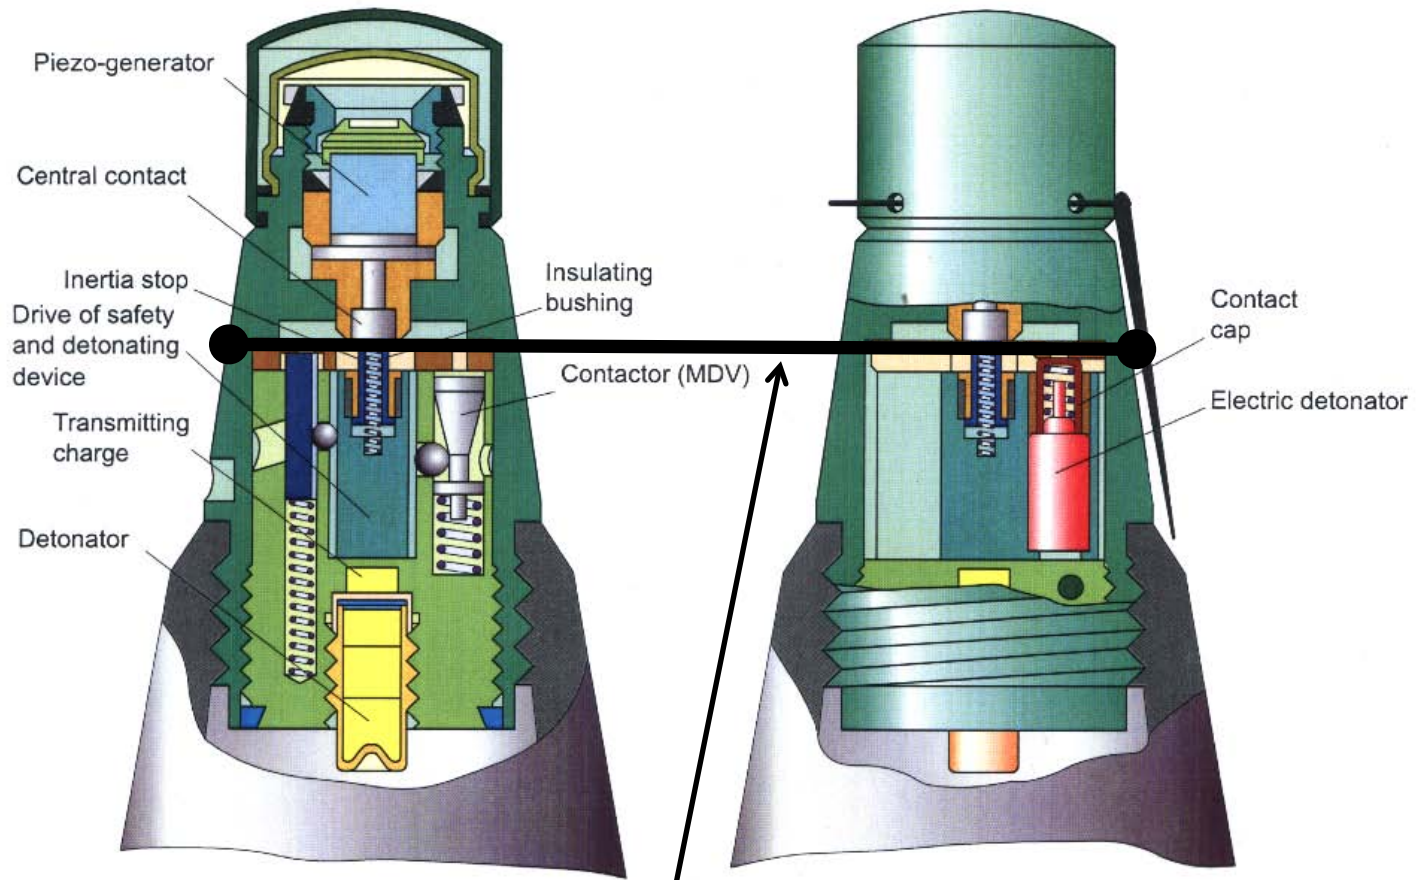
GPV-2 Fuze

Modification Line

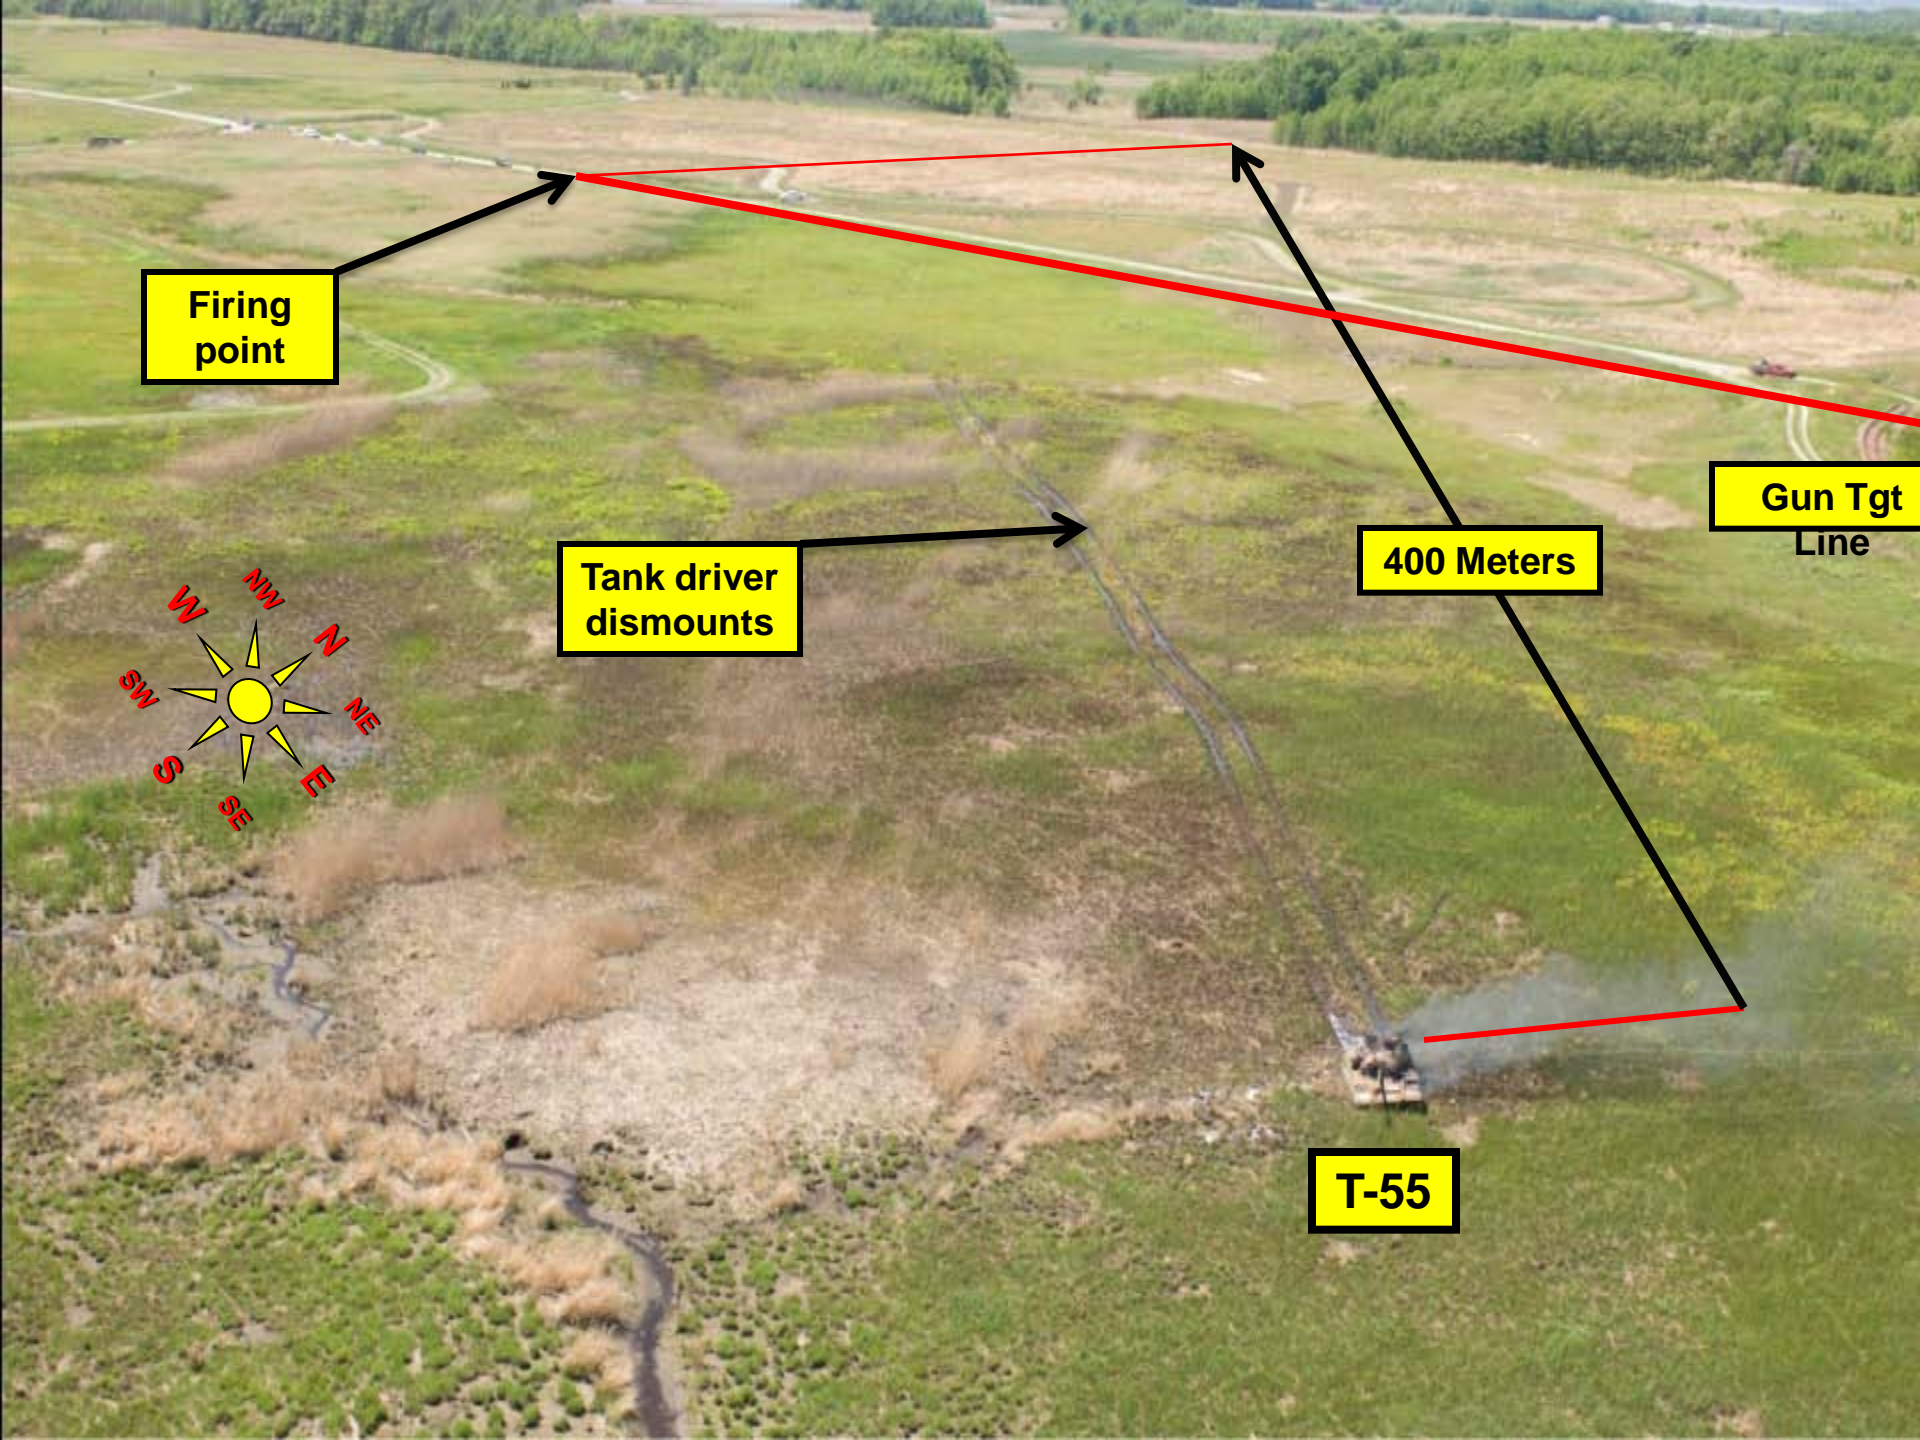
DATE:	TIME:	EVENT:
21 May 09	~0925	Tank began to move forward to reach speed of 16-18 KPH
	~0925	Gunner pulled the trigger
	0925	HEAT round prematurely detonated in the gun tube

Firing point

Tank driver dismounts

400 Meters
