Army Corrosion Summit

Army Aviation Corrosion Engineering Case Studies

**Aviation and Missile Research,
Development and Engineering Center**

Date: 10 February 2010

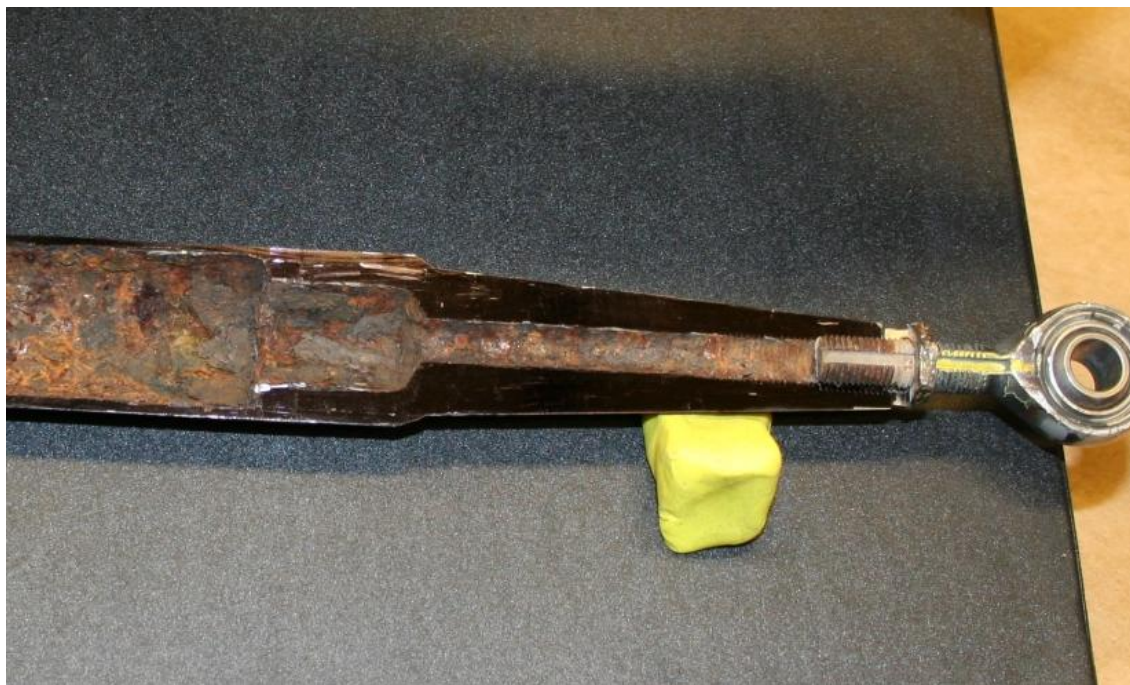
- A Category I Quality Deficiency Report (QDR) investigation of the FWD Fast Rope Insertion Extraction (FRIES)/External Rescue Hoist support rod (P/N LEX-1583-05), consisting of microscopic, ultrasound, and metallurgic examination revealed severe corrosion of the inside surface of the rod. Subsequent investigation of additional ship sets revealed several support rods within the FWD FRIES/External Rescue Hoist truss assembly exhibiting similar corrosion.

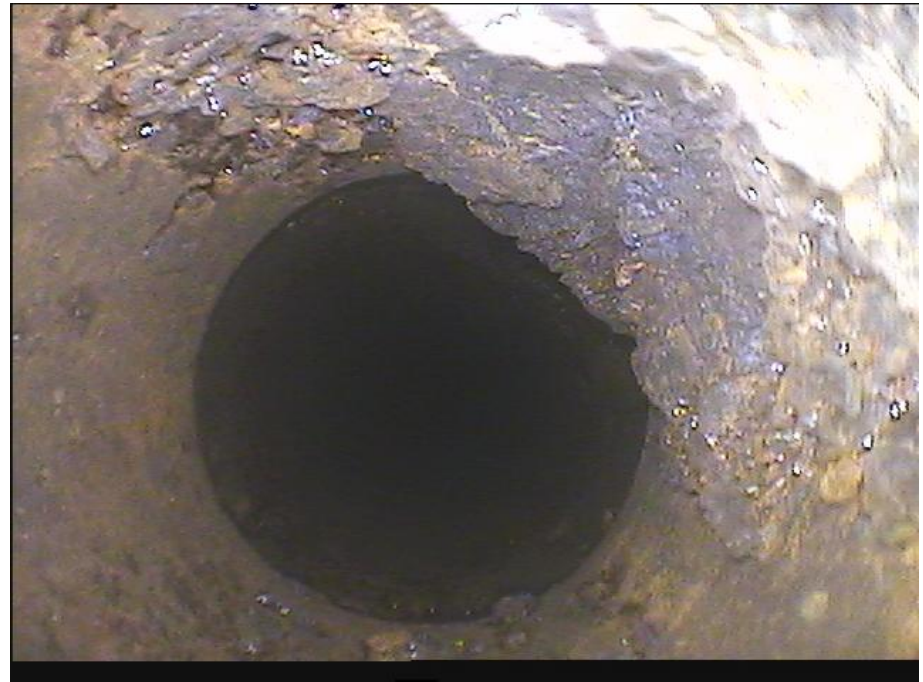
Interior view of severely corroded Support Rod

- **Resolution**
- ASAM H-47-09-ASAM-04 is issued
- Requires inspection and grading of the corrosion severity
- Thoroughly dry the rod and treat interior with MIL-C-16173, Grade 3
- Restrict usage of the FRIES station based on corrosion severity

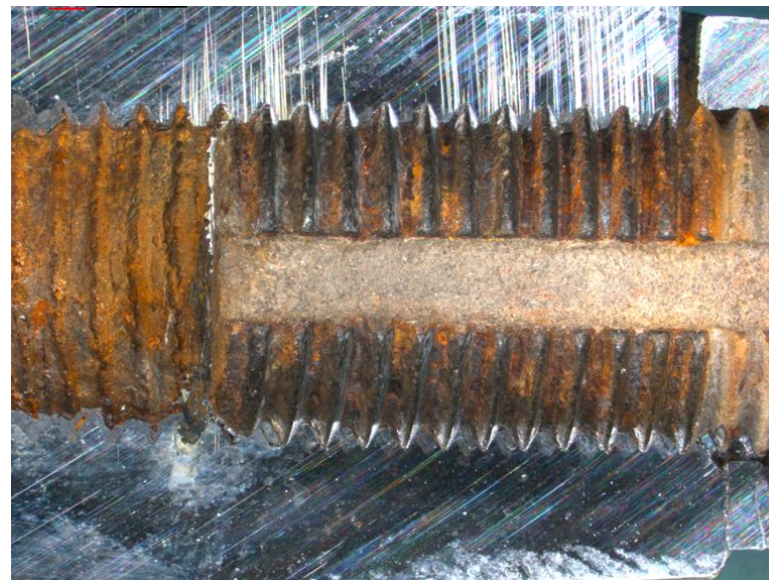
Example of rod end threads of a seized in place rod end. Notice the extent of the corrosion and pitting

- Result – The rest of the story
- Aircraft were restricted until support rods were replaced
- All support rods have been replaced
- The old rods have been scrapped

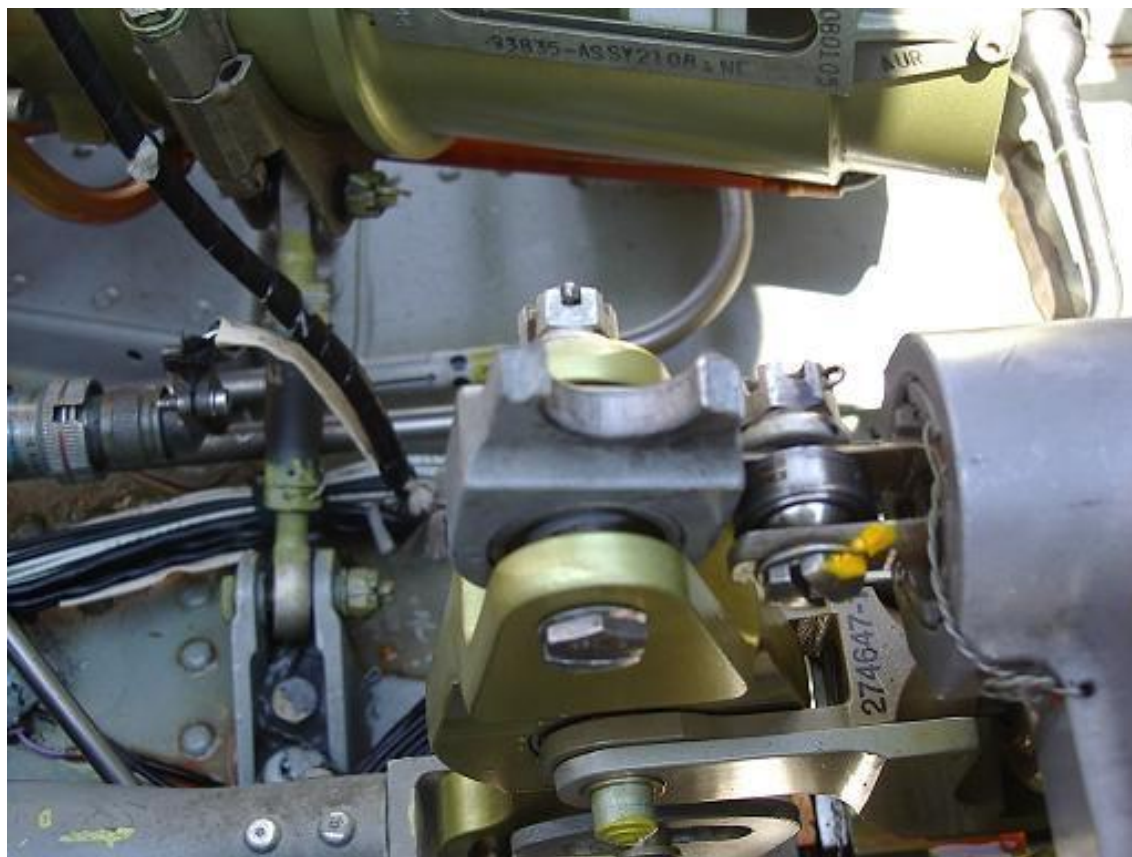
H-60 SAS Link

- **The Problem**
- During ground taxi of a Navy aircraft, it would not turn right despite full right pedal input. Inspection of the aircraft revealed the Stability Augmentation System (SAS) Link, PN 70410-02334-044, on the Yaw Boost Servo was fractured. Analysis determined that the Link failed due to Stress Corrosion Cracking (SCC), and indicated the material to be 7075-T6 Temper.

Problem: HS-11 reported that during preflight flight control checks, pilot noticed a thump. Pilot continued with preflight checks and noted that all flight controls felt normal and that the anomaly did not return. During ground taxi aircraft would not turn right despite full right pedal input. The aircraft was shutdown at which time the SAS Link, P/N 70410-02334-044, on Yaw Boost Servo, P/N 70410-22910-045, was found fractured.

Cause: Lab analysis determined that the link failed due to stress corrosion cracking (SCC) through its cross section. Subsequent to this failure, the link further fractured due to overload. Hardness and conductivity testing indicate a -T6 temper condition which has poor resistance to SCC. Newer SAS Links (-045) are manufactured in the -T73 temper condition which is less susceptible to SCC. However, drawing for older SAS Links (-044) allows manufacture in the T-6 temper condition. SAS Link is used on Yaw and Collective Boost Servo Assemblies (P/N 70410-22910-045) and Pitch and Roll Trim Assemblies (P/Ns 70410-22760-050/-051/-053).

Risk Assessment: HRI = 12. Medium Safety Risk

Required Action: Bulletin for one-time inspection:

- Inspect for and remove all -044 SAS Links .
- Inspection to be conducted either visually if link p/n is legible or via eddy current conductivity testing if p/n is not legible.

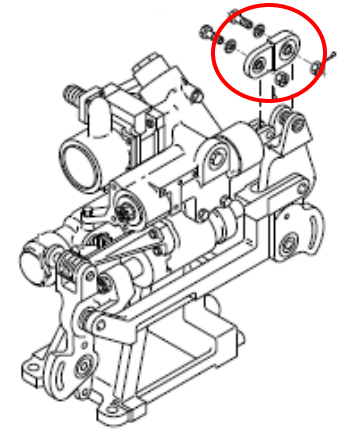
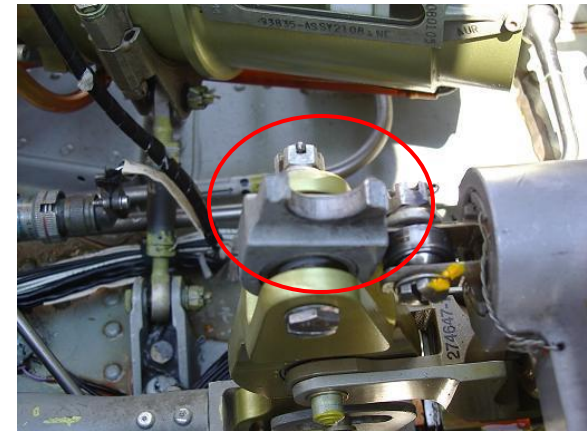
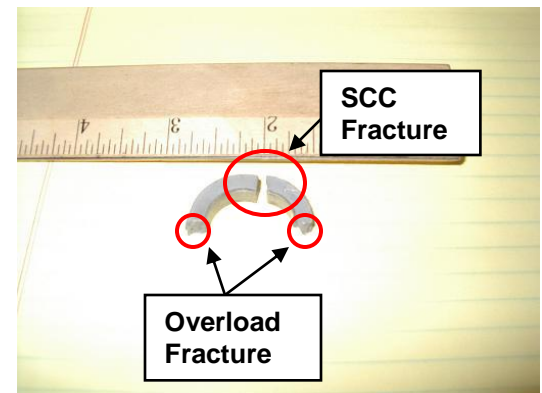
- **The Investigation**
- Drawing review – the link was not to print
 - 7075-T651 versus 7075-T73
 - Press fit versus adhesive and staked
- Structural Analysis
- Failure Analysis
- Risk Analysis

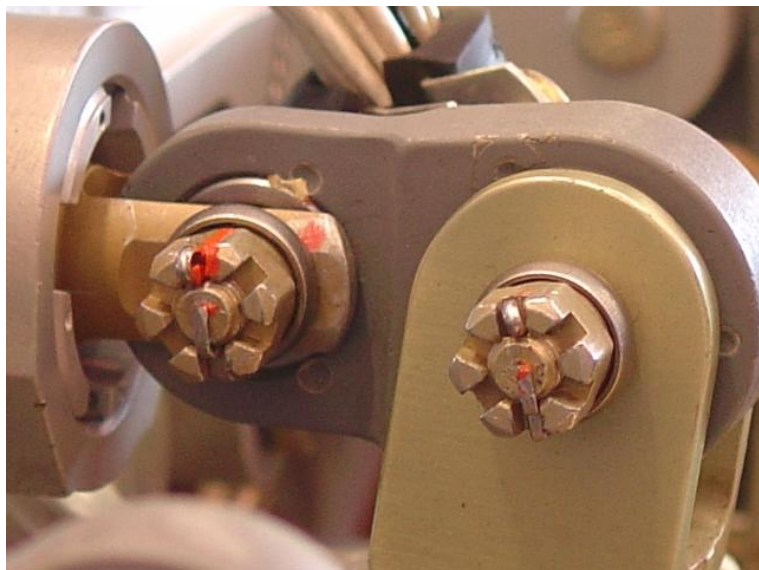
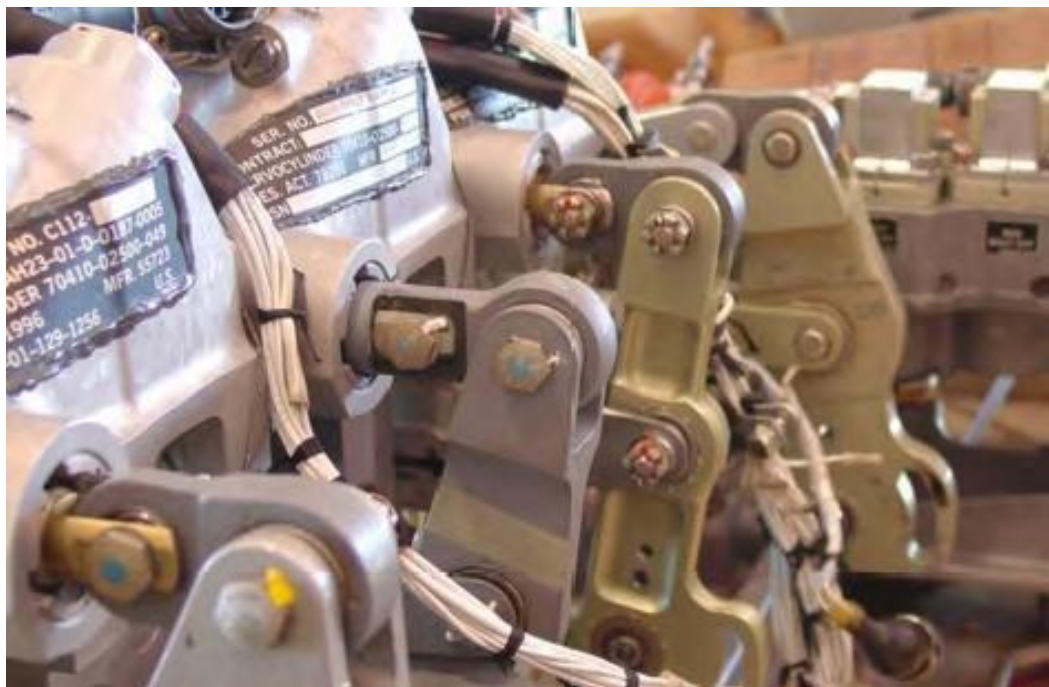
- The Outcome
- As of 13 Jan, 1052 aircraft, 3165 links inspected
- 999 links failed (T6)
- 362 Aircraft with new links
