DOURA POWER STATION  
UNITS 5 AND 6  
BAGHDAD, IRAQ

SUSTAINMENT ASSESSMENT

**SIGIR PA-07-103**  
**JULY 18, 2007**

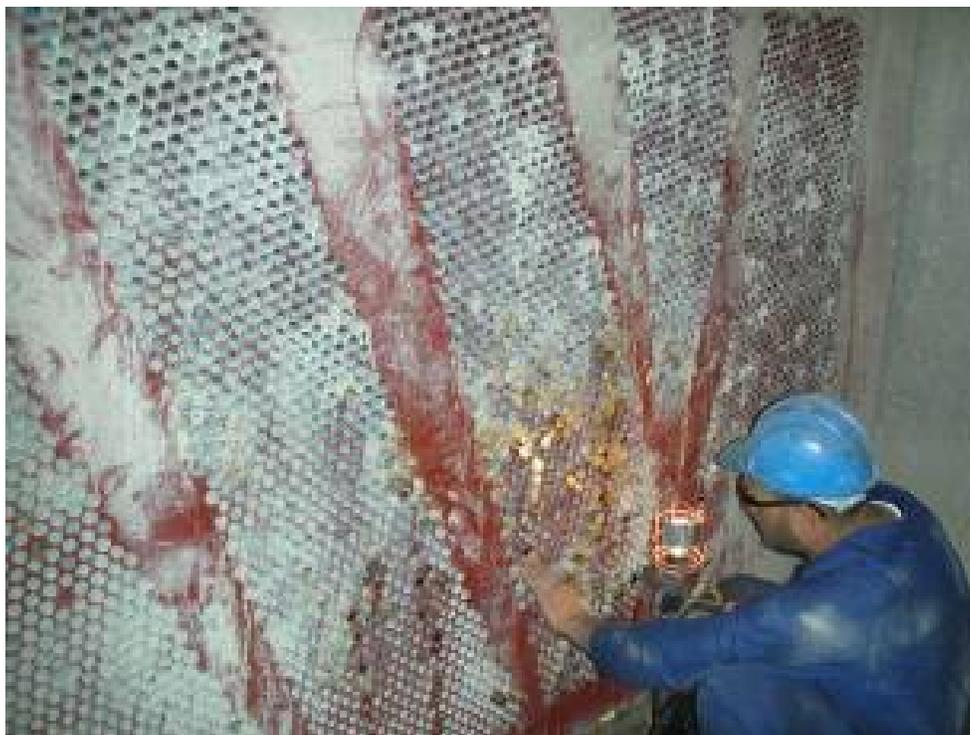
**Site Photo 2. Condenser cleaning and repair. (Photo courtesy of GRD Electricity Sector)**

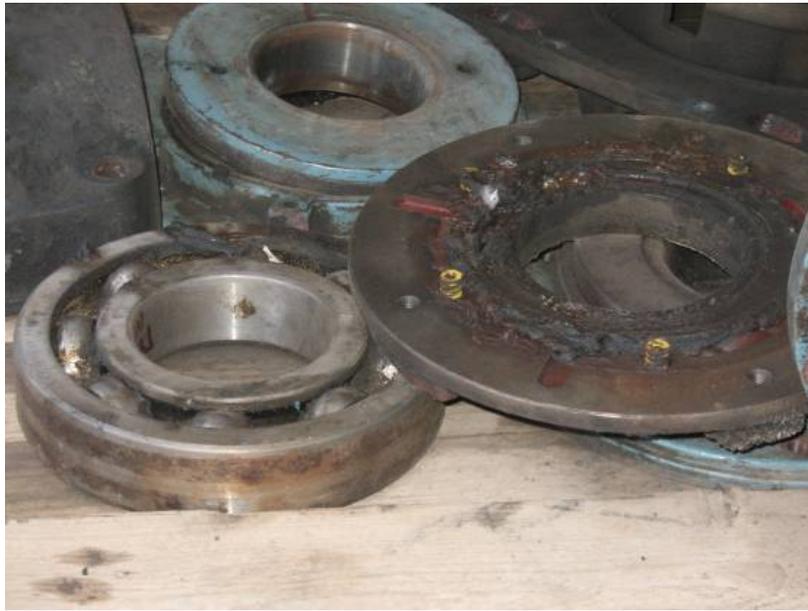
In addition, ineffective general maintenance of the exciter resulted in an oil and dust accumulation in the rotor end windings and rectifier wheel areas. The film of oil, dust, and mud created short circuit paths between the end winding connectors of the exciter. When combined with other operational problems, a short circuit (flashover) occurred and the exciter was rendered inoperable when the rotor windings were damaged. SIGIR observed a large bearing that failed and damaged the shaft on a piece of component equipment because of inadequate lubrication. One of the resident Electricity Sector managers agreed that lubrication is a key component of any effective preventative maintenance program. In this case, the bearing ran nearly dry and generated so much heat that it had to be cut for mechanics to remove the bearing from the rotating shaft (Site Photos 3 and 4).

**Site Photo 3. Inadequate lubrication caused bearings to fail. (10 June 2007)**

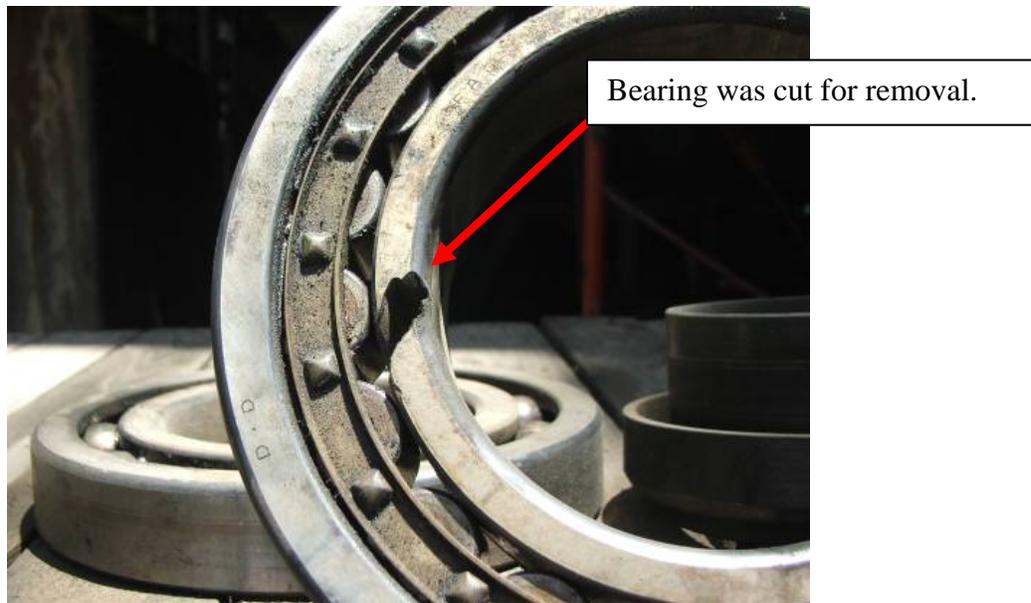
**Site Photo 4. Mechanics had to cut bearing before removal. (10 June 2007)**

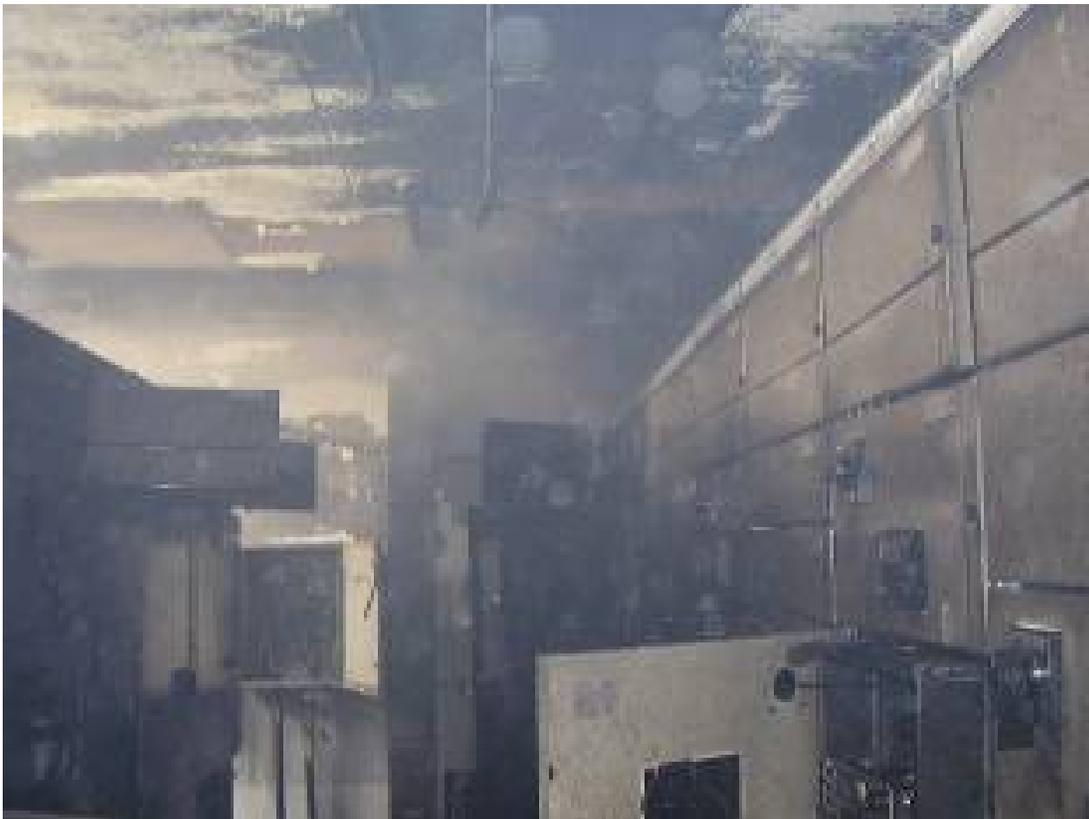
plant to the community surrounding the power station. While on site, SIGIR observed the control center for Unit 5 and 6 main oil pumps after it was ruined by a devastating fire on 31 May 2007 (Site Photo 5).

An ad-hoc cable tap caused the fire, which rendered the control center inoperable. As a result, approximately 100 village houses that previously obtained power directly from the ad-hoc cable tap or circuit have been and will be without power until the control center is rebuilt and Unit 5 is re-started and operational. Although discussed with the MOE, GRD Electricity Sector managers stated that they were not certain whether the MOE would authorize disconnecting the ad-hoc cable taps throughout the plant. In the meantime, to prepare for restarting Unit 5, inspectors observed that contractor personnel have been and were attempting to minimally repair the control center (Site Photo 6).

**Site Photo 5. Oil Station control center after May 2007 fire. (Photo courtesy of Electricity Sector)**

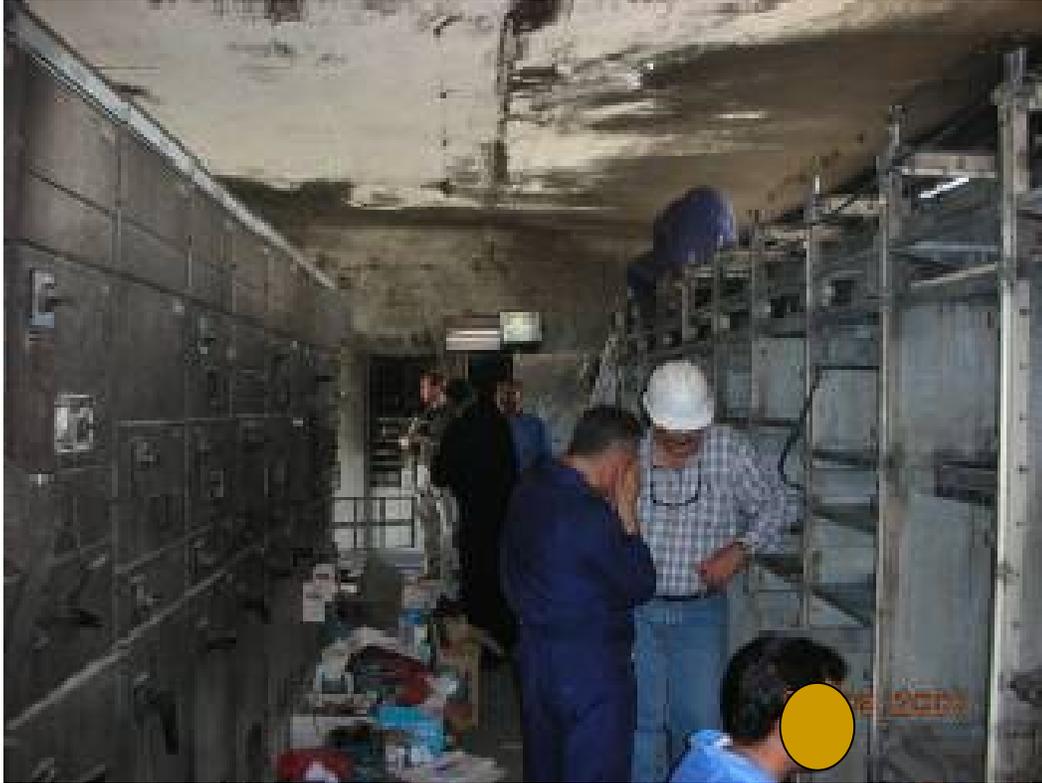
**Site Photo 6. Control center cleanup and repair work in progress.**  
(Photo courtesy of Electricity Sector)

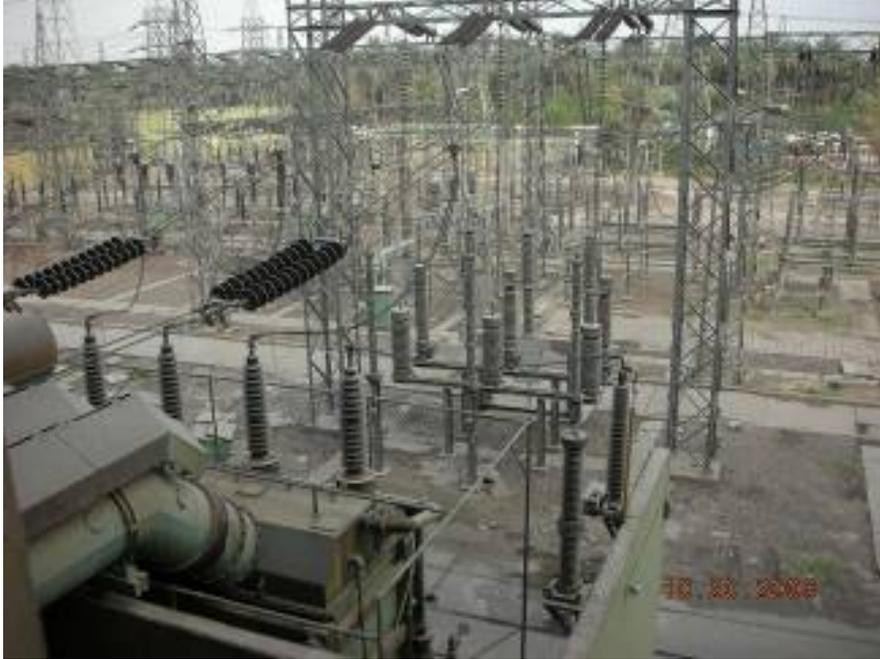
**Switchyard.** While operational at the time of our site visit, the switchyard should be overhauled. GRD Electricity Sector managers explained that, in the past, several insulators have been damaged from bullets and shrapnel and that most of the insulators need to be cleaned. The breaker control and protection circuits need to be tested (Site Photo 7). Resident GRD Electricity Sector managers, while working on the Unit 5 and 6 section of the switchyard, observed that several protections and controls have been bypassed and some high voltage breakers would not work remotely or were leaking SF6 insulating gas. Additionally, GRD Electricity Sector managers were not aware of any switchyard control or standard operating procedures (SOP) utilized by the MOE. Nonetheless, the MOE has total control of the switchyard and only allows contractor personnel to work on the Unit 5 and Unit 6 section(s) of the switchyard. Based on discussions with the resident GRD Electricity Sector manager, the switchyard lineup should be changed to ensure that power is distributed evenly from Units 3 through 6 to each outgoing line to avoid overloading any particular line section in the switchyard. At the time of our site visit, the resident GRD Electricity Sector manager stated that such a recommendation would be made in a timely manner before restarting Units 5 and 6.

**Site Photo 7. Unit 5 transformer and 132 kV switchyard is in questionable condition.  
(Photo courtesy of Electricity Sector)**
