SPECIAL WEAPONS AND TACTICS
(SWAT) POLICE STATION
HILLA, IRAQ

SIGIR PA-05-018
JANUARY 30, 2006

SUBJECT: Report on Project Assessment of the Special Weapons and Tactics (SWAT)
Police Station in Hilla, Iraq (Report Number SIGIR-PA-05-018)

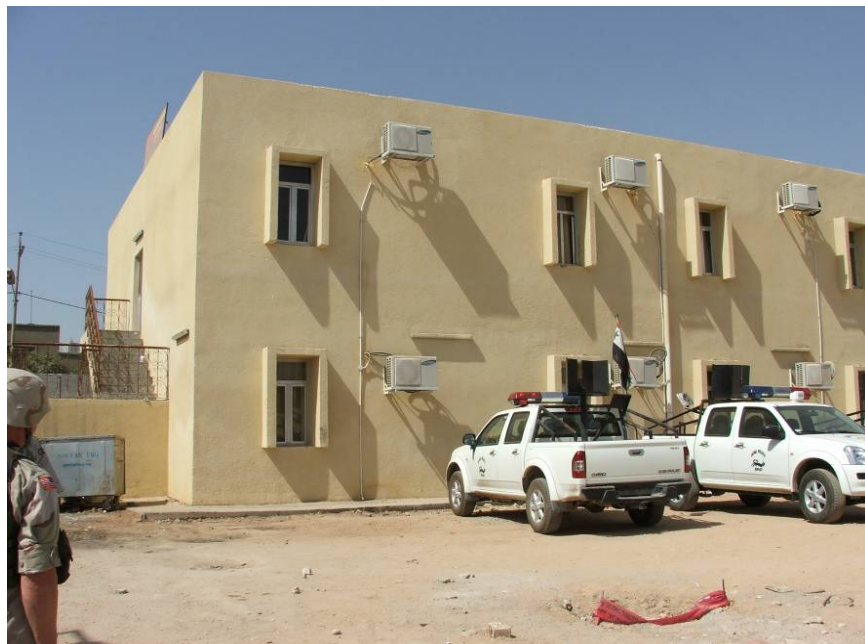
The contract and design required the construction of a two-story facility with reinforced concrete footings, reinforced concrete slab, reinforced concrete columns and beams, and stucco over block exterior. The building design required a 28.78 M (94 feet (ft)) by 13.66 M (50 ft) facility with two external stairways, one on each end of the building. Each floor included three large open rooms and a common lavatory. The contract required the facilities to include A/C units. The site visit verified the building was constructed and currently occupied. We observed the A/C, lights, and fans to be operational. For an illustration of the external front of the two-story sleeping quarters building, see Site Photo 1.

Site Photo 1. Exterior Front of Two-Story Sleeping Quarters Building

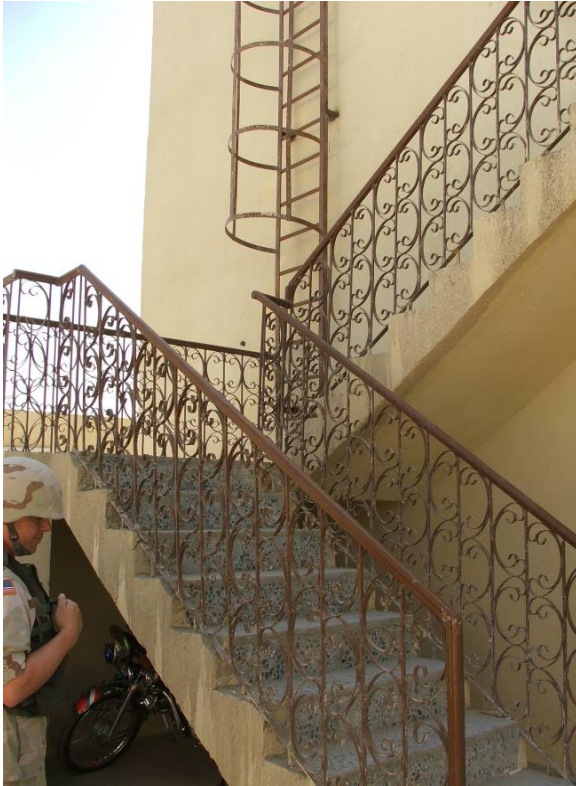
During the site visit, we identified discrepancies in the construction of the handrails on the external staircases and the finishing of the concrete sidewalks. For example, the handrails lower cross member was imbedded in the concrete stairs. The lower member should be located above the concrete stairs with anchoring points imbedded into the concrete. Detail design drawings were not included in the design package, which would have clarified proper installation of the handrails. See Site Photos 2 and 3 for illustrations of the external stairwell and a close up of the lower rail imbedded into the concrete steps, respectively. Surface finishing of the concrete sidewalk and access areas was of poor quality. The surface was rough and uneven with the appearance that the finishing was not completed. For an illustration of the surface finishing near the sleeping quarters building, see Site Photo 4.

Site Photo 2. Sleeping Quarter's External Staircase

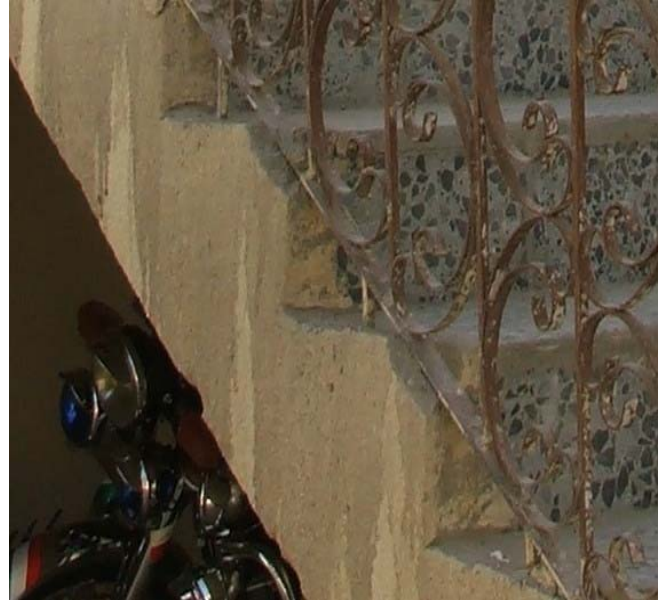
Site Photo 3. Close-Up of Stairwell

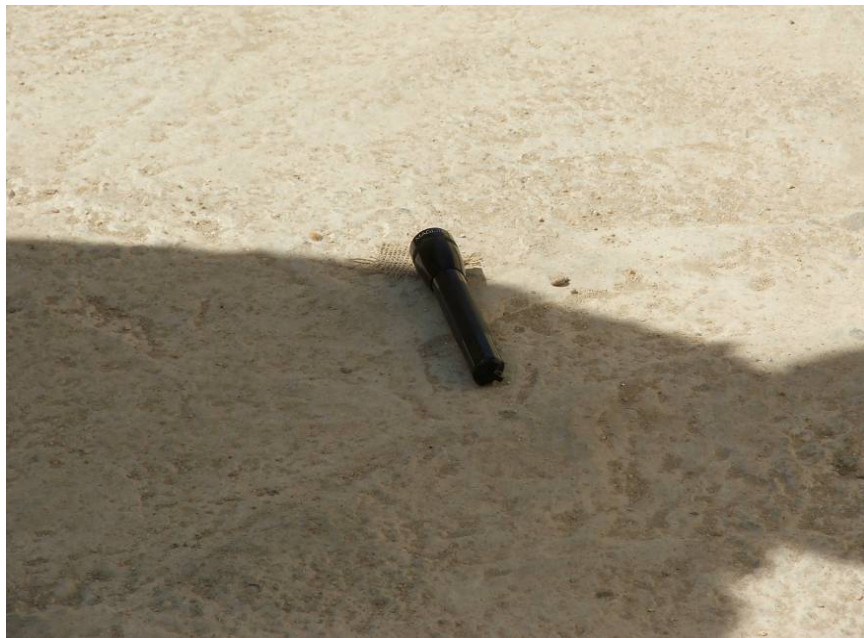
Site Photo 4. Concrete Surface Adjacent to Sleeping Quarters Building

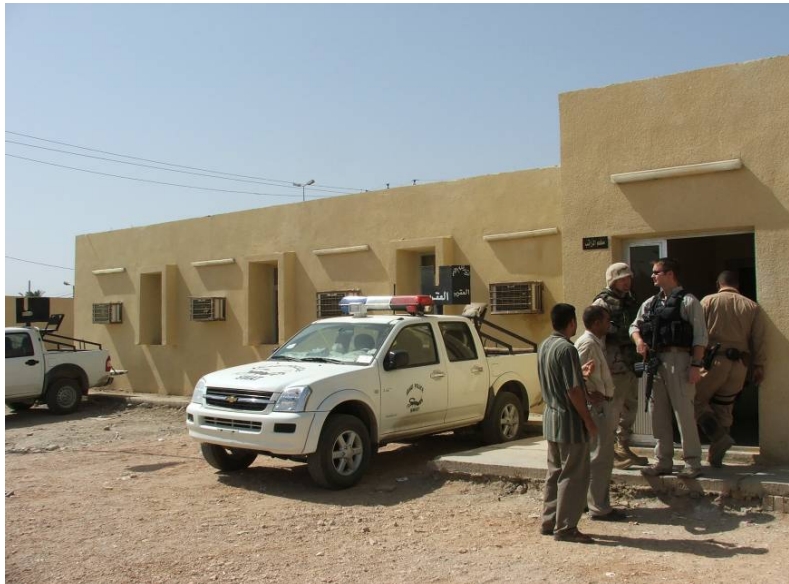
The contract and design required the construction of a one-story facility with reinforced concrete footings, reinforced concrete slab, reinforced concrete columns and beams, and stucco over block exterior. The building design required a 16.93 M (55.5 ft) by 16.61 M (54.5 ft) facility. The building included one large area for dining, one room for food preparation, two rooms for storage, and a common lavatory. The contract required the facility to include A/C units. During the site visit, we verified the building was constructed and used as a dining facility. For an illustration of the exterior front of the dining facility, see Site Photo 5. For an illustration of the dining facility's interior dining room, see Site Photo 6. We observed A/C, lights, and fans to be operational.

Site Photo 5. Exterior View of Dining Facility

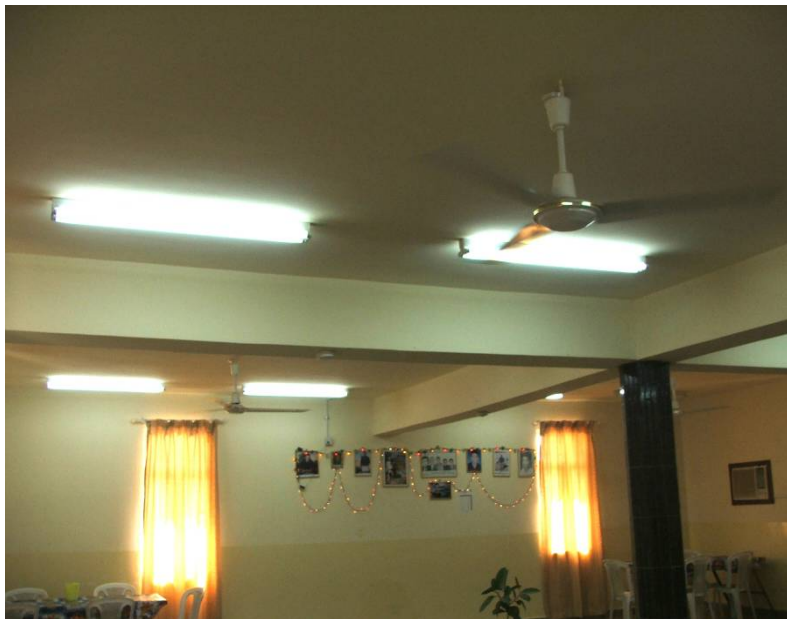
Site Photo 6. Interior of Dining Area

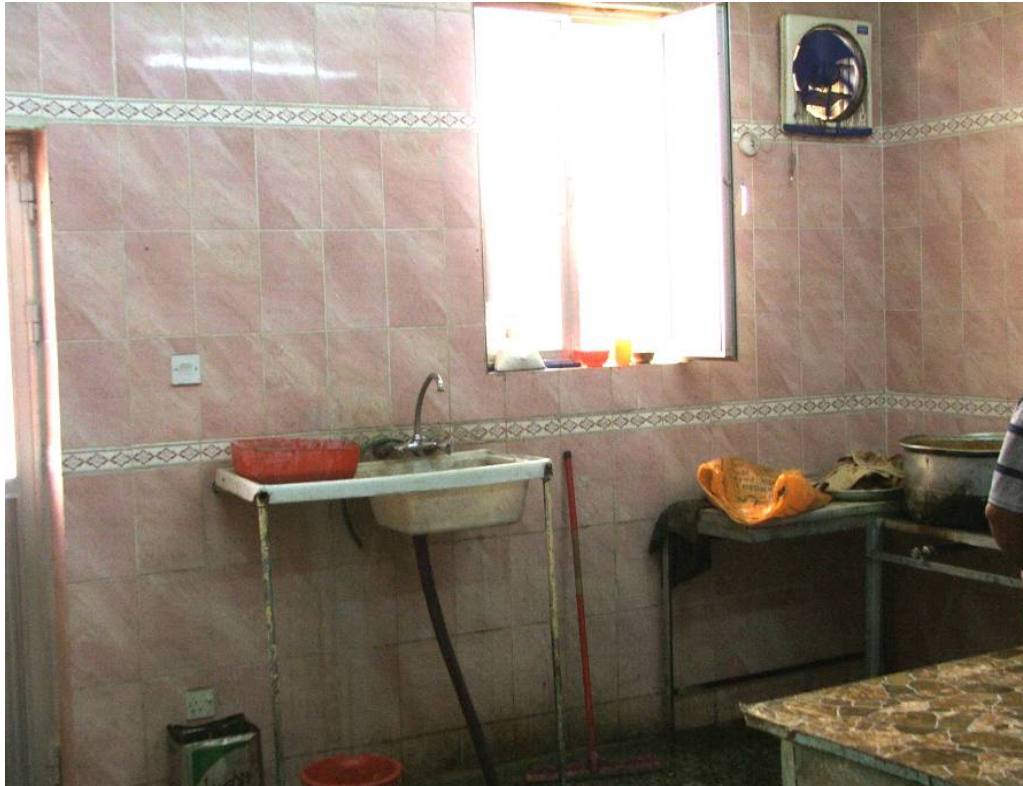
During the site visit, we noted discrepancies, including the quality of appliances in the food preparation area. The contract required “catalog cuts” for all types of equipment installed under this contract. The contract stated, “[c]uts shall include the manufacturers name, address and telephone number, rating and physical size of equipment.” The contractor did submit catalog cuts in the design submittal but the equipment currently installed in the kitchen does not match the equipment listed in the catalog cuts. Currently there is a small sink, worktable, and cooking stove located in the food preparation room. For an illustration of the dining facility’s interior food preparation room, see Site Photo 7.

Site Photo 7. Interior of Kitchen Area

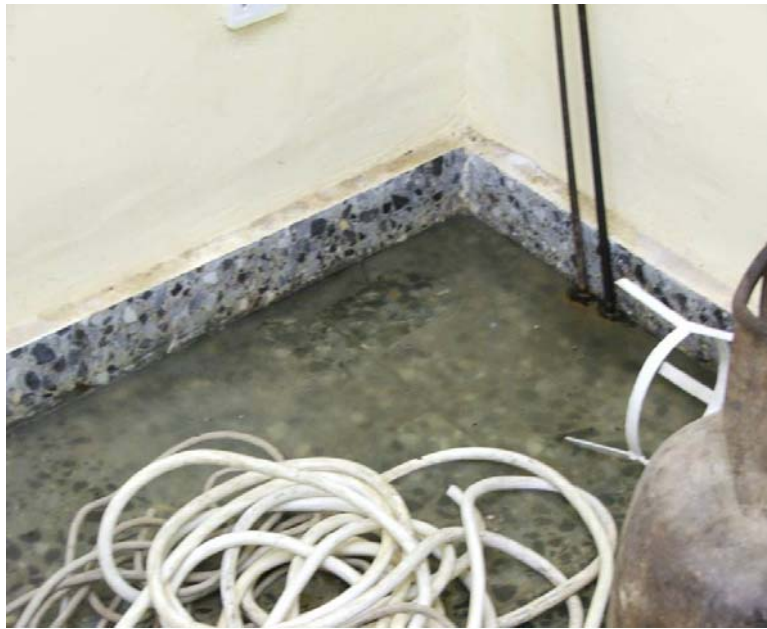
During the site visit, we observed standing water in the corner of the food storage room. For an illustration of the standing water collecting in the corner of the food storage room, see Site Photo 8. A drain was not located in the corner where we observed the standing water in the food storage room. The contract required drawings show approximate locations of all plumbing equipment, piping floor plans, control accessories, plumbing riser plans, and equipment schedules along with enlarged (1:50 scale) plans and sections for the lavatories, kitchen, and other congested areas. The contractor did not submit plumbing or piping designs as part of the design submittal.

Site Photo 8. Standing Water Located in the Corner of the Dining Facility's Food Storage Room

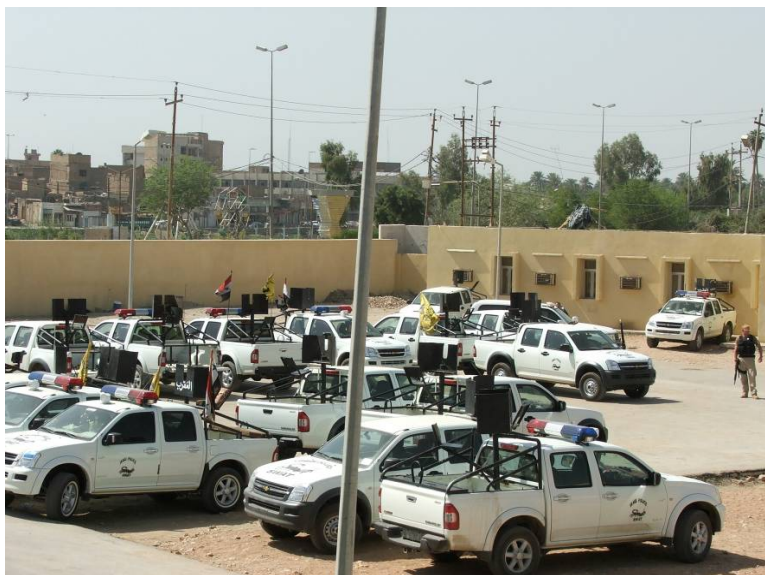
The contract's SOW did not specifically address the requirement for a helicopter pad; however, a 26 January 2005, USACE Memorandum for Record stated, "The contractor was aware of the requirement for a heli [helicopter] pad and included it in the initial bid for the project." At the time of the site visit, the helicopter pad was in place, but was of poor quality. The construction of the pad consisted of a concrete base overlaid by an asphalt surface. For illustrations of the helicopter pad area with vehicles parked on top of the pad and the edge of the helicopter pad surface, see Site Photos 9 and 10, respectively. The edge of the pad shows that concrete has broken away from the pad. The USACE Area Engineer stated he is in discussions with the contractor to repair or replace the helicopter pad.

Site Photo 9. Helicopter Pad Area with Non-Plumb Light Poles

- “Helicopter Pad. After reviewing site conditions, it was determined that the helicopter pad would not meet minimum clearance requirements due to nearby existing buildings and power lines. A settlement was negotiated converting the pad to a parking area and providing a credit to the government.”

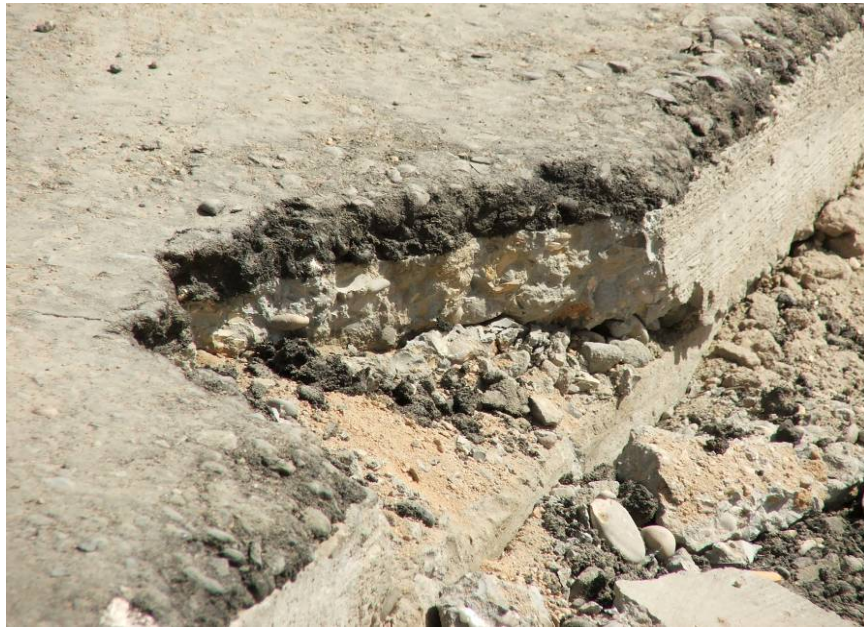
Site Photo 10. Edge of Helicopter Pad

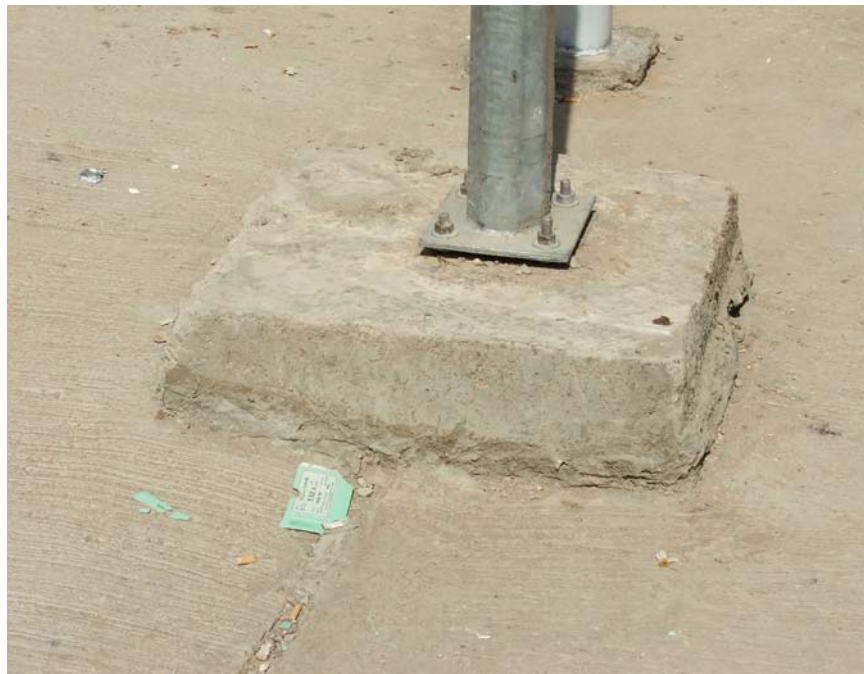
The contract required that the contractor provide a complete design illustrating all existing and proposed new work for the outward oriented perimeter lighting and exterior lighting system. The contractor did not submit lighting plans as part of the design submittal. During the site visit, we noted that the light posts around the helicopter pad were not plumb, and the bases of the lighting poles were not flush with the concrete footings. For an illustration of the light pole concrete footing and light pole base, see Site Photo 11.

Site Photo 11. Concrete Footing and Light Post Base

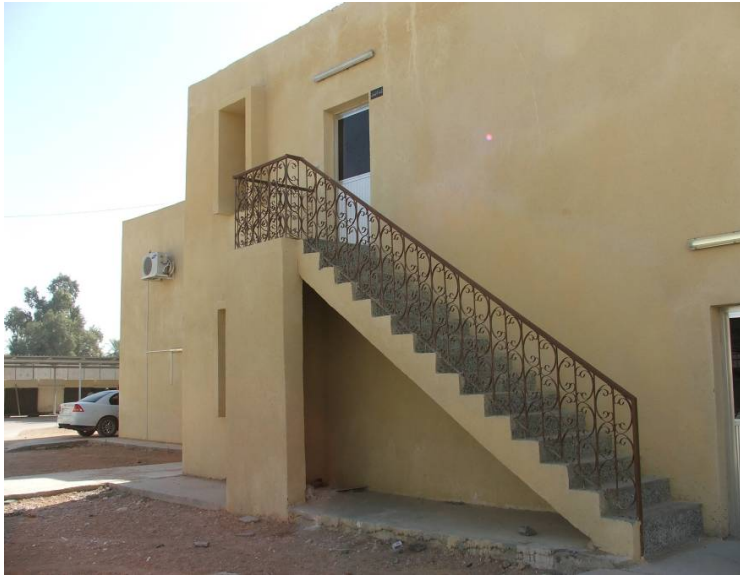
The contract and design required the construction of a two-story facility with reinforced concrete footings, reinforced concrete slab, reinforced concrete columns and beams, and stucco over block exterior. The building design required a 5.99 M (19.7 ft) by 14.51 M (47.6 ft) facility with one external staircase. The contract required the facility to include A/C units. During the site visit, we verified the building was constructed; however, we did not assess the interior of the facility. For an illustration of the exterior wall of the Operations Room facility and the external staircase, see Site Photo 12. During the site visit, we noted discrepancies in the construction of the handrails of the external staircases. The handrails discrepancies of the Operations Room facility are identical to those of the Sleeping Quarters facility. For an illustration of the external stairwell, and a close-up of the lower rail embedded into the concrete steps, see Site Photo 13.

Site Photo 12. Exterior of Operations Room Building

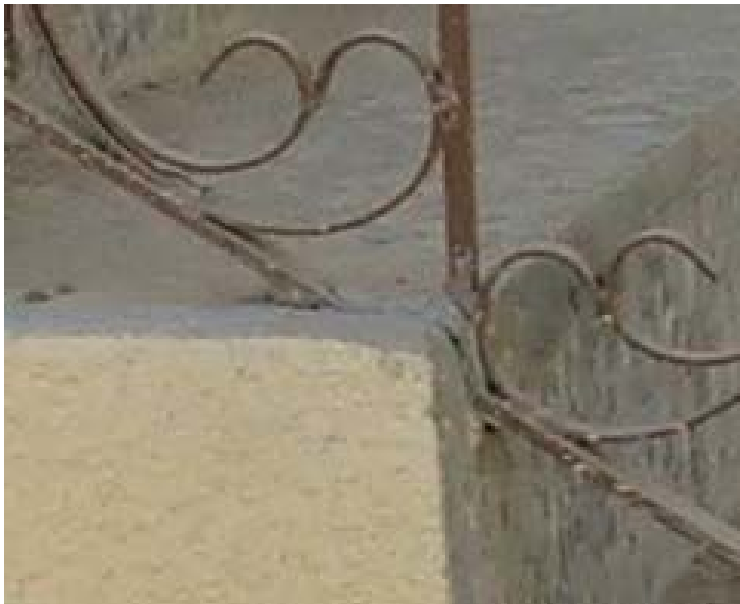
Site Photo 13. Lower Stairwell Railing of Operations Room

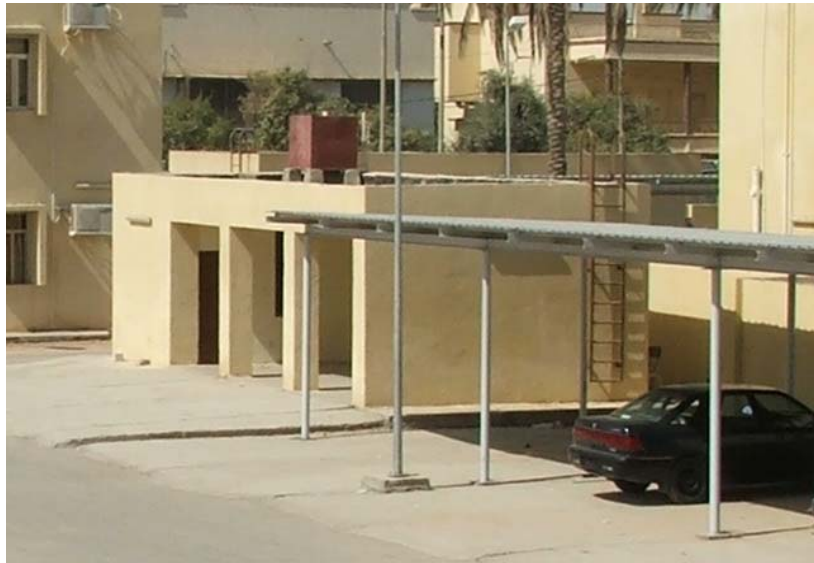
The contract and design required the construction of a one-story facility with reinforced concrete footings, reinforced concrete slab, reinforced concrete columns and beams, and stucco over block exterior. The building design required a 4.75 M (15.6 ft) by 12.25 M (40.2 ft) facility consisting of a small office, lavatory, and three-open vehicle bays. During the site visit, we verified the building was constructed. For an illustration of the exterior of the Vehicle Affairs building, see Site Photo 14. During the site visit, we noted that the concrete sidewalk adjacent to the Vehicles Affairs building was cracked. For an illustration of the cracks in the sidewalk at the Vehicle Affairs building, see Site Photo 15.

Site Photo 14. Vehicle Affairs Building

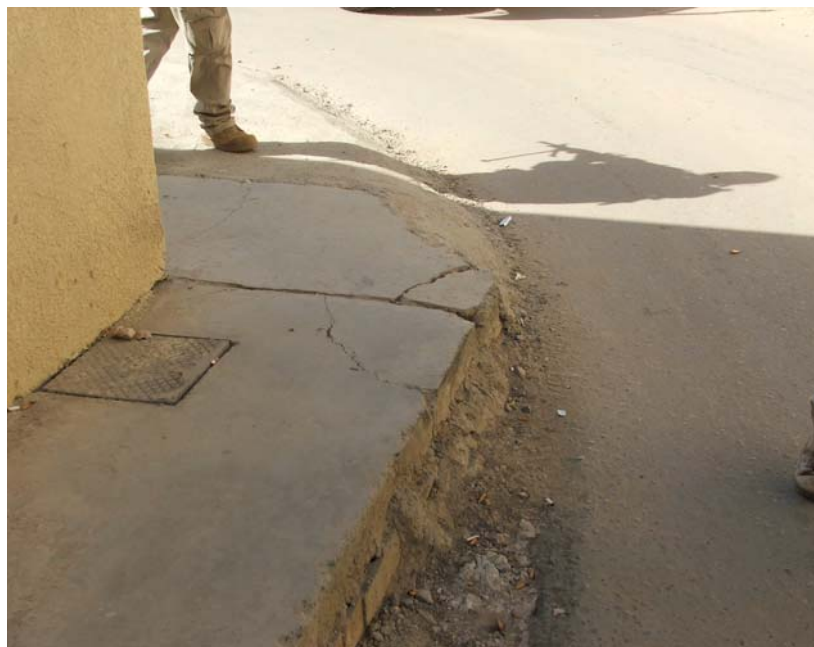
Site Photo 15. Sidewalk of Vehicle Affairs Building

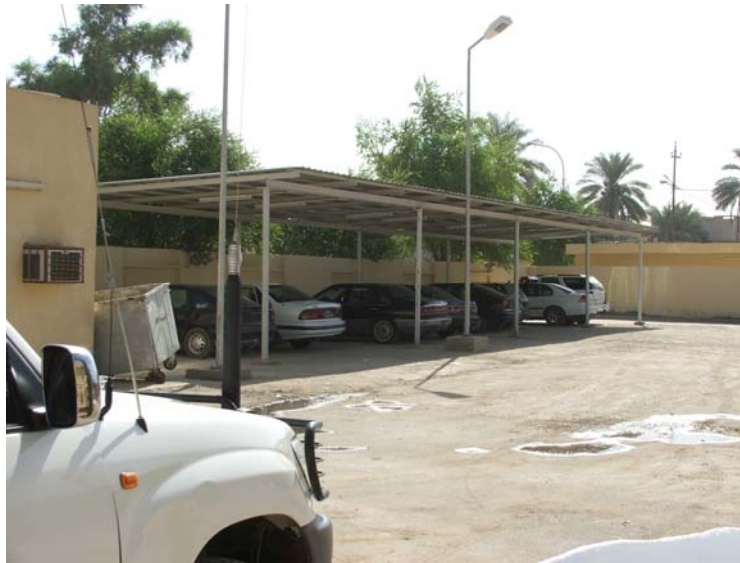
The contract and design required the construction of two covered areas for automobile parking: one 16-bay and one 10-bay carport. During the site visit, we verified that four covered metal-framed carports were located on site, all of which appeared to be new construction. A single eight-bay carport was located adjacent to the Vehicle Affairs building, and another eight-bay carport was located adjacent to the main entrance. Two additional carports were also located near the front entrance. During the site visit, we noted no discrepancies of the carport steel frame construction. For an illustration of the eight-bay carport located adjacent to the main entrance, see Site Photo 16.

Site Photo 16. Eight-Bay Carport Located Adjacent to Main Entrance

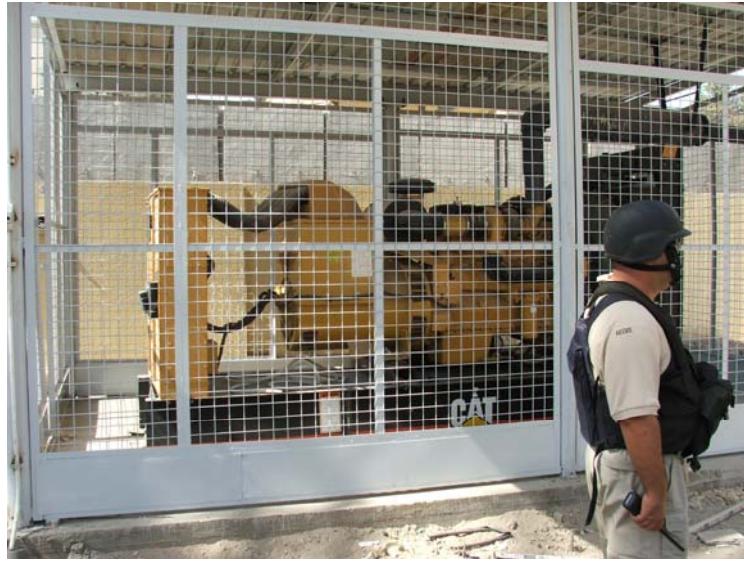
Site Photo 17. Generator Unit with Mesh Enclosure

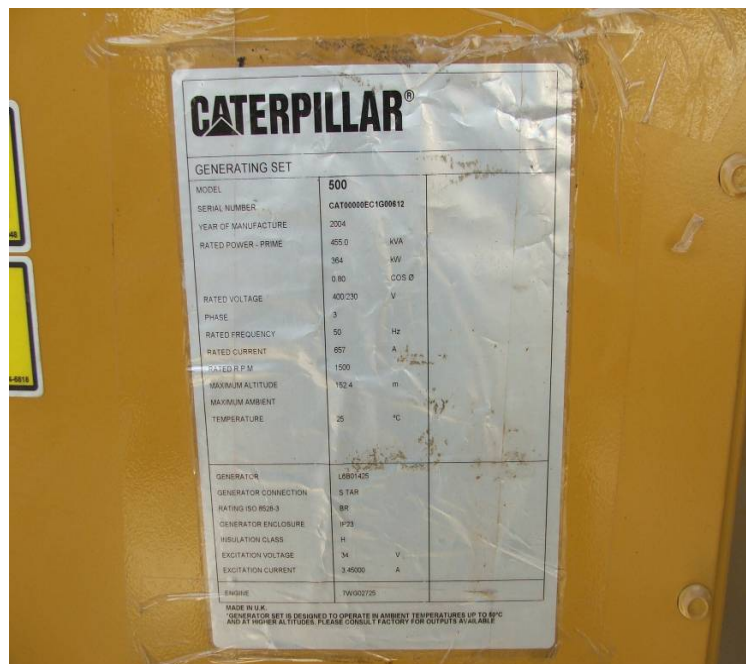
The engine block factory nameplate showed the Engine Serial Number as 7WG02725, although the engine block serial number was partially painted over. For illustrations of the paper copy of the generator nameplate and the engine block factory nameplate, see Site Photos 18 and 19, respectively.

Site Photo 18. Paper Copy of Factory Nameplate

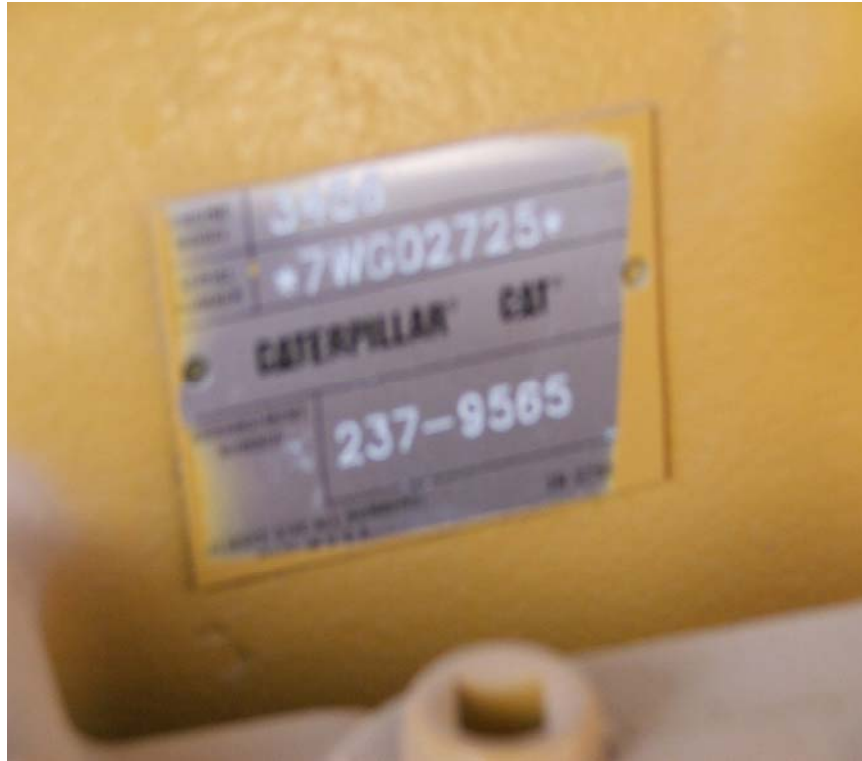
Site Photo 19. Engine Block Factory Nameplate

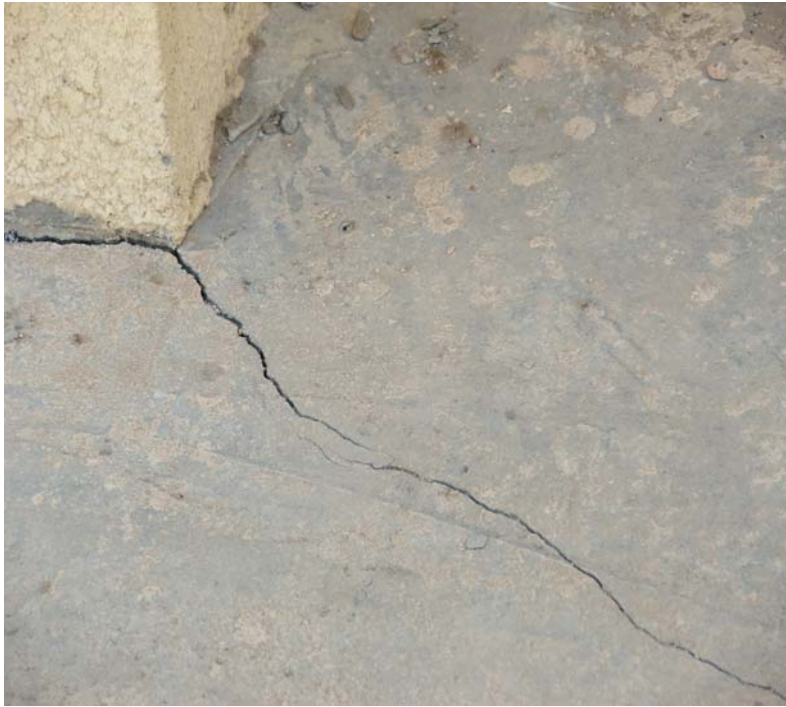
The contract's SOW required the renovation of the remaining buildings after the demolition of the damaged buildings. The SOW stated, "the second phase is the renovation of remaining buildings to temporarily house SWAT personnel as described in the attached Bill of Materials (BOM)." A complete assessment of the renovation of the existing facilities was not completed, although we conducted a walk through of the renovated buildings. Observations of cracks in the new side walks, cracks in the stucco exterior of the building, improperly installed stairwell railings (similar installation to the sleeping quarter and operations room facility), and cracks in the interior security walls are signs of poor workmanship during the rehabilitation of the facilities. For illustrations of the cracks in the front of renovated building #2 and in the interior security walls behind the Vehicle Affairs building, see Site

Site Photo 20. Cracks in Concrete Sidewalks of Renovated Building #2

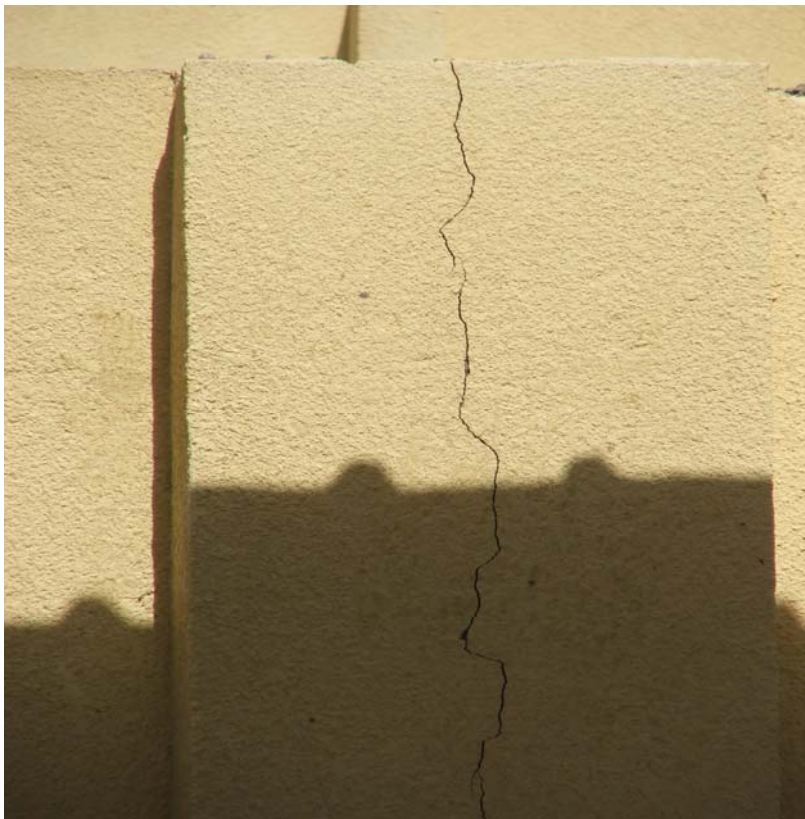
Site Photo 21. Cracks in Stucco of Interior Security Wall

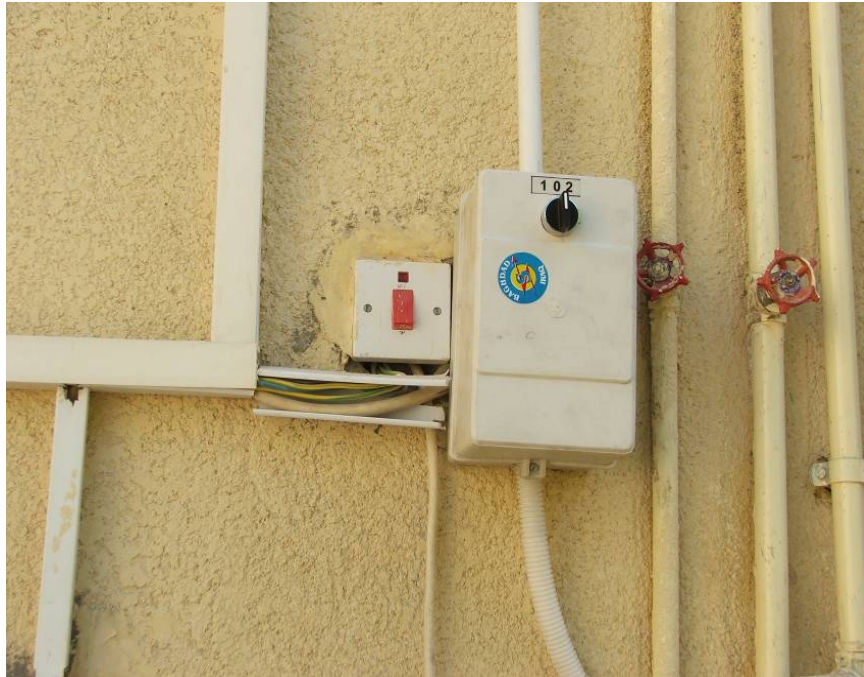
Photos 20 and 21, respectively. Site Photo 22 illustrates exposed electrical wires located in the exterior of renovated building 10.

Site Photo 22. Renovated Building 10, Exterior Electrical Switches
