BORDER FORTS
NUMBERED 602, 604,
628, AND 634
SULAYMANIYAH, IRAQ

SIGIR PA-05-021

JANUARY 31, 2006

SUBJECT: Report on Project Assessments of Border Forts Numbered 602, 604, 628, and 634 in Sulaymaniyah, Iraq (Report Numbers SIGIR PA-05-021, PA-05-022, PA-5-023, and PA-05-024)

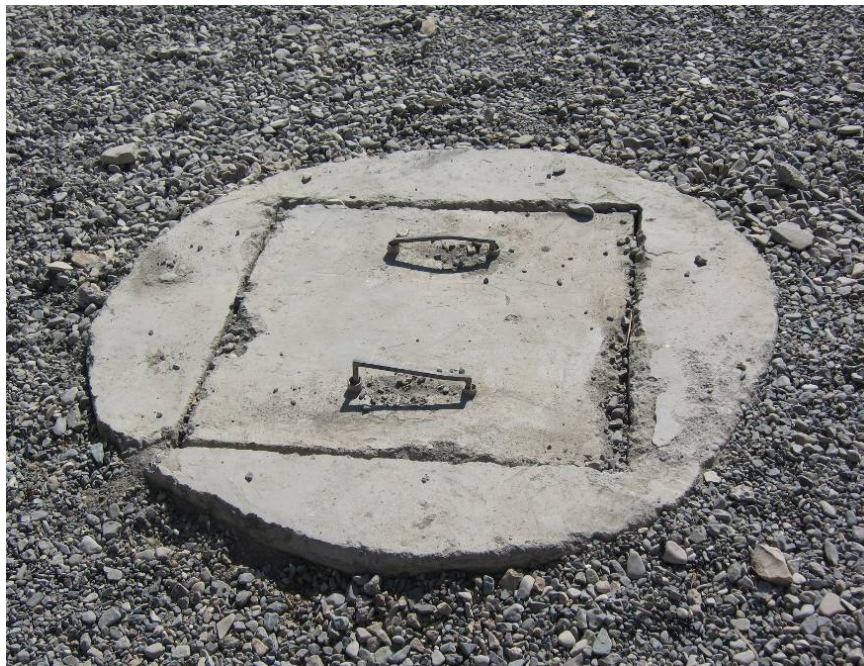
The contract and design required the construction of two septic tanks and four soakaways for collection and disposal of wastewater, including all required associated pipes and fittings. During the site visit, we verified that the construction of two septic tanks and four soakaways was completed. Site Photo 26 shows the top cover surface of one of the septic tank with two access ports and Site Photo 27 shows one of the soakaways. The soakaway access port was made of concrete, appeared to be poorly constructed, and showed signs of deterioration.

Site Photo 27. Access Hatch of Soakaway (Safrah #634 Border Post)
