UMM QASR WATER SCHEME, IRAQ

PROJECT NUMBER SIGIR-PA-05-028

JULY 24, 2006

SUBJECT: Report on Project Assessment of the Umm Qasr Water Scheme, Iraq (Report
Number SIGIR-PA-05-028)

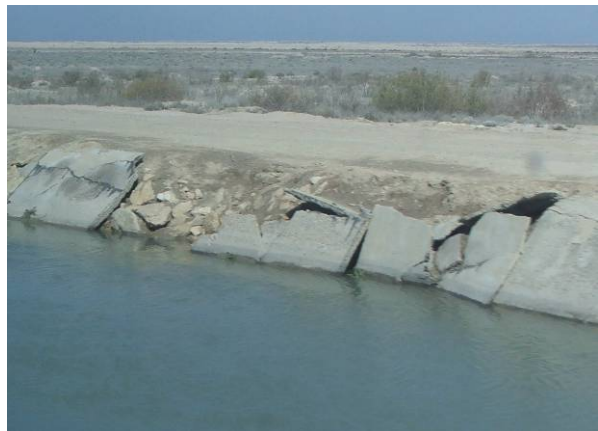
Site Photo 5 shows an example of the SWC with undamaged embankment and concrete liners. Site Photos 6 through 9 show examples of areas along the lined section of the canal where repairs and maintenance are required. Site Photo 10 shows an area where native rock instead of concrete panels was used for repair.

Site Photo 6. Example of concrete liner failure

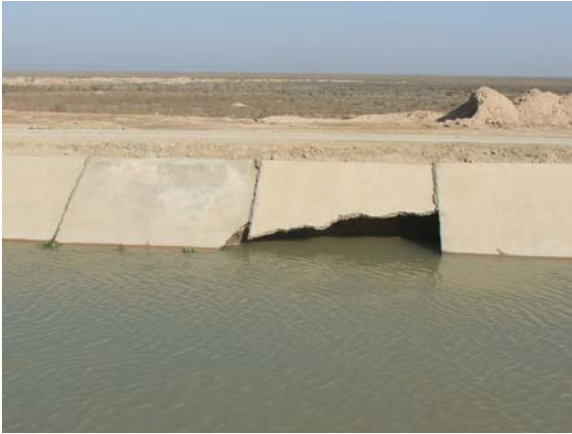
Site Photo 7. Example of under-cutting of canal

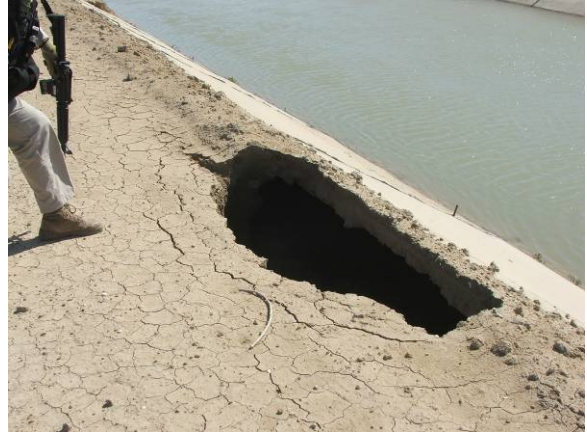
Site Photo 8. Example of under-cutting of canal

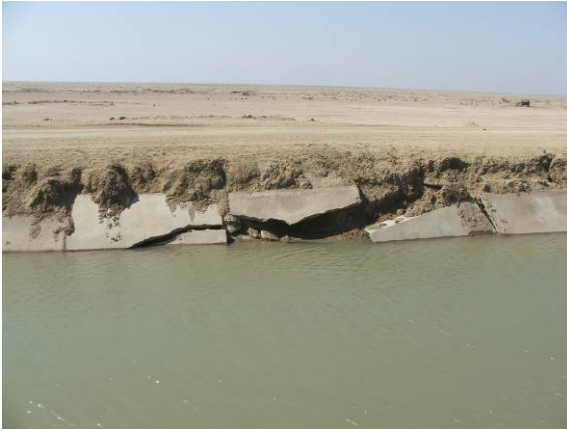
Site Photo 9. Example of concrete liner failure

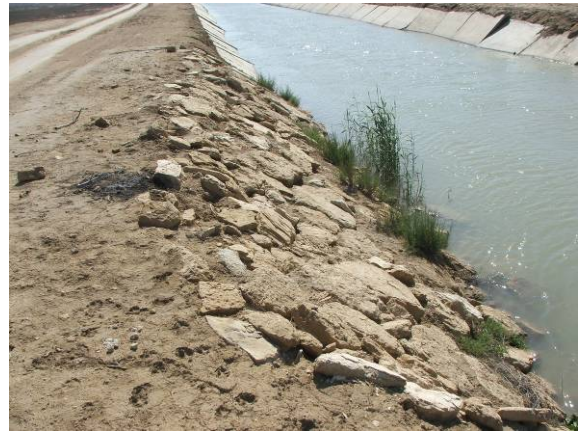
Site Photo 10. Repair of concrete liner

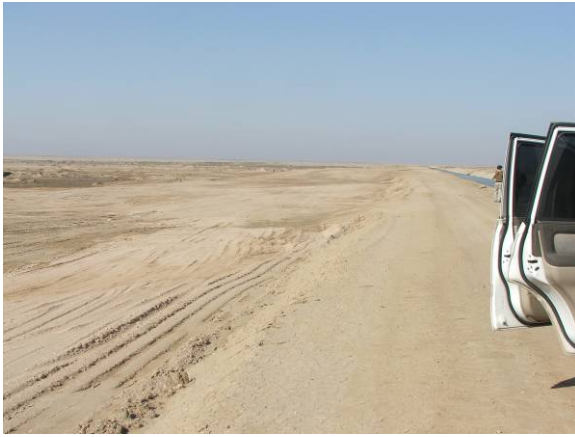
During the site assessment, both areas where emergency repairs were completed were visited. The area in the vicinity of km 168 showed signs of recent repair activities of the canal bank. It appeared the concrete liners were repaired with a concrete slurry applied instead of utilizing prefabricated concrete tiles. The concrete liners were not completely intact and several areas along the canal bank showed signs of being undercut by soil erosion, causing large voids in the embankments. Similar conditions were observed at the area in the vicinity of km 188 emergency repair with the addition that surface erosion of the side banks were observed. Maintenance equipment, maintenance staff, or signs of recent maintenance activities were not observed at either of the locations.

Site Photo 11. km 168 repair area

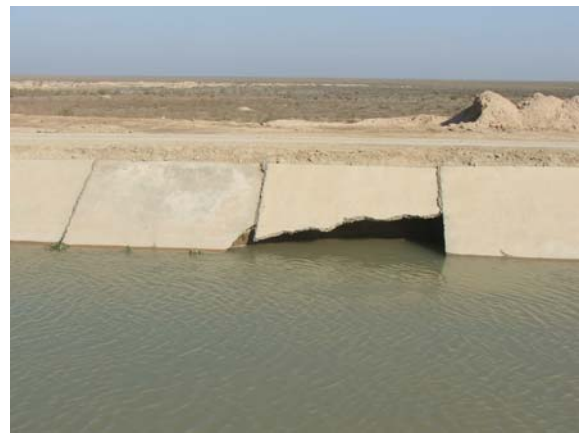
Site Photo 12. Example of under-cutting of canal sidewall in vicinity of km 168

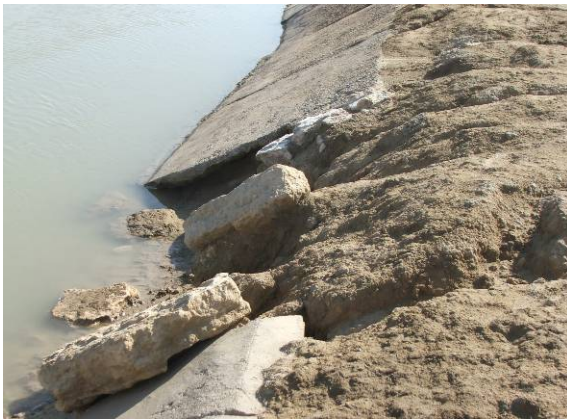
Site Photo 13. Example of concrete liner failure at km 168 repair area

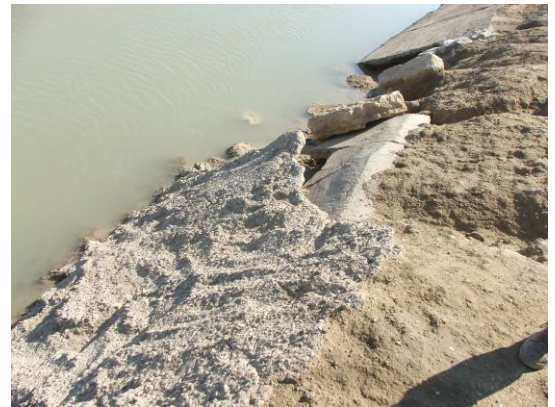
Site Photo 14. Repair of concrete liner with concrete slurry at km 168 repair area

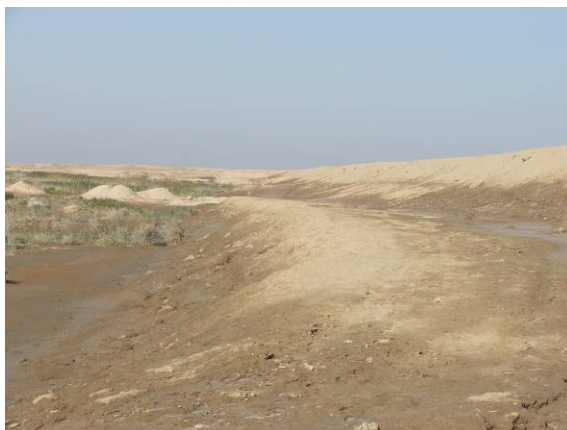
Site Photo 15. km 188 repair area

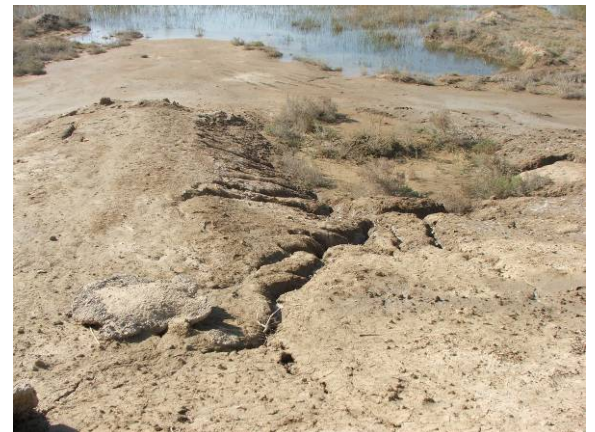
Site Photo 16. Surface erosion of canal banks at km 188 repair area

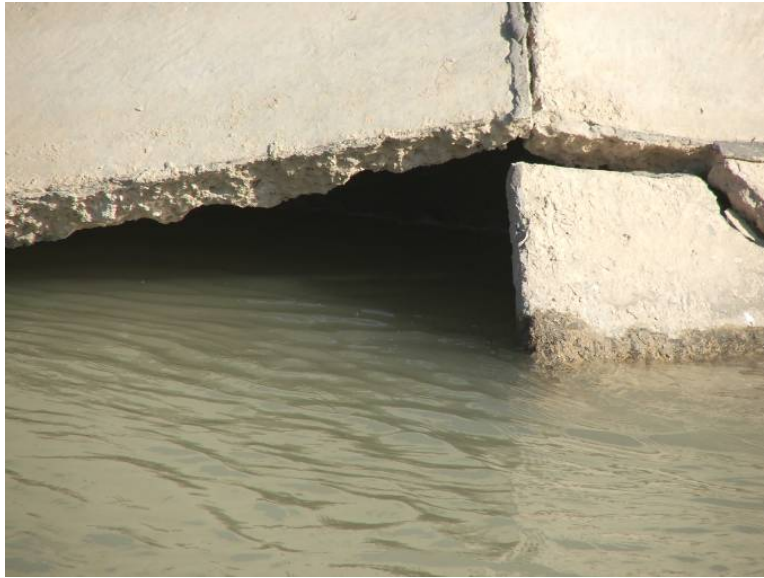
Site Photo 17. Example of under-cutting of canal sidewall in vicinity of km 188

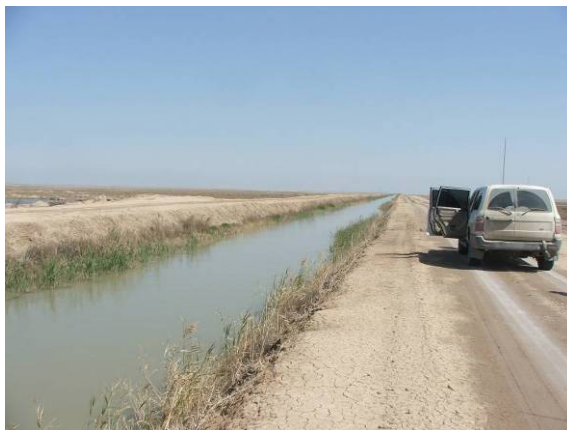
The 45 km unlined portion of the SWC we were able to visit was located between km 193 and the settling basins (km 238). Signs of past maintenance activities were observed and included dredge spoils located parallel to the canal route. Dredge spoils included a combination of soils and vegetation. Maintenance equipment, maintenance staff, or signs of recent maintenance activities were not observed at any point of the unlined section of the canal. A single set of tire prints from a heavy equipment vehicle was observed parallel to the canal. The main channel appeared free of vegetation, although vegetation was observed growing on the sides of the canal. The sluice gates which control water from the SWC to the settling basins and the settling basins themselves appeared serviceable.

Site Photo 18. Unlined portion of SWC

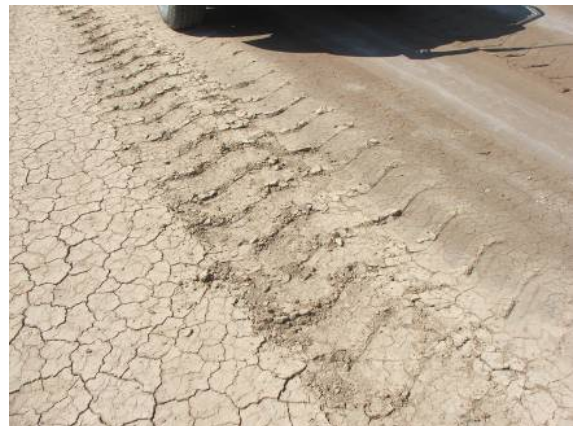
Site Photo 19. Recent tire tracks from heavy equipment vehicle

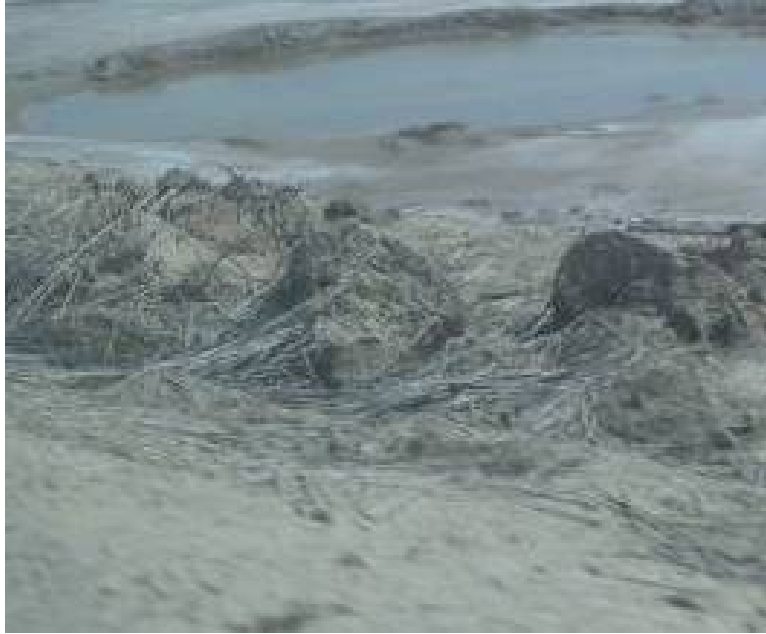
Site Photo 20. Dredge spoils located parallel to unlined section of SWC
