PRIMARY HEALTH CARE CENTERS
NUMBERED KE-01, KE-02,
KE-03, KE-04, AND KE-05
KIRKUK, IRAQ

SIGIR PA-06-042
SIGIR PA-06-043
SIGIR PA-06-044
SIGIR PA-06-045
SIGIR PA-06-046

APRIL 25, 2006

SUBJECT: Report on Project Assessments of Primary Health Care Centers Numbered
KE-01, KE-02, KE-03, KE-04, and KE-05 in Kirkuk, Iraq (Report Numbers
SIGIR-PA-06-042, PA-06-043, PA-06-044, PA-06-045, and PA-06-046)

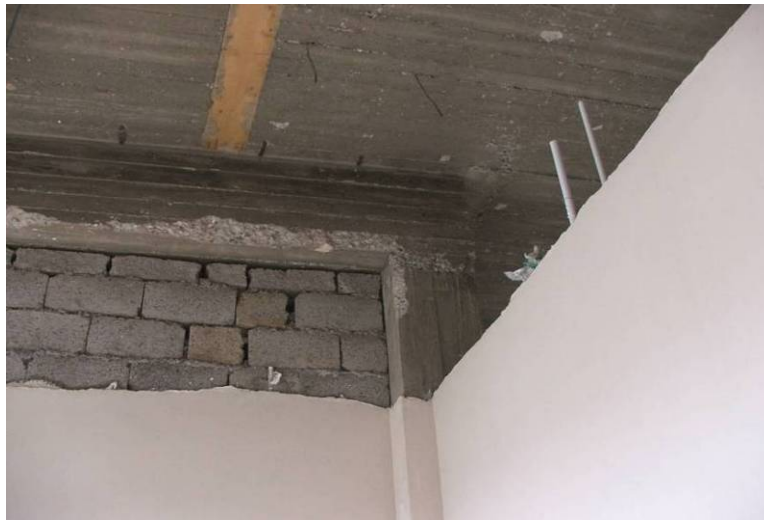
We identified what appeared to be concrete segregation, honeycombs, and reinforcement bar exposure on the surface of the load-bearing reinforced concrete ceiling beams (Site Photo 1 and Site Photo 2). We observed some significant discrepancies with the columns, such as columns with chipped concrete (Site Photo 3) and a column that was not plumb (Site Photo 4).

Site Photo 1. Load-bearing ceiling beam (PHC Hai Alasra Wa Al Mafqodeen)

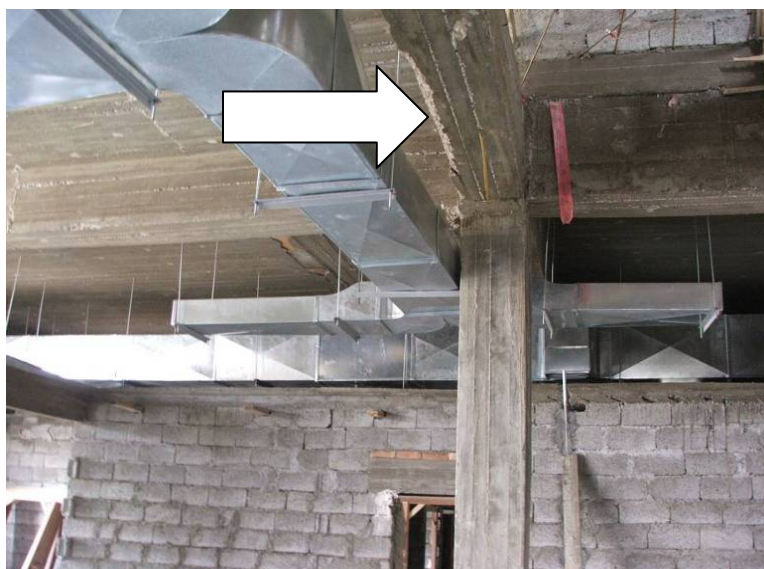
Site Photo 2. Honeycombing on ceiling beam (PHC Hai Alasra Wa Al Mafqodeen)

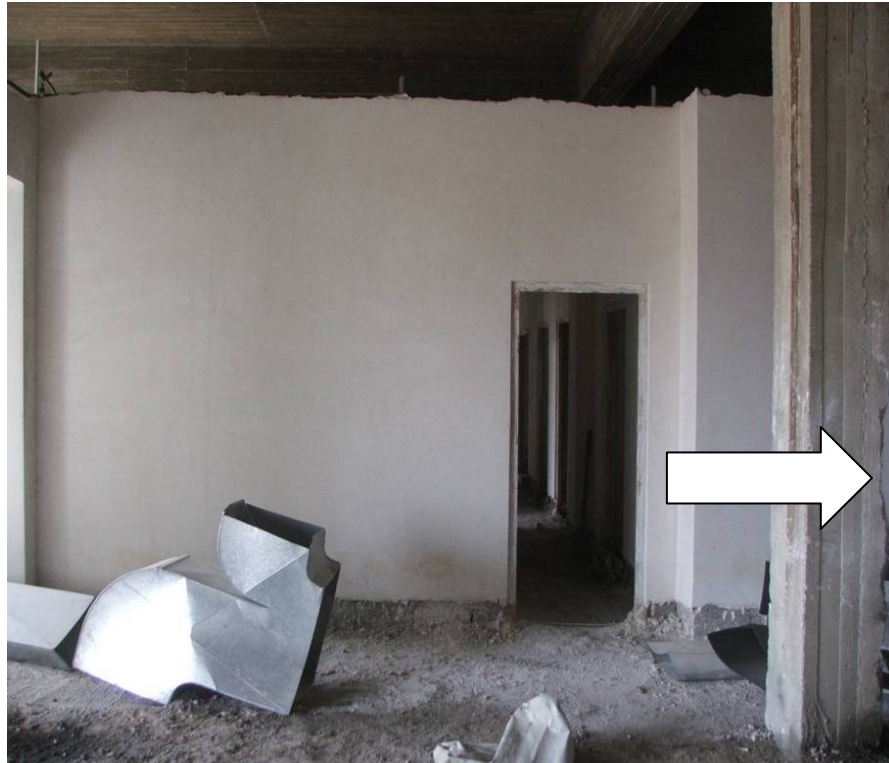
Site Photo 3. Honeycombing of concrete column (PHC Hai Alhajjaj)

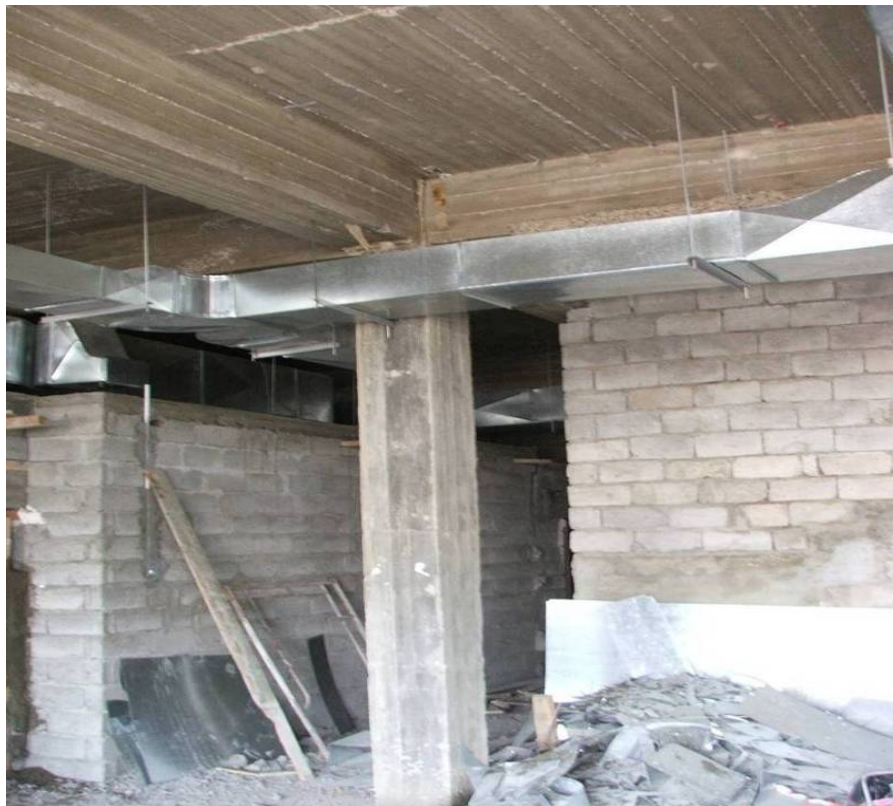
Site Photo 4. Column that is not plumb (PHC Hai Alasra Wa Al Mafqoodeen)

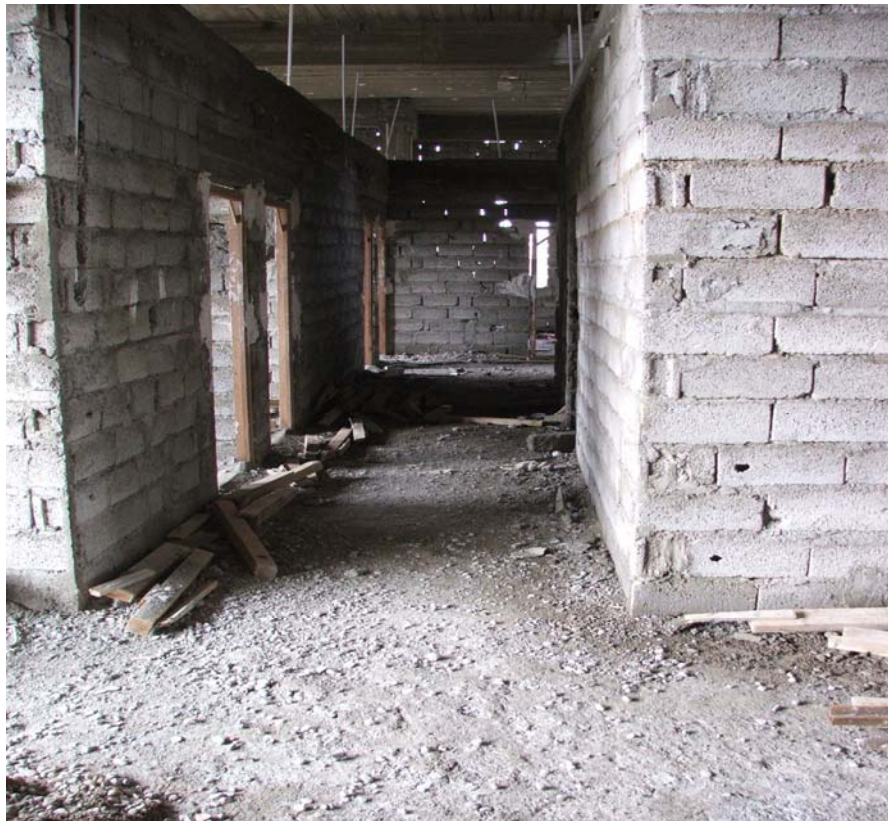
At the time of the assessment, some cinder block walls had been constructed and then plastered with gypsum. We identified numerous defects in workmanship of the nonload-bearing walls such as gaps in the walls, the use of broken blocks or other materials, and improper and uneven block placement. For an illustration of poor workmanship with block work, see Site Photo 5. From the contractor and USACE documentation available, it appears the poor block workmanship was not corrected before the walls were plastered over with gypsum. The gaps in the wall of Site Photo 6 are apparent by the sunlight shining through the pieces of the far wall. Site Photo 1 is also an example of gypsum plasterwork applied to a block wall with unfilled gaps in between the blocks.

Site Photo 6. Sunlight through gaps in walls (PHC Hai Tis'een)

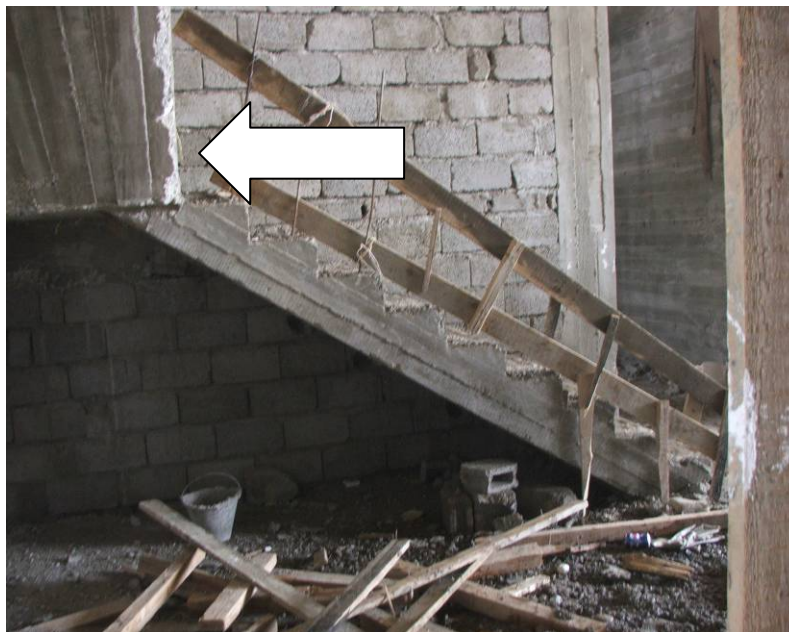
Site Photo 9. Concrete honeycombing on side of stairwell (PHC Hai Tis'een)

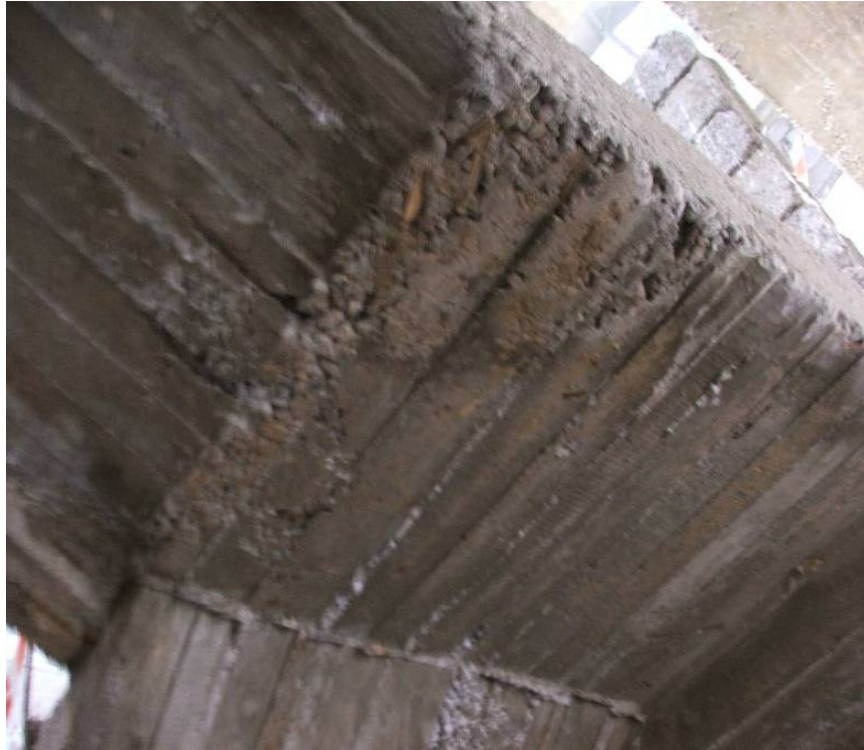
Site Photo 10. Concrete segregation underneath stairwell (PHC Hai Al Wesity)

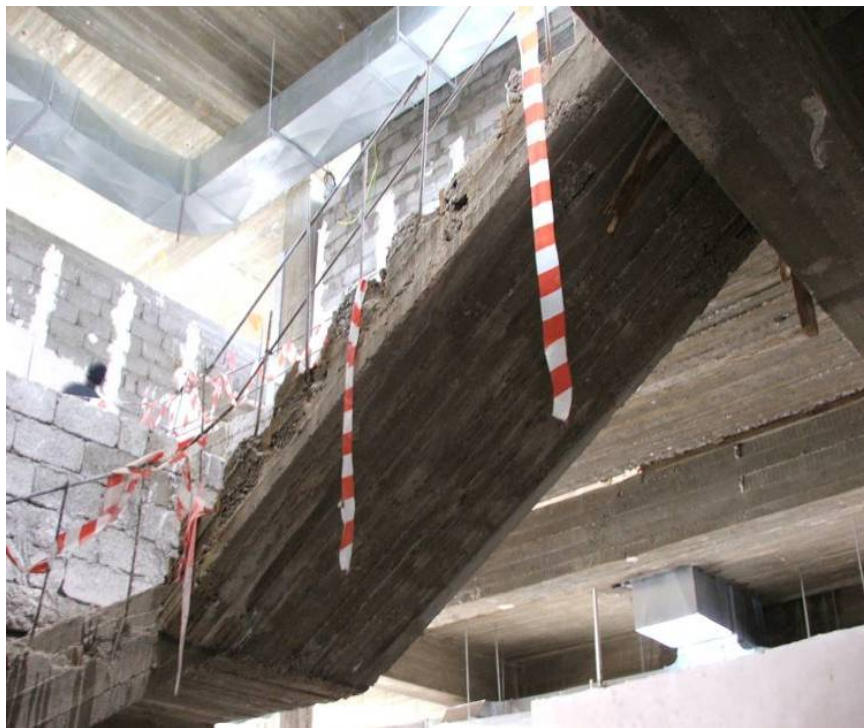
Site Photo 11. View of stairwell (PHC Hai Al Wesity)

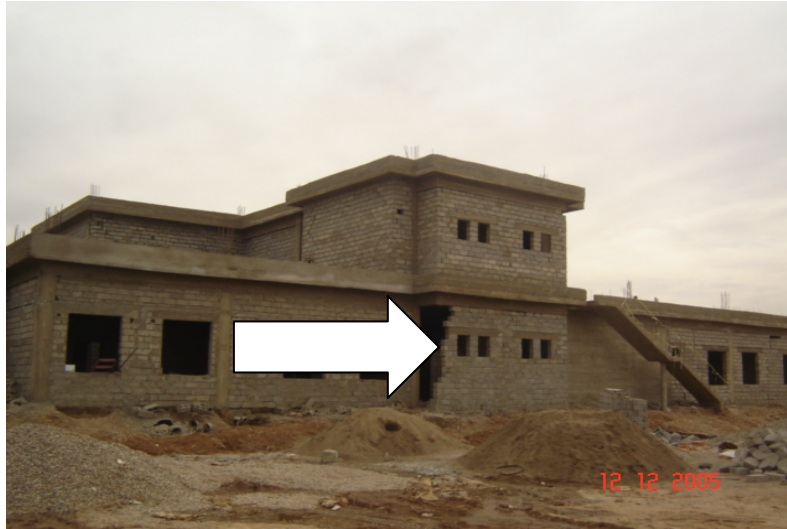
Site Photo 18. View of Hai Alhajjaj on 12 December 2005. According to the PCO construction database, this PHC was 56% complete (Photo courtesy of the USACE)

Based upon Parsons' completion spreadsheet, the PCO construction database, and RMS' completion percentages of 56% and 58%, respectively, for the Hai Alhajjaj PHC (Site Photo 18) appears to be high, considering that the block walls, roofing, utilities and interior finishing work were not complete.

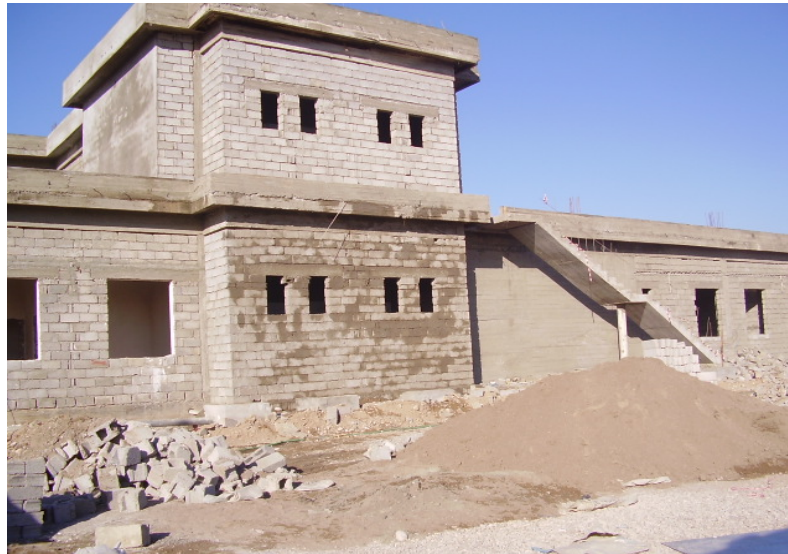
Site Photo 19. View of Shiqaq Hai Musalla on 10 December 2005. According to the PCO construction database, this PHC was 56% complete (Photo courtesy of the USACE)

Based upon Parsons' spreadsheet, the PCO's construction database completion percentage of 56% appears to be high for the Shiqaq Hai Musalla PHC (Site Photo 19). From the available photo and information, the concrete work appears to be completed, which according to Parsons' spreadsheet, puts the PHC at approximately 50% complete.

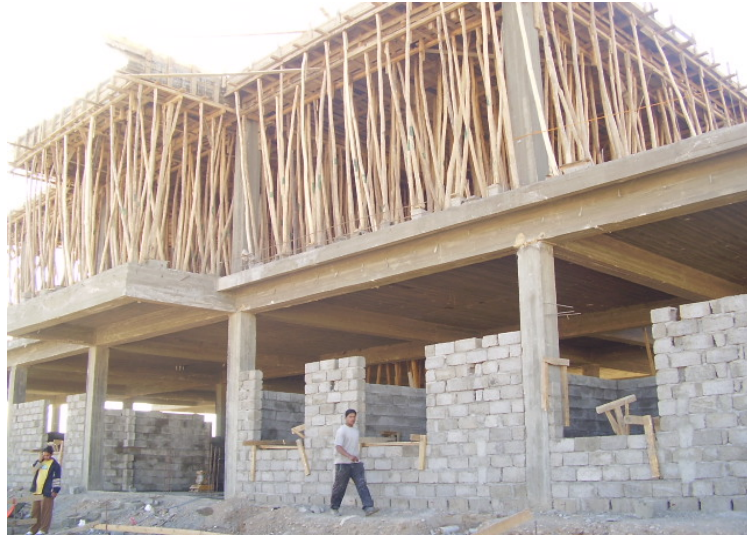
Site Photo 20. View of Hai Tis'een on 7 December 2005. According to the PCO construction database, this PHC was 46% complete (Photo courtesy of the USACE)

The PCO construction database and RMS' completion percentages of 46% and 38%, respectively, for the Hai Tis'een PHC (Site Photo 20) appears high, considering the block work on the ground floor is not complete and that the reinforced concrete work on the first floor is not complete and the upstairs blocking, roofing, utilities and interior finishing had not commenced.

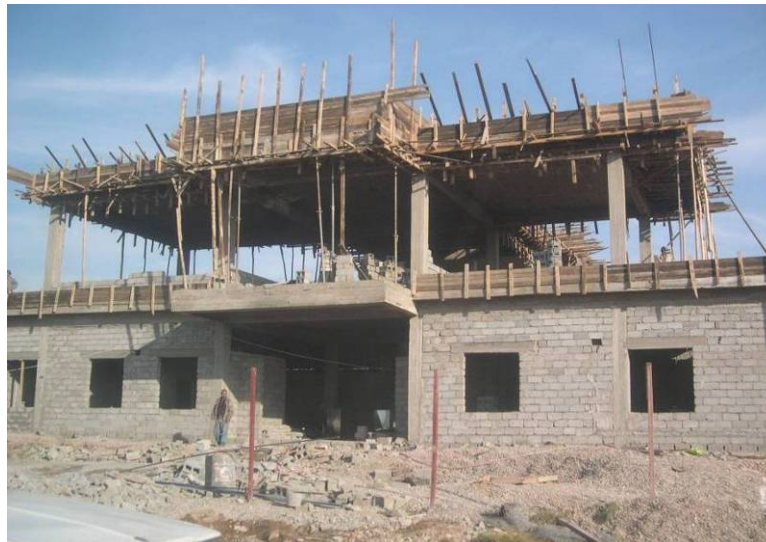
Site Photo 21. View of Hai Al Wasyt on 7 December 2005. According to the PCO construction database, this PHC was 50% complete (Photo courtesy of the USACE)

the reinforced concrete work on the first floor is not complete and the first floor blocking, roofing, utilities and interior finishing work have not commenced.

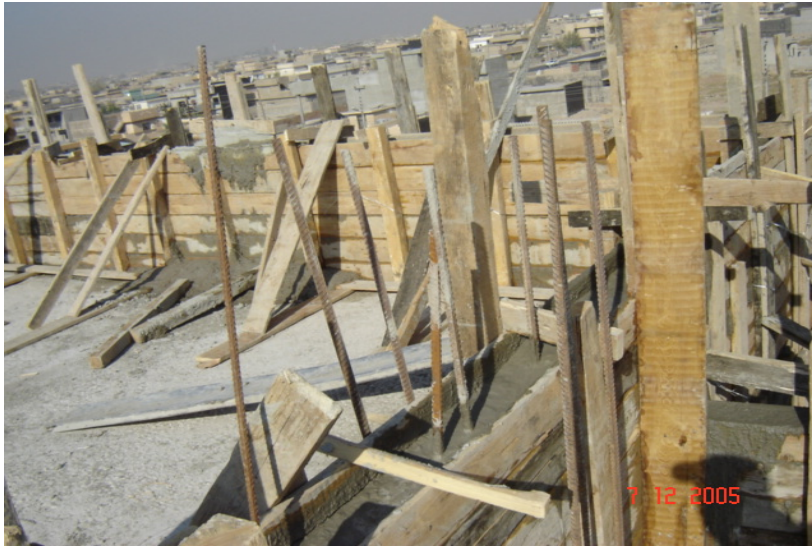
Site Photo 22. View of Hai Alasra Wa Al Mafqoodeen on 7 December 2005. According to the PCO database, this PHC was 50% complete (Photo courtesy of the USACE)

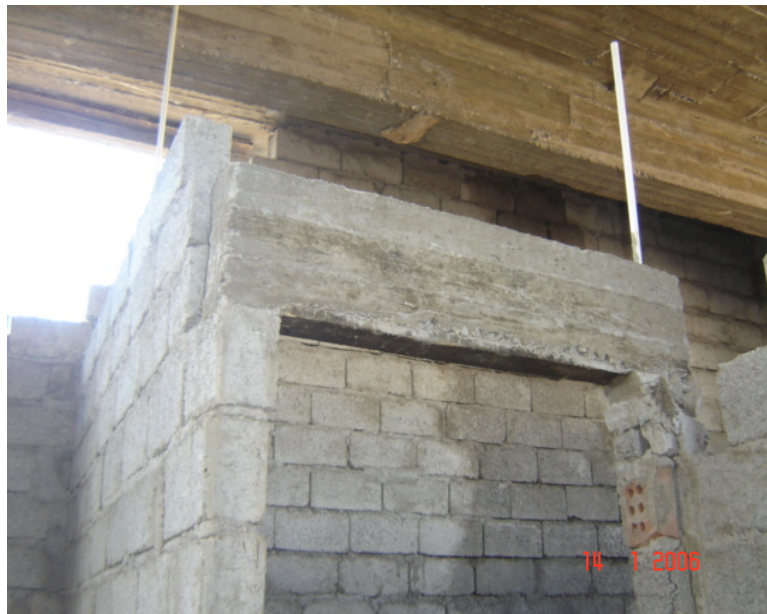
Further, the daily QA reports were not sufficiently complete and accurate. For example, the LN QA daily reports did not always document the existence of construction concerns. Specifically, one LN QA daily report included a photo of poor concrete quality beneath a lintel (Site Photo 23); however, the narrative daily report did not mention this problem nor does it mention if the LN QA engineer brought this problem to the contractor's attention. From reviewing the LN QA daily reports, we were unable to determine if the contractor corrected this problem.

Site Photo 23. Example of a site photo included with the daily report. Taken by the USACE LN QA for PHC Shiqaq Hai Musalla (Photo courtesy of the USACE)

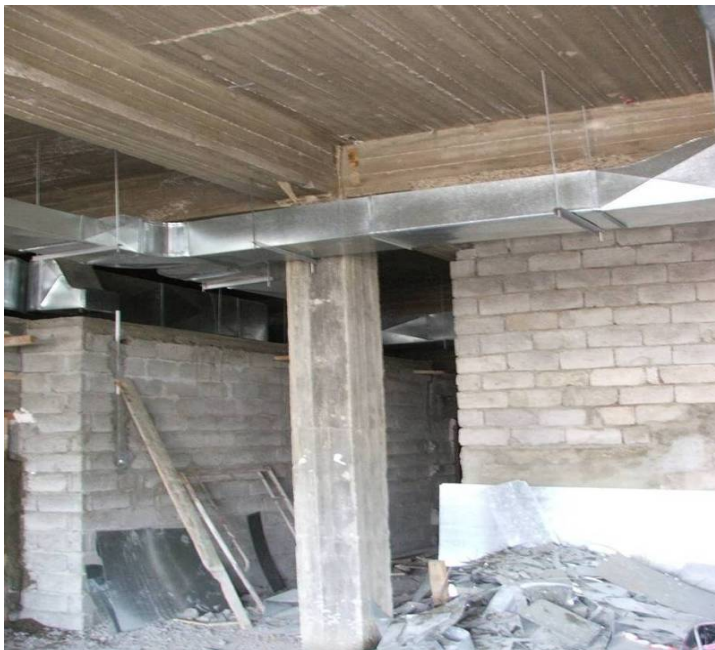
SIGIR Response. We agree that structural integrity is a serious matter. Our site visit identified significant discrepancies with the columns, such as columns with chipped concrete and an interior reinforced concrete column that was not plumb (see Site Photo 4 repeated below). If the Gulf Region Division made inquiries to the contractor’s task manager in October 2005, the site photo from our February 2006 visit documents that the contractor did not correct this issue. According to the Gulf Region Division, the contractor’s LN QCR was to “investigate.” However, the daily QC reports and required deficiency logs do not indicate this problem was ever brought to his attention; consequently, this issue was not adequately resolved. In addition, the fact the LN QCR, who was required to be on site daily, did not identify this issue on his own raises questions about his qualifications for the position. Further, the LN QA engineer, who was required to be on site daily, did not identify this issue, either.

Site Photo 4. Column that is not plumb (PHC Hai Alasra Wa Al Mafqodeen)

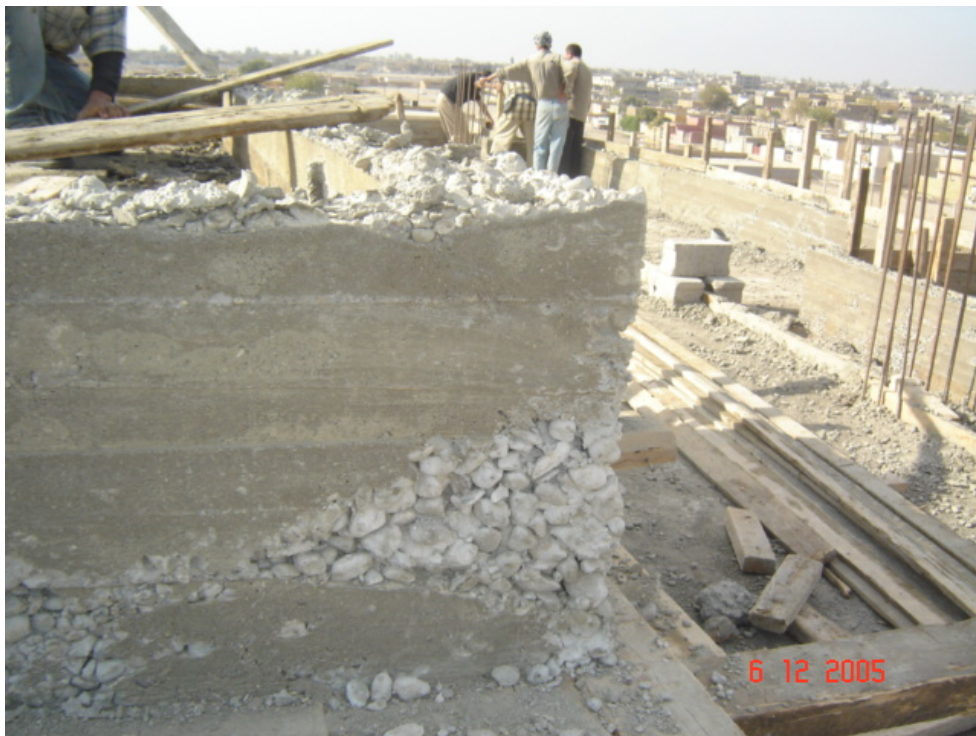
The Gulf Region Division's comments state that, "Poor concrete work has been a significant problem with the PHC contractor's work." However, we found only one instance where the USACE LN QA engineer documented the occurrence of this problem out of all five clinic projects. The LN QA engineer for the Hai Alhajjaj PHC provided Site Photo 25 with his daily QA report. The daily QA report stated, "there is segregation appears in the poured parapet." According to the daily QA report, the LN QA engineer answered the question about any verbal instructions given to the contractor with "NO." We reviewed the daily QC reports and there is no mention of any concrete issues raised by the LN QA engineer. In addition, the segregation issue was not listed in the required deficiency log. Therefore, even though the LN QA engineer identified and documented poor concrete workmanship, he did not point the issue out to the contractor. Since the USACE project engineer reviewed the daily QA reports, he should have followed up with the contractor and the LN QA engineer to determine the issues were adequately addressed and corrected.

Site Photo 25. Extensive segregation of concrete in the parapet

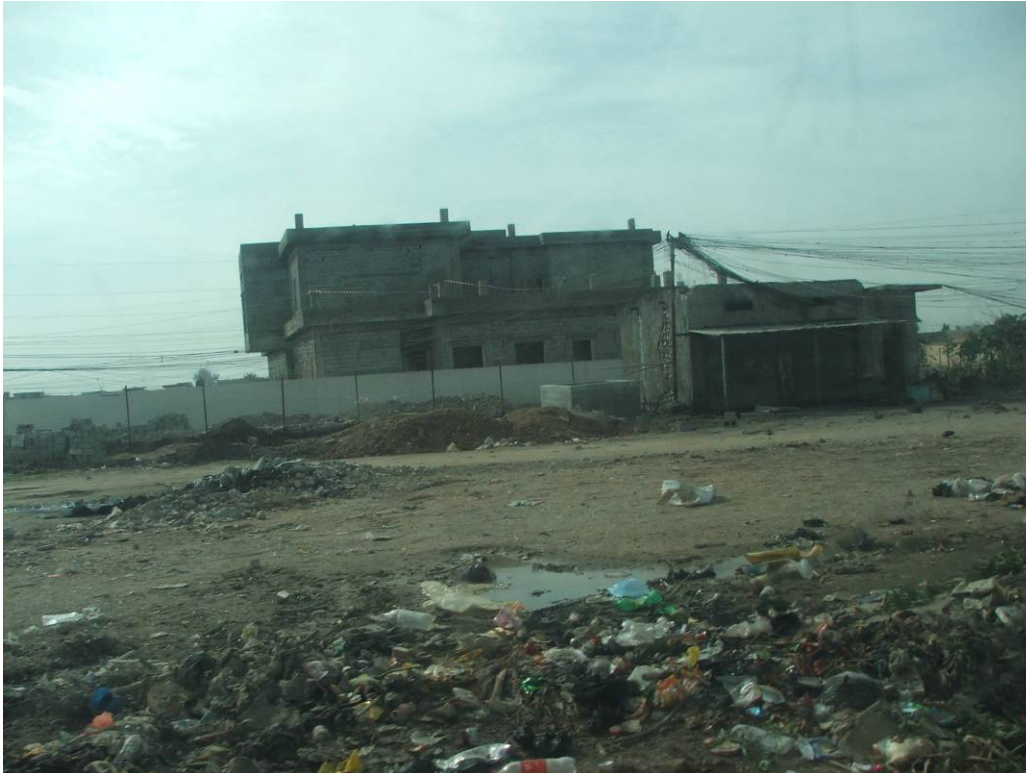
he would simply have a security team drive him by each site – he would not stop or get out of the vehicle during his survey. Site Photo 26 is a “windshield survey” of the Hai Alhajjaj PHC we took from inside the security vehicle. Without pulling up into the parking area of the PHC and stepping outside the security vehicle, this is the view of the PHC. We do not feel the Gulf Region Division project engineer would be able to identify any significant issues either inside or outside the PHCs from this view alone.

Site Photo 26. “Windshield survey” of the Hai Alhajjaj PHC

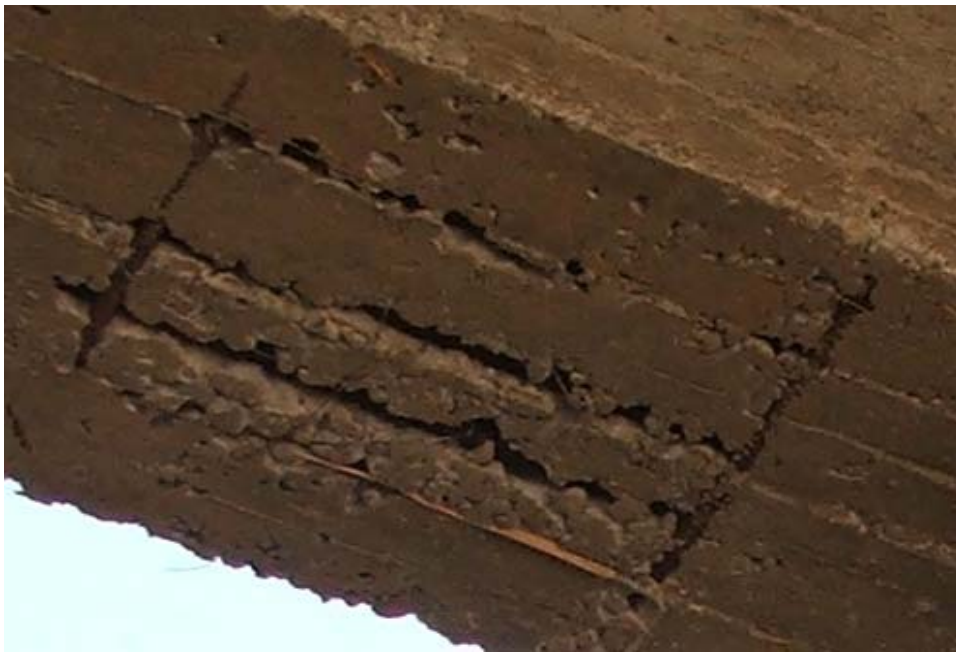
In September 2005, the assessment team met with the Parsons' PHC Task Manager who stated Parsons had become aware of concrete problems throughout the country, which required an analysis to determine potential corrections needed. Parsons provided us with a 21-page presentation, which dealt with the proper pouring of concrete for columns and stairs and potential fixes for "minor" segregation and honeycombing. However, it appears that Parsons' analysis did not identify the significant amount of concrete segregation and honeycombing in the PHCs. One of the techniques for "fixing" the concrete segregation and honeycombing in the columns, beams, and slabs is to put on a "smooth finish." This appears to be similar to the USACE's solution to the issue of poor concrete work on non-load bearing walls, which is to cover it with "mortar or gypsum" and then it will appear "acceptable to the Iraqis."

Site Photo 27. Close-up view of concrete first floor ceiling concrete beam

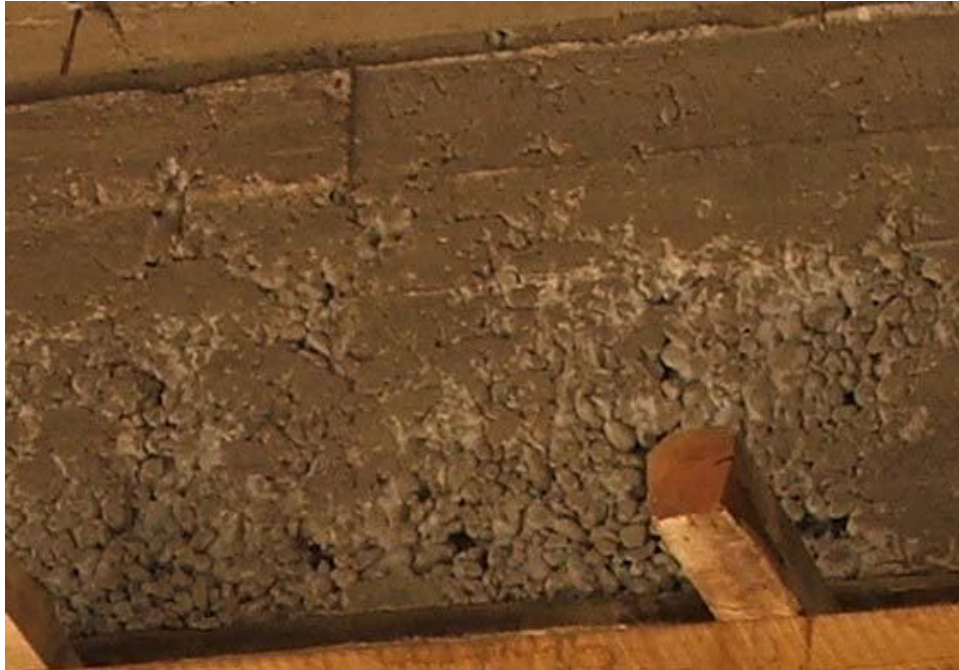
Site Photo 28. Close-up view of concrete first floor ceiling concrete beam

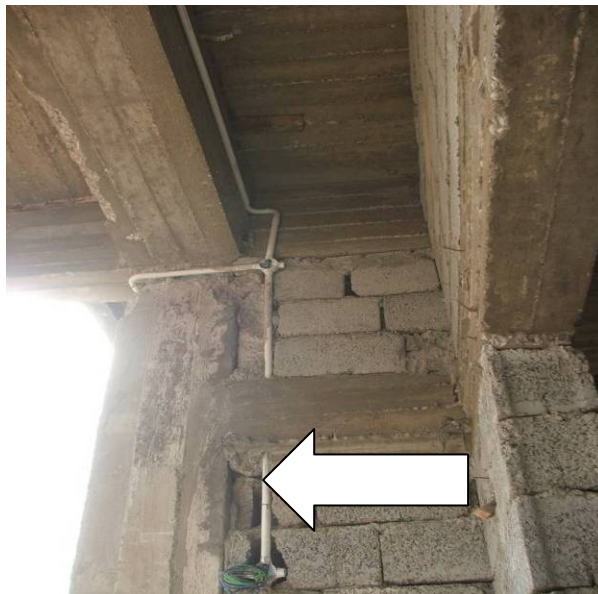
Site Photo 32. Example of broken blocks used in wall construction

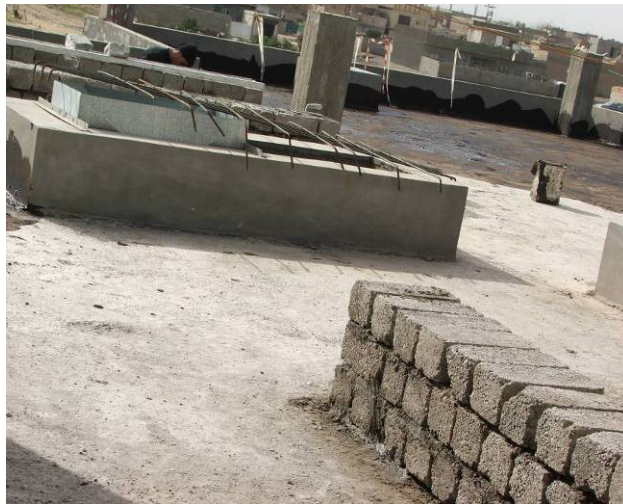
Site Photo 33. Roof partially covered with tar

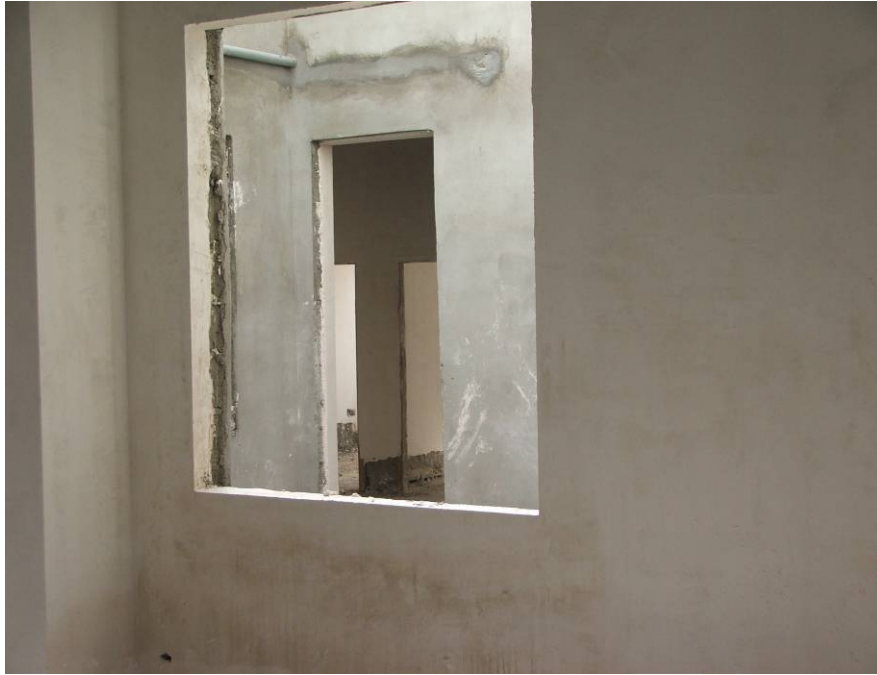
The contractor had neither completed the installation of window frames nor installed any windows or security grilles (Site Photo 49). We observed the beginning of tile installation (Site Photo 50). Interior walls had not been painted and fabrication of the suspended ceiling had not started. We did not observe any doors, window, or hardware on site.

Site Photo 49. Window opening without window frame

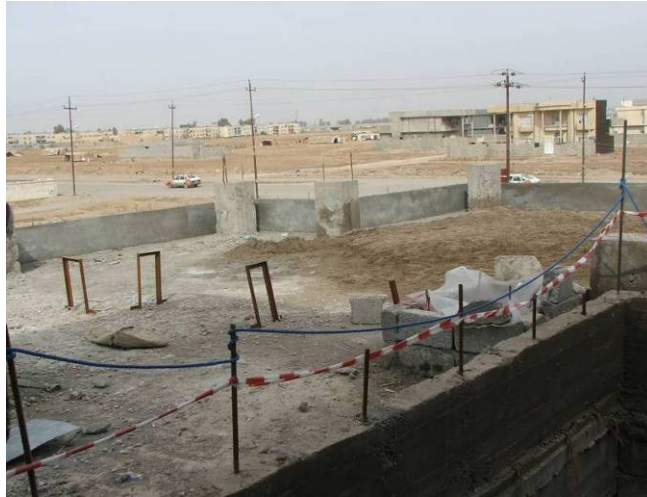
Site Photo 66. Roof in need of cleanup prior to tarring

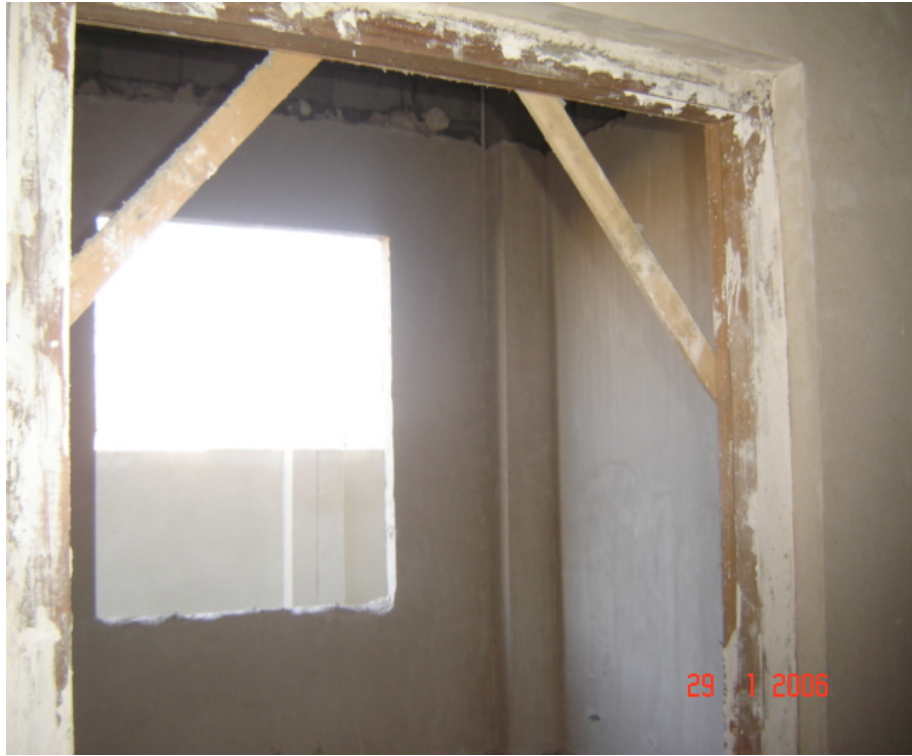
**Site Photo 74. Example of window without window frame and grilles
(Photo courtesy of the USACE)**

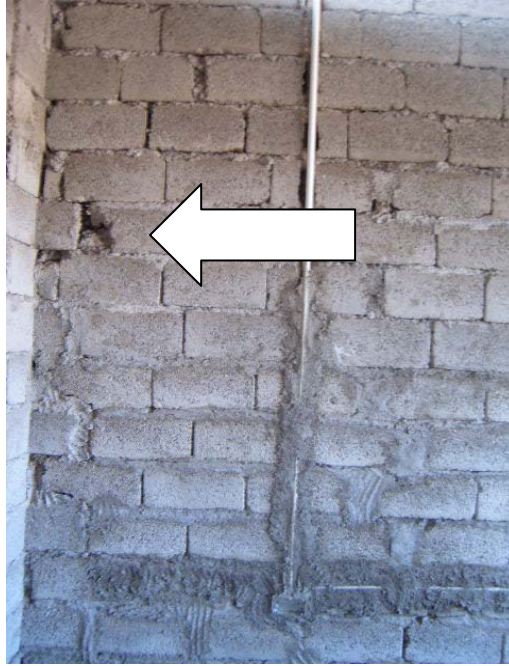
Site Photo 79. Example of broken blocks in wall construction

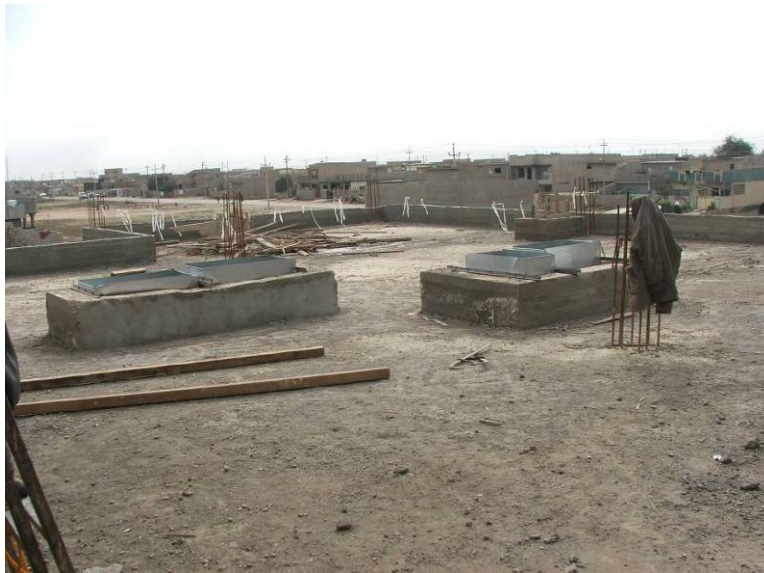
Site Photo 80. Condition of the roof

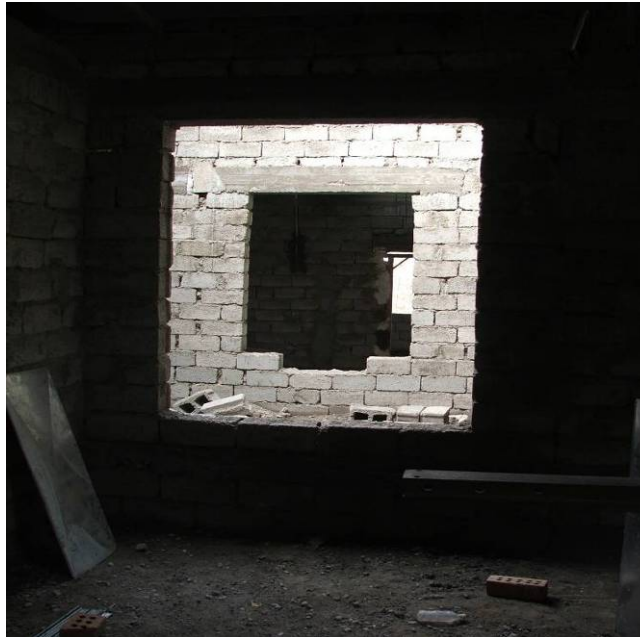
Site Photo 86. Windows without frames
