SUMMARY REPORT
GROUND PROJECT SURVEYS
FOR THE QUARTER ENDED
DECEMBER 31, 2005

SIGIR PA-06-048
APRIL 13, 2006

SUBJECT: Summary Assessment Report of Ground Project Surveys for the Quarter
Ended 31 December 2005 (Report Number SIGIR-PA-06-048)

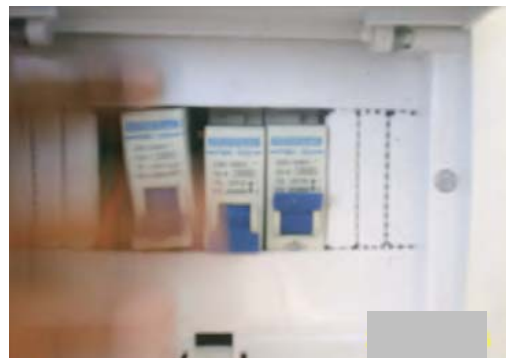
- Lack of conduit for electrical wiring that was routed outside the building.
- Improper installation of circuit breakers and missing electrical outlets at switch locations. Site Photo 43 shows the circuit breaker panel at Project 19220.
- A door was inoperable and a ceiling area appeared unfinished.

Site Photo 43: Circuit breakers at Project 19220

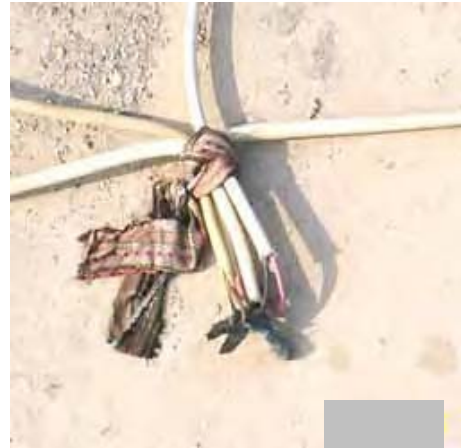
- Roof repair was not a line item in the contract, although the roof was in need of renovation.
- The main building showed no apparent sign of recent painting, although the contract stated, “paint entire exterior of building with 3 coats of good quality exterior enamel paint.”
- Electrical work was of poor quality as evidenced by several wires lacking conduit, and improperly completed electrical connections. Site Photo 49 shows an example of electrical connections at Project 19223.

Site Photo 49: Electrical wires without proper connections at Project 19223
