NASIRIYAH FIRE STATION
NASIRIYAH, IRAQ

SIGIR PA-06-053
JULY 24, 2006

SUBJECT: Report on Project Assessment of the Nasiriyah Fire Station, Nasiriyah, Iraq
(Report Number SIGIR-PA-06-053)

Nasiriyah Fire Station, Nasiriyah, Iraq

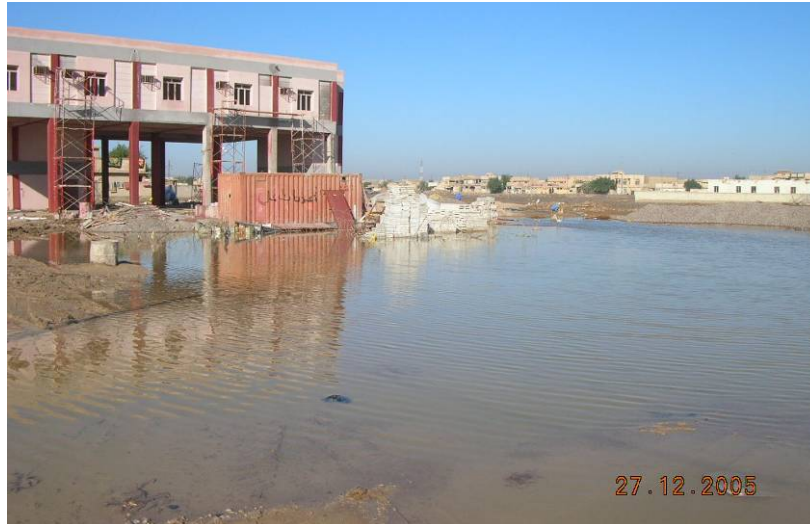
plain and the topography of the fire station site is level. The site does not drain very well since it is relatively flat. Site Photo 1 shows standing storm water runoff in front of the fire station site. The city street is located approximately 125 meters (m) away from the fire station.

**Site Photo 1. Standing water on the front side of the of the fire station –
Photo provided by USACE**

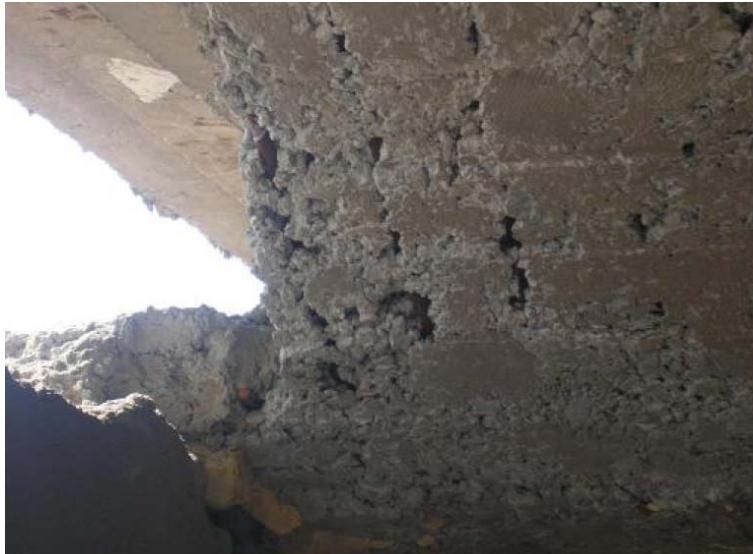
“The cast-in-place columns, beams and slabs where fresh concrete is exposed show indications of improper placement of reinforcing steel with insufficient overlap on the steel bars to provide load transfer; poor quality control on concrete mix preparation, placement, vibration, and curing; and generally poor construction practices that may result in loss of vertical and horizontal control.”

Site Photos 3, 4, and 5 provide examples of some of the concrete problems, such as segregation, poor quality workmanship, and insufficient length of overlapping reinforcement.

**Site Photo 3. Segregated concrete on stairs due to improper placement –
Photo provided by USACE**

Subsequent to the inspection, the USACE GRS contracting officer issued a stop work order, dated 2 September 2005, because of the concerns regarding the structural integrity of the fire station.

The contractor met with USACE GRS personnel and submitted a plan for correcting the problems. The contractor's plan, approved by USACE on 24 September 2005, included the removal and replacement of deficient concrete stairs. In addition, the plan included the use of an epoxy patching material to repair the voids and areas of segregated concrete. Based on a review of the USACE Quality Assurance Representative's (QAR) deficiency log, the concrete deficiencies noted in the stop work order were corrected by January 2006.

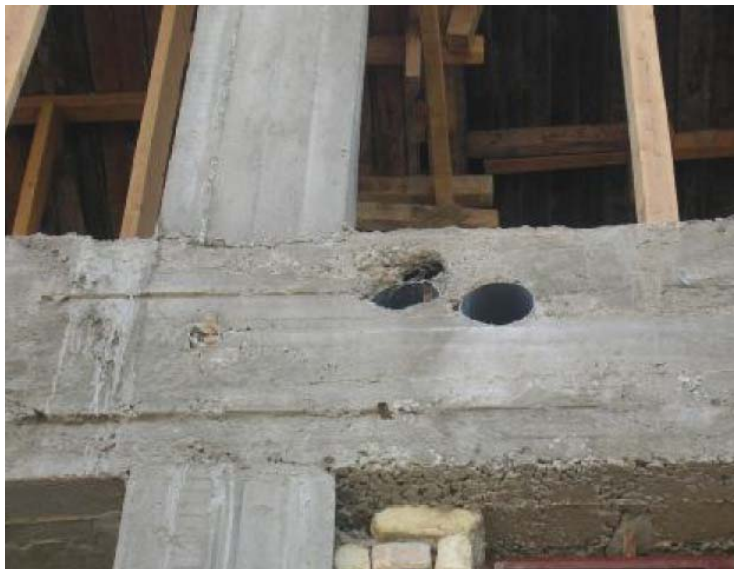
**Site Photo 4. Hole in concrete beam above pipe sleeve; also segregated concrete on bottom of
beam – Photo provided by USACE**

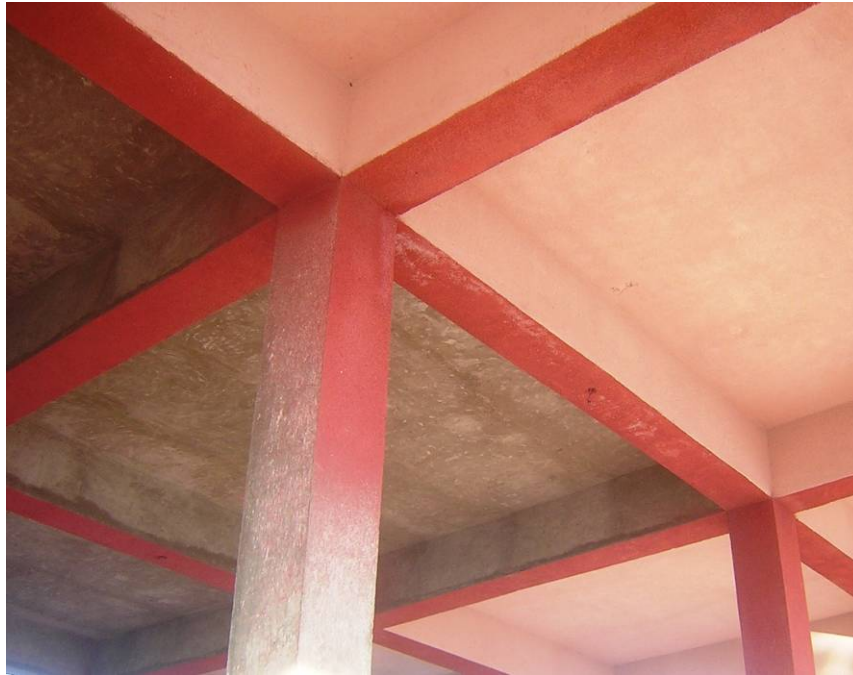
Site Photo 6 shows part of the structural frame supporting the third level after repairs to structural concrete had been completed and during the painting phases. The reinforced concrete beams' cross sectional dimensions are 400 mm by 650 mm. The reinforced concrete columns' cross sectional dimensions are 400 mm by 400 mm. If there were voids in the concrete, the contractor filled them using the epoxy patching material. After patching, the contractor applied a cement-sand plaster mix to the concrete surfaces prior to painting the surfaces.

Site Photo 6. Reinforced columns and beams supporting level 3 – Photo provided by USACE

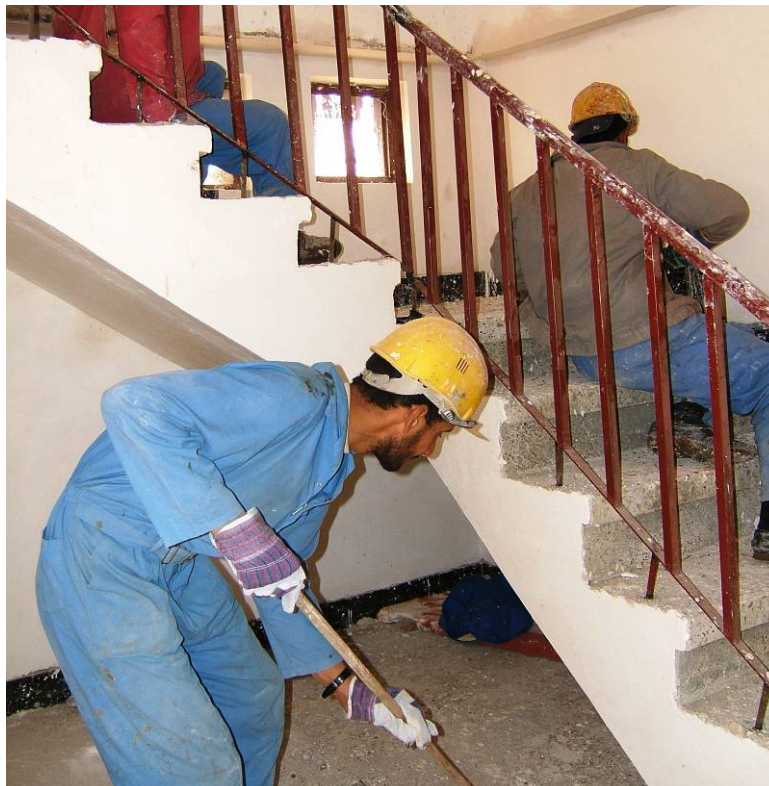
In addition, the contractor replaced reinforced concrete stairs as directed by USACE. After the new stairs were in place and properly cured, the contractor placed terrazzo tile on the stair risers and treads. The other exposed surfaces of the stairs were finished with cement-sand plaster. The design for the stairs required each step to have a 300 mm run and 170 mm rise. Site Photo 7 shows one section of a set of stairs, after the stairs were painted and tile was placed. The rise and run dimensions appear to meet the dimension requirements in the design.

Site Photo 7. Concrete stairs at ground level – Photo provided by USACE

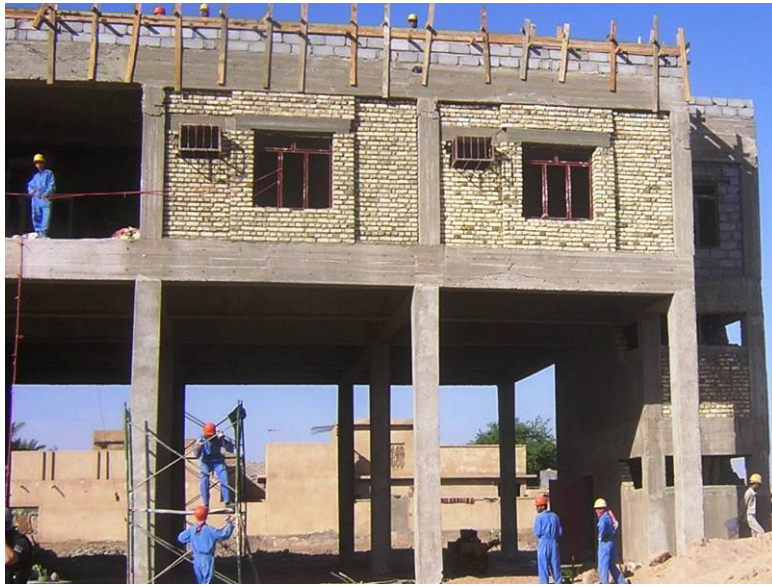
construction progress photos, the contractor utilized bricks (Site Photo 8) and block (Site Photo 9) to construct masonry walls. The drawings did not specify the type of bricks required for the construction of the block walls.

Site Photo 8. Exterior brick walls on third level – Photo provided by USACE

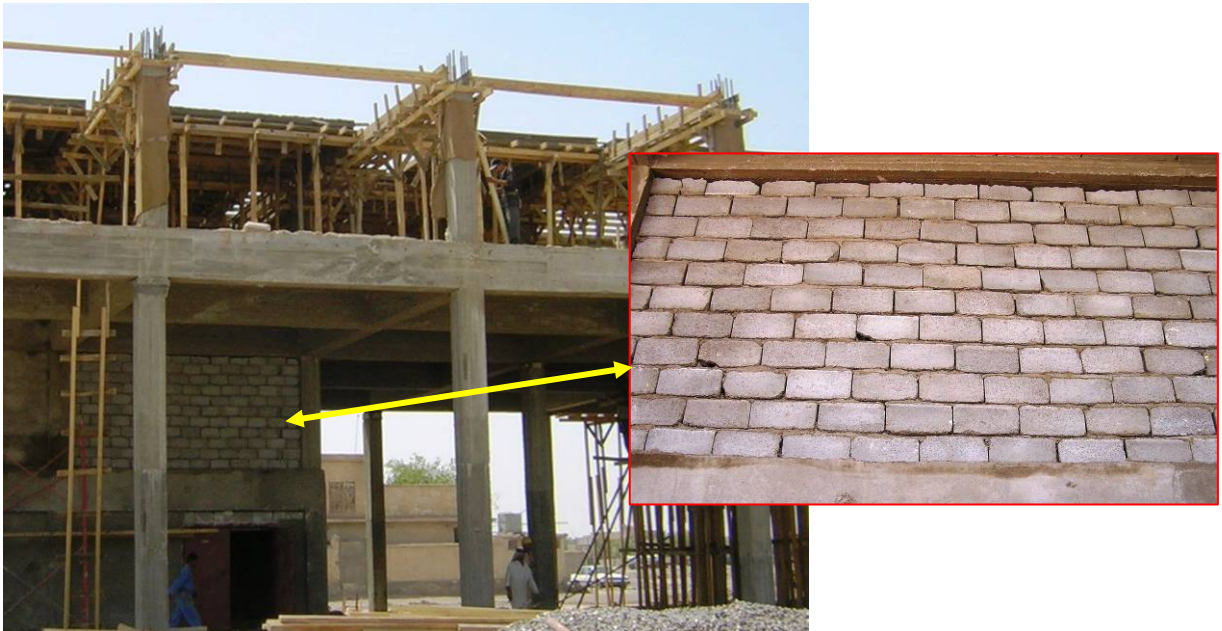
Site Photo 9. Block wall on mezzanine level – Photo provided by USACE
