MUTHANNA VILLAGE ROADS  
SEGMENT 4  
GOVERNORATE OF  
MUTHANNA, IRAQ

**PROJECT NUMBER SIGIR-PA-06-055**

**JUNE 30, 2006**

SUBJECT: Report on Project Assessment of the Multhanna Village Roads Segment 4,  
Muthanna Governorate, Iraq (Report Number SIGIR-PA-06-055)

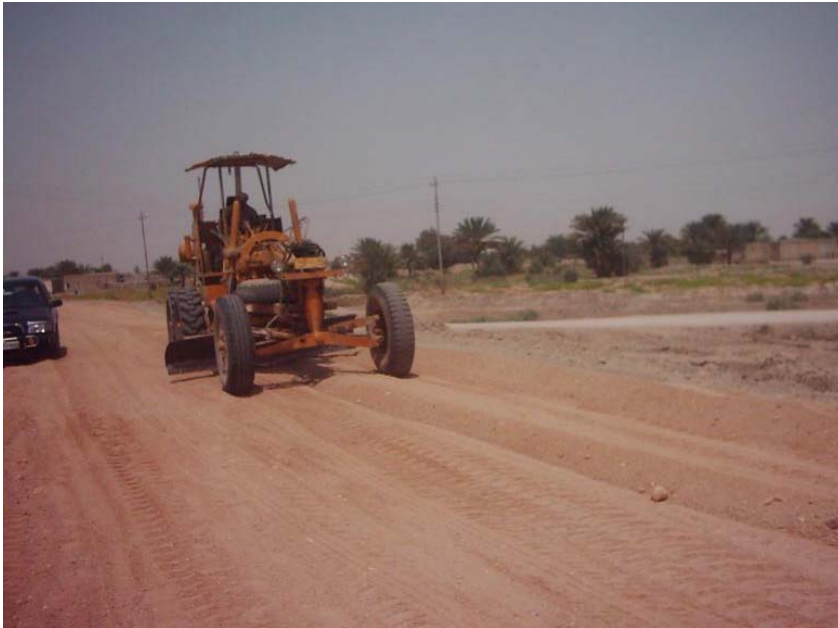
**Site Photo 1. Contractor motor grader leveling the sub-base – Photo provided by USACE**

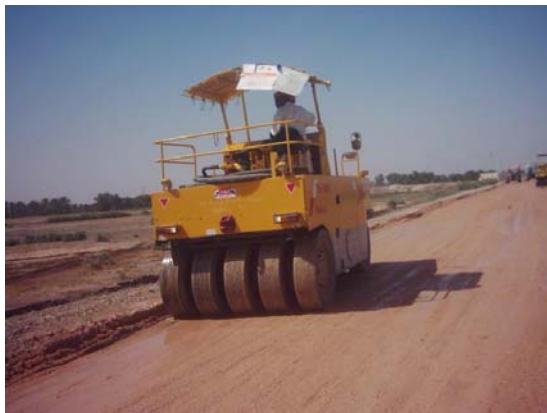
**Site Photo 3. Compacting the sub-base with a pneumatic rubber tired roller – Photo provided by USACE**

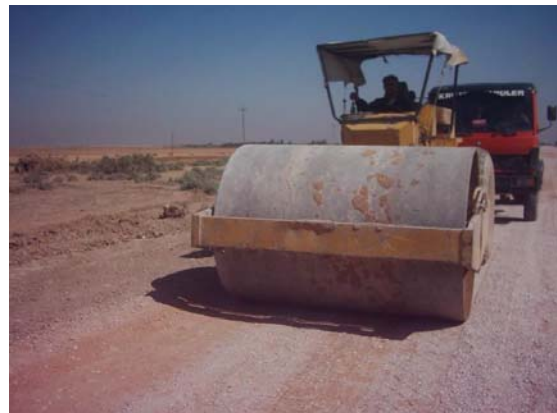
**Site Photo 4. Compacting the sub-base with a steel wheeled roller – Photo provided by USACE**

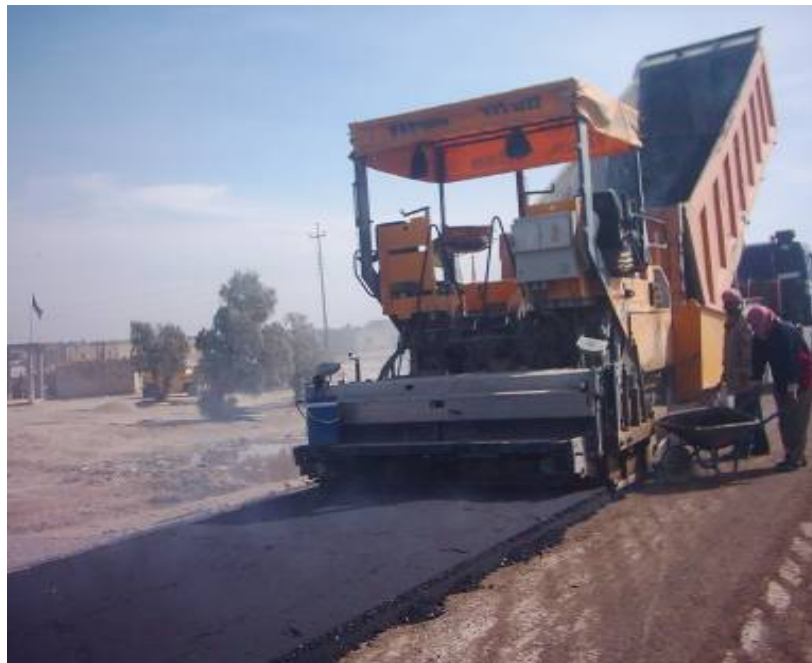
**Site Photo 5. Placing and spreading asphalt concrete pavement –Photo provided by USACE**

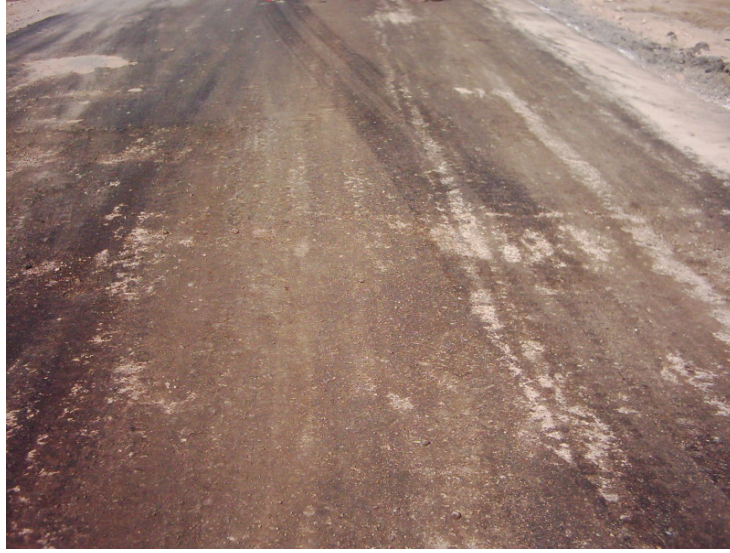
- The prime coat<sup>5</sup> application rate did not meet coverage requirements (not less than 0.5-1.2 liters per square meter) prior to paving between stations 14+500 and 14+650 (Site Photo 7).
- The outside edge of the pavement between stations 9+500 and 10+000 was uneven, resulting in some of the asphalt mix sloughing off from the mat (Site Photo 8).
- The improperly constructed fill to support the base and sub-base layers and the lack of adequate sub-base width in roadway sections between stations 0+000 and 9+5000 (Site Photo 9).

**Site Photo 7. Lack of sufficient prime coat on sub-base prior to paving – Photo provided by USACE**

The QAR's deficiency log indicated the contractor took corrective action to fix the prime coat problems. According to the USACE RE, the pavement edge problems will not be corrected until the 1.75 m wide shoulders are in place alongside the paved base layer. Once the shoulder work is complete the deficient pavement areas will be repaired to their required widths. In the case of the problems shown in Site Photo 9, the USACE RE reported the road will be repaired when the additional borrow is available to widen the roadway fill structure (Diagram 3) in order to obtain the required section widths for the sub-base, pavement, and shoulders.

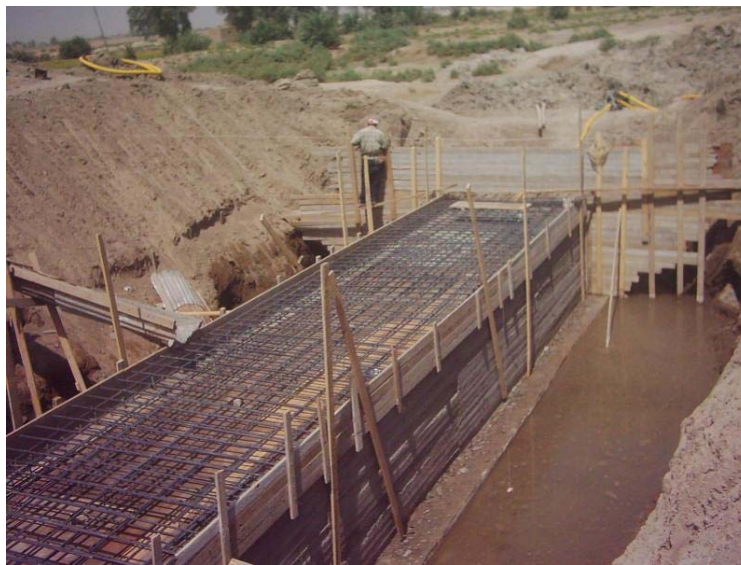
**Site Photo 11. Construction of reinforced concrete box culvert – Photo provided by USACE.**
