WEST BAGHDAD INTERNATIONAL
AIRPORT SPECIAL FORCES BARRACKS
BAGHDAD, IRAQ

SUSTAINMENT ASSESSMENT

SIGIR PA-07-100
APRIL 24, 2007

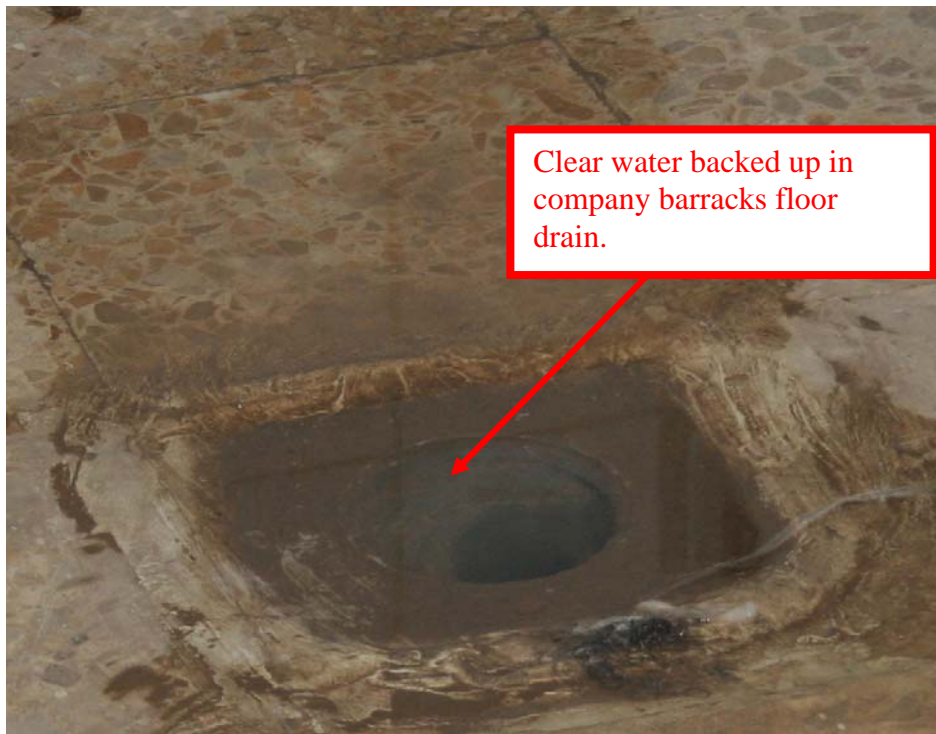
Site Photo 6 shows the clear standing water on the floor of a barracks bathroom.

Site Photo 6. Clear water backed up in floor drain of company barracks.

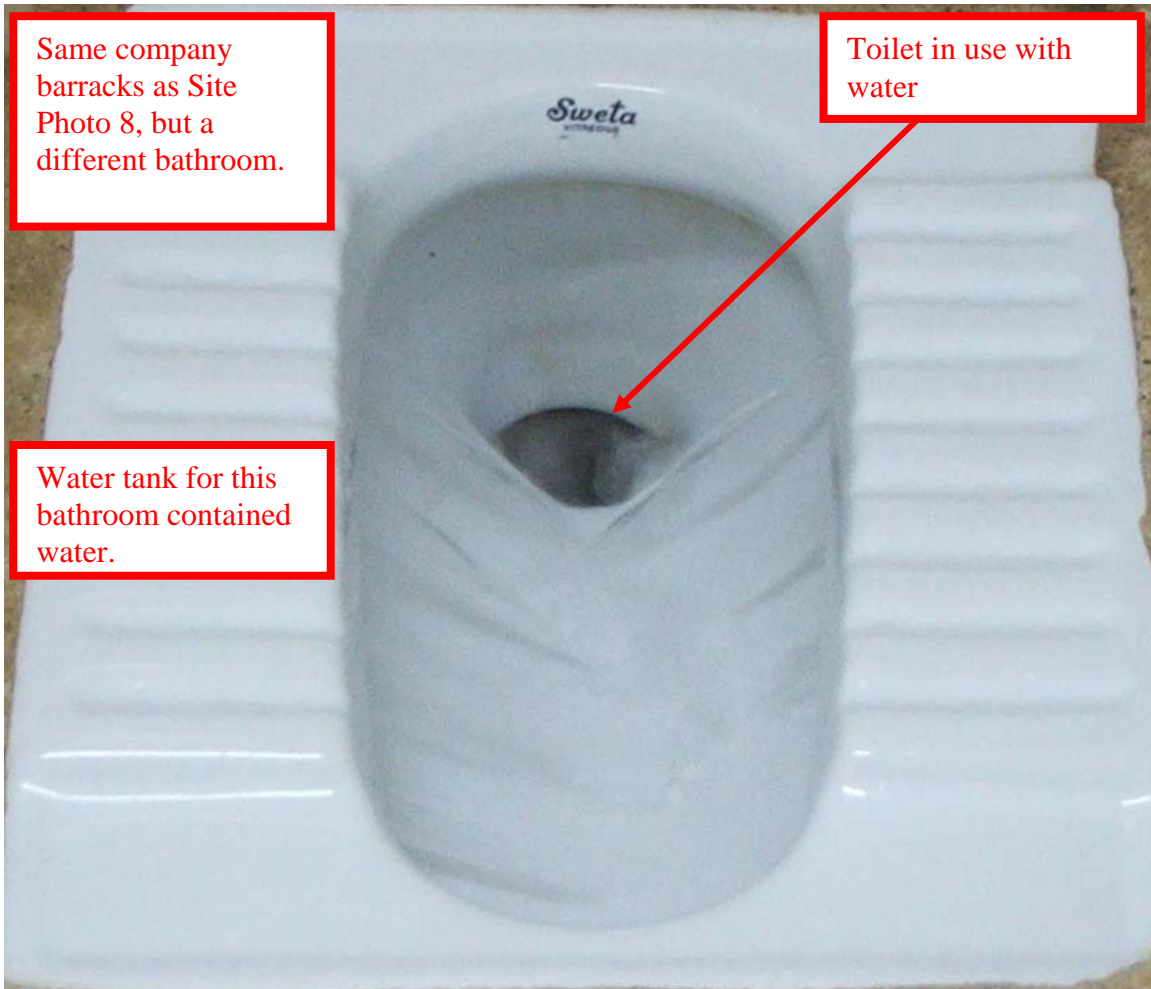
Although water tanks beside one company barracks bathroom contained no water, the barracks other bathroom water tanks were observed to contain water. The bathroom drains, as did the toilets, with flowing water. Site Photo 9 shows water flowing in the other barracks bathroom toilet. This toilet was free from material and dirt.

Site Photo 9. Toilet in use with water in the company barracks.

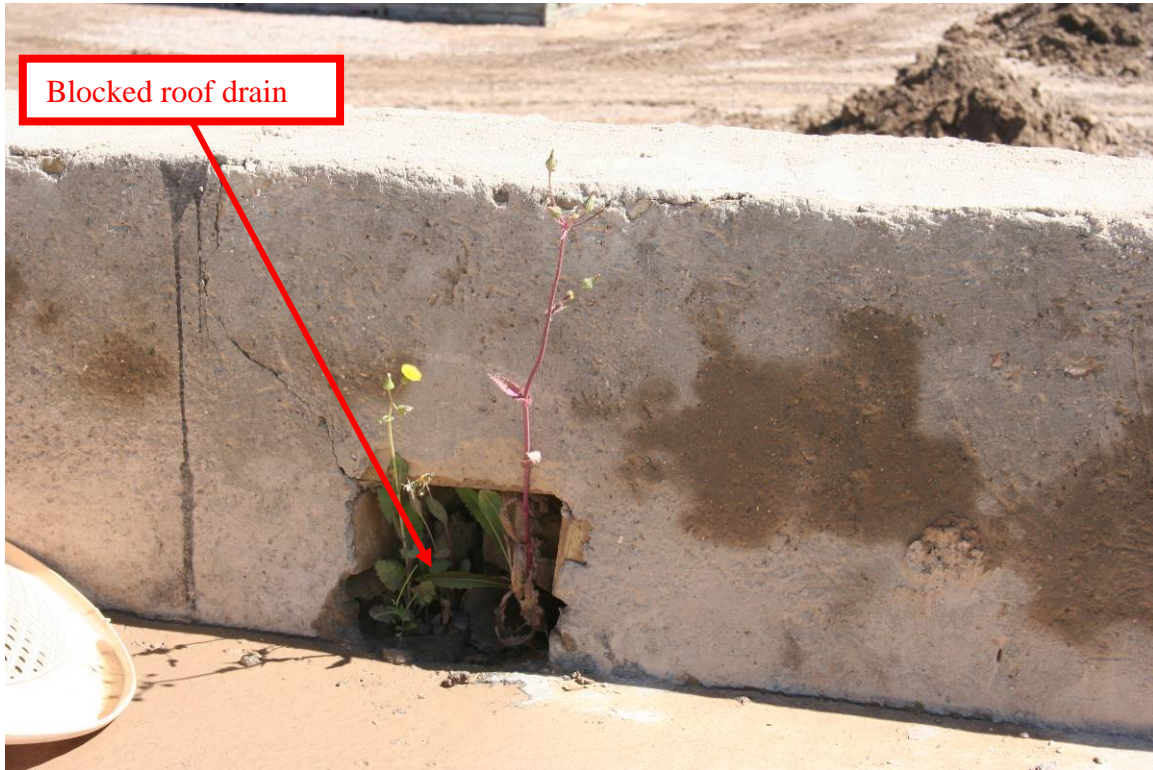
Drains for the roof were found to be blocked by cans, plastic bottles and other debris. Site Photo 14 shows a flowering plant growing from one drain. Site Photo 15 shows another drain area that contained a number of bottles, cans and debris. A number of water stains were noted in this particular barracks. For example, Site Photo 16 shows the ceiling corner of the clinic below the drain seen in Site Photo 15. Water seepage stains were observed, along with what appears to be biological growth.

Site Photo 14. Plant growth in roof drain blockage.

Recommendation 3: SIGIR’s recommendation to ensure that drains are clear and debris is removed is valid. The Iraqi military leadership must play a role in preventing abuse of infrastructure, to include proper disposal of waste in order to ensure proper hygiene as well as to prevent damage. The use of the roof as a waste disposal area is completely unacceptable and must be addressed and enforced by the Iraqi base leadership. Multi National Security Transition Command – Iraq advisors will inform Iraqi leaders of this issue so they can work the resolution, to include repairs.

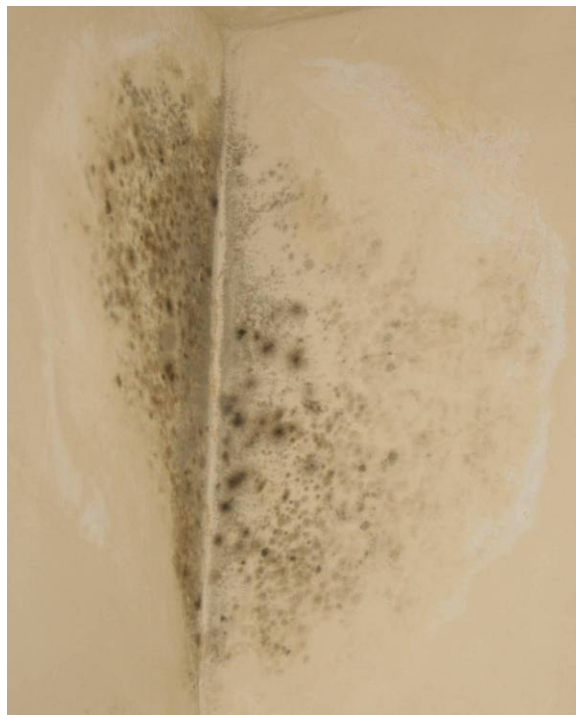
Site Photo 16. Water stain and biological growth in a barracks clinic.

The water leaks and stains observed in at least three barracks were likely the result of water migrating through the walls from the roof. This was likely due to the debris on the roofs that blocked drains and plugged downspouts, which allowed standing water to seep into the walls. To eliminate water damage, it's recommended that all cans, bottles, and debris be removed from the roofs.
