TALLIL MILITARY BASE  
CAMP UR  
NASIRIYAH, IRAQ

SUSTAINMENT ASSESSMENT

**SIGIR PA-06-087**  
**SIGIR PA-06-088**  
**APRIL 25, 2007**

## **Tallil Military Base (Camp Ur) Sustainment Assessment Nasiriyah, Iraq**

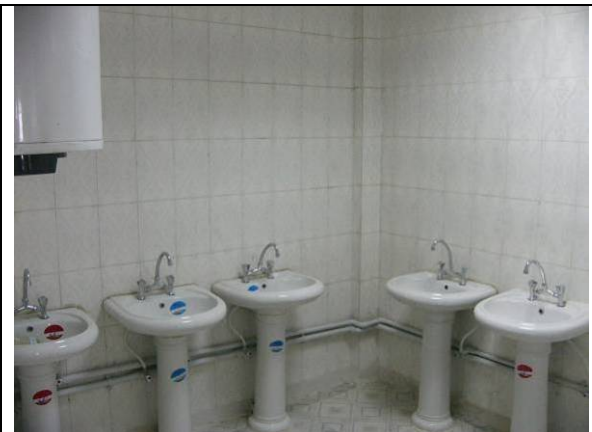
**Site Photo 1. Example of bathroom sinks immediately after construction  
(From Weston photo log)**

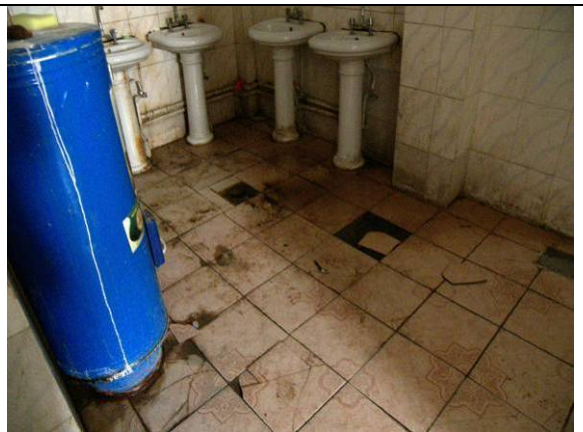
The shortage problem was compounded by using plumbing and fixtures that are closer to household grade than commercial grade. The fixtures, supply lines and valves were flimsy and easily broken after being exposed to the volume of use. Floor tile was installed over a sand base and not adequately sealed. Water seeped through the joints causing tile breakage and damage to the ceiling on the ground level. These problems were also identified during the warranty period where seven of thirty-two work requests involved repairs to bathrooms. Also, during a February 2006 site inspection an AFCEE representative noted eighteen warranty items associated with bathroom floors and fixtures.

Inadequate maintenance and apparent abuse by the occupants further compounded the problem. Un-repaired water leaks damaged floors and ground floor ceilings. Broken fixtures left sinks, showers and toilets unusable. Abusive use such as standing on western toilet seats, slamming shower doors, and stuffing water bottles down toilet drains damaged plumbing and fixtures. These abuses were also noted in an AFCEE representative's site visit report dated 2 February 2006 which cited eighteen examples of soldier abuse to the bathrooms including drains filled with debris, discarded drain covers and cracked toilets. The report commented that the abuse started when the Iraqi soldiers occupied the facility. Site Photos 1 through 7 show the damage to the facilities SIGIR inspected.

**Site Photo 2. Bathroom floor and sinks at inspection**

1. Although MNSTC-I should insure the barracks' bathrooms have the required compliment of commercial grade sinks, toilets, and showers, undertaking significant corrective action without insuring the facilities will be properly maintained would not be cost effective. Therefore, MNSTC-I should consider delaying corrective action until Operations and Maintenance (O&M) demands are met. MNSTC-I should also determine if the broken air conditioners are warranty issues that should be repaired by the contractor.

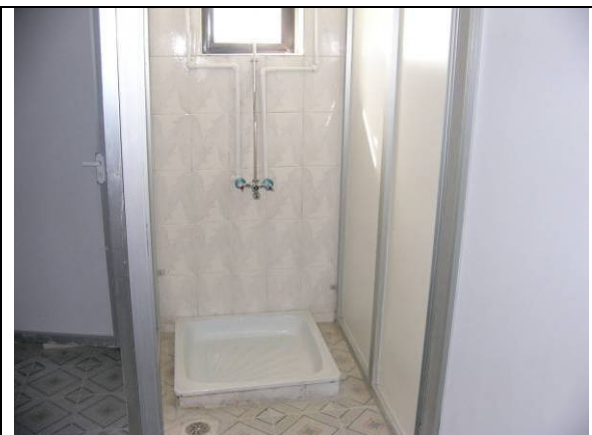
**Site Photo 3. Example of a finished shower immediately after construction  
(From Weston photo log)**

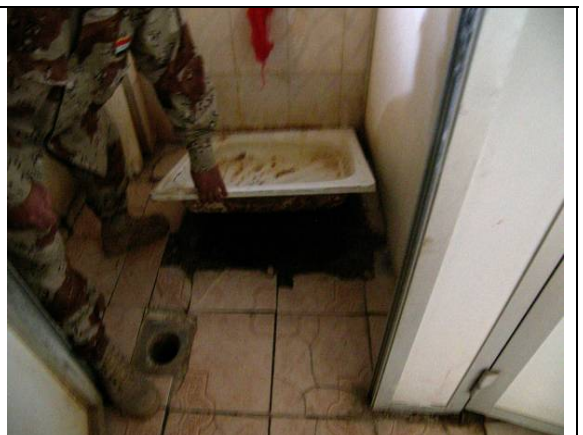
**Site Photo 4. Dislodged shower floor pan at inspection**

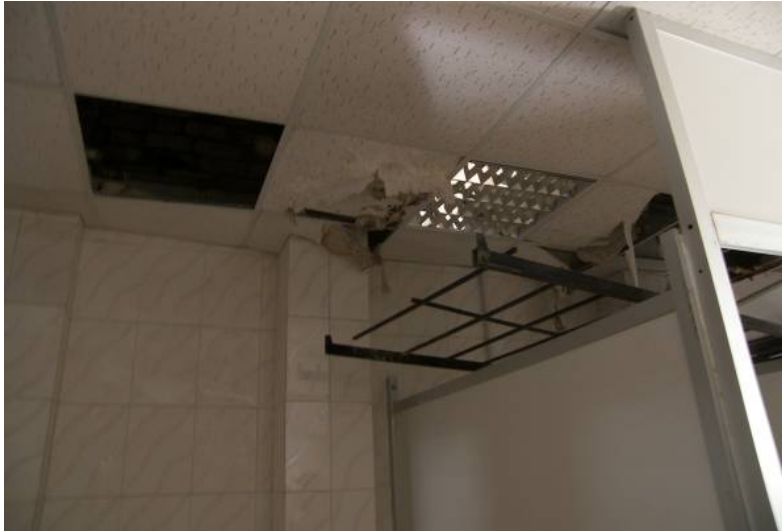
Eighteen enlisted/transient barracks were built on the base. Each has a maximum capacity of 156 soldiers, 72 on the ground floor and 84 upstairs. The inspection found that leaks from the upstairs floor caused damage to floor tiles and ceiling damage to the ground floors. Also, fixtures, toilets, showers and sinks were damaged. The design provided for fewer sinks than required for the upstairs bathrooms. The inadequate design, combined with low quality fixtures and poor quality workmanship made the facilities too fragile for the volume of use they experienced. The problem was compounded by poor maintenance and abuse by the tenants.

**Site Photo 5. Ground floor ceiling water damage caused by leak and excess water from the bathroom above. The bed frame was apparently used to protect the person below in case the ceiling collapsed.**

3. MNSTC-I should notify the GoI and JHQ that GSU maintenance on the barracks is inadequate and will significantly shorten the useful life unless immediate repairs are made and the occupants are trained on the proper use of the facilities and adequate oversight is maintained..

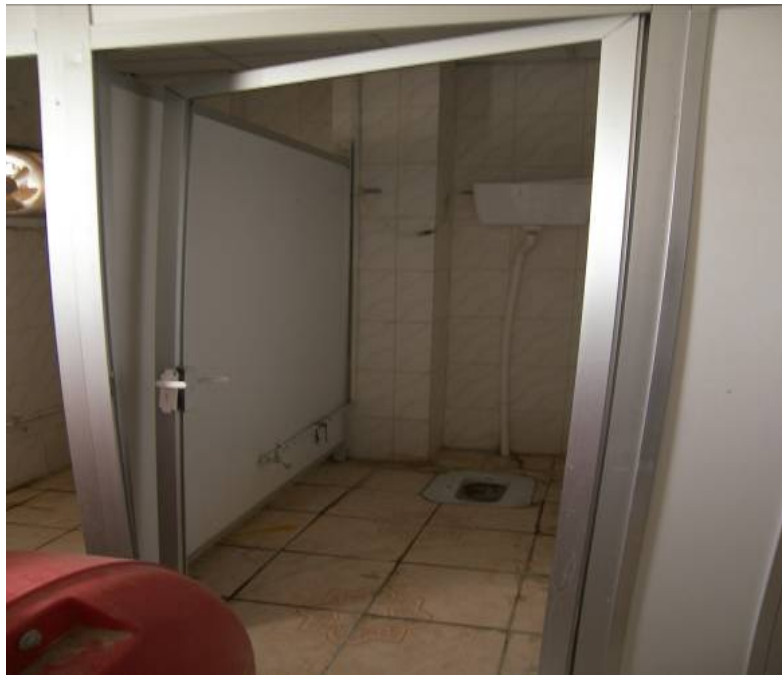
**Site Photo 6. Closed toilet door frame with missing center panel**

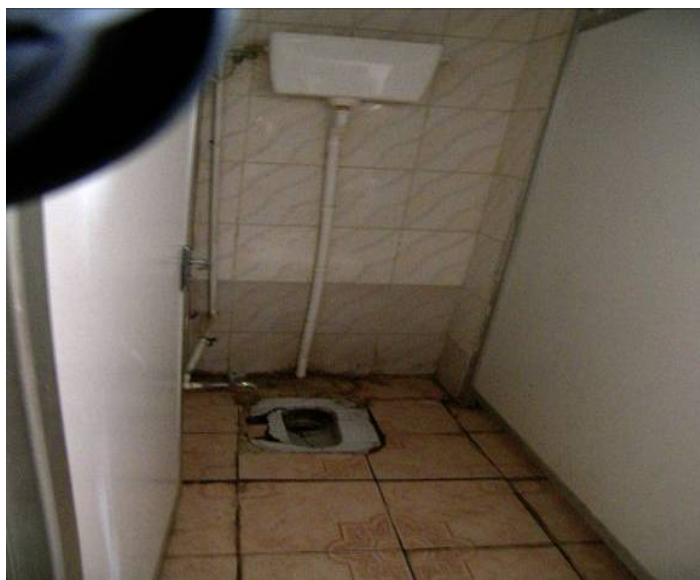
**Site Photo 7. Broken eastern toilet**

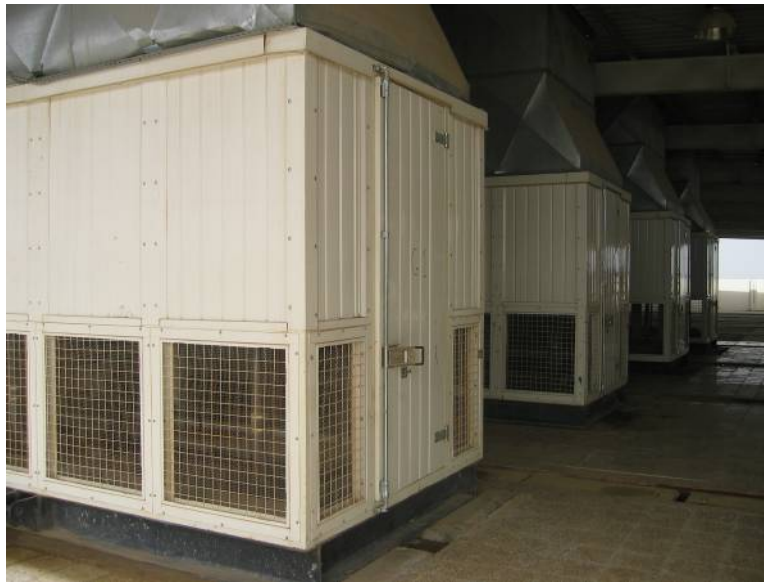
Three of the four remaining generators were operational. The fourth had been waiting for a replacement turbocharger that was ordered in July 2006. The plant manager said that the three generators are sufficient to supply power to the base in the winter but higher demand for air conditioning will pose a problem during the summer. The fourth generator will be needed to supplement power during routine maintenance. The generators were not operating at the time of our inspection due to fuel shortages at the base. The plant manager said the generators operate from ten to

twelve hours per day beginning in late afternoon. Site Photo 8 shows the condition of the generators at the time of our inspection.

**Site Photo 8. Remaining base plant generators.**

Recommendation #4 Generator Turbocharger: During a follow-up meeting to clarify its response, MNSTC-I officials noted that they will contact the Base Support Unit at Tallil and offer assistance to expedite the delivery and installation of the turbocharger.

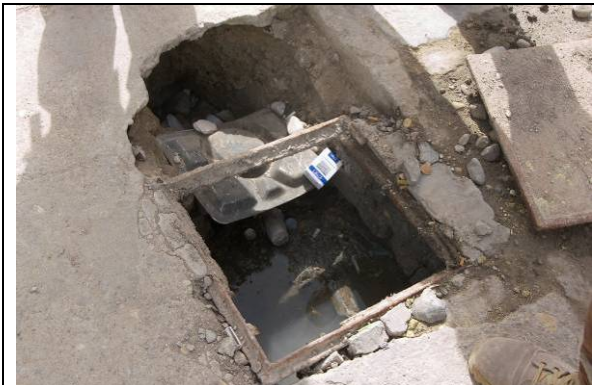
SIGIR's inspection disclosed a number of sidewalks and drain cleanout holes with un-repaired damage from inadequate workmanship and vehicle traffic. The sidewalks and cleanout holes were designed for pedestrian traffic. Quality issues existed at the time the base was delivered to the USG. An AFCEE warranty inspector visited the site on February 2 and 3, 2006 and noted that approximately 70% of the concrete work done on sidewalks was of poor quality and would need to be replaced.

Warranty requests provided by AFCEE show that repairs were made to sidewalks in the 100, 200, 600, 700 and 800 complex areas from May 25, 2006 to June 3, 2006. Our inspection showed that quality and damage issues still existed at the facility. Site photos # 9 and #10 show the sidewalks and drain cleanout holes at the time of our inspection.

**Site Photo 9. Broken drain cleanout hole**

2. MNSTC-I should review the sidewalk and storm drain conditions and determine if they are still covered by the warranty. If the sidewalk damage is covered under the warranty, the contractor should be required to make the necessary repairs. If the warranty is void due to vehicle damage, MNSTC-I should either fund the repair or notify the GSU that they are responsible for repairing the damage.

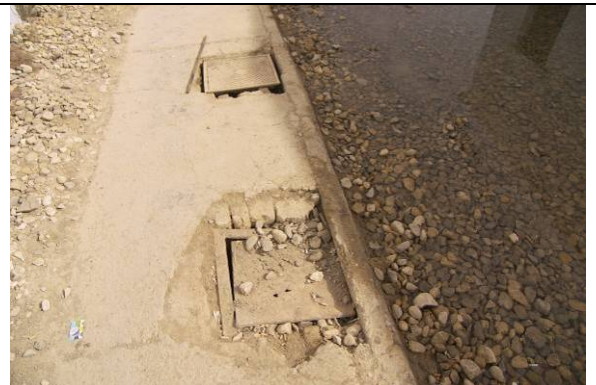
**Site Photo 10. Drainage cleanout holes and standing water that should drain into the system**
