BAB SHAMS POLICE STATION  
MOSUL, IRAQ

SUSTAINMENT ASSESSMENT

**SIGIR PA-06-091**  
**APRIL 25, 2007**

SUBJECT: Report on Bab Shams Police Station Sustainment, Mosul, Iraq  
(Report Number SIGIR PA-06-091)

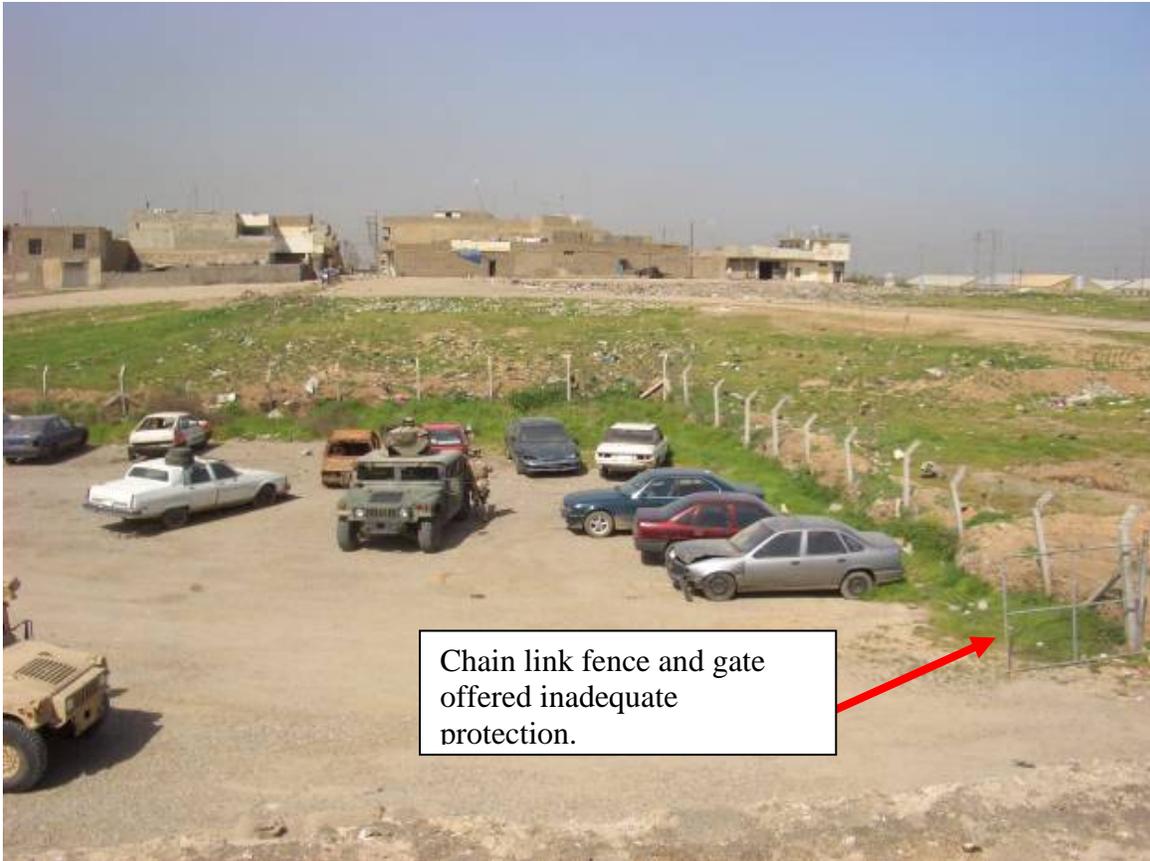
**USACE Pre-Construction Photo 3. Without a solid block wall, police station was vulnerable to direct fire and tactical observation from nearby buildings and open fields.**

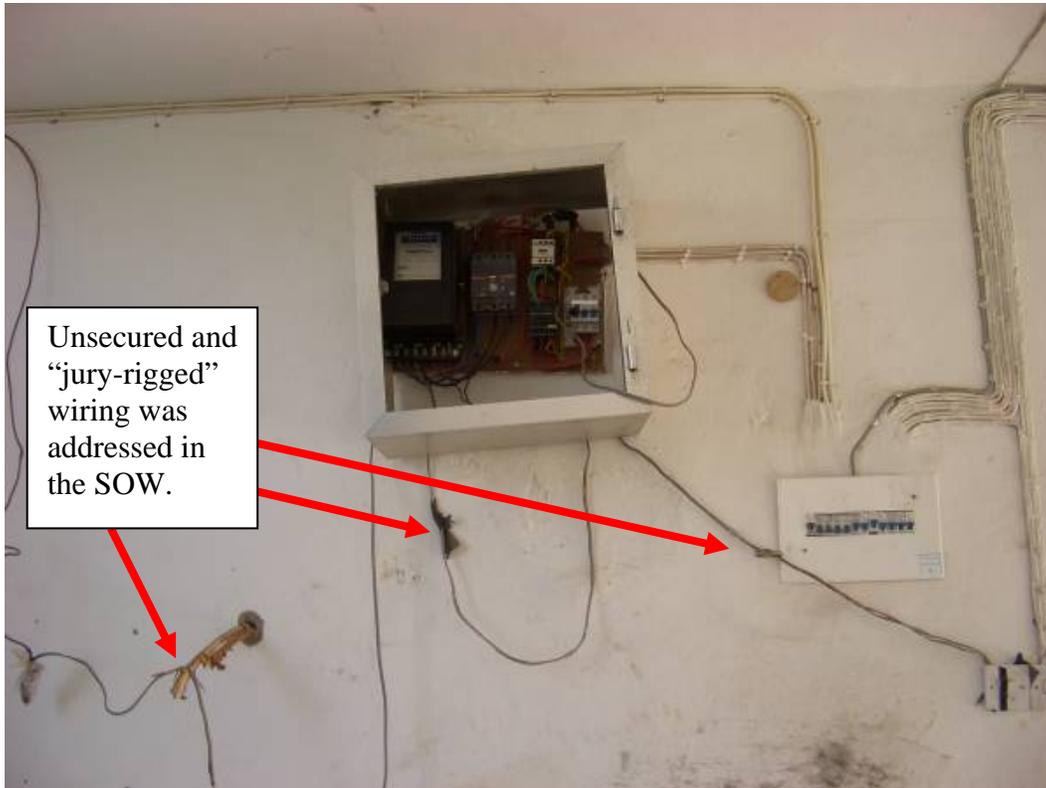
**USACE Pre-Construction Photo 6.**

The SOW specified that the pre-existing electrical system needed to be significantly upgraded during renovation. The contractor was required to repair exposed wiring, add wiring/circuits, switches, plug-ins, fluorescent lighting ballasts, building perimeter lighting, and other electrical upgrades. In addition, the SOW included a requirement to securely attach all wiring to walls. An example of the pre-existing condition of the electrical system is shown in USACE Pre-Construction Photo 6. The photo shows “jury-rigged” and unsecured wiring.

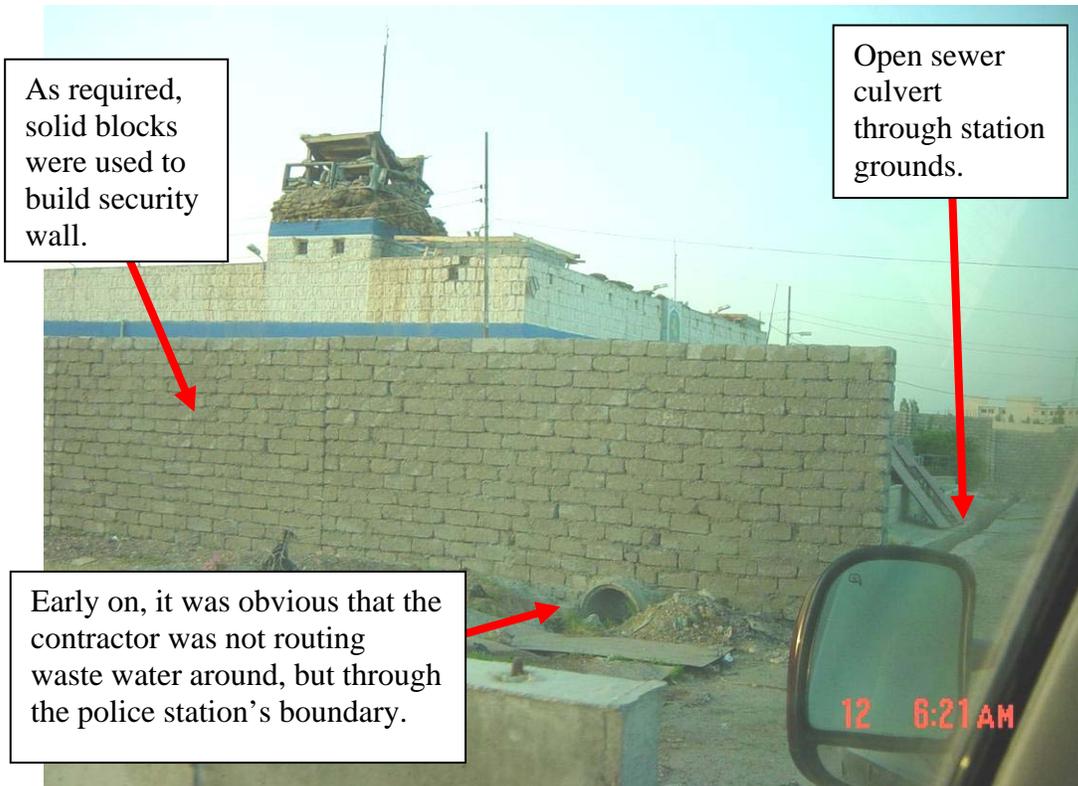
USACE Construction Photo 2 (12 Jun 05)

Contrary to SOW requirements, USACE Construction Photos 2 and 3 show that sewer water was not being routed around the perimeter of the police station, but through the station's boundaries. Issues related to the location of the sewer water conveyance system are addressed in the Site Assessment section of this report.

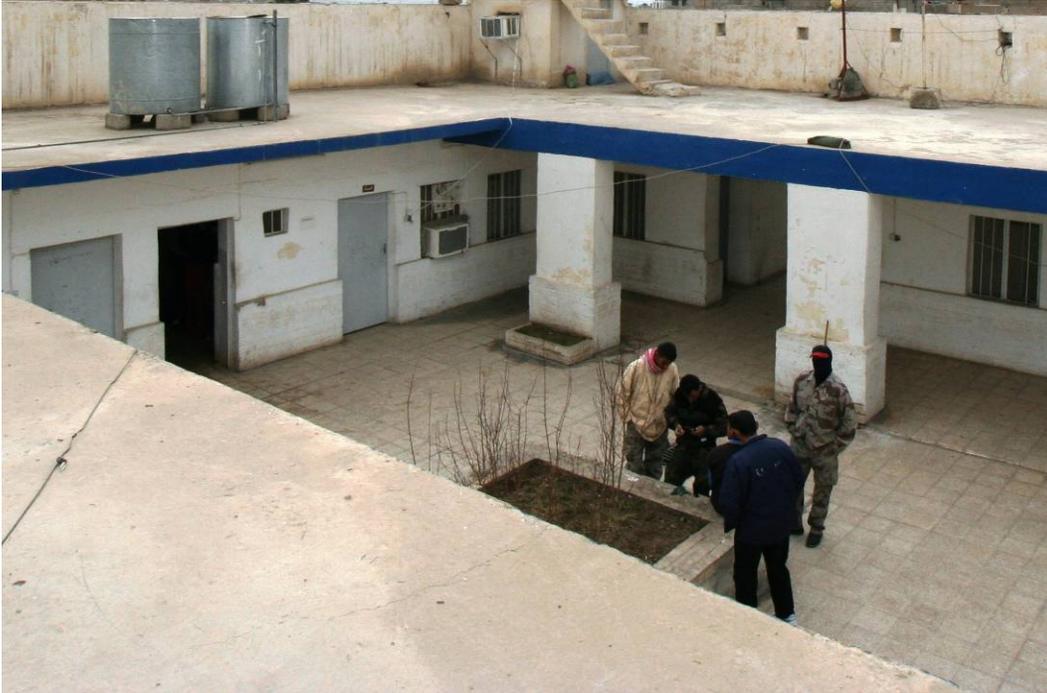
Most elements of the renovation project appeared to meet SOW requirements and the facility appeared to be able to operate at full capacity<sup>4</sup> when observed. Site Photo 1 confirmed that the same area shown in USACE Construction Photo 13 appeared to be or remained functional on 28 January 2007. Several toilets were flushed and several sinks were partially filled and drained to verify operability. In addition, the inspectors observed several sewer line traps and confirmed that they were open and that sewage generated within the police station building was able to flow. Site Photo 2 shows the specific traps observed by the inspectors. The area around the traps was dry and did not show evidence of routine plugging or backed-up sewage.

**Site Photo 1. Observed condition of the same general area shown in USACE Construction Photo 13 appeared functional.**

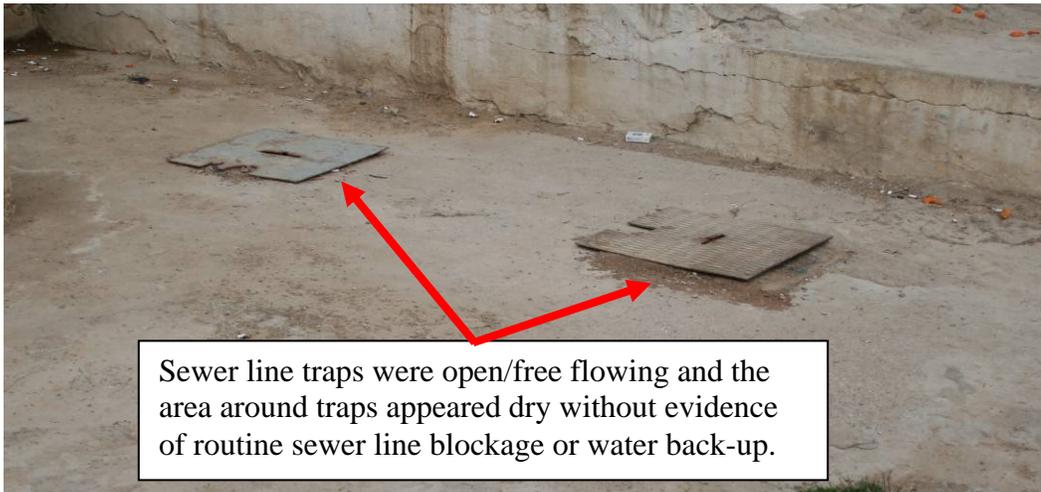
**Site Photo 2.**

Sewer line traps were open/free flowing and the area around traps appeared dry without evidence of routine sewer line blockage or water back-up.

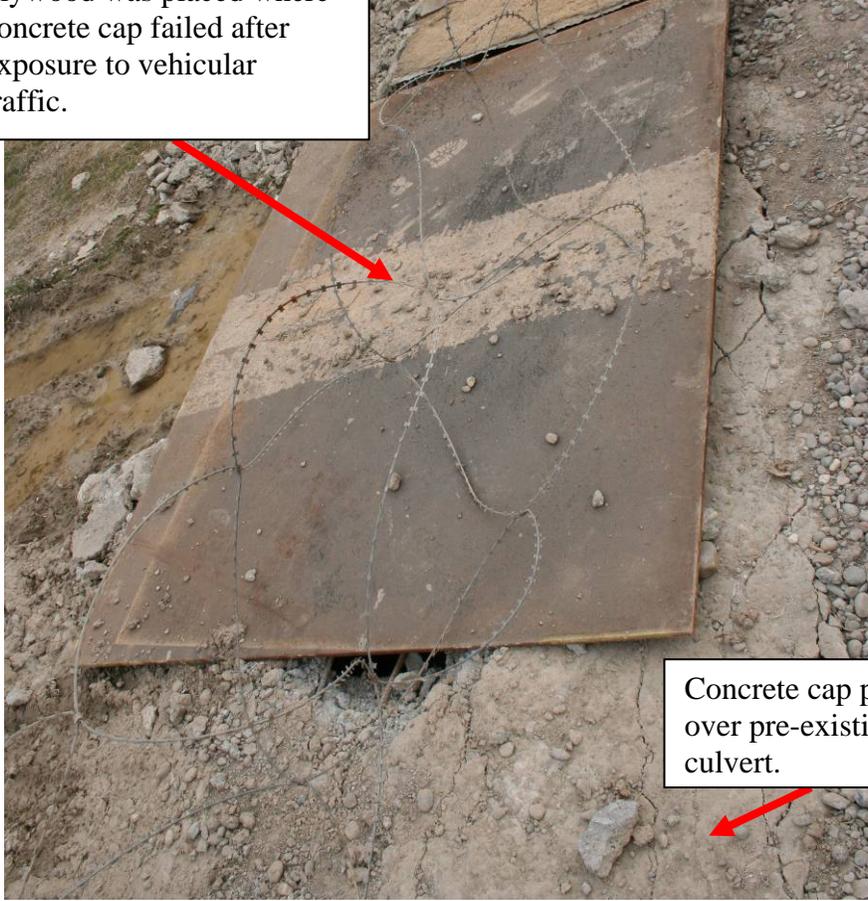
Site Photo 3.

A review of the USACE construction photos and the on-site inspection by SIGIR inspectors revealed that the original contract requirement for rerouting the sewer water was not met. Instead, the contractor capped some sections of the existing sewer channel that ran through the grounds of the IP Station. SIGIR also found construction quality, drainage, health and security concerns with the current design and construction.

Rather than route sewer water around the perimeter of the station, the contractor merely capped the pre-existing open culvert with concrete. SIGIR inspectors observed that the construction of the concrete cap was poor for a number of reasons and had collapsed under the weight of vehicle traffic (Site Photo 3). As shown in Site Photo 4, the concrete was not uniformly mixed, was cast too thin and was cast without rebar or wire to improve the tensile strength.

Plywood was placed where concrete cap failed after exposure to vehicular traffic.

Concrete cap placed over pre-existing open culvert.

USACE/IRMO should survey the site’s current condition and develop cost effective plans to (1) route waste water around the perimeter of the police station and (2) securely attach wire to the security perimeter wall.

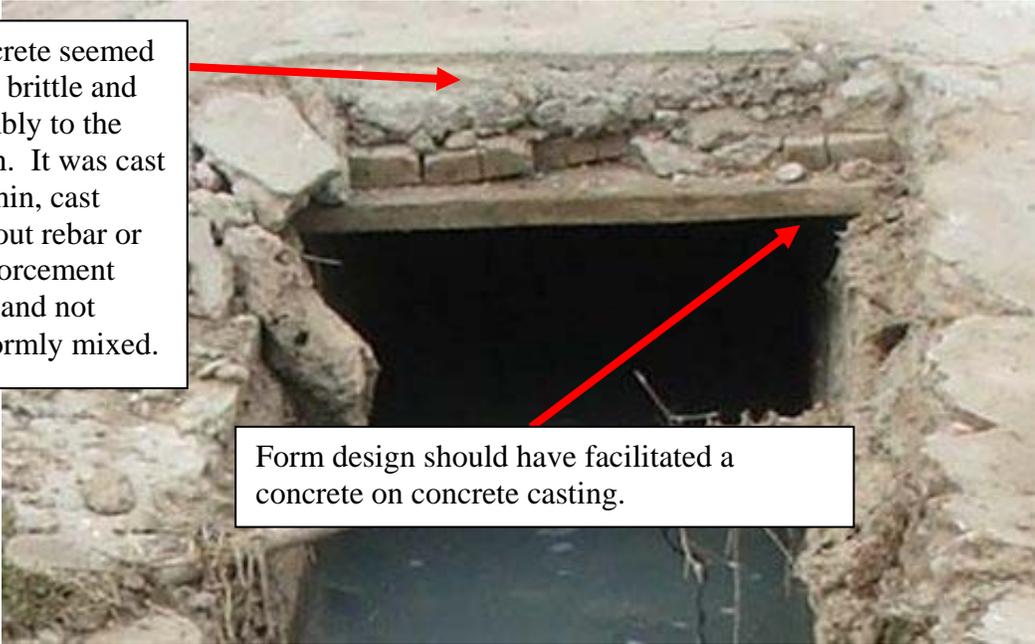
Site Photo 4.

In addition, forms should have been constructed in such a manner that the new concrete material would have been placed to touch the culvert's concrete side wall, which is concrete on concrete without wood between the new casting and the existing sidewall. The technique used by the contractor only increased the likelihood of concrete failure. As the wood rots, more stress is placed on the casting as it settles towards a concrete on concrete position.

Concrete seemed to be brittle and crumbly to the touch. It was cast too thin, cast without rebar or reinforcement wire and not uniformly mixed.

Form design should have facilitated a concrete on concrete casting.

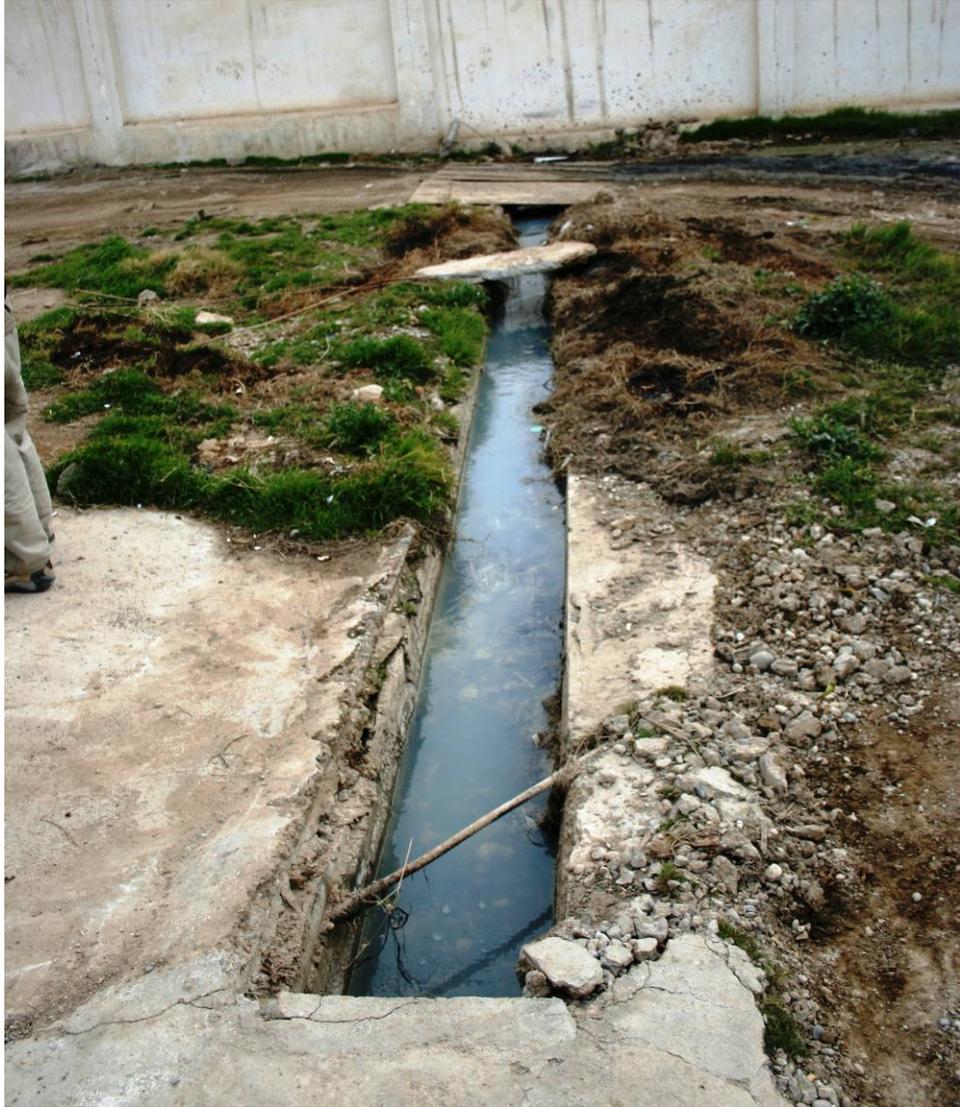
**Site Photo 5.**

Before renovation, the chain linked fence (USACE Pre-Construction Photo 3) that surrounded the IP station did not impede runoff water. Conversely, the new solid block security wall (USACE Construction Photo 3 and Site Photo 5) on the low<sup>5</sup> side of the compound could block or impede the flow of rain water runoff and sewage water flow (Site Photo 6). The runoff from within the compound, combined with the regular sewer water flow and rain water runoff channeled into the station from outside the compound, could lead to standing water conditions within the compound.

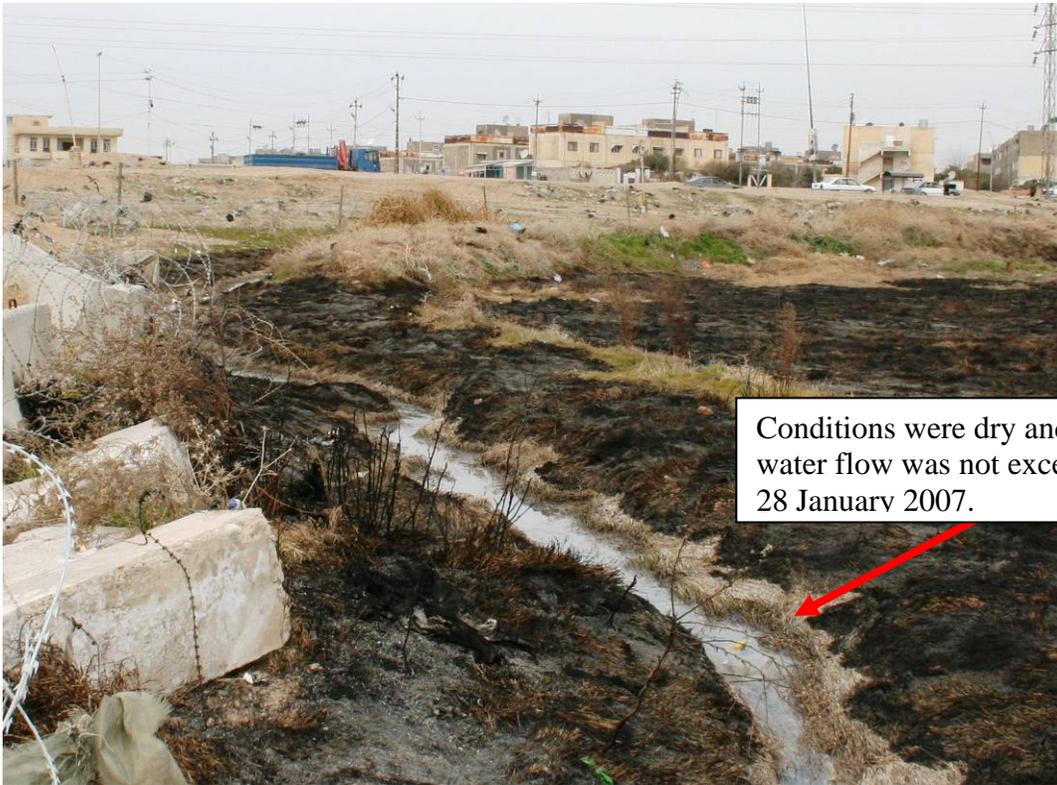
**Site Photo 6.** Outside the entrance, there was a sizeable area with sufficient slope to generate substantial runoff to IP station boundaries.

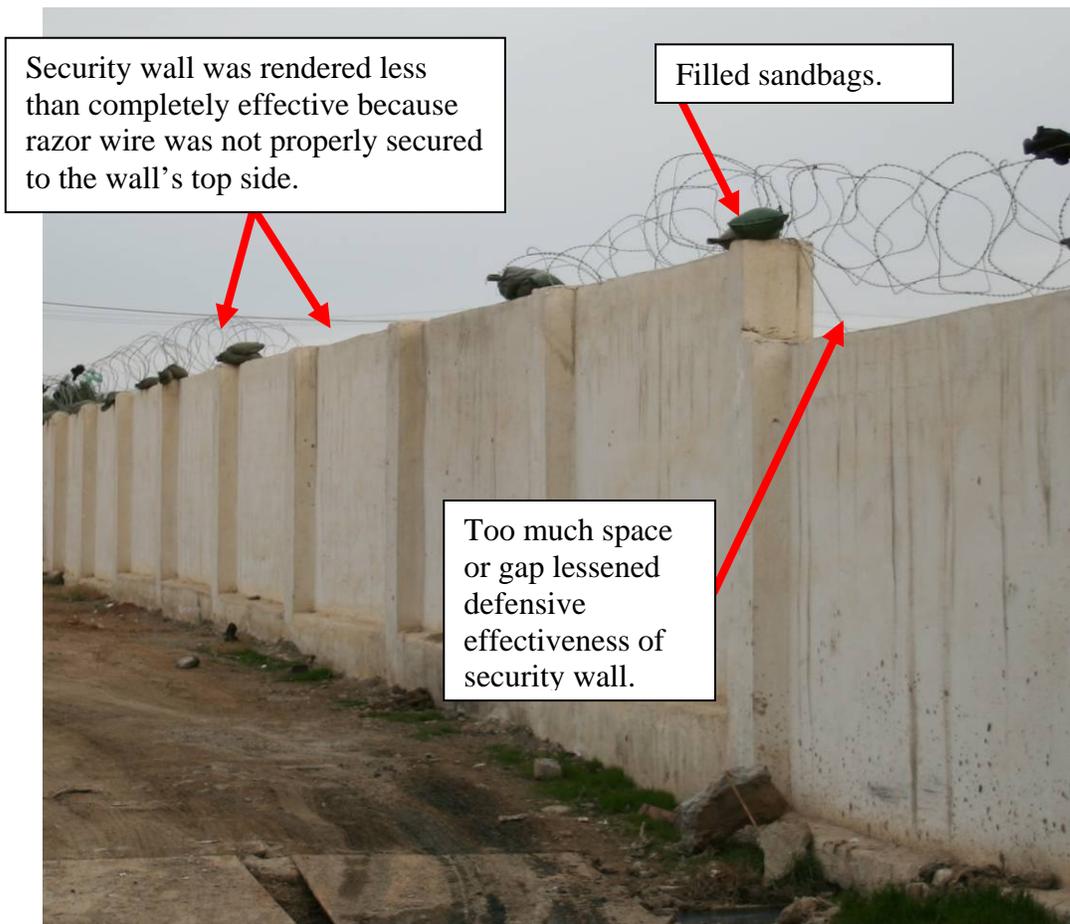
Site Photo 9.

All requirements related to the construction of the security wall were met with the exception of the barbwire which was not adequately secured and placed on the top side of the wall. Site Photo 9 shows that the wire was merely held in place by sand bags that could be pushed or pulled off by personnel wanting to scale the wall. Without the sand bags in place, the wire does not stay in place atop the wall. In addition, the wire was stretched in such a manner that spaces or gaps between the wire and wall developed. SIGIR inspectors observed several places where the wire was not attached or placed in a manner that enhanced the defensive effectiveness of the security wall.

A review of the USACE final inspection report dated 23 September 2005, disclosed that the wire for the top of the perimeter wall was not installed and was “still piled up on the ground where it was unloaded from the delivery truck”. USACE officials were aware of

the problem; however, it appeared that issues related to the wire were not adequately addressed before final payment to the contractor was approved by the USACE RE.

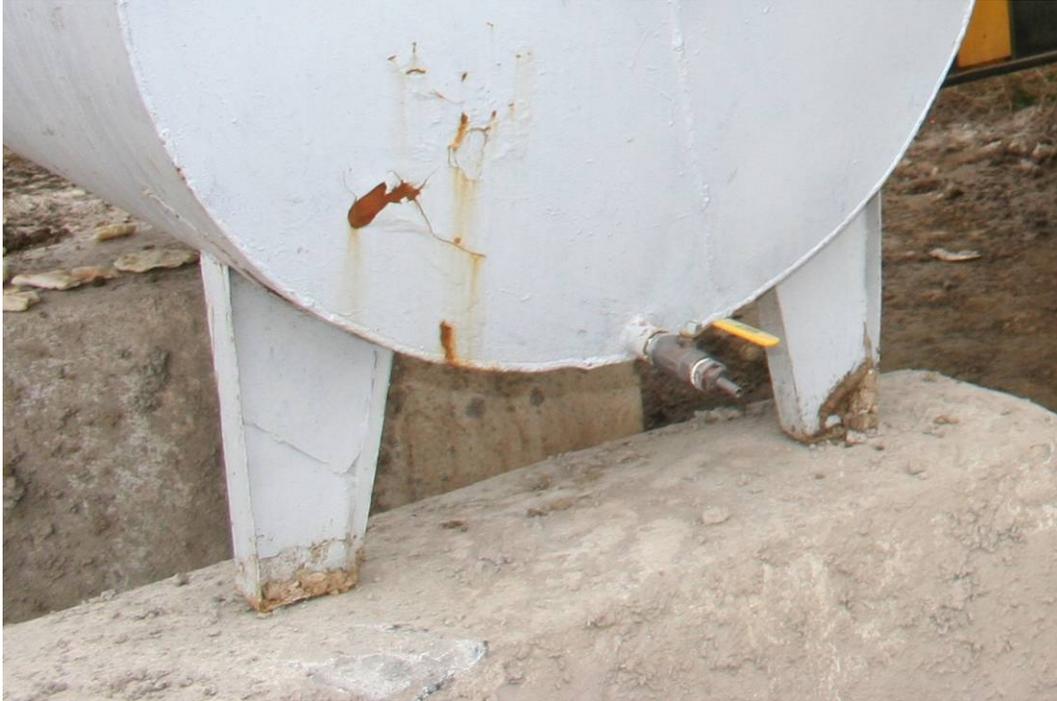
It appeared that the contractor installed, in accordance with SOW requirements, a new working generator with a fuel tank and automatic controls to start and switch to generator power in the event of disruption or loss of power from the municipal power grid. However, the generator system was inoperable when observed by SIGIR inspectors on 28 January 2007. IP personnel told SIGIR inspectors that various electrical control components “*did not work*” and no one knew how to operate or fix the generator. At the time of the site visit, the relay control panel door on the generator system was wide open and switch and control components were exposed to the elements. In addition, the inspectors checked and verified that the generator’s oil level was low (at the add mark when cold). While the oil was dirty and gritty to the touch, there was no visible evidence of metal shavings to suggest excessive engine wear. Lastly, the fuel line between the fuel tank and engine had been removed (Site Photo 10).

**Site Photo 10. Fuel line between the tank and the generator engine had been removed.**

- Make the generator operational.
- Reinstall lighting, switches, and other electrical components that have been removed or damaged.
- Implement an effective equipment and facility operations and maintenance program staffed with trained personnel.

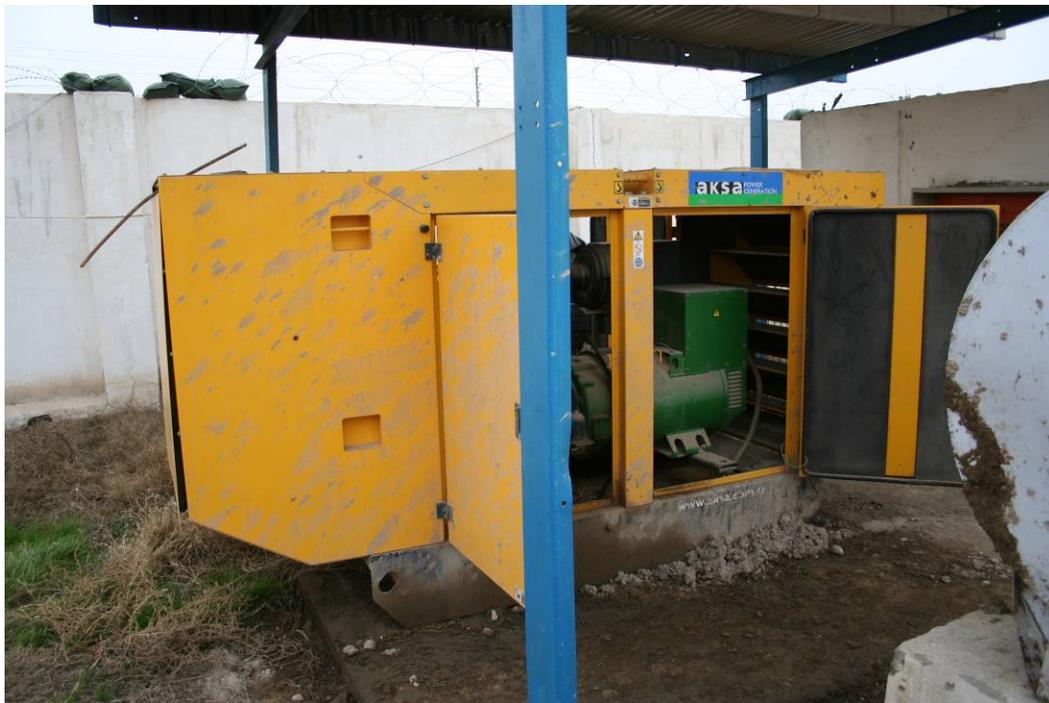
The new generator, which cost \$79,000, appeared to have been abandoned (Site Photo 11). Issues related to automatic transfer switch and controls will be addressed in the next section of this report.

**Site Photo 11. Without a fuel line and working controls, the new generator appeared abandoned.**

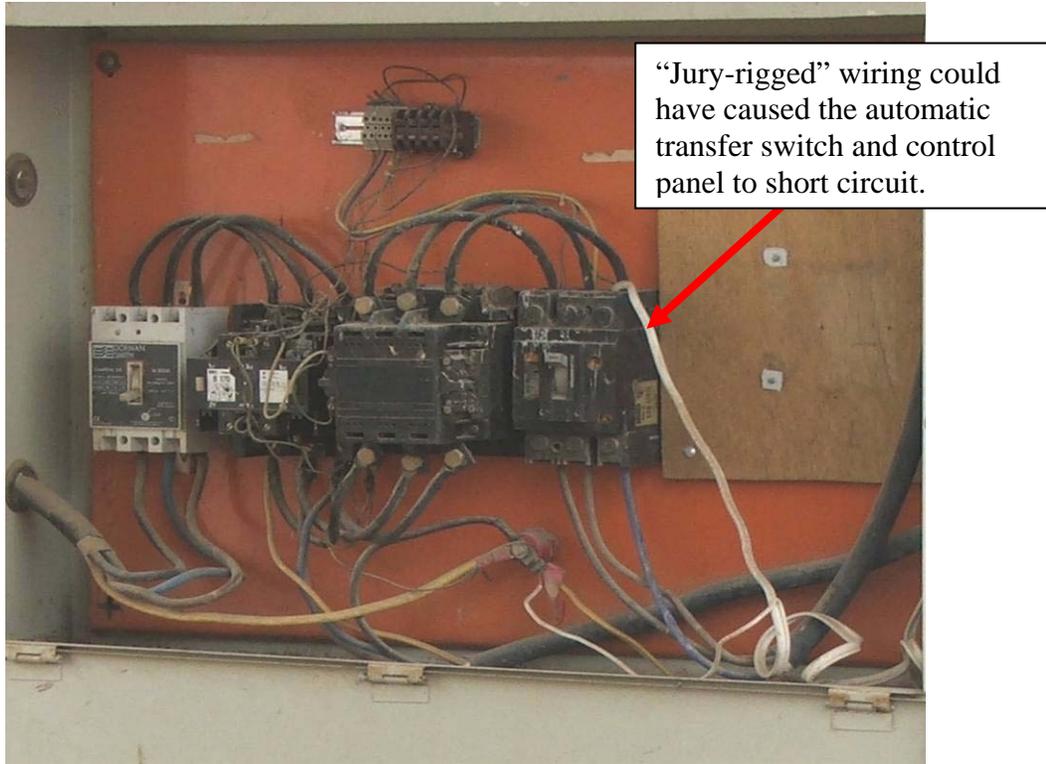
**Site Photo 12.**

SIGIR inspectors observed that the automatic transfer switch and control panel had been tampered with and that the door on the automatic transfer switch and controls panel was wide open and the expensive switching components were exposed. While the inspectors were told by IP personnel that the transfer switches were broken, we could not determine when or by whom the “jury-rigged” wiring was added to the circuitry (SIGIR Site Photo 12). In any case, “jury-rigged” wiring likely could have caused the automatic transfer switch and control panel components to short circuit and break down.

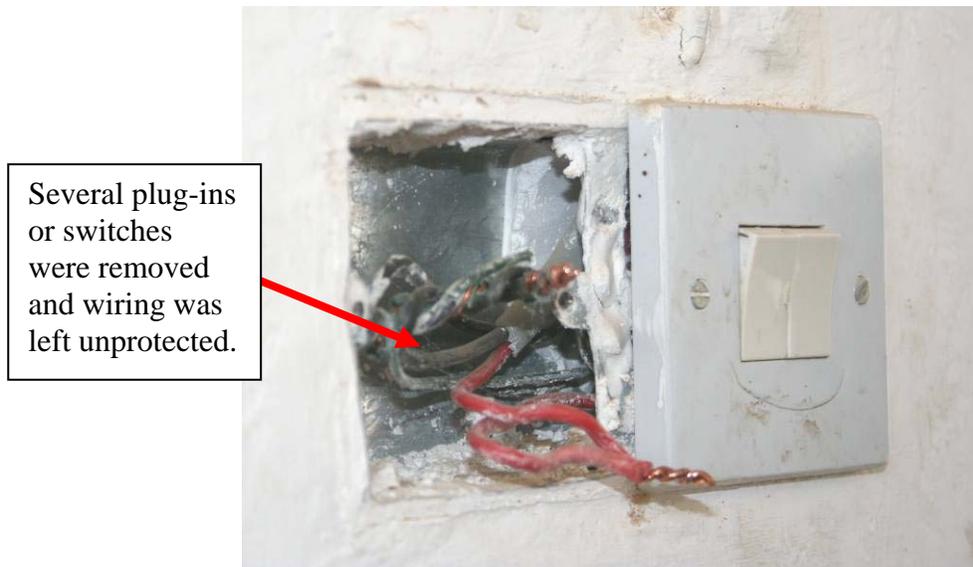
**Site Photo 13.**

Throughout the facility, SIGIR inspectors observed that numerous switches or plug-ins had been removed. In every case of a missing switch or plug-in, the wiring was crudely twisted together in order to keep the circuit closed as a means to allow power to flow to draw points (lights, switches, plug-ins, etc.) farther down the circuit. SIGIR Site Photo 13 is an example of one of several places where a switch or plug-in was removed.

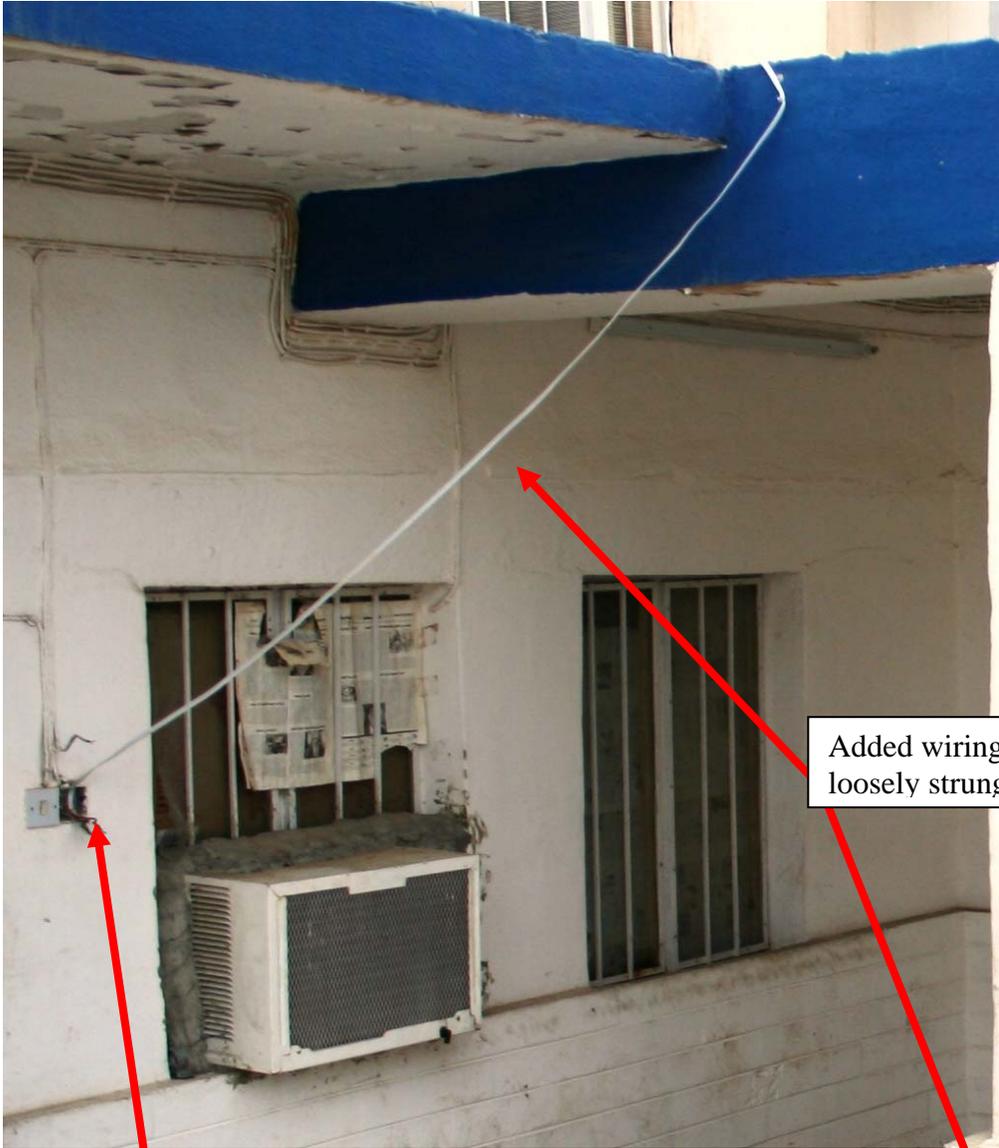
Site Photo 14.

In Site Photos 14 and 15 a typical form of tampering observed by SIGIR inspectors is shown. Site Photo 14 shows how added wiring was loosely strung. Site Photo 15 is a close up and it shows the technique used to “tap into” an existing circuit. Specifically, the existing circuit and load requirement was maintained by twisting the wiring together in order to close the existing circuit. However, the “jury-rigged” wiring that fed a draw point only added to the circuit’s potential load or draw.

Added wiring was loosely strung.

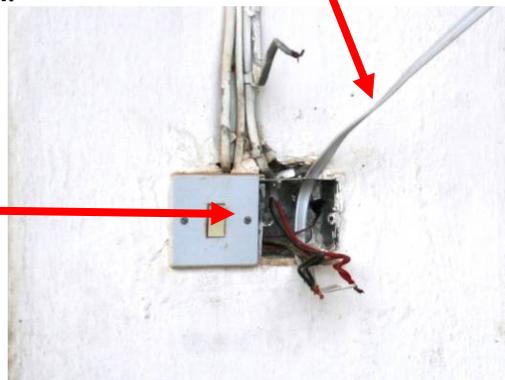
Site Photo 15.

Switch or plug-in was removed and added wiring "tapped into" the circuitry.
