GAUGLI-ASHUR POLICE STATION MOSUL, IRAQ

SUSTAINMENT ASSESSMENT

SIGIR PA-06-092 APRIL 26, 2007

SUBJECT: Report on Project Assessment of the Gaugli-Ashur Police Station Renovation, Mosul, Iraq (Report Number SIGIR-PA-06-092)

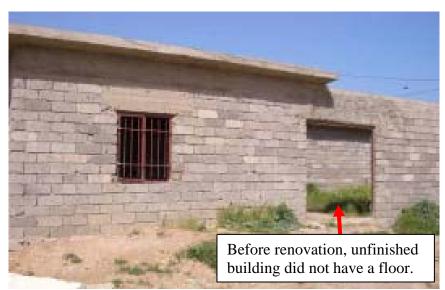
USACE Pre-Construction Photo 2.

The previously started but not finished detention center needed to be completed. Renovation work included installing a floor, detention cell, and steel bars over windows.

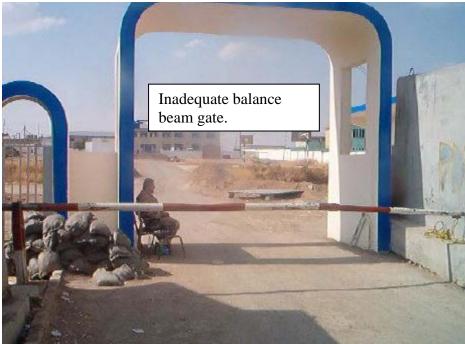
USACE Pre-Construction Photo 3.

Force protection was an important aspect of the renovation project. Accordingly, the SOW included requirements to install a heavy metal gate to prevent unauthorized access to the facility and construct rooftop guard houses. Before renovation, the balance beam gate shown below did not provide adequate security.

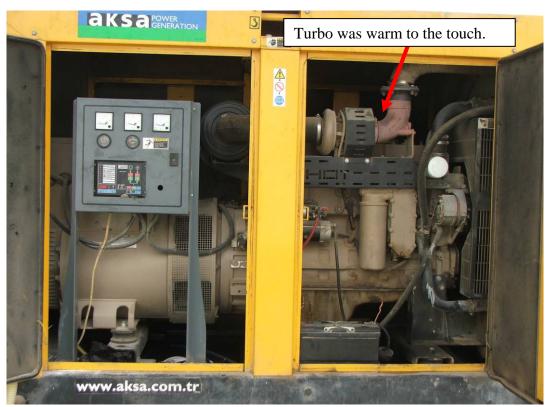
IP personnel stated that the generator and transfer switch system were operational and often used at night. SIGIR verified that the generator's oil level was full and the engine's turbocharger was warm to the touch (Site Photo 1). Accordingly, it was very likely that the generator system had been running the previous night.

Site Photo 1. The generator installed per requirements appeared completely operational without any signs of neglect. When checked, the oil level was full and did not feel gritty. Belts and hoses appeared serviceable.

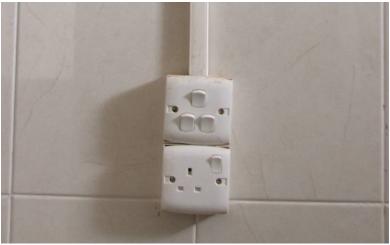
While on site, SIGIR did not observe any instances of potentially harmful electrical system tampering. Wiring improvements appeared compliant with SOW requirements (Site Photo 2). In addition, several showers, sinks, and toilets were tested to verify that they were fully operational. Interior and exterior plumbing improvements included new and upgrade showers, toilets, water heaters, piping, and sink installations appeared proper (Site Photo 3). Also, it appeared that numerous water supply tanks had been installed throughout the facility (Site Photo 4). SIGIR did not observe any evidence of chronic septic tank overflow and there was no sewer water standing² in the area. Interior and exterior painting appeared complete and compliant with SOW requirement in terms of paint type, color, and placement scheme. Rooftop guard houses were placed in such a manner that fields of fire and observation were maximized in order to improve the station's defensive position if

Site Photo 2. Throughout the facility wiring, switches, and plug-ins were securely fastened to walls as required by the SOW.

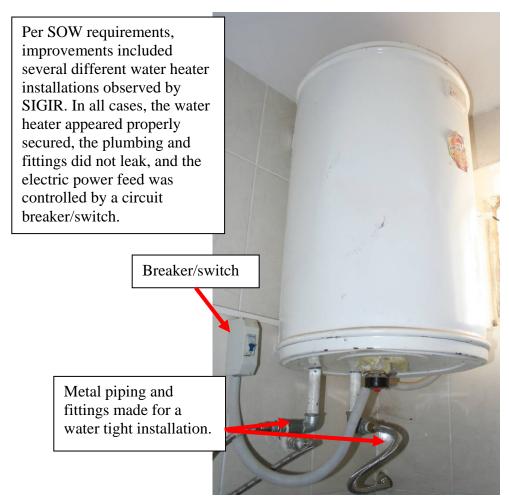
Site Photo 3. Water heater.

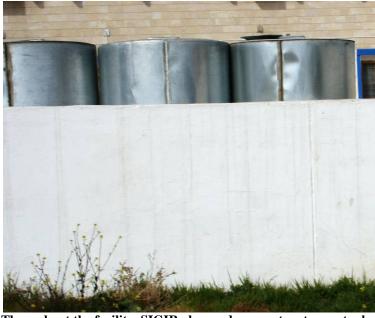
Site Photo 4. Throughout the facility, SIGIR observed new water storage tanks to meet SOW requirements to provide adequate supply.

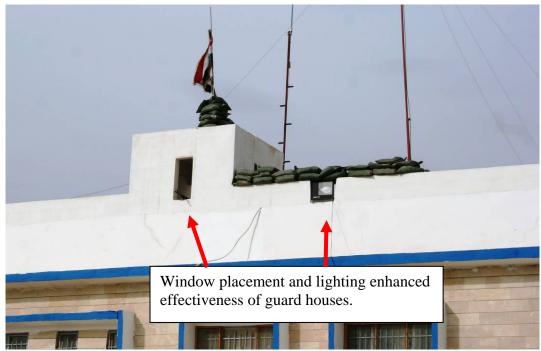
Site Photo 5. As required, new rooftop guard houses and lighting upgrades improved force protection capability.

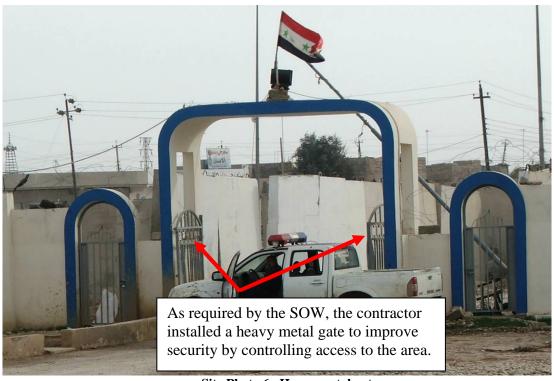
attacked (Site Photo 5) and a heavy gate to control access to the area was installed by the contractor to meet SOW requirements (Site Photo 6). Lastly, SIGIR observed the detention center was functional and in use (Site Photo 7).

Site Photo 6. Heavy metal gate.
