MINISTRY OF DEFENSE BUILDING  
BAGHDAD, IRAQ

SUSTAINMENT ASSESSMENT

**SIGIR PA-07-102**  
**JULY 17, 2007**

## Ministry of Defense Building Baghdad, Iraq

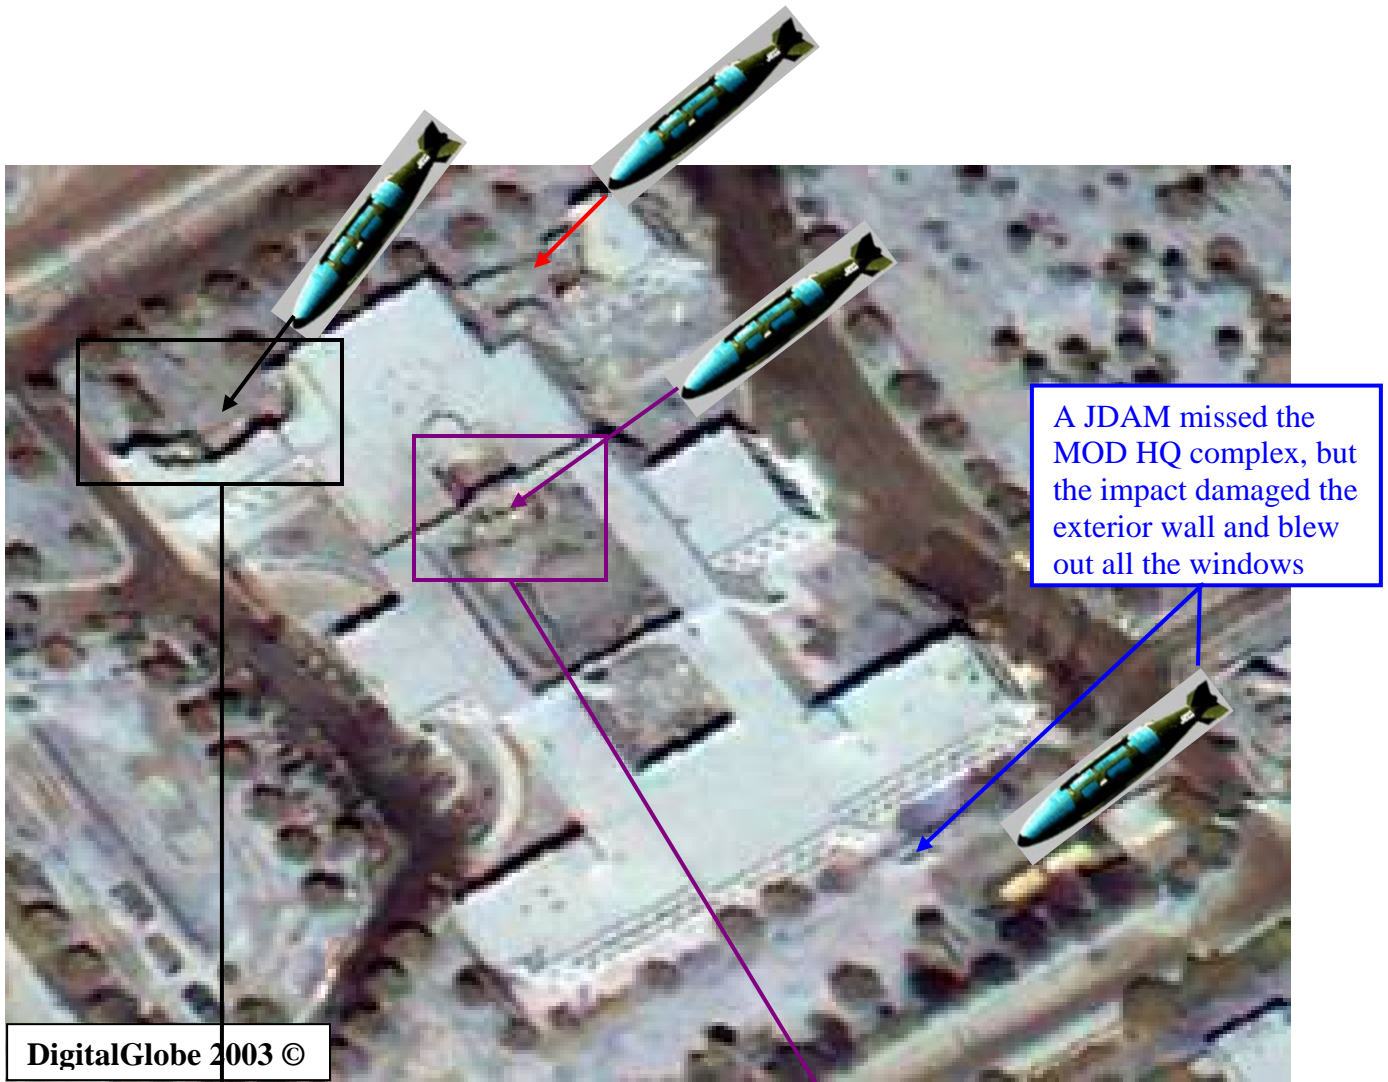
The MOD HQ complex is situated in the International Zone. The facility consisted of an H shaped building with entrance and exit foyers (Aerial Image 1). The original construction of this building started in 1957 and was completed in 1961. This complex received catastrophic damage from both the 2003 Joint Direct Attack Munition (JDAM) bombing barrage of Baghdad and subsequent looting (Aerial Image 2 and Site Photos 1 and 2).

Aerial Image 2. Aerial view of 2003 JDAM bombing damage to the MOD HQ building

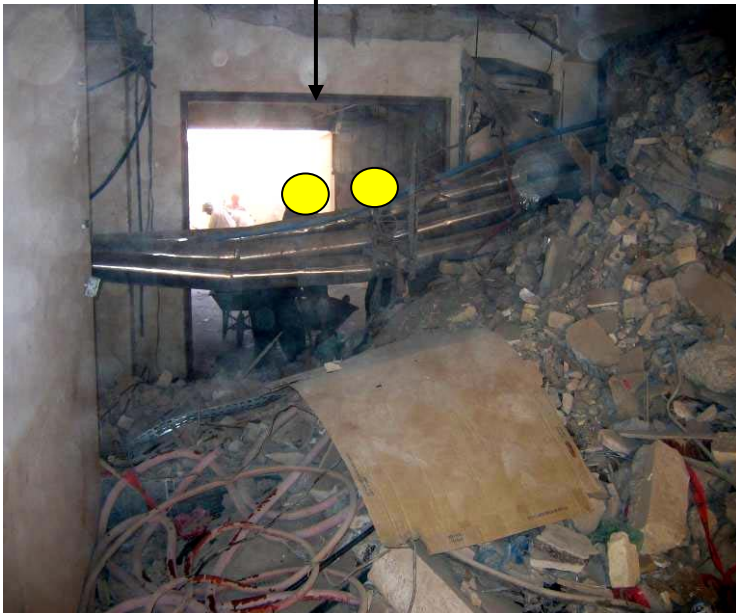
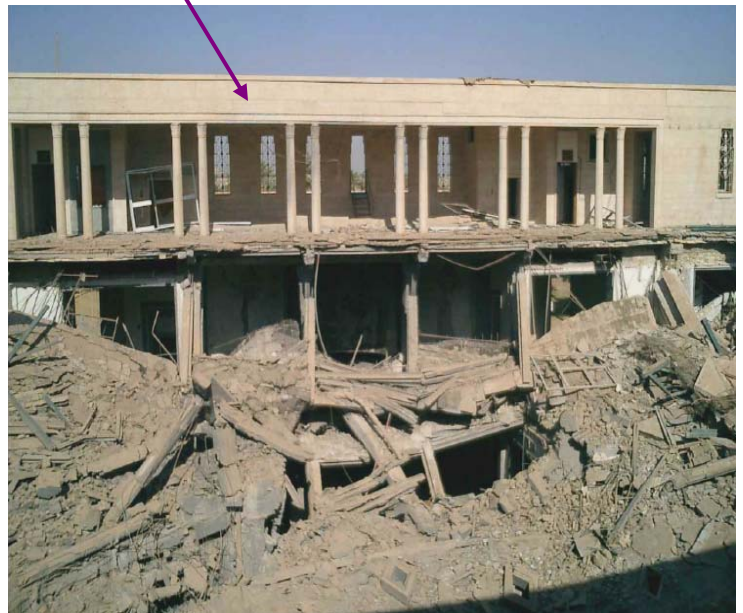
Site Photos 1 and 2. Interior and exterior JDAM bomb damage to the MOD HQ building (Photos courtesy of Laguna Construction)

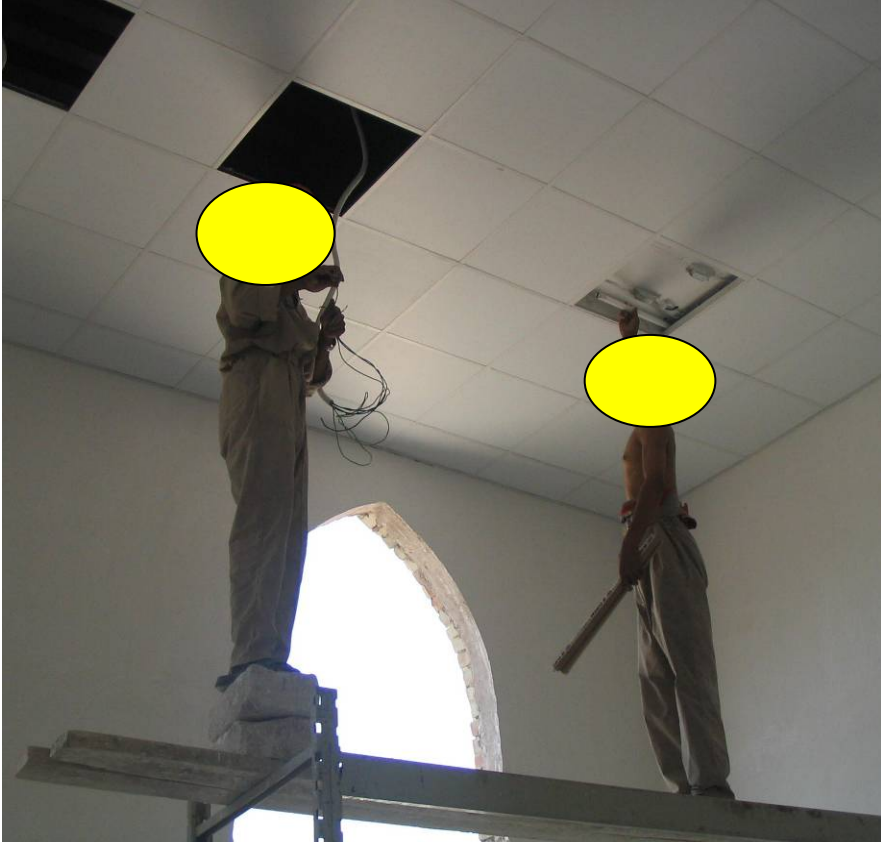
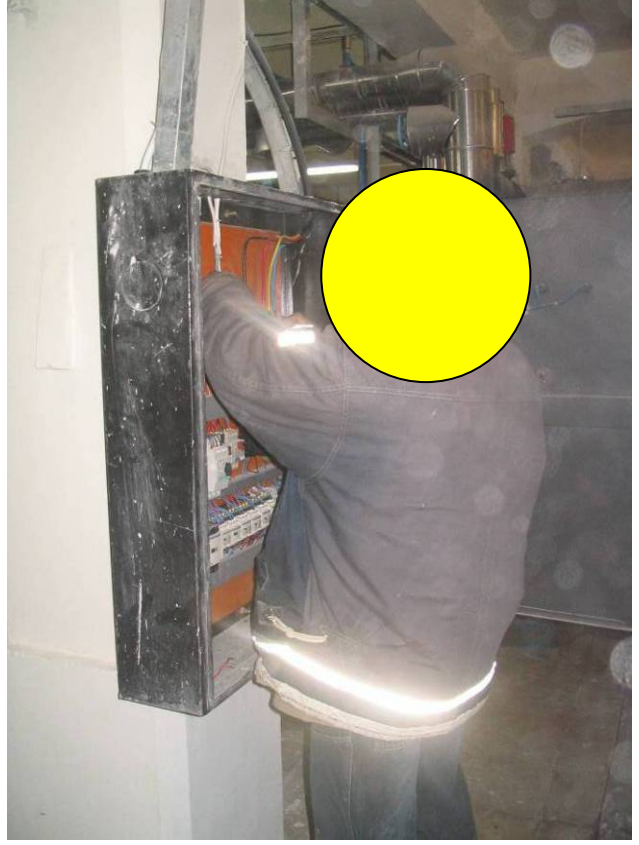
Site Photos 3 and 4 document the installation of electrical wiring within the interior of the MOD building. The installation of air conditioning duct work and the construction of the third floor are captured in Site Photos 5 and 6. Finally, the progression of work on the severely damaged left wing of the MOD HQ complex is shown in Site Photos 7-9.

**Site Photos 3 and 4. Installation of electrical wiring in the MOD HQ building (Photos courtesy of Laguna Construction)**

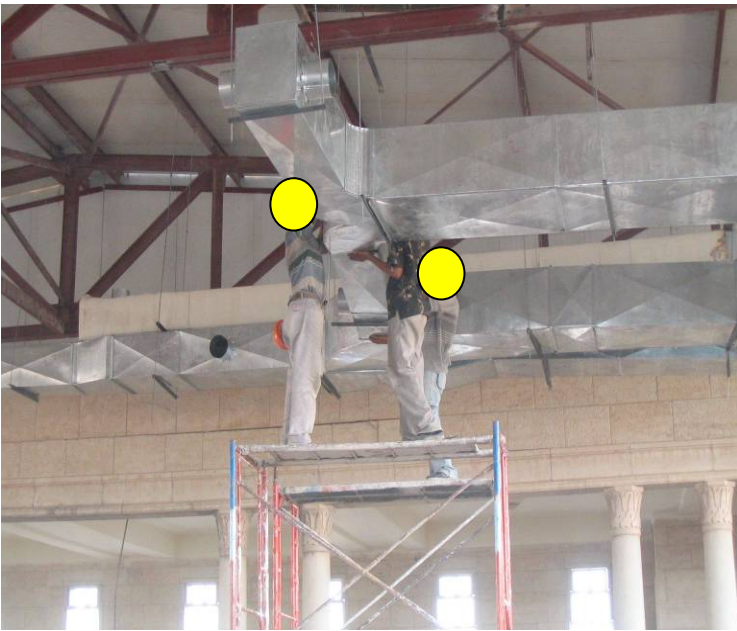
**Site Photo 5. Installation of air conditioning duct work (Photo courtesy of Laguna Construction)**

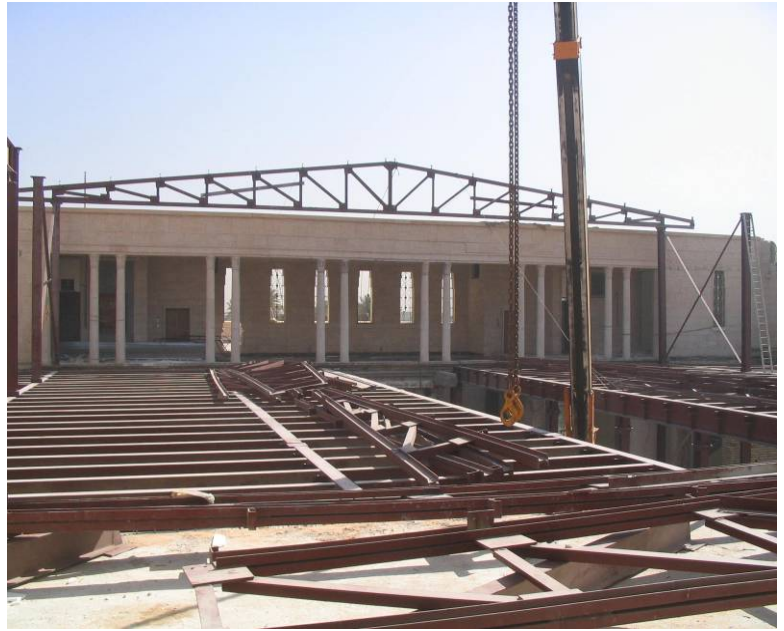
**Site Photo 6. Construction of the third floor (Photo courtesy of Laguna Construction)**

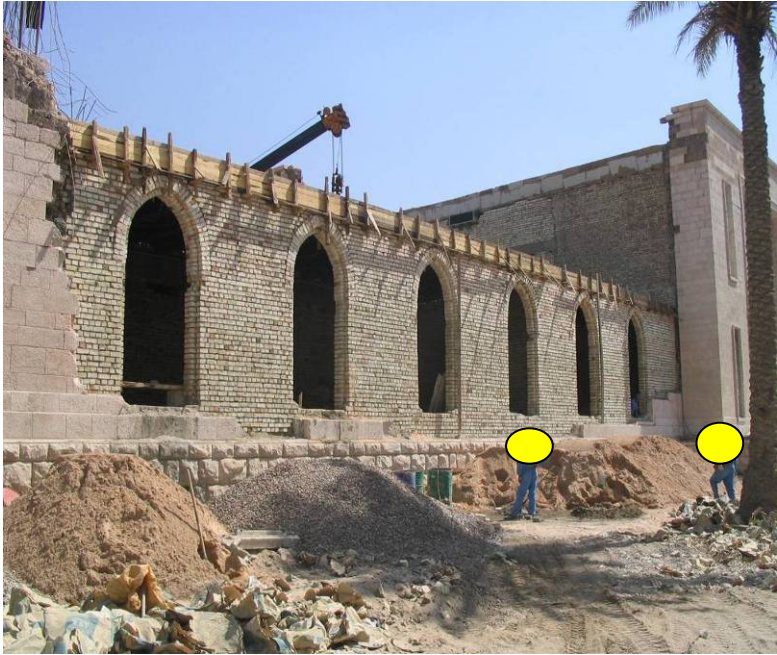
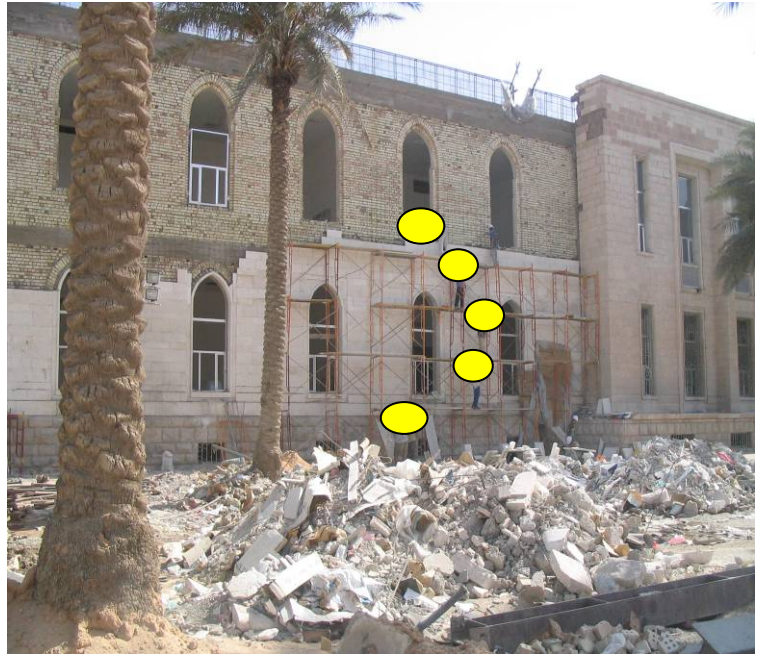
**Site Photos 7 and 8. Early construction work on the severely damaged left wing of the MOD HQ building  
(Photos courtesy of Laguna Construction)**

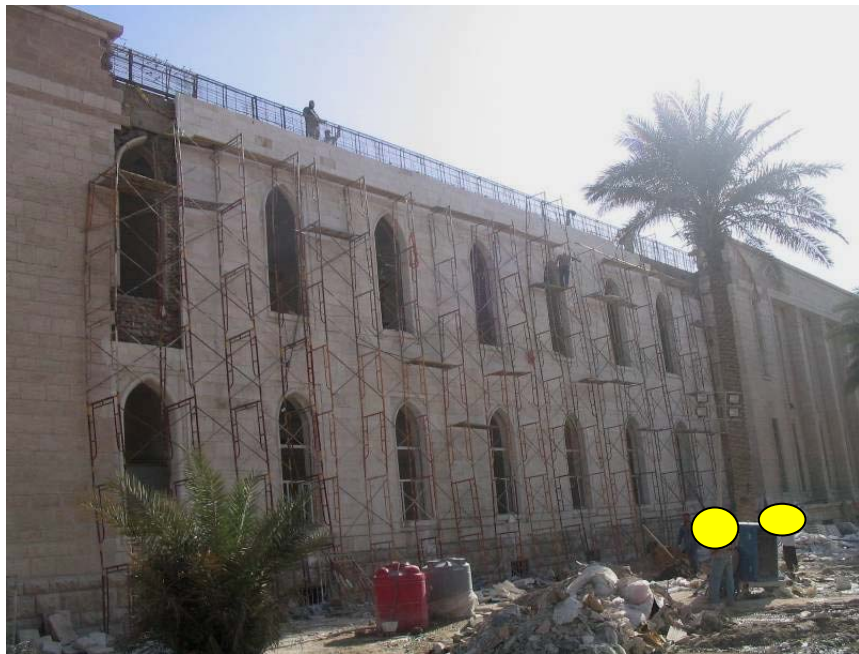
**Site Photo 9. Near completion of the left wing of the MOD HQ building  
(Photo courtesy of Laguna Construction)**

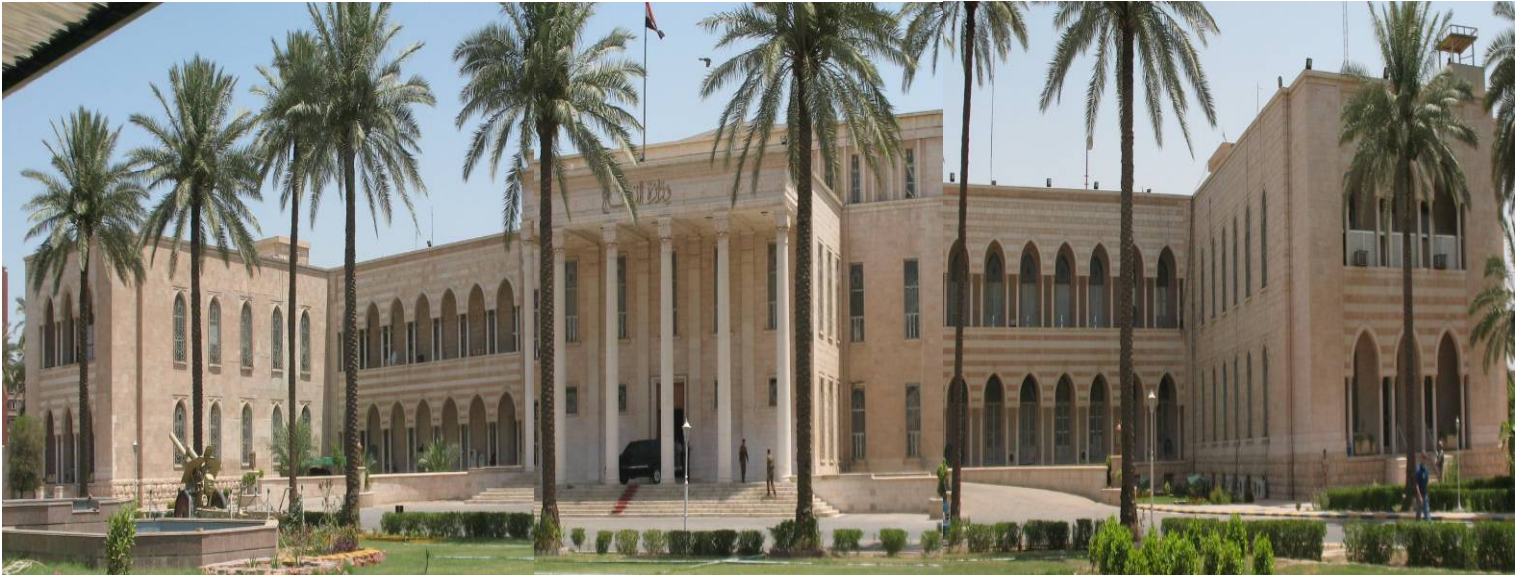
**Site Photo 10. Exterior view of the renovated MOD HQ building**

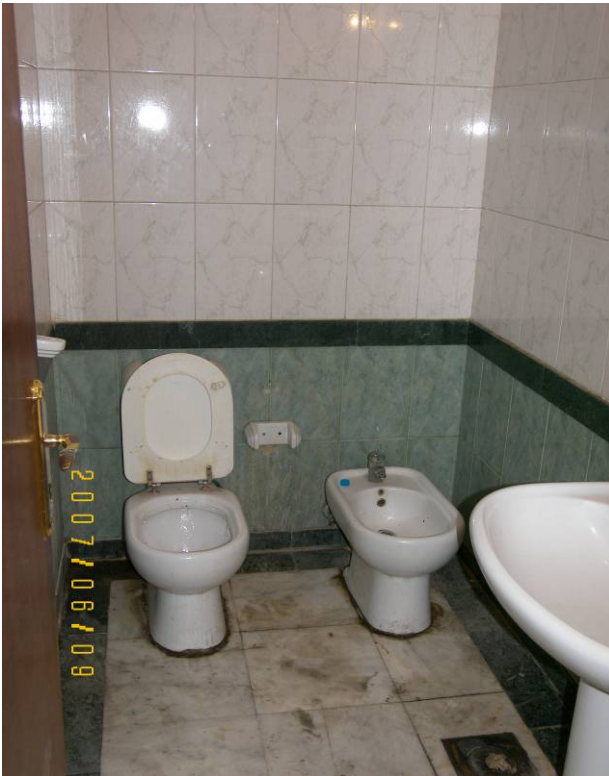
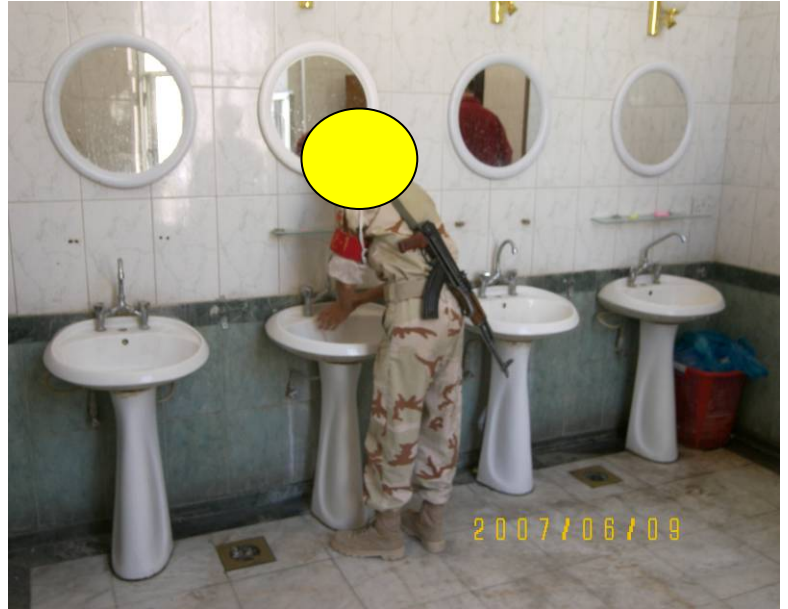
During our site visit, we did not detect any instances of potentially harmful electrical system tampering. Wiring improvements appeared compliant with the SOW requirements. In addition, we tested several toilets and sinks to verify they were fully operational. Interior and exterior plumbing improvements included new toilets, sinks, water heaters, and piping (Site Photos 11 and 12).

**Site Photos 11 and 12. Newly installed toilets and sinks within the MOD HQ bathrooms**

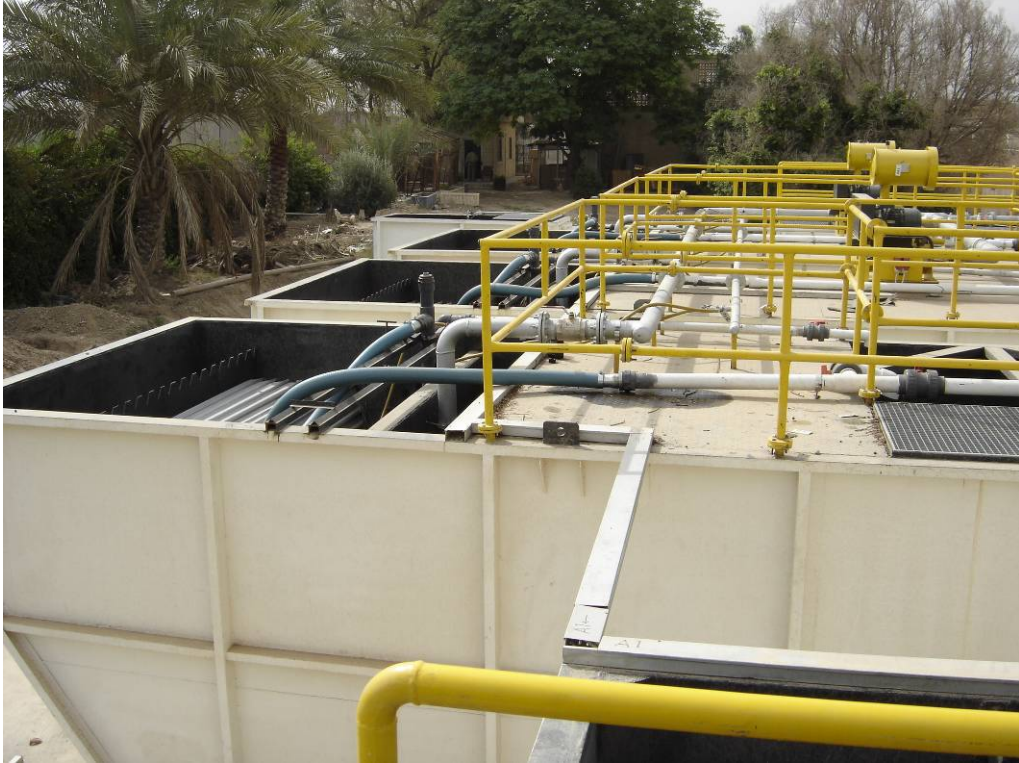
According to the contractor, prior to the installation of the WWTP, all waste water leaving the MOD HQ building was deposited directly into the Tigris River. In order to avoid continuing the practice of depositing untreated waste water into the Tigris River, the contractor-provided packaged WWTP appears to meet the MOD's needs in terms of total waste water volume. This packaged WWTP, located outside the MOD HQ building, captures and treats the waste water before it is discarded into the Tigris River. The design required that a wet-well collect all waste water from the entire building and a sewage lift station, with properly sized mechanical components and pipes, delivers effluent to the packaged WWTP for treatment. We inspected the installed packaged WWTP (Site Photo 13). We did not observe any abnormalities in the present operation of the WWTP nor did the WWTP exhibit any signs of malfunction. The WWTP appeared to be fulfilling its intended operational goals. According to the contractor's site photos, it appears the MOD personnel are performing adequate maintenance on the WWTP (Site Photo 14). Continual maintenance of the WWTP will prolong its life expectancy and effectiveness.

**Site Photo 13. Packaged WWTP outside the MOD HQ building**

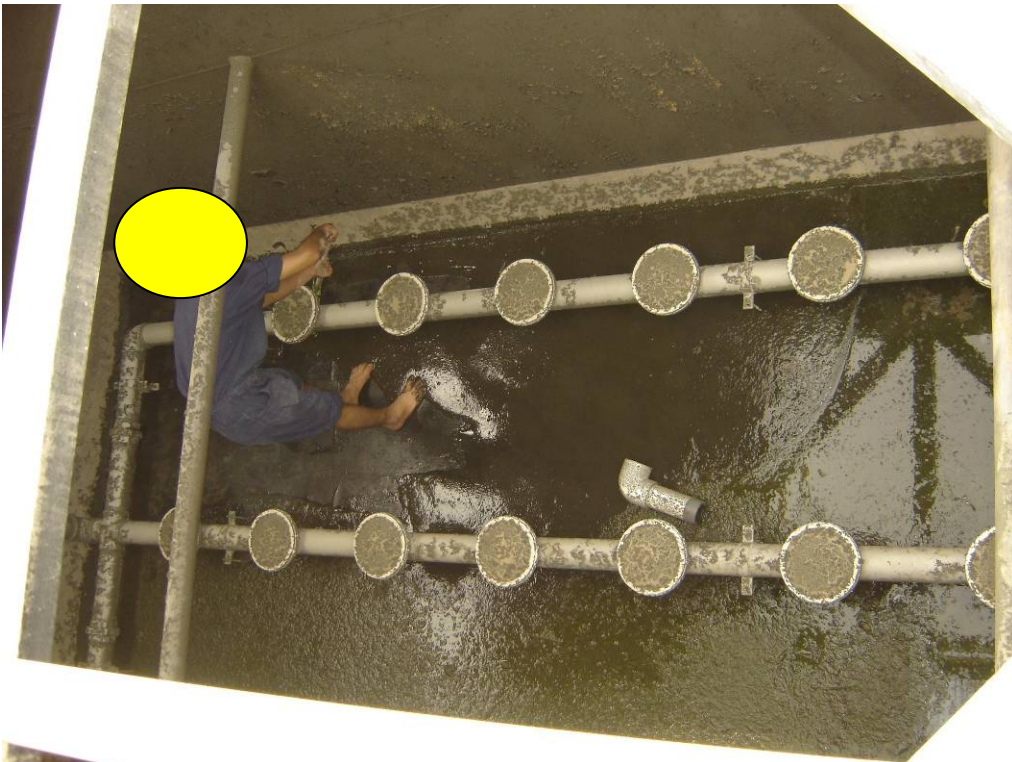
**Site Photo 14. MOD personnel performing routine maintenance on the packaged WWTP**

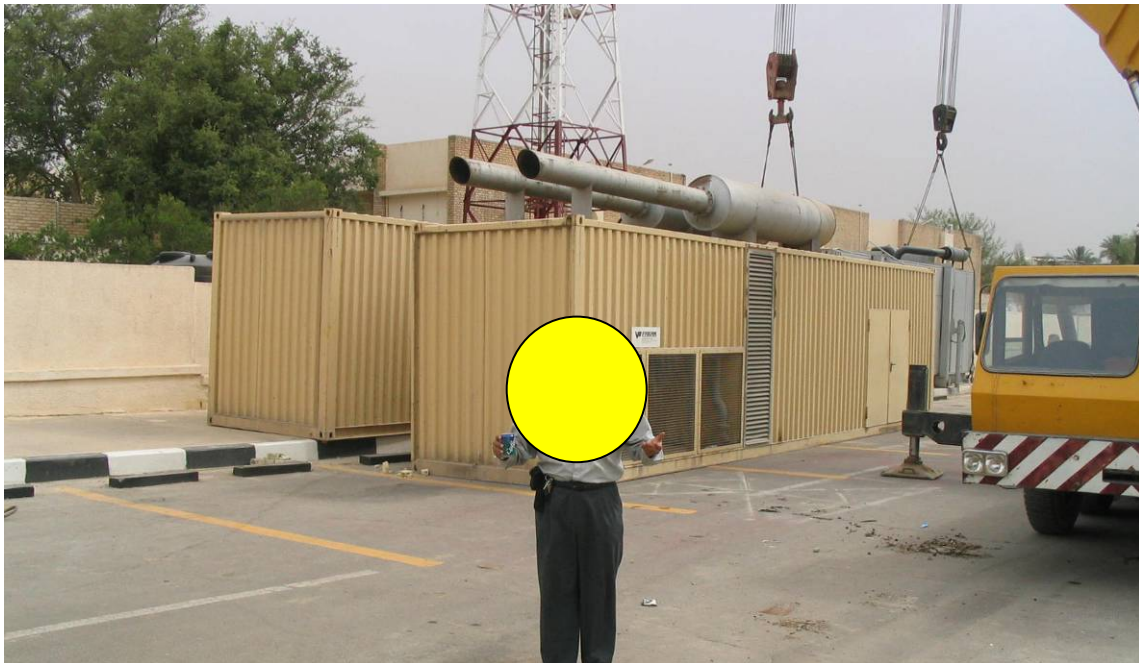
We inspected the MOD HQ building's major support systems, such as lighting, data and voice communication, HVAC, water pumps, and WWTP, all of which appeared to be functioning adequately. The primary source of all MOD HQ building power is the Baghdad power grid; however, it is also supported by two 2-Megawatt (MW) generators and other lesser capacity generator sets. The contract required the refurbishment of two existing large generators, which were successfully commissioned with the required automated controls and transfer switches (Site Photo 15). At the time of our visit, the MOD HQ building was operating off of the Baghdad power grid; consequently, we were unable to observe the functioning of special controls and transfer switches that bring the generators on line. However, MOD personnel stated that the generators and transfer switch system were operational and continuously used when the Baghdad power grid was down<sup>1</sup>.

**Site Photo 15. Contractor repositioning the refurbished two 2-MW generators  
(Photo courtesy of Laguna Construction)**

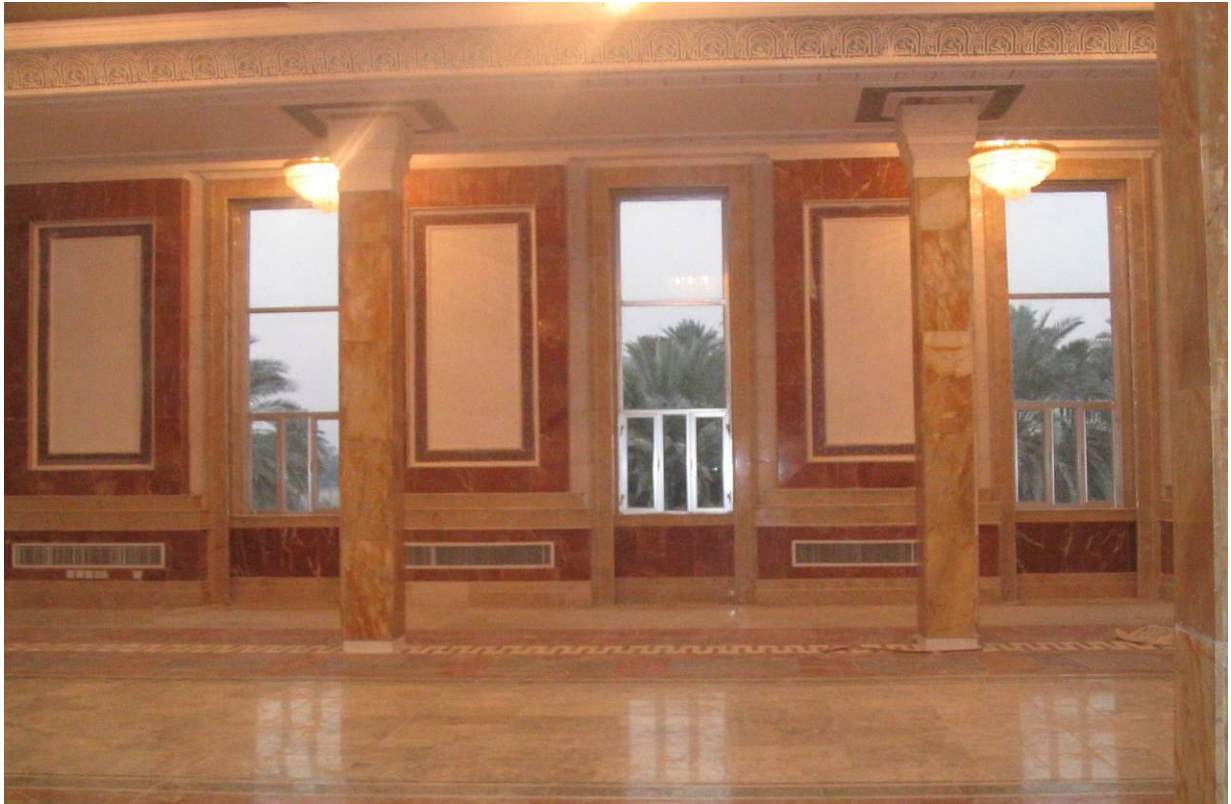
**Site Photo 16. A finished interior ballroom within the MOD HQ building  
(Photo courtesy of Laguna Construction)**

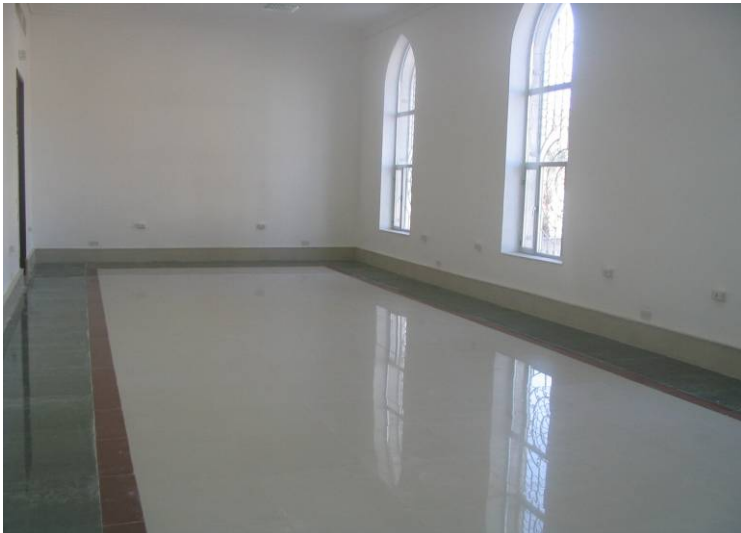
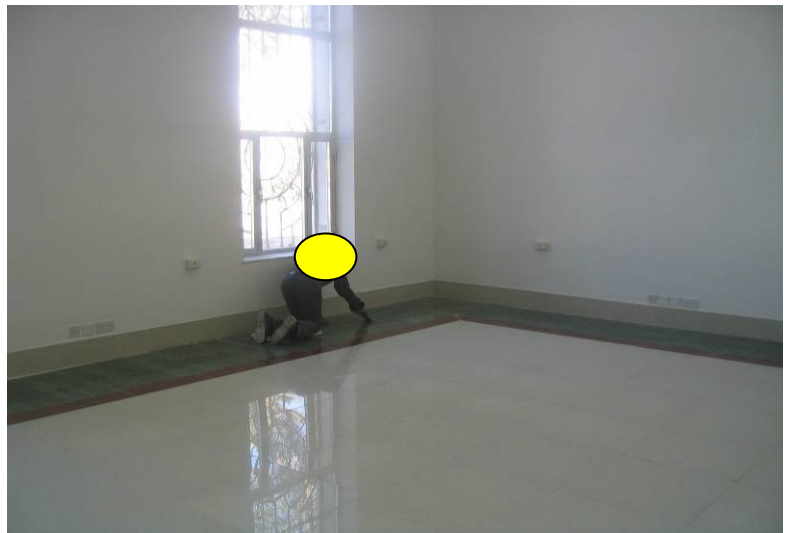
**Site Photos 17 and 18. Quality workmanship done to the interior of the MOD HQ building  
(Photos courtesy of Laguna Construction)**

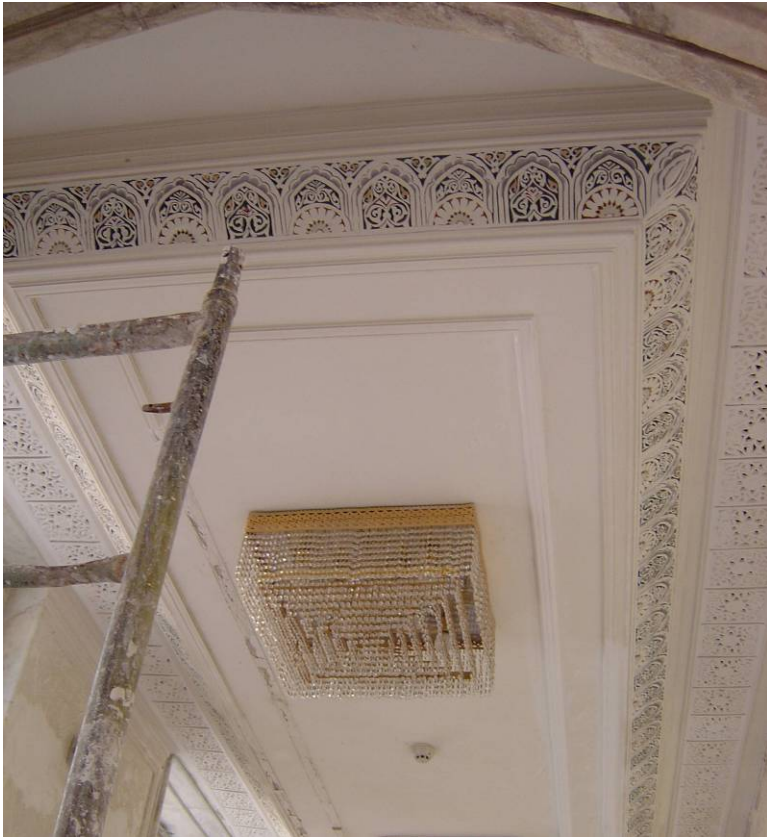
During our site inspection of the MOD HQ building's interior, we observed the contractor's detailed and quality workmanship. Site Photos 16-18 document the aesthetic beauty of the contractor's interior workmanship. According to the contractor, every effort was made to retain the elegance of this former palace<sup>2</sup>. An example of the contractor's attention to even the most minute detail is the ceiling tiles. For the ceilings in the hallways and office areas, any existing ceiling tiles were replaced with exact replicas. The contractor stated the reason for this was the previous ceiling tiles were inscribed with the name of Saddam Hussein; while the new replicas did not have this inscription (Site Photos 19-21).

**Site Photo 19. Installation of new ceiling tiles and fixtures  
(Photo courtesy of Laguna Construction)**

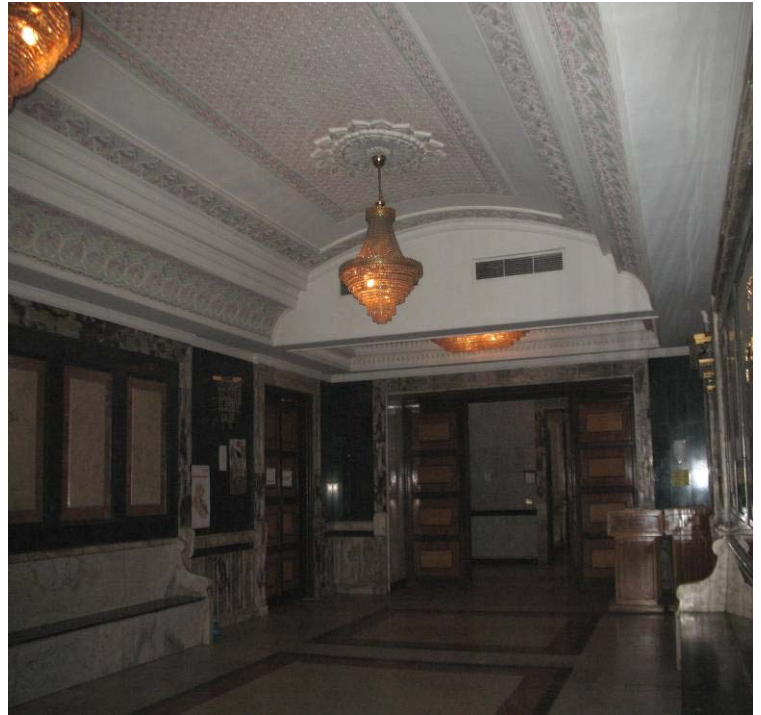
**Site Photo 20. Newly renovated ceiling**

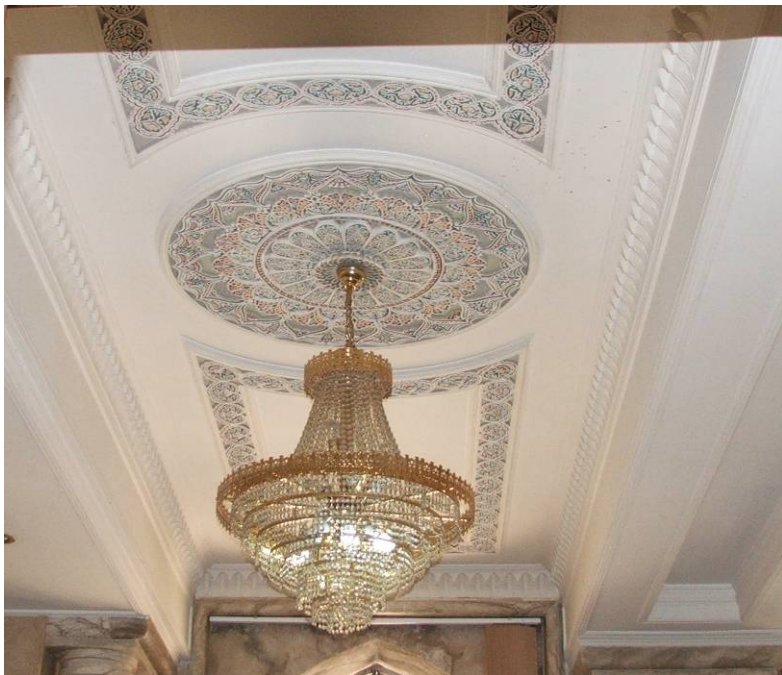
**Site Photo 21. Ceiling tile and light fixture**

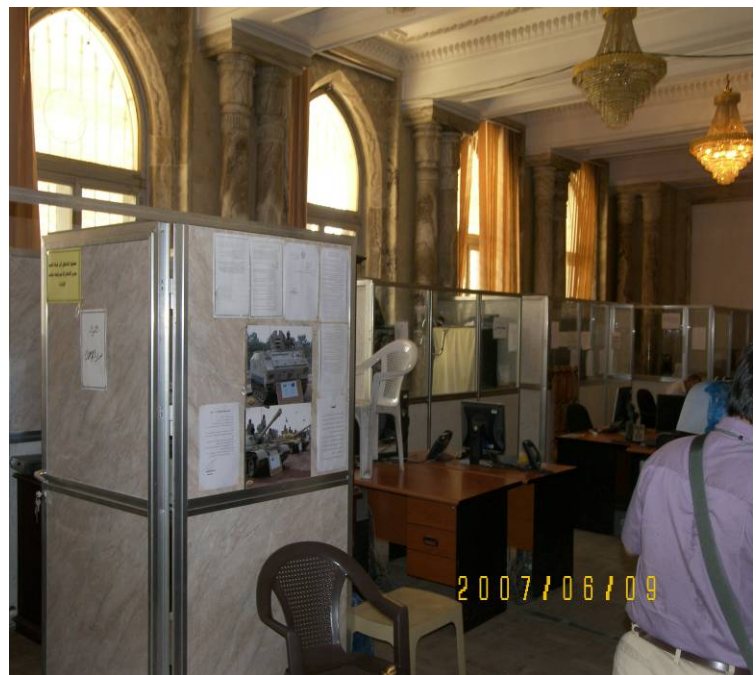
According to the contractor and MOD officials, the current usage of the building far exceeds the original intent of providing working space for approximately 450 MOD personnel. It is currently estimated that more than 3,000 MOD personnel now work in the MOD HQ building on a daily basis. However, accommodations for the additional MOD personnel were made without major disturbance to the contractor's work. For example, large ballrooms were turned into office space through the use of cubicles (Site Photo 22).

**Site Photo 22. Interior ballroom turned into additional office space through the use of cubicles**
