NINEWA PROVINCIAL POLICE
HEADQUARTERS
MOSUL, IRAQ

SIGIR PA 06-072
OCTOBER 10, 2006

SUBJECT: Report on Project Assessment of the Ninewa Provincial Police Headquarters,
Mosul, Iraq (Report Number SIGIR-PA-06-072)

Ninewa Provincial Police Headquarters, Mosul, Iraq

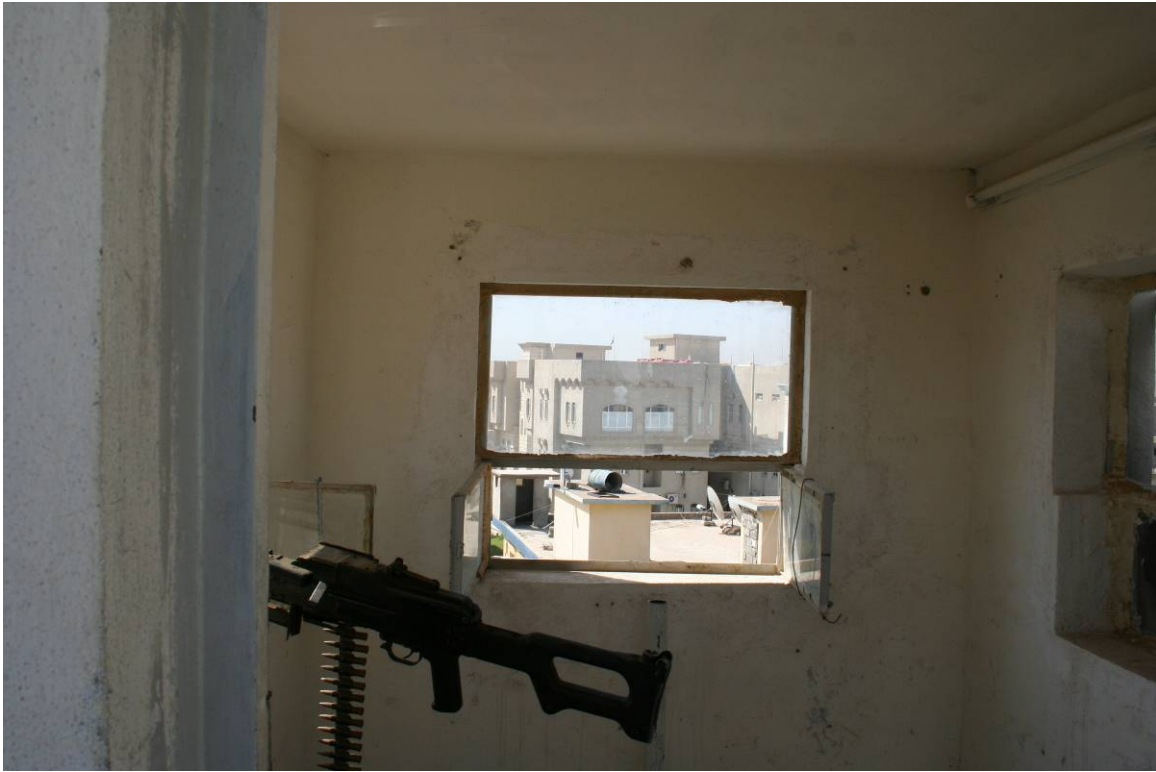
The guardhouses on the commander building did not include a fan as required and were constructed with an extra window. As a result, exposure of the guards was increased. There was no evidence that roof repairs were completed in accordance with contract terms. The contractor did not install 81 of the 134 air conditioner units specified in the BOQ. The contractor neither renovated the existing water supply system nor provided new water supply and distribution systems components when required. Old and corroded galvanized water tanks and pipes were not replaced. Throughout the facility, wall and bathroom construction and refurbishment were very substandard. Walls and enclosures were crudely constructed. Wall repainting was not complete. Multiple bathroom defects were the result of the contractor's failure to comply with numerous design and specification requirements. For example, showers were not tiled from floor to ceiling, existing wall tiles and surfaces were improperly painted, defective toilet fixtures were not replaced, and defective plumbing hardware was sometimes by-passed or painted to avoid replacement with new hardware. While a new bathroom addition was completed, it was not constructed to specifications. The generator supplied by the contractor was placed at the wrong location without a hookup. Although required, the main septic tank was not replaced with the required tank with three times the capacity of the original. Debris, rubble, and waste materials

Site Photo 1. Contrary to contract requirements, four guardhouses were built without a fan, but with an extra window which increases the exposure of the guards.

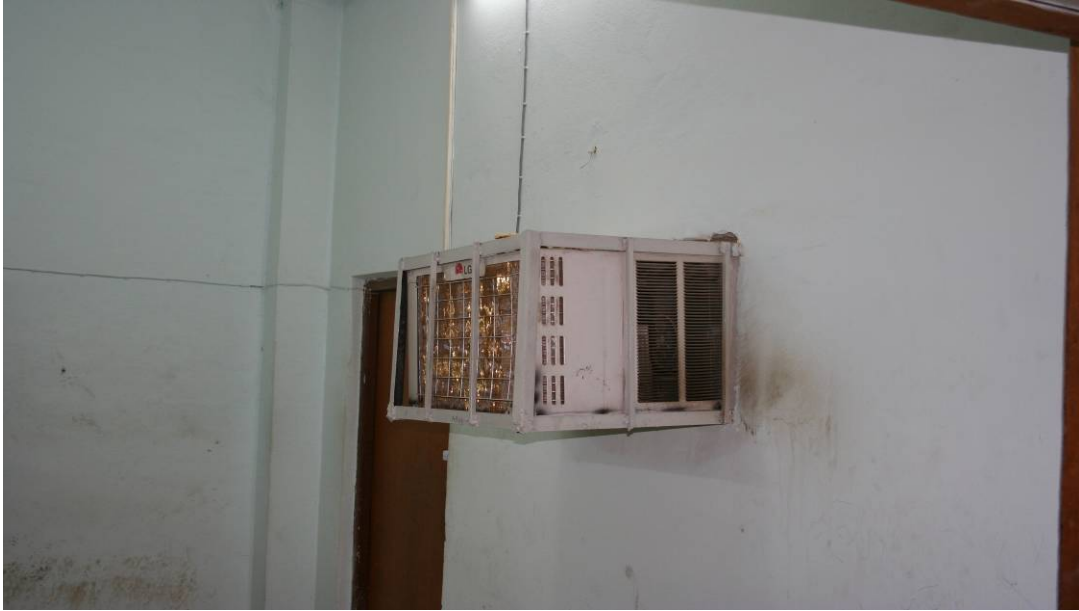
Site Photo 2. This window air conditioner unit should not have been installed in a building interior location because contained units release large amounts of heat into the ambient interior air. The contractor should have installed a more costly split-unit system designed for use in an interior location such as this.

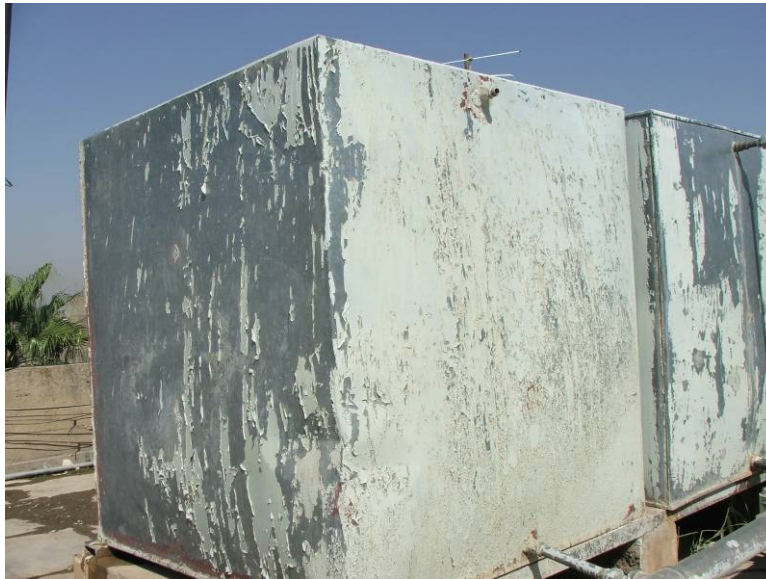
Site Photo 3. Existing water tanks left in place versus installing new units as required.

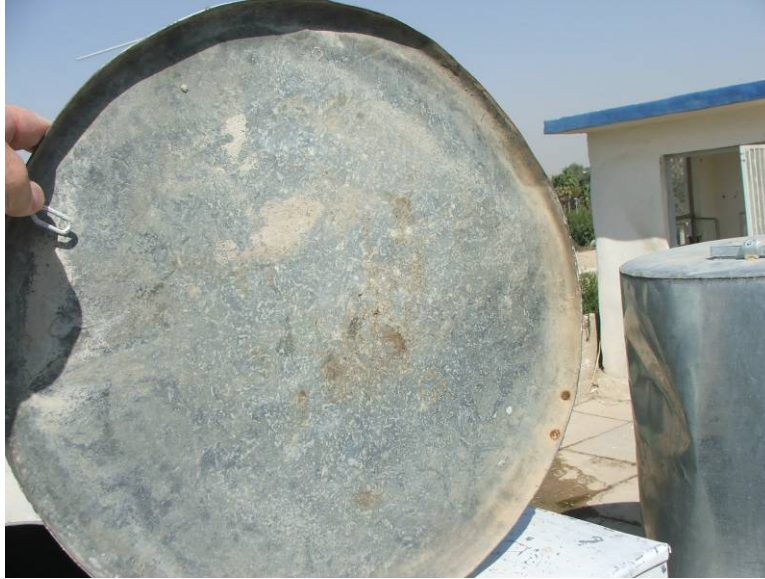
Site Photo 4. Lid from existing galvanized tank showed substantial corrosion.

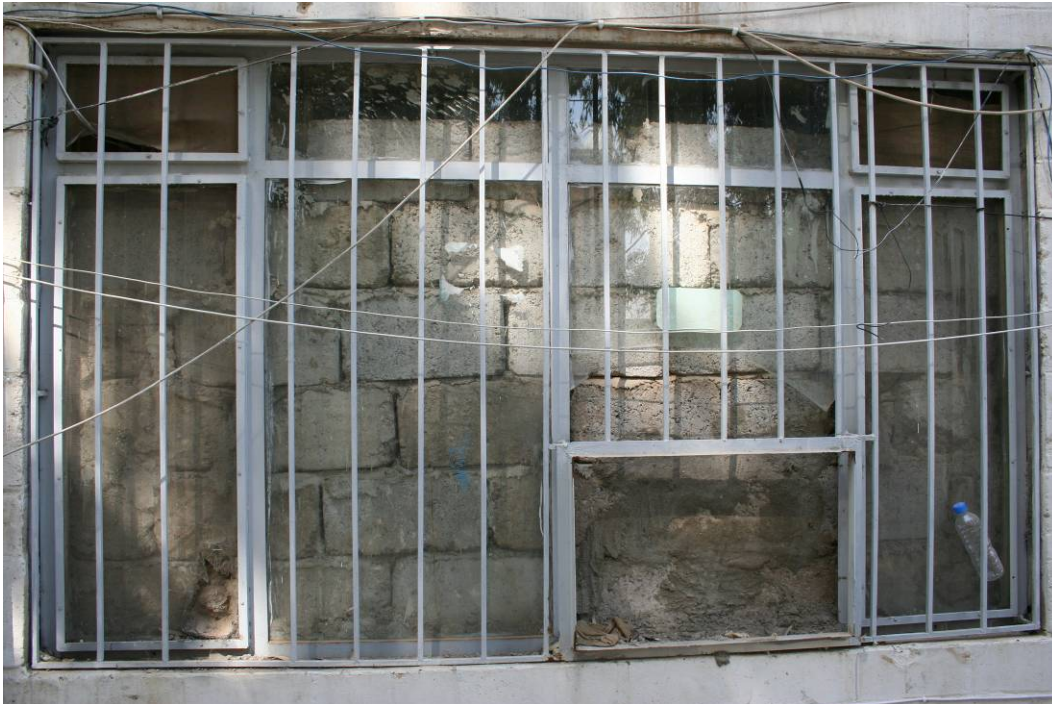
Throughout the facility, construction of windows and doorways was poorly completed. Window and door frames should have been removed and roughed in with blocks or other suitable framing material to facilitate flush finish work with plaster or other appropriate wall board material.

Site Photo 5. Blocks with only horizontal mortar joints merely stacked outside a window.

Site Photo 5 shows that the wall's top course (row) falls short of covering the window from bottom to top. The SOW requirement to enclose exterior exposures in a weather tight manner was not met.

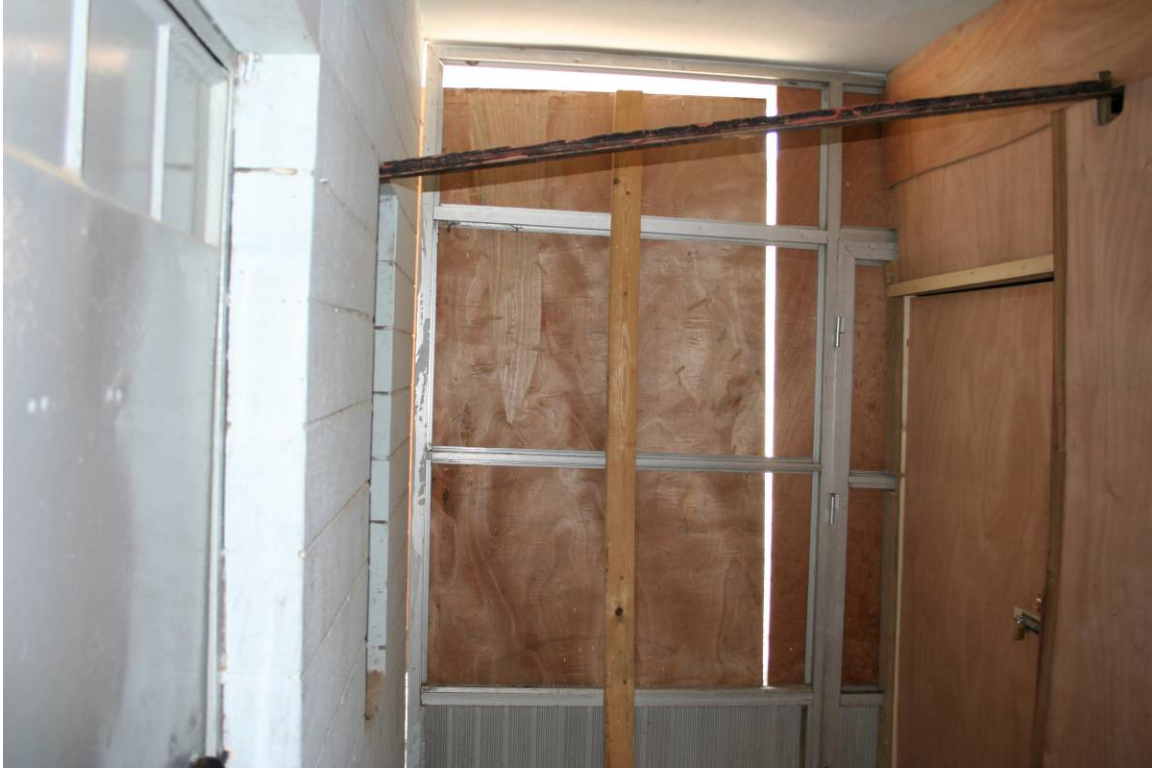
Site Photo 6. Plywood used to enclose metal frame was crudely held in position by tacking to only one piece of 2 by 4 lumber. The fit was not weather tight.

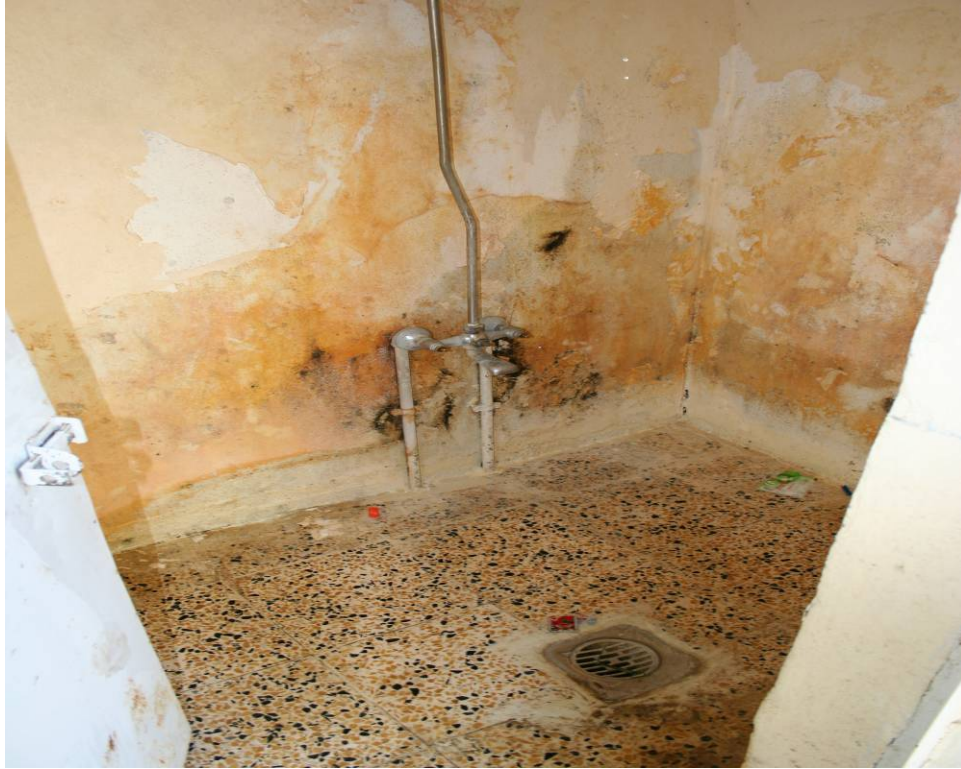
Site Photo 7. The shower wall was painted with plaster versus being grouted with tile from floor to ceiling as required.

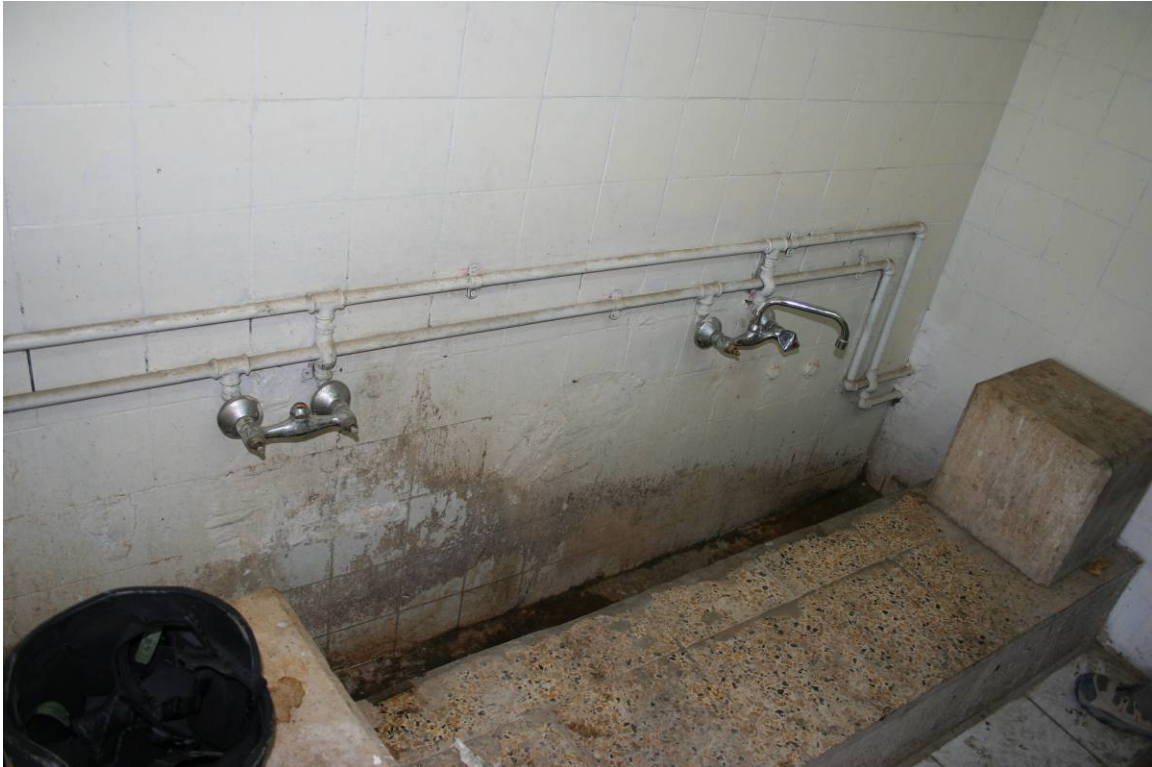
Site Photo 8. Existing wall tile was painted and existing leaking faucets were not replaced. Left faucet was capped/disabled instead of being replaced.

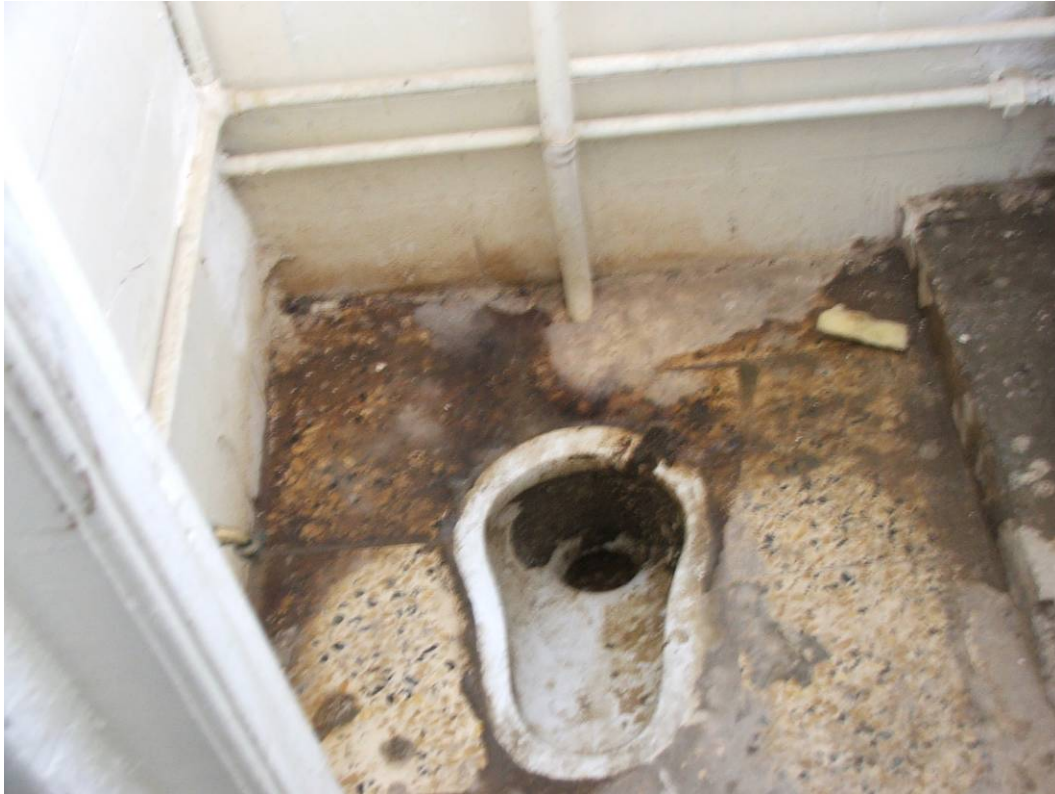
Site Photo 9. Original water closet toilet fixture should have been replaced. The wall should have been tiled and grouted from floor to ceiling and not painted.

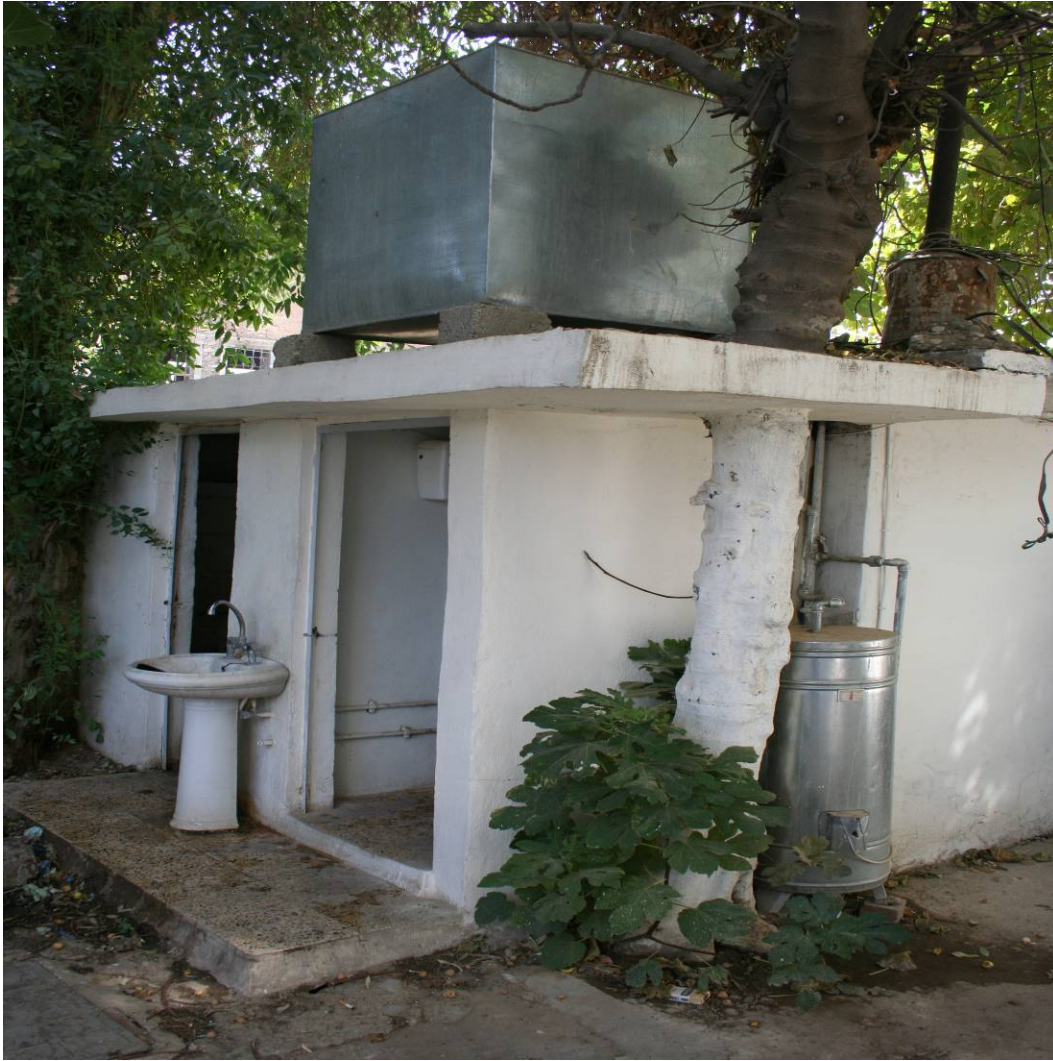
Site Photo 10. “Shady Construction” trees were not removed when the new latrine was built.

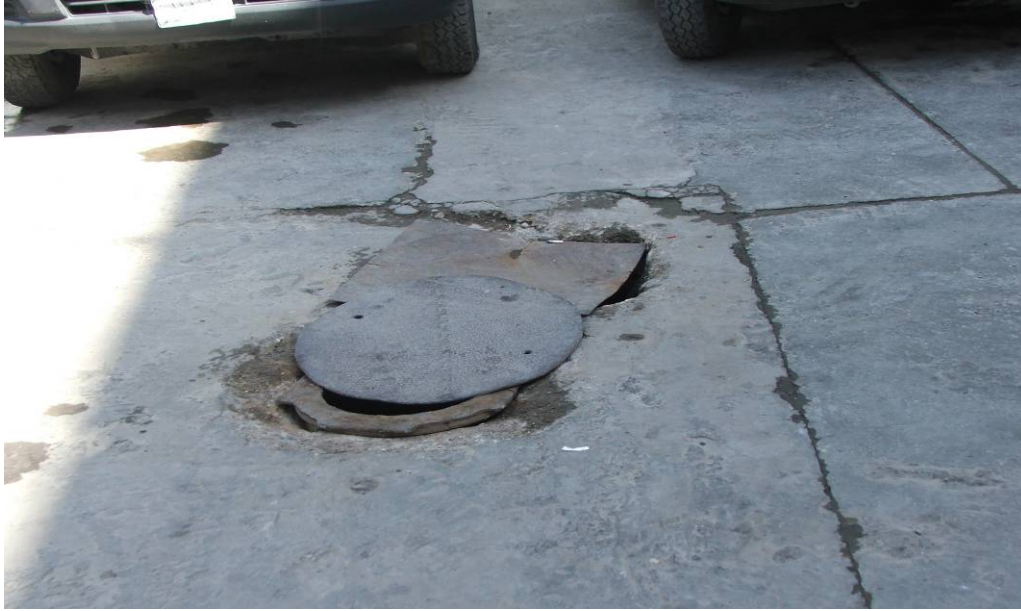
The contractor did not replace the main septic tank with a new tank three times the volume as required in the contract. Rather, the contractor added additional tanks of an unspecified and unverified size to the system. Such a course of action was outside of the design requirements. Concrete work to cover connecting pipe trenches was poor and manhole covers were generally nothing more than make-shift pieces of metal or wood. In addition, there was no evidence to support whether the underground sewer lines and system were inspected, repaired, and pressure tested as required by the contract.

Site Photo 11. Main septic tank was not replaced with one three times the capacity.

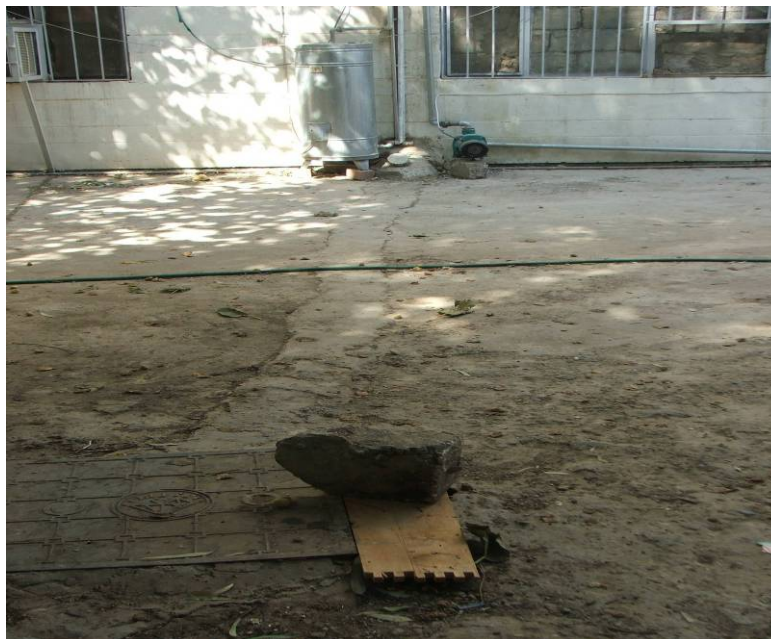
Site Photo 12. Manhole cover made of tin/wood and concrete work over the trench which was substandard.

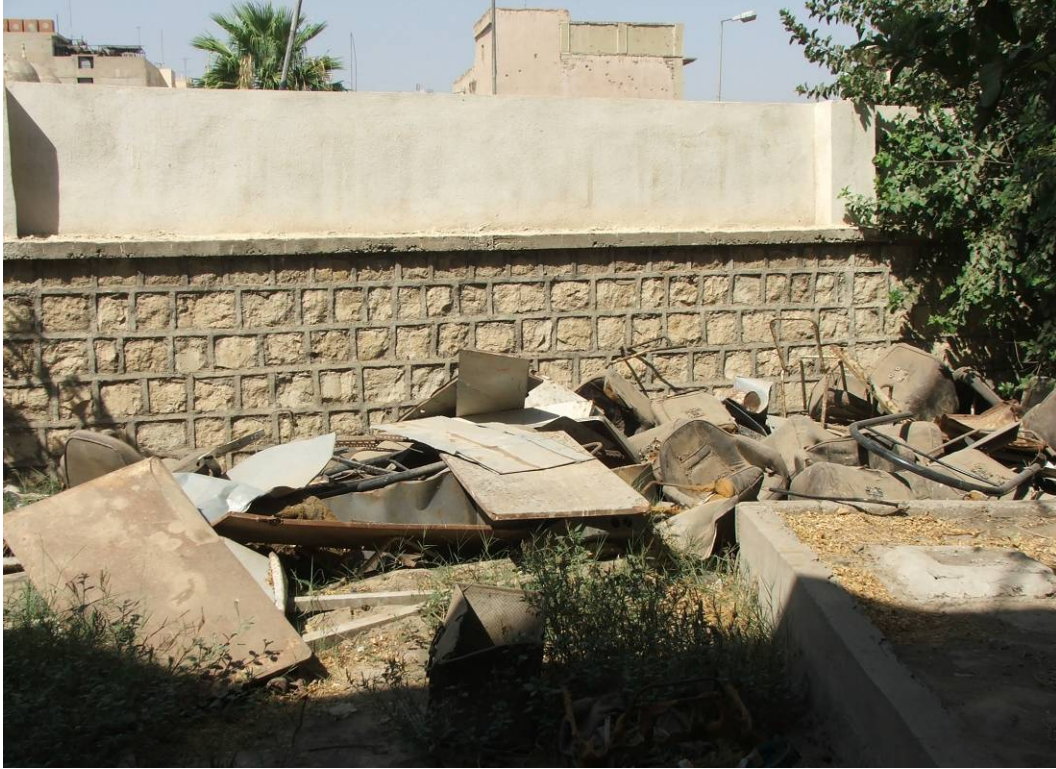
The contract required the contractor to clear and remove all existing debris and rubble at the site location defined as each building's interior, exterior, roof, and perimeter. In addition to soil and waste material, the contract specified that unused hangers, wires, cable trays, conduit, plumbing, damaged ductwork, and all inserts from ceilings and walls were to be removed. Lastly, the contractor was required to provide a final cleanup of all buildings. At the time of our site visit, there was a substantial amount of debris lying about the facility and it appeared that a final cleanup was never conducted (Site Photos 13 & 14).

Site Photo 13. Substantial amount of debris on the Police HQ grounds was not removed.

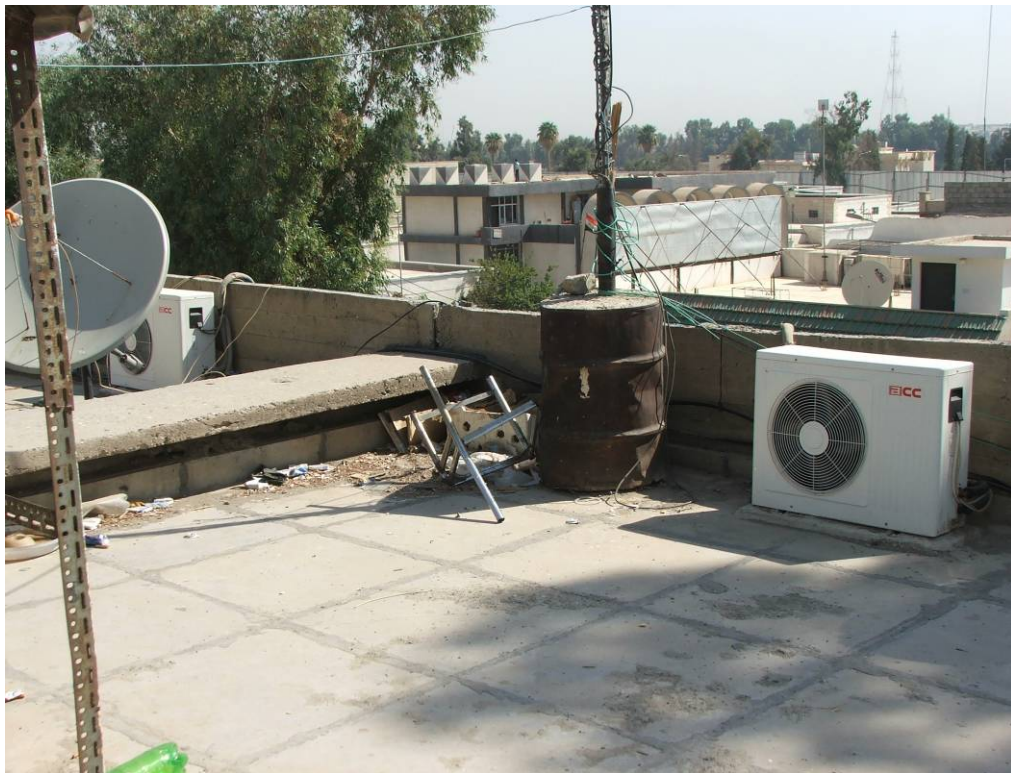
Site Photo 14. All debris was not removed from rooftop.

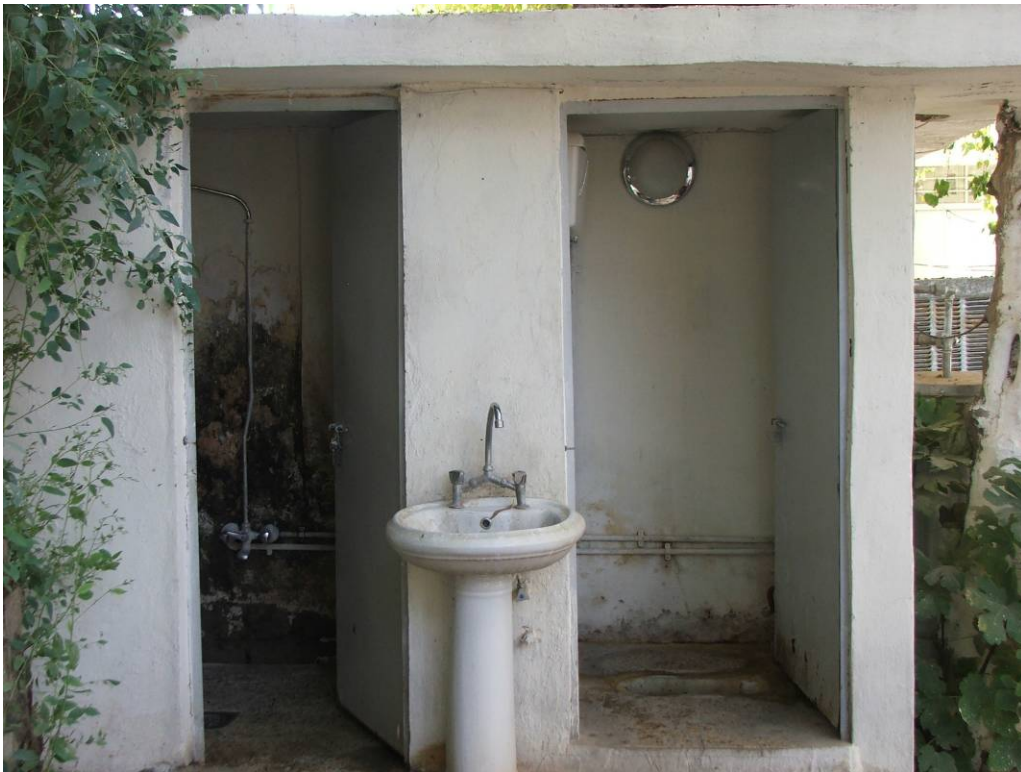
However, the contractor built a new latrine with only 1 shower, 1 toilet, 1 sink and no changing room. Had the contractor built a latrine compliant with contract requirements, two trees in the way would have required removal. However, neither tree was removed. The first tree is shown to the far left of the photo while the second tree is shown in the photo's center (Site Photo 10). Rather than removing the second tree, the latrine's concrete roof was cast around the tree. The new latrine was missing numerous requirements (sinks, showers, urinals, toilets, and a changing room) and the finished construction was substandard.

Site Photo 15. Frontal view of bathroom, which should have included 10 individual showers, 12 toilets, 10 urinals, 10 sinks, and a changing room.

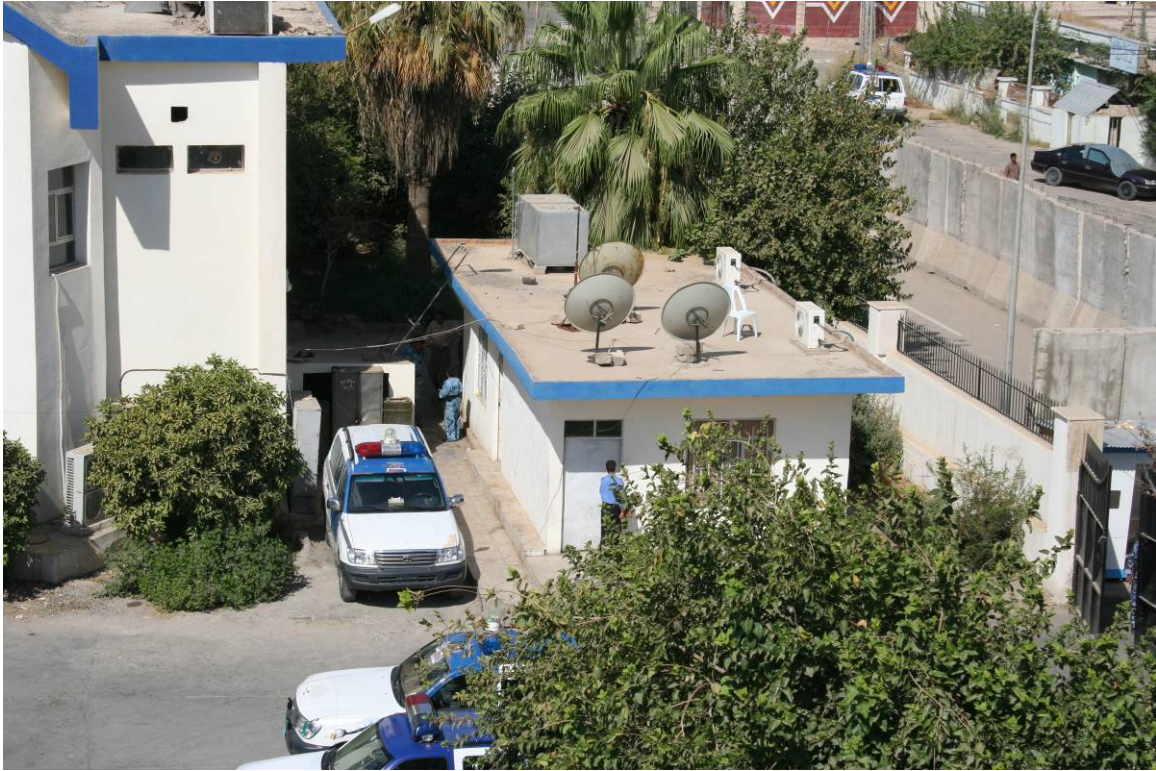
Site Photo 16. Only two (left edge of rooftop) of six split-unit air conditioners required by the SOW and BOQ were installed in the new reception center.

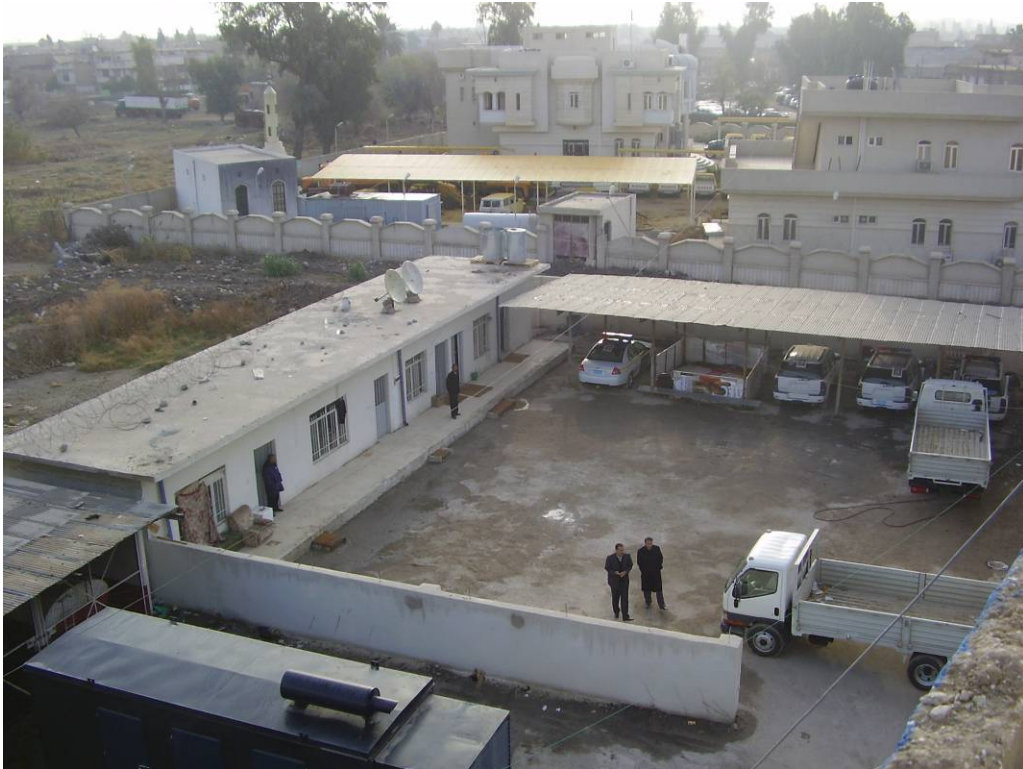
Site Photo 17. Generator was delivered (bottom left), but never connected and load tested by the contractor.

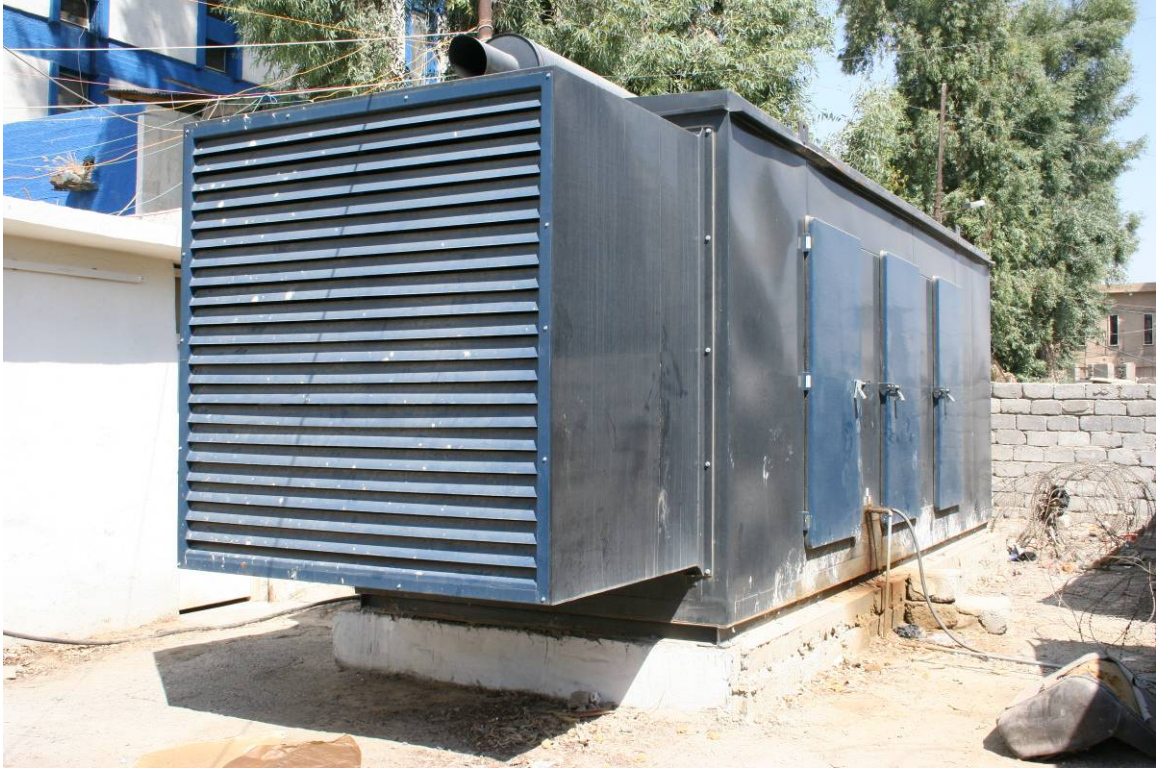
Site Photo 18. Final site, where the generator was placed by Iraqi Police (IP).

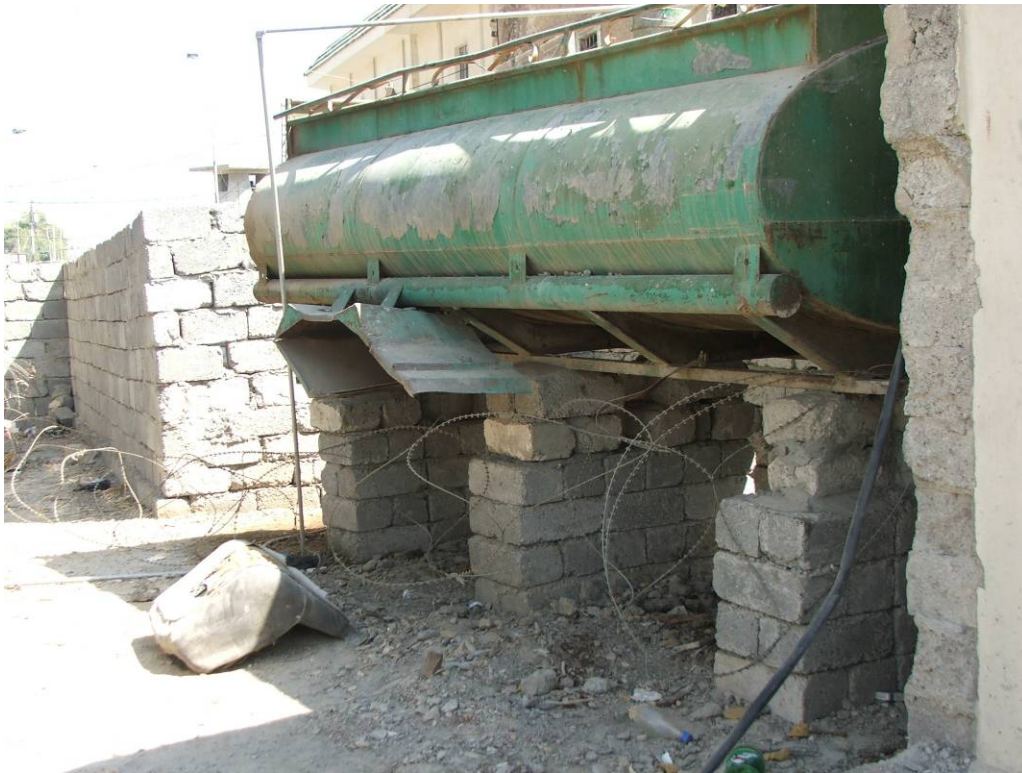
Site Photo 19. Old fuel truck tank used to supply the generator placed by the IP.
