WASTE WATER TREATMENT PLANT
AL KASIK MILITARY TRAINING BASE
AL KASIK, IRAQ

SIGIR PA-06-074
JANUARY 29, 2007

SUBJECT: Report on Waste Water Treatment Plant, Al Kasik Military Training Base, Al Kasik, Iraq (Report Number SIGIR PA-06-074)

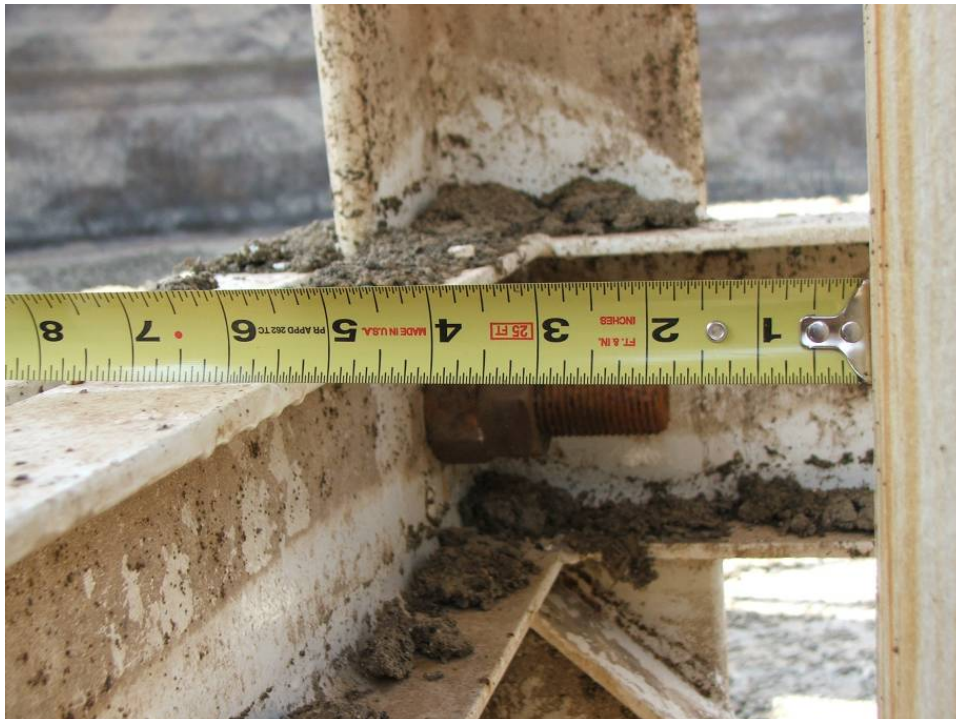
The main vertical supporting shaft of the rotating scraper arms was observed to be off center by over 2 1/8 inches. Site Photos 5 and 6, show the off center position of the main vertical shaft following the break down of the scraper arm assembly.

Site Photo 5. Main shaft was positioned approximately 5 5/8 inches from the static frame.

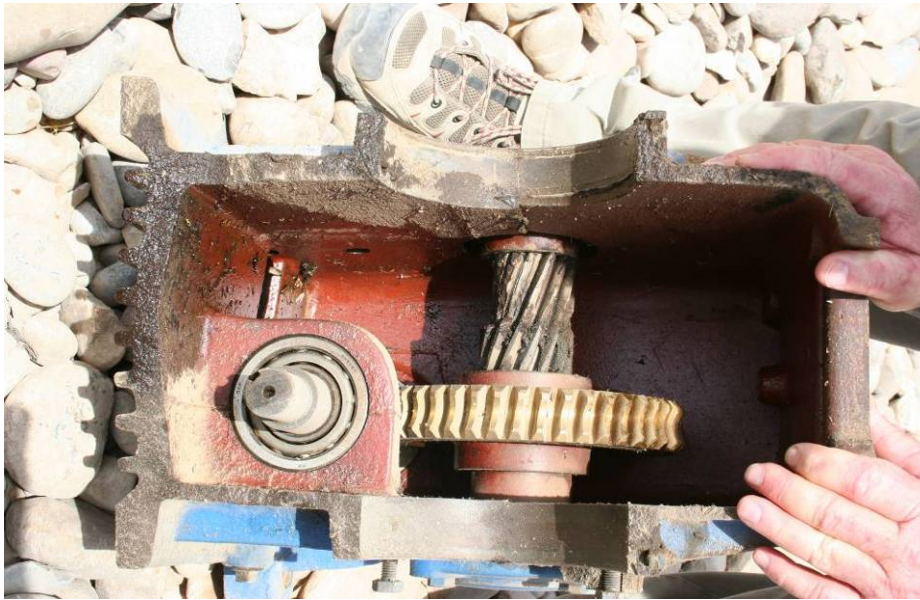
Immediately following the cable failure and subsequent contact between the dropped side of the horizontal sweep arm assembly and tank wall and floor, the clarifier gearbox, for all practical purposes, completely failed. The gearbox was lying in two pieces at the base of the clarifier tank. A fracture that bisected the gearbox housing ran the length of the cast metal casing. The oily coating and a distinct oil line observed indicated that the gearbox was operated with adequate lubrication before failure. Site Photo 10 shows the broken gear and fractured gearbox case. Based on the assessment team's observations of the failed cable, the off balanced horizontal sweep arm assembly, the off center vertical main shaft, the broken condition of the gearbox, discussions conducted with plant operators and Coalition Military Assistance Training Team/Regional Support Unit (CMATT/RSU) personnel, and a review of maintenance documentation (modest as it was), it is very unlikely that the gearbox failure was due to inadequate lubrication.

Site Photo 10. "Chewed/sheared" gear teeth and a fractured gearbox case illustrate that abnormal force broke the gear box.

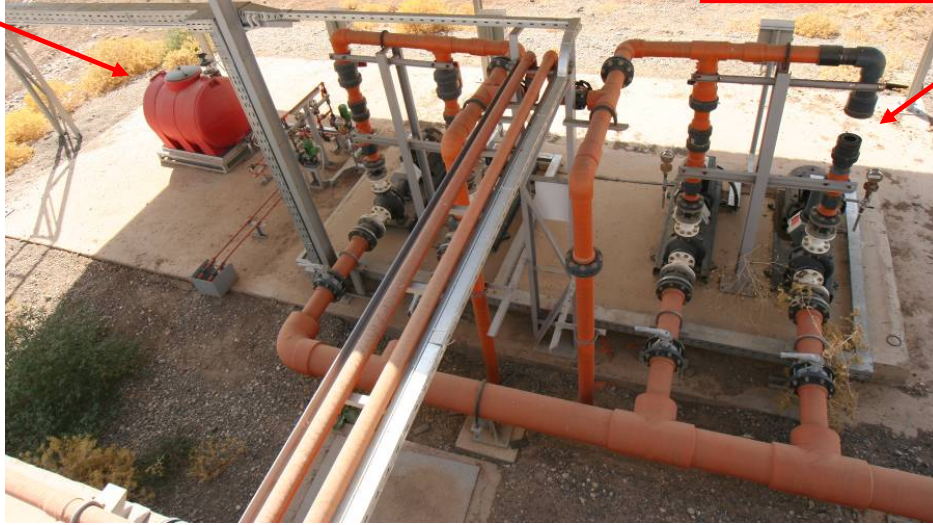
Back Flush Side Showing Missing Nipple.

Site Photo 21. Effluent supply and back flush inlet piping systems.

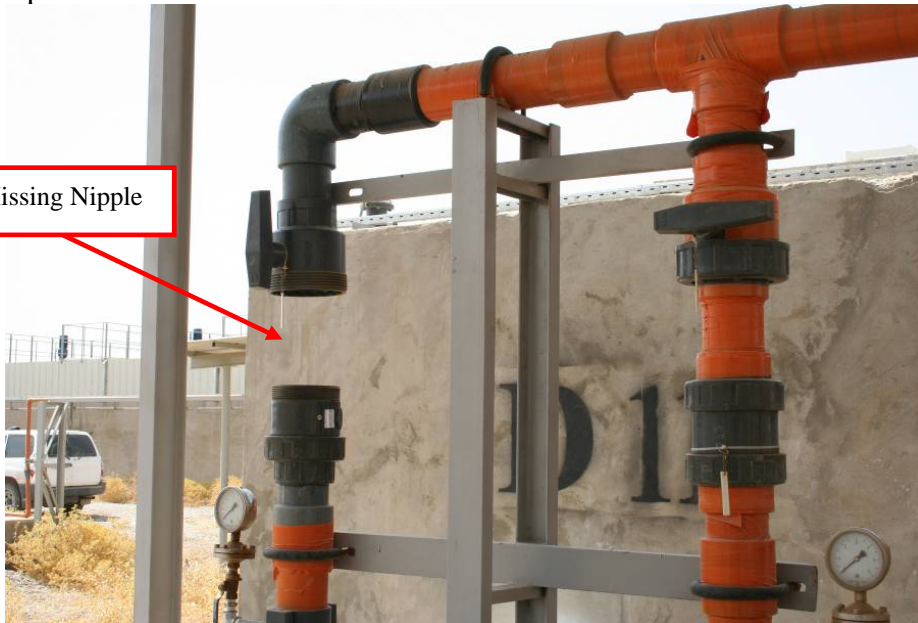
Missing Nipple

The assessment team observed that a pipe nipple on the back flush side of the inlet system was missing. A backup or spare nipple was not a required element of the Task Order and the WWTP operators claimed that the non-standard sized nipple could not be purchased locally. As a result, back flush operations could not be performed. Site Photo 22 shows the back flush inlet line was missing the relatively minor piece.

Site Photo 22. Missing nipple meant that back flushing could not be performed.
