AL HILLAH POLICE FIRING RANGE
AL HILLAH, IRAQ

SIGIR PA-06-076
JANUARY 08, 2007

SUBJECT: Report on Project Assessment of the Al Hillah Police Firing Range,
Al Hillah, Iraq (Report Number SIGIR-PA-06-076)

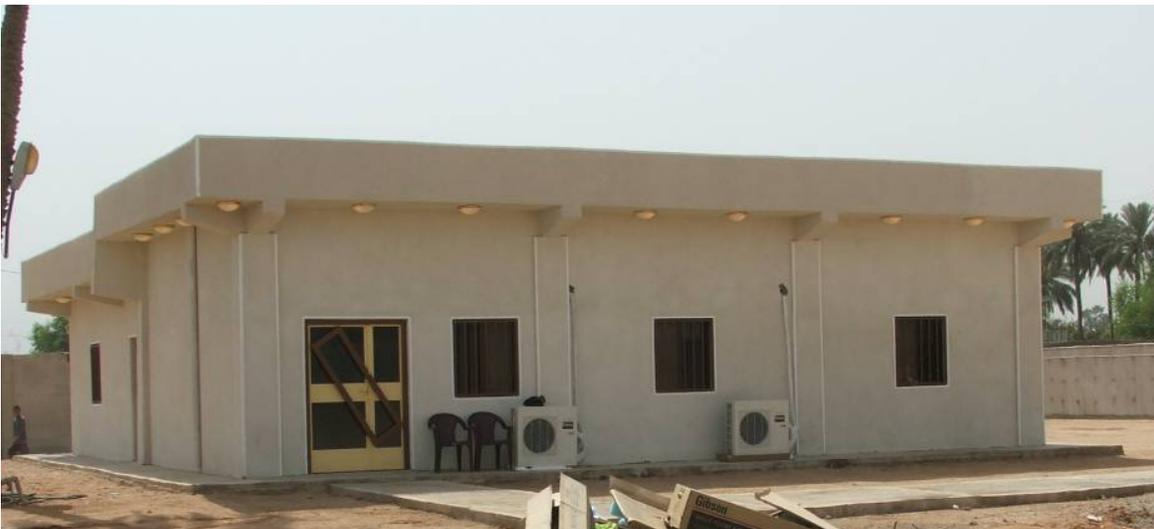
We inspected each room of the building (Site Photo 1) as well as the exterior and the roof. The building's exterior walls were plastered, textured, and painted. A concrete walkway was constructed around the perimeter in accordance with the design.

Site Photo 1. Range control building

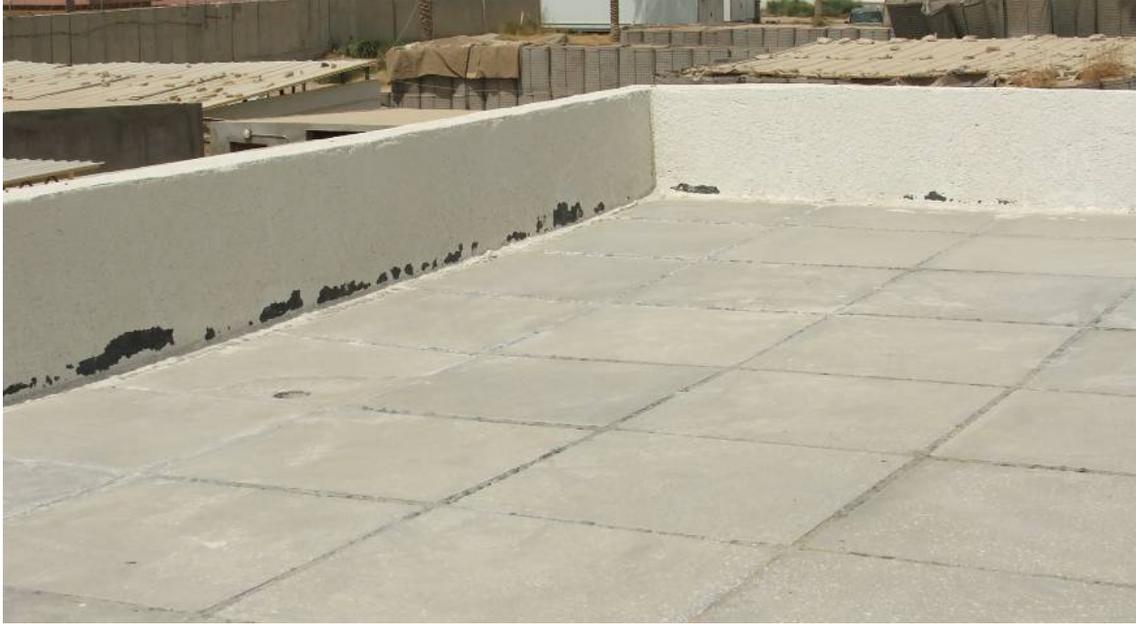
The roof construction consisted of concrete tiles and mastic joints, and a plastered and textured parapet. Site Photo 2 shows the roof. The roof appeared adequately constructed, although we did notice a portion of the finish coat of paint peeling away from the interior of the parapet wall.

Site Photo 2. Range control building roof

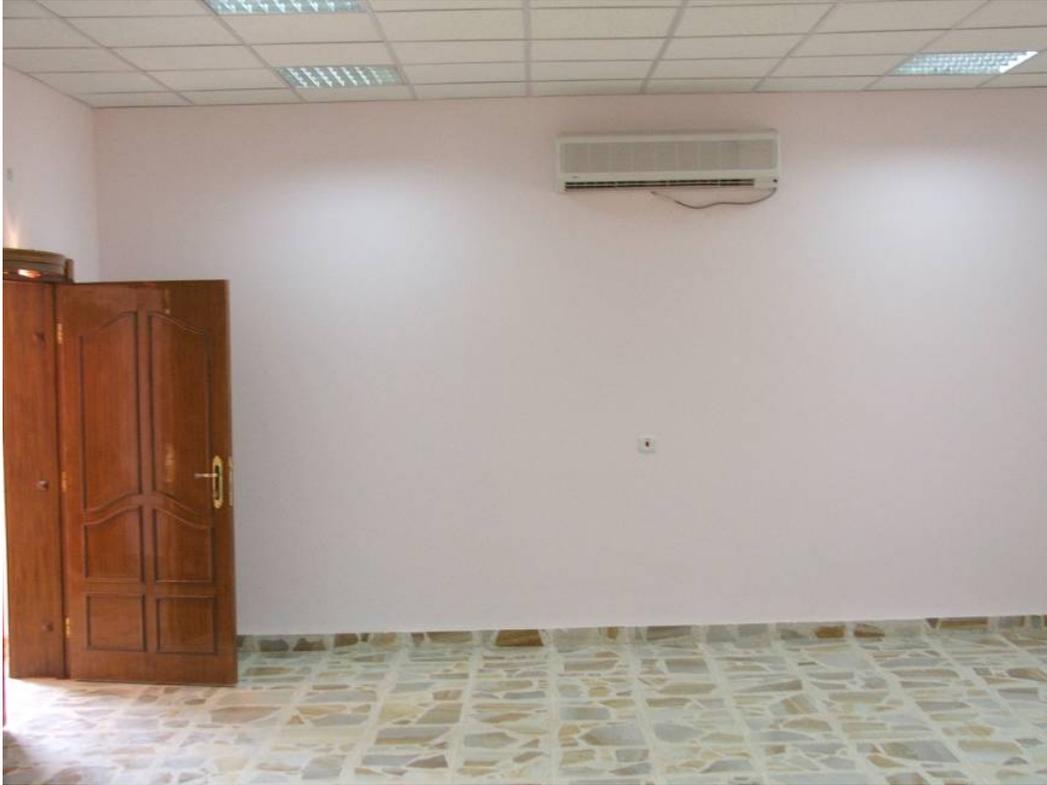
In summary, we did not observe any significant deficiencies with the range control building construction. Site Photos 3-5 provide examples of the features in the building observed during our inspection.

Site Photo 3. Range control building waiting room

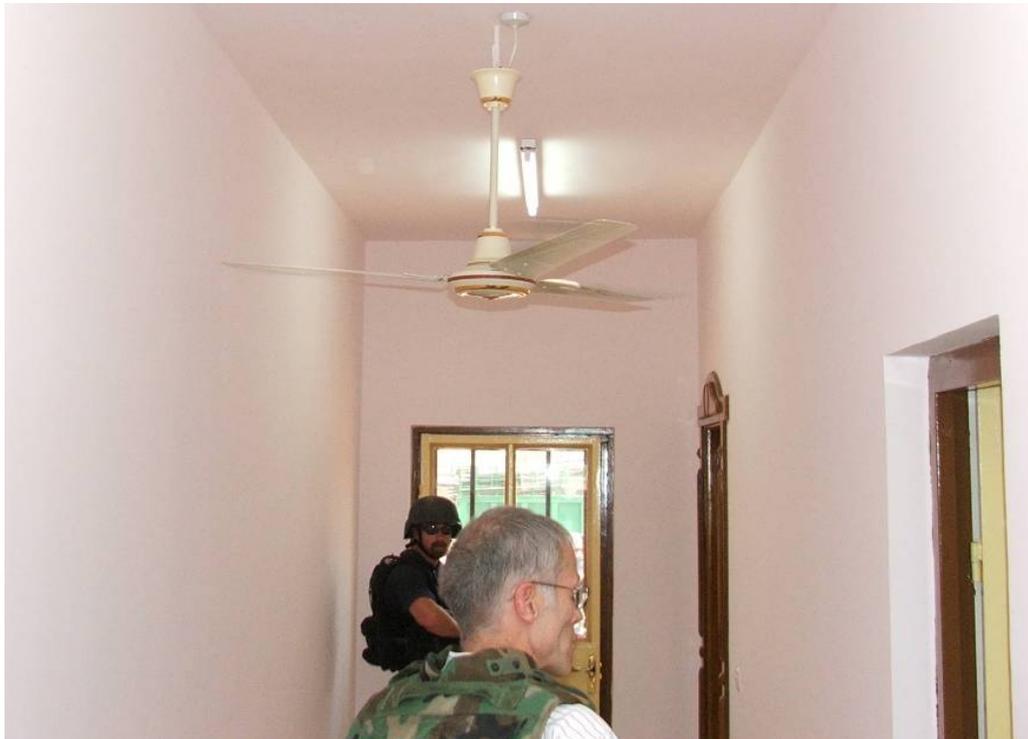
Site Photo 4. Hallway in range control building

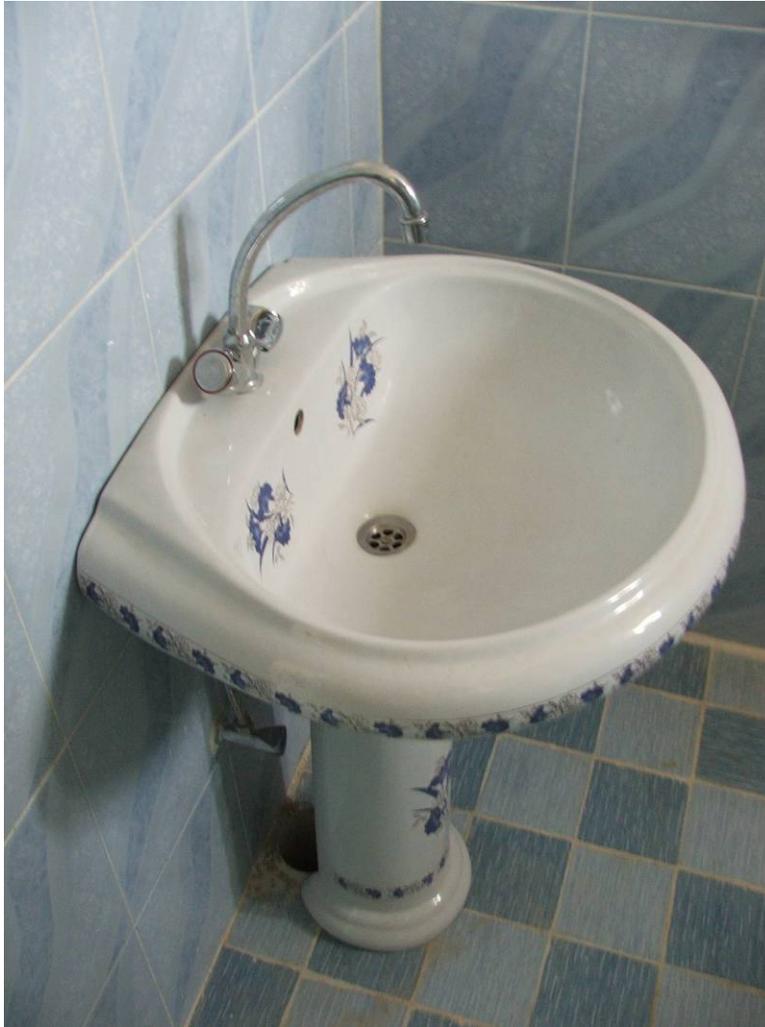
Site Photo 5. Wash basin and tile work in one of the range control building bathrooms

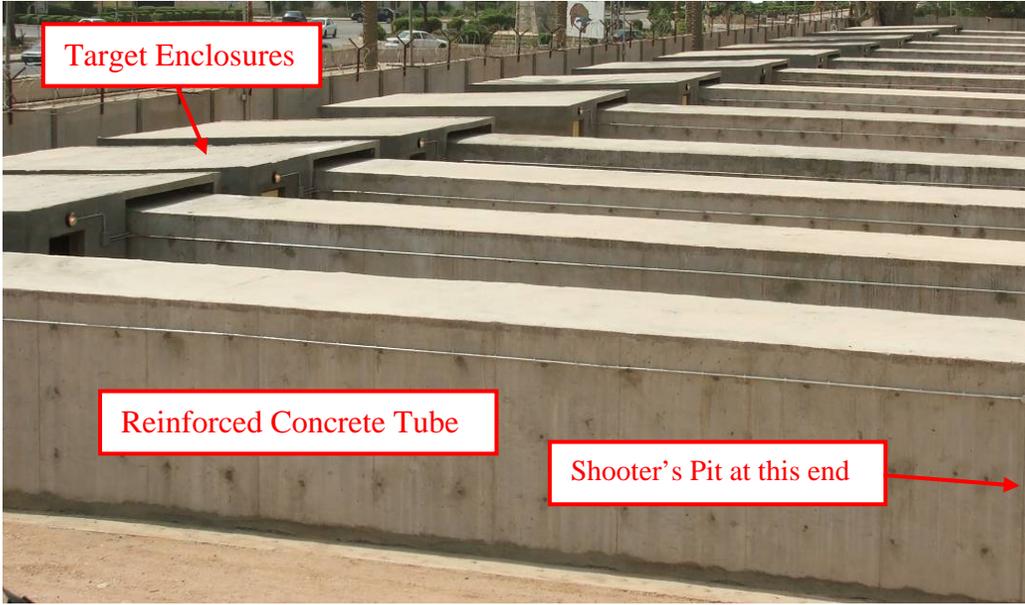
The design for the rifle firing tubes shown in Site Photos 6, 7, and 8 called for a reinforced concrete tube, 25 m in length. The target was housed in an enclosure constructed with grout filled masonry sidewalls and a reinforced concrete back wall and cover. The 2 m wide by 2.1 m high firing tube was designed with reinforced concrete side walls, floor, and cover, each 10 centimeters (cm) thick.

Site Photo 6. Rifle firing tubes

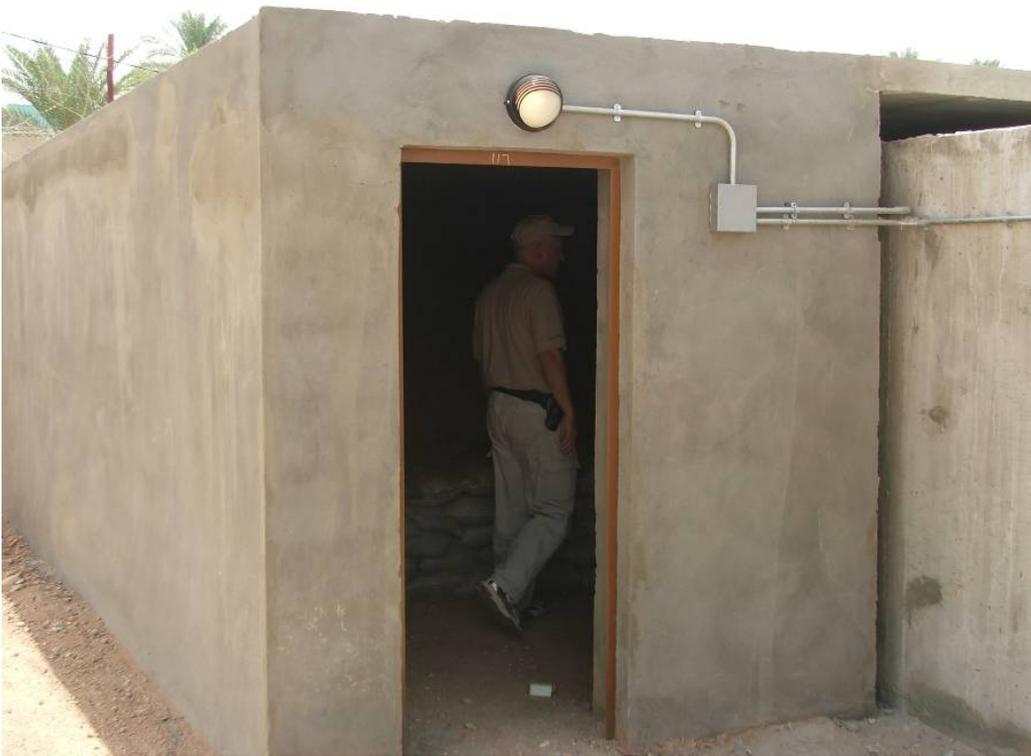
Site Photo 7. Target enclosure entrance

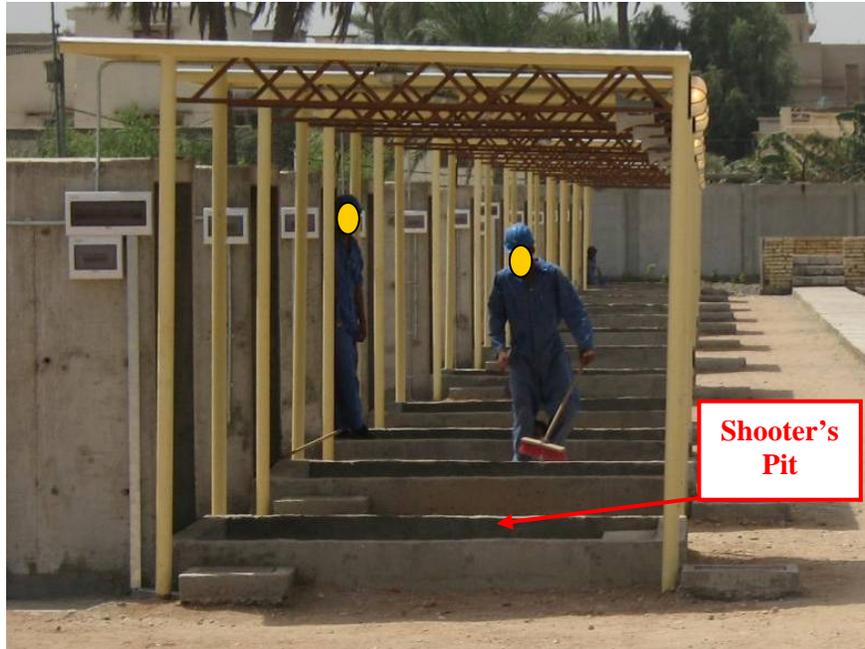
Site Photo 8. Shooter's pit at rifle firing tubes

The reinforced concrete shooter's pit at the end of the firing tube was below grade so that the pit floor was 0.75 m below the floor of the firing tube. The outside dimensions of the pit were 2 m wide by 3 m long, and the pit was covered with a metal cover supported by truss frame and four steel posts. The shooter's pit contained an overhead fluorescent light fixture as well as an exterior light mounted to the outside of the metal cover frame.

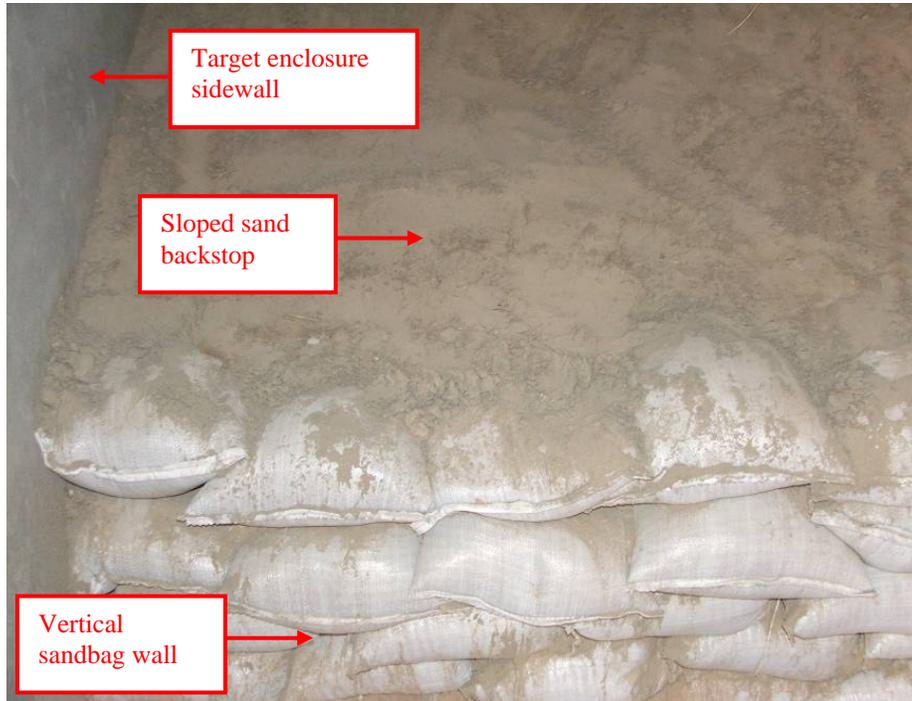
The actual constructed backstops were built in a slightly different manner. Instead of starting the backstop slope from the floor slab, the contractor had raised the toe of the slope by constructing a short vertical sandbag wall about 2 feet high. The sloped portion of the backstop wall started at the top of this sandbag wall and continued to the target enclosure back wall. Site Photo 9 shows the backstop in one of the target enclosures. We found the backstops adequately constructed, although there may be an issue with the stability of the two foot vertical sandbag walls when filled with bullet holes.

Site Photo 9. Backstop behind target

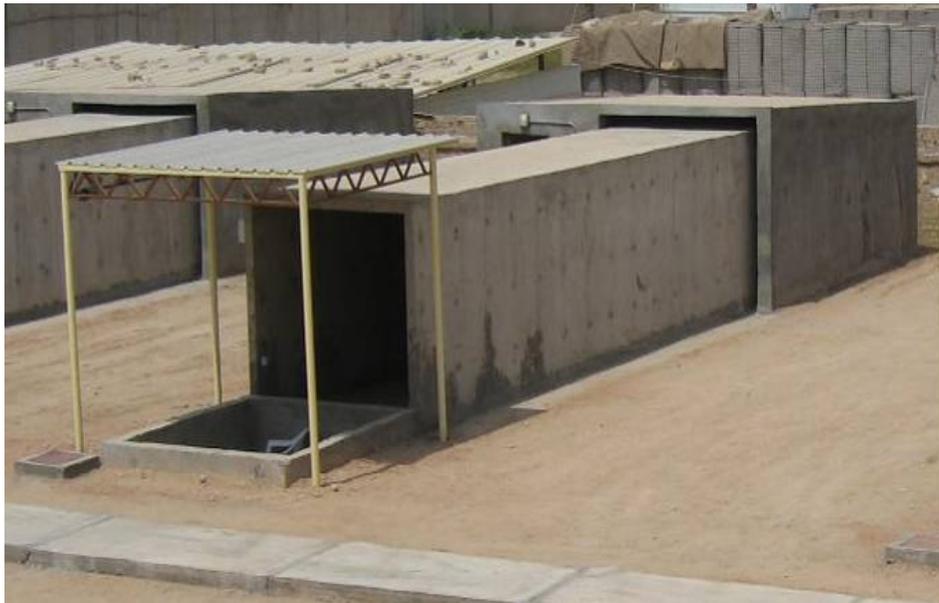
The design for the pistol firing tubes was similar to the rifle firing tubes except the reinforced concrete tube length was 10 m. Site Photo 10 shows one of the 12 pistol firing tubes. During our inspection, we verified the correct dimensions associated with the pistol firing tubes. The construction appeared to meet contract requirements.

Site Photo 10. One of the 12 pistol firing tubes

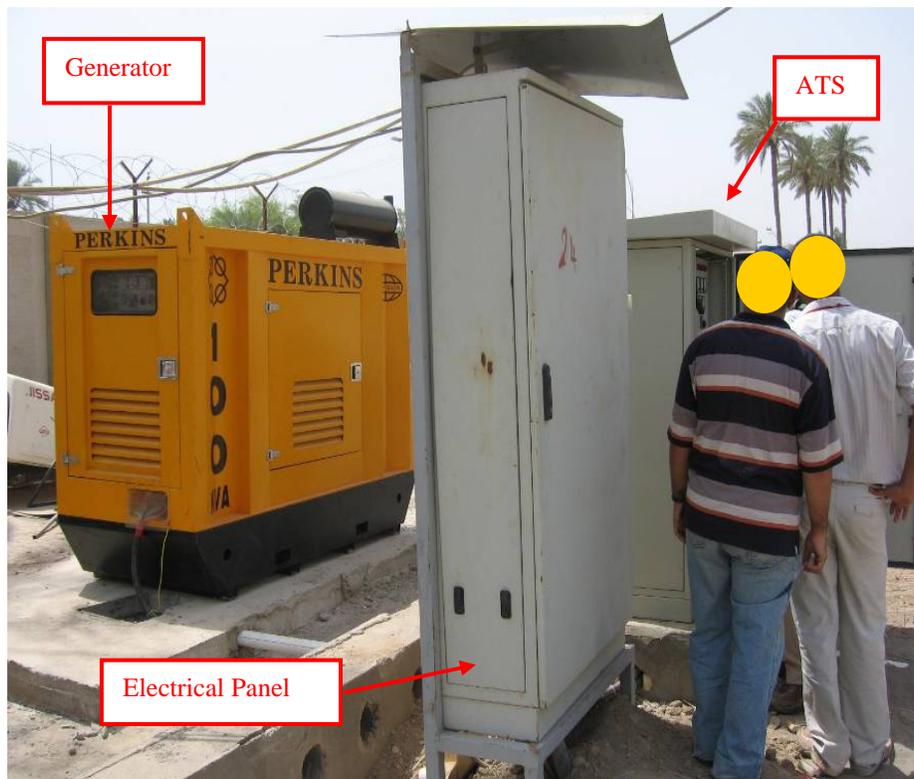
Site Photo 11 shows the 100 kVA generator installed on the concrete slab, the electrical panel, and the automatic transfer switch (ATS). The generator cover and the external fuel tank were not yet installed.

Site Photo 11. Generator, electrical panel, and automatic transfer switch (ATS)

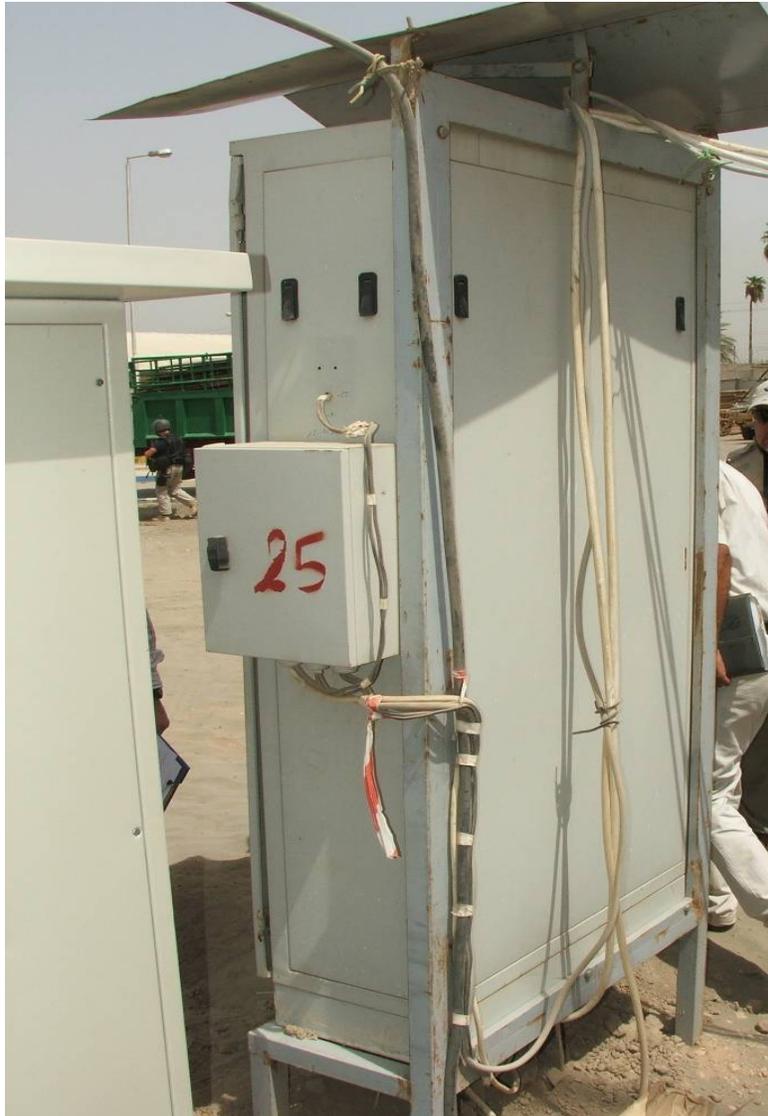
On the rear side of the electrical panel shown in Site Photo 12, we found some portions of the metal frame rusted. Additionally, the cable connecting the ATS to the panel was not enclosed in rigid conduit.

Site Photo 12. Rear side of electrical panel
