402<sup>ND</sup> BATTALION IRAQI ARMY  
HEADQUARTERS BARRACKS  
AL HILLAH, IRAQ

**SIGIR PA-06-077**  
**JANUARY 29, 2007**

SUBJECT: Report on Project Assessment of the 402nd Battalion Iraqi Army Headquarters  
Barracks, Al Hillah, Iraq (Report Number SIGIR-PA-06-077)

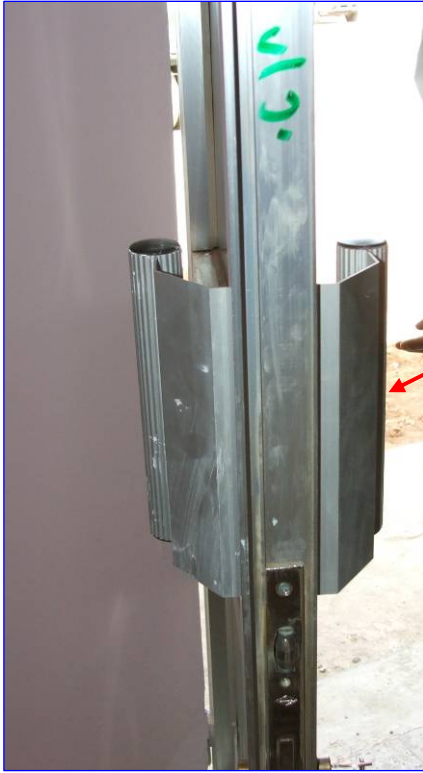
**Site Photo 1. Barracks entrance door cross section**

Although the interior appeared satisfactory, the two entry/exit aluminum doors in the barracks sleeping quarters did not appear to be "good quality," especially for the high traffic expected with a 75-man barracks. Site Photos 1 and 2 provide closer views of one of the aluminum doors and associated hardware. In addition, the doors did not have sweeps. Noticeable gaps were present between the thresholds and bottom of the doors as seen in the door shown in Site Photo 3.

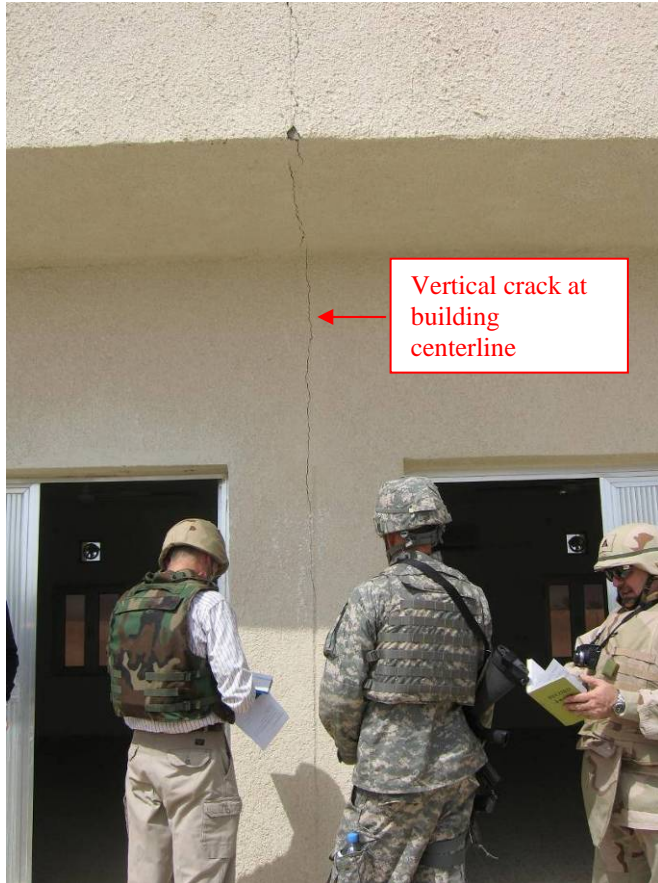
The design included two, two-ton HVAC units in each classroom augmented with a ceiling fan, and two wall exhaust fans, which we verified as installed. Overall, the building appeared satisfactory, except we did observe a noticeable crack in the exterior near the center of the building. The crack ran on both sides of the building, beginning at the sidewalk and continuing vertically in the wall and along the soffit and parapet as shown in Site Photos 5 and 6. The structural design for the building shows in the center of the building, a 480 mm masonry wall consisting of two, side by side masonry wall sections, each 240 mm thick. The design also shows the dual masonry walls supporting two adjoining bond beams, each 250mm thick. The design does not show any tying mechanism between the dual masonry walls or connecting reinforcing steel or dowels in the two concrete beams. Based on this design and the presence of the vertical crack along the building centerline, it appears there should be an expansion joint in the center of the building to allow for the differential movement of each side of the building.

Vertical crack at building centerline

**Site Photo 5. Vertical crack in front side of classroom building exterior**

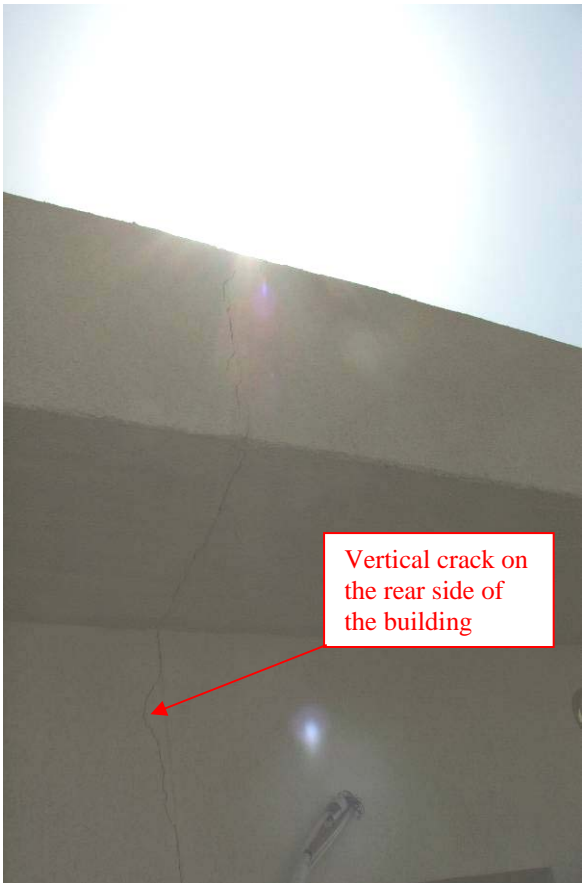
Vertical crack on the rear side of the building

**Site Photo 6. Vertical crack in opposite side of classroom building exterior**

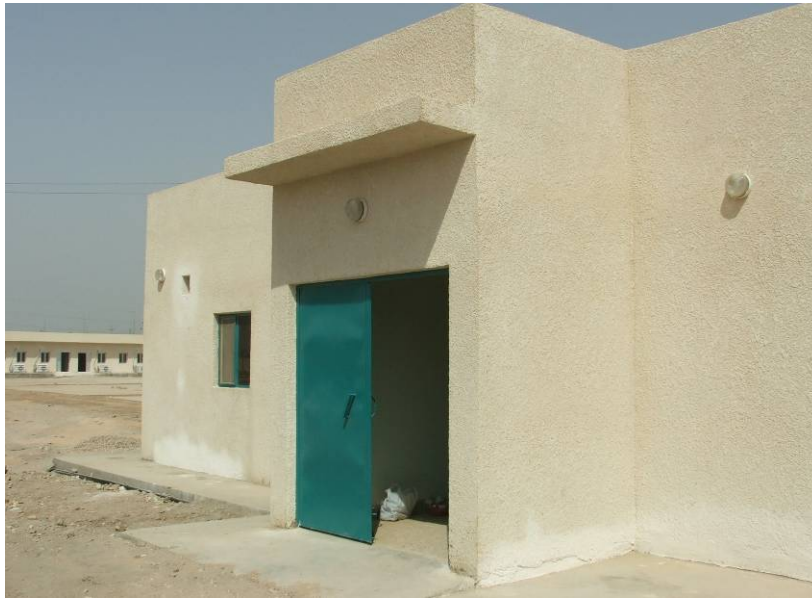
**Site Photo 7. Exterior of the medical clinic**

The medical clinic was designed as an addition to an existing medical clinic with a covered breezeway to connect the addition to the existing clinic. The building we inspected was a stand-alone facility without a connecting breezeway; however, in accordance with the design, it did contain an entrance area and three rooms: a patient ward, a storeroom, and a laboratory. Site Photo 7 shows the front side of the medical clinic, including the main entrance.

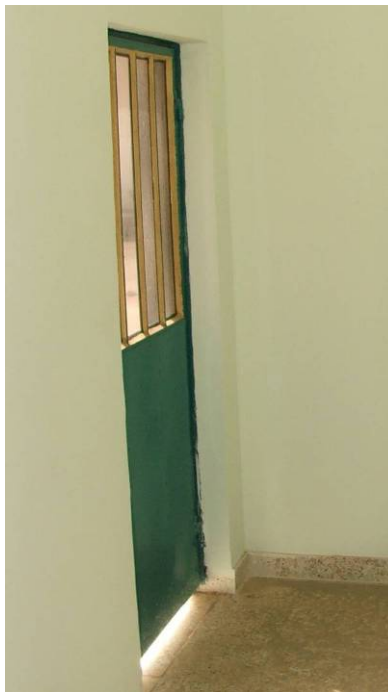
**Site Photo 8. Medical clinic exterior door**

The SOW required a plastered and painted finish for the ceilings inside the medical clinic and ceramic tile walls and floors for the ward area and the laboratory. We found ceramic wall and floor tile in the laboratory, but the patient ward room contained plastered and painted walls and ceilings, and mosaic floor tile. We found no deficiencies with the quality of workmanship in either room. The other required interior finishes included fluorescent lighting, metal windows, wooden interior doors, and metal exterior doors, which we observed in our inspection. Although they appeared to be installed correctly, we did observe a noticeable gap at one exterior door location between the threshold and the bottom of the door as shown in Site Photo 8.

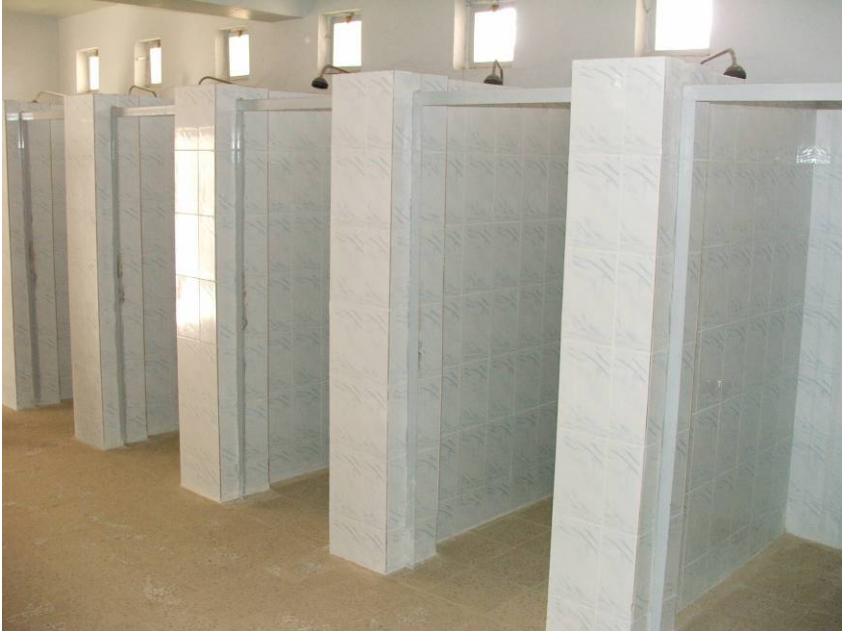
The project scope included construction of two single story ablution buildings, each one near one of the new barracks. The design for each 8 x 10 m building included seven individual showers, eight water closets, and a hand washing station with eight faucets, and three electric water heaters, which we verified during our inspection. The SOW required a sand-cement exterior wall finish. The SOW also required the contractor to plaster to a smooth finish and paint interior walls and ceilings, and to install mosaic floor tile. During our inspection, we observed plastered and painted ceilings, and mosaic floor tiles. The contractor had also installed ceramic tile to a height of about six feet along the walls as shown in Site Photo 10. We did not find any noticeable deficiencies associated with the ablution building interior and exterior construction. However, we did observe what appeared to be low quality plumbing fixtures (shower heads, water supply lines, faucets, drain covers, etc.) installed in the showers, wash stations, and water closets. Site Photo 11 shows the type of plumbing materials used in the water closets, which includes flexible water hoses, plastic supply tanks, and plastic tubing from the tank to the toilet.

Considering the heavy usage the ablution buildings will receive, this type of low quality material will pose continual maintenance problems for the Iraqi Army.

**Site Photo 10. Ceramic tile finish on shower walls in ablution buildings**

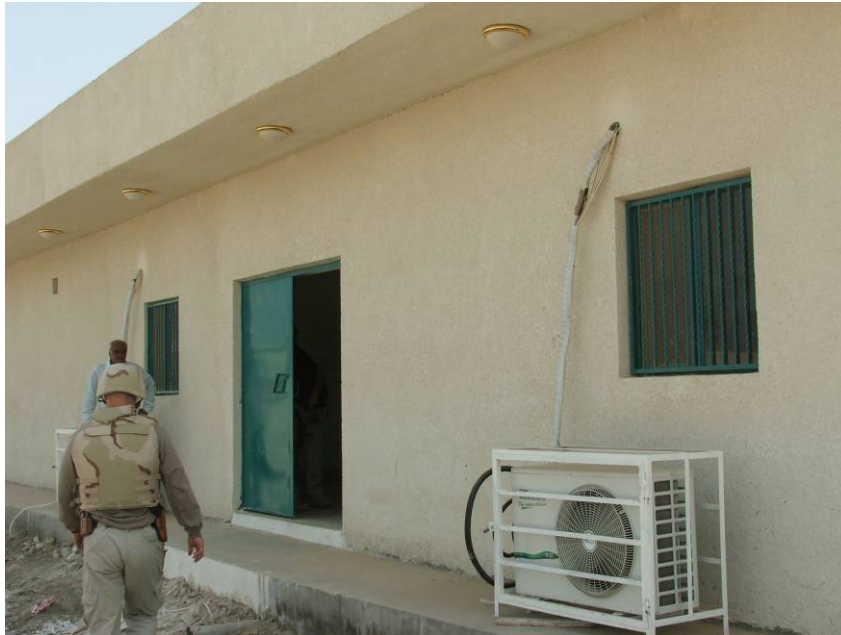
**Site Photo 12. Exterior view of armory entrance**

We found the armory constructed as designed with no significant deficiencies. We also observed the contractor had installed mosaic tile in every room over the concrete floor slab. Site Photo 12 shows the front of the armory building including, the steel entrance door, windows with metal grilles, and one of the two-ton HVAC units.

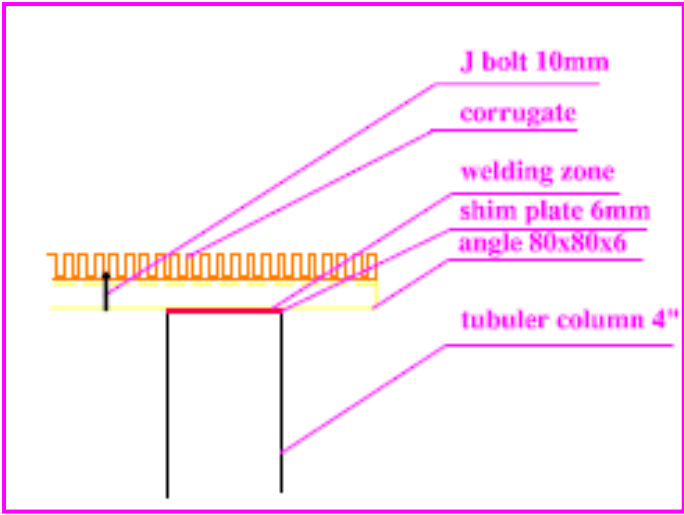
**Figure 1. Design detail for covered parking (sunshade)**

The design detail for the structural frame supporting the corrugated roof sheeting (Figure 1) showed an 80 x 80 x 6 angle supporting the roof sheeting. No units were provided for

the angle, although it is assumed the dimensions are in millimeters. Figure 1 also shows the angle welded to a shim plate at the top of the column. There were no details provided on the type or size of weld or the type and thickness of the corrugated roof sheeting. The design also did not show any lateral cross bracing perpendicular to the angle support shown in Figure 1.

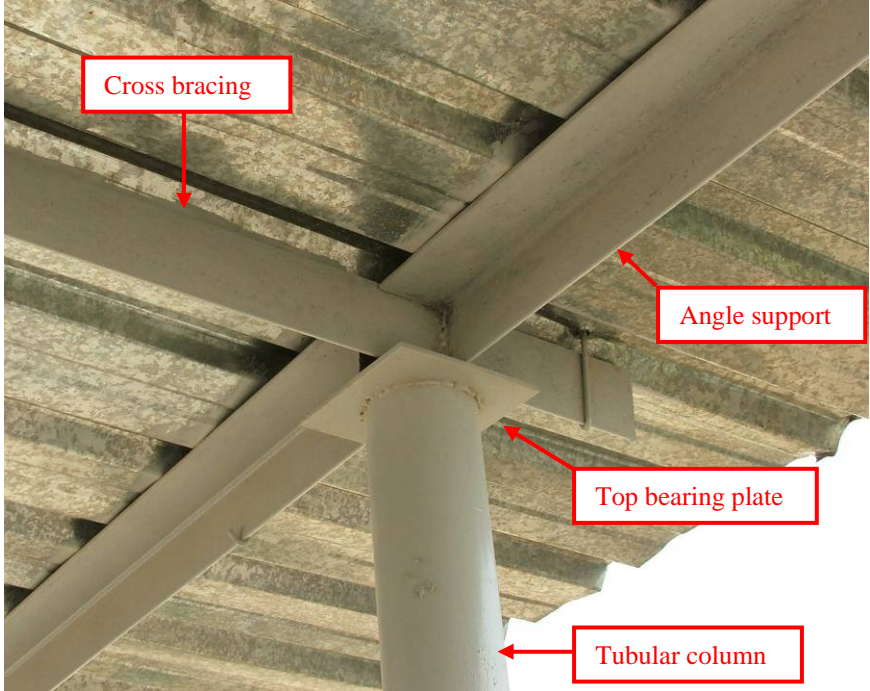
**Site Photo 13. Typical column support for covered parking (sunshade)**

The assessment team inspected both parking sunshades and found no significant deficiencies based on the SOW requirements and the design. We did note that many of the four inch tubular columns consisted of spliced sections of pipe welded together to form one tubular column. The design did not provide any details as to whether welded pipe columns were allowed.

Site Photo 13 shows the actual welded angle connections at the bearing plate (i.e., shim plate) at the top of each tubular column. Also shown is the lateral cross bracing. The roof sheeting material appeared to be a thin gage sheet metal, connected to the frame with J-bolts as depicted in Figure 1.

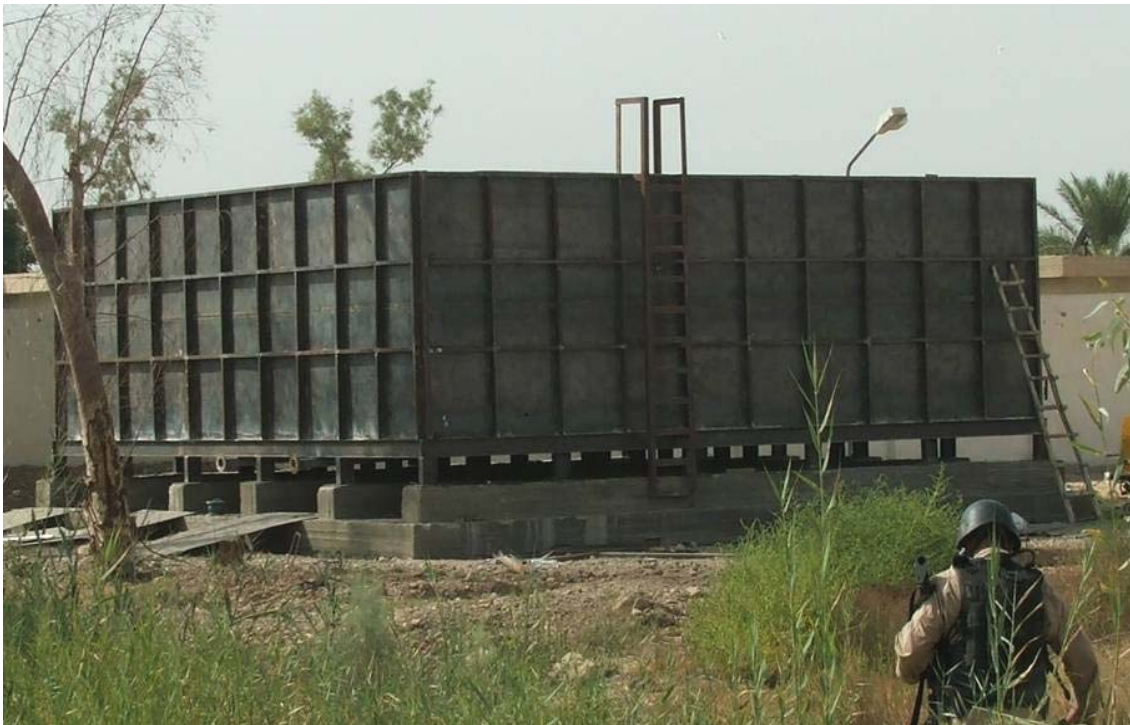
**Site Photo 14. 300 m<sup>3</sup> water storage tank under construction**

During our assessment, we observed a partially completed water tank as shown in Site Photo 14 that met the size requirements for a 300 m<sup>3</sup> tank. The tank was supported by a concrete foundation and structural steel frame. The tank sides consisted of steel plate, spot-welded to the structural steel supports. Site Photo 15 shows the spot welding along one side of the tank. The steel plates appeared to be approximately 0.25 inches thick.

Given the lack of details in the design, the assessment team could not determine whether the water tank construction met the standards of the design. However, we were concerned with the quality of the spot welds and if there was sufficient steel plate thickness to withstand the hydrostatic pressures associated with a fully filled 300 m<sup>3</sup> water tank. We discussed our concerns with the USACE Babil RE and PE. We also recommended the USACE GRS structural engineer assess the adequacy of the water tank construction.
