## **Quantitative Three-Dimensional Analysis of Structural Damage in Penetrated Magnesium via XCT**

**ARL-TR-5359**

**September 2010**

**Weapons and Materials Research Directorate, ARL**

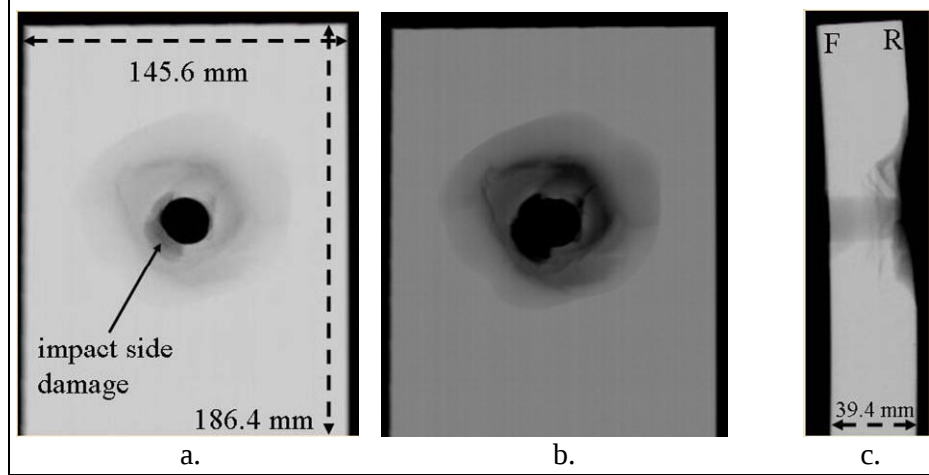
hole that was pushed out from the rear of the specimen. The second photograph (figure 1b) includes a ruler to indicate the size of the hole near the rear face, which is ~25 mm across. Digital radiographs (DRs) of the specimen were taken through its thickness and width (edge on) using the 420-keV x-ray tube and linear detector array (LDA) setup in centered rotate-only (RO) mode. The x-ray technique (parameters) of the DRs of the specimen were (400 keV, 2.0 mA) and geometries of source-to-object distance (SOD) = 750.00 mm and source-to-image distance (SID) = 940.00 mm. Figure 2 shows two through thickness DRs (a and b) and one edge on DR (c) of the specimen. The first two DRs have been processed or “windowed” differently to accentuate one or some features over others. In the first, the penetration hole itself is emphasized and shows a darker area to the lower left of the hole due to missing material in the front (impact) side of the specimen. In the second image, the overall damage and the perimeter of the pushed out region of material in the exit side of the specimen is emphasized. It shows the main hole and the region with impact side missing material as all black. In the edge on (side) image of the specimen with the impact side on the left, the main hole is evident, as well as severe damage in the middle and rear regions of the specimen and the missing material that was pushed out of the exit side. This is also the first image that shows some of the nature of the approximately parallel lateral, or “petal-like,” damage mode in the middle and towards the rear of the specimen, which is significantly more visible in the cross-sectional XCT images.

Figure 2. Through thickness (a and b) and edge on (c) digital radiographs of the Mg plate.

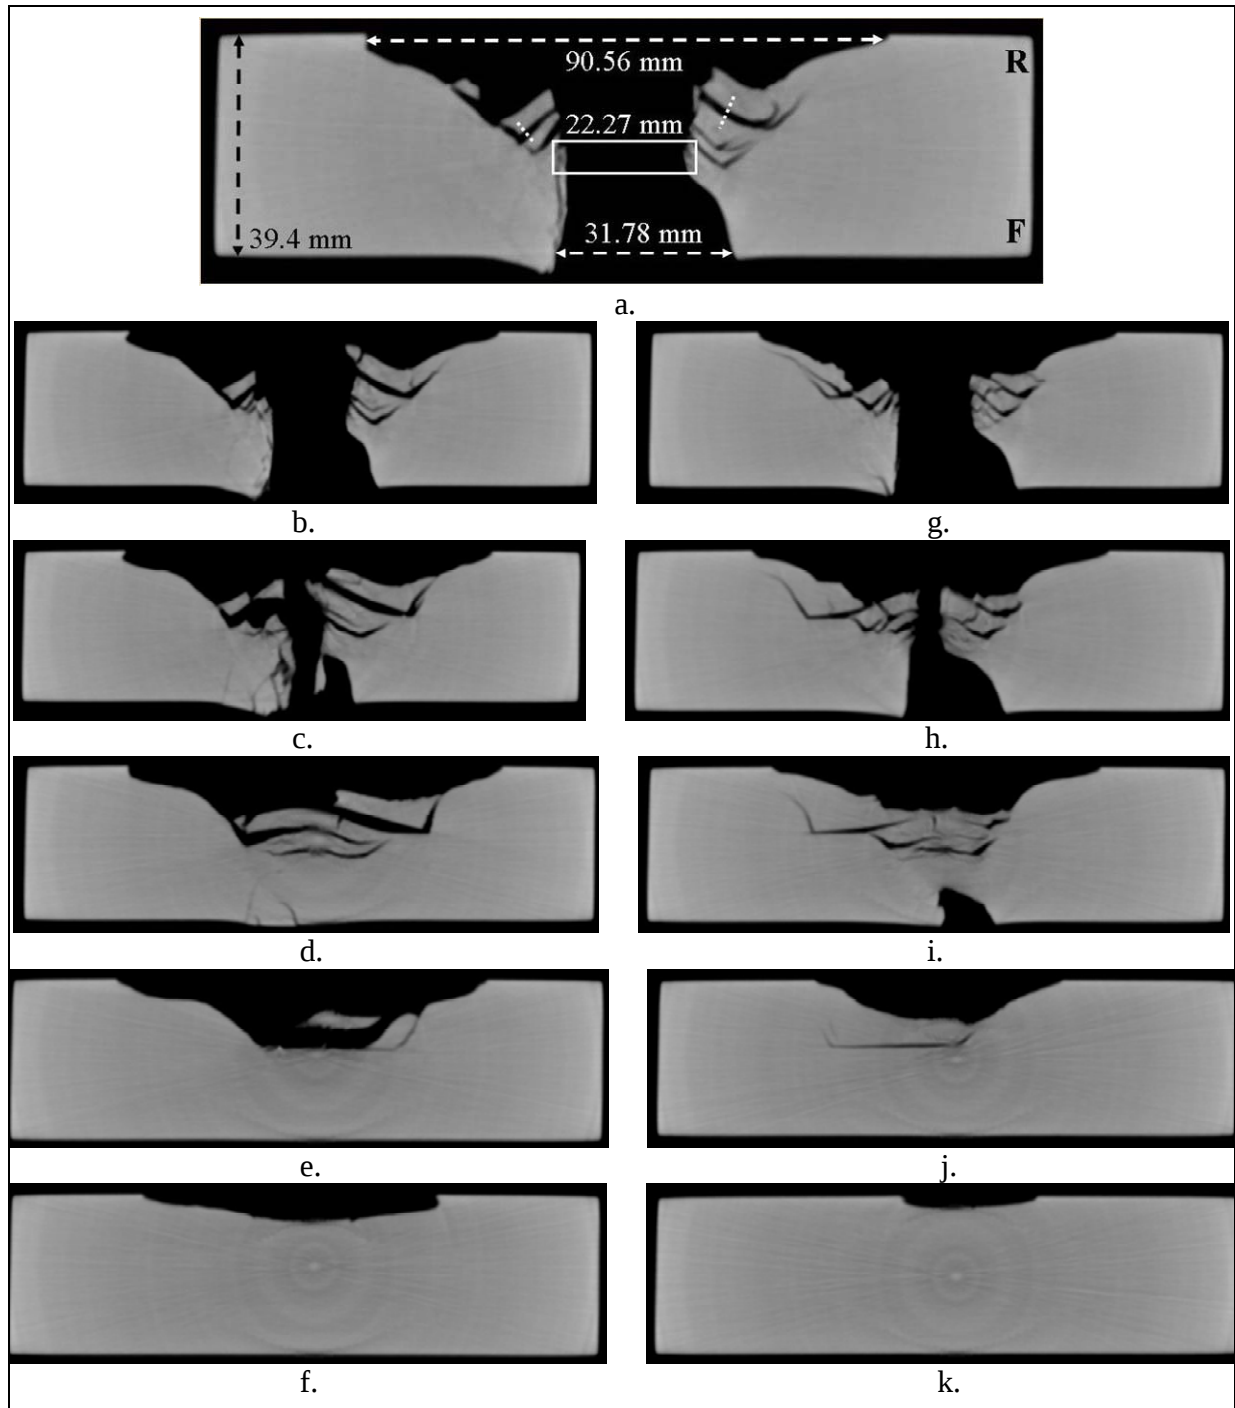
Figure 3 shows a series of CT scans (images) of the specimen, with the first at the vertical position of 116.30 mm (figure 3a), which was within 0.20 mm of the position of the center line of the main penetration hole. The scans in figures 3b–f were taken at vertical positions of 121.25, 126.20, 131.15, 141.05, and 150.95 mm, respectively. The scans in figures 3g–k were

taken at positions of 111.35, 106.40, 101.45, 91.55, and 81.65 mm, respectively. The impact and exit sides of the specimen are at the bottom and top of the images, respectively, and the thickness is 39.4 mm. The missing material towards the front of the specimen adjacent to the main hole is indicated by the shoulder on the right hand side of the cavity wall in figure 3a. A series of approximately parallel lateral, or “petal-like,” cracks on both sides of the penetration cavity are evident. The cracks have the appearance of starting in one direction from the sides of the cavity and then turning or bending back from the original direction towards the rear of the specimen. At some depth into the specimen, the lateral damage mode stops and a relatively large amount of material is pushed out of the exit side. The width of the cavity at the very front and rear of the specimen is 31.78 and 90.56 mm, respectively. The narrowest width is 22.27 mm, which is in the middle thickness region. The width of the uppermost cracks towards the rear of the specimen on both the left and right hand side of the penetration cavity is about 1.4 mm. The scans in figures 3b–f are 5.15, 10.10, 15.05, 24.95, and 34.85 mm above the main hole center line, respectively. The parallel lateral cracking damage mode is evident in figures 3b–e, to a lesser extent. These images do not show a high level of cracking oriented approximately in a through thickness direction. The scans in figures 3g–k are 4.75, 9.70, 14.65, 24.55, and 34.45 mm below the center line, respectively. The same lateral damage mode is evident in figures 3g–j, with a similar relative lack of through thickness cracking.

Figure 3. Cross-sectional CT scans (images) of damage in the Mg plate: (a) vertical position of 116.30 mm, (b) 121.25 mm, (c) 126.20 mm, (d) 131.15 mm, (e) 141.05 mm, (f) 150.95 mm, (g) 111.35 mm, (h) 106.40 mm, (i) 101.45 mm, (j) 91.55 mm, and (k) 81.65 mm.

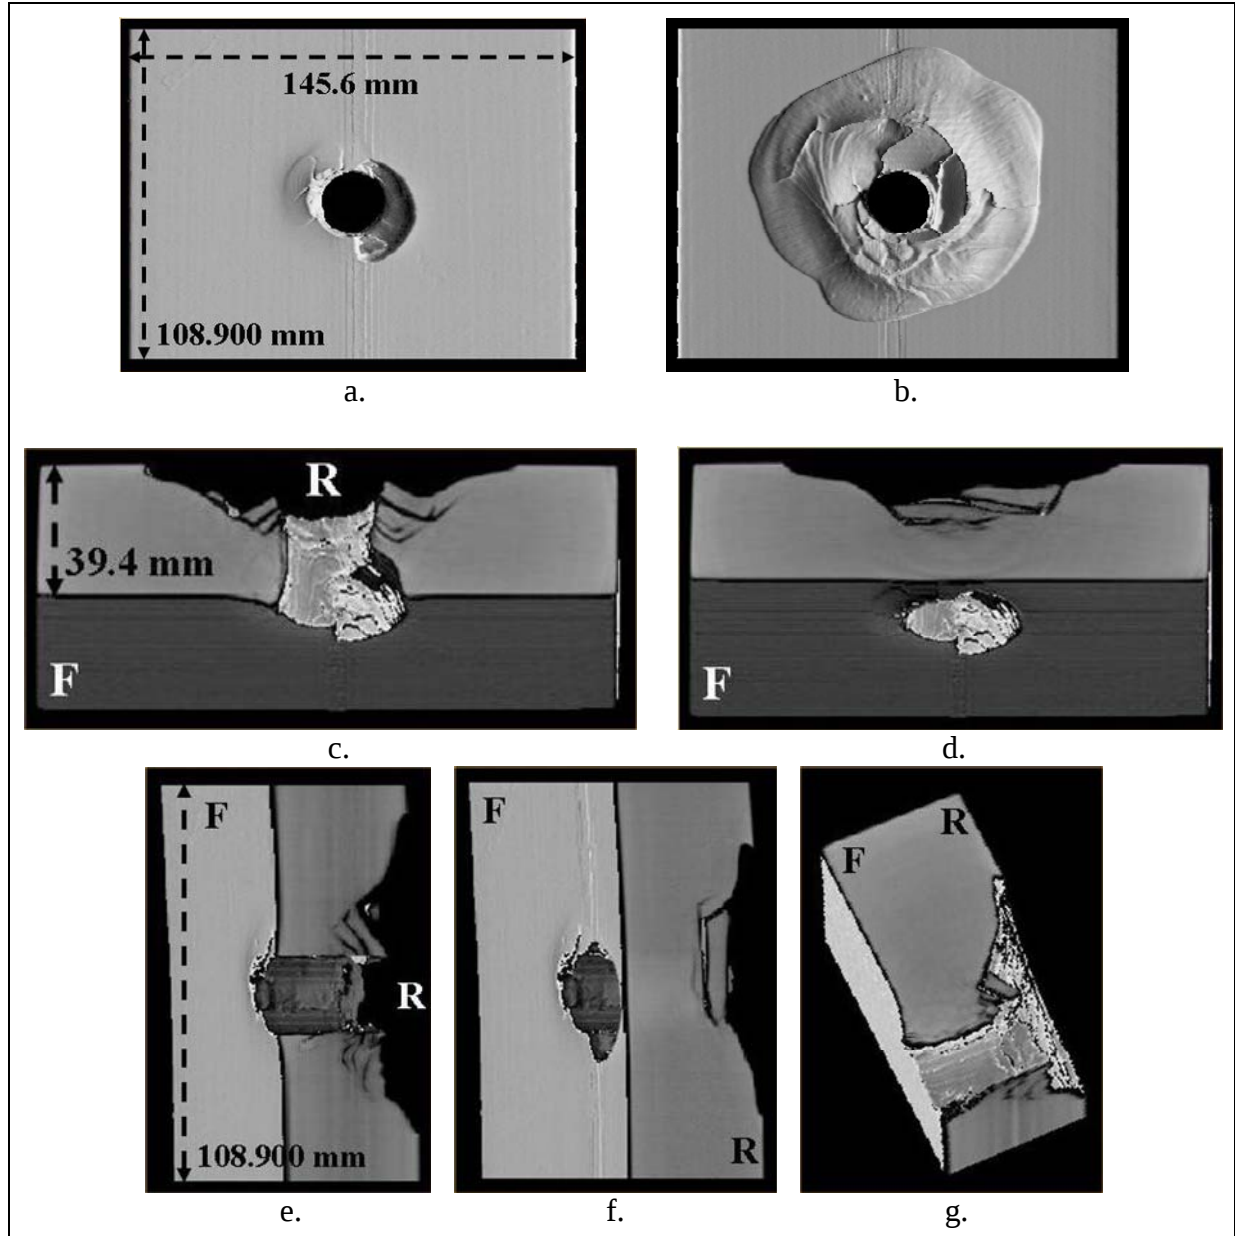
The excellent dimensional accuracy and the digital nature of XCT images allow the accurate volume reconstruction of multiple adjacent or overlapping slices. A virtual 3-D solid image is created by electronically stacking the XCT images, which have thickness over their cross-sections (i.e., voxels), one on top of the other from the bottom to the top of the specimen, or scanned height, to generate its virtual volume. Figure 4 shows a set of seven 3-D solid images of the scanned volume with sections virtually removed in figures 4c–g. The method of virtual sectioning, which is essentially only showing a portion of each scan, allows viewing of generated surfaces anywhere in the scanned volume in 3-D space. Figures 4a and b show views of the impact and exit side, respectively, of the entire scanned volume. The very light vertical banding down the middle of the images (top and bottom) is an image artifact from the reconstruction. It is not an indication of a real physical feature in the specimen. The relative shading of lighter and darker gray in the damaged areas is produced by virtual lighting. Physical texture in the surface of the damage in the rear of the specimen is visible in figure 4b. In figure 4c, the impact side of the specimen is at the bottom of the image and the sectioned surface is approximately halfway between the top and the bottom of the main penetration hole. In figure 4d, the sectioned surface is just above the top of the main penetration hole. The relatively lighter surface of the penetration cavity in figures 4c and d is due to the angle of the virtual lighting. In figure 4e, the impact side of the specimen is on the left side of the image and the sectioned surface is approximately halfway between the left and right sides of the main hole. In figure 4f, the sectioned surface is just to the right of the main penetration hole. In figure 4g, two adjacent sectioned surfaces are shown with the impact side of the specimen on the left side of the image. The main penetration hole has been virtually cut in half both horizontally and vertically. All of the sectioned surfaces in figures 4c, e, and g, which are mutually orthogonal, show the parallel lateral cracking damage mode. This is indicative that this damage mode has a significant degree of symmetry about the trajectory of the penetration. Figures 4d and f also show similar damage in the rear side of the specimen.

Figure 4. A series of virtual 3-D solid volumes of the damage in the Mg plate: (a) front side, (b) rear side, (c) horizontally sectioned through center of penetration hole, (d) horizontally sectioned just above top of penetration hole, (e) vertically sectioned through center of penetration hole, (f) vertically sectioned just to right of penetration hole, and (g) horizontally and vertically sectioned through center of penetration hole.

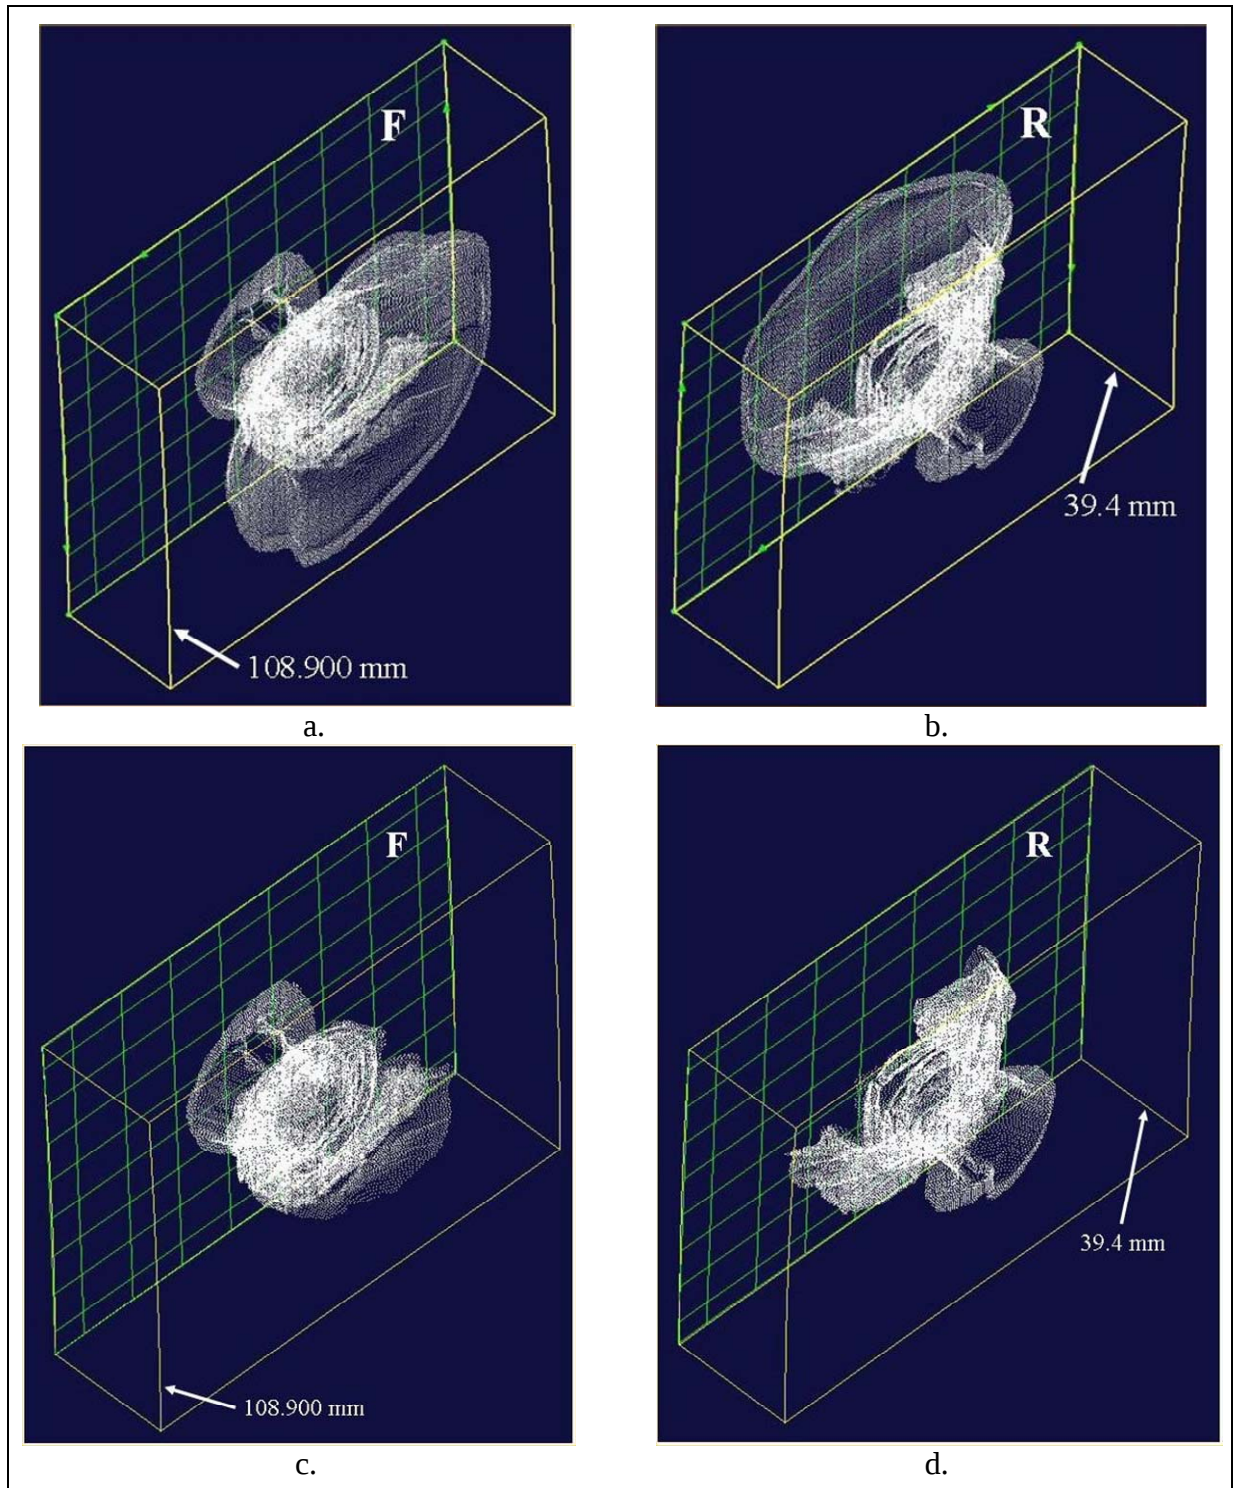
Figures 6a and b are isometric views of the damage point cloud only from exit side and impact side perspectives, respectively, with the boundaries of the scanned volume shown in wireframe mode for reference. The face of the specimen that is away from the view perspective is gridded for ease of interpretation. Figures 6c and d are isometric views of the damage point cloud with the front region of damage removed to provide an unobstructed view of the other damage. Figure 7 is a top down view of the point cloud of the rear region of damage with some overlap into the middle damage. Figure 8 is an approximate top-down view of the point cloud of the middle region of damage with a small portion of the rear damage to better show the orientation of the lateral cracks relative to the shallow cone of material pushed out the rear of the specimen. The point cloud is tilted backward a few degrees from a top down view in order to separate the upturned ends of the cracks from the surrounding damage as much as possible. Figure 9 is a top-down view of the point cloud of the front region of damage, with some points on the front surface of the specimen to the left and right of the entrance hole. The surface around the entrance hole on the left side is physically raised on the specimen.

Figure 6. Isometric views of 3-D damage point cloud only with physical boundaries of scanned volume shown as wireframe and face away from the view gridded (F indicates front and R indicates rear): (a) rear view, (b) front view, (c) rear view with rear damage removed, and (d) front view with rear damage removed.

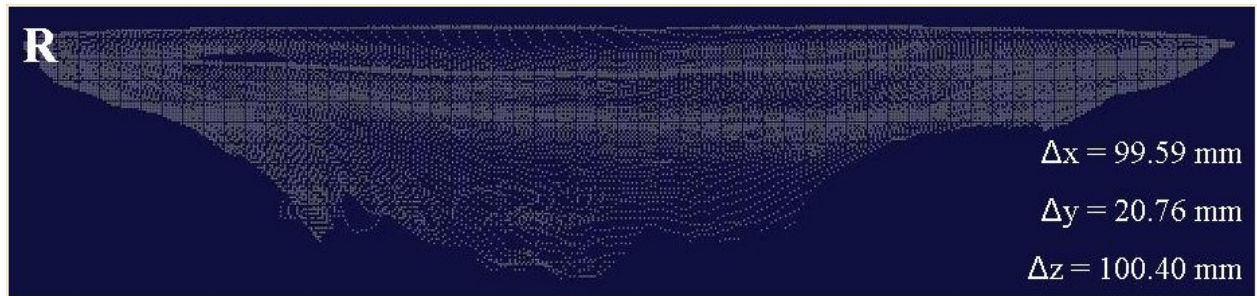
Figure 7. Top-down view of rear section (thickness) of damage point cloud only (R indicates rear side).

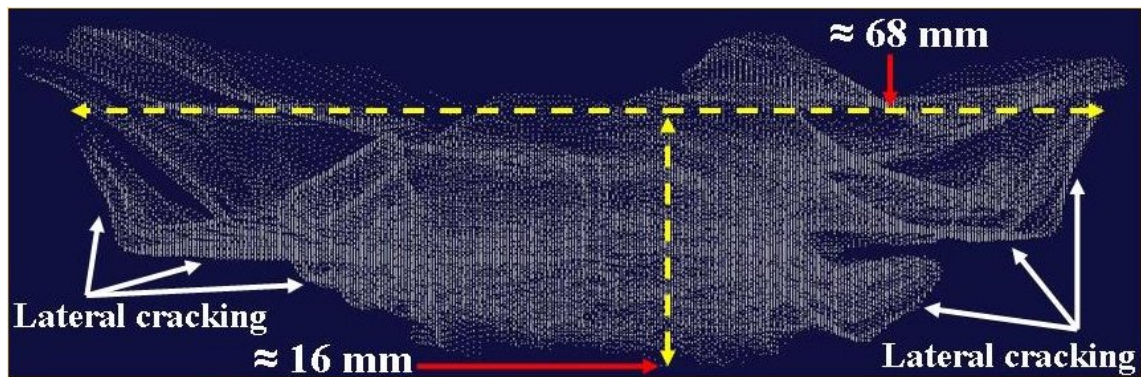
Figure 8. Top-down view of middle section (thickness) of damage point cloud only. The front side of plate is below the bottom of the image.

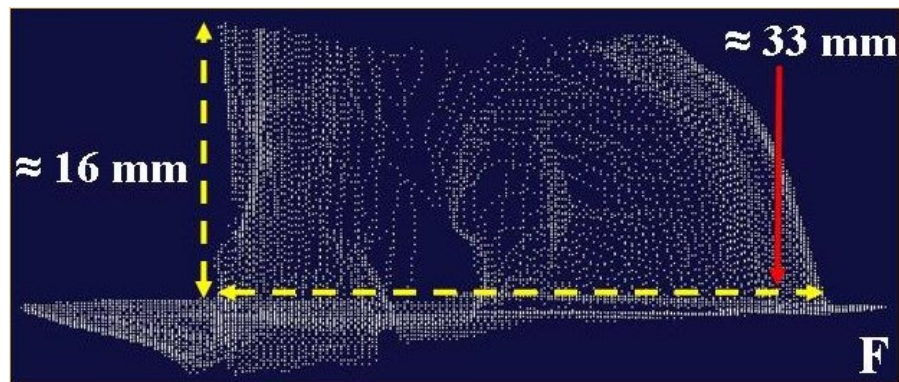
Figure 9. Top-down view of front section (thickness) of damage point cloud only (F indicates front side).

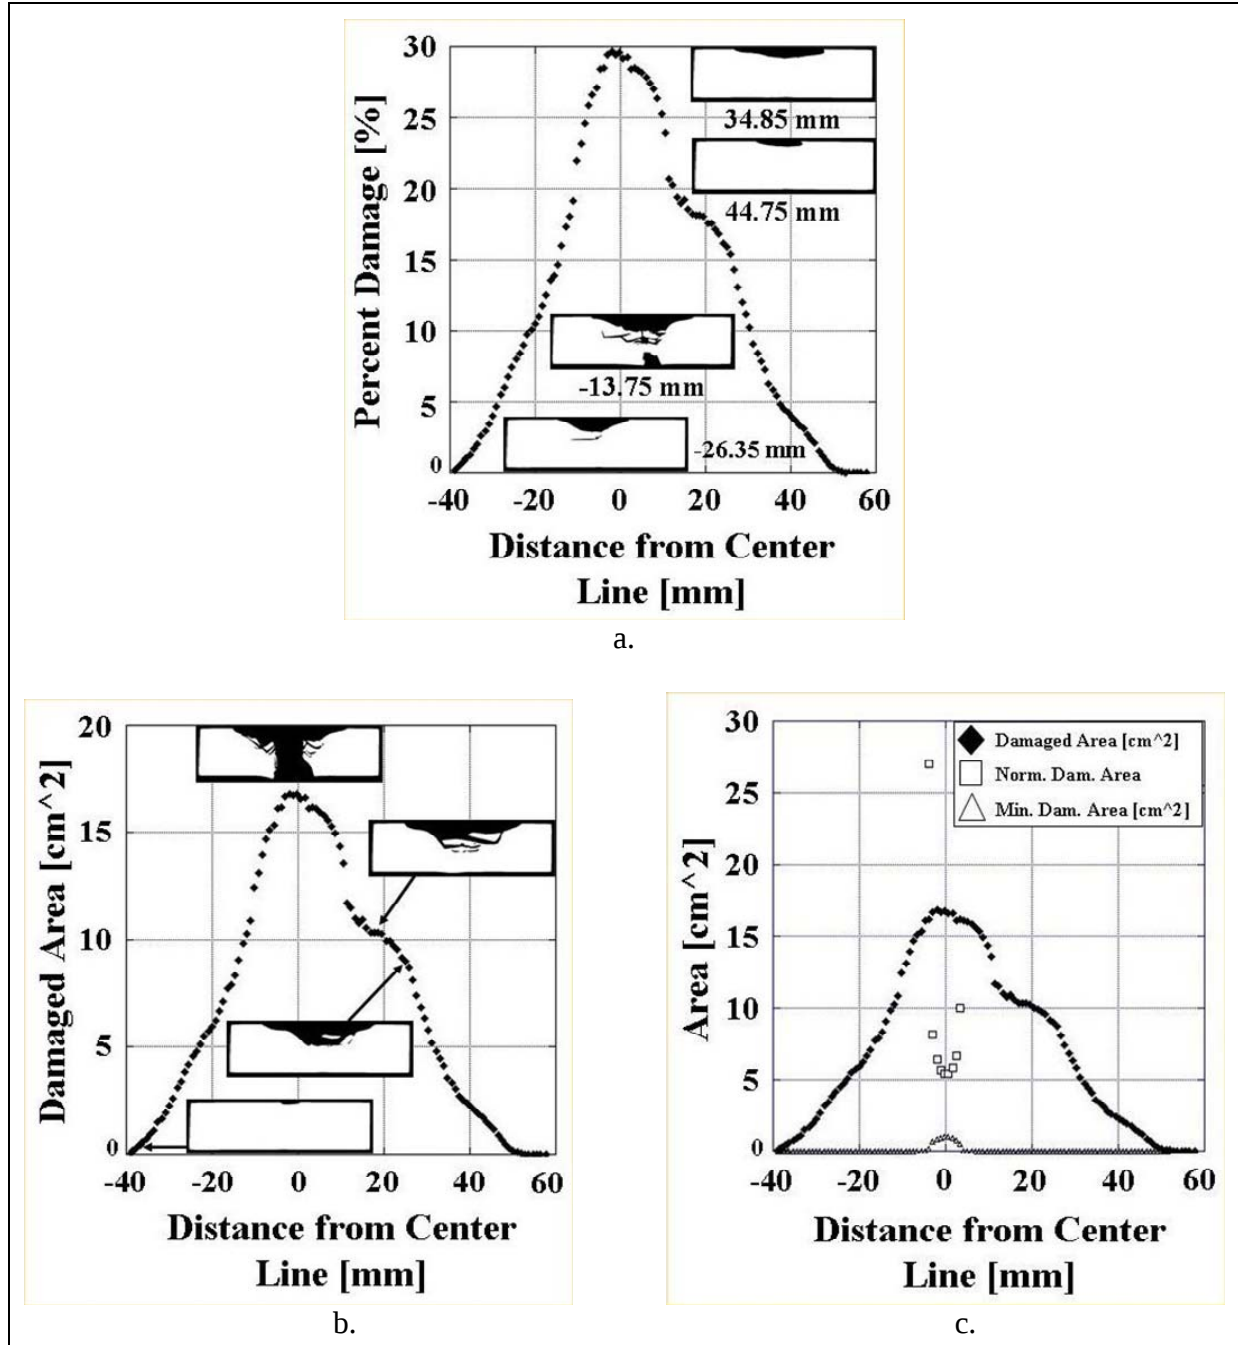
One approach to representing the damage data is to plot the percent damage relative to the cross-sectional area of the specimen against the vertical distance above and below the center line of the penetration cavity. This does show the trend in the overall damage from the bottom to the top of the cavity, as seen in figure 10a. Individual segmented binary XCT scans are overlaid on the plot to show the damage at specific locations. However, in this case the amount of damage is not in terms of an absolute quantity since the cross-sectional area depends in part on the width of the specimen as cut from the larger test plate. A more informative representation of the data is shown in figure 10b in which the pixel area,  $0.036 \text{ mm}^2$  from an areal pixel density of  $2758 \text{ cm}^{-2}$ , was used to convert number of pixels in a damaged state to total damaged area and plot it versus the distance from the center line. Again, individual segmented binary XCT scans are overlaid on the plot to show the damage at specific locations. The most interesting feature of this plot is the shoulder on the right about 20 mm above the center line. The two binary images shown in this vicinity appear to indicate that less material remained on the left side of the penetration cavity. Figure 10c shows the damaged area plot as well as minimum possible damage from complete penetration and normalized damaged area plots.

The minimum damage plot (triangles) is based on the amount of damage that would be present due to a uniform penetration hole through the thickness of the specimen with a diameter equal to the diameter of the base of the threat. Therefore, the minimum damage is 0 if the distance above or below the center line is one threat radius or greater. The normalized damaged area plot (squares) is simply the damaged area plot (black diamonds) divided by the minimum damage plot. It shows that the damaged area produced by the penetration at the center line is approximately  $5\times$  greater than the damage that would exist from a minimum complete penetration hole.

Figure 10. Plots of damage vs. vertical distance from center line of penetration cavity (positive indicates above and negative indicates below center line): (a) percent damaged area perpendicular to faces, (b) damaged area perpendicular to faces, and (c) damaged area, minimum damage area, and normalized damaged area on same plot for comparison.

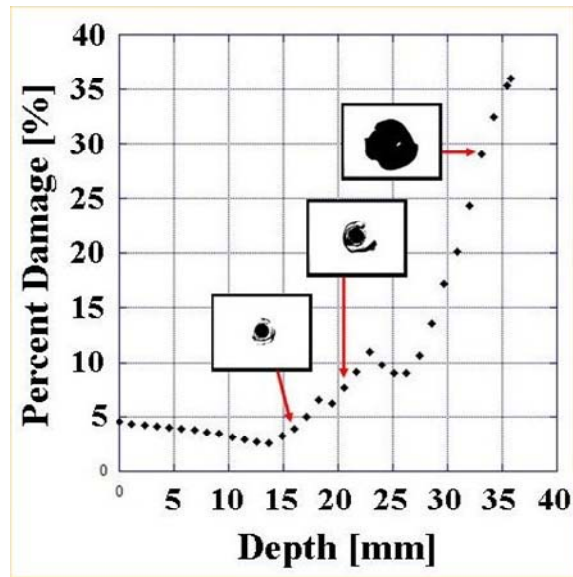
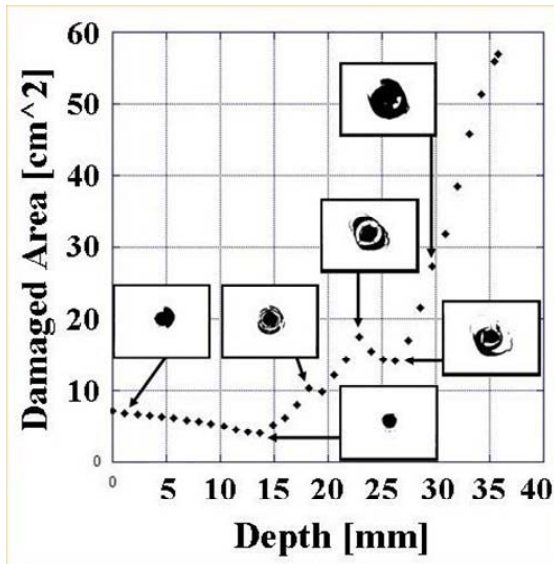
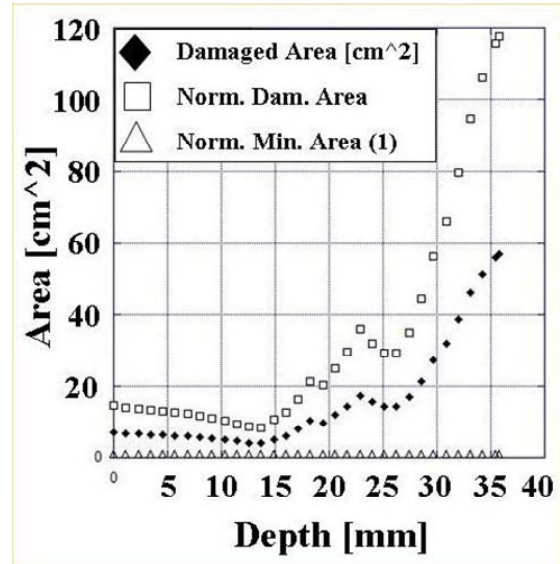
Figure 11a is a plot of the percent damaged area parallel to the faces of the specimen versus depth from its impact face. Individual segmented binary vertical slices are overlaid on the plot to show the damage at specific locations. Figure 11b is a plot of the damaged area parallel to the faces of the specimen versus depth from its impact face. Again, individual segmented binary vertical slices are overlaid on the plot to show the damage at specific locations. The plot has two local maxima and three local minima. This behavior of local peaks and valleys is due to the parallel lateral cracking damage mode in the middle of the specimen. The local spatial periodicity of the minima-to-minima (two) and maxima-to-maxima (one) segments of the damage is about 5 mm. The plot also shows that the area of the penetration hole necks down to a minimum at a depth of about 14 mm and a steep rise after a depth of about 26 mm, which is indicative of the large amount of material pushed out the back of the specimen. Figure 11c shows the damaged area plot as well as normalized minimum and normalized damaged area plots. Again, the normalized minimum plot (triangles) is based on the amount of damage that would be present due to a uniform penetration hole through the thickness of the specimen with a diameter equal to the diameter of the base of the threat. In this case, the minimum possible damage area as a function of depth is a constant, so this plot is normalized to one. The normalized damaged area plot (squares) is the damaged area plot (black diamonds) divided by the constant minimum damage area. In this way, the normalized damaged area plot gives a factor difference between the actual damaged area and the minimum possible damage with complete penetration (factor = 1). For example, at a depth of about 14 mm the damaged area is about nine times greater than the minimum possible damage area for a uniform through thickness hole. Similarly, at the two depths of the local maxima, about 18 and 22.5 mm, the damaged area is about 20 and  $37\times$  greater than the minimum, respectively. The through-thickness damaged area is at least approximately one order of magnitude or greater than the minimum possible damage area throughout the penetration cavity.

Figure 11. Plots of damage vs. depth (distance from front face): (a) percent damaged area parallel to faces, (b) damaged area parallel to faces, and (c) damaged area, normalized minimum area, and normalized damaged area on same plot for comparison.
