**OFFICE OF THE SPECIAL INSPECTOR GENERAL
FOR AFGHANISTAN RECONSTRUCTION**

**INSPECTION OF ABDUL MANAN SECONDARY SCHOOL
CONSTRUCTION PROJECT IN KAPISA PROVINCE:
INSUFFICIENT PLANNING, SAFETY PROBLEMS, AND POOR
QUALITY CONTROL AFFECT PROJECT RESULTS**

SUBJECT: SIGAR Inspection Report 10-2: Inspection of Abdul Manan Secondary School Construction Project in Kapisa Province: Insufficient Planning, Safety Problems, and Poor Quality Control Affect Project Results

Summary of Report: SIGAR Inspection 10-2 October 26, 2009 Inspection of Abdul Manan Secondary School Construction Project in Kapisa Province: Insufficient Planning, Safety Problems, and Poor Quality Control Affect Project Results

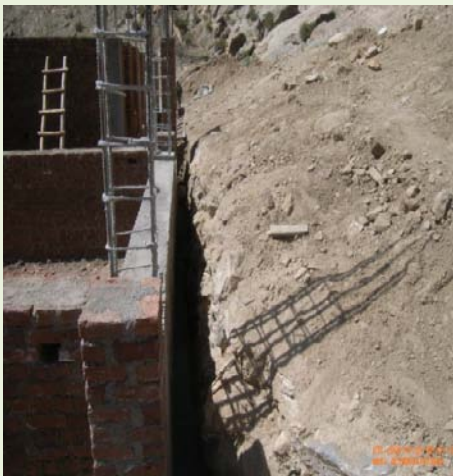
The photo at left shows the rear wall of the school structure constructed adjacent to the vertical wall of the excavation, leaving no room for the security perimeter wall. Contrary to accepted construction practices, the contractor was forced to excavate the area around the wall after it was built.

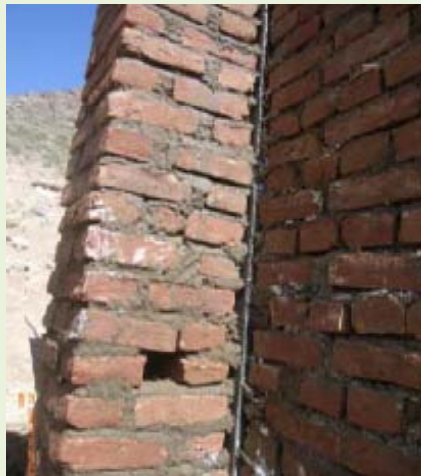
The photo at the right is an example of substandard masonry work which had to be demolished and rebuilt. (Photos provided by SIGAR)
