THI QAR VILLAGE ROADS
SEGMENT 3
GOVERNORATE OF
THI QAR, IRAQ

SIGIR-PA-06-059
OCTOBER 26, 2006

SUBJECT: Report on Project Assessment of Thi-Qar Village Roads Segment 3 Project,
Thi-Qar, Iraq (Report Number SIGIR-PA-06-059)

Thi Qar Village Roads – Segment 3 Governorate of Thi Qar, Iraq

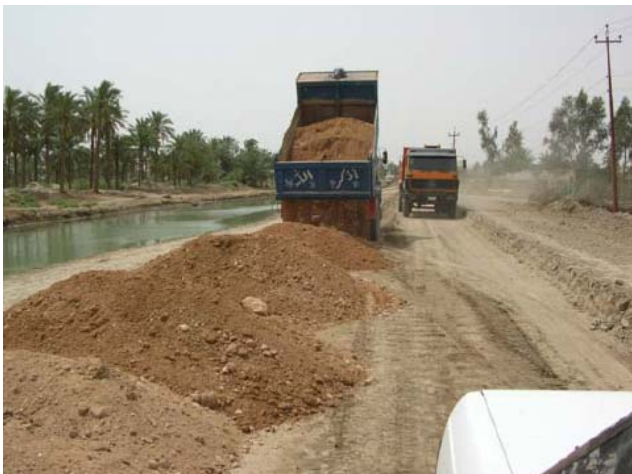
Site Photo 1. Trucks delivering material to the roadway (Photo provided by USACE)

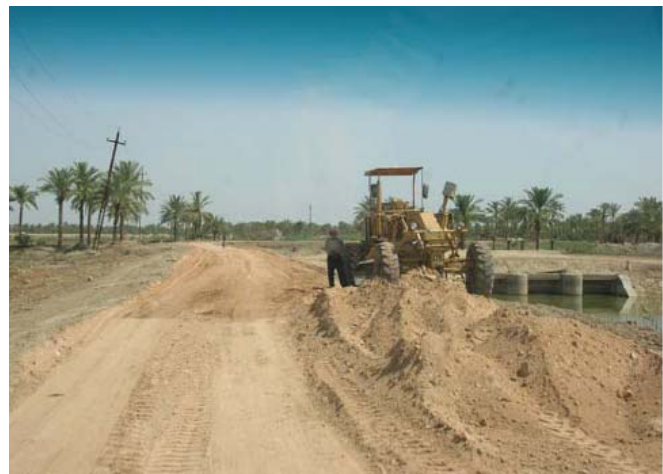
Site Photo 2. Fill material being leveled. (Photo provided by USACE)

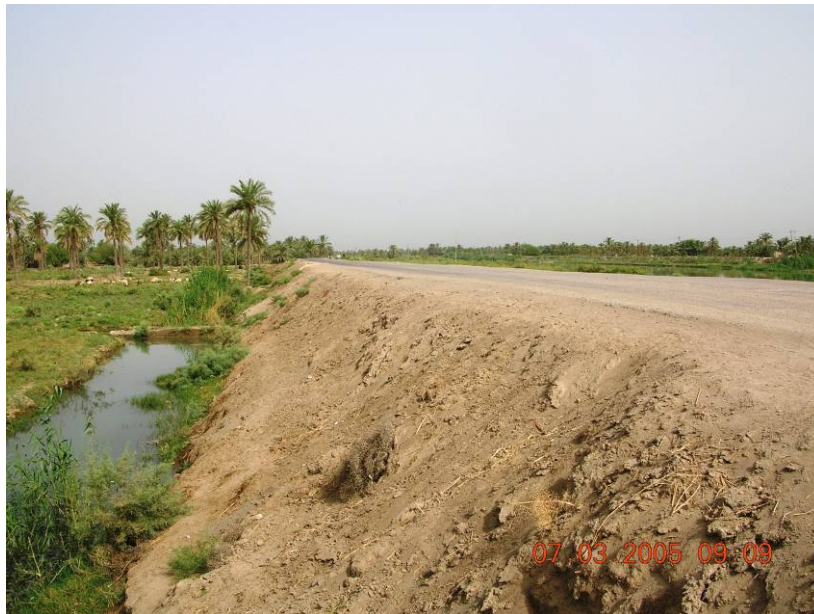
There was one area of concern noted by the assessment team as shown in Site Photo 3. The material utilized to construct the fill section appears to contain organic matter. The Iraqi Standard Specifications for Roads and Bridges notes that soil containing more than 12 percent organic matter (as tested by British Standard 1327) is unsuitable. The contract files did not contain any record of tests for organic

matter, so it is unclear whether the amount of organic matter in the embankment shown in Site Photo 3 exceeds the 12 percent threshold. Based on subsequent photographic evidence, the effects of the organic material appear to be insignificant.

Site Photo 3. Embankment with organic matter in the fill. (Photo provided by USACE)

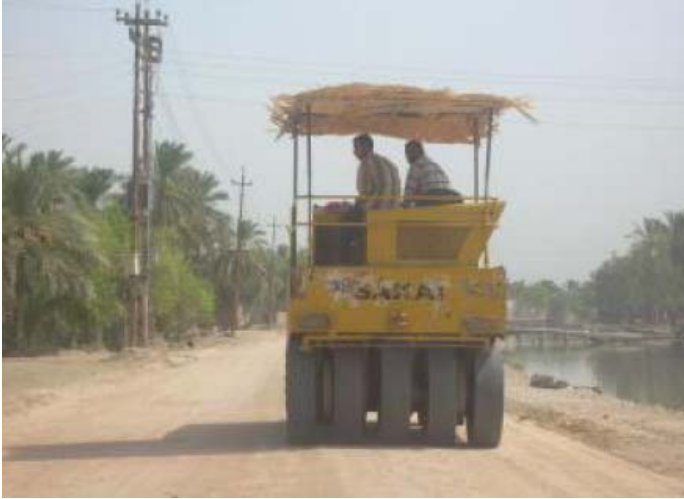
**Site Photo 4. Rolling operations to compact sub-base.
(Photo provided by USACE)**

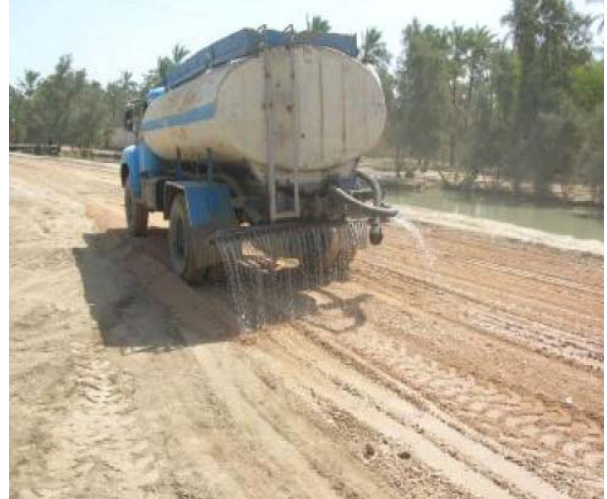
**Site Photo 5. Watering the sub-base.
(Photo provided by USACE)**

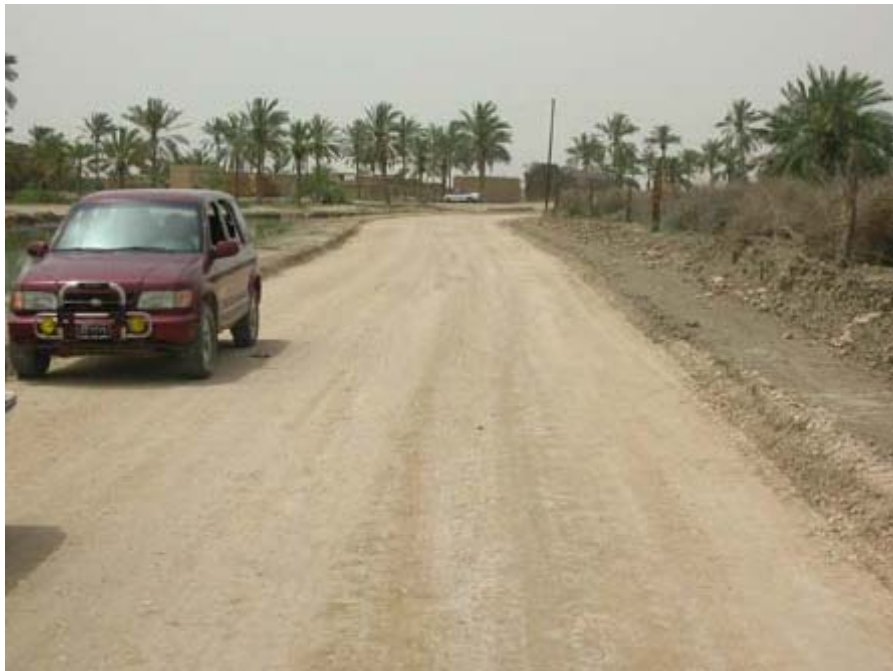
Site Photo 6. Compacted sub-base. (Photo provided by USACE)

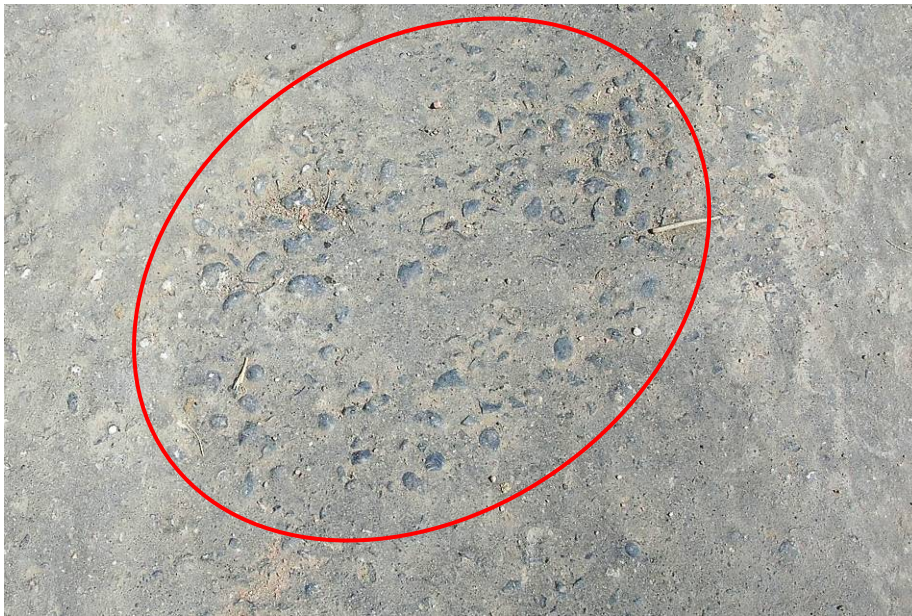
construction. The USACE RE indicated on 17 July 2005, that within the first 500-750 meters of the project from the railroad station (*the southern limit of the project*), the asphalt appeared to have too much aggregate on the top layer (Site Photo 7).

**Site Photo 7. Exposed aggregate on surface of asphalt base course.
(Photo provided by USACE)**

Based on the contractor's response to the USACE RE, the mix contained a higher proportion of course aggregate. Although the contractor indicated a mix with a higher proportion of course aggregate provided grater stability (against rutting), the pavement was also subject to increased possibility of cracking and potential raveling. Nonetheless, the contractor stated they would repair the section in question by overlaying base course with a fine mix of asphalt.

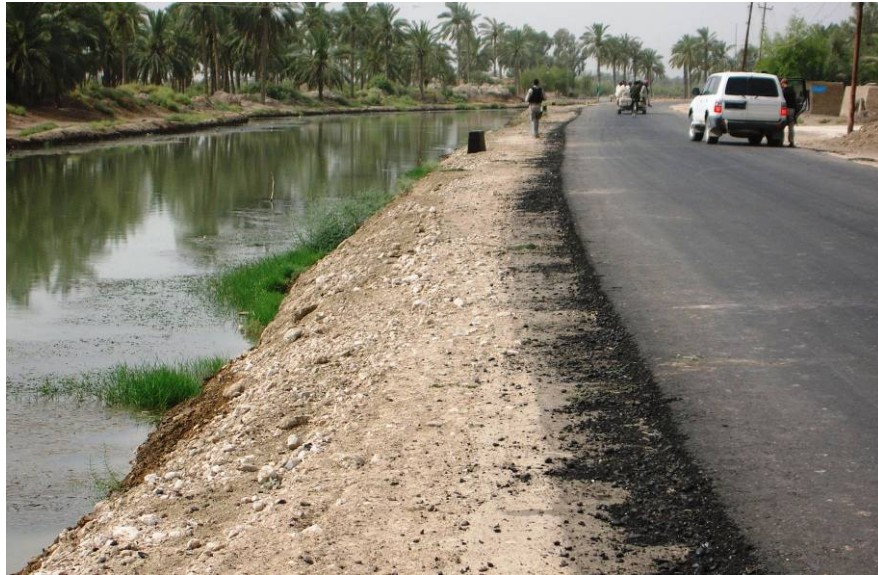
The other issue noted by the USACE RE was the outside edge problem as shown in Site Photo 8. In correspondence to the contractor, the USACE RE stated:

“Ideally, there should be a definitive borderline along the side of the asphalt road and the shoulder. In other words, you should be able to clearly see where the asphalt stops and the shoulder starts.”

Site Photo 8. Outside pavement edge with a non-uniform edge. (Photo provided by USACE)

The contractor indicated the edge would be corrected when the shoulders were constructed.

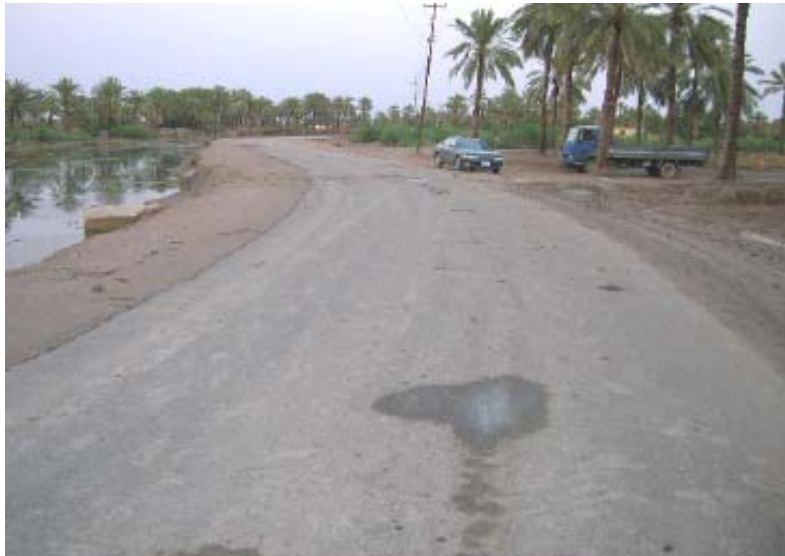
Site Photo 9. Curved section of Thi Qar Village road in April 2006. (Photo provided by USACE)

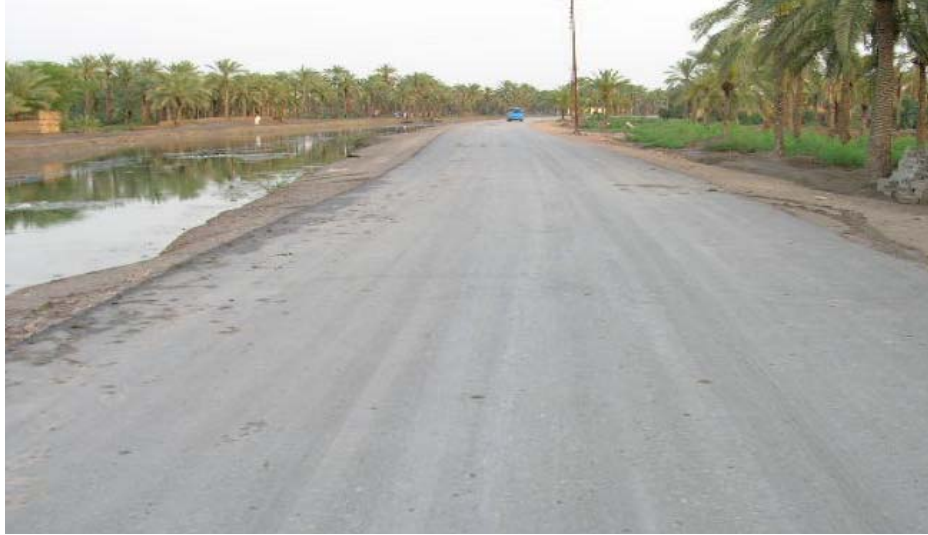
**Site Photo 10. Straight section of Thi Qar Village road in April 2006.
(Photo provided by USACE)**

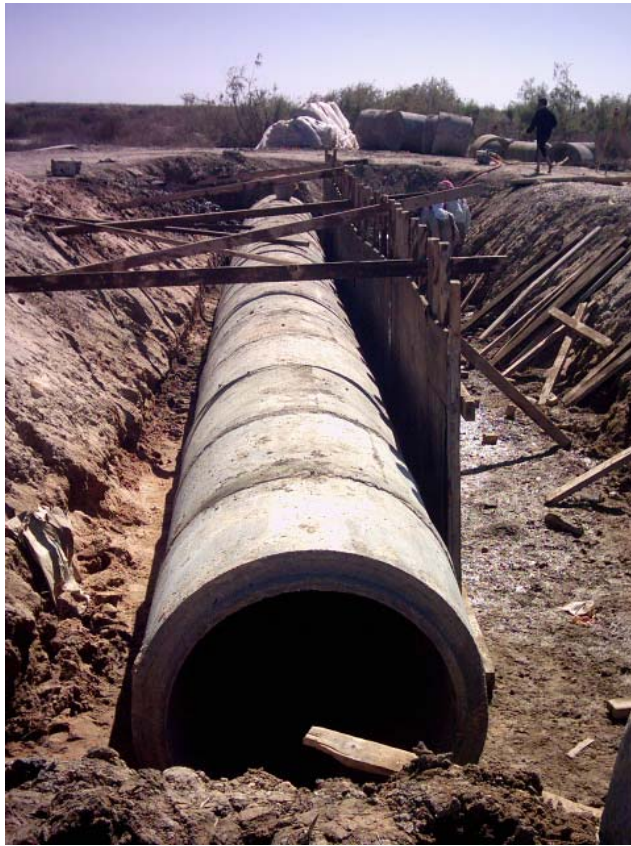
Site Photo 11. Reinforced concrete pipe culvert under construction.
(Photo provided by USACE)
