ERDC/CERL TR-11-21

Civil Works Hydropower R&D Program

Cavitation-Resistant Coatings for Hydropower Turbines

Final report

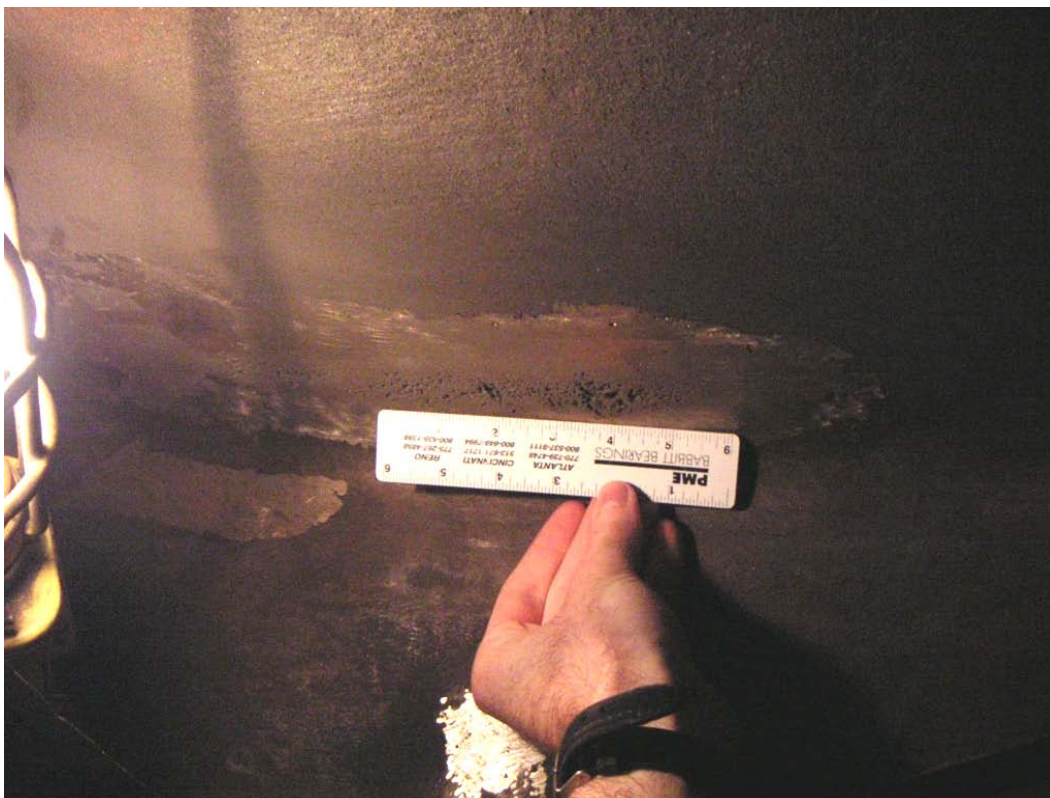
RUNNER DISCHARGE SIDE AT BAND: Cavitation was present on every bucket, on the fillet between the bucket and the band. The area and extent of the damage was approximately the same in all locations.

Figure 1. Typical cavitation damage areas on lower one-third of suction side of buckets after approximately 1 year of operation since last repair.

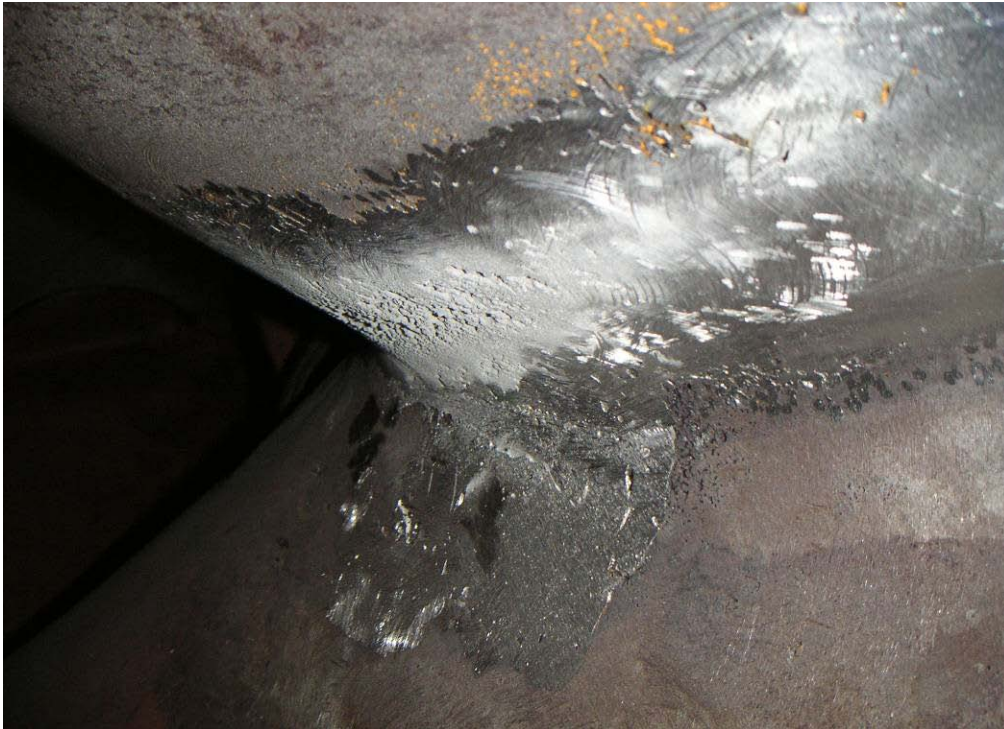
Figure 2. Typical cavitation damage areas on upper one-third of suction side of buckets after approximately 1 year of operation since last repair.

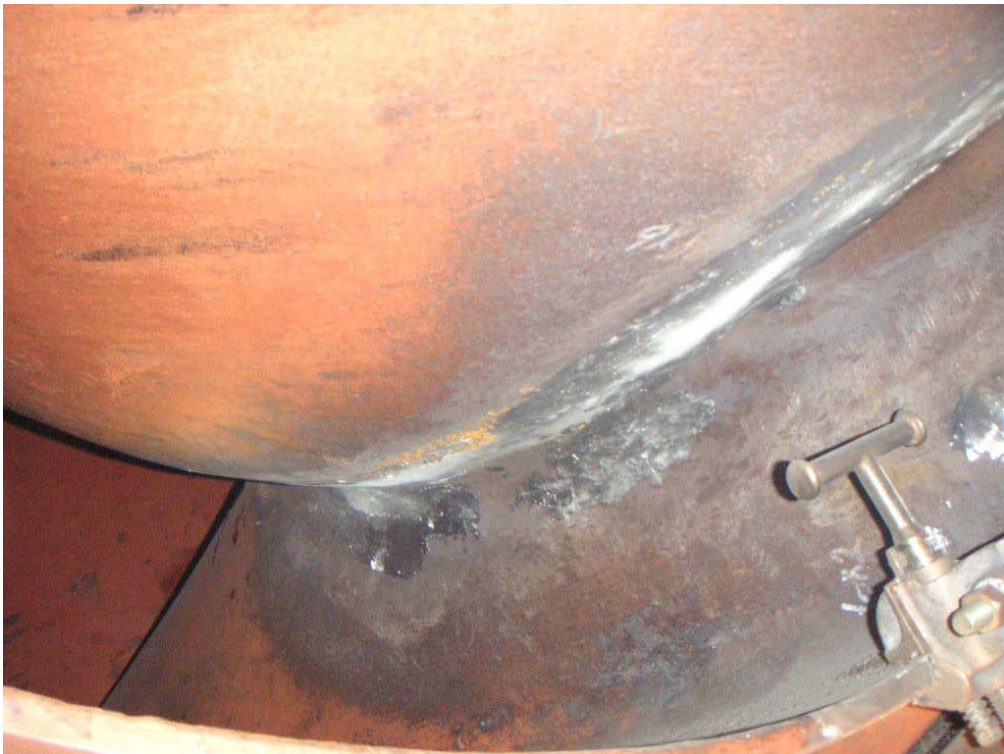
Figure 3. Typical cavitation damage area showing that cavitation-prone area covers much of area near fillet on suction side of buckets.

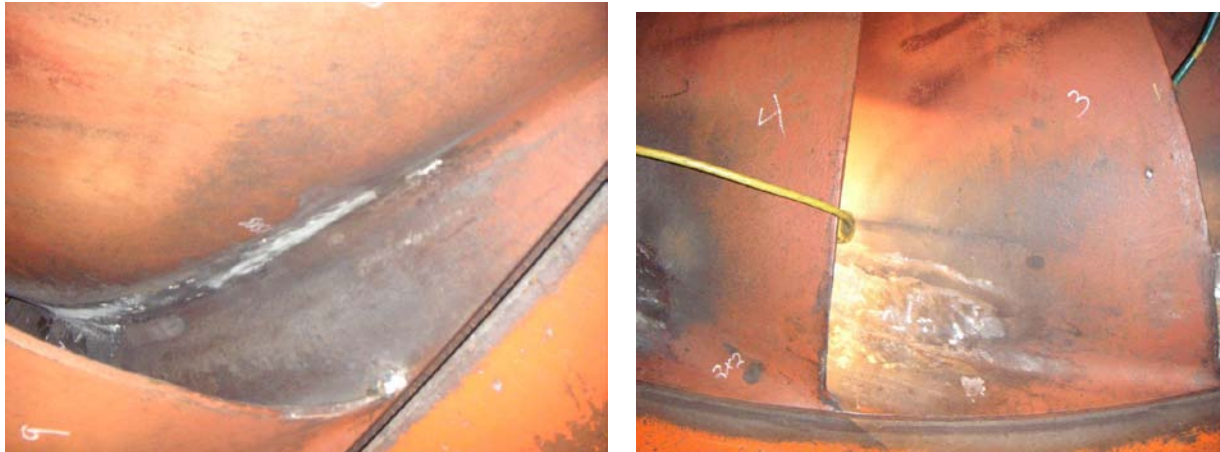
Figure 4. Typical cavitation repair areas on discharge side of buckets.

Prior to application of the coatings, the existing cavitation was repaired on each of the test buckets. The base metal of the runner is cast steel, QQ-5-681, class 3. The repair conducted by site personnel consisted of fill welding the area with 309 stainless and grinding the repair smooth. The coating applicator Flame Spray Incorporated (FSI) then abrasive blasted the surfaces with aluminum oxide grit. The surface roughness of the substrate before coating as well as that of the applied coating was recorded and documented by FSI (see Appendix A). The sketches in this appendix show the average roughness (Ra) in microinches (1000 μ in. is equivalent to 1 mil or 0.001 in.). The sketches include a line indicating the direction the instrument was oriented while making the reading. The sketches also show the location of a number of spots indicating cavities remaining in the surface after the grinding and abrasive blasting. Such cavities are inevitable. Some of the larger holes show an estimated diameter (\emptyset) and depth (\downarrow) in inches; however, the majority of the holes that are shown simply as spots were too small to accurately estimate.
