# F-111 Adhesive Bonded Repair Assessment Program (FABRAP) - Phase I Testing, Preliminary Results

*Paul J. Callus, Paul Chang, David Dellios, Kelvin J. Nicholson, Andrew  
Rider, Ivan Stoyanovski and Eudora Yeo*

DSTO-TN-1024

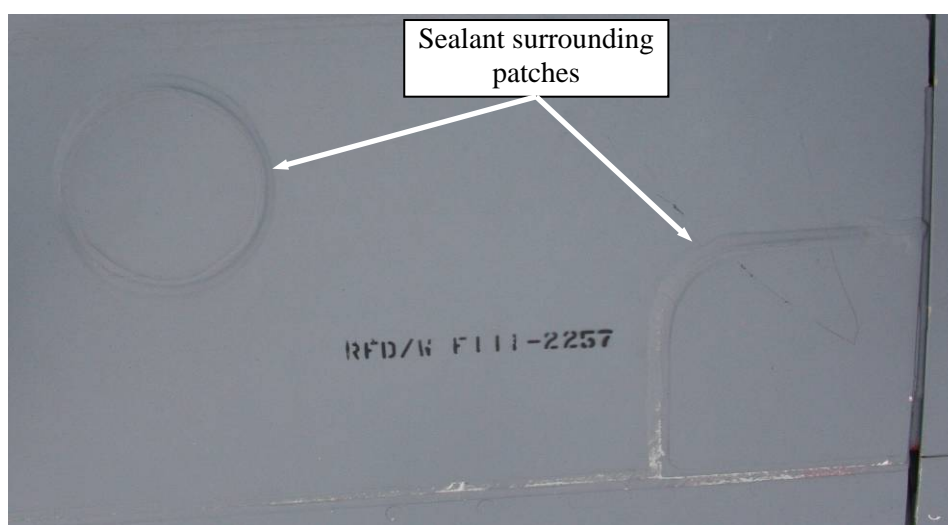
*Figure C.1: Photograph of the sealant around two bonded repairs and their RFD/W identification number*

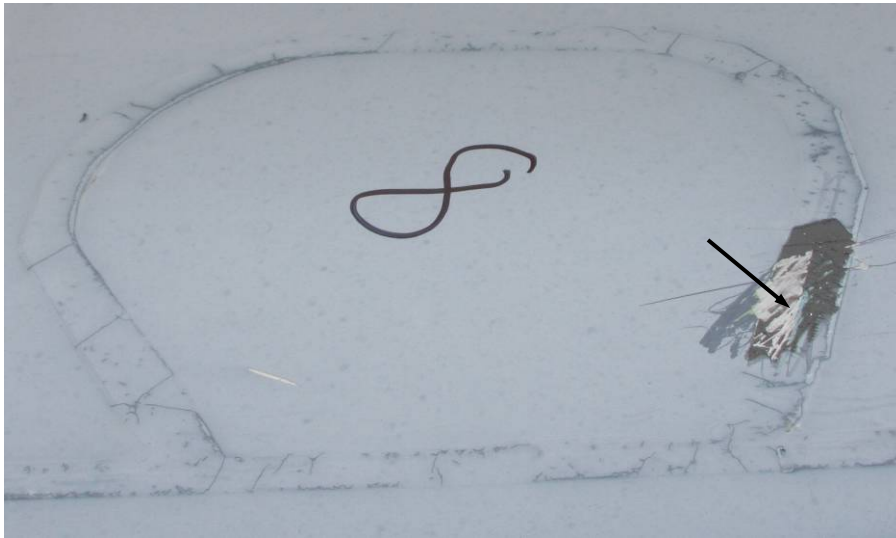
*Figure C.2: Photograph of a patch with sufficient sealant removed to identify the blue FM300 adhesive (arrowed)*

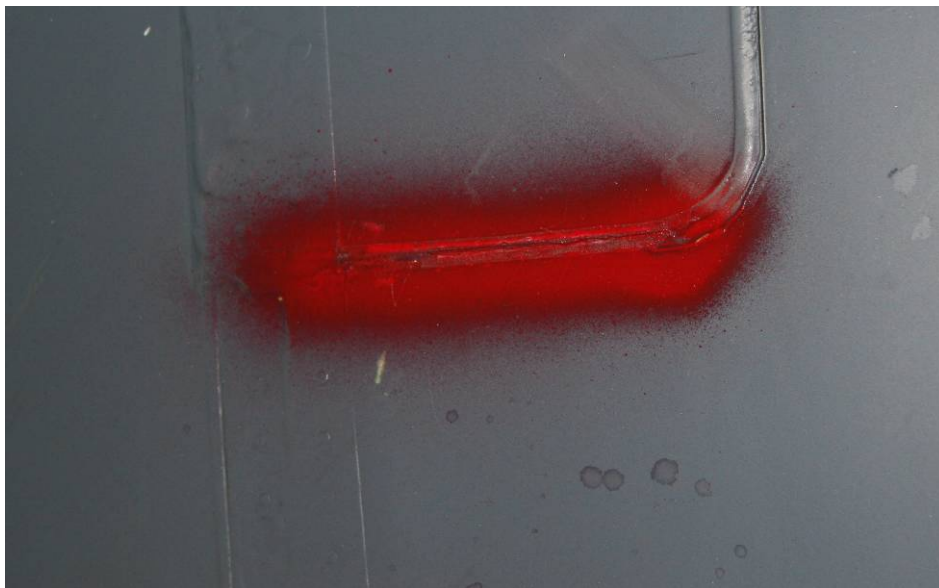
AF130 and AF131 adhesives are brown and contain asbestos. If the adhesive colour is in the yellow to brown range, consult bonding technicians with experience in identification of adhesives containing asbestos. Patches bonded with these adhesives are to be marked with Rust Away red enamel paint as shown in Fig. C.3 and not handled under FABRAP. Any exposed AF130 or AF131 adhesive is to be sealed with a continuous film of Rust Away red enamel spray paint. Where there was any doubt, adhesives were treated as potentially containing asbestos.

*Figure C.3: Photograph of a patch containing AF131 adhesive marked with red enamel paint*

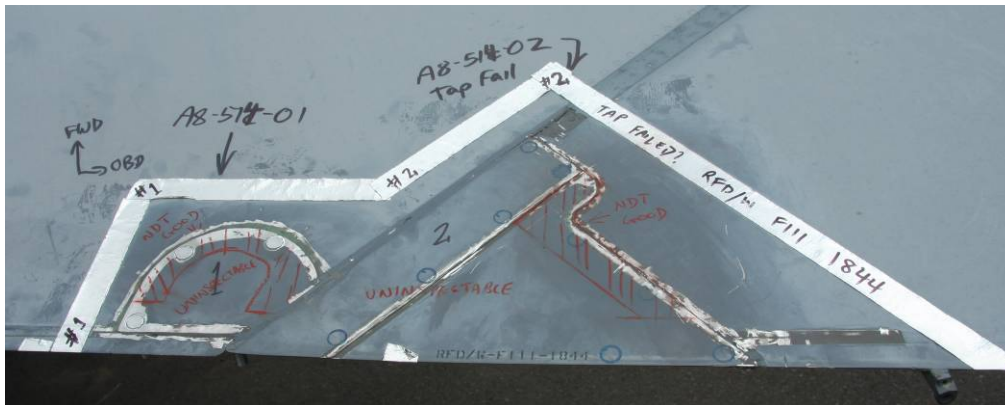
Figure C.4: Photograph of two patches that had been inspected and marked up by 6 Squadron

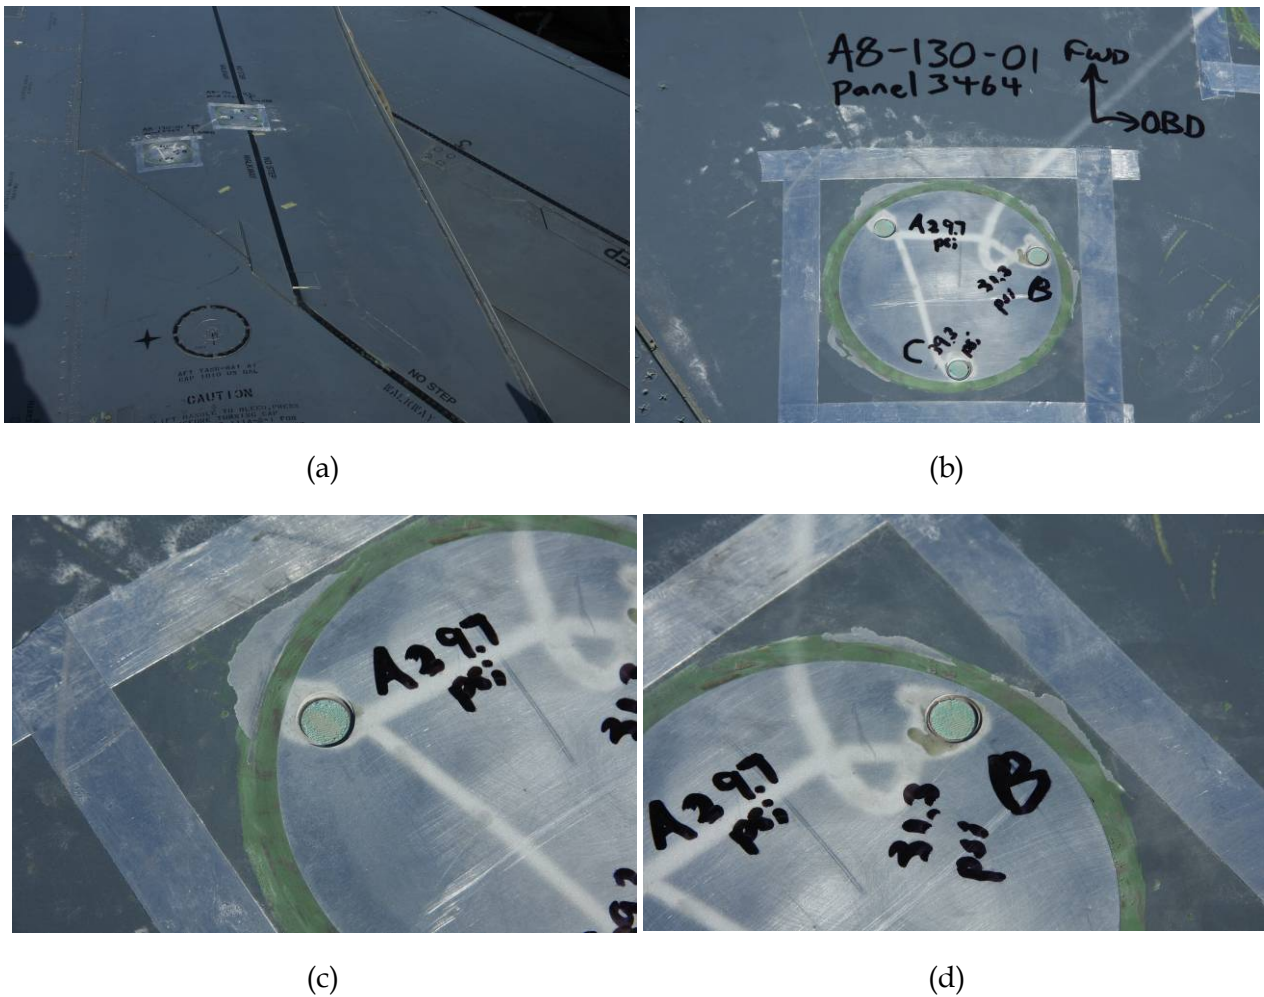
Figure C.11 A typical set of post-test photographs showing the (a) panel, (b) patch, and (c) and (d) two of the stubs
