Monitoring Completed Navigation Projects Program

Periodic Inspections of Hilo, Kahului, Laupahoehoe, and Nawiliwili Breakwaters, Hawaii

Armor Unit Monitoring for Period 2001-2005

October 2011

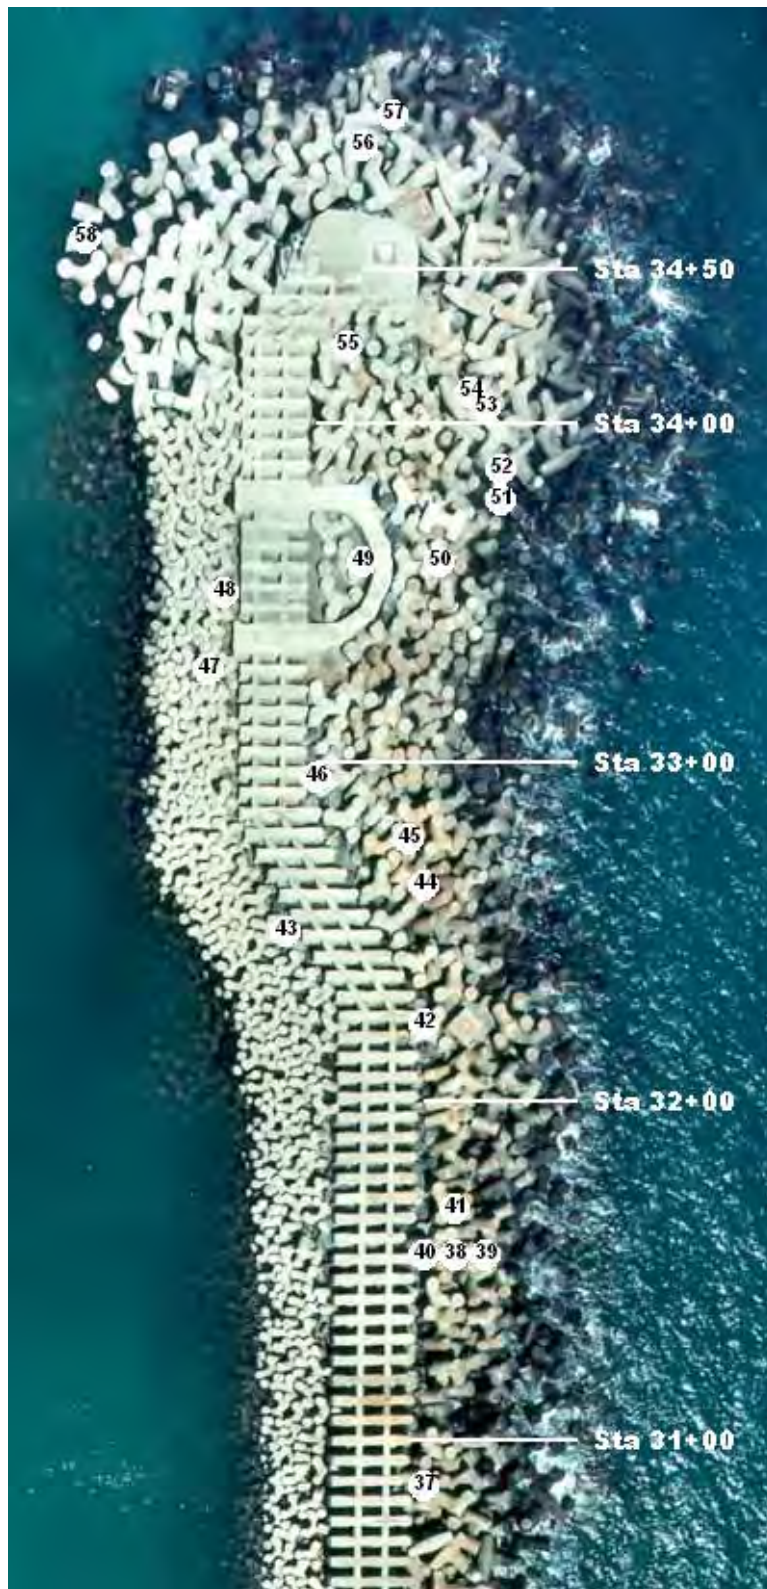
Figure 31. Approximate damage locations on Kahului East Breakwater, photograph 1.

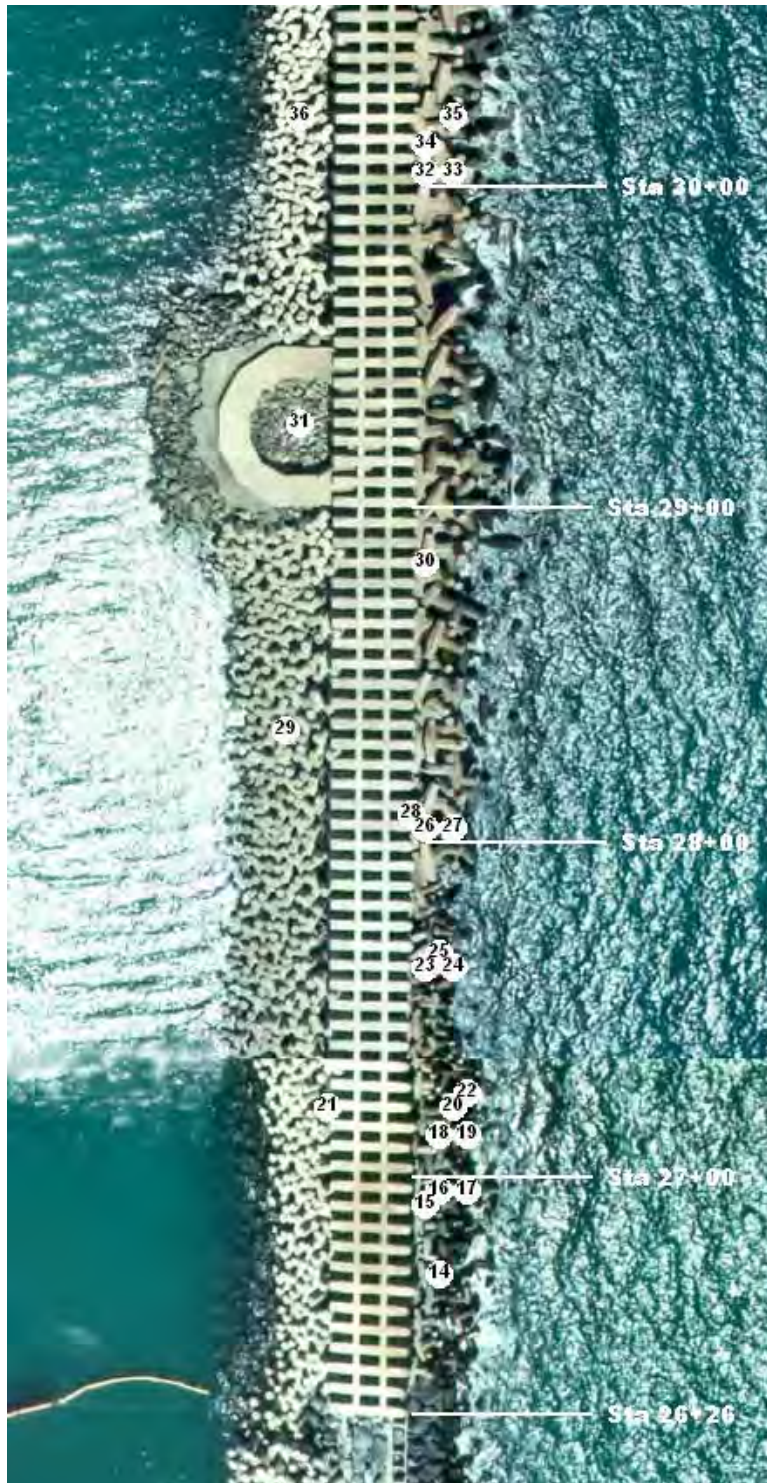
Figure 32. Approximate damage locations on Kahului East Breakwater, photograph 2.

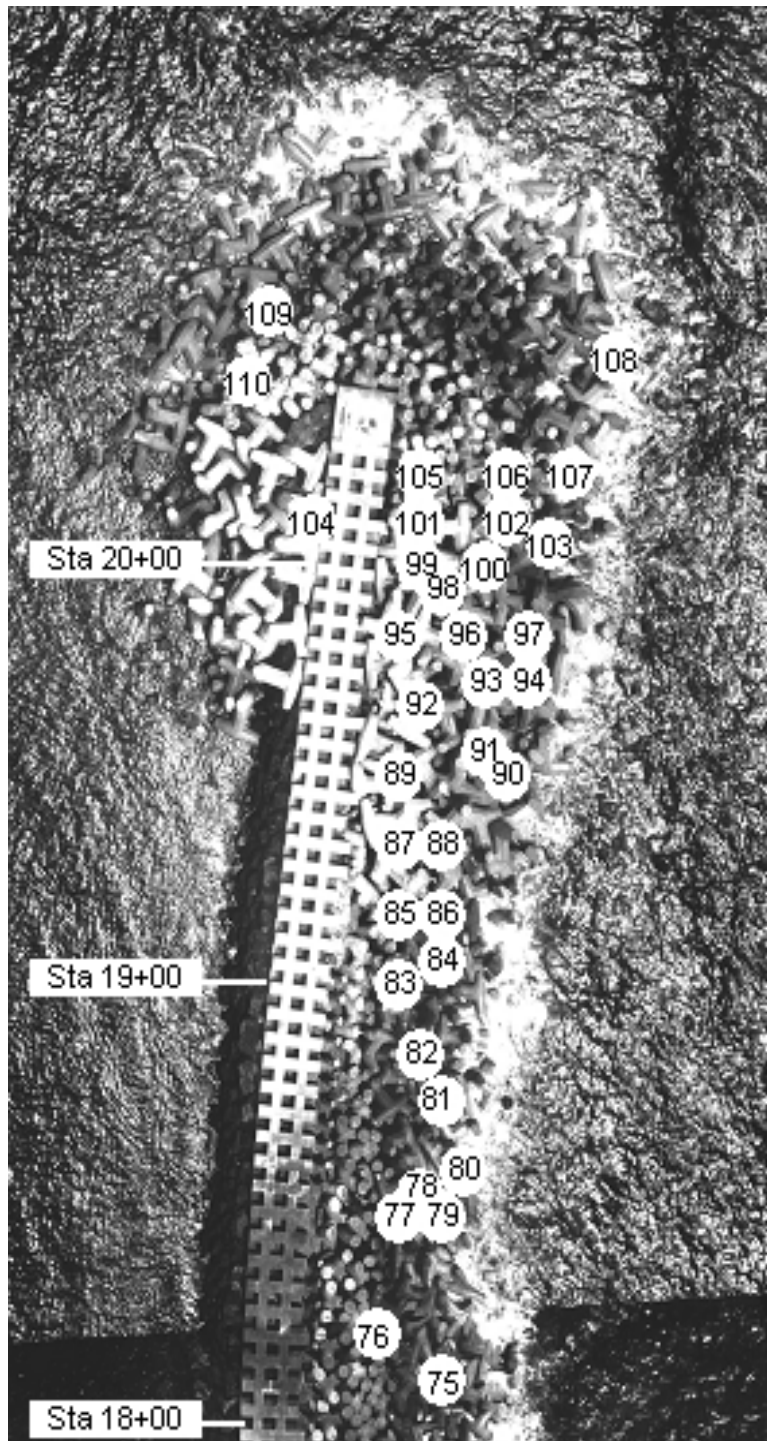
Figure 35. Approximate damage locations on Nawiliwili breakwater, photograph 1.

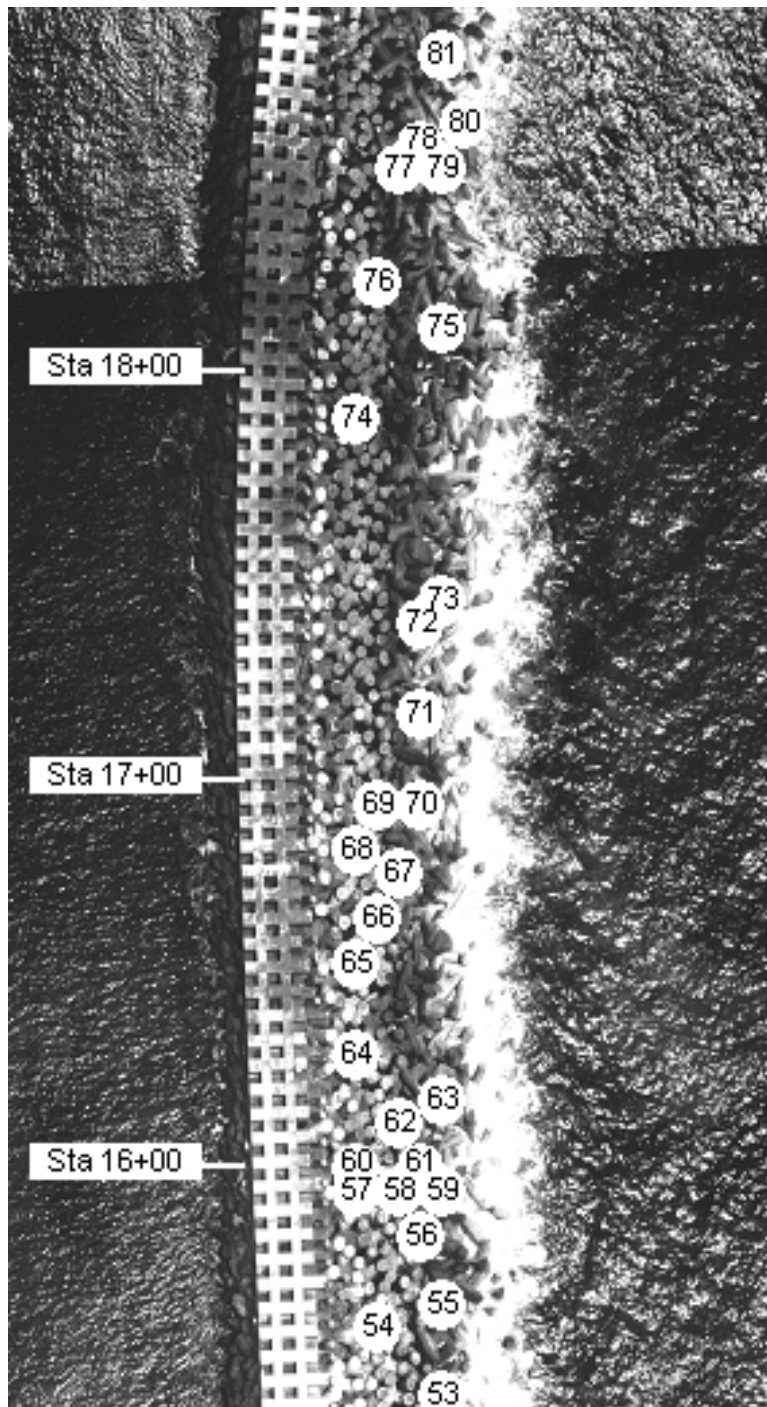
Figure 36. Approximate damage locations on Nawiliwili breakwater, photograph 2.

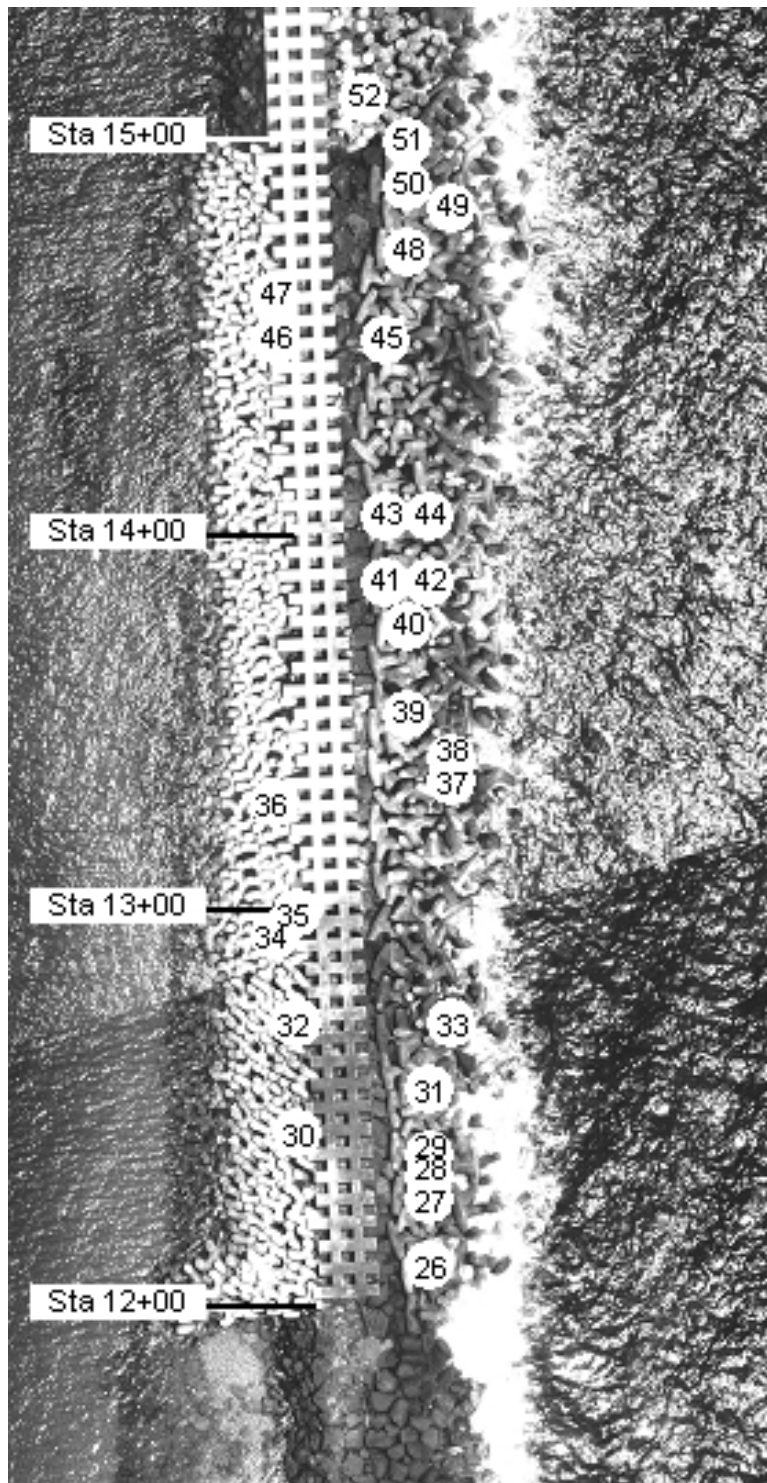
Figure 37. Approximate damage locations on Nawiliwili breakwater, photograph 3.

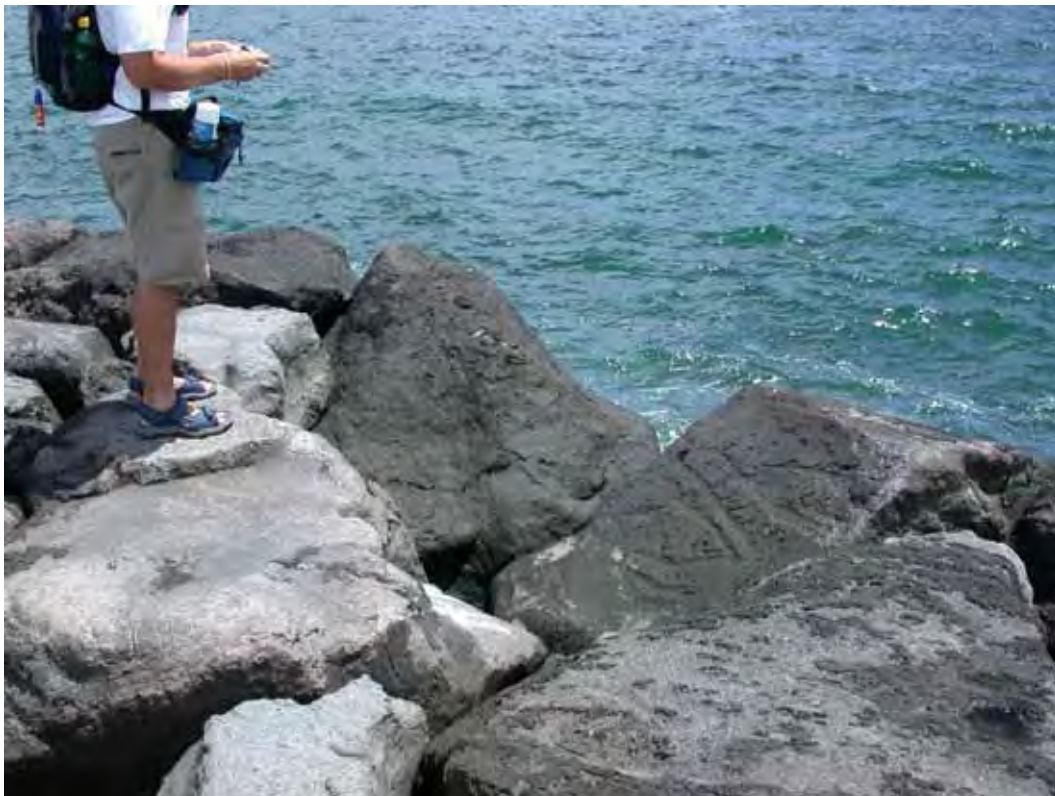
Figure A5. Damage location 4, sta 9+08, ocean side, void.

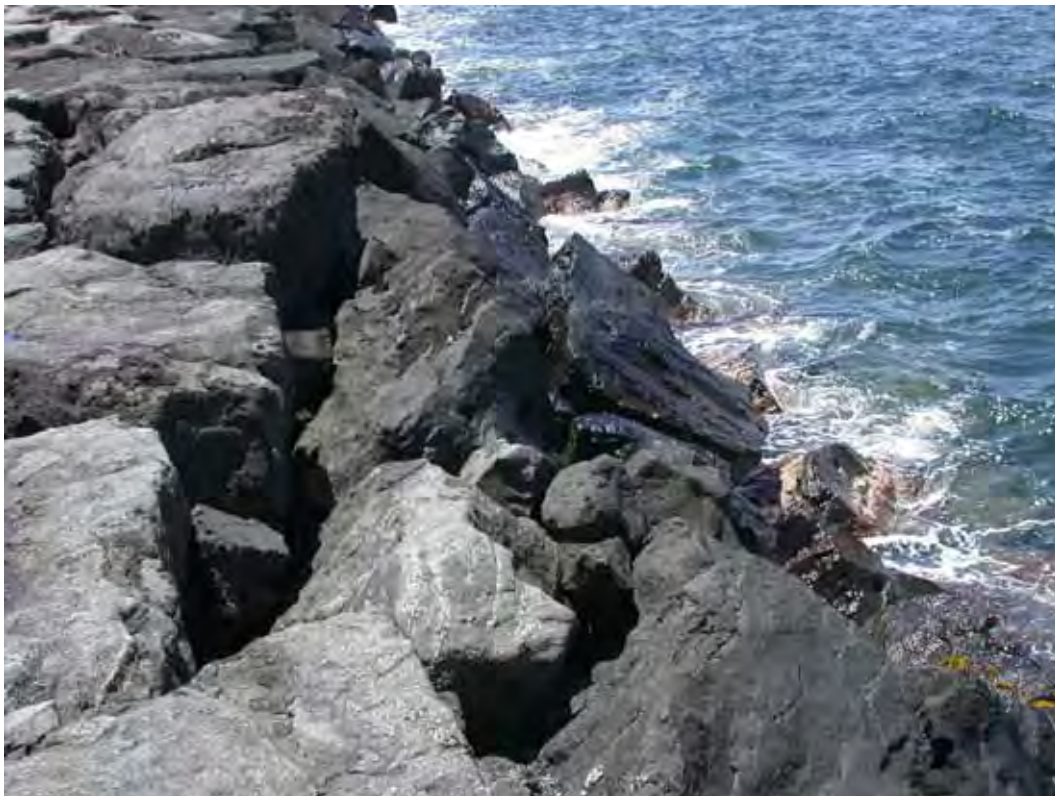
Figure A26. Damage location 25, sta 25+30, hinge stone separating.

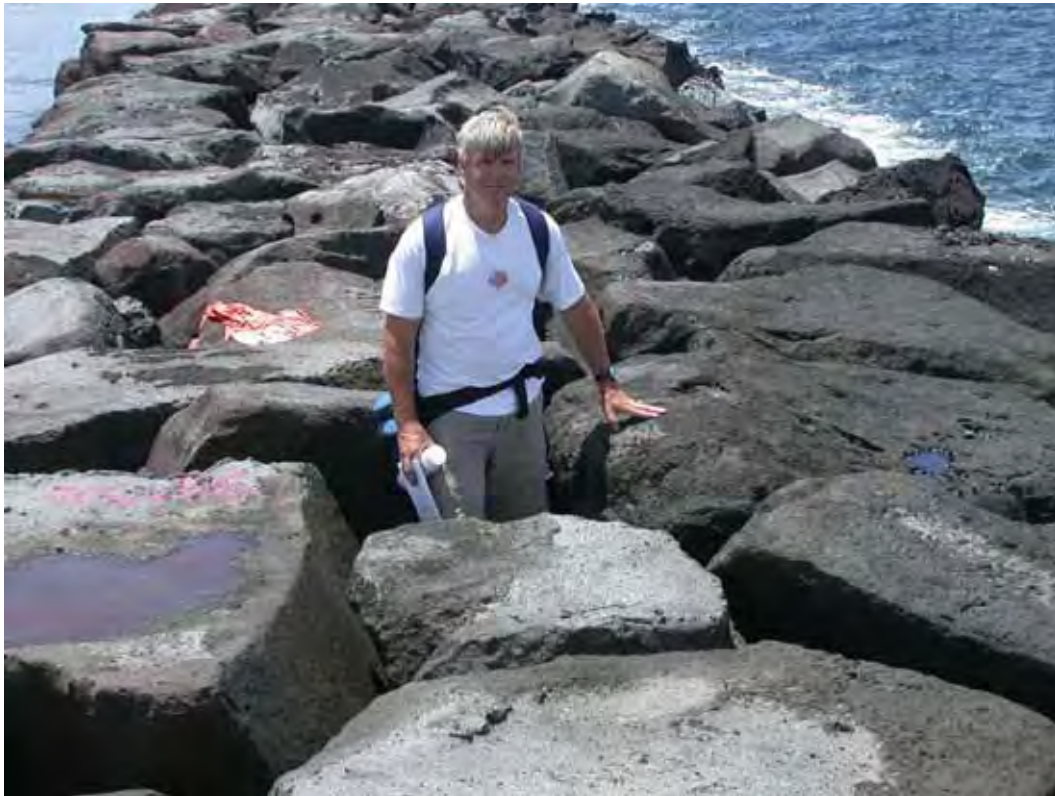
Figure A28. Damage location 27, sta 25+85, void at crest.

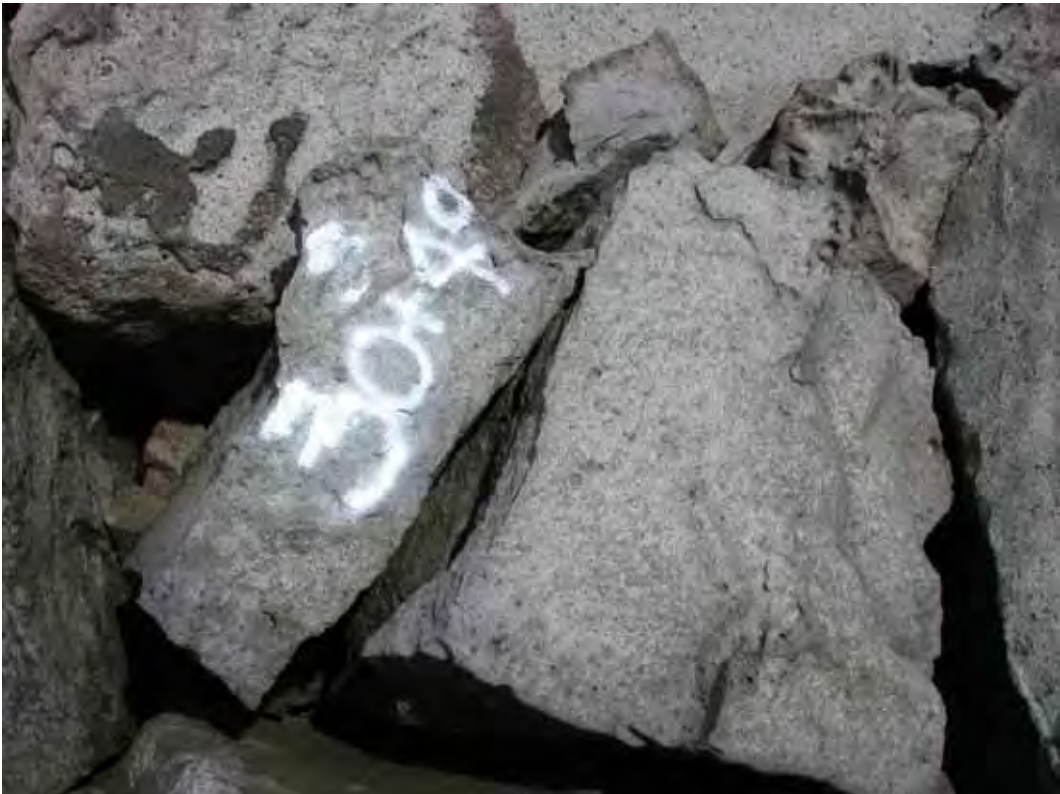
Figure A32. Damage location 34, sta 30+40, broken stone on crest.

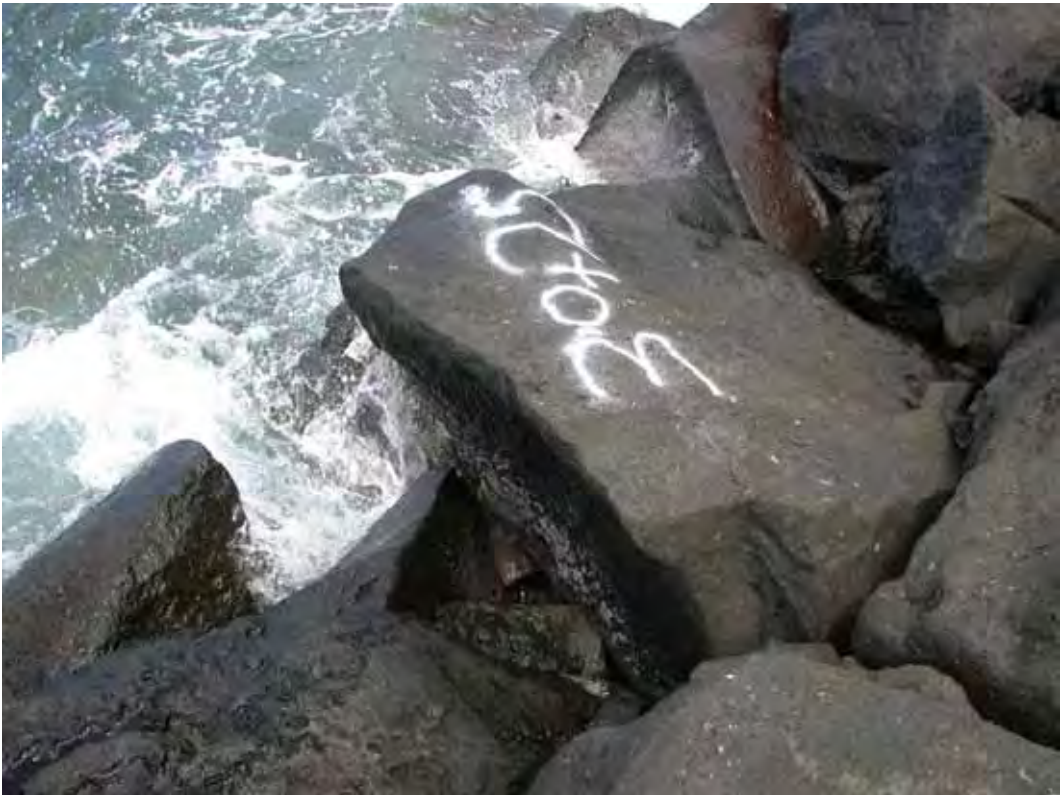
Figure A33. Damage location 35, sta 30+25, ocean side, overhanging hinge stone.

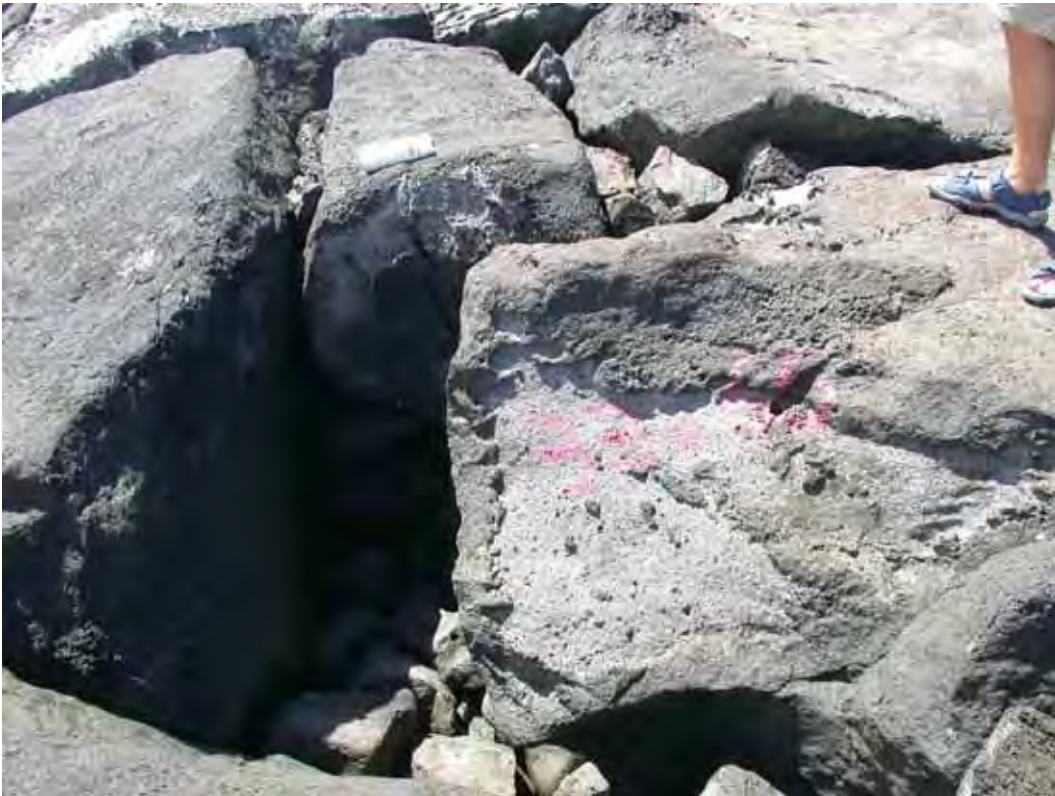
Figure A36. Damage location 38, sta 33+65, void at crest (3 ft x 6 ft x 4.5 ft).

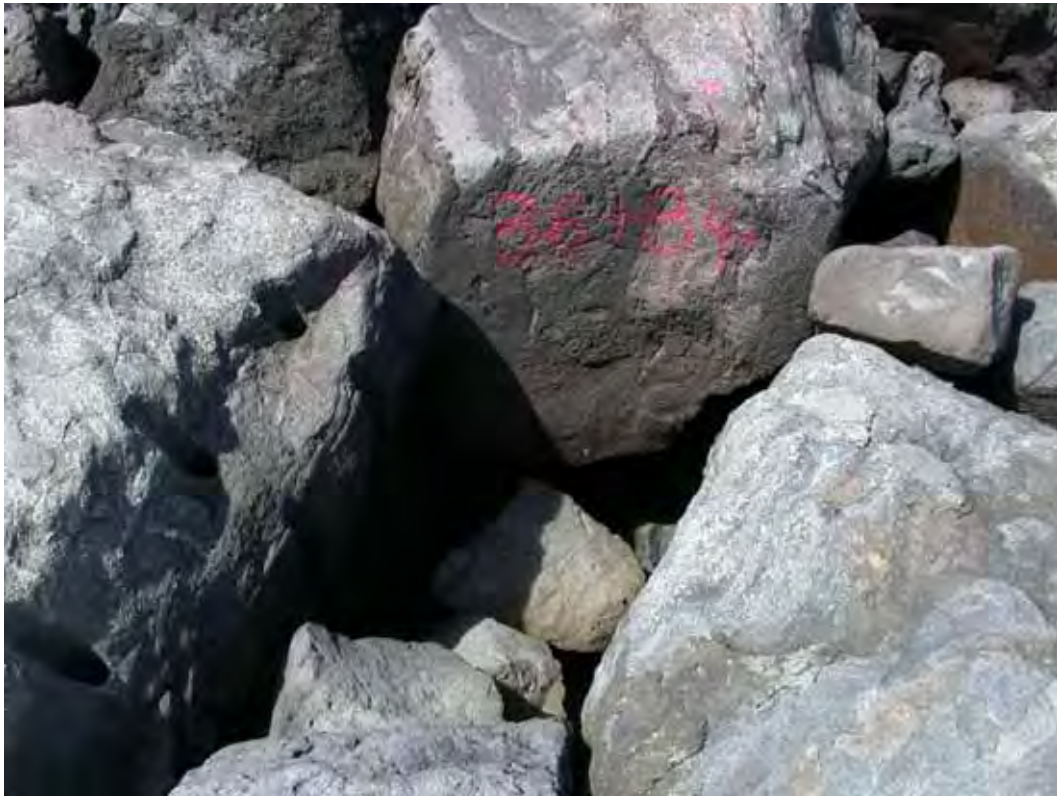
Figure A38. Damage location 40, sta 35+84, void at crest.

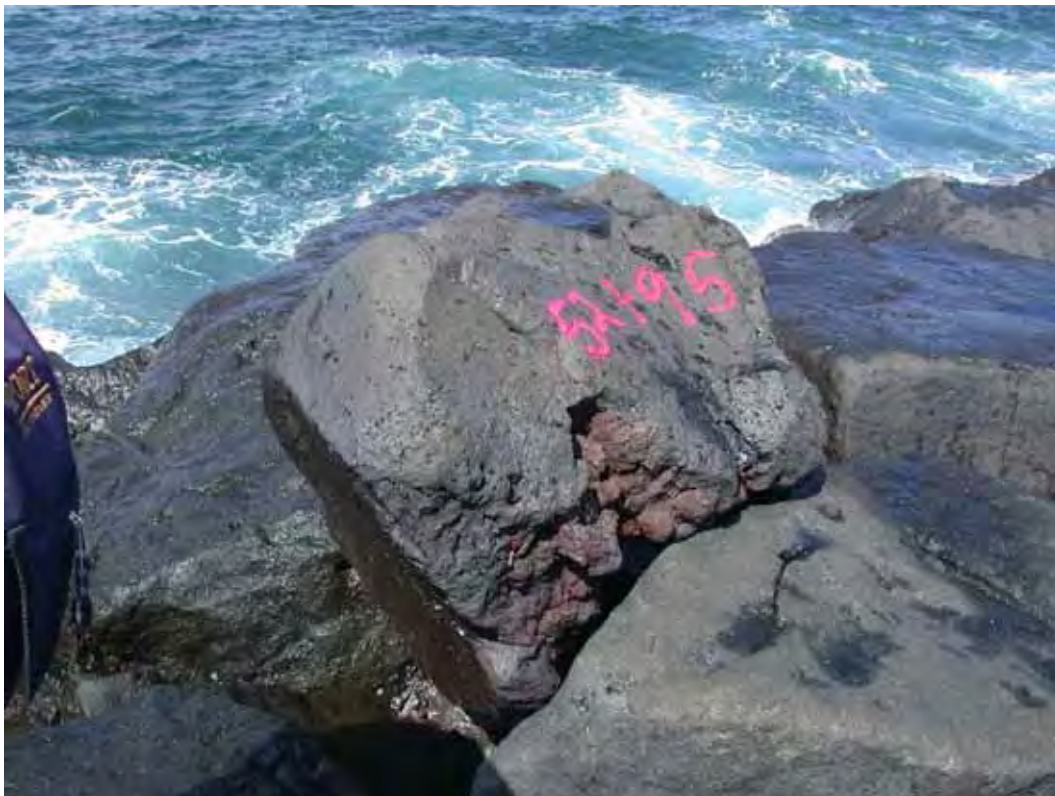
Figure A48. Damage location 52, sta 52+95, ocean side, perched armor stone.

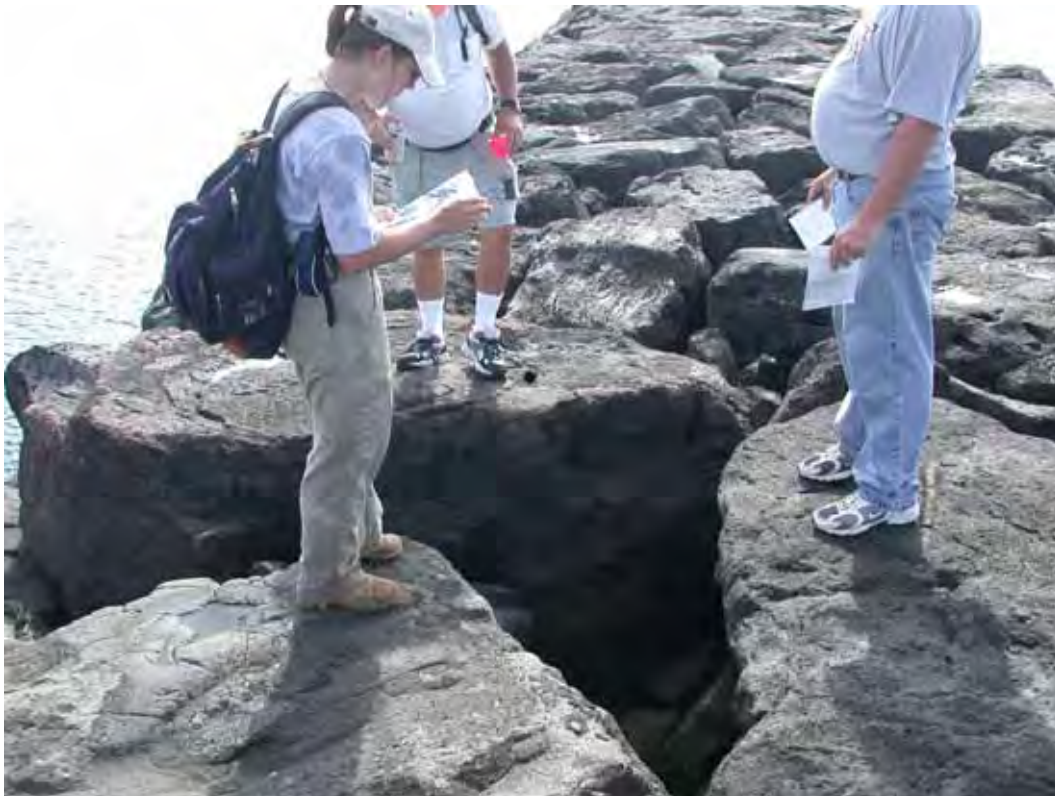
Figure A55. Damage location 59, sta 60+80, harbor side, void at crest (2 ft x 4 ft x 4 ft).

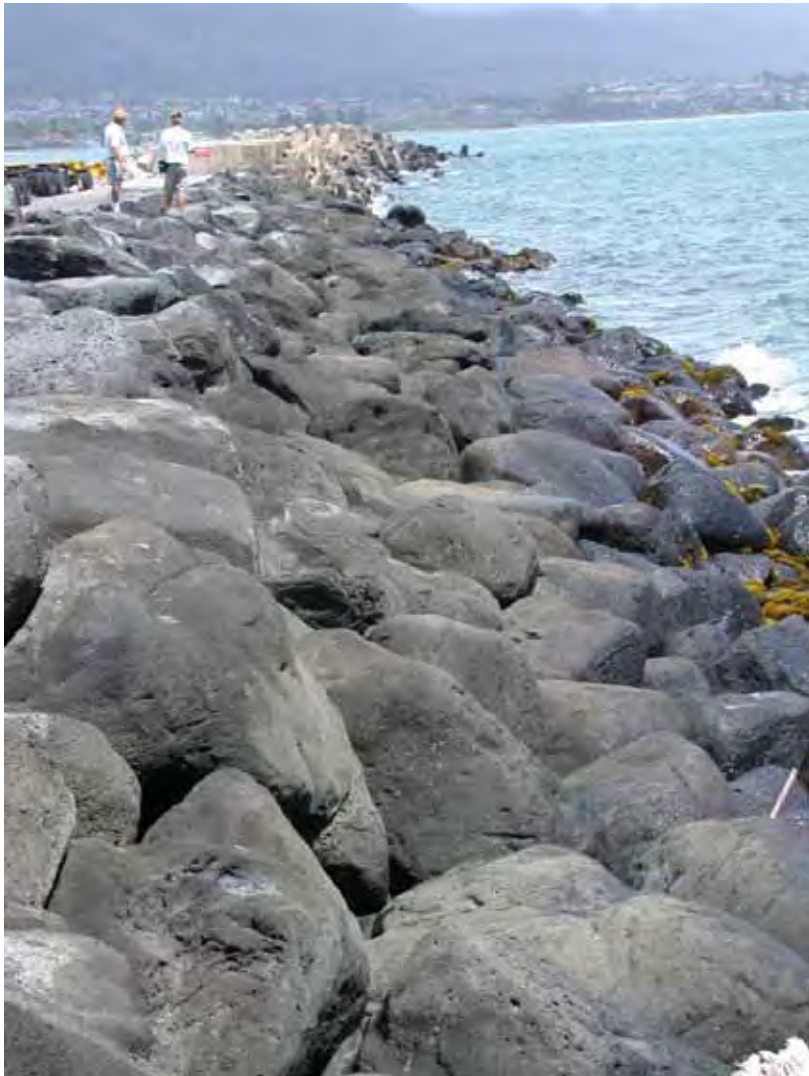
Figure B3. Damage location 8, sta 19+00-21+00, ocean side, side slope flattening.

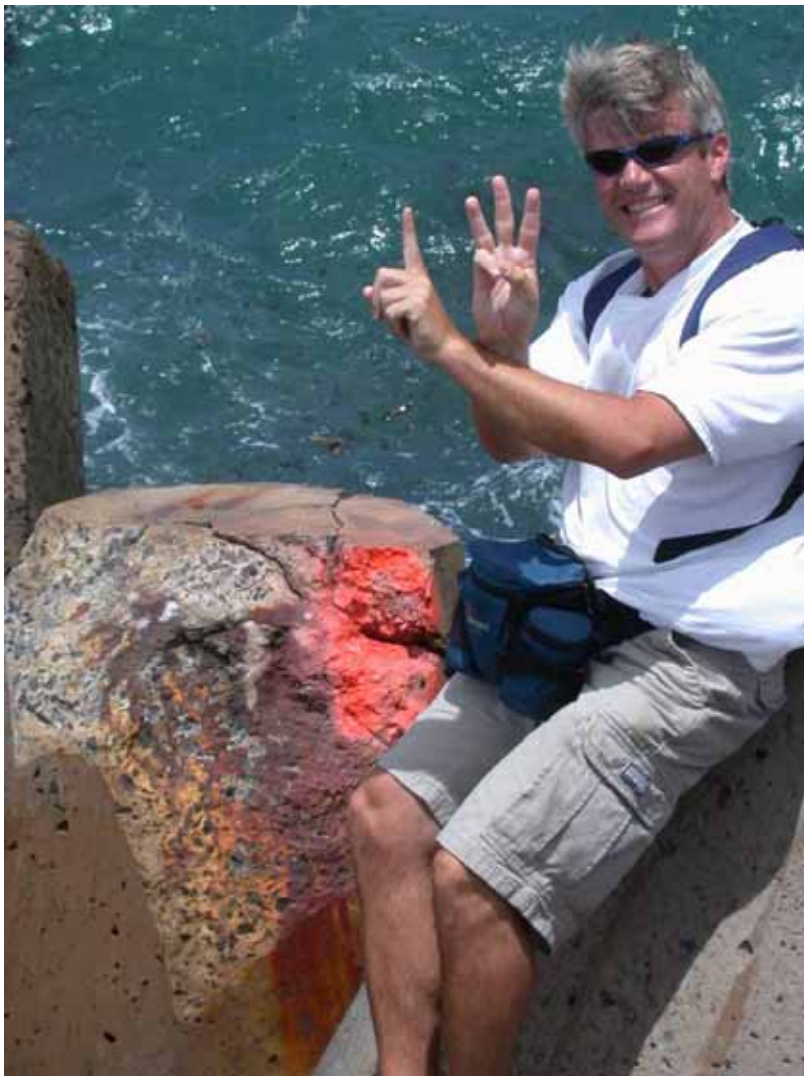
Figure B22. Damage location 27, sta 28+04, ocean side, rib #30, dolosse with tip chip.

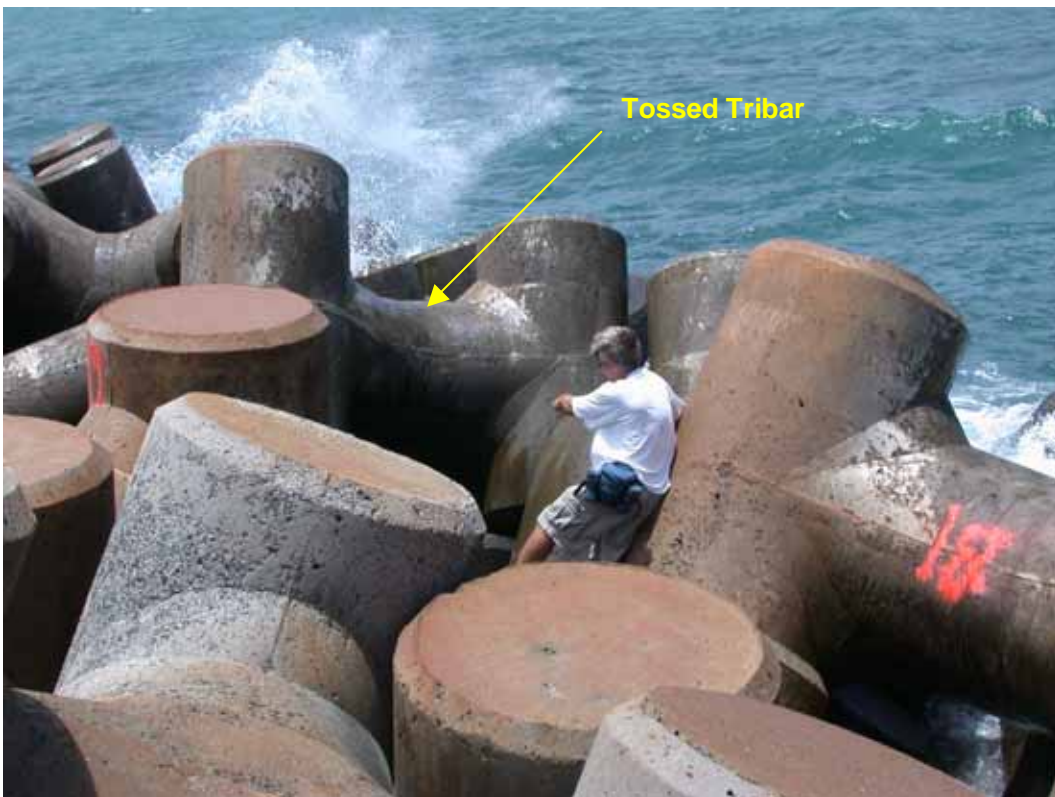
Figure B30. Damage location 39, sta 31+54, ocean side, rib #88, tossed 9-ton tribar.

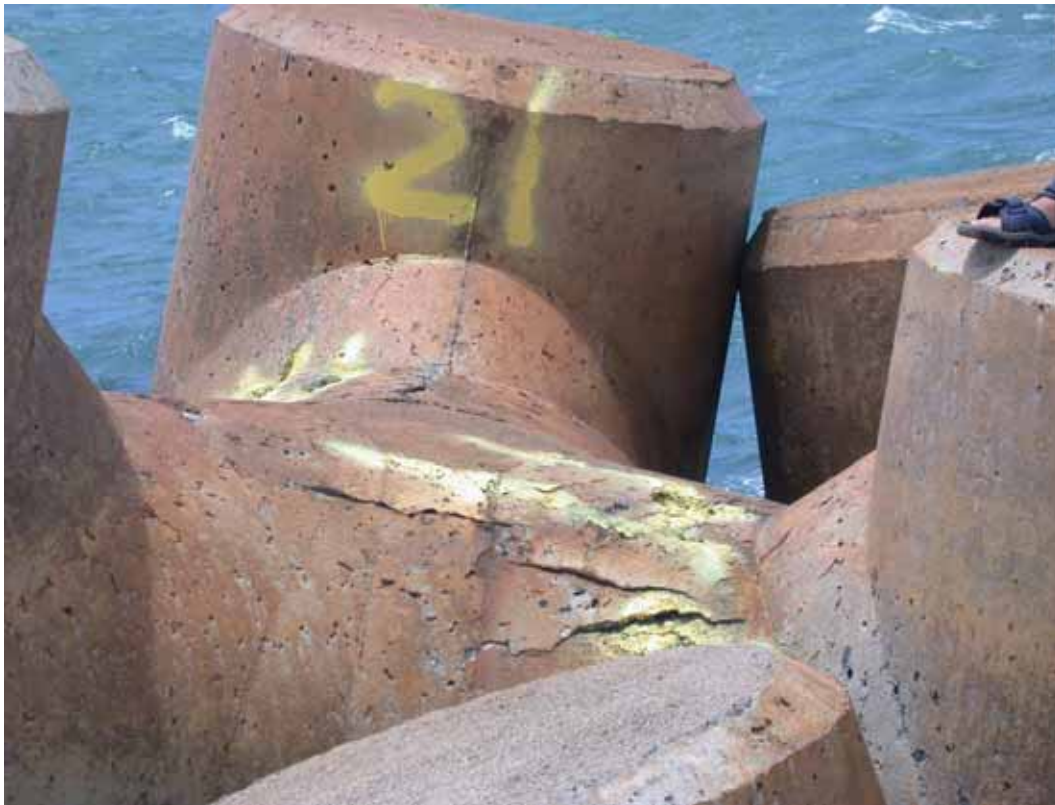
Figure B34. Damage location 45, sta 32+74, ocean side, rib #108, tribar with spalling.

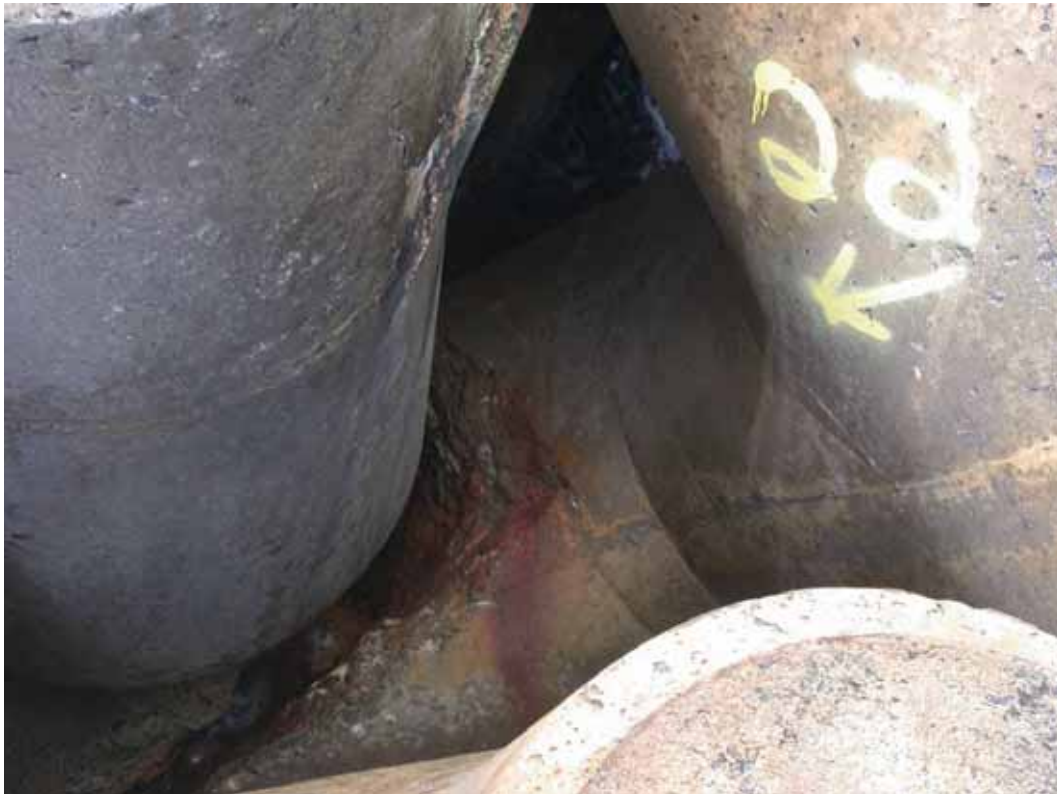
Figure B37. Damage location 50, sta 33+52, ocean side, rib #121, tribar with top of leg broken.

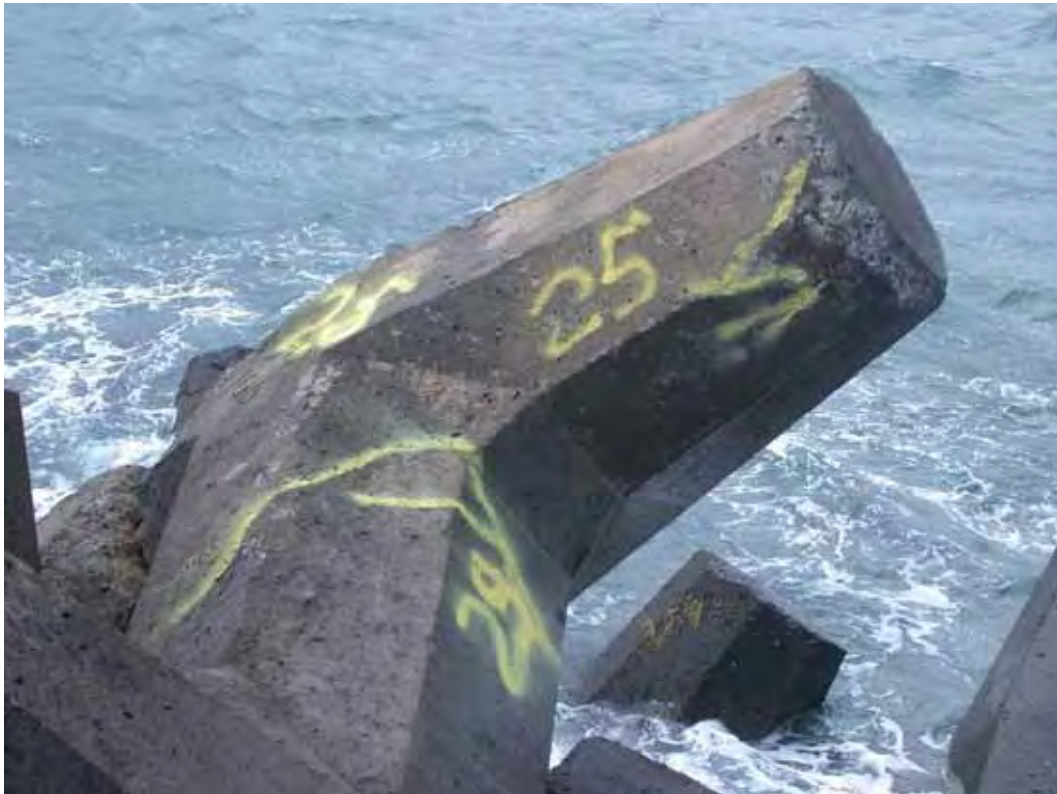
Figure B41. Damage location 56, head, 0 deg, dolosse with tip chip.

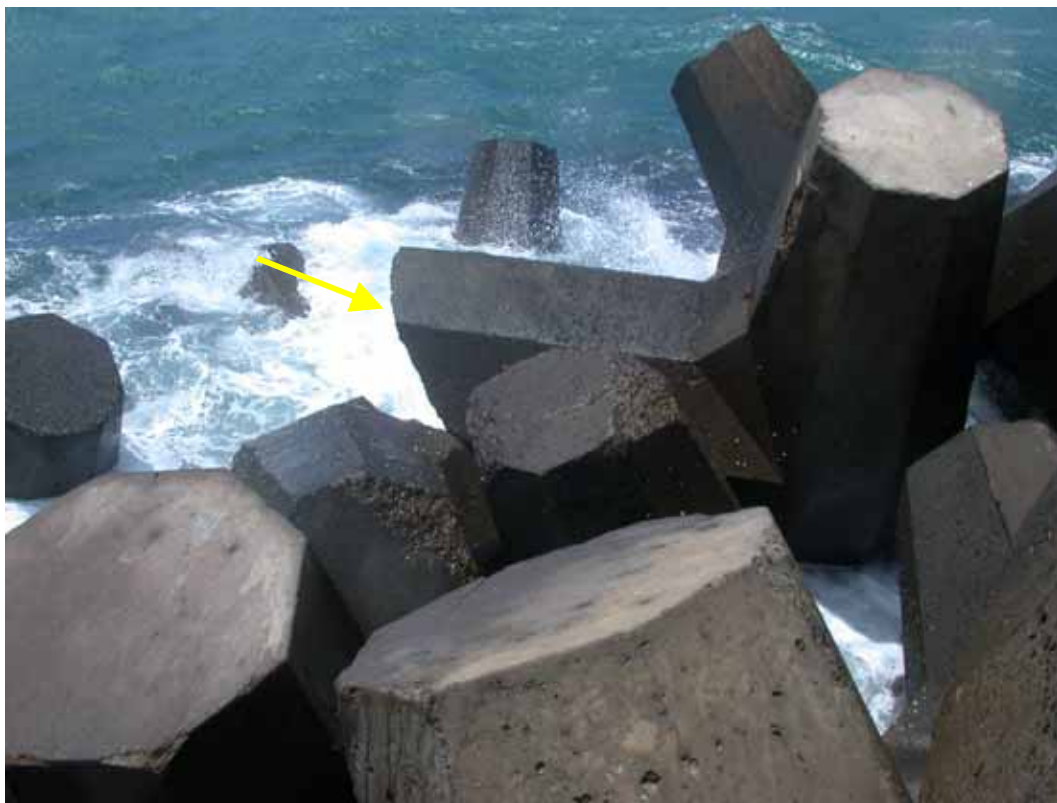
Figure B42. Damage location 57, head, 0 deg, dolosse with fluke break.

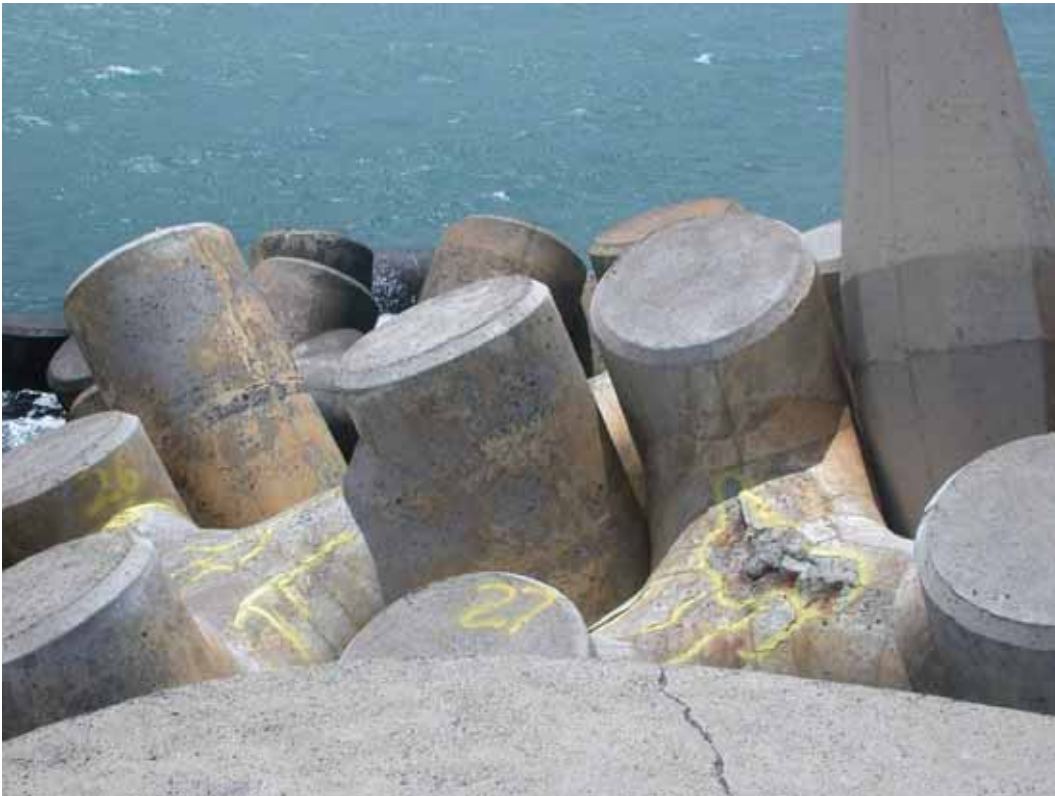
Figure B43. Damage location 58, harbor side of head, tribar with cracking and spalling.

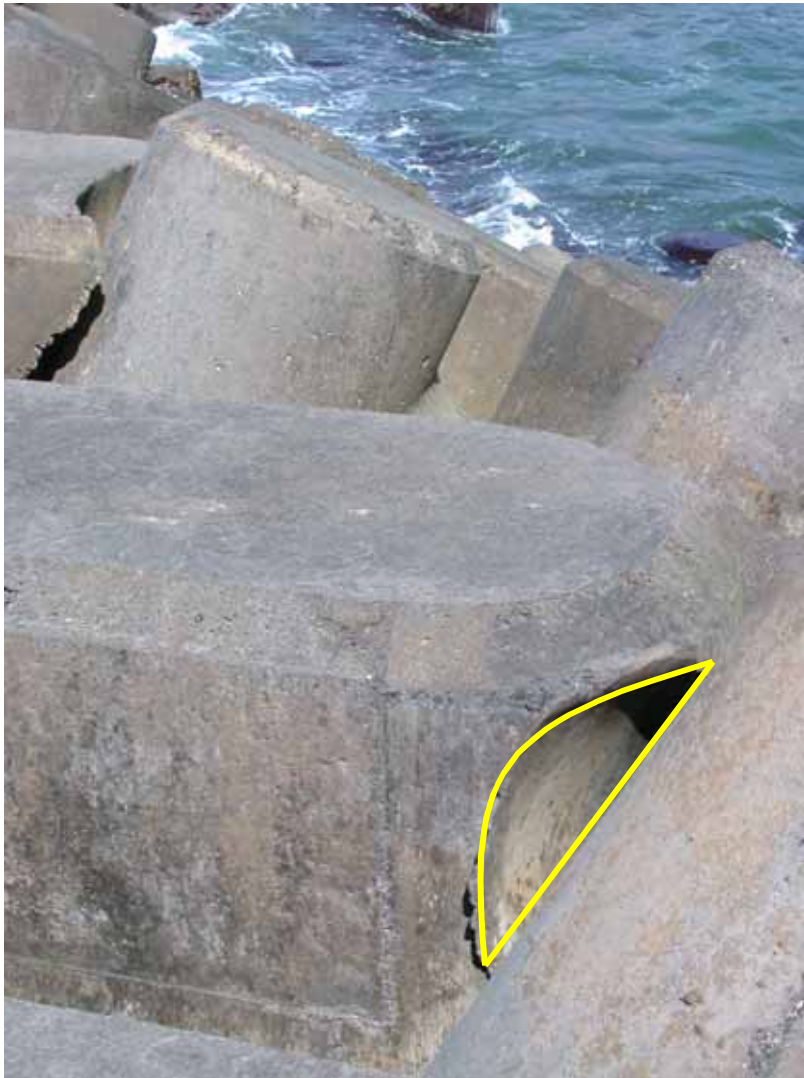
Figure B46. Damage location 3, sta 18+74, ocean side, rib #13, 8" separation of tribar from rib cap.

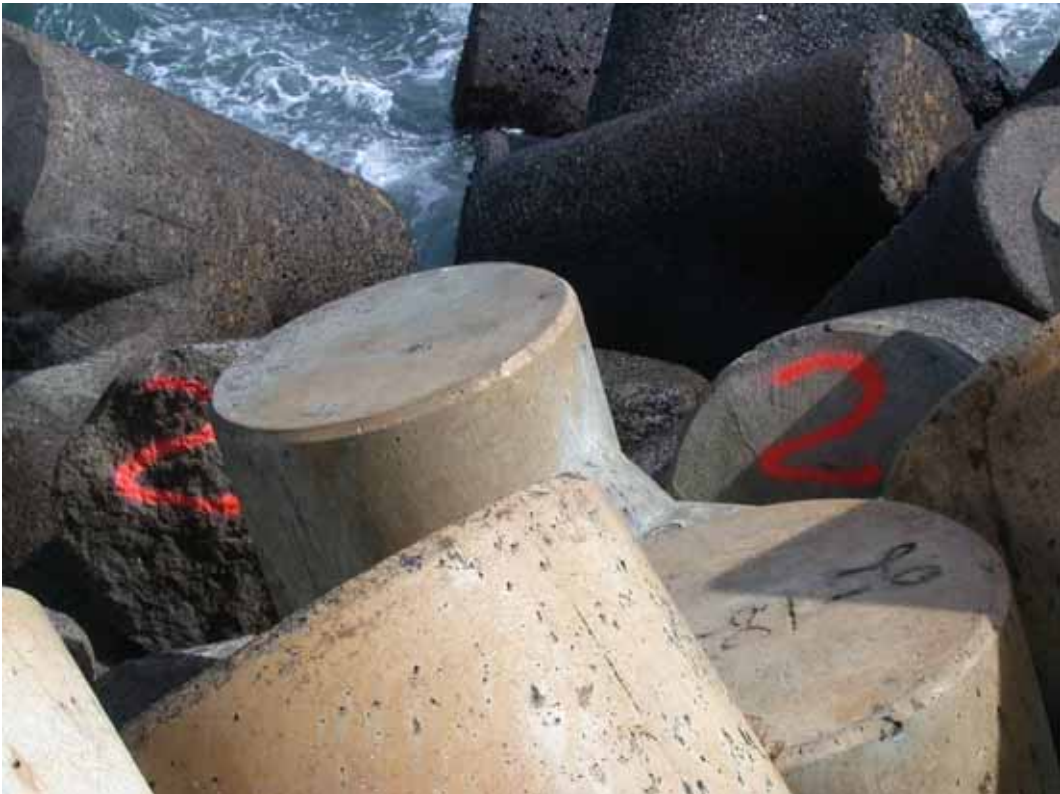
Figure B51. Damage location 9, sta 20+66, ocean side, rib #37, tribar with can break.

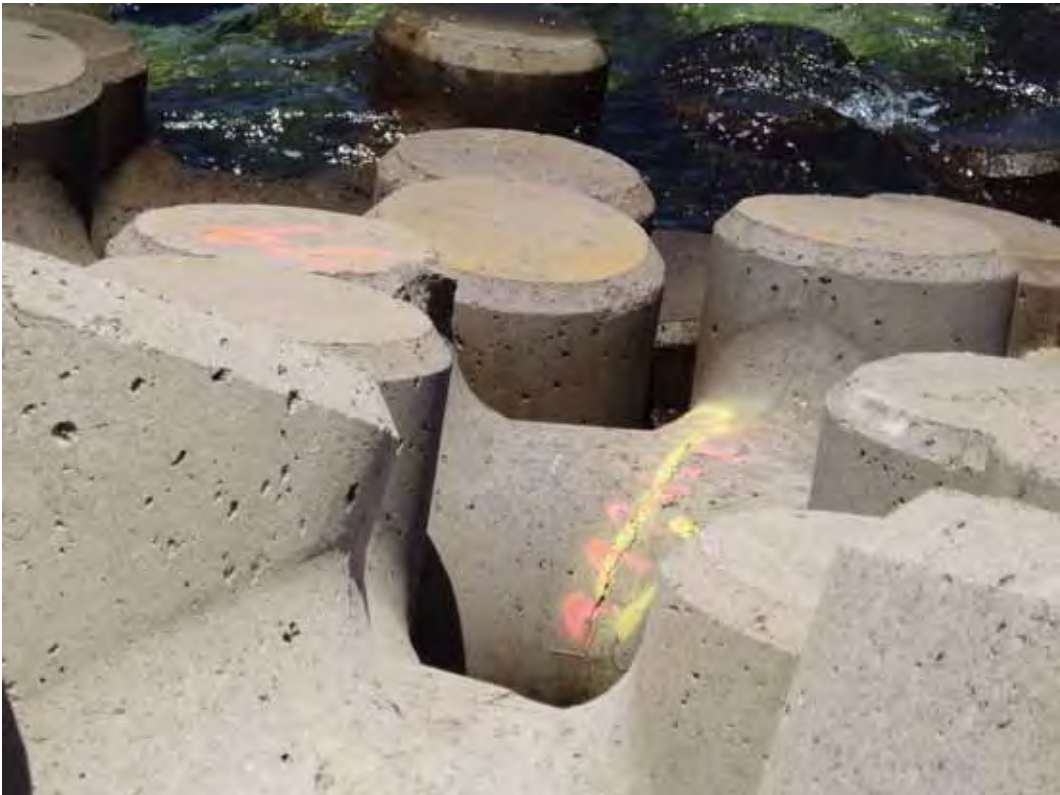
Figure B52. Damage location 10, sta 20+74, ocean side, rib #38, tribar with broken leg.
