Monitoring Completed Navigation Projects Program

Periodic Inspections of Hilo, Kahului, Laupahoehoe, and Nawiliwili Breakwaters, Hawaii

Armor Unit Monitoring for Period 2001-2005

October 2011

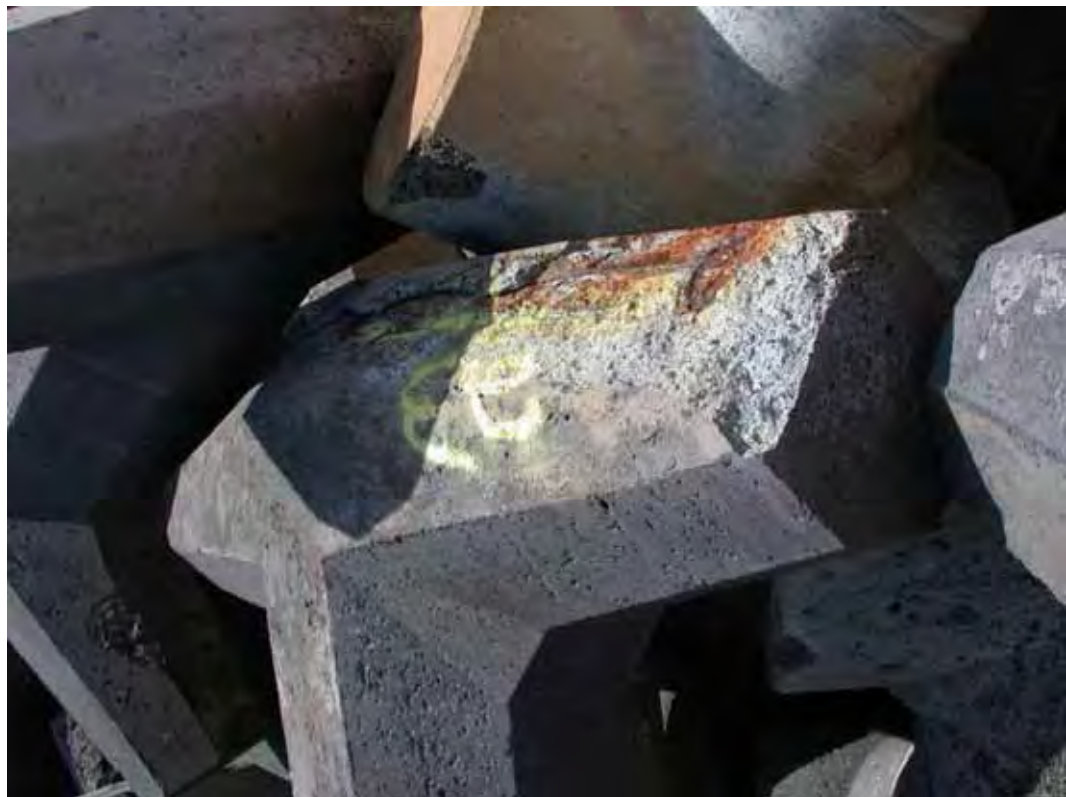
Figure B66. Damage location 29, sta 22+14, ocean side, dolosse with spalling.

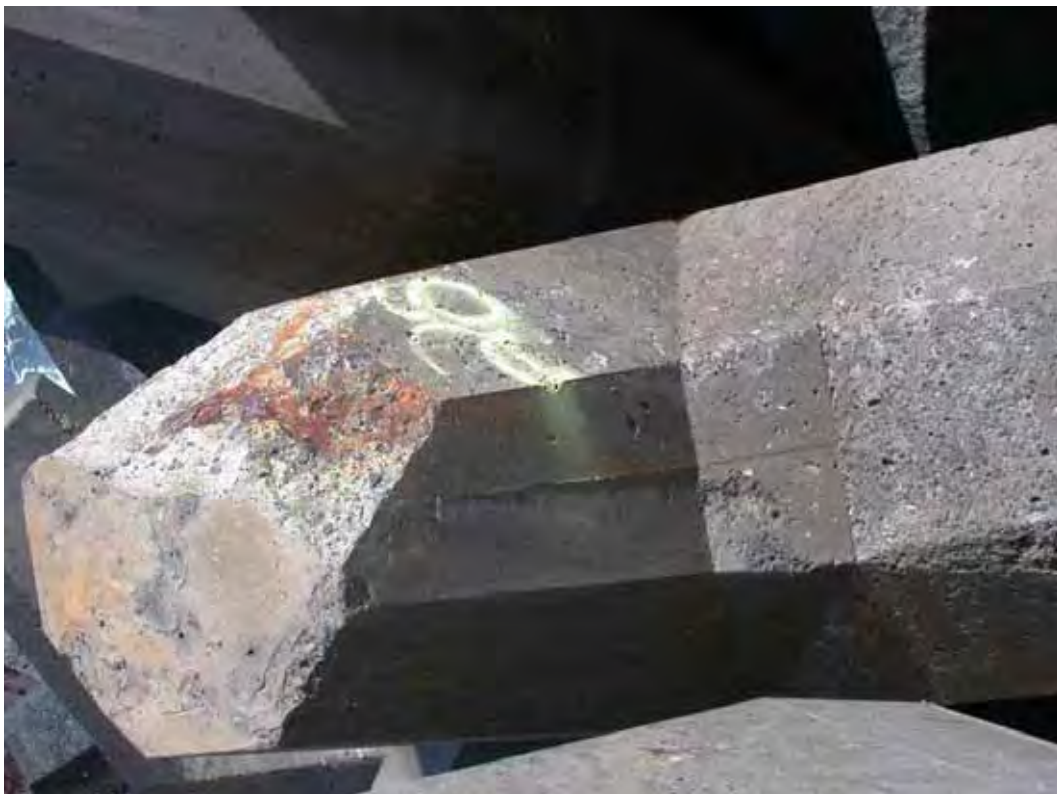
Figure B70. Damage location 35, sta 22+38, ocean side, dolosse with tip break.

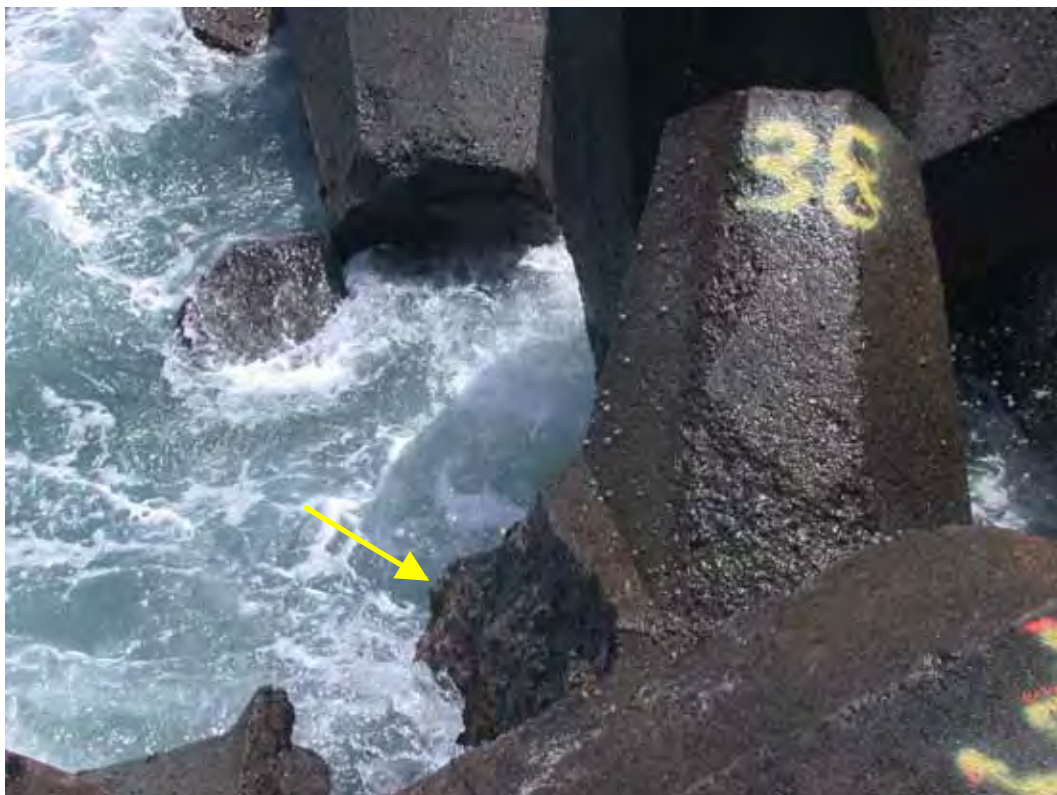
Figure B84. Damage location 53, sta 23+00, ocean side, dolosse with shank-fluke break.

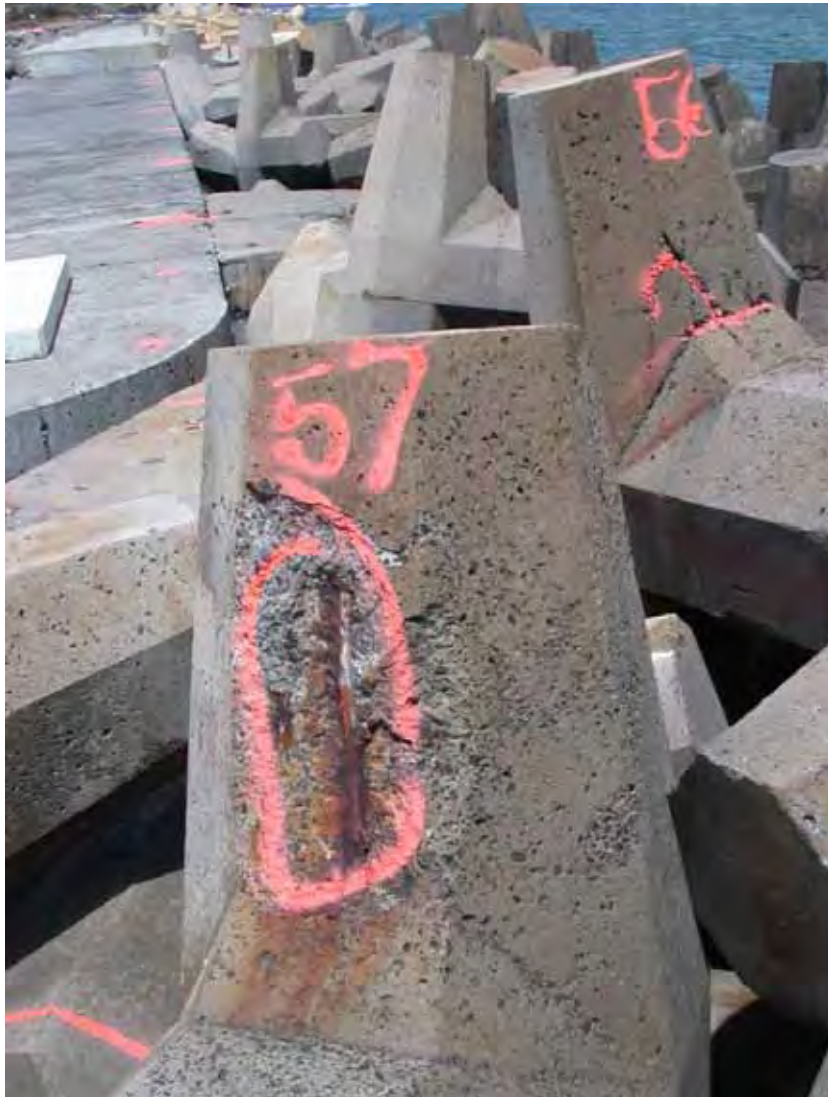
Figure B93. Damage location 71, 30 deg ocean side of head, dolosse with spalling and exposed rebar.

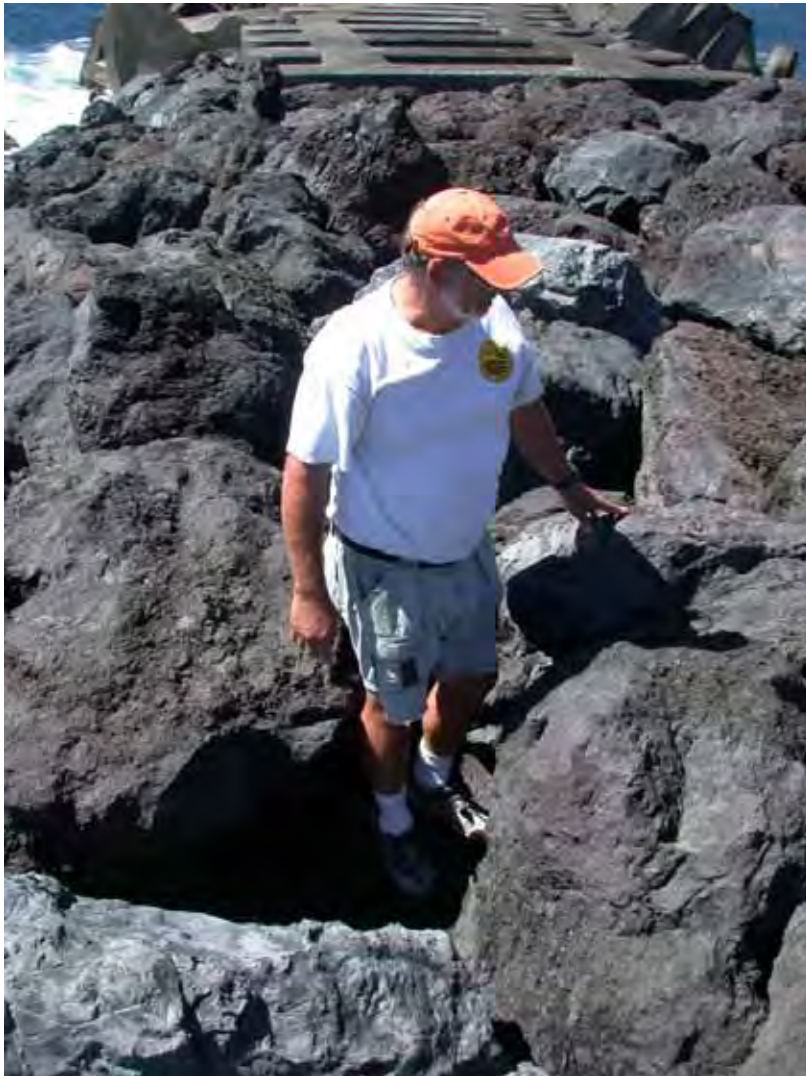
Figure C3. Void.

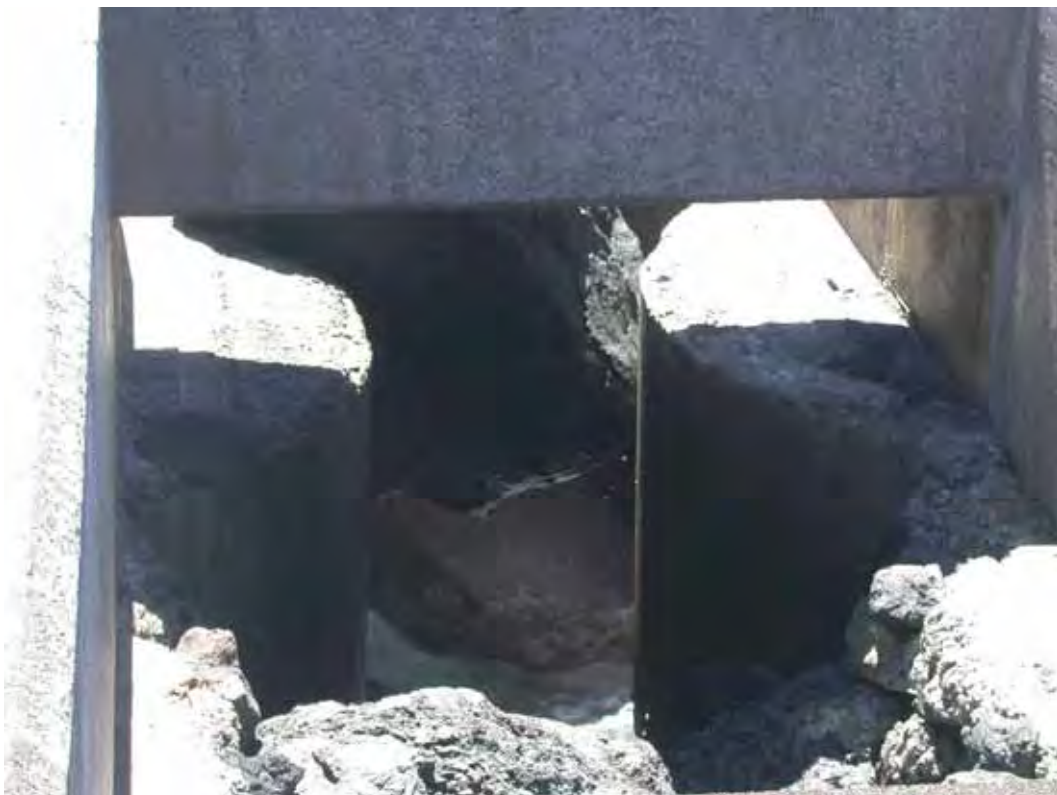
Figure C16. Underlayer loss and shifting of stones between ribs.

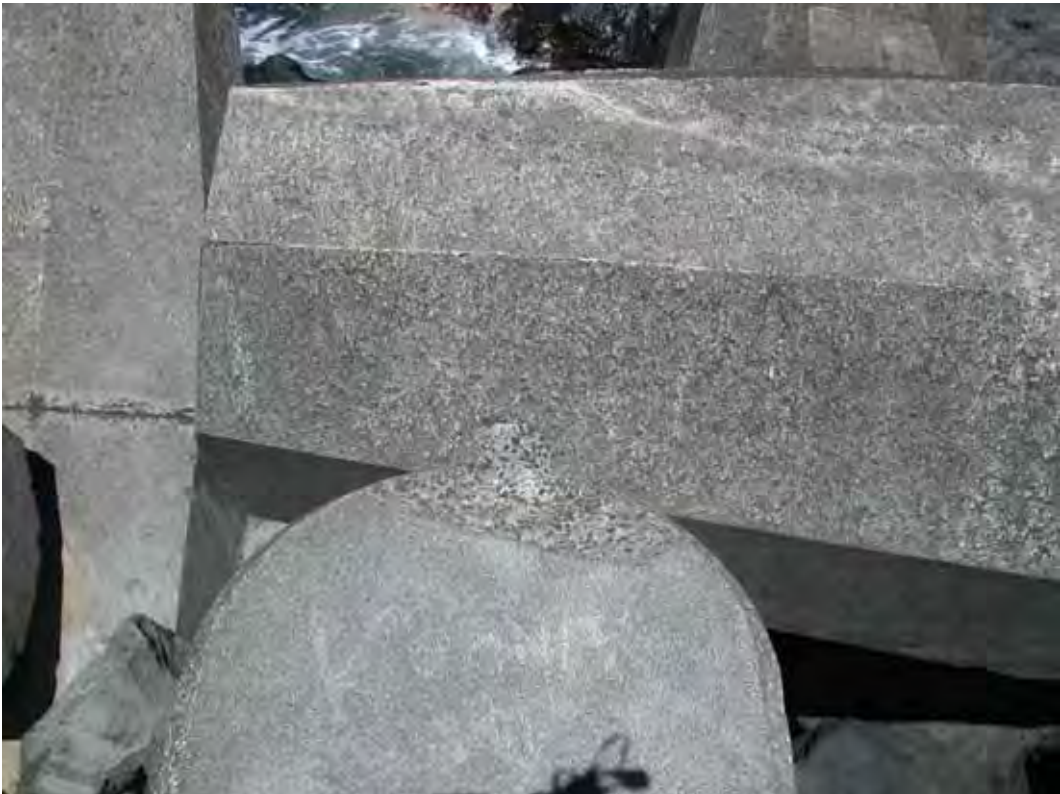
Figure C17. Rib damage possibly caused by displaced armor stones.

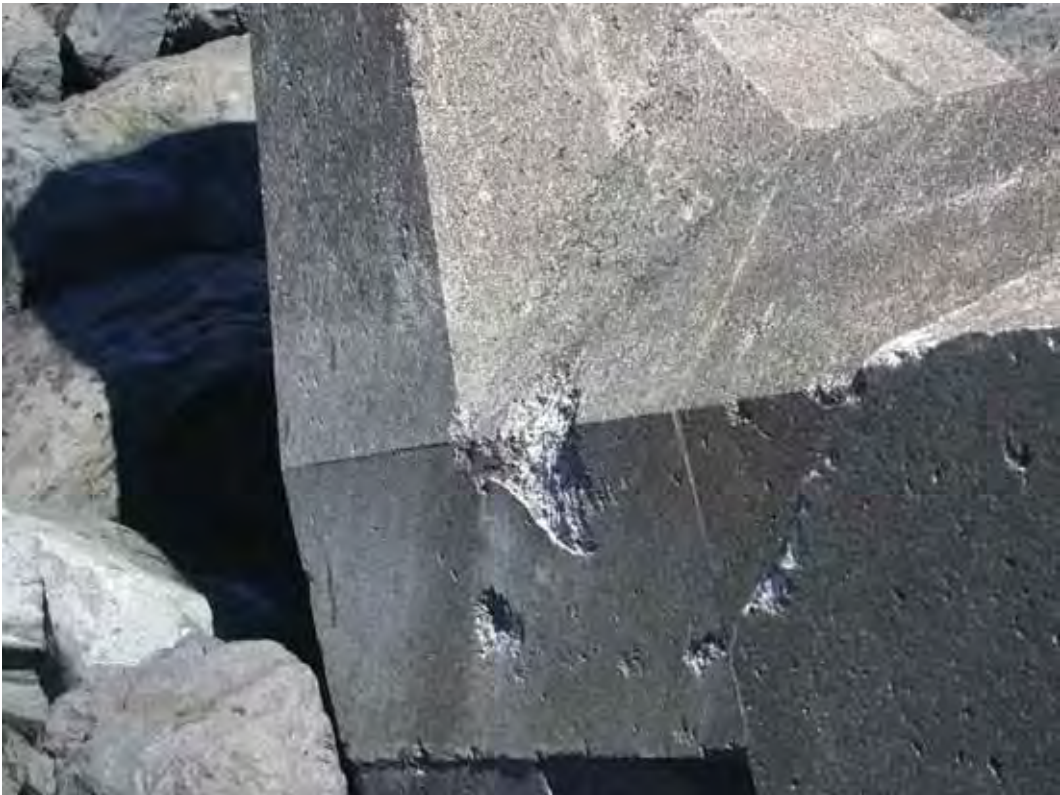
Figure C18. dolosse damage possibly caused by displaced armor stones.

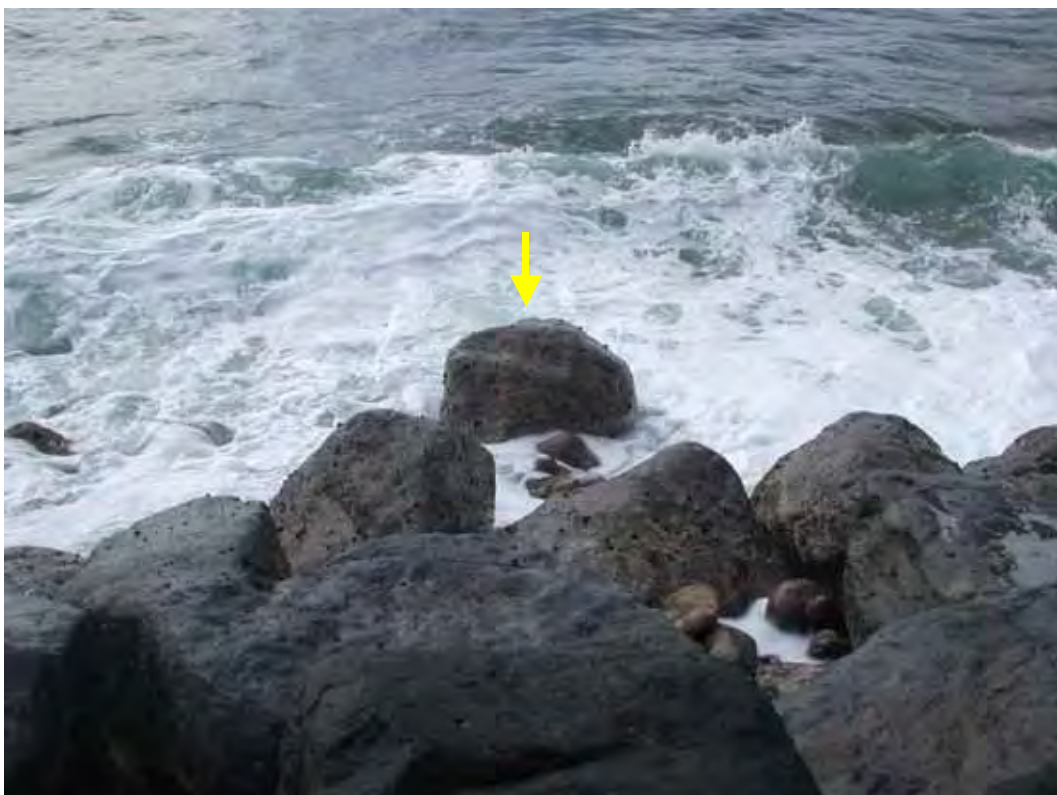
Figure D2. Damage location 1, sta 5+50, ocean side, dislodged armor stone at toe.

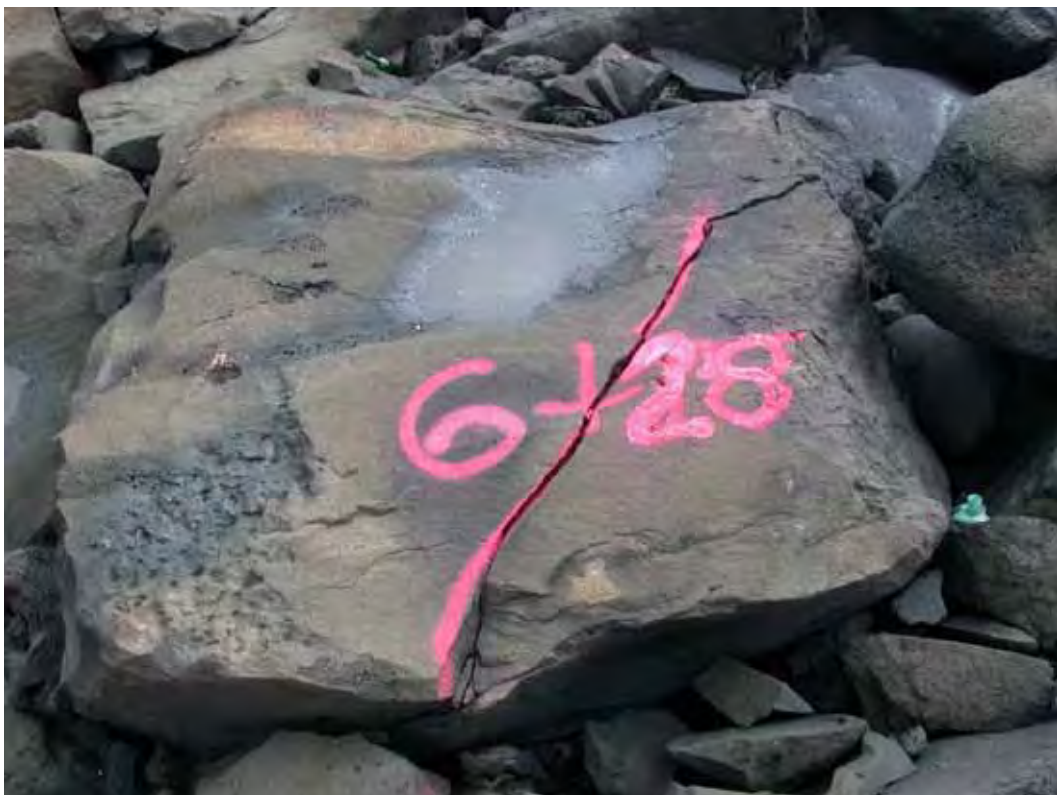
Figure D6. Damage location 5, sta 6+28, cracked armor stone on crest.

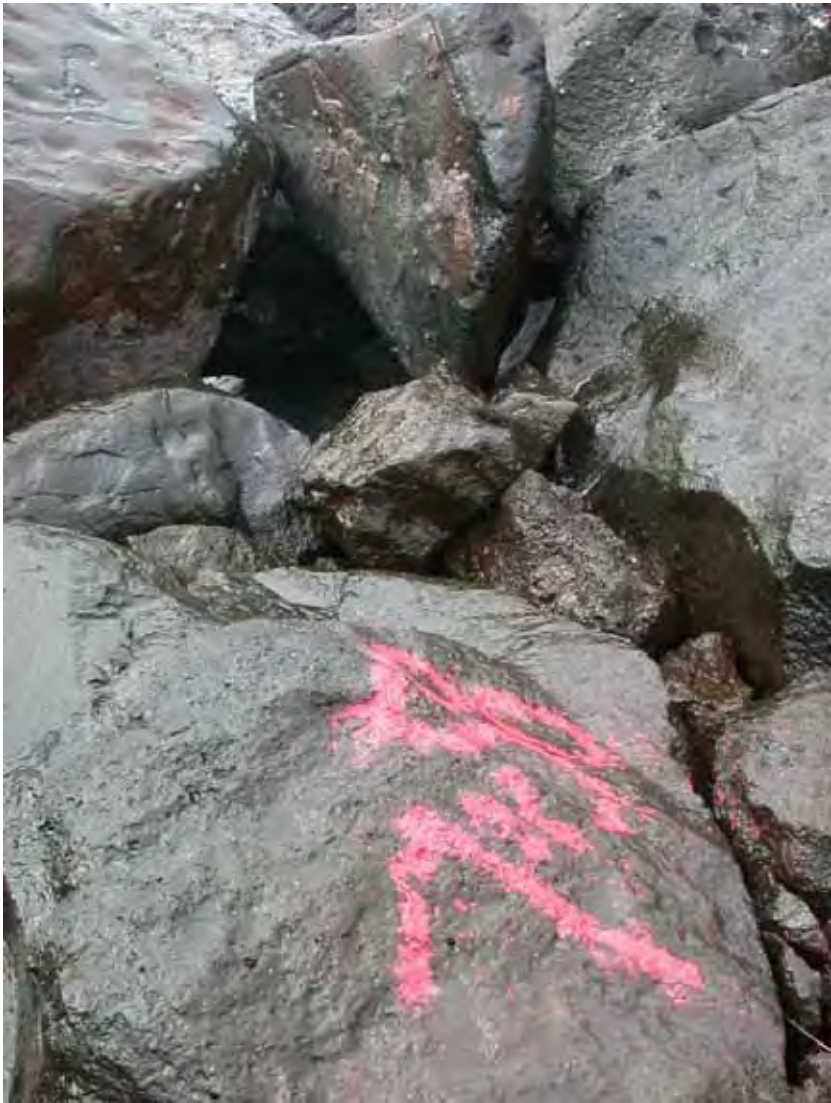
Figure D10. Damage location 9, sta 7+58, settling of crest.

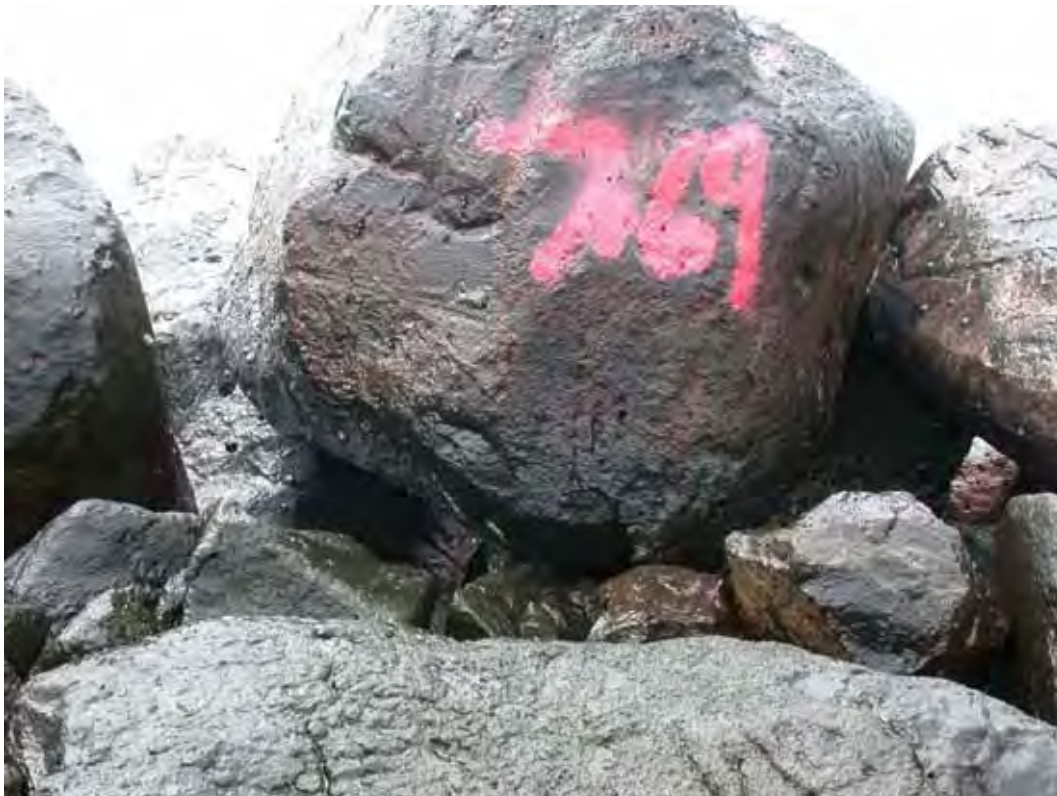
Figure D11. Damage location 10, sta 7+69, ocean side, bridging.

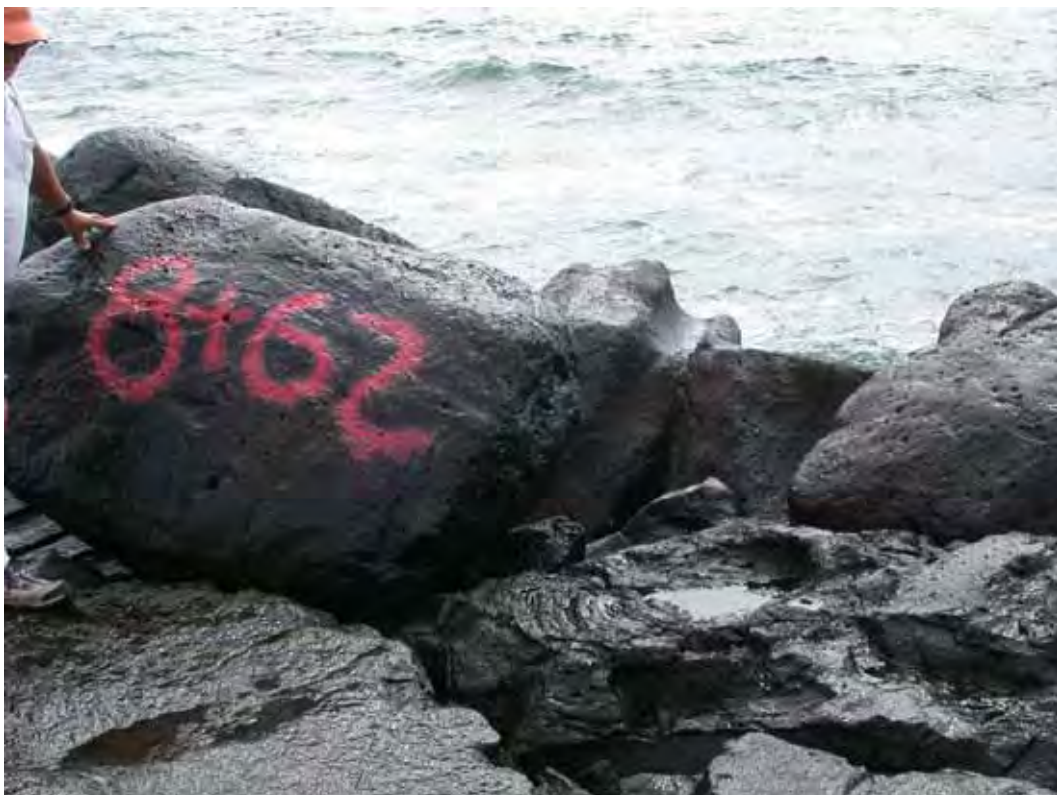
Figure D12. Damage location 11, sta 8+62, ocean side, perched armor stone with void.

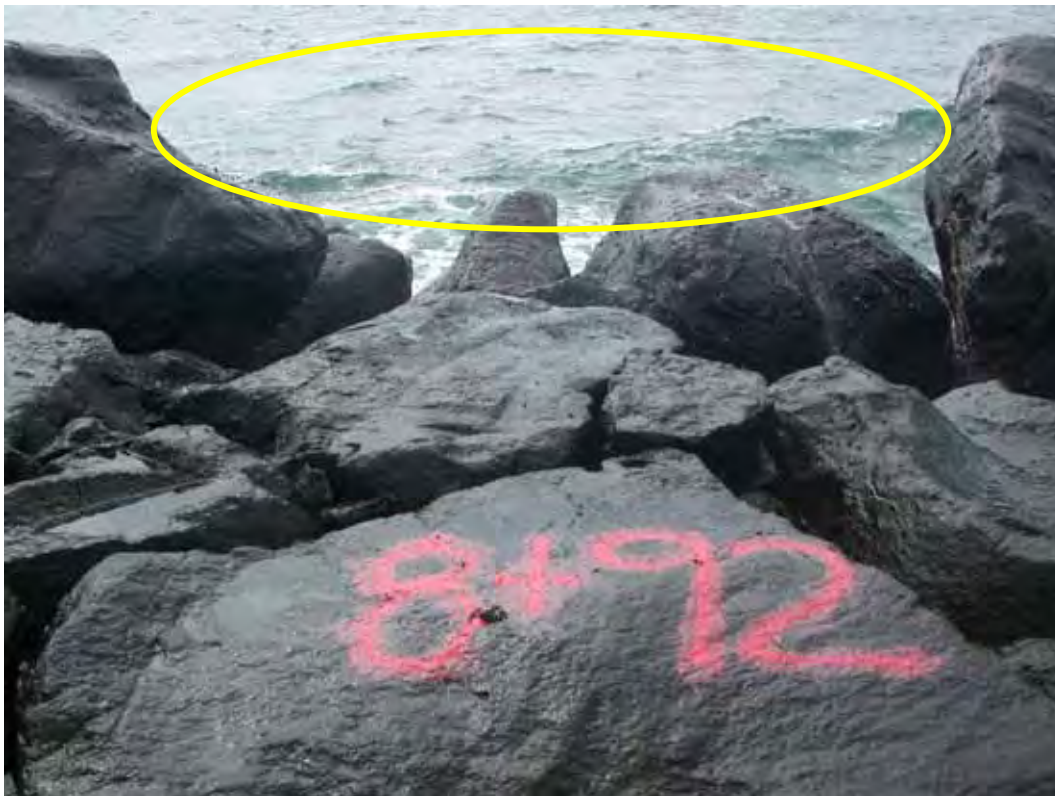
Figure D13. Damage location 12, sta 8+92, ocean side, void.

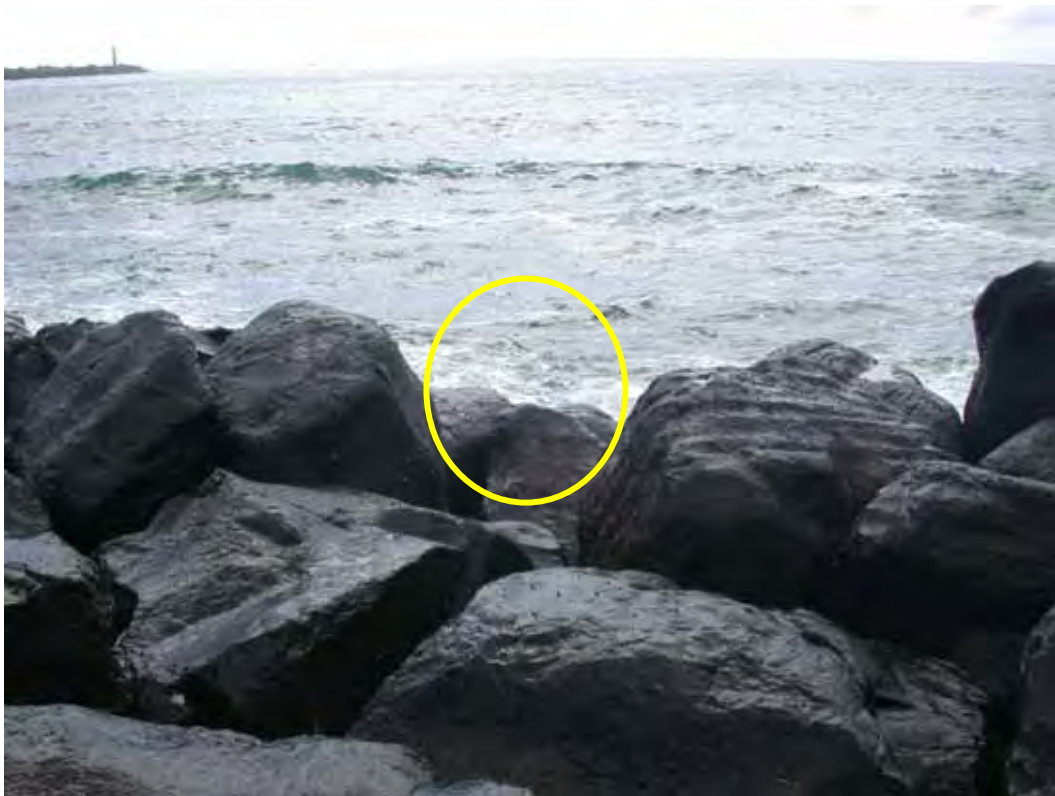
Figure D17. Damage location 16, sta 9+67, ocean side, void at hinge.

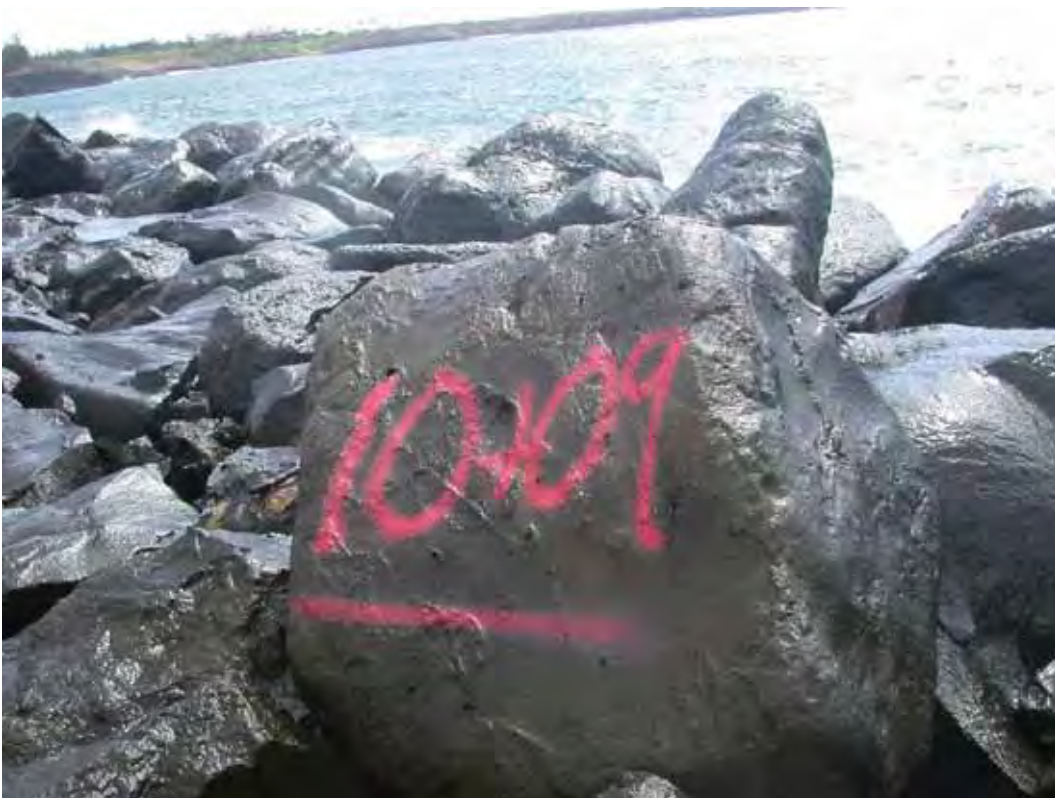
Figure D19. Damage location 18, sta 10+09, perched armor stone with void on crest.

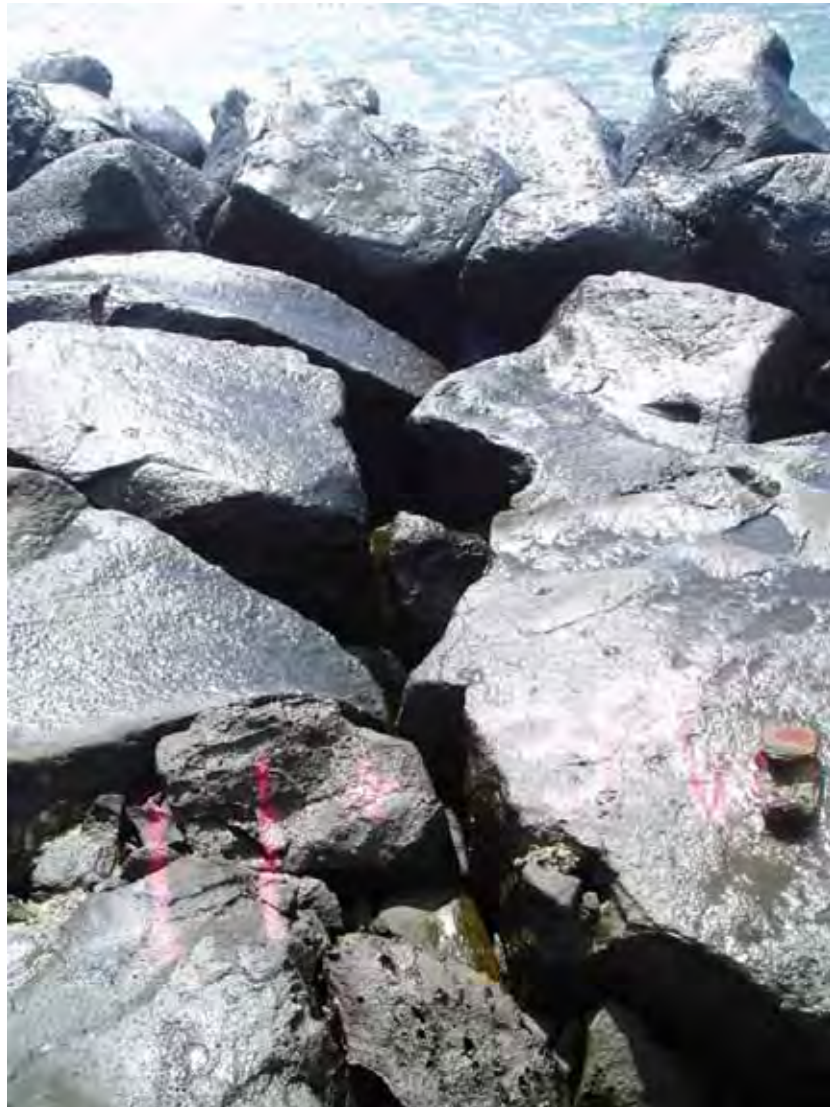
Figure D23. Damage location 25, sta 11+39, ocean side, depression/settling of crest, 5 ft x 4 ft void on crest.

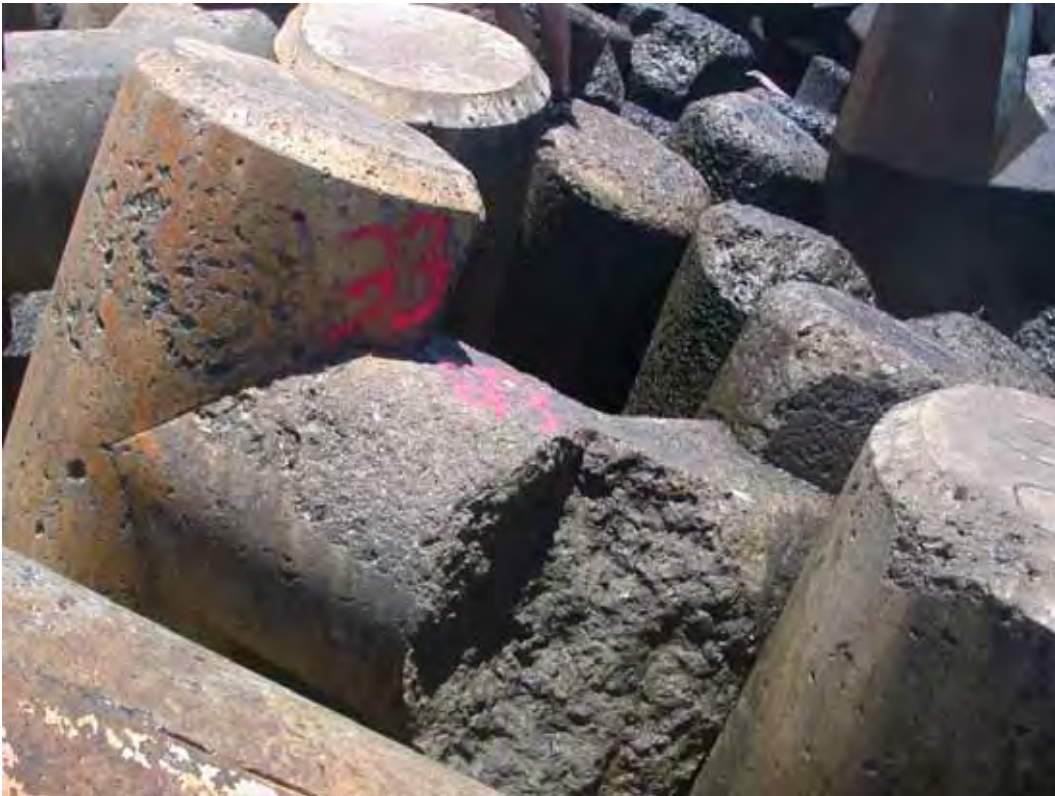
Figure D49. Damage location 65, sta 16+50, ocean side, rib #76, tribar with broken leg.

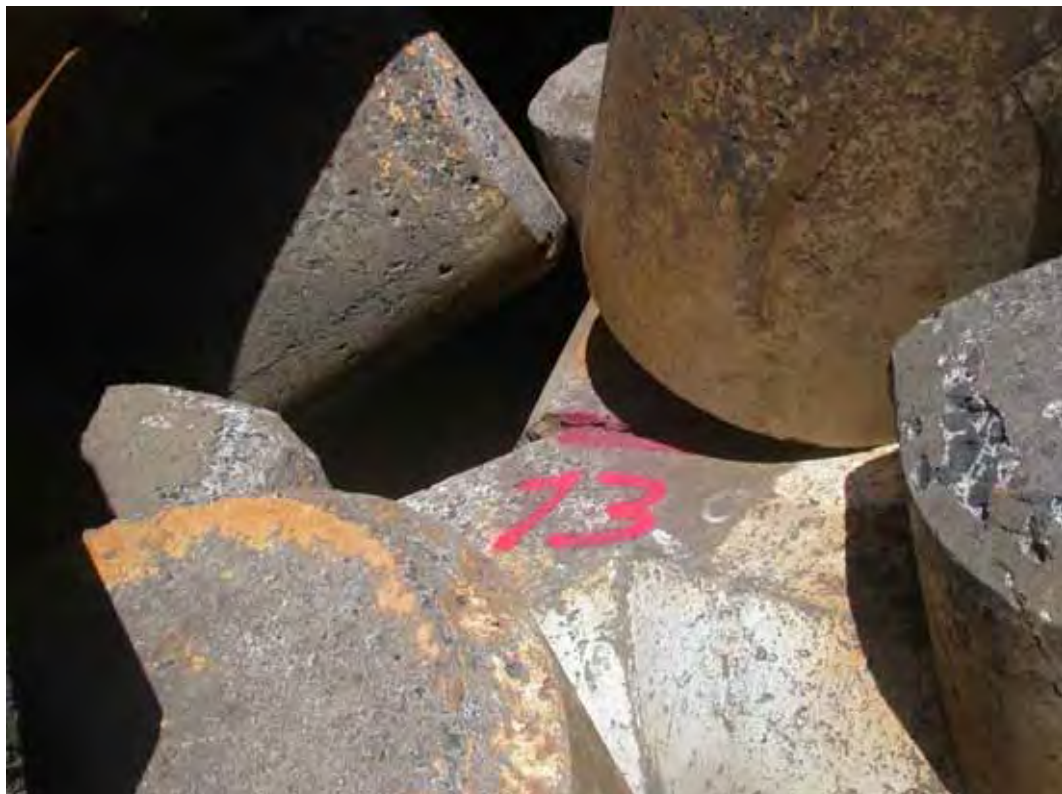
Figure D75. Damage location 106, sta 20+26, ocean side, rib #137, tribar with broken leg.
