Australian Government
Department of Defence
Defence Science and
Technology Organisation

Helicopter Transmission Oil Discolouration

Andrew Becker and Paul Rawson

DSTO-TR-2672

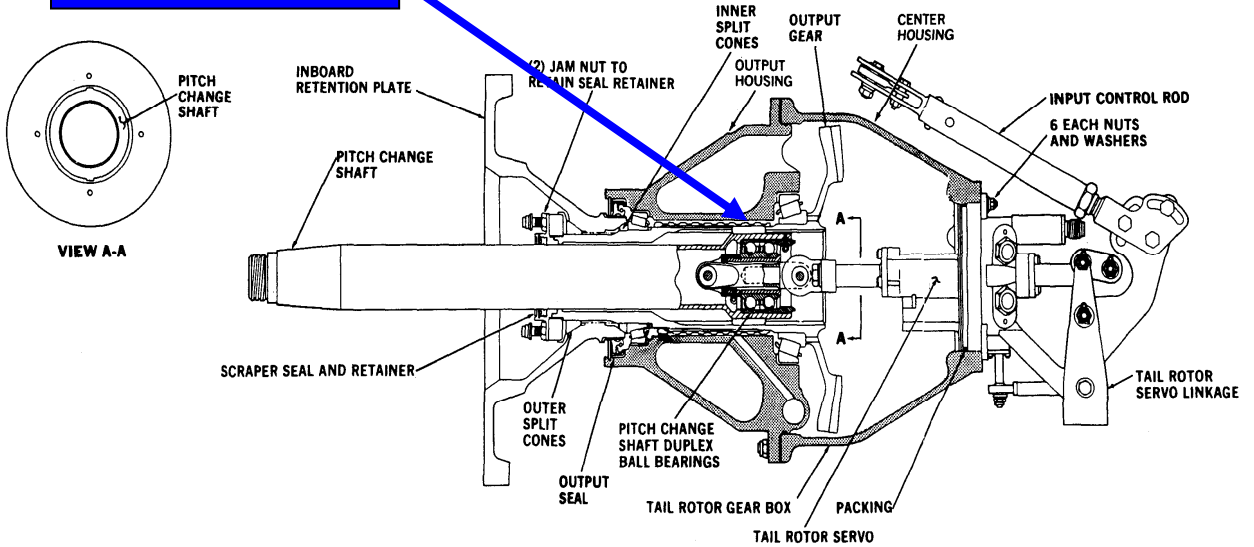
Figure 7: Cross-section of Seahawk/Black Hawk TRGB showing location of Oilite® slider bearing

The pitch change shaft for the tail rotor blades passes through the oil-wetted section of the gearbox and is fitted with an Oilite® bronze slider bearing to accommodate sliding of the shaft (see Figure 1). It is expected that this bearing will wear in service and that the particles generated from that wear will also accumulate in the oil. At present, the degree of slider bearing wear is assessed by one of the following methods:

There is currently no indication that the Oilite® slider bearings are experiencing any abnormal wear. Wear particles accumulating in the oil due to normal in-service wear of the slider bearing would be expected to react directly with the quinizarate and form the purple discolouration/deposit since the bronze bearing material is copper-rich. The serviceability check for the TRGB specifically states that purple discolouration is not a reason for rejecting the gearbox [14].

3. The TRGB Bronze bushing should be checked for excessive wear if the TRGB oil continues to discolour significantly after an oil change out.

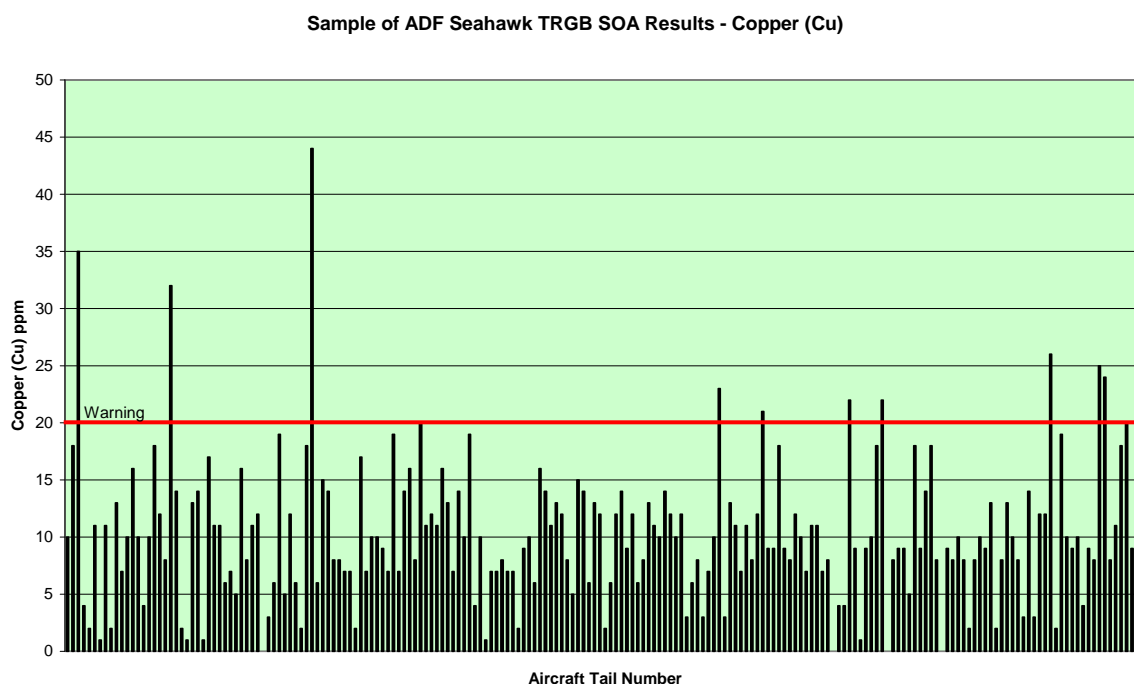
1. By measuring the level of copper in the Spectrometric Oil Analysis (SOA) reports. This oil analysis technique is currently only applied to ADF Seahawk aircraft. The technique is limited to detecting particles less than 8 micron (approximately), however it should detect slider bearing wear. The relative movement of the Oilite® bearing is exclusively sliding and therefore any debris generated is expected to be within the detectable range of SOA. Historical SOA results from Seahawk confirm that copper is being detected (see Figure 2).
2. By visual inspection and dimensional check as part of the routine flight controls inspection. This inspection specifically contains limits for nicks, dents, scratches and outer diameter wear [18].

Figure 8: Sample of ADF Seahawk TRGB SOA Results for Copper (Cu)

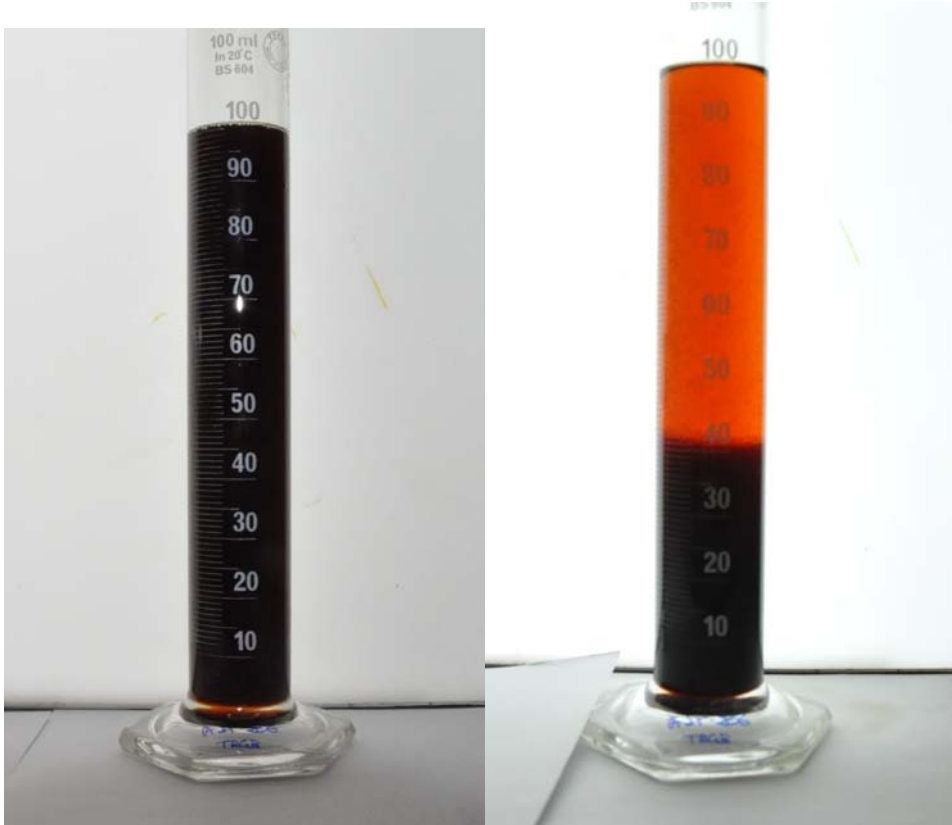
Figures A1 and A2. A25-206 TRGB oil before and after 48 hours standing

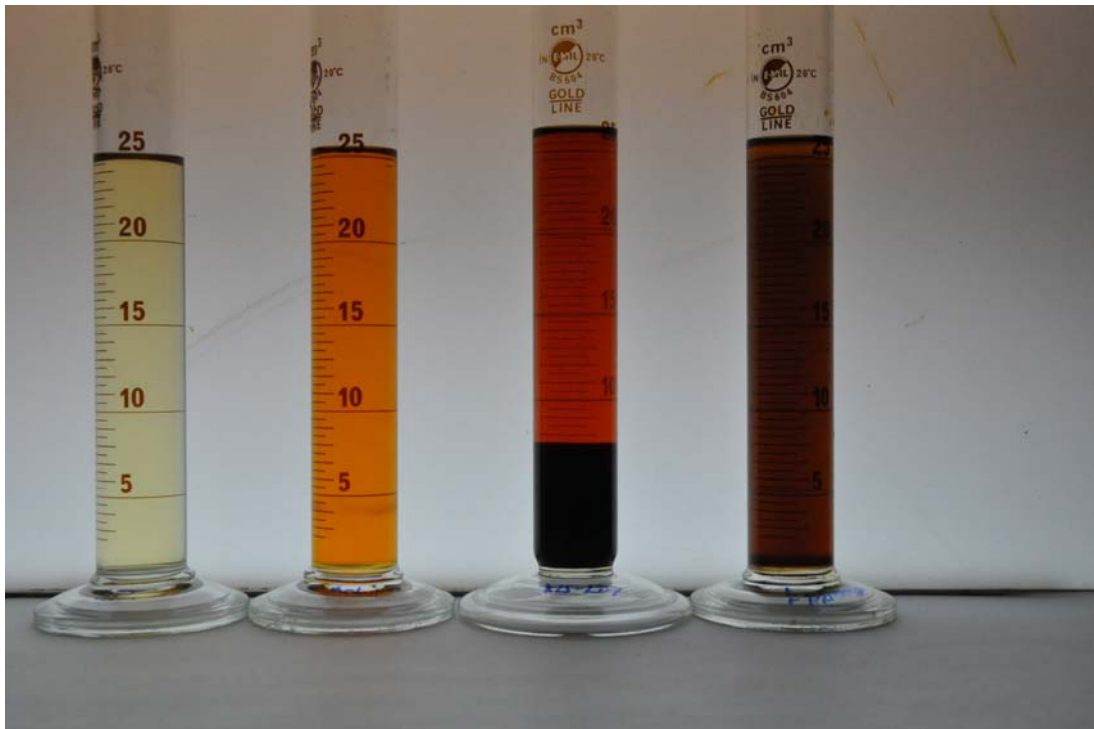
Figure A4. MIL-PRF-23699 Fluids after 48 hours standing.

Left to right: BP Turbo oil 2380, Mobil Jet Oil 2, Discoloured A25-207 TRGB oil. 50% A25-207 TRGB oil mixed with BP Turbo oil 2380. Note the BP Turbo oil 2380 was observed to darken in colour after 48 hours.

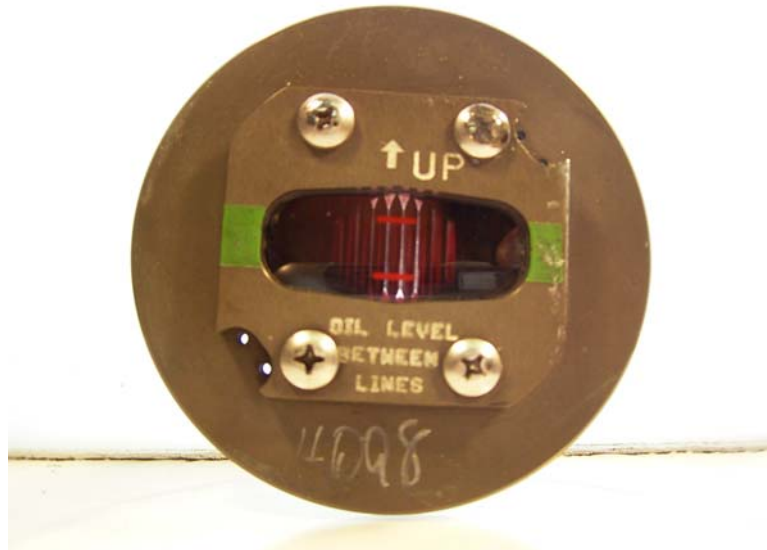
Figure B1. Sight glass from a Black Hawk, rear lit showing obscuration with red stain
