MISSE-6 Post-Flight Examination, Disassembly and Analysis Results

FINAL REPORT

December 21, 2010

Post Flight Inspection and Test Results for MISSE-6 Power Distribution System and Boeing Experiment Data Wiring.

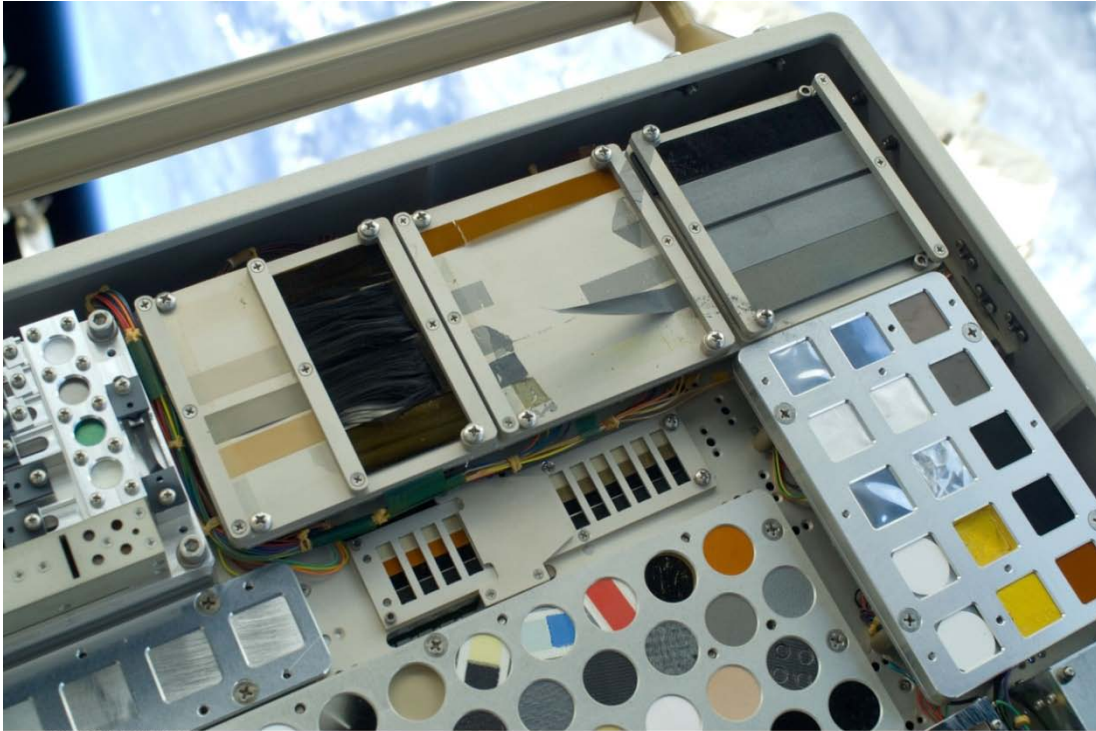
ISS020E037356

Figures 4 through 11 are close-up images taken on-orbit following the 17 month exposure. Damage to particular specimens is evident in Figure 9, which shows failed thin film specimens on the Ram (AO/UV) side of MISSE-6B. Post-flight, the ram side of MISSE-6B generally showed the most visible damage. Virtually all specimens on the “wake” (UV exposed) side of both 6A and 6B were intact and looked in reasonable condition post-flight.

Figure 9. MISSE-6B AO/UV side on-orbit, showing damage to thin films (NASA image).

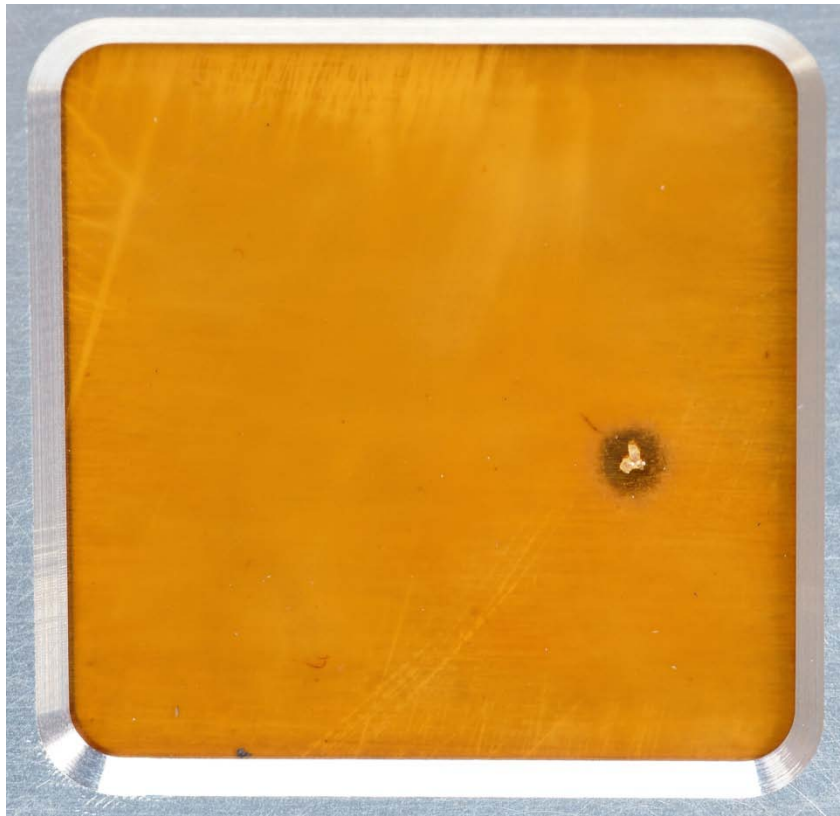
Figure 16. Impact in thin film specimen from MISSE-6 (NASA image).

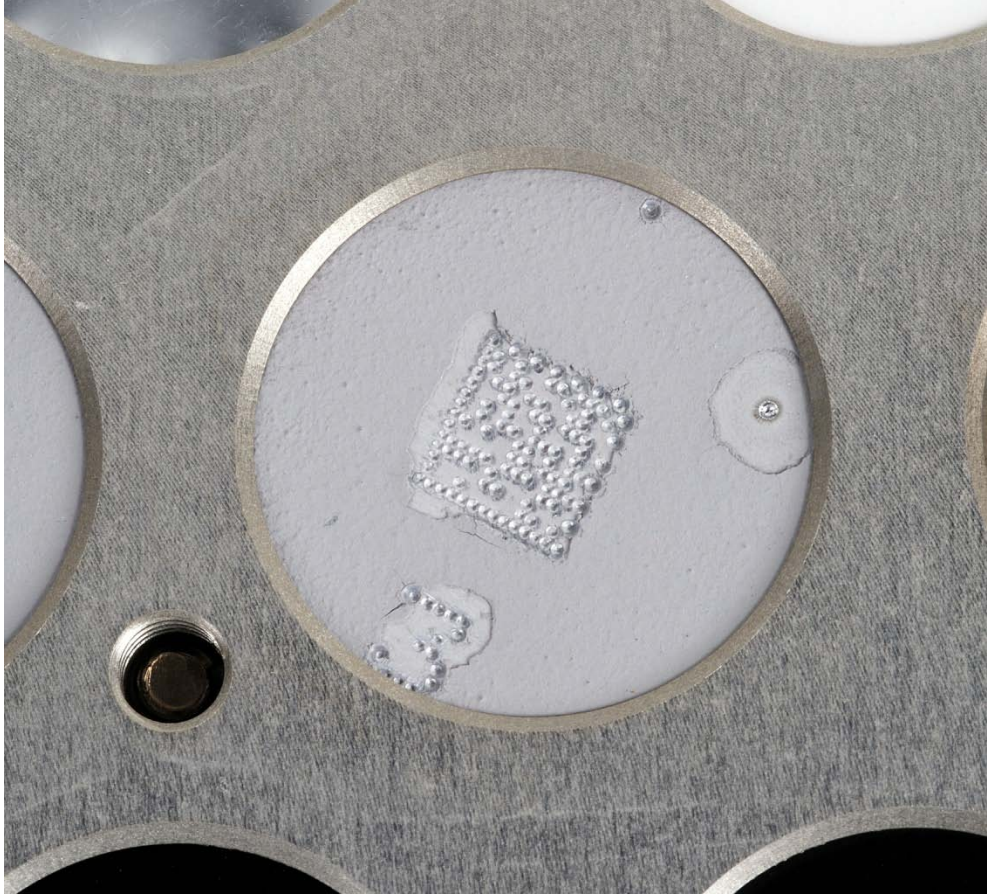
Figure 17. Impact on specimen from MISSE-6 (NASA image).

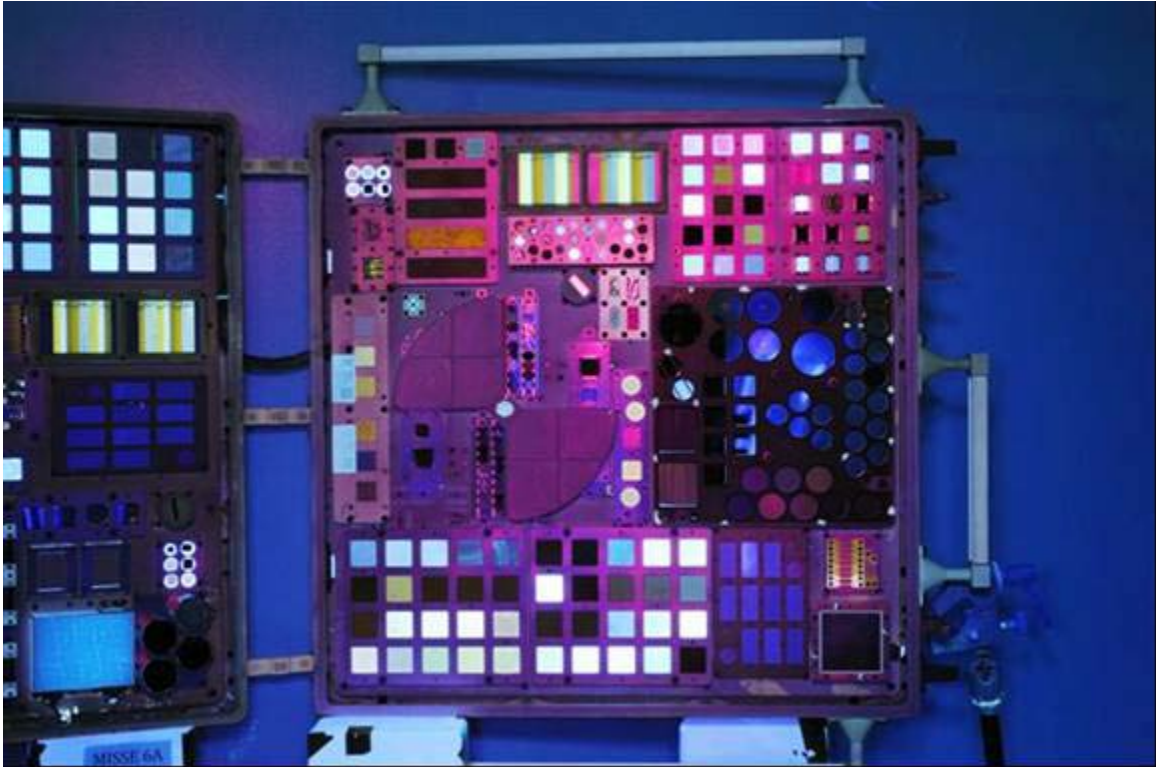
Visual inspection of both MISSE-6A and MISSE-6B did not reveal any obvious molecular contamination. These observations were supported by inspections under black light, which also showed the surfaces to be generally clean. Representative black light images for MISSE-6A are shown in Figures 19 and 20. Results from MISSE-6B are similar.

Figure 19. Black light image of MISSE-6A ram-facing surface.

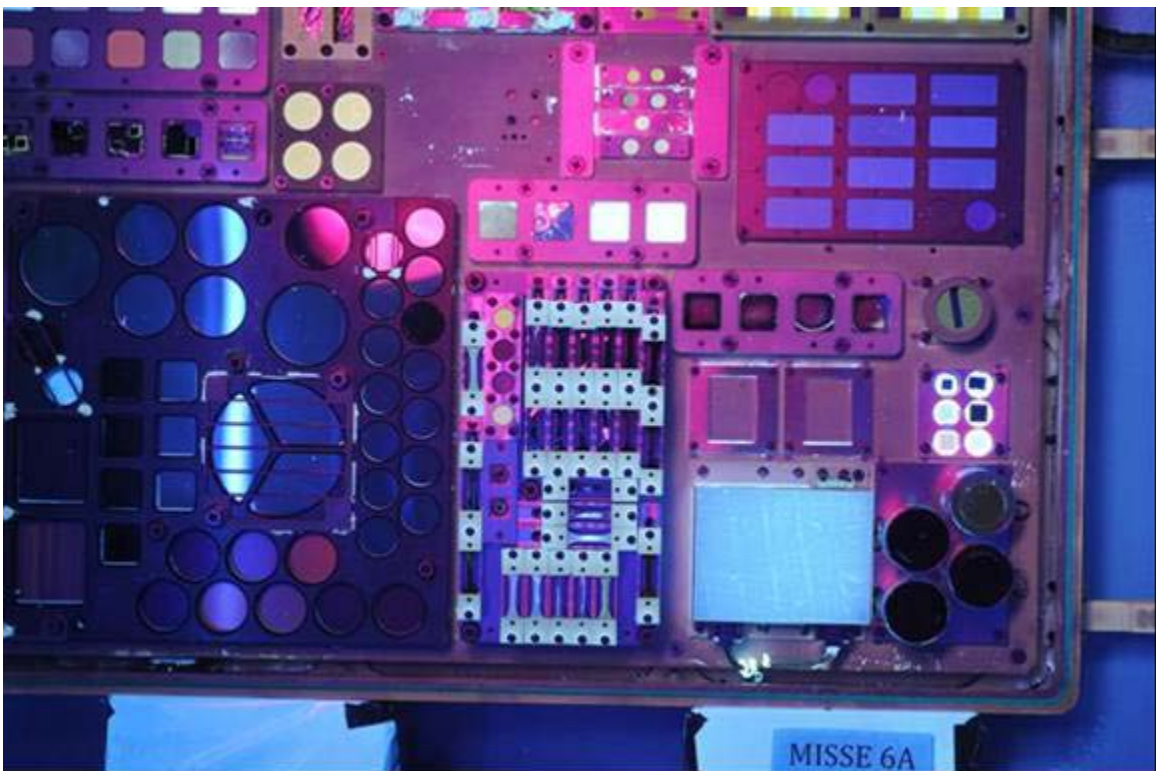
Figure 20. Black light image of MISSE-6A wake-facing surface.

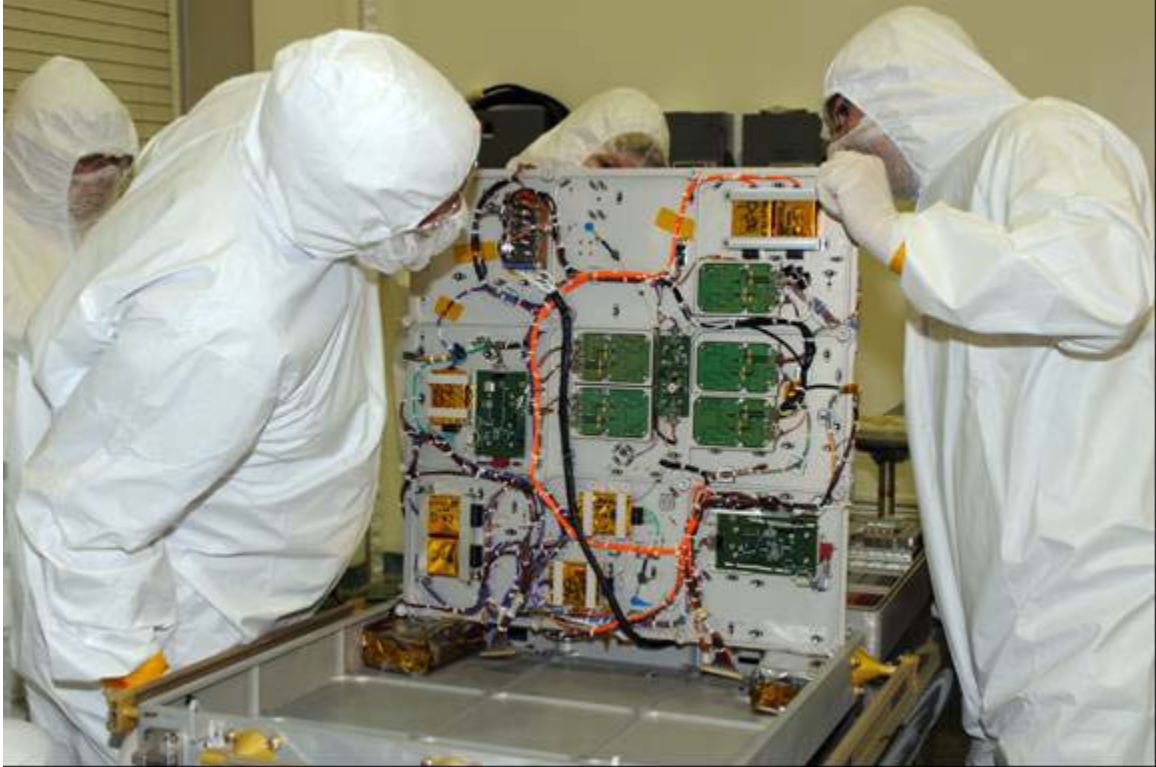
Figure 27. Inspection of MISSE-6B tray from the ram-facing side, post-flight (NASA Image).

The underside of the tray and hardware are in good condition post-flight. As with previous MISSE flights, the silver-coated nut plates are significantly oxidized.

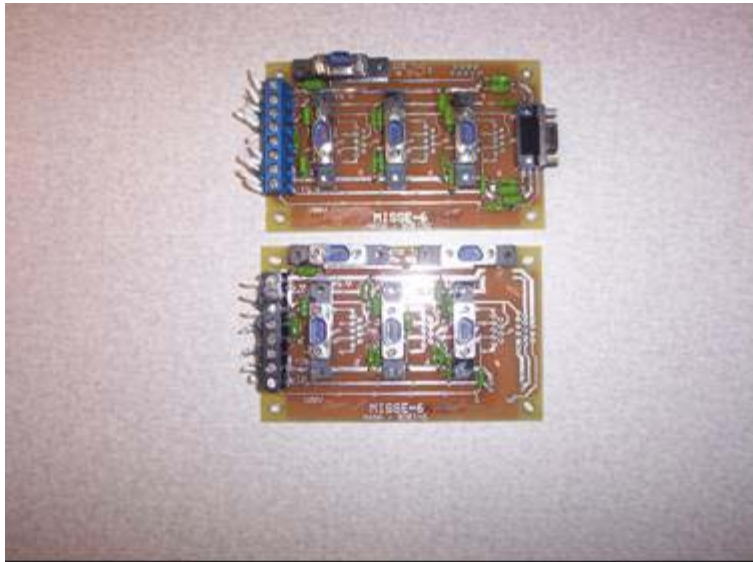
Figure A29: Post Flight Photos of 6A-UV (above) and 6A-AOUV (below) power distribution boards

During de-integration each individual power line from the power distribution board was visually inspected, photographed, and labeled. The power wiring and the power distribution boards were removed and shipped back to the Boeing Radiation Effects Lab. Continuity checks were performed on all traces and fuses on the power distribution board and on all wiring. For 6A-UV the only anomaly discovered was a blown fuse feeding +5V to connector slot 5. This power plug was connected to the PSI experiment P1. The cause of the short is unknown.

During de-integration each individual power line from the power distribution board was visually inspected, photographed, and labeled. The power wiring and the power distribution boards were removed and shipped back to the Boeing Radiation Effects Lab. Continuity Checks were performed on all traces and fuses on the power distribution board and on all wiring. For 6A-AOUV No Anomalies were discovered during visual or electrical inspections.

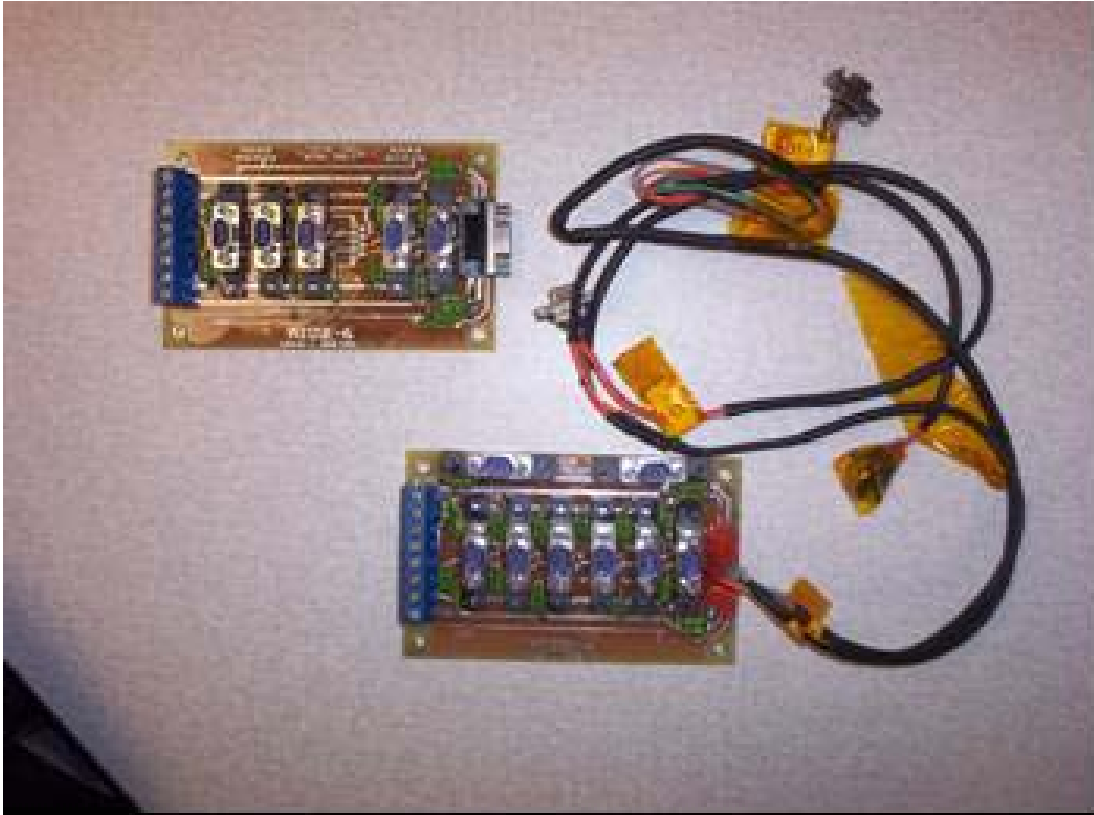
Figure A36: Post Flight Photos of 6B-UV (above) and 6B-AOUV (below) power distribution boards

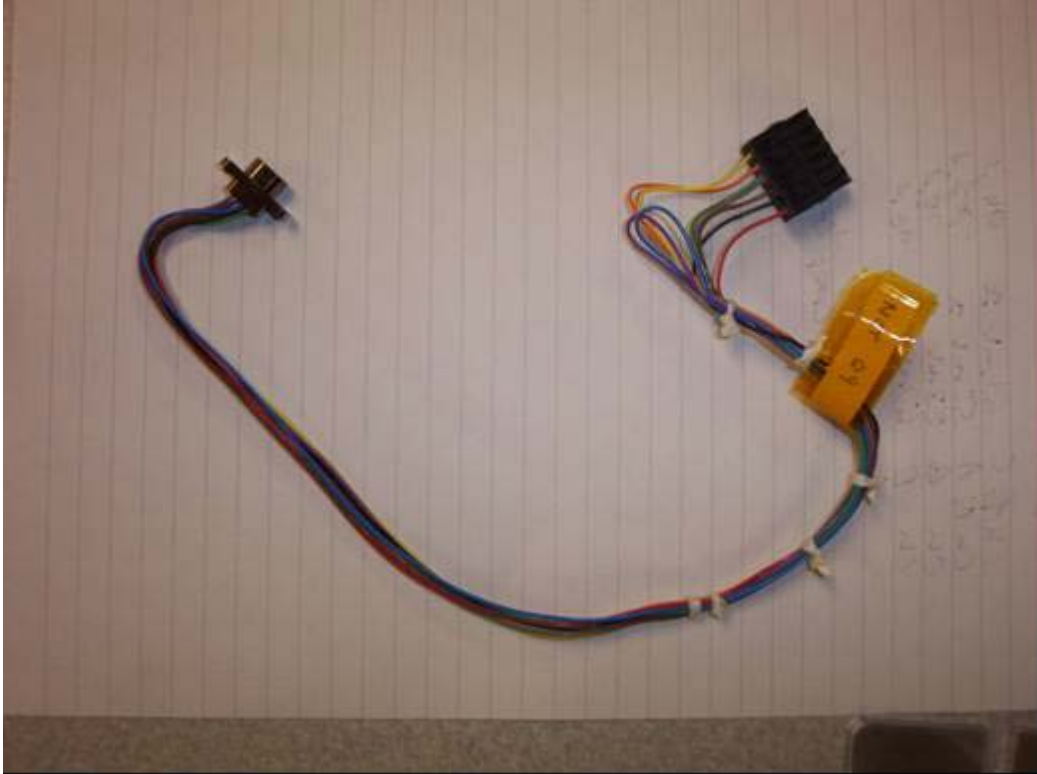
The data wiring for the Boeing experiments including QCMs and Rotor/Sensor were labeled, removed, and several of the wire bundles were shipped back to Boeing for post flight inspections. Inspections were conducted at Boeing on Data wiring for Q7, Q8, Q9 and the rotor-sensor. Results showed that Q7 and Q8 were properly wired to their data loggers.

Figure A42: the properly wired data interface for a QCM

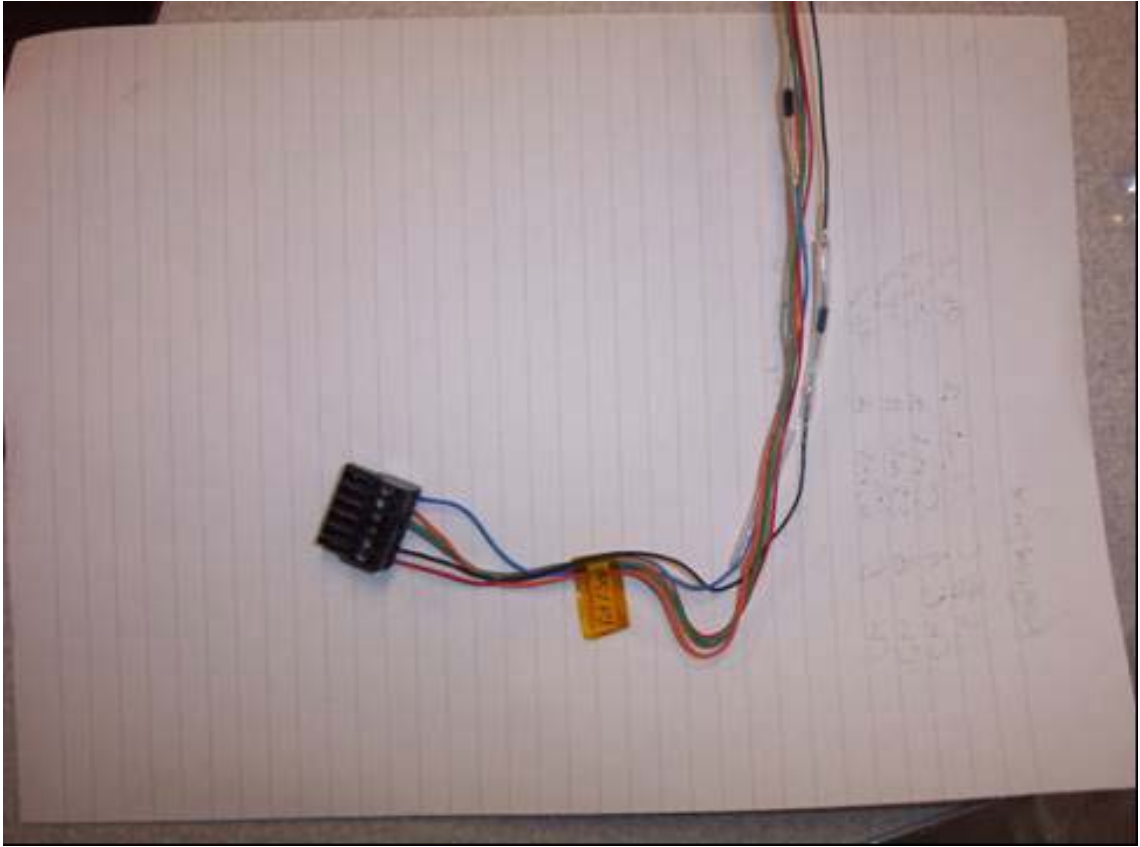
In addition, Q9 was properly wired into datalogger D8, and the rotor sensor was properly wired into datalogger D9. Datalogger D9 was a SP-4000-4CW, a current sensing datalogger, channel 1 of the data logger was connected through a 1kOhm resistor to the black data wire from the rotor. Channel 2 of D9 was unpopulated. Channel 3 was connected to the orange wire from the rotor. Channel 4 was connected through a 10KOhm resistor to the blue wire from the rotor connector.

Figure A436: Rotor wiring to D9
