In Situ Corrosion and Heat Loss Assessment of Two Nonstandard Underground Heat Distribution System Piping Designs

Final Report on Project F07-AR01

June 2011

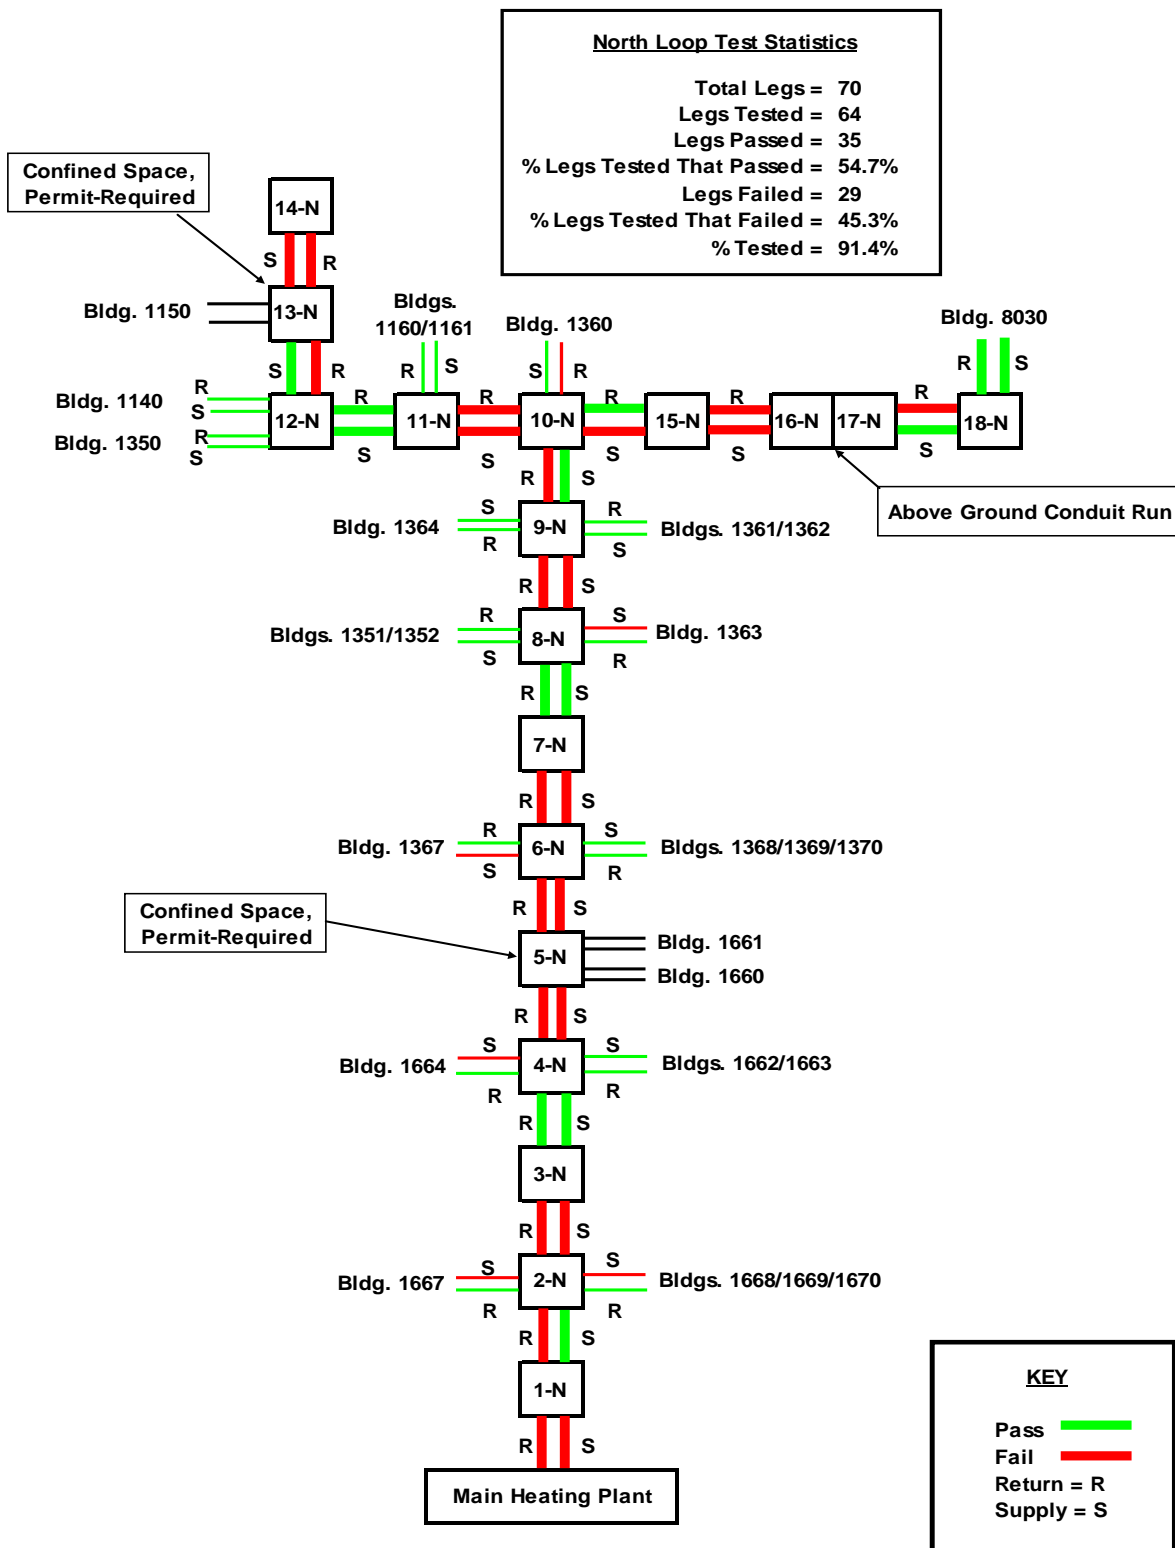
Figure 8. Fort Carson Phase I pressure test results in schematic form.

North Loop pressure test results, showing a pass/fail indication, are illustrated on a schematic drawing in Figure 8. In accordance with the requirements of the SOW and authority of the designated HDS expert, 91.4% of the North Loop was tested to provide a statistical evaluation of system integrity with respect to pressurization performance. As shown in Figure 8, a failure rate of 45.3% was determined for the North Loop. Detailed valve-pit and conduit segment test data and observations are included in Appendix H.

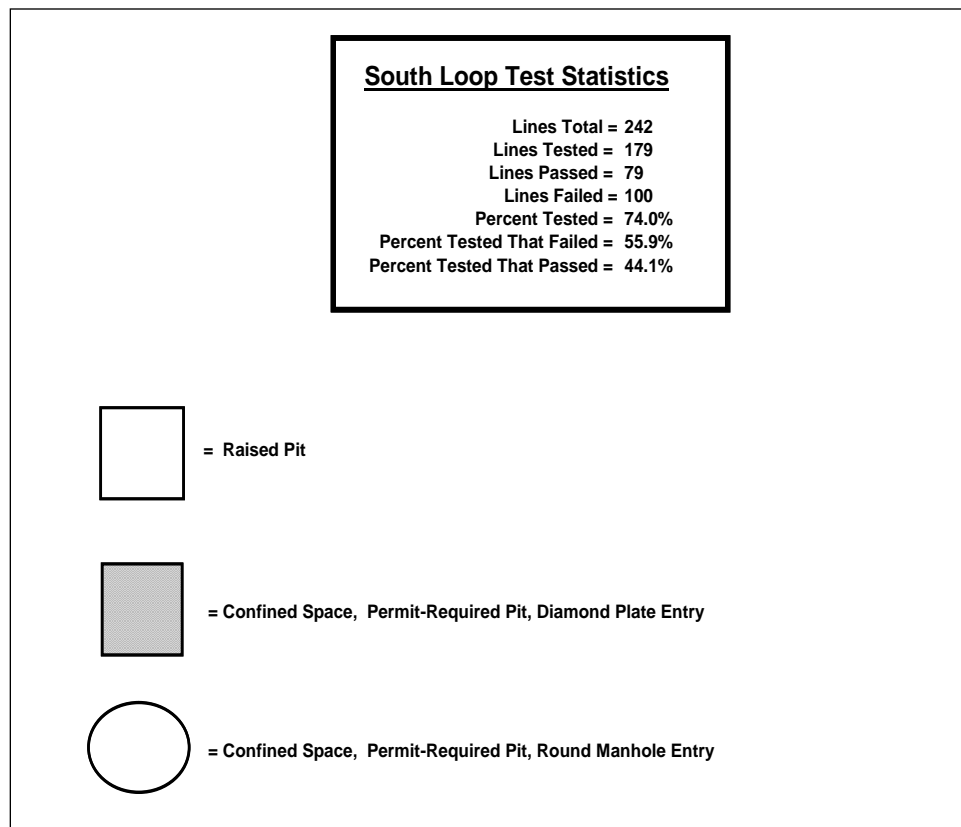
Figure 9. Fort Carson South Loop pressure test summary and legend for Figure 10.

Figure 9 summarizes the test results for the South Loop, indicating a failure rate of 55.9%. It also provides a legend for structures shown in Figure 10, the South Loop schematic diagrams. (Note that Figure 10 extends across five pages.) Detailed test results for each valve pit and conduit segment test data are provided in Appendix I.

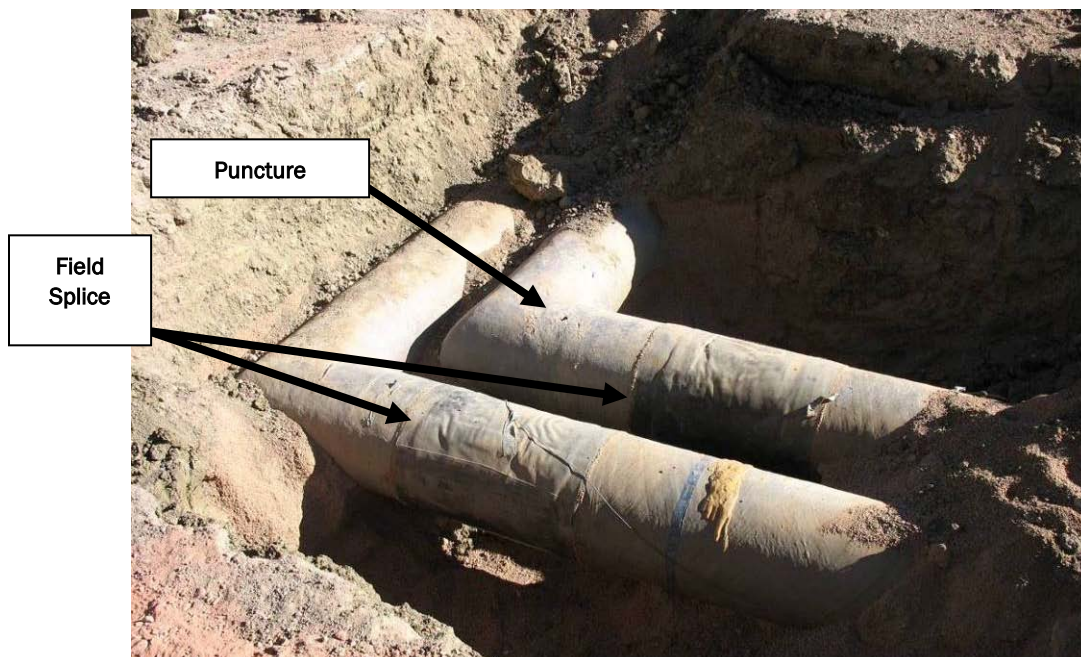
1. Site Location: North Loop. Approximately 50 feet north of MH-2N, east of Bldg. 1667. Vanguard ICT as-built Ref. Sheet No. M-4
2. Conduit Size: Supply (East) – 70.75" Circ. (22.5" Dia.); 12" HTWS per Ref. Sheet No. M-4; Return (West) – 71" Circ. (22.6" Dia.); 12" HTWS per Ref. Sheet No. M-4
3. Conduit Temperature: Supply and Return – Slightly warm to touch when first exposed, temperature dropped quickly to ambient after exposure.
4. Outer Jacket Condition: Supply – Good; Return – Good.
5. Damage Observation (Abrasion, wear, damage, workmanship): In general, outer casing shows no significant damage, wear or abrasion; construction workmanship is good. Field splice boot and casing at elbow apparently damaged during excavation. Boot was cut and casing punctured/eroded. Repair completed by filling cavity behind puncture with

Figure 18. Site 3 elbow inspection showing defects, facing northeast.

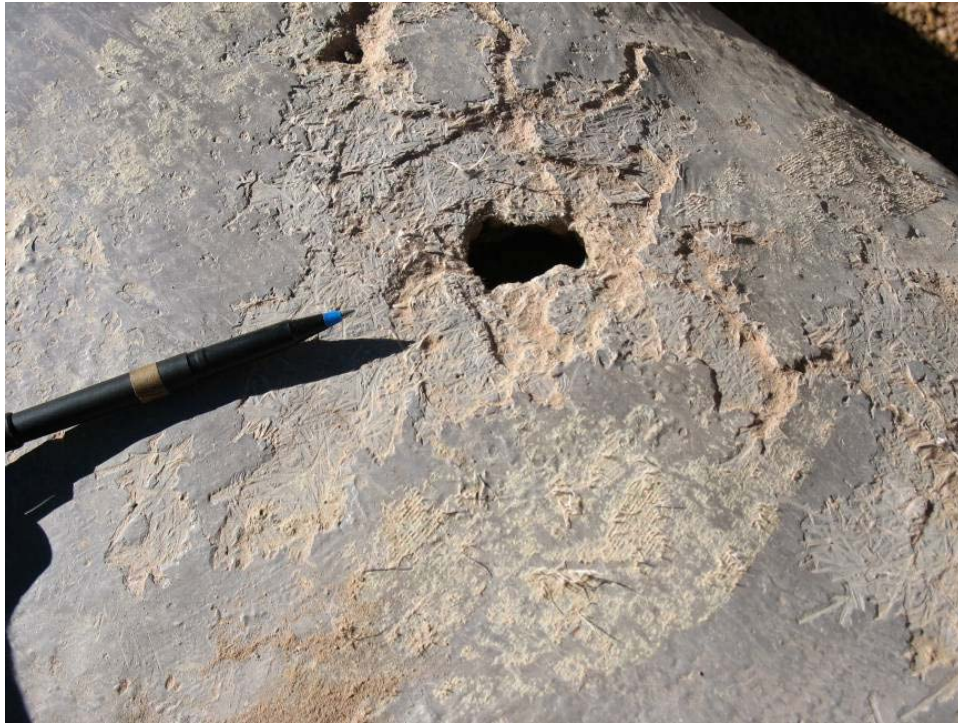
Figure 19. Conduit outer casing showing backhoe puncture and erosion at site 3.

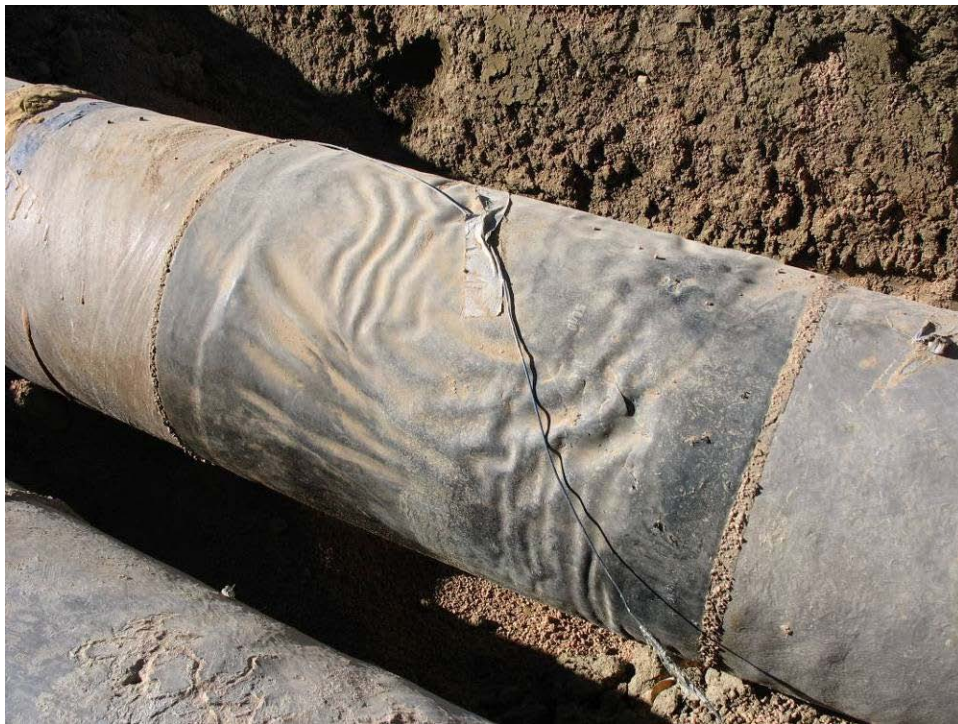
Figure 20. Cut in splice boot at site 3.

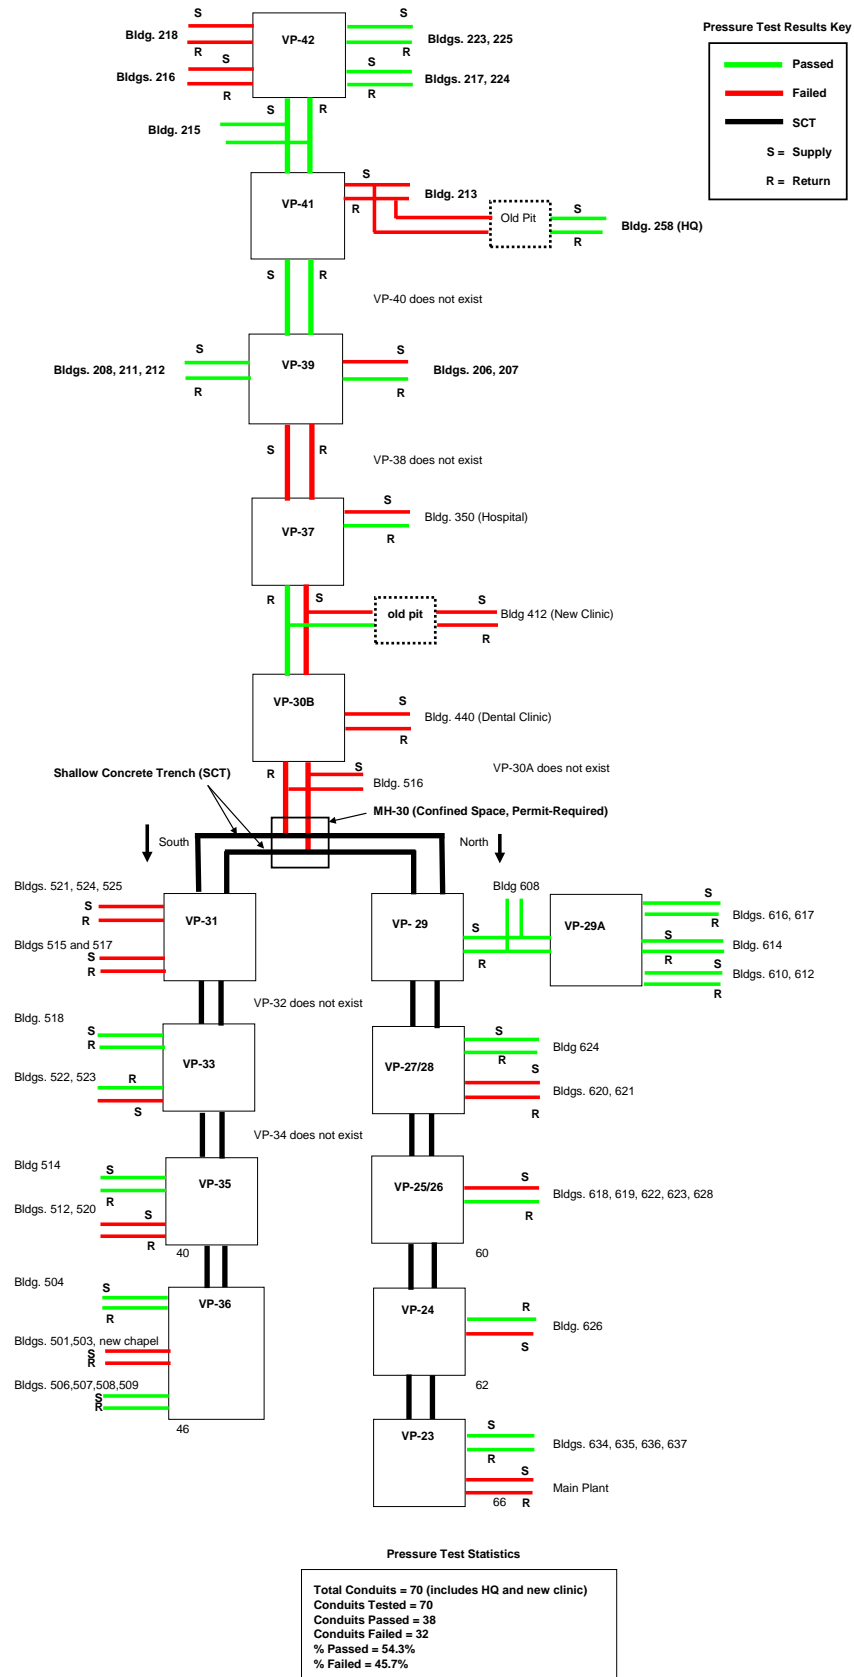
Figure 35. Fort Stewart South Loop pressure test results in schematic form.

South Loop pressure test results, showing a pass/fail indication, are illustrated on a schematic drawing in Figure 35. In accordance with the SOW and the authority of the designated UHDS expert, 100% of the South Loop was tested to provide a statistical evaluation of system integrity with respect to pressurization performance. As shown in the box at the bottom of Figure 35, a failure rate of 45.7% was determined for the South Loop. This box also summarizes other test results. Detailed valve pit and conduit segment test data and observations are included in Appendix H.

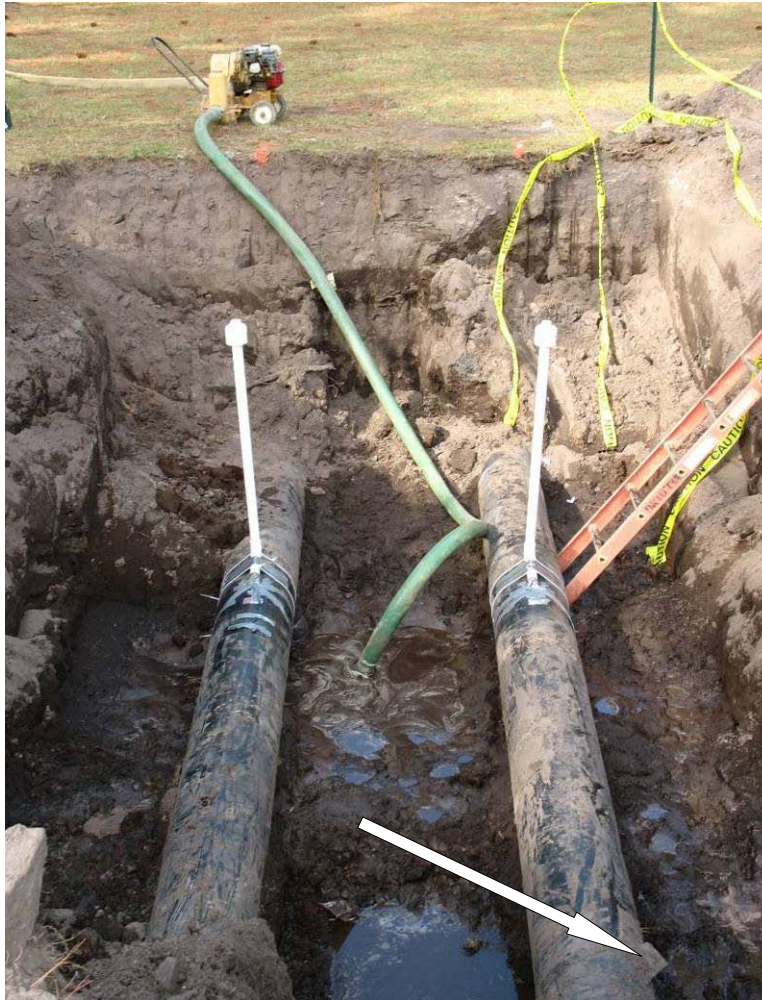
Figure 36. Site 1 excavation with installed instrumentation, facing north, showing damage to outer jacket occurring during excavation (see arrow).

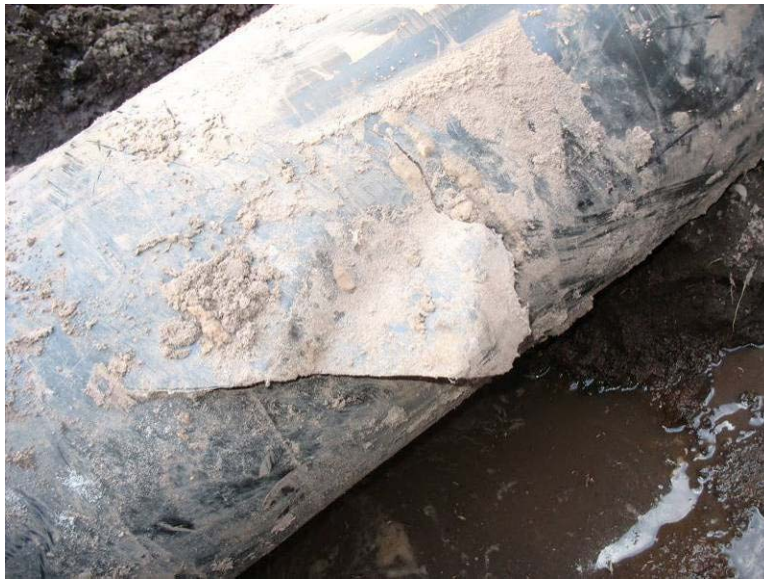
Figure 37. Detail of damaged HDPE casing on excavation return conduit at site 1.

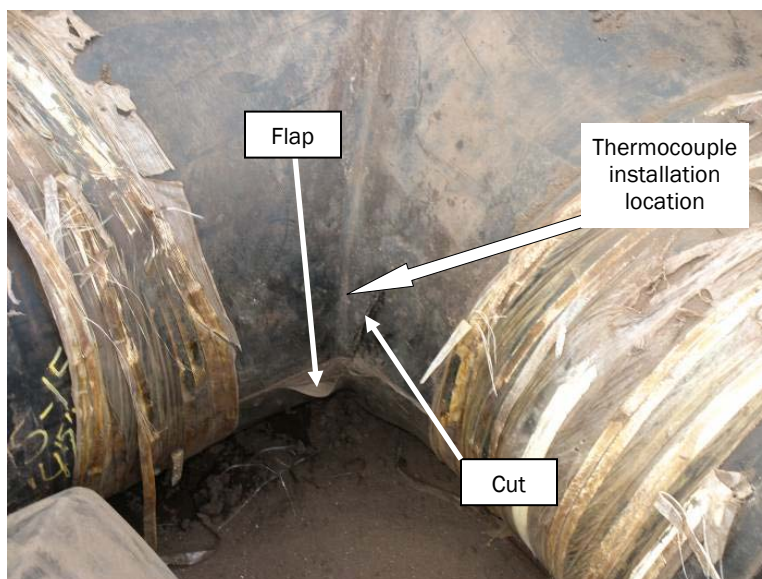
sulation crushes, its thermal conductivity increases resulting in higher heat loss from the carrier and higher conduit outer jacket temperatures. Thermocouples were mounted on the inside and outside radii of the damaged elbow to document performance in service.

Figure 42. HDPE casing flaws in supply elbow.

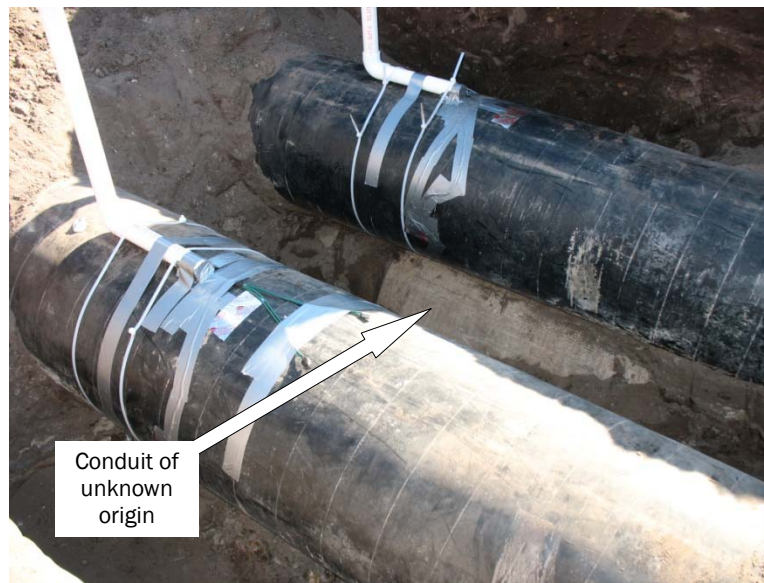
Figure 45. Site 3 excavation showing cement-like conduit of unknown origin directly beneath south UHDS supply line.

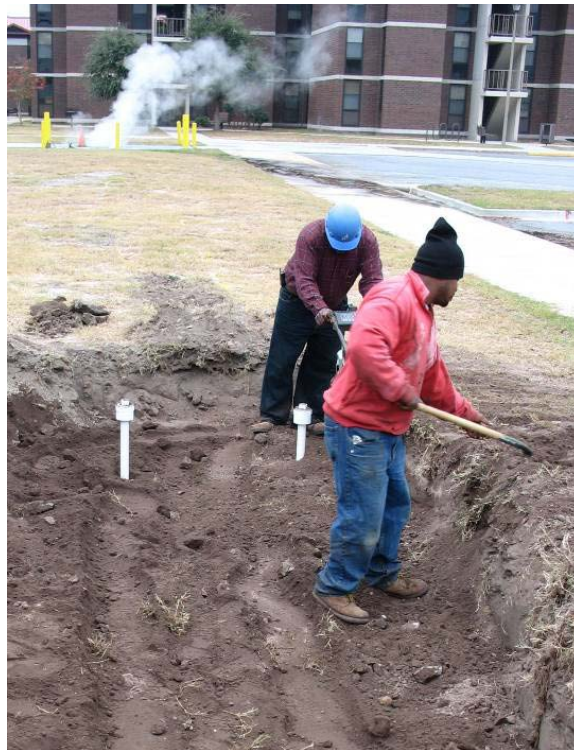
Figure 52. Heat flux sensor installation burial showing steam rising from failed isolation valve at VP-23 in background.

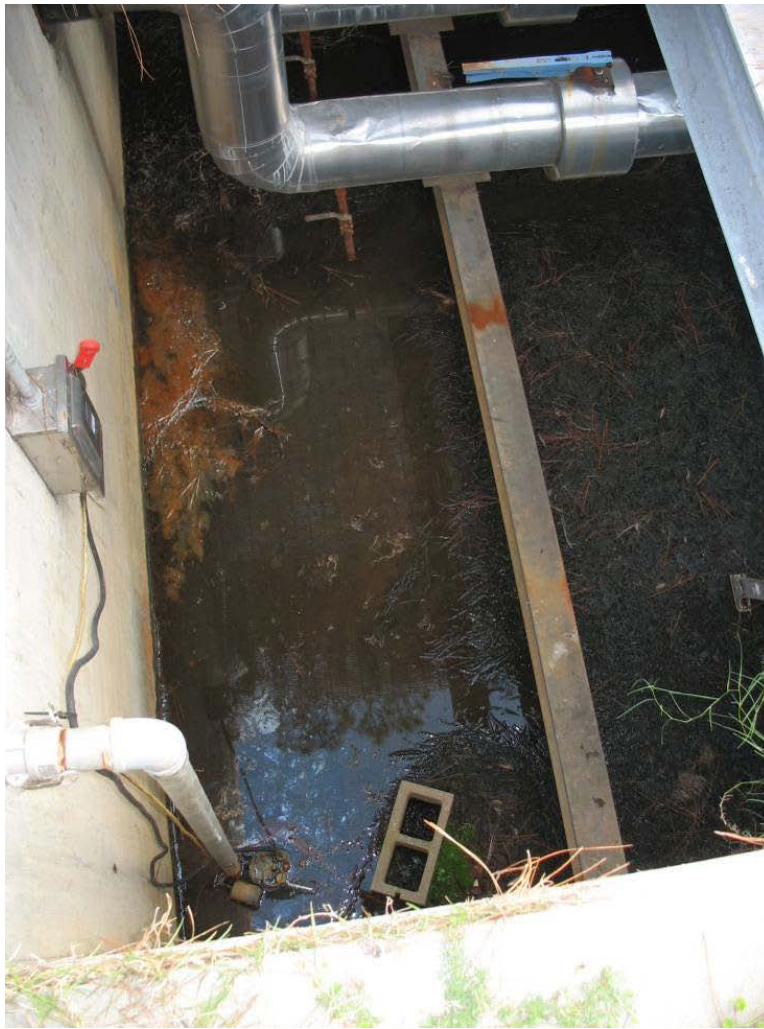
Figure 53. Water accumulation in valve pit due to clogged pump inlet.

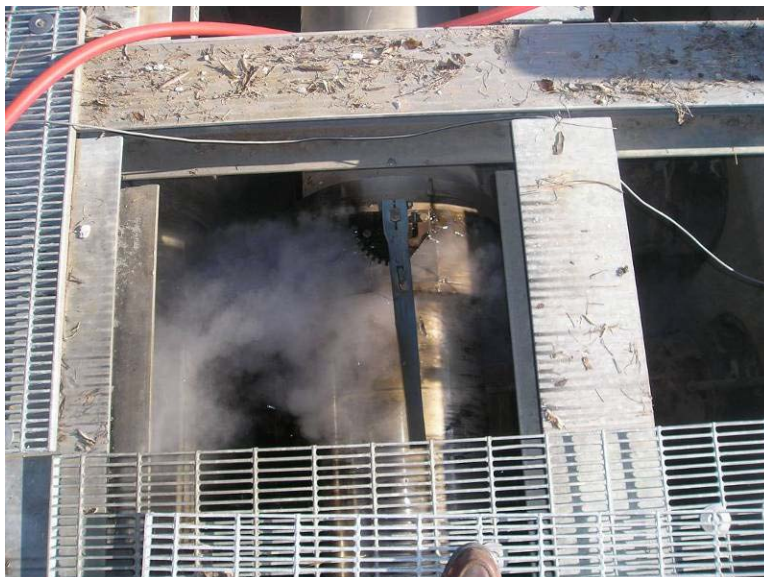
Figure 54 and Figure 55 illustrate the effects of various failures on valve pit VP-23A. This pit houses supply and return connections from the central heating plant to the north and south UHDS networks. The sump failed, allowing water to submerge the conduits for an extended period. This flooding fully destroyed the pipe insulation at several locations, exposing the conduit to corrosive conditions and causing significant heat loss. To aggravate this problem, packing failure on one of the isolation valve stems allowed continuous ventilation of steam into the pit, further aggravating corrosivity and heat loss. These conditions were first noted onsite in August 2007 and had not been corrected as of February 2008. It was determined that the valve design was unrepairable, and that system shutdown was required to replace the unit. Again, the substandard components appear to be the consequence of the procurement instrument.

Figure 54. Steam issuing from failed isolation valve in VP-23.

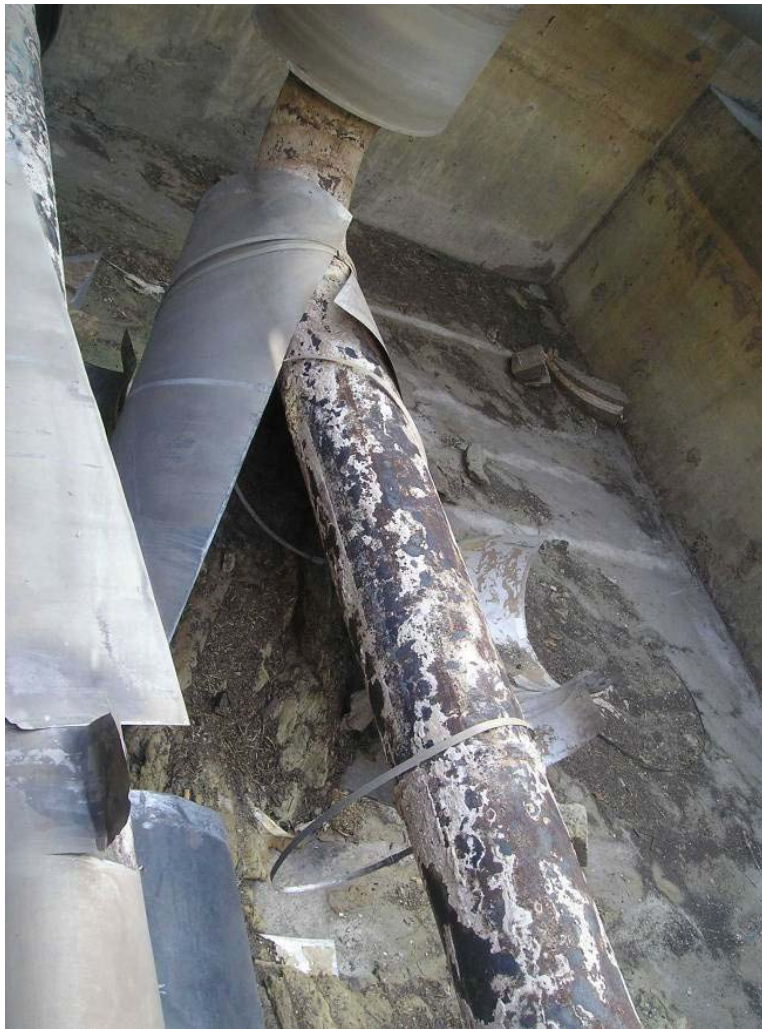
Figure 55. Main trunk carrier pipe in VP-23 fully exposed due to conduit failure.
