Organic Finishing Technologies

B-52 Paint Life Cycle Extension

Steve Finley, CTC
Support Contractor to
Mr. Tom Naguy
Air Force Research Laboratory

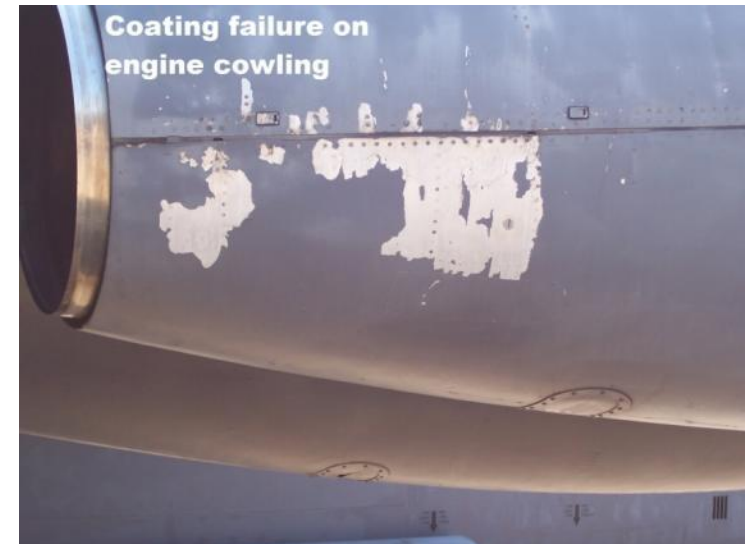
- **Barksdale Inspection Results**
 - **Several adhesion failures noted on multiple aircraft**
 - **No corrosion was detected during the visual inspection**
 - **No facility to accomplish maintenance touch up**
 - **Color, gloss, and film thickness readings taken on the two aircraft with advanced performance coating (APC)**

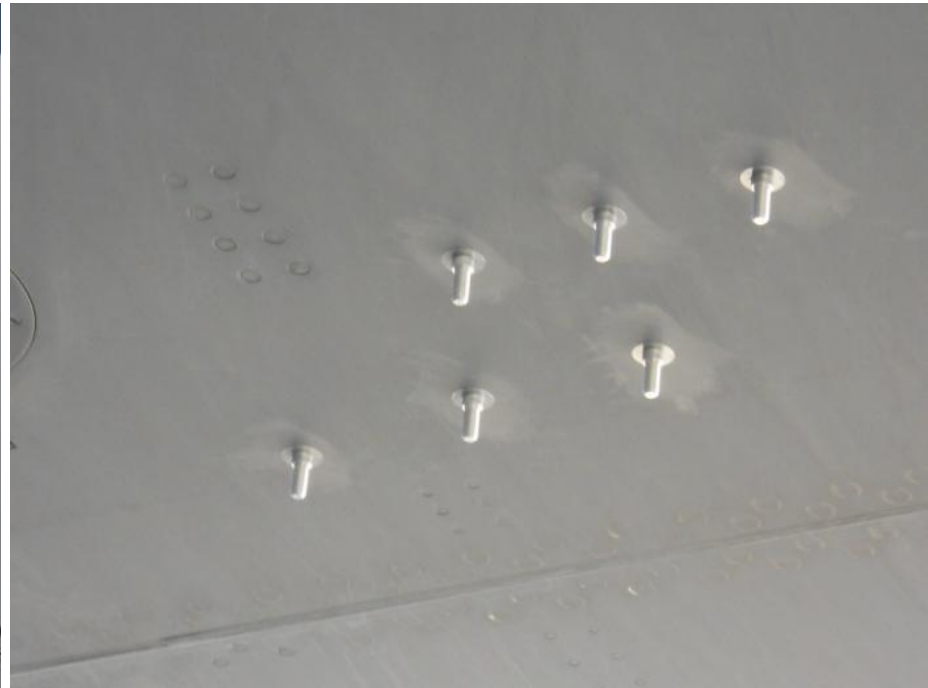
- Twelve studs glued to each aircraft
- Six under the right wing
- Six on the aft fuselage right side

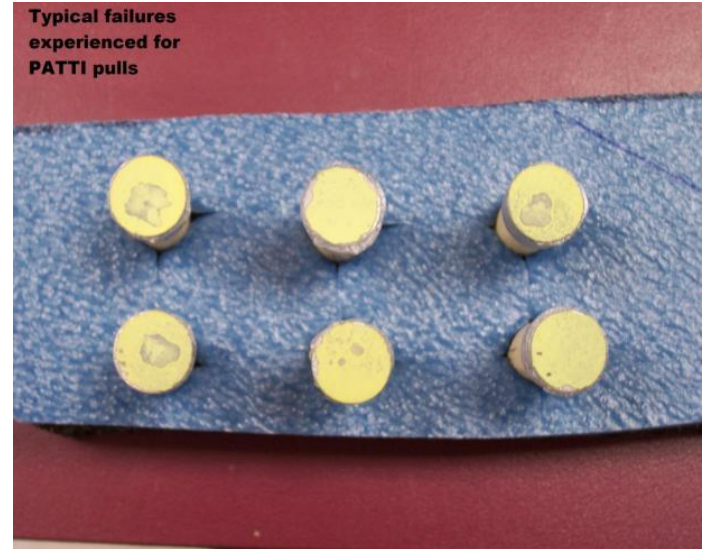
- **X-Ray Photoelectron Spectroscopy (XPS)**
 - Primer samples collected for XPS analysis
 - Coating was sanded to the base primer layer
 - Dust was collected on tape
 - PATTI studs were used for analysis
 - Fourteen samples were analyzed
- **Cr +6 level equal to or greater than fresh applied primer in 13 of 14 samples**
