# Coating Performance in Duluth Superior Harbor—Part 2

RICHARD I. RAY AND BRENDA J. LITTLE, FNACE,  
Naval Research Laboratory, Stennis Space Center, Mississippi

*Nine coatings were evaluated for corrosion protection of carbon steel coupons and I-beams around Duluth Superior Harbor after 46 and 35 months, respectively. Coupons were intentionally scribed to metal before exposure. Part 1 (September 2012 MP) described the coatings used and the locations of coupons and I-beams. Part 2 discusses the results of the evaluation.*

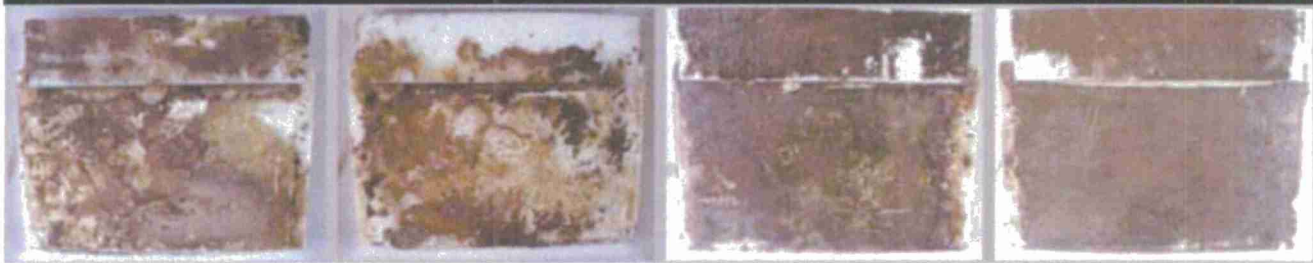
FIGURE 1

(Side A) Coating 1 (Side B)  
**U.S. Coast Guard Cell B**  
 White two-part solvent-free polyamine epoxy  
 Total exposure time 46 months

**Observations**  
 Few byssal threads still attached  
 Both sides covered in sponge material  
 Top layer of coating peeling in places  
 Corrosion evident in scribe (artificial defect)  
 Muddy coating on surface

(Side A) Coating 1 (Side B)  
**U.S. Coast Guard Cell C**  
 White two-part solvent-free polyamine epoxy  
 Total exposure time 46 months

**Observations**  
 Few byssal threads still attached  
 Algae growing on one side of coupon  
 Top layer of coating peeling from scribe  
 Corrosion evident in scribe (artificial defect)  
 Muddy coating on surface

Coating 1 coupons.

to the intentional scribe area. The topcoat of Coating 1 was peeling from the scribe. Coatings 4, 5, 6, 7, and 9 remained intact and there were no indications of delamination even in the scribe area. Figures 1 through 4 present descriptions and observations.

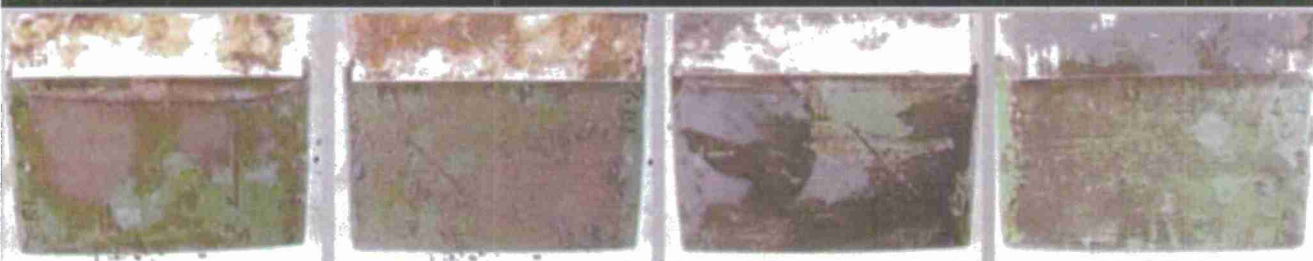
FIGURE 2

(Side A) Coating 4 (Side B)  
**U.S. Coast Guard Cell B**  
 Green two-part solvent-free polyamine epoxy  
 Total exposure time 46 months

**Observations**  
 Few byssal threads still attached  
 Coating appears intact even in scribe area  
 Corrosion evident in scribe  
 Muddy coating on surface

(Side A) Coating 4 (Side B)  
**U.S. Coast Guard Cell C**  
 Green two-part solvent-free polyamine epoxy  
 Total exposure time 46 months

**Observations**  
 Few byssal threads still attached  
 Coating appears intact even in scribe area  
 Corrosion evident in scribe  
 Muddy coating on surface except where silicone caulk used to attach Teflon holder

Coating 4 coupons.

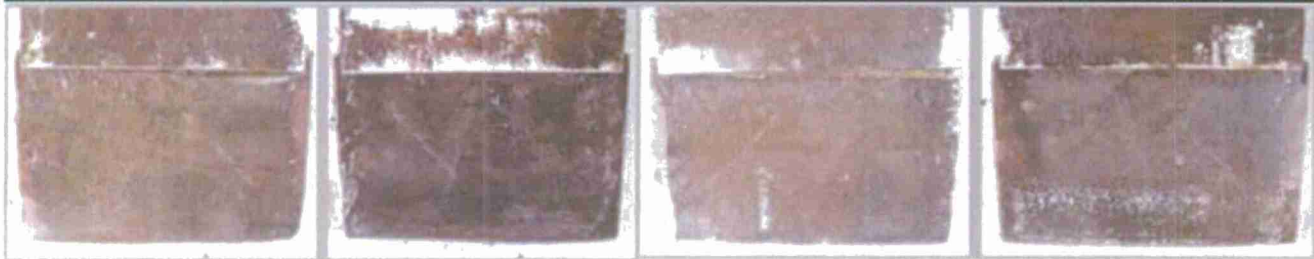
**FIGURE 3**

**Coating 5**  
(Side A) (Side B)

**U.S. Coast Guard Cell C**  
Red urethane micaceous iron oxides  
and refined coal tar  
Total exposure time 46 months

**Observations**  
Few byssal threads still attached  
Some algae on coating surface  
Coating appears intact even in scribe area  
Corrosion evident in scribe  
Muddy coating on surface

**Coating 9**  
(Side A) (Side B)

**U.S. Coast Guard Cell C**  
Blue/grey zinc primer/vinyl copolymers  
Total exposure time 46 months

Coatings 5 and 9 coupons.

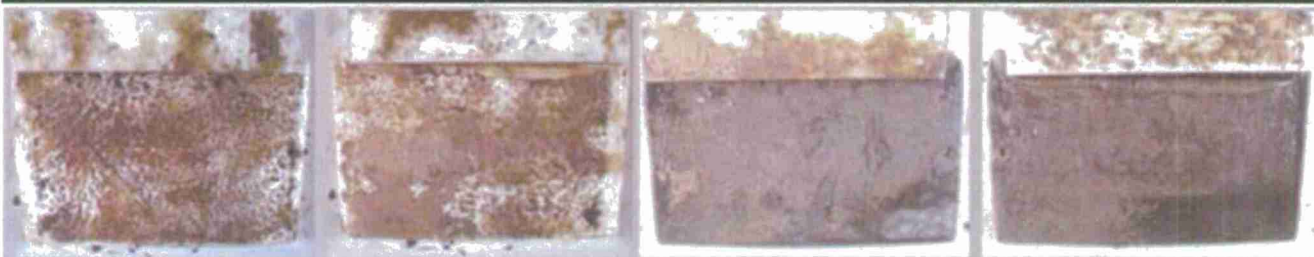
**FIGURE 4**

**Coating 6**  
(Side A) (Side B)

**U.S. Coast Guard Cell B**  
White amine epoxy (one coat)  
Total exposure time 46 months

**Observations**  
Few byssal threads still attached  
Coating appears intact even in scribe area  
Coating lumpy and thick  
Corrosion evident in scribe  
Muddy coating on surface

**Coating 7**  
(Side A) (Side B)

**U.S. Coast Guard Cell C**  
Black polysulfide modified epoxy novolac  
Total exposure time 46 months

**Observations**  
Few byssal threads still attached  
Some algae on coating surface  
Coating appears intact even in scribe area  
Corrosion evident in scribe  
Muddy coating on surface

Coatings 6 and 7 coupons.

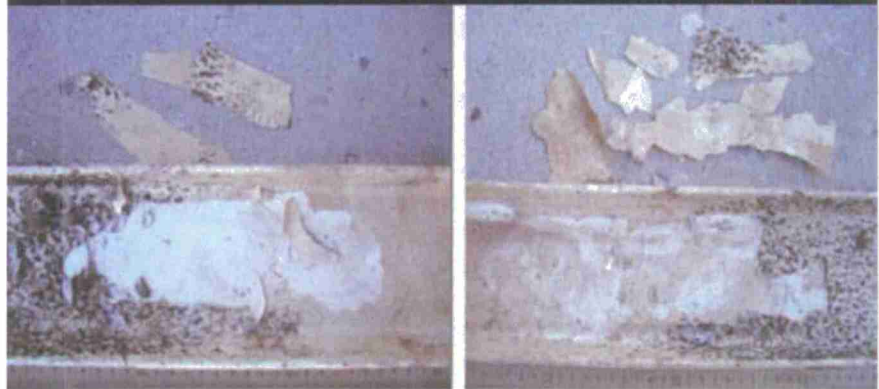
FIGURE 5

The topcoat of Coating 1 delaminated and peeled from the surface of the I-beam (Figure 5).

The I beams were not scribed so the intentional defect was not necessary to initiate the delamination. The base coat remained intact and no localized corrosion was obvious. Coating 7 peeled from the surface in large sections, exposing uncoated steel with corrosion and tubercles (Figure 6).

Coating 1 shown on the I-beams.

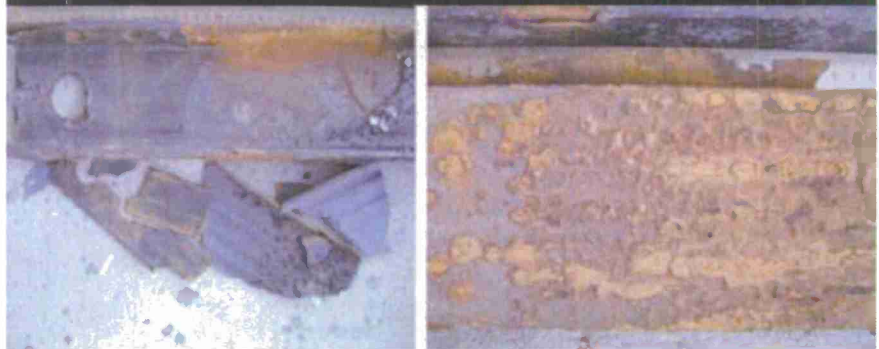
FIGURE 6

Coating 7 shown on the I-beams.
