# ESTCP Cost and Performance Report

(WP-200620)

## Cold Spray for Repair of Magnesium Components

November 2011

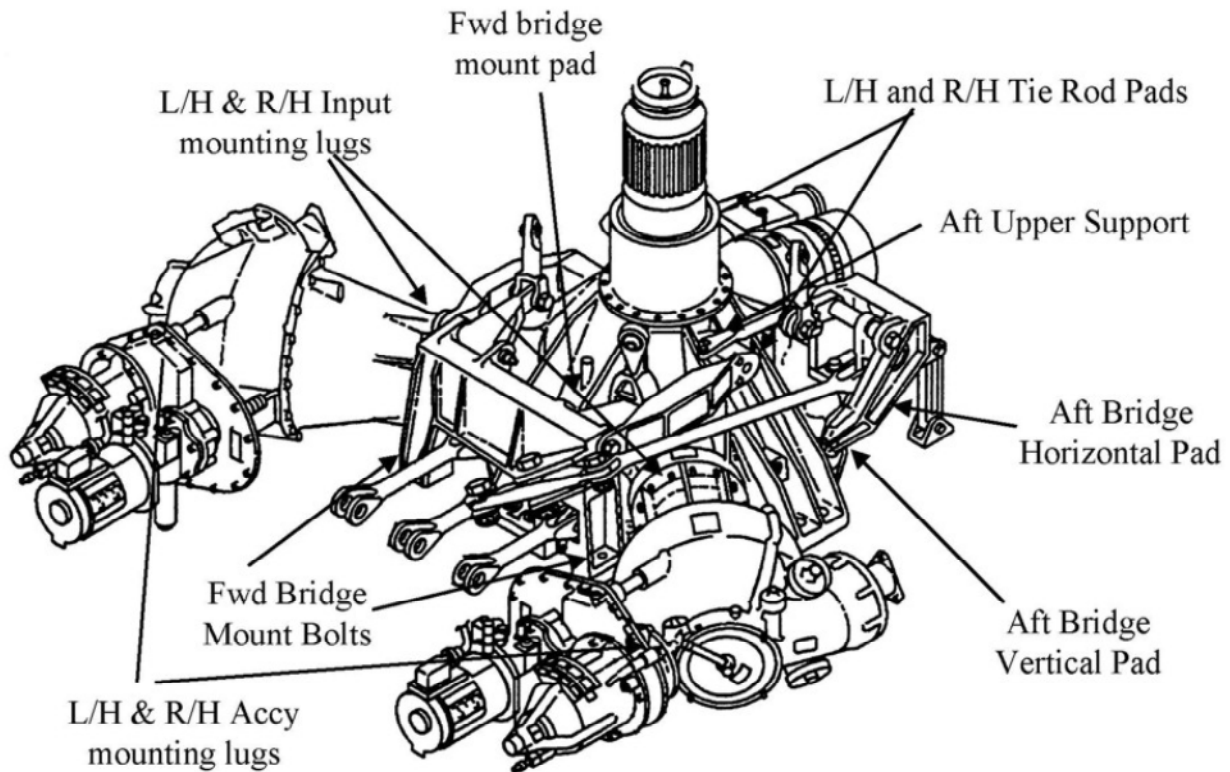
Figure 1 is a schematic of the main transmission housing for the H-60 helicopter showing the areas most susceptible to corrosion. Because of the localized nature of the corrosion, surface treatments intended to mitigate the problem would have to be applied only in these specific areas. A combination of galvanic and crevice corrosion is the primary corrosion mechanism for Mg alloy gearboxes. Water and salt spray tend to accumulate in the recessed holes around the bolts, and galvanic corrosion occurs between the cadmium (Cd)-plated bolt head and the surrounding Mg alloy, as well as between the shank of the bolt and the inner diameter (ID) of the hole. In addition, gearboxes usually have Cd-plated steel studs and bushings press fitted into them, and galvanic corrosion occurs around these areas (see Figures 2 and 3). In particular, Rosan inserts are frequently used to hold bushings, fittings, and threaded fasteners into housings (see Figure 4). These fittings are designed to be press fitted into the housing, where their teeth bite into the Mg alloy and create a high degree of plastic deformation. Any coating or surface treatment that is applied to the Mg at repair facilities must be able to withstand the insertion. When corrosion becomes excessive, material is removed and an Al shim is glued in place of the missing Mg alloy. This can be done up to a thickness of 0.100 inches. Obviously, these shims cannot carry load and thus lead to weakening of the structure.

**Figure 1. Schematic of an H-60 Main Transmission Housing showing areas most susceptible to corrosion.**

Most of the corrosion occurs at attachment points where a dissimilar metal is in contact with the coated Mg component. This includes flanges, mounting pads, tie rods, lugs and mounting bolts.

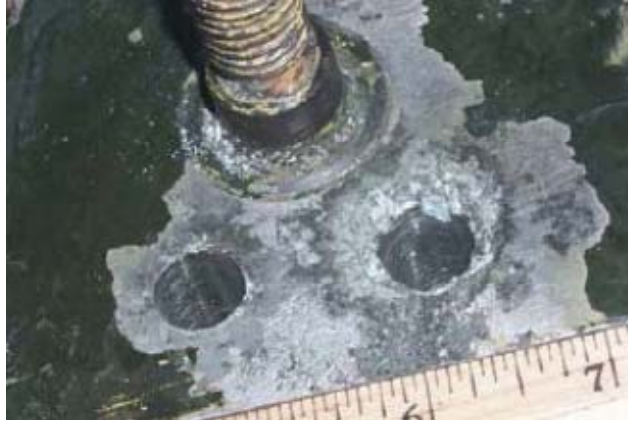
**Figure 2. Corrosion around a stud and hole on a helicopter Mg gearbox housing.**  
(Courtesy Robert Kestler, FRC-E)

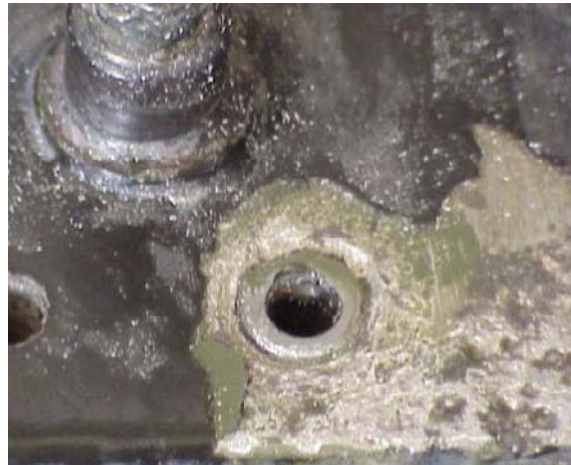
**Figure 3. Corrosion around an insert on a helicopter Mg gearbox housing.**  
(Courtesy Robert Kestler, FRC-E)

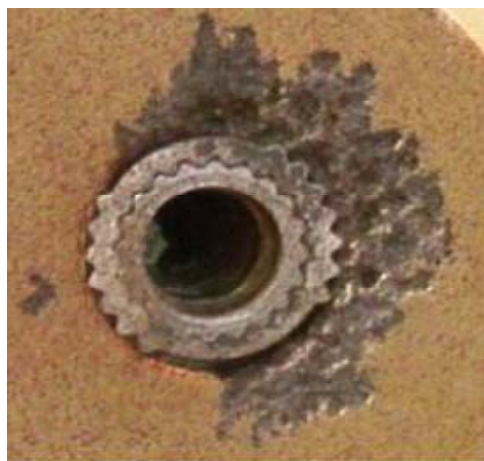
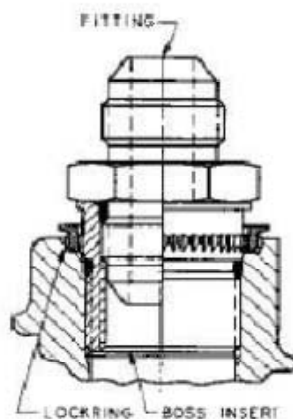
**Figure 4. Rosan insert: corrosion around insert on a helicopter Mg gearbox housing (left) and cross section of insert with fitting (right).**  
(Courtesy Robert Kestler, FRC-E)

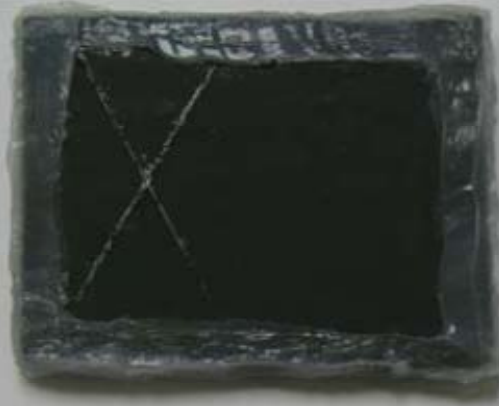
The scribing of the Stack-Up samples was conducted in two steps. Samples were first scribed through the Stack-Up to the Cold Spray surface. The specimens were then tested to 1000 hours of exposure in order to evaluate the Cold Spray coating compatibility with the Stack-Up. All samples reached the 1000 hours of exposure with no blistering or peeling of the Stack-Up. A second scribe was then made through the Stack-Up and the Cold Spray into the substrate. The samples were then retested in the chamber. This result showed that the galvanic corrosion is definitely a concern since all these specimens tested worse than Mg coated with just the Stack-Up. Figure 13 shows an EV31-T6 panel coated with CP-Al N<sub>2</sub> after testing the top coat and Cold Spray compatibility (a) and after testing with a scribe through to the substrate (b). The roughness around the scribing in (a) is attributed to initial poor curing of one of the Stack-Up layers. Subsequent low temperature bake-out improved the scribing. Frequent inspection intervals are suggested for the first sets of coatings implemented since the correlation between this laboratory test and real world performance is difficult to predict.

EV31-CP-Al-N2-8  
with Rockhard  
B117 Scribed to Coating  
1000 hrs

**Figure 13. An EV31-T6 panel coated with CP-Al N<sub>2</sub> after (a) testing the top coat-Cold Spray compatibility and (b) after testing with the scribing through to the substrate.**

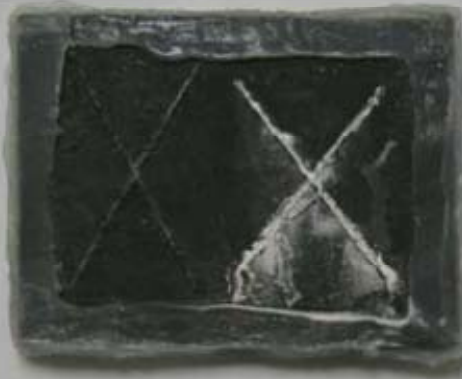
b

EV31-CP-Al-N2-8  
with Rockhard  
B117 Scribed to substrate  
Failed- 15 hrs

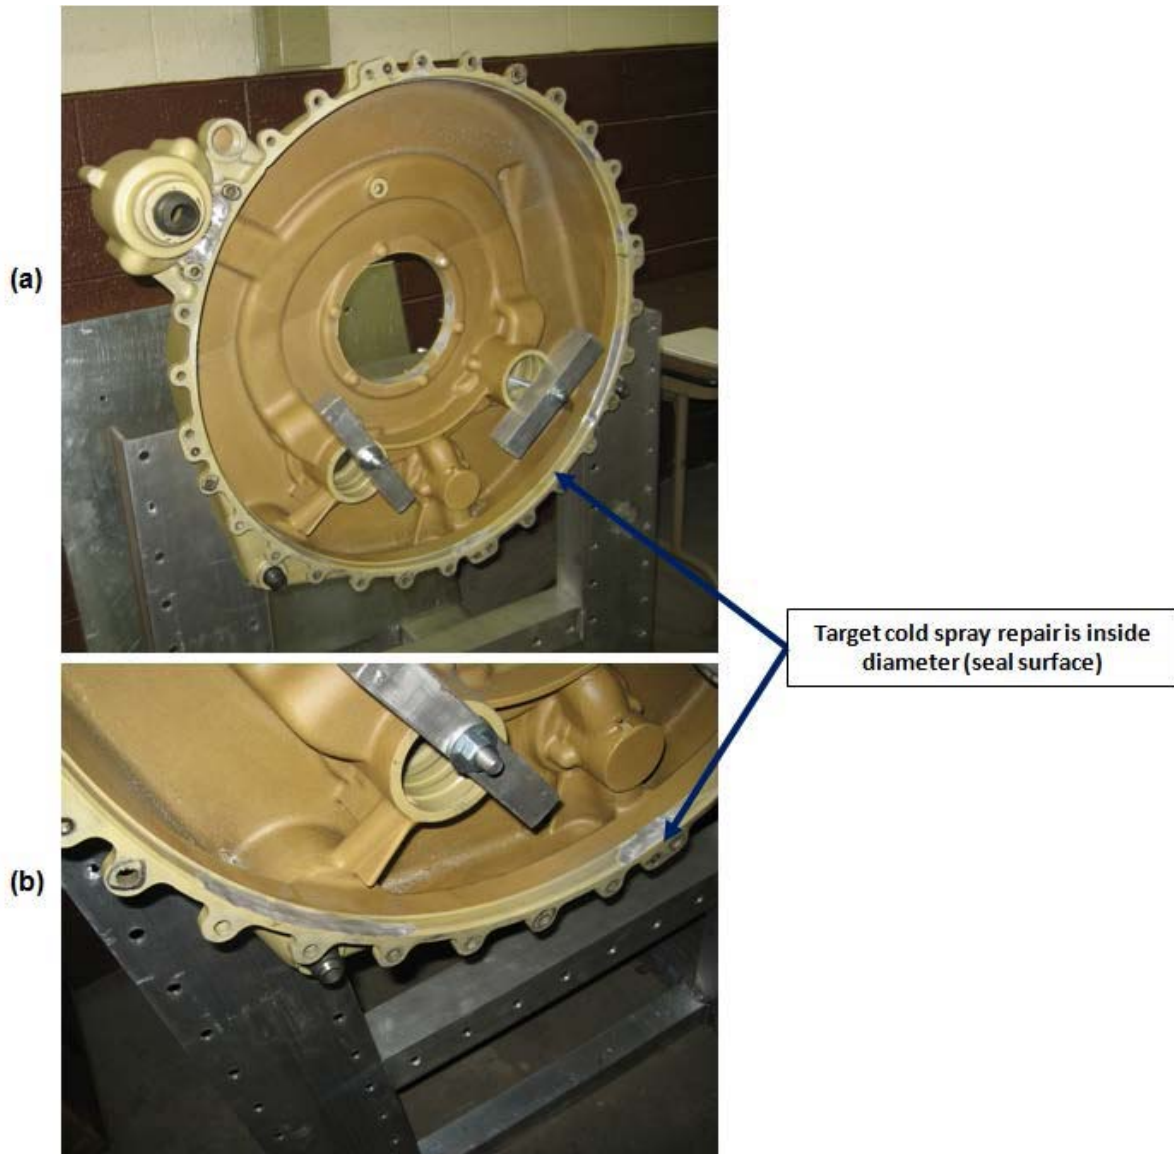
**Figure 14. SAC H-60 Sump (a) and detail of inside diameter showing simulated corrosion damage (b).**

The first Cold Spray application that SAC is considering implementing is the repair of corroded areas on the H-60 sump. Currently, SAC uses an HVOF Al-12Si repair technique, but this coating is limited in use due to both thickness and performance limitations. Figure 14 shows an H-60 sump and the corresponding repair area of interest. At SAC's request, ARL then transferred the coating process parameters to a potential Cold Spray subcontractor, ASB Industries in Akron OH, in order to start the full-scale repair qualification process required to implement this repair.

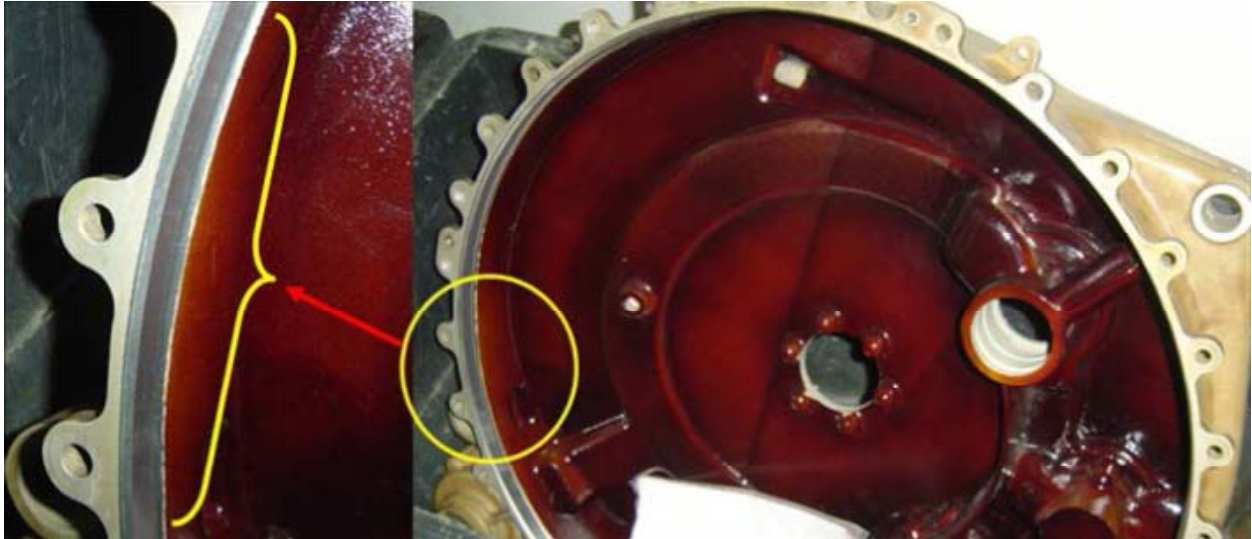
The H-60 Main Sump Gearbox (Figure 15) is currently repaired by SAC using an HVOF Al-12Si coating together with a bond coat. This method is not satisfactory as the HVOF coating tends to crack on insertion of Rosan fitting and does not reclaim the mechanical properties of the Mg alloy. It is expected that the use of Cold Spray coating will allow these gearboxes to be reclaimed, largely eliminating condemnations.

**Figure 15. Flange repair area of H-60 Main Sump Gearbox.**
