Periodic Inspections of Concrete-Armored Coastal Structures

by Robert R. Bottin, Jr.

PURPOSE: This Coastal and Hydraulic Engineering Technical Note (CHETN) provides information on the long-term structural performance of selected concrete-armored navigation structures to their environment. Inspections of coastal structures at Ofu Harbor, American Samoa; Nawiliwili, Laupahoehoe, and Kahului Harbors, HI; and Manasquan Inlet, NJ, are discussed herein. The response of stone-armored coastal structures to their environment was presented in ERDC/CHL CHETN-III-65.

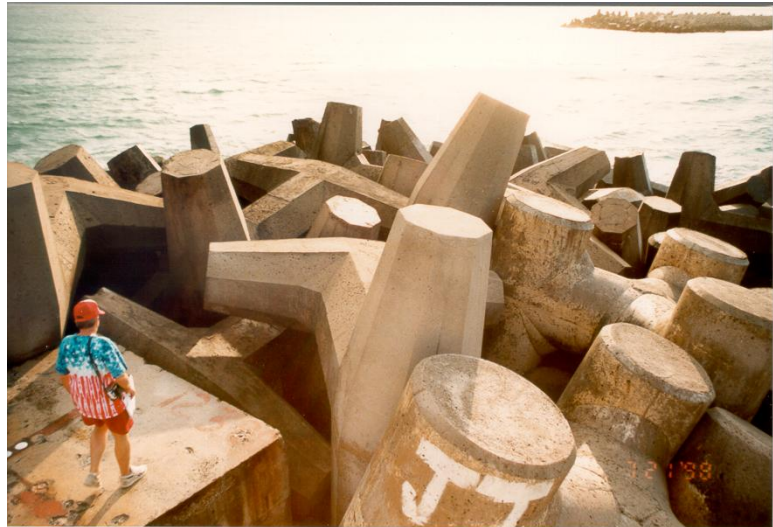
Figure 3. Head of Kahului west breakwater

During the initial photogrammetric survey of August 1993, selected armor units (5,443.10- and 27,215.54-kg (6- and 30-ton) dolos and 5,896.70-, 8,164.66-, 9,979.03-, and 31,751.47-kg (6.5-, 9-, 11-, and 35-ton) tribars) were targeted (three targets each) and precise positions of these units were obtained. Centroid data positions and orientations of the targeted armor units relative to the x, y, and z axes were obtained as well. Documentation of broken/cracked armor units by foot was not conducted as part of the periodic inspection in 1993.

The August 2001 photogrammetric survey indicated close agreement between positions of the concrete armor units relative to the 1993 survey for most of the targets. For the east breakwater, maximum movements of the targets established on the concrete armor units in the horizontal and vertical directions, respectively, were 0.94 m (3.1 ft) and 1.52 m (5.0 ft); however this level of difference occurred for only one target for the horizontal and one target in the vertical position. Both these targets were on units situated around the seaward head of the structure. The average movements of all horizontal and vertical targets on the east breakwater were 0.15 and 0.16 m (0.51 and 0.54 ft), respectively. Maximum movements of the targeted armor unit centroids on the east breakwater were 0.54 and 0.67 m (1.8 and 2.2 ft) in the horizontal and vertical directions, respectively, while average movements were 0.12 and 0.17 m (0.39 ft and 0.57 ft) in the horizontal and vertical directions. For the east breakwater, changes in the rotation angle of the armor units varied from 0.03 to 24.57 deg with an average of 3.09 deg. For the west breakwater, maximum movements of the targets in the horizontal and vertical directions were 0.13 and 0.11 m (3.8 and 1.9 ft), respectively; however, this level of difference occurred on only one armor unit. The average movements of all horizontal and vertical targets, respectively, were 0.11 and 0.06 m (0.42 and

0.36 ft). Maximum horizontal and vertical centroid movements, respectively, for the west breakwater were 0.64 and 0.18 m (2.1 and 0.6 ft), while average movements were 0.11 and 0.06 m (0.37 and 0.21 ft) in the horizontal and vertical directions. Changes in rotation angles varied from 0.0 to 17.32 deg for the west breakwater with an average of 2.02 deg. Even though some units had moved 0.91 to 1.5 m (3 to 5 ft) on the breakwaters, visual observations indicated they had not broken and continued to be functional. A broken armor unit survey conducted during August 2001 revealed 29 broken or cracked armor units above the waterline on the east breakwater and 58 on the west structure. Of the 29 broken units on the east breakwater, 19 were 5,443.10-kg (6-ton) dolosse, two were 8,164.66-kg (9-ton) tribars, four were 27,215.54-kg (30-ton) dolos, and four were 31,751.47-kg (35-ton) tribars. Of the 58 broken units on the west breakwater, four were 5,896.70-kg (6.5-ton) tribars, one was a 9,979.03-kg (11-ton) tribar, 16 were 17,236.51-kg (19-ton) tribars, 18 were 18,143.64-kg (20-ton) dolos, 11 were 27,215.54-kg (30-ton) dolos, five were 29,937.1-kg (33-ton) tetrapods, and three were 31,751.47-kg (35-ton) tribars. Concentrations of broken armor units were identified on various areas of the breakwaters. Considering the types of breaks for the 52 broken dolosse on both structures, 75 percent had shank-fluke breaks, 16 percent had fluke-shank breaks, 9 percent had mid-shank breaks. Of the dolos breaks recorded, 78 percent were straight and 22 percent were angled. Considering the types of breaks for the 35 tribars and tetrapods on the breakwaters, 89 percent included units with breaks through the center sections where one or more legs had separated, and 11 percent had just portions of a leg broken off the unit. These data establish a base from which to evaluate future breakage in subsequent surveys. Even though some breakage has occurred, the structures appeared to be in good condition overall.

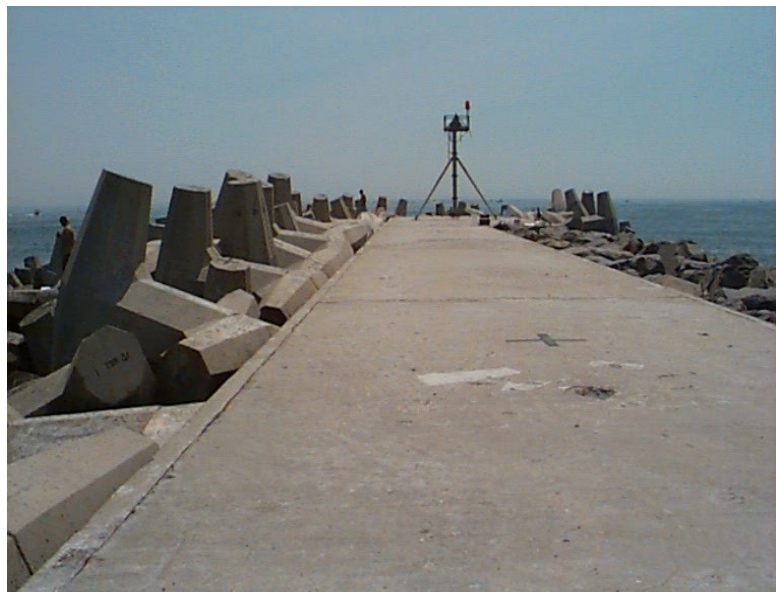
Figure 5. Manasquan north jetty

During the major rehabilitation of 1982, the outer 121.92 m (400 ft) of the north jetty (Figure 5) and 76.2 m (250 ft) of the south jetty were armored with 14,514.96-kg (16-ton) dolosse. The jetty crests were concrete caps with elevations of +4.26 m (+14 ft). Side slopes for the dolosse were 1V:2H. Additional repairs were conducted in 1997 that included the placement of 29 CORE-LOCs™ on the north jetty and 16 CORE-LOCs on the south structure. Also, some of the dolosse were repositioned to improve interlocking and allow space for the new CORE-LOCs. Several broken dolosse were removed. The CORE-LOCs used for the repairs were 17,236.51-kg (19-ton) units.

The May 1994 photogrammetric survey indicated that the targeted dolosse on the north and south jetties had been dynamic since the initial monitoring ended in 1984. Horizontal movement had ranged up to 2.01 m (6.6 ft) and vertical displacement (subsidence) as much as 1.62 m (5.3 ft). Dolos movement on the north jetty was slightly greater than those on the south. From 1984 to 1994 about 73 percent of the targeted units on the north jetty and 86 percent of the units on the south jetty had moved less than 0.3048 m (1 ft). Conversely, about 13 and 4 percent of the north and south jetty units, respectively, had moved distances greater than 0.91 m (3 ft). With regard to el changes between 1984 and 1994, 93 percent of the dolosse on the north jetty and 95 percent of those on the south structure had subsided. Between 1984 and 1994, the average movements of horizontal and vertical targets on the north jetty were 0.2743 m and 0.2438 m (0.9 ft and 0.8 ft), respectively; and on the south jetty the average movement was 0.1828 m (0.6 ft) both horizontally and vertically. The 1994 broken armor unit survey revealed 17 broken/cracked dolosse as opposed to five in 1984. Of the broken/cracked units, nine were located on the north jetty and eight were situated on the south structure. Pieces of the armor units were separated on 10 dolosse. Four dolosse were broken and being held together by rebar, and four had only hairline cracks. Considering the types of breaks, the majority (10 units) had shank-fluke breaks. There were five mid-shank breaks and two fluke-shank breaks. There were nine angled breaks and eight straight ones. Fifteen of the 17 units were

concentrated around the jetties' seaward heads. An area of concern was noted during the walking inspection at the tip of the south jetty where a broken unit had resulted in exposure of the core stone under the jetty cap. During the period October 1991 through March 1994, three major storm events (northeasters) occurred in the vicinity of Manasquan Inlet. These events probably significantly contributed to the armor unit movement and breakage at the heads of the jetties.

The August 1998 photogrammetric survey revealed significantly less dolos movement between 1994 and 1998 as detected during previous survey periods. Movement of dolos targets in the horizontal direction ranged from 0 to 0.55 m (0 to 1.8 ft), and vertical displacement ranged from 0 to 0.07 m (0 to 0.22 ft). Only three target positions on the north jetty moved over 0.15 m (0.5 ft) in the horizontal direction, and all other targets on the north structure moved 0.08 m (0.25 ft) or less. On the south jetty, all targets moved 0.06 m (0.21 ft), or less, horizontally. In the vertical direction, target movement did not exceed 0.07 m (0.22 ft) on the north jetty and 0.06 m (0.21 ft) on the south structure. Between 1994 and 1998, the average movements of the targets on the north jetty were 0.05 and 0.03 m (0.15 and 0.09 ft) in the horizontal and vertical directions, respectively. On the south jetty, the average movements of the targets in the horizontal and vertical directions, were 0.02 and 0.03 m (0.07 and 0.09 ft), respectively. During the previous surveys, the more significant movement occurred around the heads of the jetties. During this period (1997), however, the jetty heads were rehabilitated with CORE-LOCs. Some dolosse were covered and/or repositioned during this process. Therefore, no correlation in movement could be made for armor units in areas where the more significant movement had occurred previously. During the November 1998 broken armor unit survey, eight broken/cracked dolos armor units were observed. Four broken units were observed on each structure. Of the eight broken armor units observed, six were identified in the previous 1994 survey, and two were new breaks. As stated earlier, 17 broken units were observed in 1994. During the 1997 CORE-LOC rehabilitation, however, several broken dolosse were removed from the heads of the structures. Records indicate that several northeasters occurred between 1994 and 1998. During the 1998 periodic inspection, initial base data were obtained for the CORE-LOC armor units installed on the heads of the jetties. These data will establish a base from which to evaluate the effectiveness and analyze the performance of the CORE-LOCs in subsequent inspections.
