**ALTERNATIVE FUELS COMPATIBILITY WITH
ARMY EQUIPMENT TESTING – AGED NIEDNER
RIFTS CONDUIT TESTING**

**INTERIM REPORT
TFLRF No. 426**

**by
Oliver P. Harrison
Southwest Research Institute[®]
Structural Engineering Department**

**Contract No. W56HZV-09-C-0100 (WD15-Task 5)
SwRI® Project No. 08.14734.15.501**

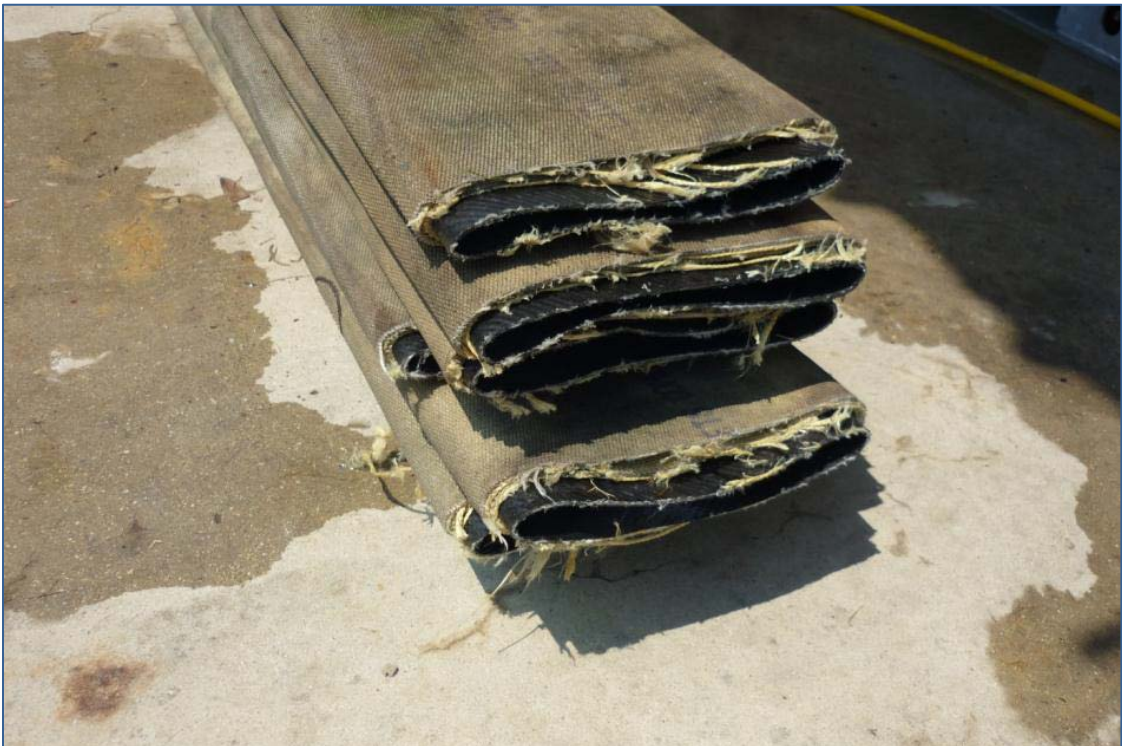
Figure 6. Liner Expansion after Cutting Specimens

The eight specimens cut from the hose reel were measured and inspected for damage. When measuring the specimens approximately 3 hours after the specimens had been cut, it was noted that the outer jacket and the inner liner were no longer even. For this reason, measurements of both the jacket and liner were recorded for each specimen. These measurements are provided below in Table 1, along with notes of any damage present. It would appear, based on the original cut length of 15 feet, that the liners expanded. Figure 5 shows the specimens just after inspection. Figure 6 shows the ends of the stacked specimens, where the difference in length of the jackets and liners is clearly visible.

- Further documentation of the liner expansion was made. The liner was found to expand immediately after cutting, and expanded a total of three inches per a 15-foot specimen over a period of 48-hours. The majority of this expansion occurred within six hours after cutting.
- As with any experimental data, testing of more specimens would provide more extensive data and a more accurate representation of the performance of the aged Niedner RIFTS conduit. Also, the liner expansion could be investigated further to determine the relationship, if any, between the hose length and the amount of liner expansion.

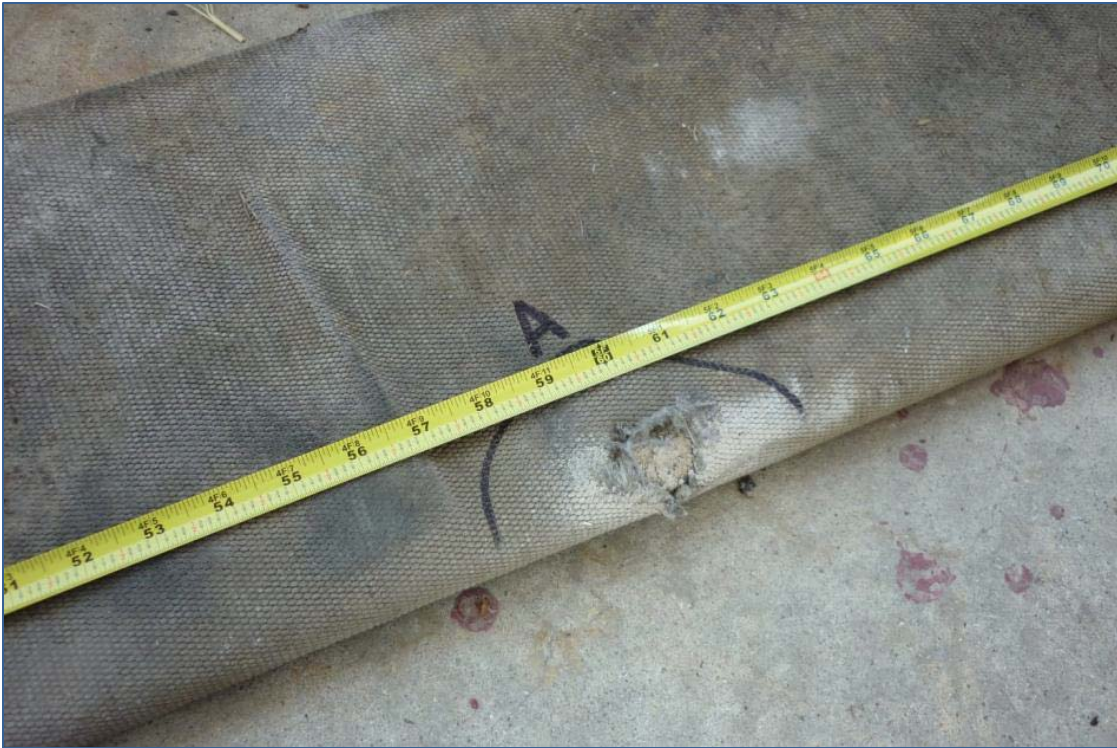
Figure 7. Hole in Outer Layer of Jacket of Specimen A

The condition of all of the cut specimens was soiled but otherwise good, with the exception of specimens A and C. There was a small hole in the outer layer of the jacket of specimen A as shown in Figure 7. This was located 60 inches from one end of specimen A. The damage to specimen C was a less significant abrasion to the outer layer of the jacket located 9 inches from one end, shown in Figure 8. Neither of the anomalies were considered to be major damage that would exclude the specimens from testing; therefore, no actions were taken to repair or remove the damage. The notes from the specimen preparation and inspection are presented in Appendix A.

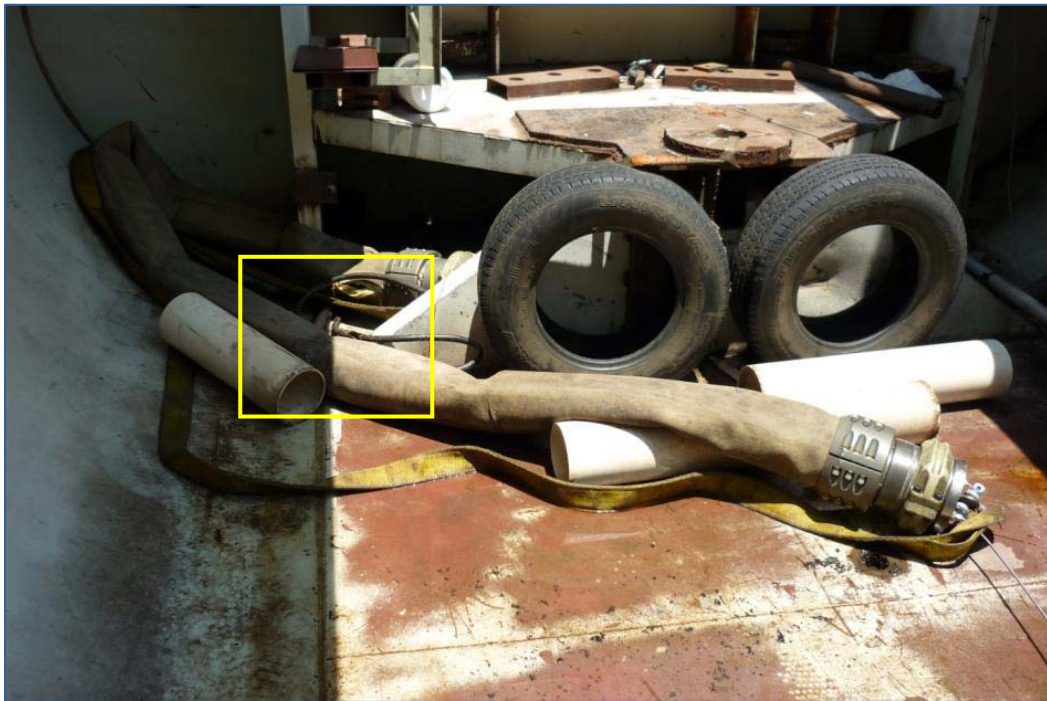
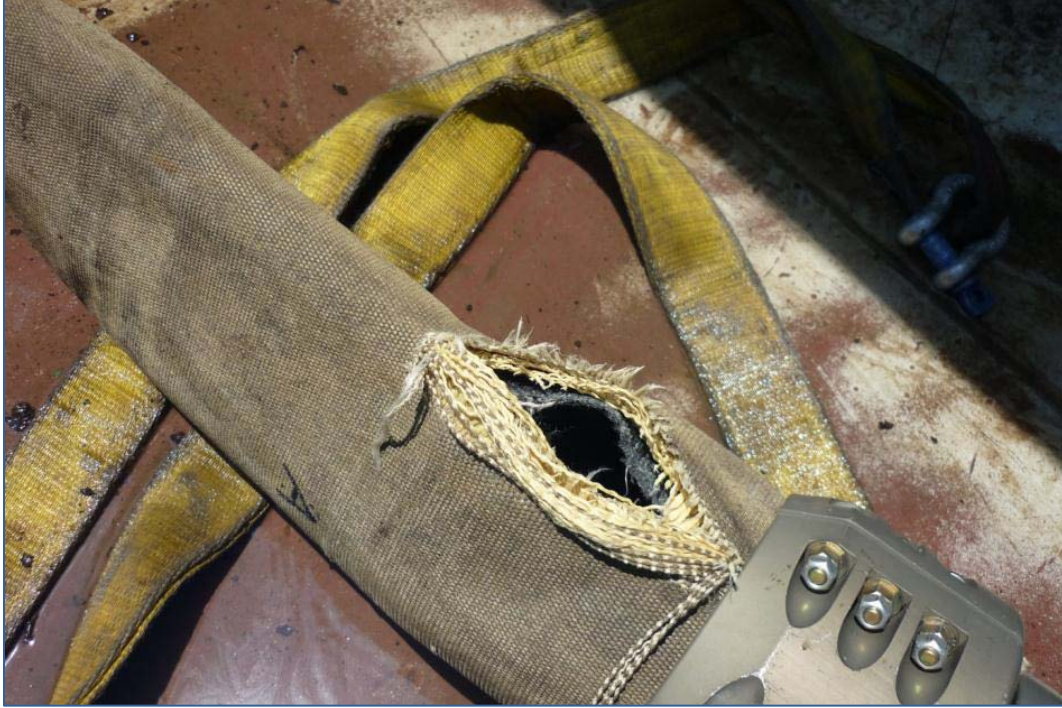
Figure 14. Specimen A Burst Testing Failure

Figure 15. Specimen A Burst Testing Failure Close-Up

Conduit Test Sample Number: <u>A</u>	Date: <u>6/9/2011 1:40 PM</u>
Date of Manufacture: <u>07-2005</u>	
Prerequisite:	
Visual Inspection Notes: <u>end fittings torqued to 45 ft-lbs.</u> <u>see preparation notes</u>	
Calibration Information:	
Pressure Transducer: <u>Omega PX329-5K65V</u>	Temperature at Test Time:
Mod# S/N: <u>060908 D330</u>	End 1: <u>94.3 °F west</u>
Cal Date: <u>6/8/2011</u>	Ambient: <u>93 °F</u>
Cal Due Date: <u>12/8/2011</u>	End 2: <u>94.1 °F east</u>
Hydrostatic Burst Test	
Conduit Length (LOA): <u>182 1/2</u> (in)	Length between Shank Ends: <u>171 7/8</u> (in)
Peak Pressure (psig): <u>1504</u> psig	Failure Mode: <u>longitudinal tear near</u>
Data Filename: <u>"BurstA"</u>	Video Record (Circle) <u>(Yes)</u> No <u>end fitting</u>
Video Tape ID # <u>"BurstA"</u>	
Test Notes/Observations:	
<u>tear at base of end fitting</u> <u>failure occurred on crease along length of hose</u> <u>approximate measurements</u> <u>* camera cable was separated when conduit failed, need to secure cable to walls of tank</u> <u>7" tear</u> <u>west</u> <u>east</u>

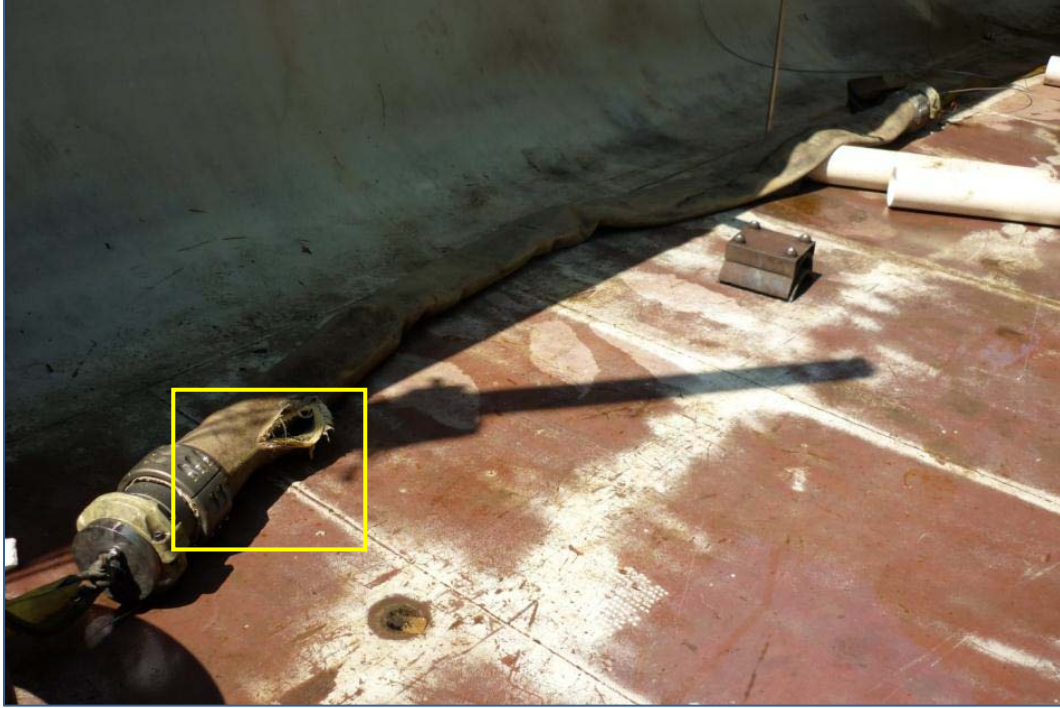
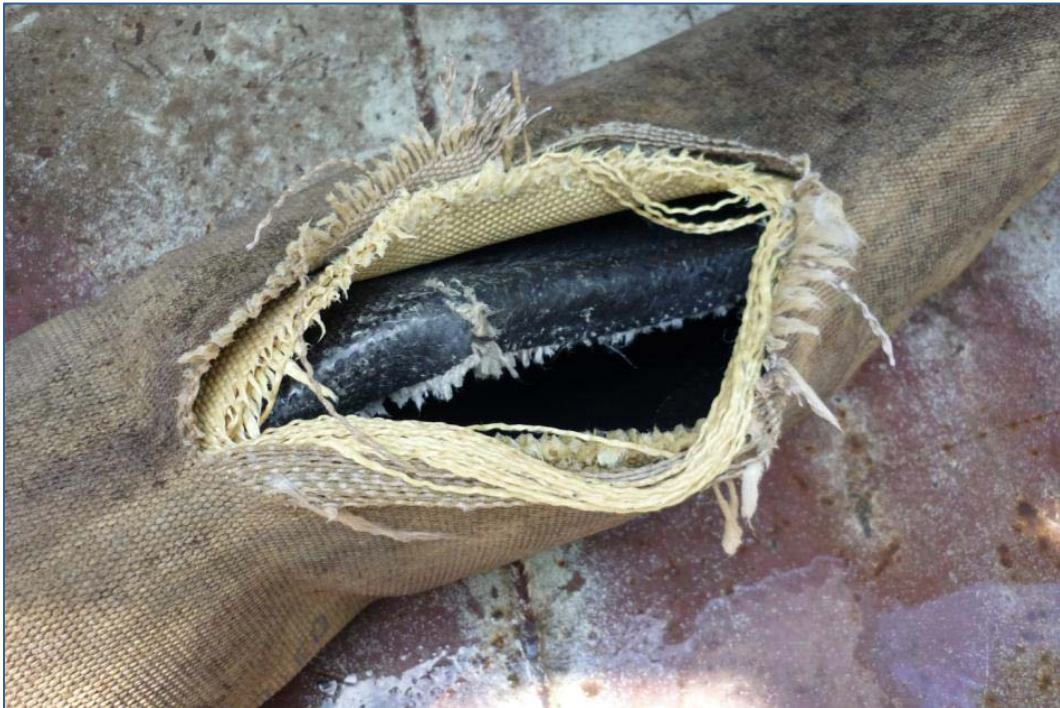
Figure 19. Specimen C Burst Testing Failure

Figure 20. Specimen C Burst Testing Failure Close-Up

Conduit Test Sample Number: <u>C</u>	Date: <u>6/10/2011 11:00 AM</u>
Date of Manufacture: <u>07-2005</u>	
Prerequisite: Visual Inspection Notes: <u>end fittings torqued to 40 ft-lbs</u> <u>see preparation notes</u>	
Calibration Information:	
Pressure Transducer: <u>Omega PX309-5K65V</u> Mod# S/N: <u>060809D330</u> Cal Date: <u>6/8/2011</u> Cal Due Date: <u>12/8/2011</u>	Temperature at Test Time: End 1: <u>81.4 °F west</u> Ambient: <u>87.5 °F</u> End 2: <u>82.7 °F east</u>
Hydrostatic Burst Test	
Conduit Length (LOA): <u>181 1/2</u> (in)	Length between Shank Ends: <u>171 3/8</u> (in)
Peak Pressure (psig): <u>1886 psig</u>	Failure Mode: <u>longitudinal tear on crease</u>
Data Filename: <u>"Burst C"</u>	Video Record (Circle): <u>Yes</u> No
Video Tape ID # <u>"Burst C"</u>	
Test Notes/Observations: <u>approximate measurements</u> <u>Same type of failure as "A" and "B"</u> <u>pressurization rate ~1200 psi/min (one more small reduction for 10" tear next test)</u>

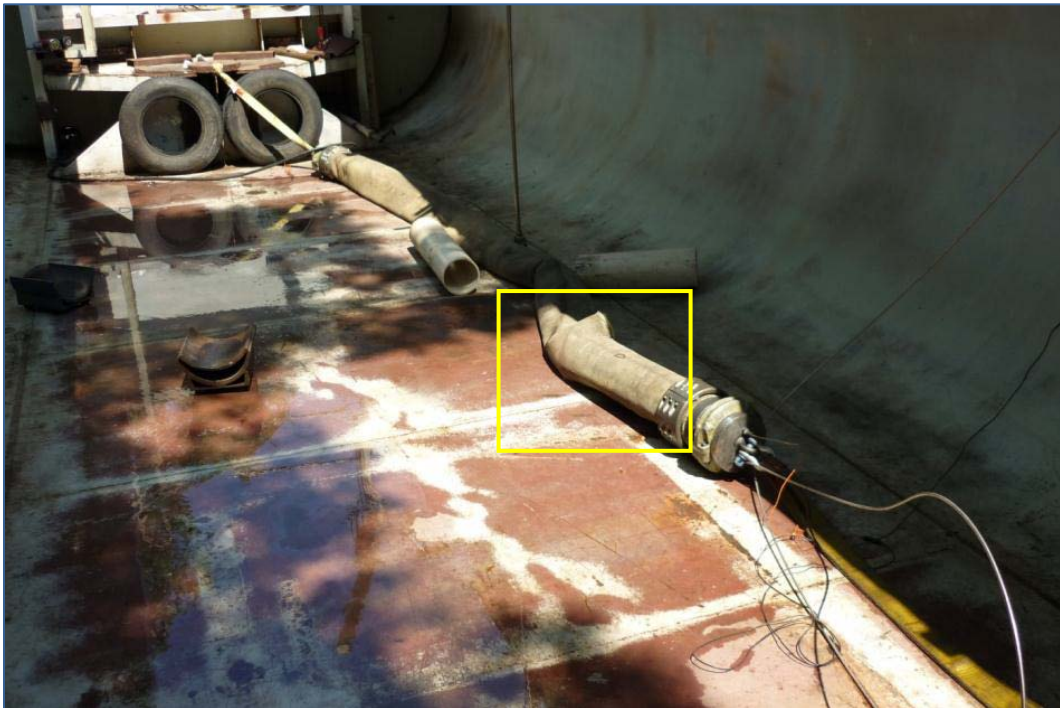
Figure 22. Specimen D Burst Testing Failure

Figure 23. Specimen D Burst Testing Failure Close-Up

Conduit Test Sample Number: <u>D</u>	Date: <u>6/10/2011 3:20 AM</u>
Date of Manufacture: <u>07-2005</u>	
Prerequisite:	
Visual Inspection Notes: <u>end fittings torqued to 40 ft-lbs</u> <u>see preparation notes</u>	
Calibration Information:	
Pressure Transducer: <u>Omega PX309-5KG-5V</u>	Temperature at Test Time:
Mod# S/N: <u>0608090330</u>	End 1: <u>85.5°F west</u>
Cal Date: <u>6/8/2011</u>	Ambient: <u>97.8°F</u>
Cal Due Date: <u>12/8/2011</u>	End 2: <u>85.7°F east</u>
Hydrostatic Burst Test	
Conduit Length (LOA): <u>181 1/2</u> (in)	Length between Shank Ends: <u>171 1/4</u> (in)
Peak Pressure (psig): <u>1767</u> psig	Failure Mode: <u>longitudinal tear on crease</u>
Data Filename: <u>"Burst D"</u>	Video Record (Circle): <u>Yes</u> / No
Video Tape ID # <u>"Burst D"</u>	
Test Notes/Observations:	
<p><u>approximate measurements</u> <u>pressurization rate</u> <u>1100 psi/min</u> (good)</p> <p><u>same type of failure as before</u></p> <p><u>10" tear</u></p> <p>west ← <u>33"</u> → east</p>

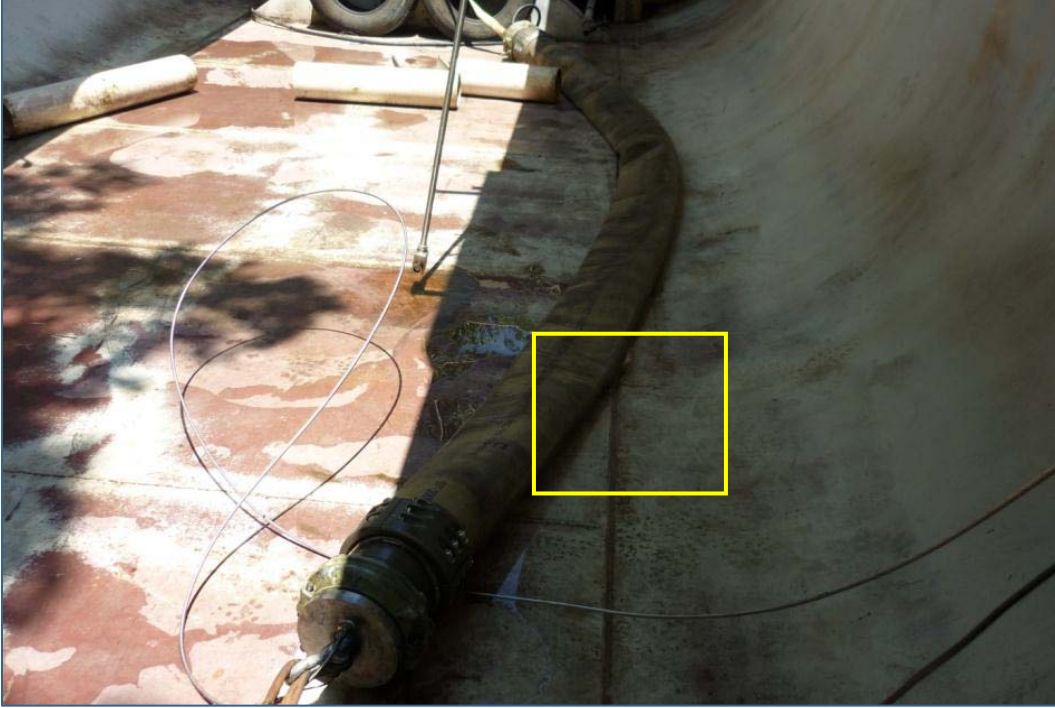
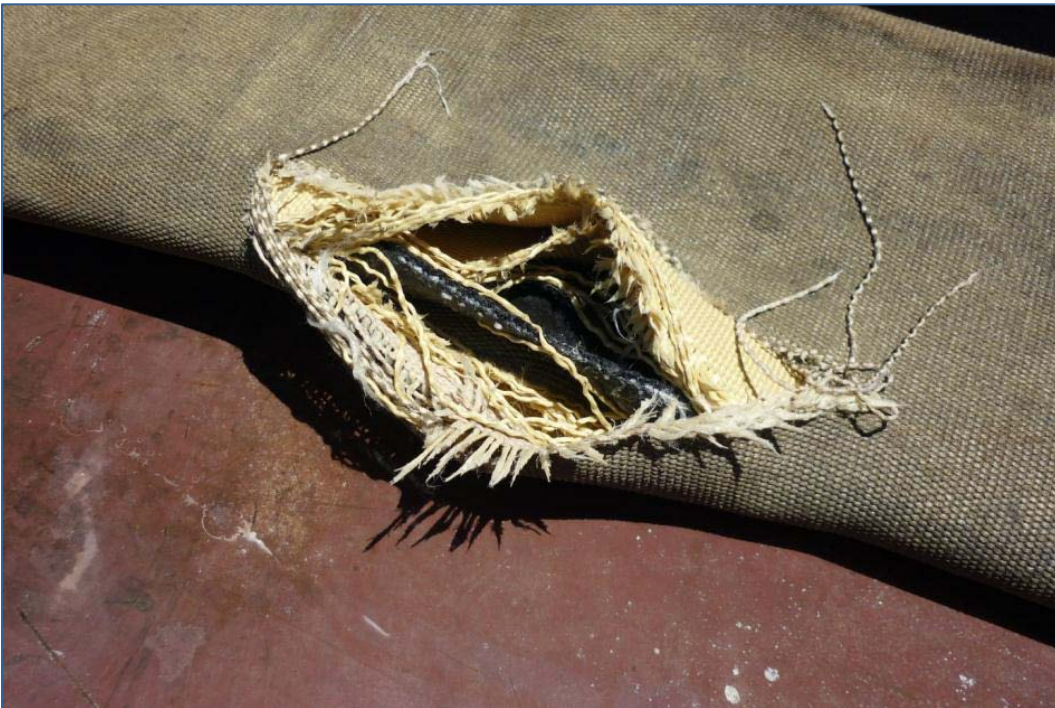
Figure 25. Specimen E Burst Testing Failure

Figure 26. Specimen E Burst Testing Failure Close-Up

Conduit Test Sample Number: E	Date: 6/13/2011 2:30 PM
Date of Manufacture: 07-2005	
Prerequisite Visual Inspection Notes: end fittings torqued to 40 ft. lbs. see preparation notes specimen stretched due to pressure cycling; stretched fibers noted on west end at edge of bending section (see photos)	
Calibration Information Pressure Transducer: Omega PX329-5KG-5V Temperature at Test Time: Mod# S/N: 0608090330 End 1: 94.1°F west Cal Date: 6/8/2011 Ambient: 99.6°F Cal Due Date: 12/8/2011 End 2: 95.7°F east	
Hydrostatic Burst Test Conduit Length (LOA): 186 1/16 (in) Length between Shank Ends: 175 15/16 (in) Peak Pressure (psig): 1324 psig Failure Mode: longitudinal tear on crease Data Filename: "Burst E" Video Record (Circle): Yes / No Video Tape ID # "Burst E"	
Test Notes/Observations similar failures as before occurred in bending section 8" tear approximate measurements did <u>not</u> occur at stretched fibers noted after pressure cycles pressurization rate: ~1300 psi/min (reduce slightly before next test)

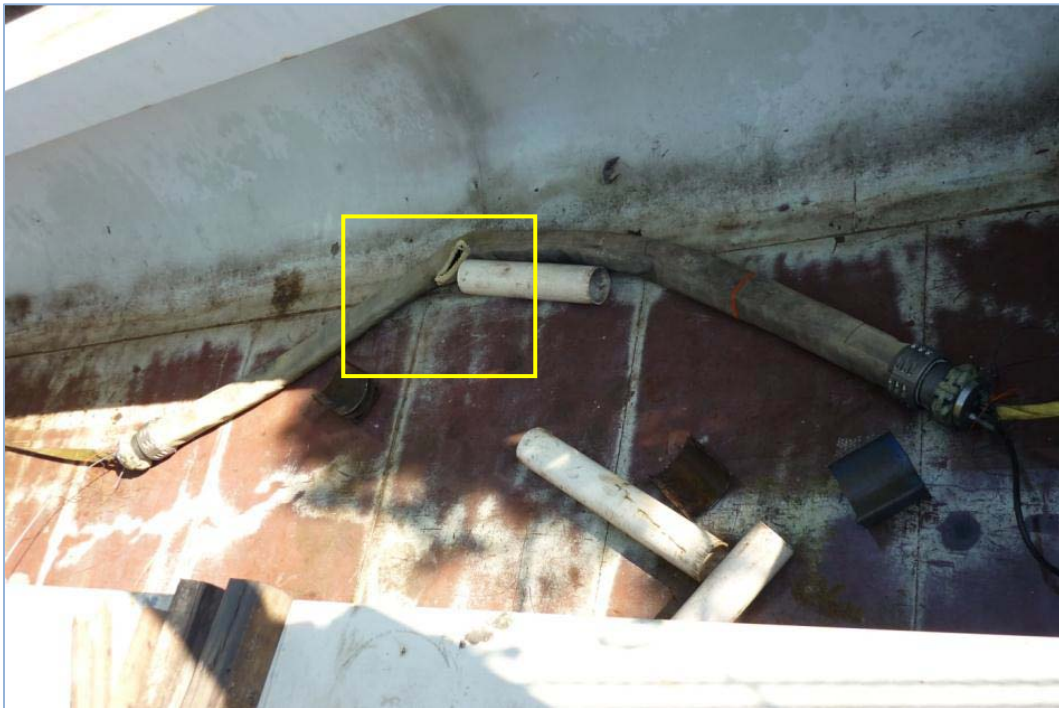
Figure 28. Specimen F Burst Testing Failure

Figure 29. Specimen F Burst Testing Failure Close-Up

Conduit Test Sample Number: F	Date: 6/14/2011 9:22 AM
Date of Manufacture: 07-2005	
Prerequisite	
Visual Inspection Notes: end fittings torqued to 40 ft-lbs. See preparation notes specimen stretched some due to pressure cycles; no damage to fibers was noted	
Calibration Information	
Pressure Transducer: Omega PX329-5K65V	Temperature at Test Time:
Mod# S/N: 0608090330	End 1: 81.9°F west
Cal Date: 6/8/2011	Ambient: 89.8°F
Cal Due Date: 12/8/2011	End 2: 83°F east
Hydrostatic Burst Test	
Conduit Length (LOA): 184 1/2 (in)	Length between Shank Ends: 174 1/4 (in)
Peak Pressure (psig): 1712 psig	Failure Mode: longitudinal tear on crease
Data Filename: "Burst F"	Video Record (Circle): Yes / No
Video Tape ID #: "Burst F"	
Test Notes/Observations	
approximate measurements pressurization rate similar failure as all others; ~ 1000 psi/min did not occur in bending section	
Conduit Section - Indicate Burst Location	
Testing Personnel:

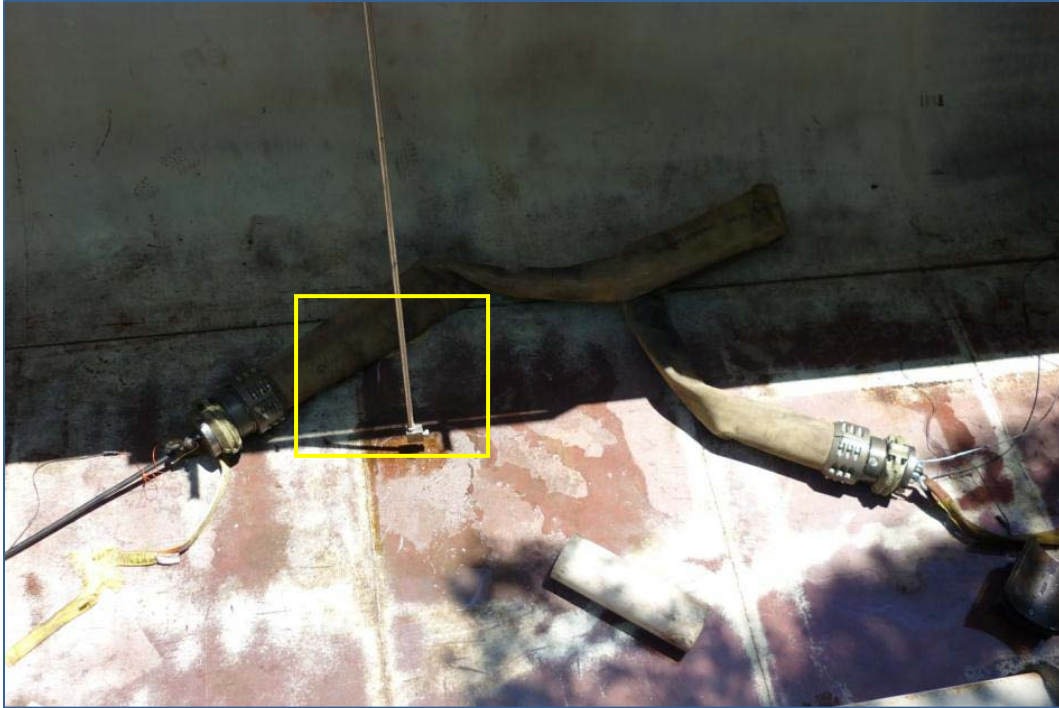
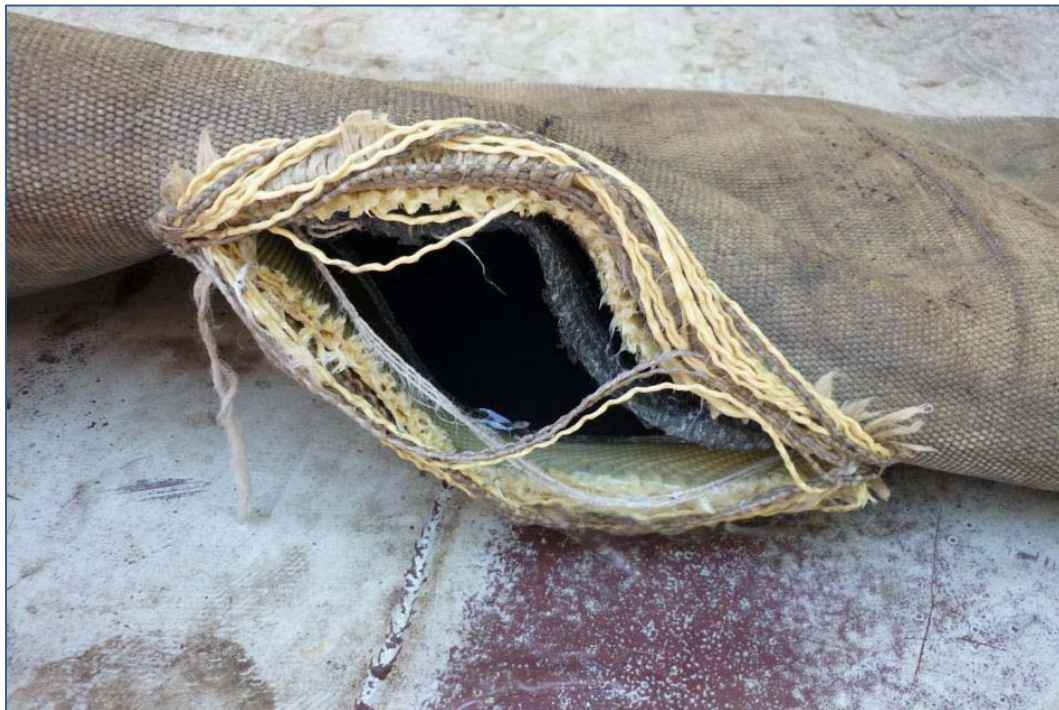
Figure 31. Specimen G Burst Testing Failure

Figure 32. Specimen G Burst Testing Failure Close-Up

Conduit Test Sample Number: <u>G</u>	Date: <u>6/14/2011</u> <u>2:08 PM</u>
Date of Manufacture: <u>07-2005</u>	
Prerequisite	
Visual Inspection Notes: <u>end fittings torqued to 40 ft-lbs.</u> <u>see preparation notes</u> <u>Similar stretching of specimen due to pressure cycles; no damage noted</u>	
Calibration Information	
Pressure Transducer: <u>Omega PX329-5KG5V</u>	Temperature at Test Time:
Mod# S/N: <u>060809D330</u>	End 1: <u>91.8°F west</u>
Cal Date: <u>6/8/2011</u>	Ambient: <u>100°F</u>
Cal Due Date: <u>12/8/2011</u>	End 2: <u>95.2°F east</u>
Hydrostatic Burst Test	
Conduit Length (LOA): <u>184 3/4</u> (in)	Length between Shank Ends: <u>174 5/8</u> (in)
Peak Pressure (psig): <u>1680</u> psig	Failure Mode: <u>longitudinal tear in crease</u>
Data Filename: <u>"Burst G"</u>	Video Record (Circle) <u>Yes</u> No
Video Tape ID # <u>"Burst G"</u>	
Test Notes/Observations	
<u>approximate measurements</u> <u>similar failure as all others occurred in bending section</u> <u>east tether broke upon failure</u> <u>10" tear</u> <u>pressurization rate ~ 1300 psi/min (valve position was not changed, though)</u>

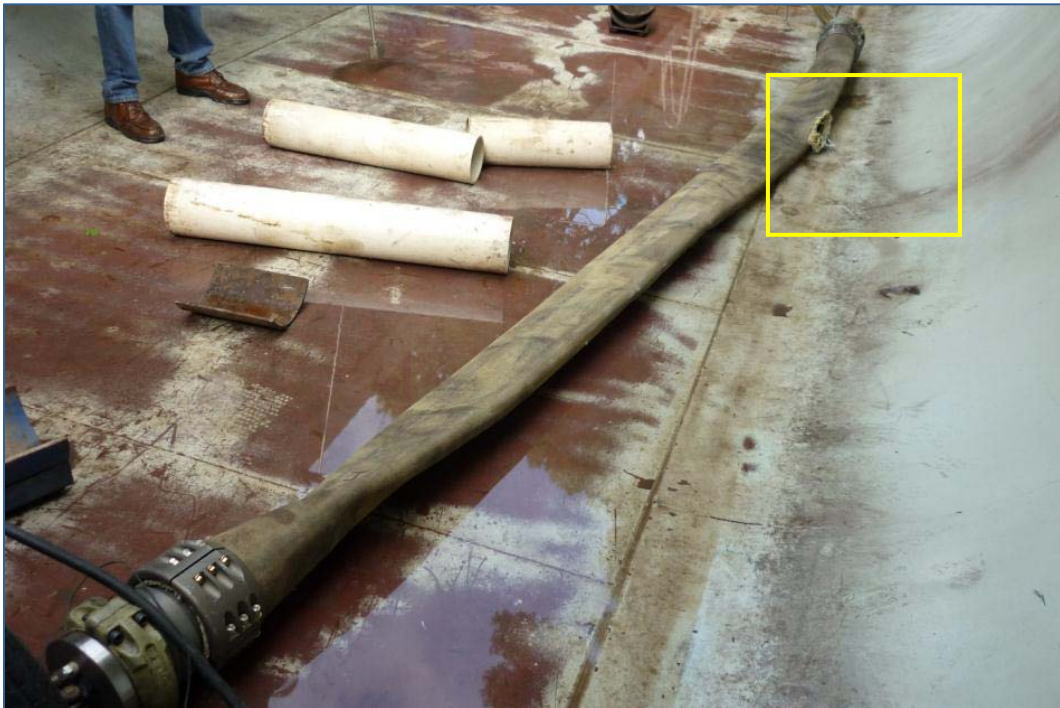
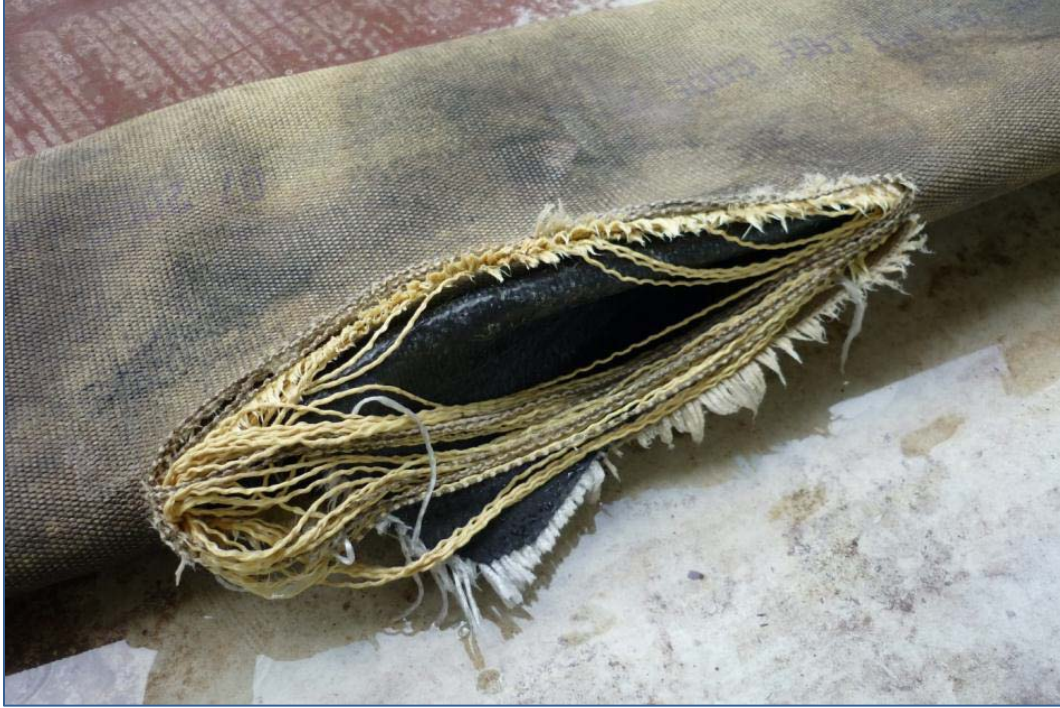
Figure 34. Specimen H Burst Testing Failure

Figure 35. Specimen H Burst Testing Failure Close-Up

Conduit Test Sample Number: <u>H</u>	Date: <u>6/15/2011 9:32 Am</u>
Date of Manufacture: <u>07-2005</u>	
Prerequisite Visual Inspection Notes: <u>end fittings torqued to 40 ft-lbs.</u> <u>see preparation notes</u> <u>same stretching of the specimen as before due to pressure cycles</u> <u>no damage noted</u>	
Calibration Information Pressure Transducer: <u>Omega PX329-5KG5V</u> Temperature at Test Time: Mod# S/N: <u>0608091330</u> End 1: <u>82.5°F west</u> Cal Date: <u>6/8/2011</u> Ambient: 82.5°F <u>84.4°F</u> Cal Due Date: <u>12/8/2011</u> End 2: <u>83.8°F east</u>	
Hydrostatic Burst Test Conduit Length (LOA): <u>187</u> (in) Length between Shank Ends: <u>176 1/2</u> (in) Peak Pressure (psig): <u>1534</u> Failure Mode: <u>longitudinal tear on crease,</u> Data Filename: <u>"Burst H"</u> Video Record (Circle) <u>Yes/No</u> Video Tape ID # <u>"Burst H"</u> <u>but bladder tear was different; it seemed to blow-out of the tear in the jacket</u>

Test Notes/Observations <u>approximate measurements</u> <u>pressurization rate ~ 1000 psi/min</u> <u>13" tear and bladder blow-out</u> <u>Failure occurred in bending section</u> <div style="text-align: center;">

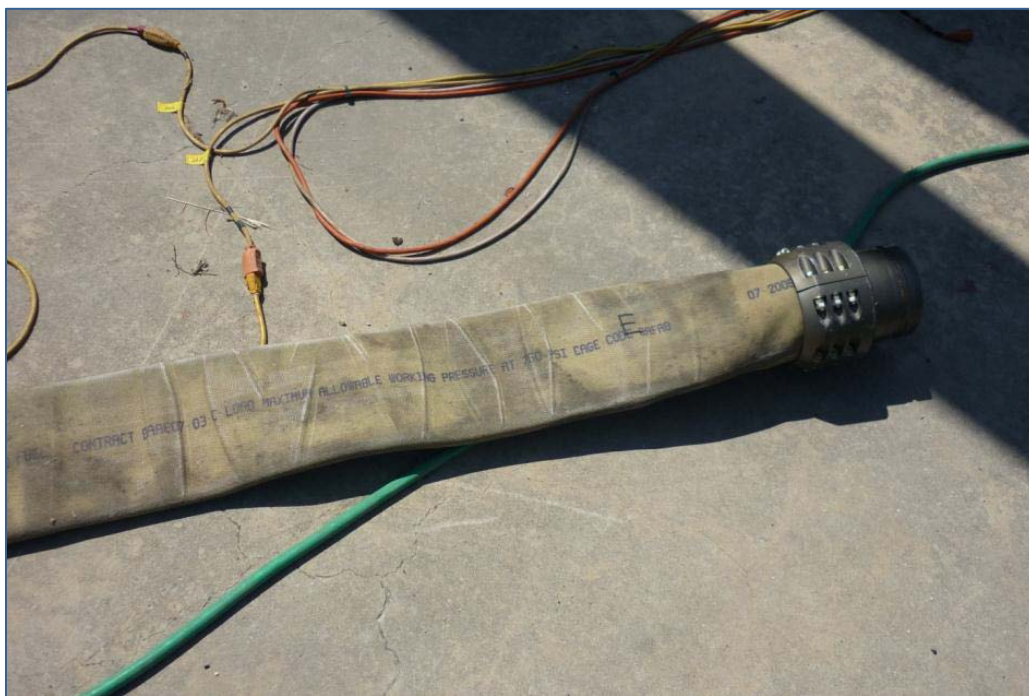
Figure 38. Creases Caused by Bending Cycles

Specimens E, F, G, and H underwent bending and pressurization cyclic testing without sustaining any considerable damage or failures; however, some effects were noted as a result of the testing. The bending cycles introduced additional creases on the specimens caused by the small (3-inch) roller, and three of these specimens failed in this region when burst. This effect is shown below in Figure 38. The pressurization cycles brought about a notable change in length for each specimen. These results are presented in Table 6. As with the previous measurements, these lengths are of the conduit (as if the end fittings were not there) pressurized to approximately 60 psig. The data sheets from the cyclic testing are provided in Appendix C.

- Specimens E, F, G, and H were subjected to cyclic testing involving 100 bending cycles and 20 pressurization cycles each. The working pressure of 550 psig was used for the pressurization cycles. Minor wear was noted due to the bending cycles, and the pressurization cycles resulted in the conduit stretching approximately 2" to 4". Three of the specimens failed in the worn region caused by the bending cycles when burst.

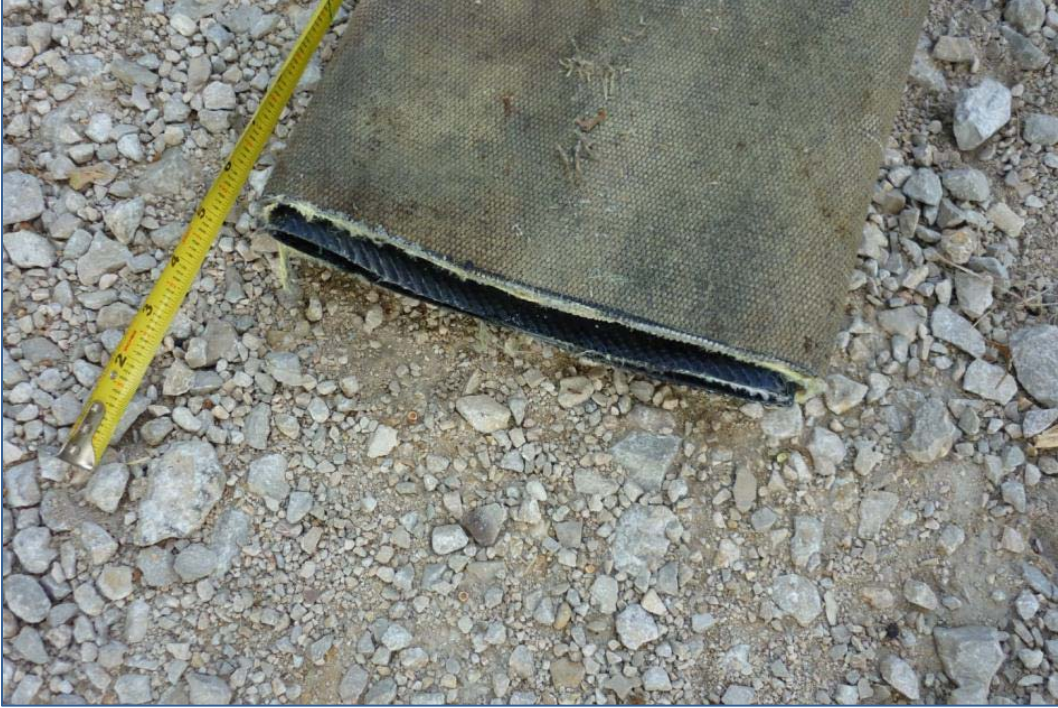
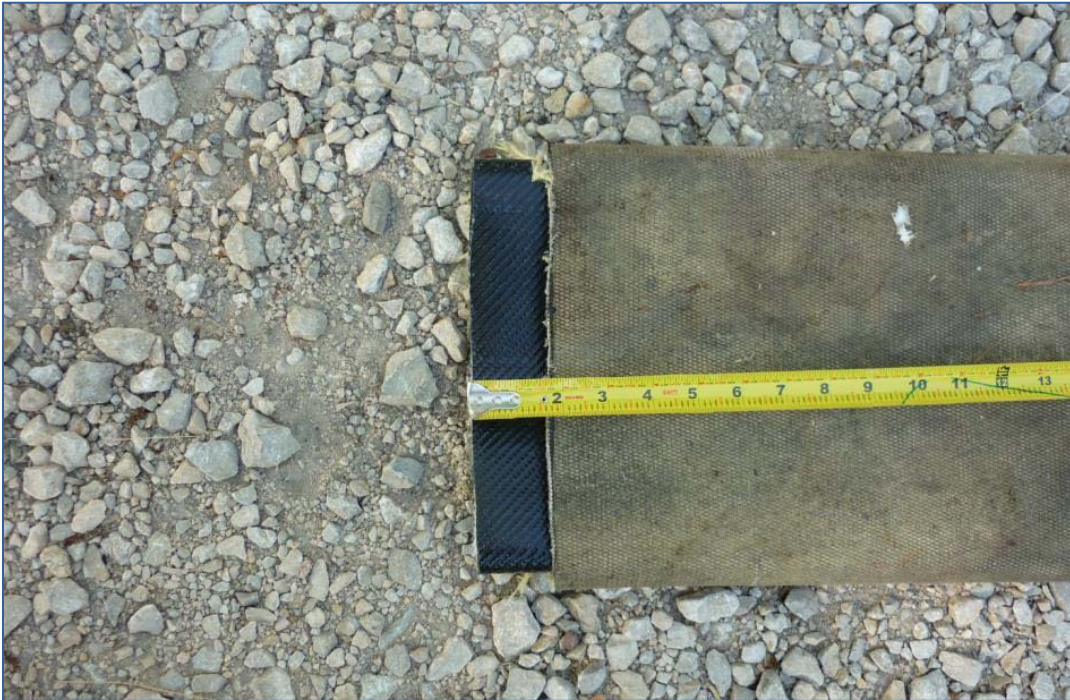
Additional information was requested by TARDEC regarding the apparent expansion of the conduit liner observed during extraction and inspection of the specimens. A ninth specimen, labeled I, was extracted from the same hose reel as the first eight samples. Because the liner had already expanded on the end of the hose reel, the first 15-foot length was cut off as scrap and then Specimen I, approximately 15 feet long, was cut. Immediately after extracting Specimen I, the jacket and liner lengths were measured. Note that the liner had already expanded approximately one inch. These measurements were repeated six times at the intervals noted in Table 7. Over a period of 48-hours from the time of extraction, the liner expanded a total of 3 inches, with the majority of this expansion occurring in the first six hours. Specimen I, just after cutting and then after 48 hours, is shown below in Figure 47 and Figure 48, respectively. Notes from this investigation are presented in Appendix E.

Figure 47. Specimen I, Immediately after Extraction

Figure 48. Specimen I, 48 Hours after Extraction
