# Regional Sediment Management (RSM) Principles in Flood Recovery: Incorporating RSM after the 2011 Missouri River Flood

by Paul M. Boyd

**PURPOSE.** This Coastal and Hydraulics Engineering Technical Note (CHETN) summarizes actions undertaken during 2011 and 2012 to incorporate US Army Corps of Engineers (USACE) Regional Sediment Management (RSM) principles into a wide variety of projects as part of flood recovery and reconstruction on the Missouri River. Significant damage was caused by the 2011 Missouri River flood, and mitigation of sediment impacts and repair of infrastructure were given a high priority in an effort to return the flood protection system to acceptable flood protection levels.

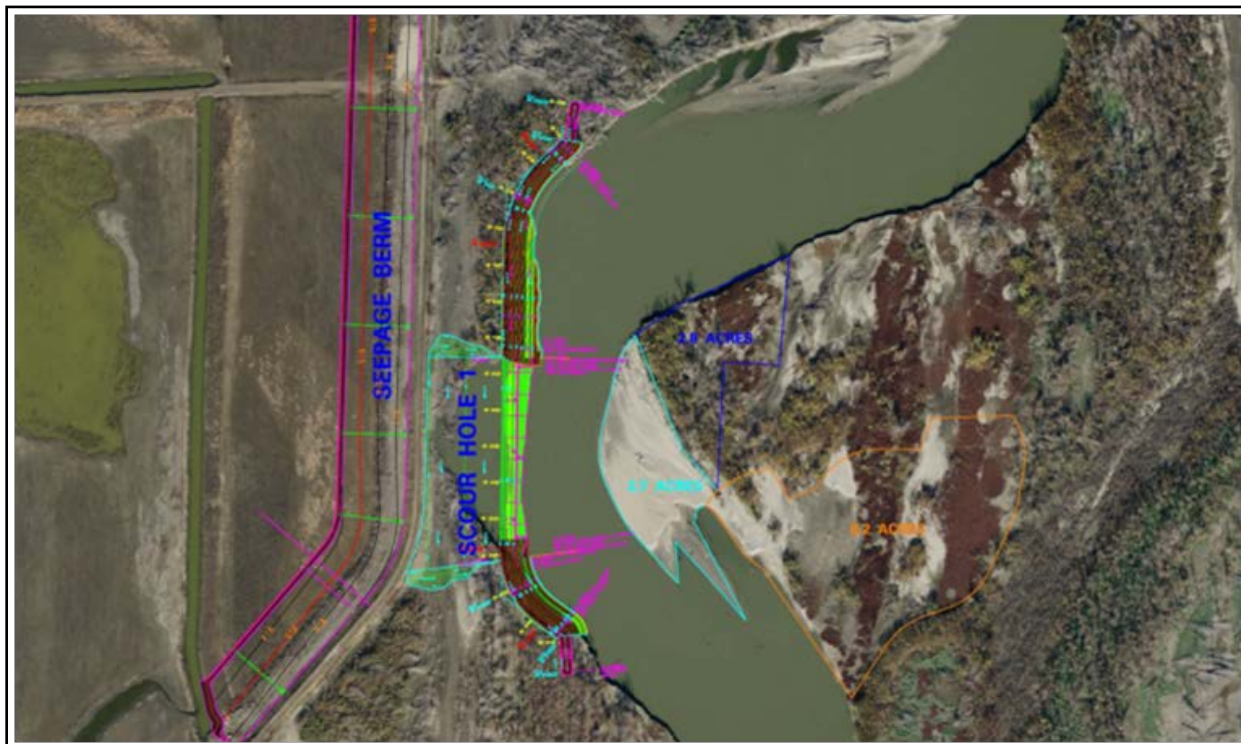
At a large bend centered within the chute, significant erosion along the outer bank threatened a Federal levee that protects adjacent homes and farmland. The eroded chute bank approached the toe of the levee causing considerable concern regarding stability. In addition to the erosion on the outer bank, a point bar formed as the channel migrated. Figure 3 shows the design drawing for repairing the levee toe.

Figure 3. Upper Hamburg Bend Chute, Missouri River, repair plan.

Approximately 30,000 tons of riprap were placed to re-establish the bank in front of the scour hole. Sediment was needed to fill and stabilize the scour hole between the riprap bank and the toe of the levee. The volume required to fill the scour hole exceeded the material available in the point bar that was to be dredged to provide fill and open up the chute channel. Therefore, an additional sediment source was required. Trucking and dredging were both considered; dredging was the more economical and timely option.

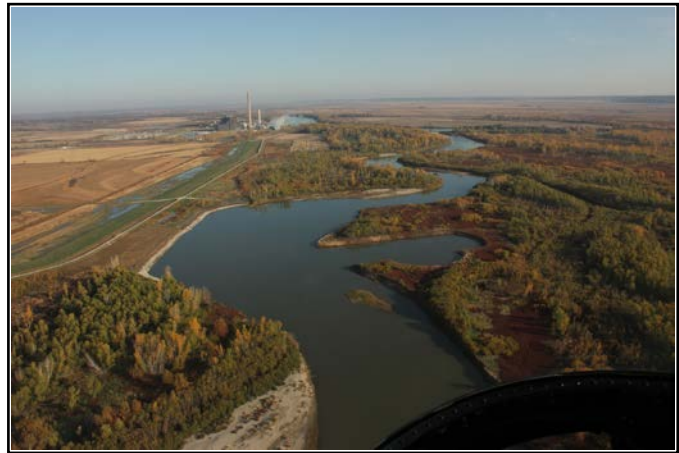
Figure 4. Repaired Upper Hamburg Bend Chute, Missouri River.

In the process of identifying a dredge material source, the design team consulted with engineers and biologists from the Missouri River Recovery Program (MRRP) tasked with designing and building appropriate habitat areas for the endangered Pallid Sturgeon. The MRRP worked with the design team to set the location, shape, and depth of an area that would meet the volume needs of the construction project, and that would create a backwater habitat area that qualifies as shallow water habitat. Completion of the project also included adding seepage blankets in multiple areas along the landward side of the levee. At the Upper Hamburg Chute site, less than 1% of the seepage blanket material was sourced from the dredging. However, at a second site just upstream, coarse sediments deposited in the river channel provided approximately 50% of the fill material needed. Figure 4 shows the final constructed repair, with the new levee toe on the left and the shallow water habitat backwater on the right.

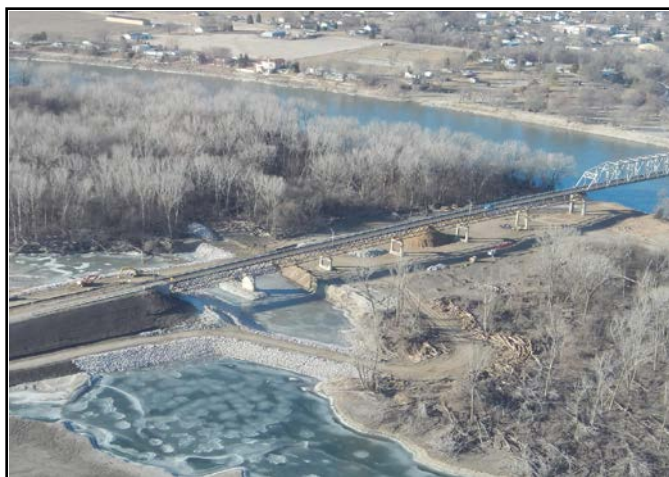
**Decatur Bridge Repair.** During the 2011 flood, the Highway 175 bridge crossing the Missouri River at Decatur, NE (RM 691), experienced significant erosion along the east end bridge abutment. As part of the effort to re-open the bridge, the abutment required significant fill and armoring for protection. During the flood, a channel formed along the nose of the abutment. This channel also caused damage to the State of Iowa Upper Decatur Bend Wildlife Management Area. As the State of Iowa developed plans to repair the bridge abutment, it became clear that additional protection was needed to prevent future damage. To build up and armor the bridge, a large amount of fill material was required. The river had formed an active channel at the toe of the abutment so very little material was available close by.

Figure 5. Bridge abutment repair at Highway 175 bridge, Decatur, NE.

also benefitted habitat creation. A number of shallow wetland areas were filled during the flood, and sandbar deposits in the Missouri River needed to be removed. Through a combination of excavation to deepen the wetlands and dredging to remove the sandbars, sufficient fill was sourced to build control structures and support bank stabilization on and around the bridge abutment. Figure 5 shows the completed project in the winter of 2011/2012. The entire project was completed in a matter of months to allow the highway to reopen.

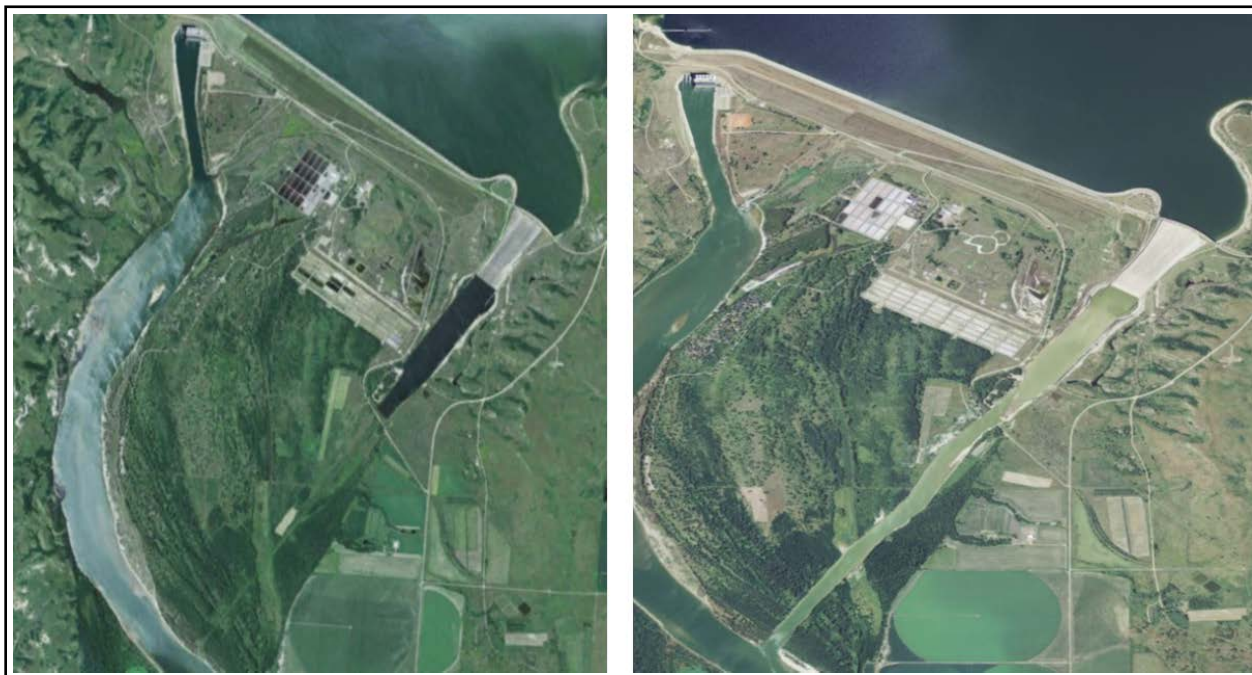
**Garrison Dam Spillway Repair.** During the 2011 flood, Garrison Dam in central North Dakota used the spillway to discharge the majority of the 160,000 cubic feet per second (cfs) peak flow at the height of the flood. During the flood, sediment deposited in the spillway approach channel, which added to a large existing sediment deposit and further limited the maximum discharge of the spillway structure. (Note that the Garrison Project spillway design discharge is considerably higher than the 2011 discharge.)

While the spillway was in use, the discharge passed through a pond at the foot of the spillway, and then through an earthen pilot channel that directed flow back to the Missouri River. Due to the magnitude and duration of the flood, the earthen channel experienced major erosion, resulting in a channel 300-ft wide and 10- to 15-ft deep. The flow also eroded the earthen embankment that served as the downstream shore of the spillway pond. The pond is part of a recreation area and serves as a water intake for the Garrison fish hatchery.

Figure 6. Garrison Dam spillway channel before (left) and after (right) the 2011 flood.

Surveys of the spillway channel indicated that approximately 900,000 cubic yards (cu yd) of material would need to be removed from the channel to regain full capacity. Approximately 100,000 cu yd of that material was attributed to 2011 flood deposits. Construction of settling ponds for the material would require hundreds of acres in an area with rolling hills and steep gullies. This solution was determined to be impractical. Two other proposed discharge locations were identified with sufficient volume: (1) disposal of the dredge material upstream of the dam on the lake bottom, and (2) filling the downstream spillway channel.

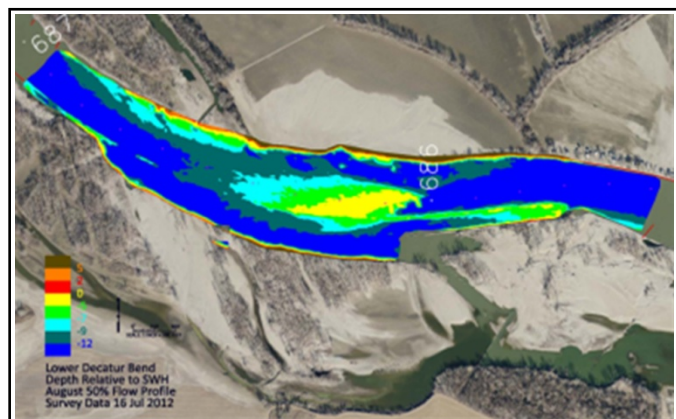
Figure 8. Channel depth in Lower Decatur Bend, Missouri River.

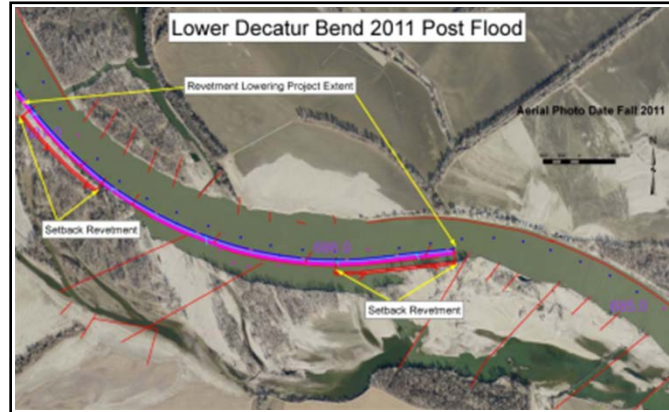
Figure 9. Lower Decatur Bend, Missouri River, repair plan.

A modified design was developed to use rock structures to slightly narrow the river in the shoaling area and to cause natural erosion of the sandbar. In conjunction with these structures, the revetment restoration was modified to include connectivity slots and large notches to maintain the habitat created during the flood. Figure 9 shows the Lower Decatur Bend repair plan.
