# **Thule Air Base Airfield White Painting and Permafrost Investigation**

Phases I-IV

June 2013

Final report

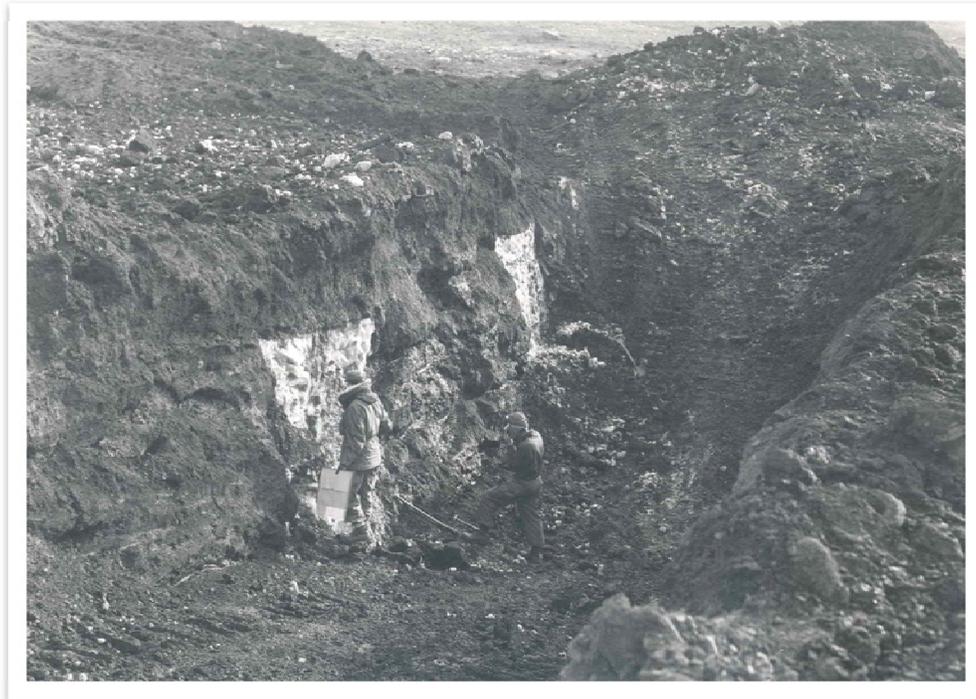
Figure 5. Ice wedges excavated at Thule in the 1960s (CRREL photo). Ice wedges such as these, located under the runway, are the cause of many previous localized depressions on the runway. Depressions that currently exist at 62+00 and 70+00 were drilled in 2009 and wedge ice was found at the 6 ft depth.

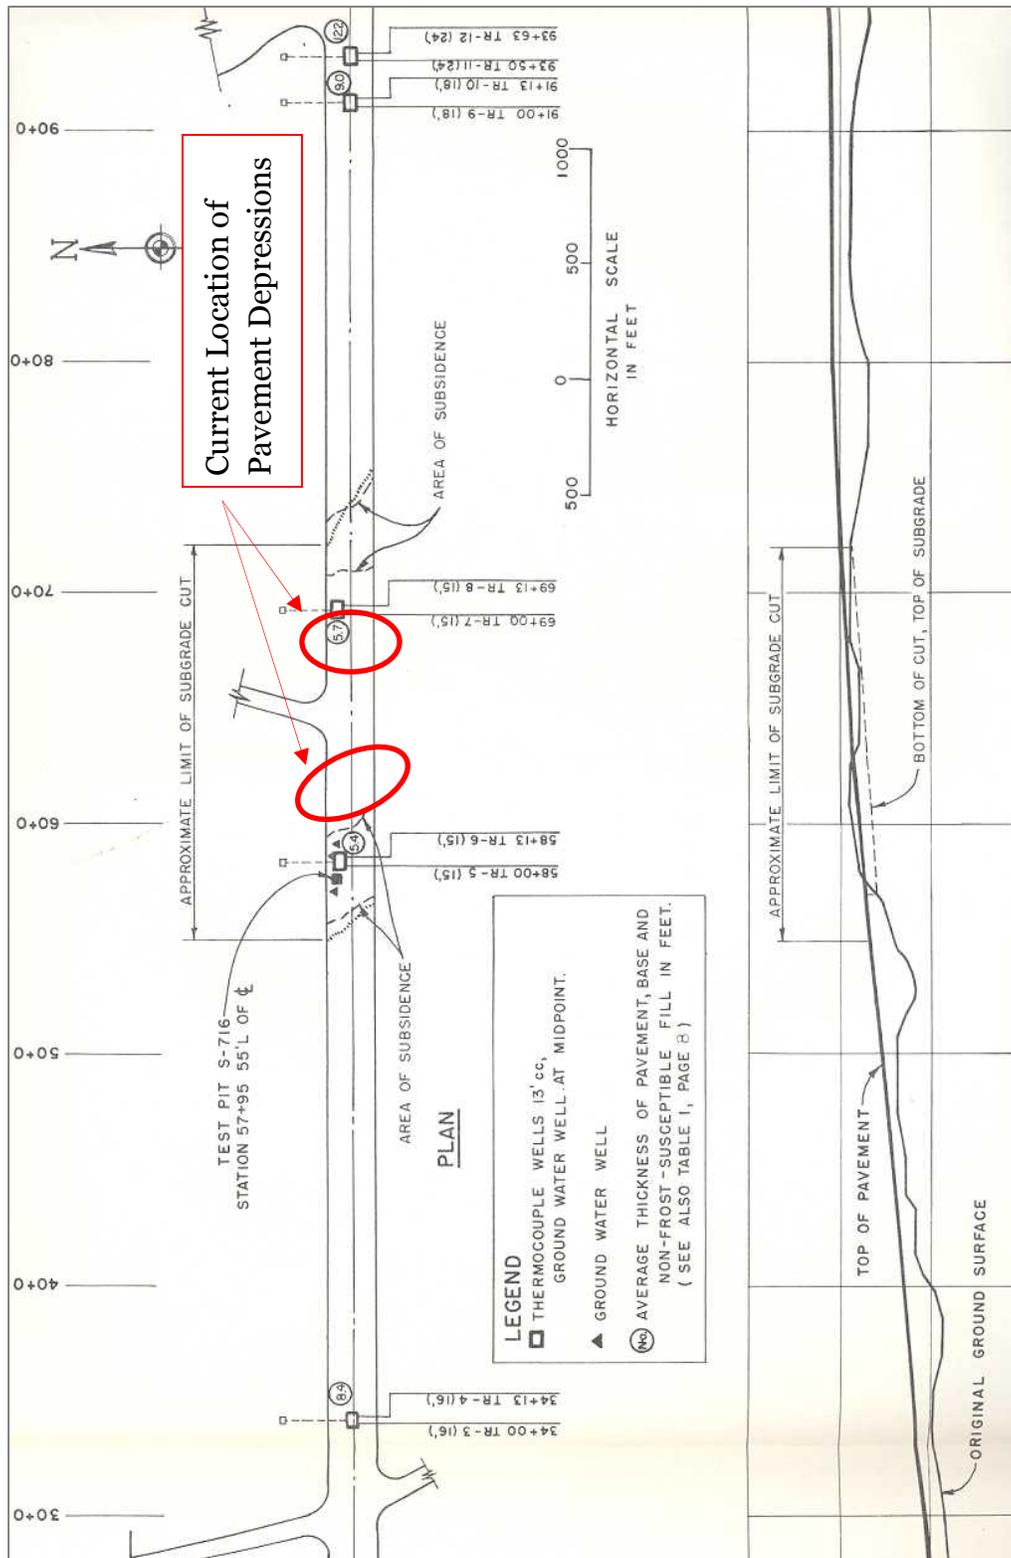
Figure 8. Plan view of depressions and test pits from ACFEL 1955 investigation (ACFEL 1955). Current depression areas are noted.

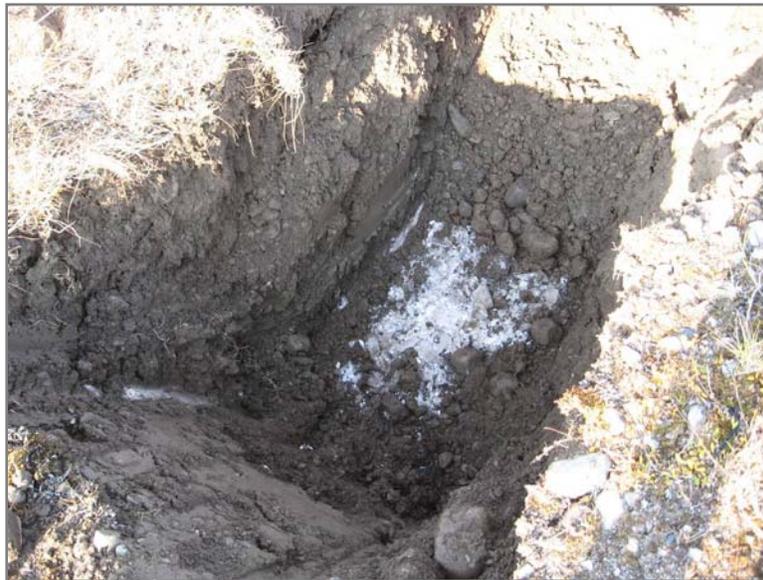
Figure 11. Test pit near Taxiway Bravo Extension. Wedge ice is seen at 5.5 ft depth.

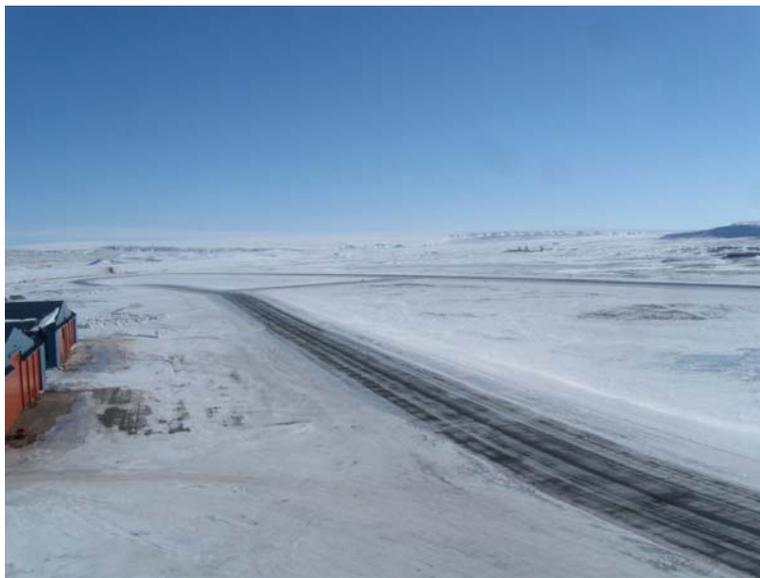
Figure 15. View from the tower April 2011, looking east to the 26 end of the runway. The faded and dark nature of the paint is very evident against the backdrop of white snow.

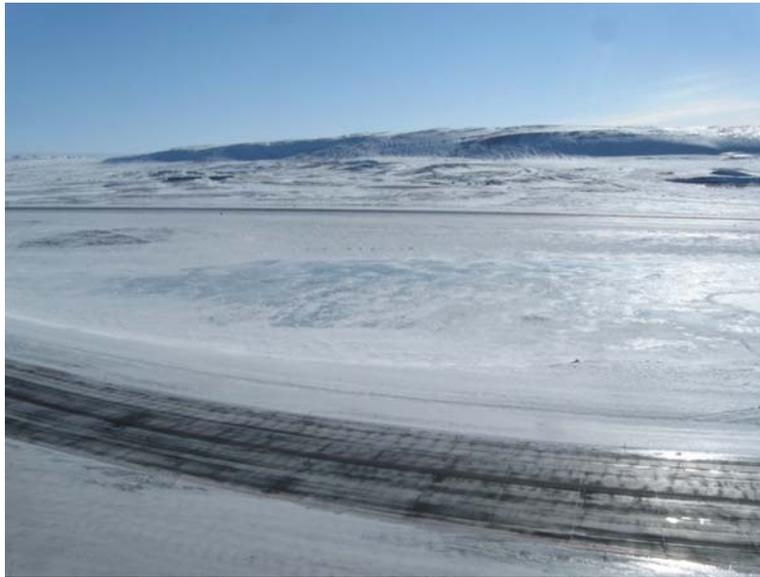
Figure 16. View from the tower in April 2011, looking directly south over Lake Eddy. The dark colored runway and taxiway are visible.

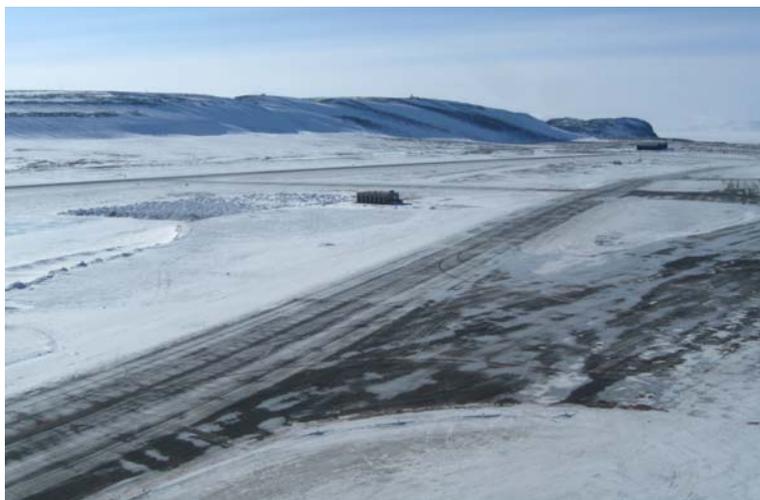
Figure 17. View from the Tower in April 2011, looking southwest to the 08 end of the runway. The dark colored runway and taxiways is visible.

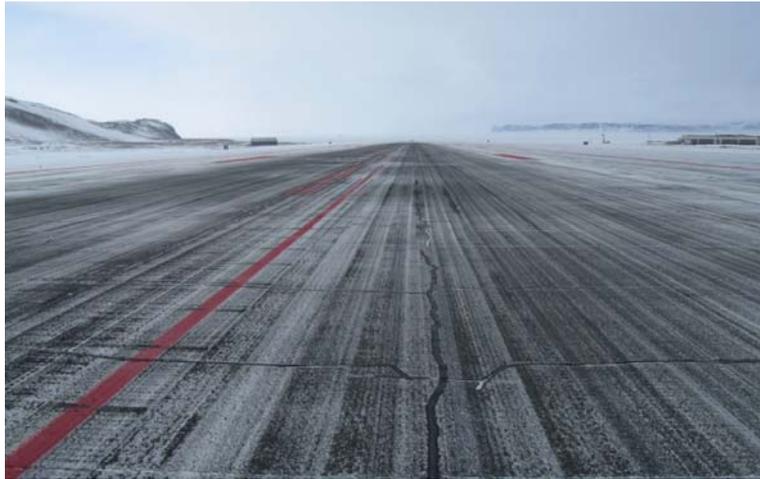
wash is reapplied (Fig. 18). Therefore, since summer 2009, the runway has had virtually no white paint along this 100-ft-wide keel during the crucial solar heating months of June, July, and early August. No thaw depressions have been created during this time, and the existing thaw depressions (namely at 62+00) have not increased in size or depth. This is especially enlightening because the summers of 2008, 2009, and 2011 were the fifth, third, and fourth warmest summers, respectively, on record since 1951 (Table 1).

Figure 18. View of the 26 end of the runway April 2011. The winter maintenance has removed the white wash coating applied the previous summer. This state persists through the warm period of June, July and early August before repainting.

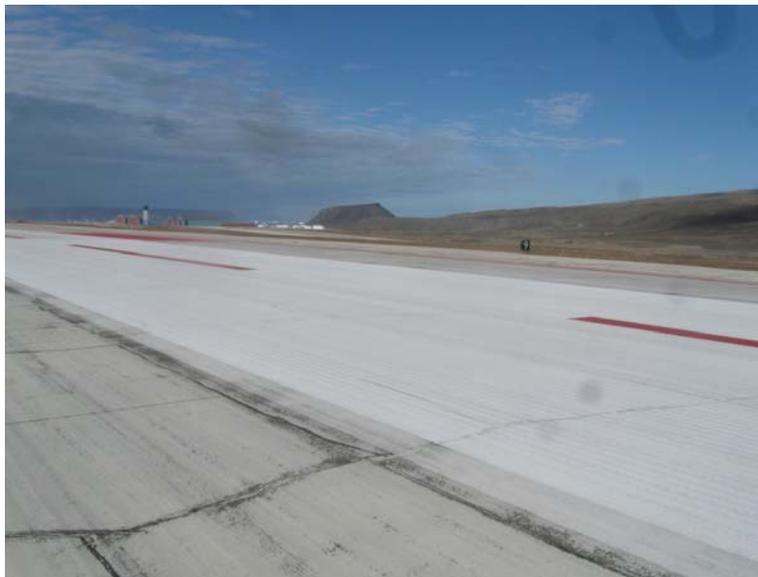
Figure 20. Bright white runway at 91+00. Albedo measured at 0.58 and the thaw depth measured at 3.9 ft.

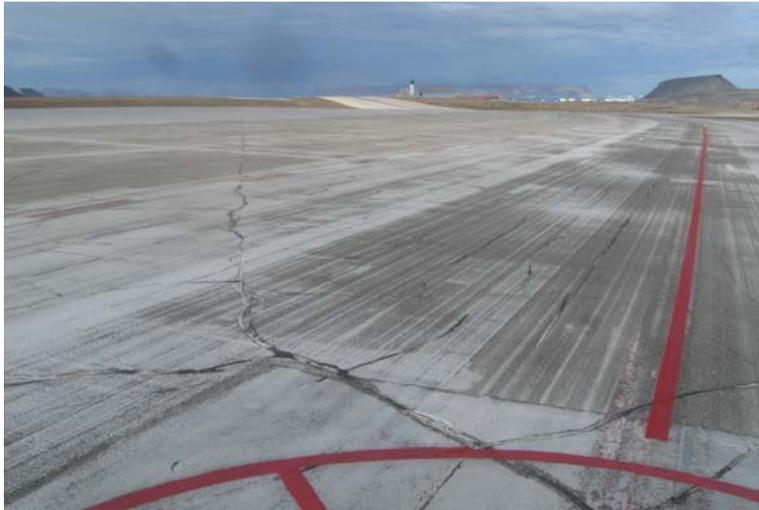
Figure 21. Brushed and faded milled surface on Txwy A at Vortac Calibration. Albedo measured at 0.26 and thaw depth measured at 5.3 ft.

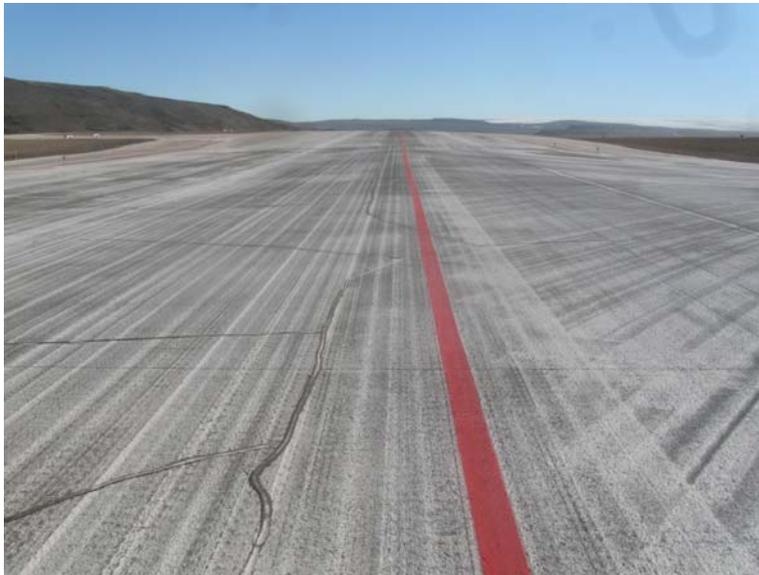
Figure 22. View east along Txwy A at Txwy Charlie. Albedo measured at 0.32. The measured thaw depth is 5.3 ft.

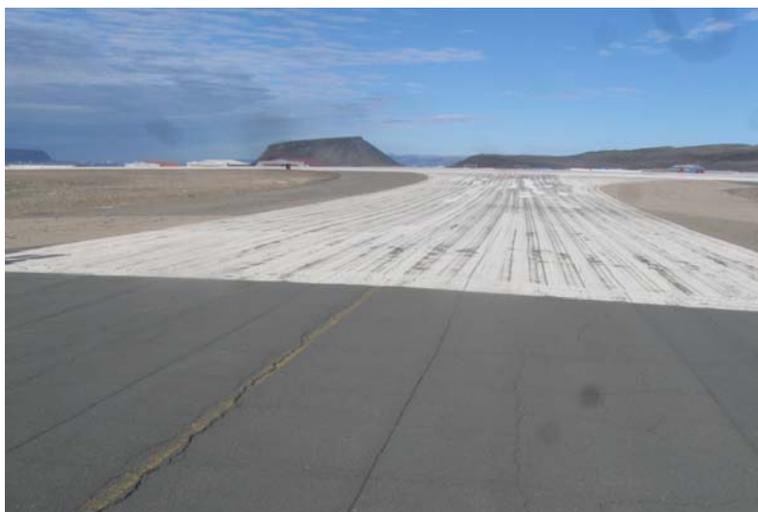
Figure 23. Old white paint transitioning to never painted surface at Txyw Bravo Extension. The white albedo measured 0.44 and the thaw depth measured 5.1 ft, while the black surface measured 0.15 and the thaw depth measured 6.5 ft.

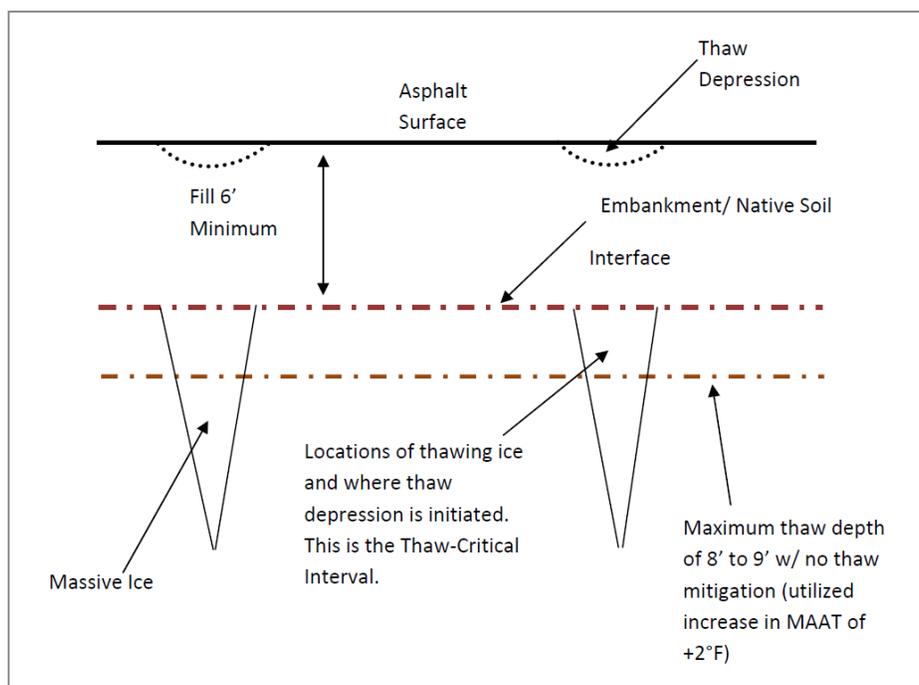
**Figure 32. Simplified physical situation causing thaw depression on and around the airfield. The fill section is inadequate to prevent summer heat energy from reaching the depth of massive ice. The thawing ice creates a void that is filled with adjoining soil and a surface depression is the end result.**

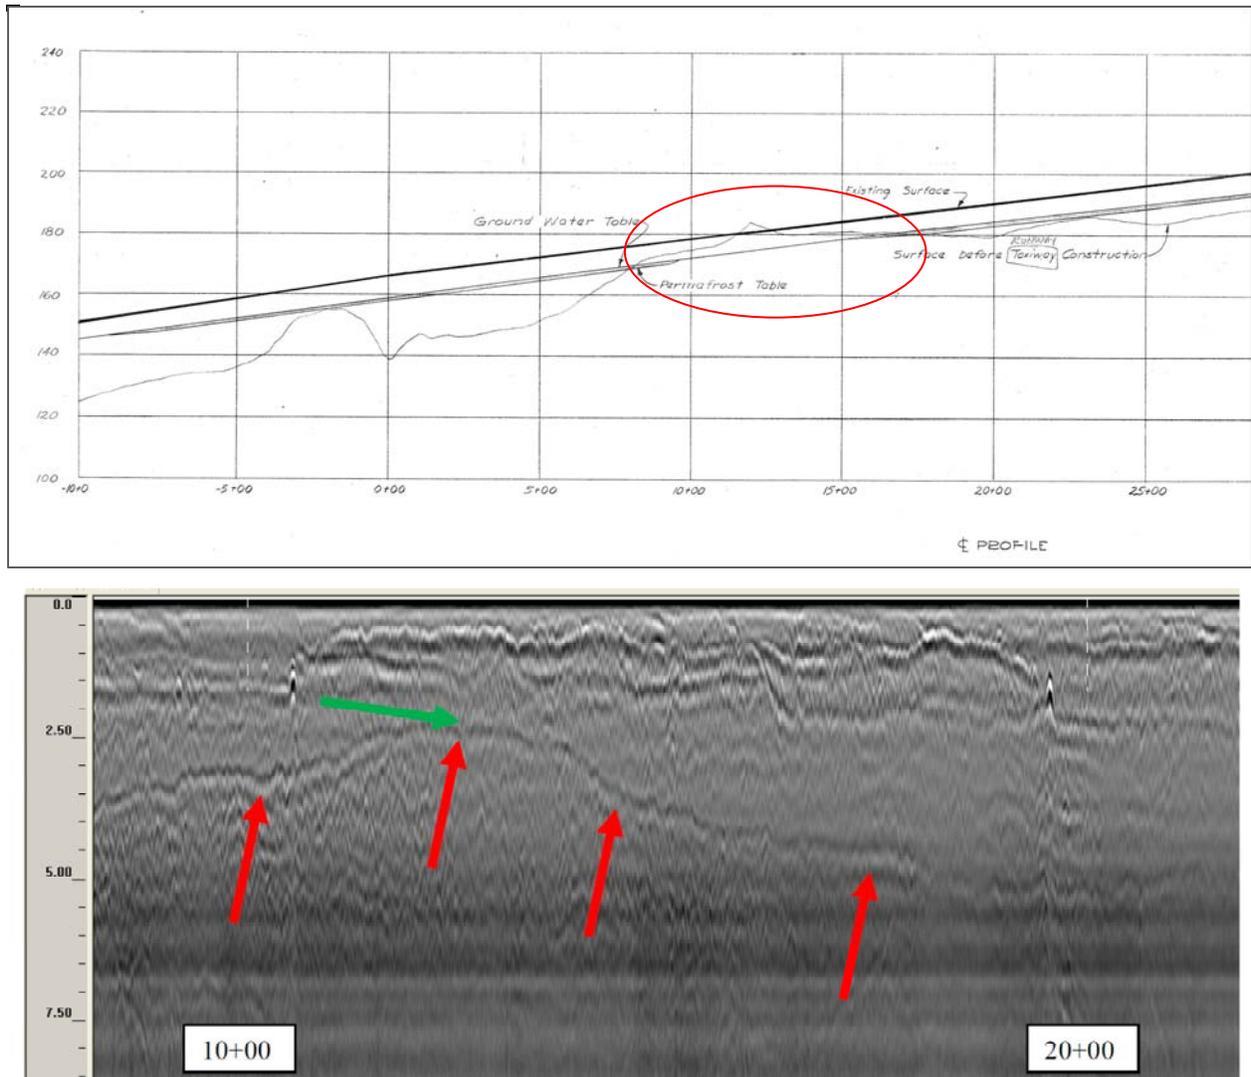
Figure 34. Top: a portion of the runway as-built provided by Metcalf & Eddy. A cut section is shown starting at 5+00 and ending at 17+00. The red oval indicates the location shown in the GPR image in the bottom figure, a portion of a radargram showing the subsurface between 8+00 and 22+00. Survey was taken on the right side of the runway between the centerline and the edge lighting. The rise in topography shown in top drawing is clearly seen at the red arrows. Green arrow indicates location where near surface ice-rich soil may exist at 8.2 ft depth.

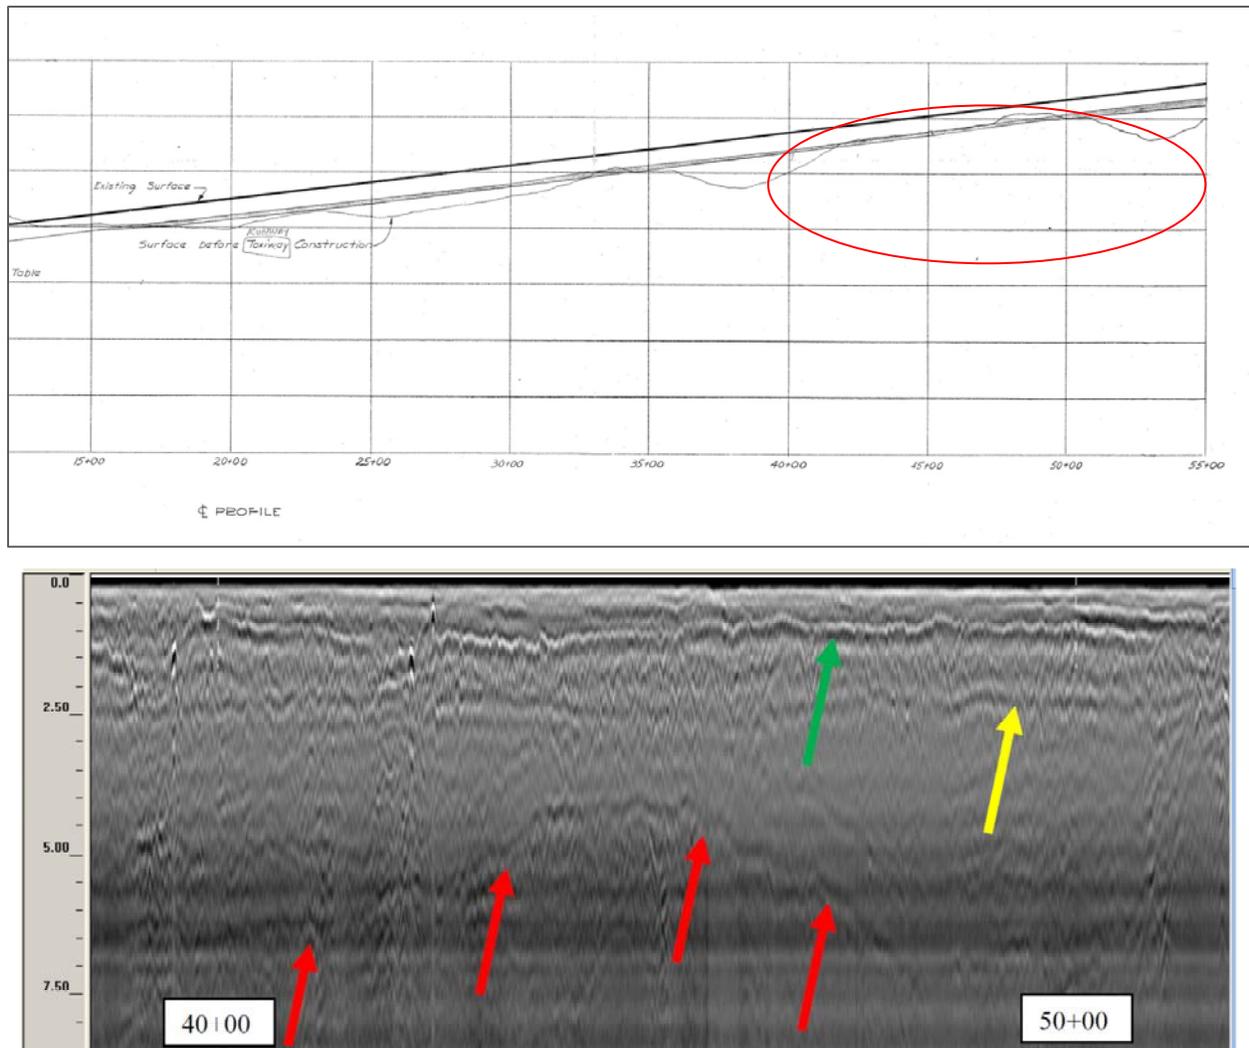
Figure 35. Top: portion of the runway as-built provided by Metcalf & Eddy. A cut section and near-cut section are shown starting at 42+00 and ending at 51+00. The red oval indicates the cut section shown in the bottom figure, a portion of a radargram showing the subsurface between 38+00 and 52+00. This survey was taken on the right side of the runway between the centerline and the edge lighting. The rise in topography shown in the top figure is marked by red arrows. The transitions to multiple lifts of coarser material for the asphalt base course (Fig. 7) are shown by the yellow arrow starting at approximately 8.0 ft. The green arrow indicates a visible strong reflector at the 3-ft depth and this most probably corresponds to the bottom extent of the 1992 repaving subgrade reworking.

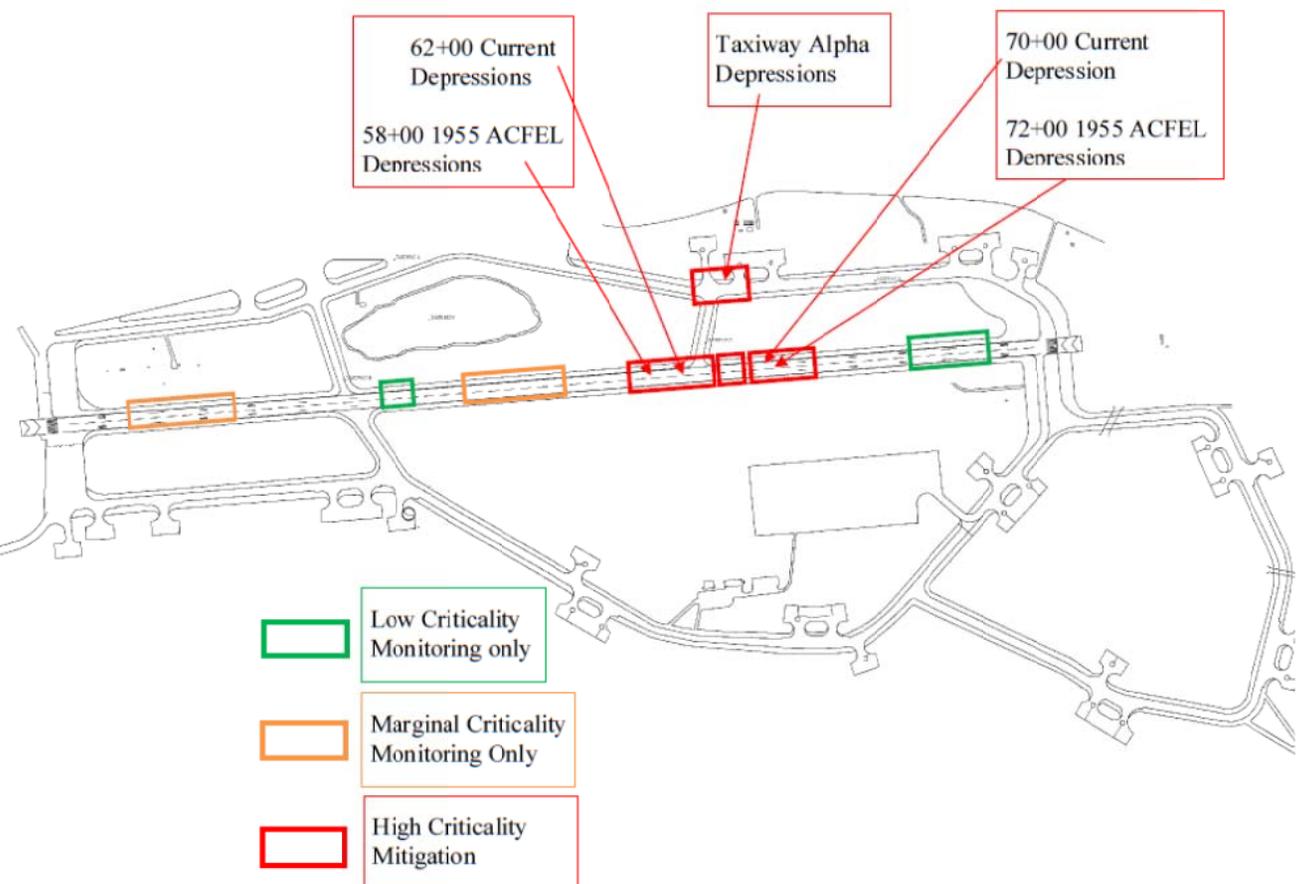
Figure 37. Plan view of the areas absolutely requiring and possibly requiring thaw mitigation.

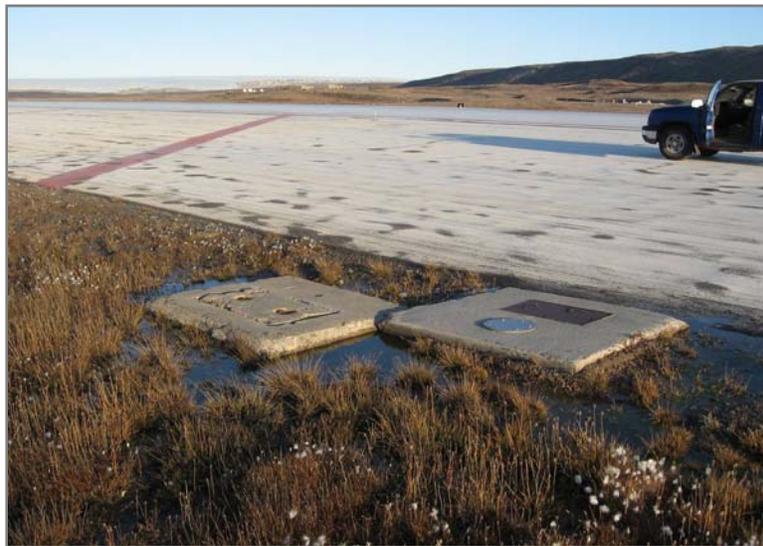
Figure 41. North shoulder of runway at 38+00. Seepage water is flowing from the electric vaults, and the visible splotchy asphalt of the shoulder is coincident with this area suggesting fatigue due to weakening of the base course or freeze–thaw problems. Water flows from the locations of the runway lighting early in the thawing season, slowly diminishing over the summer.

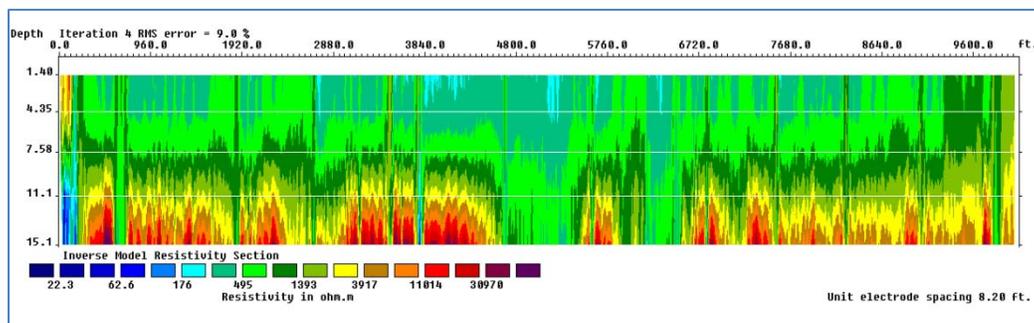
Figure 42. Runway resistivity cross-section from 00+00 to 100+00. The locations of the pre- construction surface drainage feature at ~52+00, and the location of the existing depressions at 62+00 are visible in blue with the lower resistivity (high conductivity). The undulating frozen ground boundary is also clearly defined by the yellow and red shading. (Depth scale is exaggerated in this figure.)

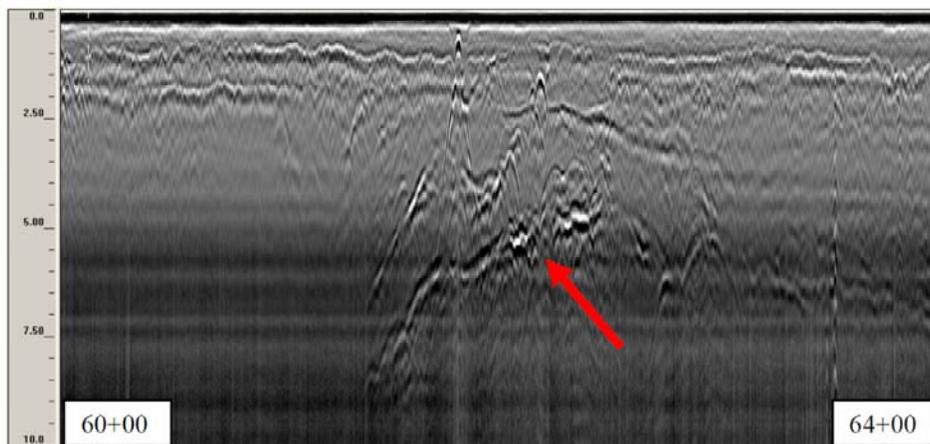
Figure 43. GPR image showing from 60+00 to 64+00. Isolated reflectors are shown at ~63+00 at a depth of ~16 ft. The bright black-white-black reflectors (red arrow) are typical of the sedimentary bedrock reflections.
