# **Realistic Safe-Separation Distance Determination for Mass Fire Hazards**

Thomas L. Boggs  
*New Directions Technology, Inc.*  
*Ridgecrest, CA 93555*

Kevin P. Ford  
*Energetics Research Division*  
*Weapons and Energetics Department*  
*Naval Air Warfare Center Weapons Division*  
*China Lake, CA 93555*

**MARCH 2013**

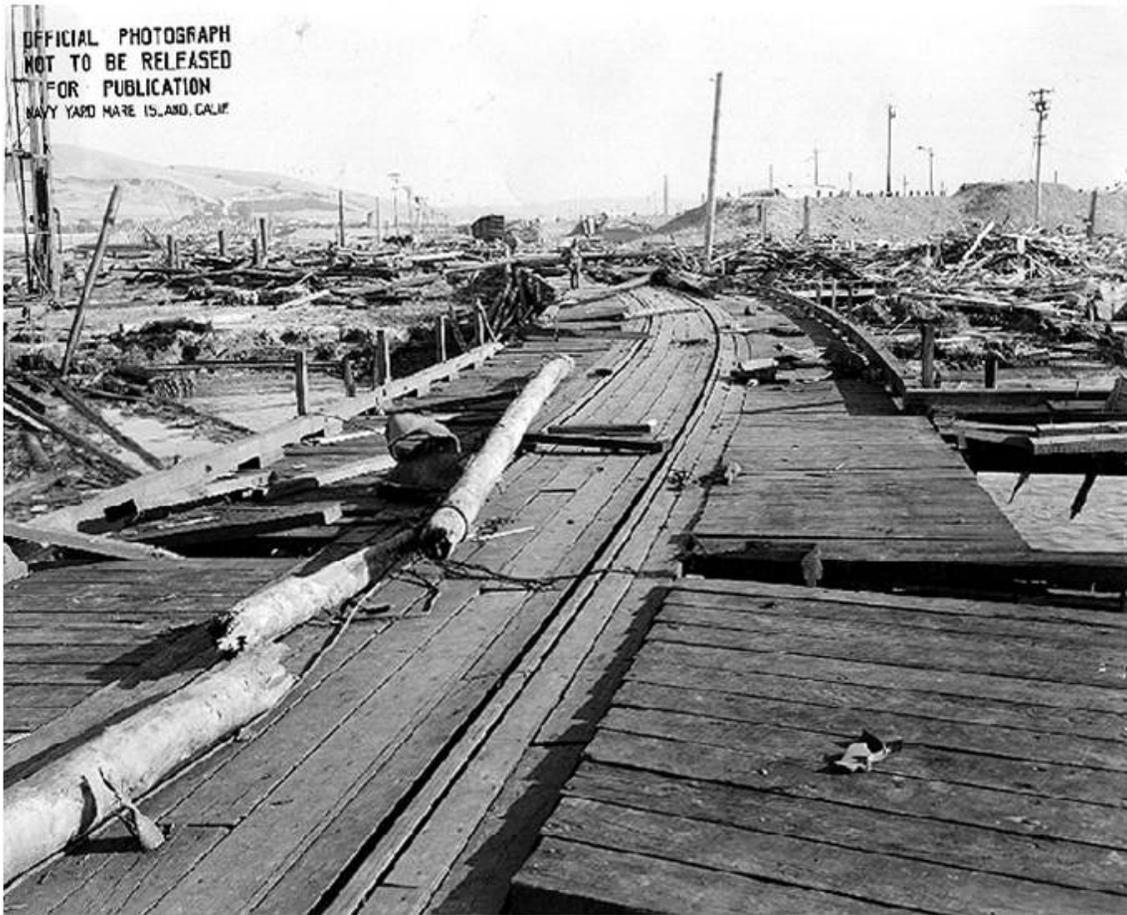
FIGURE 11. Damage at Port Chicago, CA.  
View looking south from ship pier.

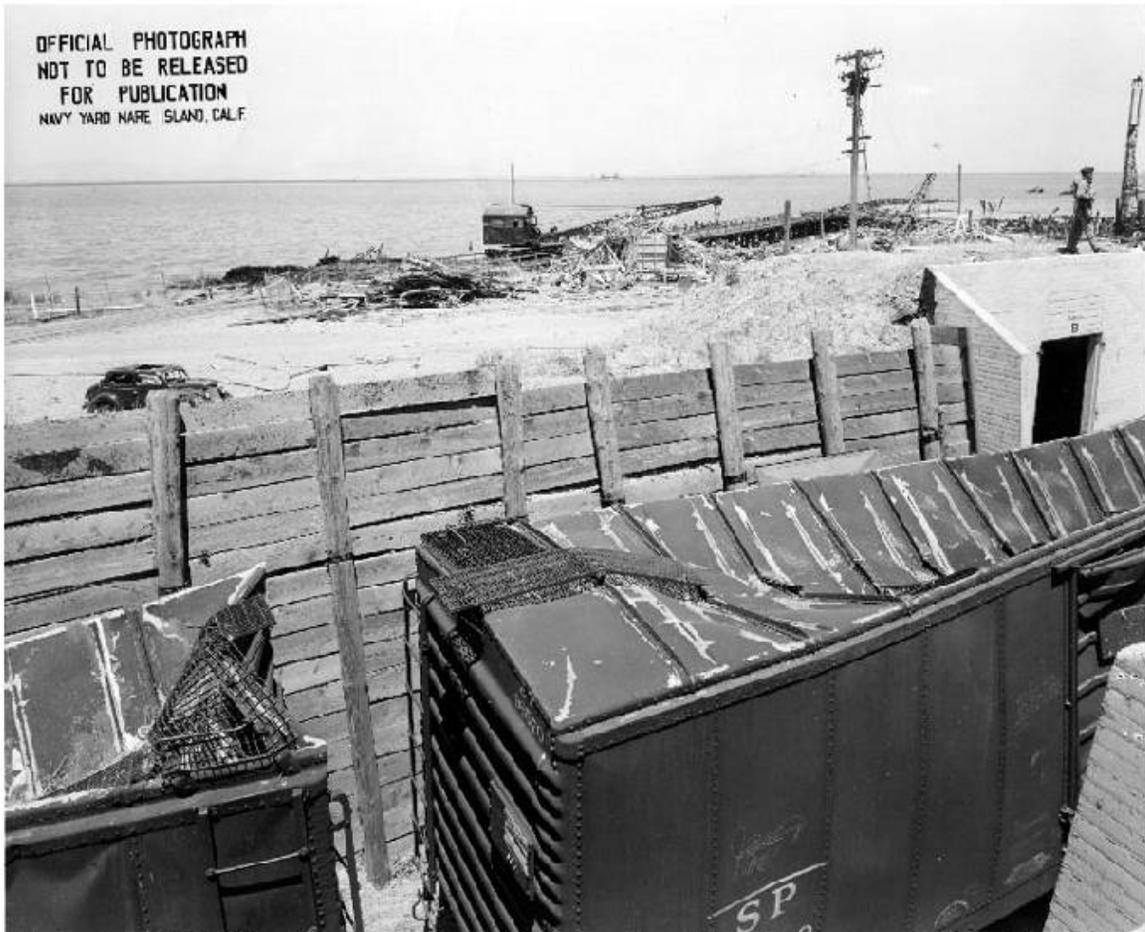
Photo # NH 96822 Damage at Port Chicago, Ca. View looking north from BM138.

FIGURE 12. Damage to Railcars in Revetments That Were Waiting to be Unloaded.

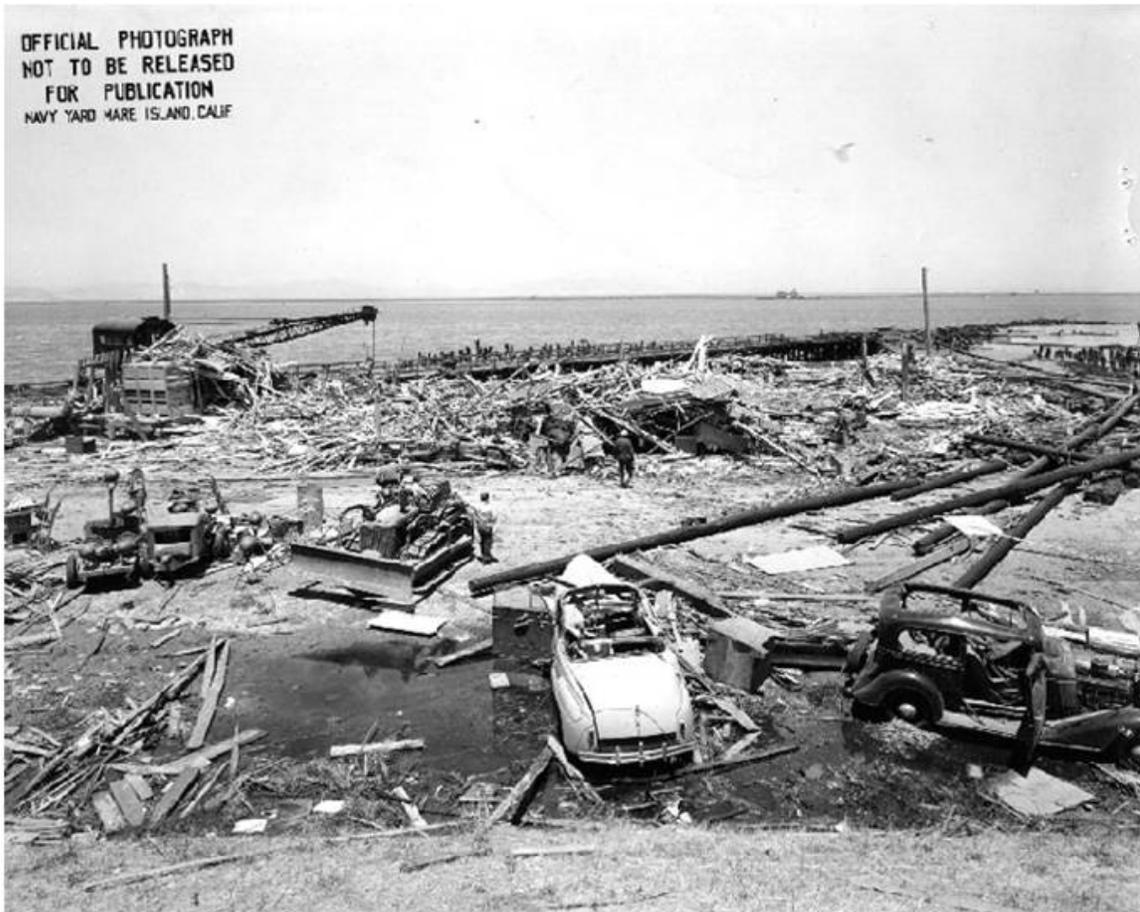
FIGURE 13. Damage at Port Chicago, CA.  
View looking north toward pier.

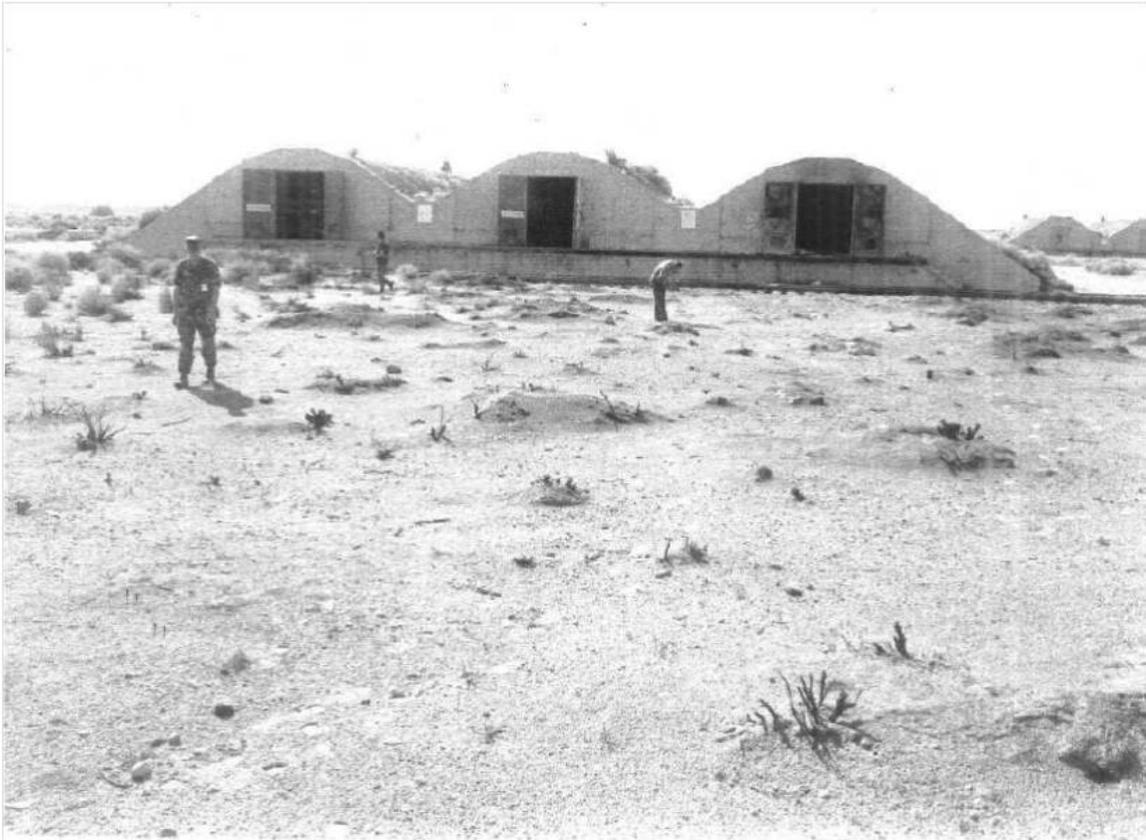
A magazine fire involving 30,715 pounds of Navy propelling charges occurred in Magazine 116-14-E at the Hawthorne AAP on 9 August 1989. The fire occurred in a Navy triple-arch magazine that was built in the 1943 to 1945 timeframe. The facility consisted of three separate earth-covered igloos that shared a common head wall and loading dock. Each igloo was concrete and arched on its long axis. It was 80 feet long x 25 feet wide and 12 feet high at the top of the arch. Each igloo was separated from the adjacent igloo by 13 feet of earth to a height of 6 feet above the floor level. It then decreased to no less than 2 feet of earth cover over the igloo roof. Each igloo had 4-foot wide double doors that opened onto a 6-foot-wide concrete loading dock. The doors were wood covered with 22-gauge steel. Each door had a 12- by 18-inch vent in the lower portion of the door. There was also a rear stack ventilator 15 inches in diameter that extended 30 inches above the level of the earth cover. The ventilator was capped with a vent cap weighing 195 pounds and made of glazed ceramic, metal, and screening. It set on top of the stack but was not fastened. Figure 16 shows the three earth-covered igloos (A, C, and E) making up the Magazine 116-14 after the accident. The fire occurred in unit E. Figure 17 shows the door to Magazine 116-14-E after the accident. There were no fatalities involved in this accident.

FIGURE 16. Magazine 116-14 With Igloos A, C, and E (Left to Right) After the Accident. Notice the burned sagebrush in front of E.

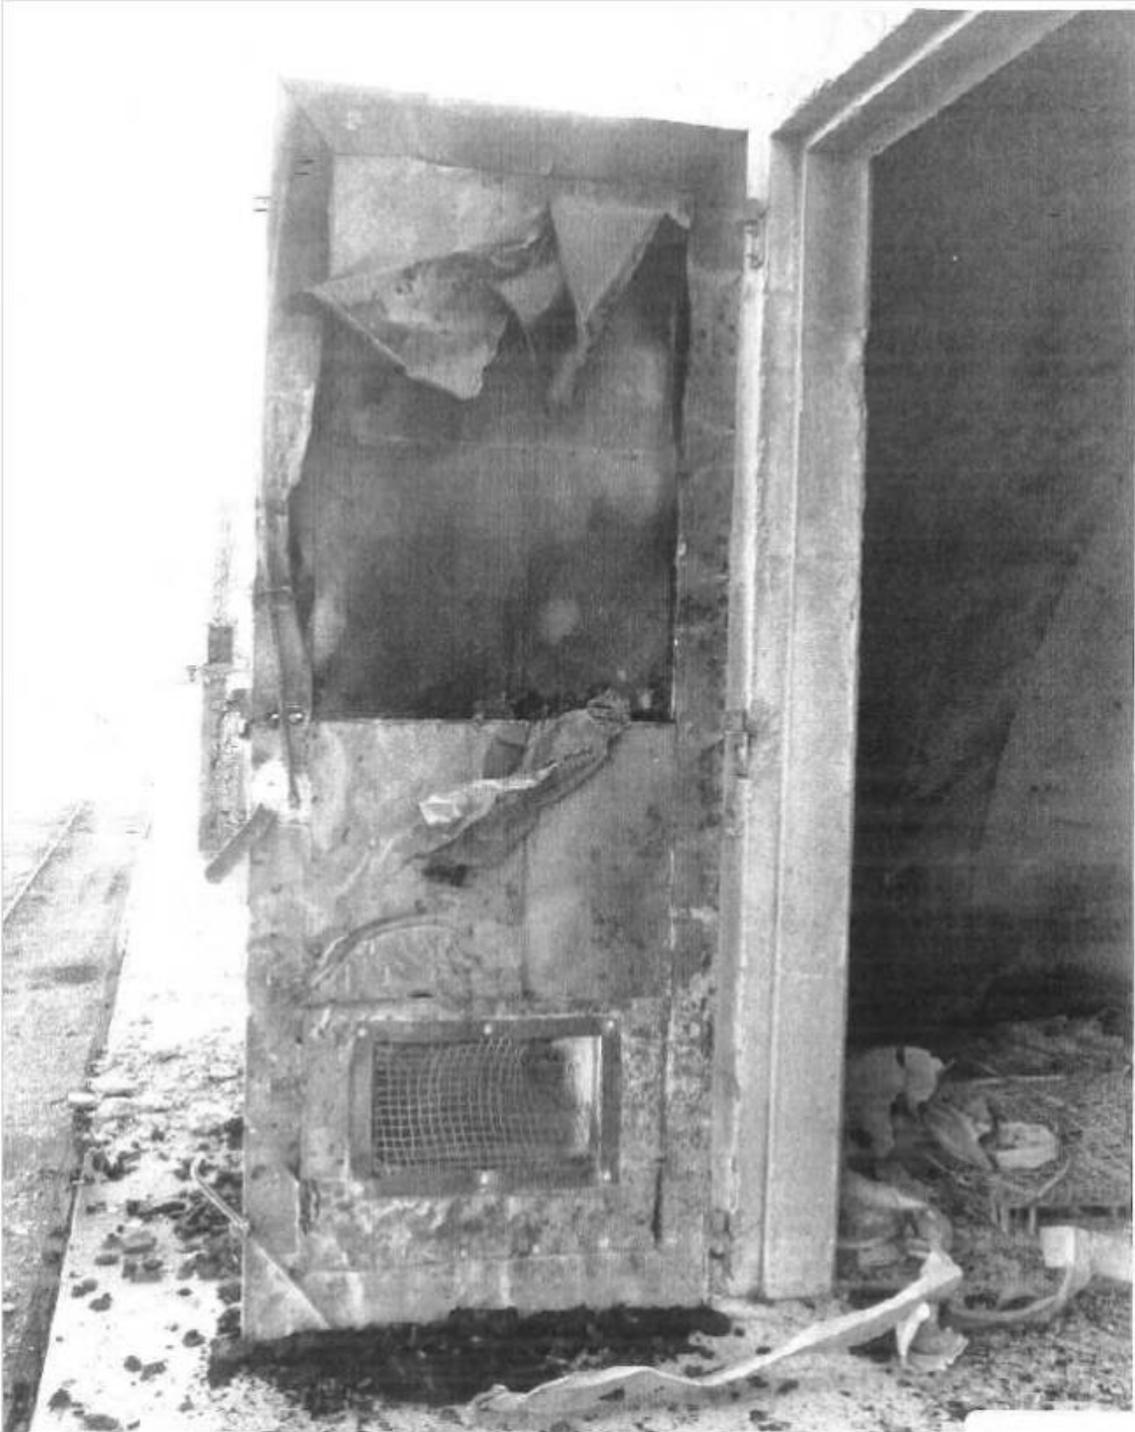
FIGURE 17. Door to Magazine 116-14-E After the Accident.

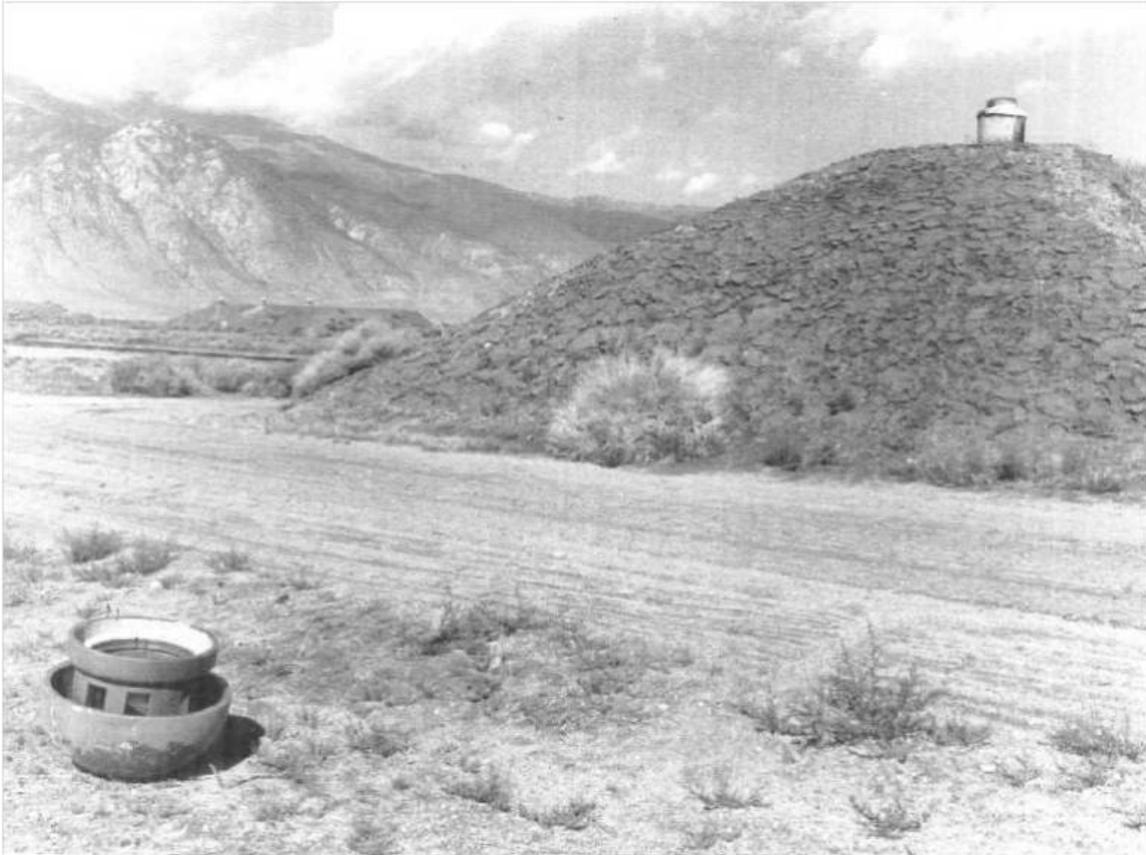
The post accident investigation indicated that the reaction was a rapid deflagration but there was no detonation. The 195-pound vent cover was found 65 feet from the magazine (Figure 18).

FIGURE 18. 195-Pound Vent Cap Found 65 Feet From the Magazine After the Accident.

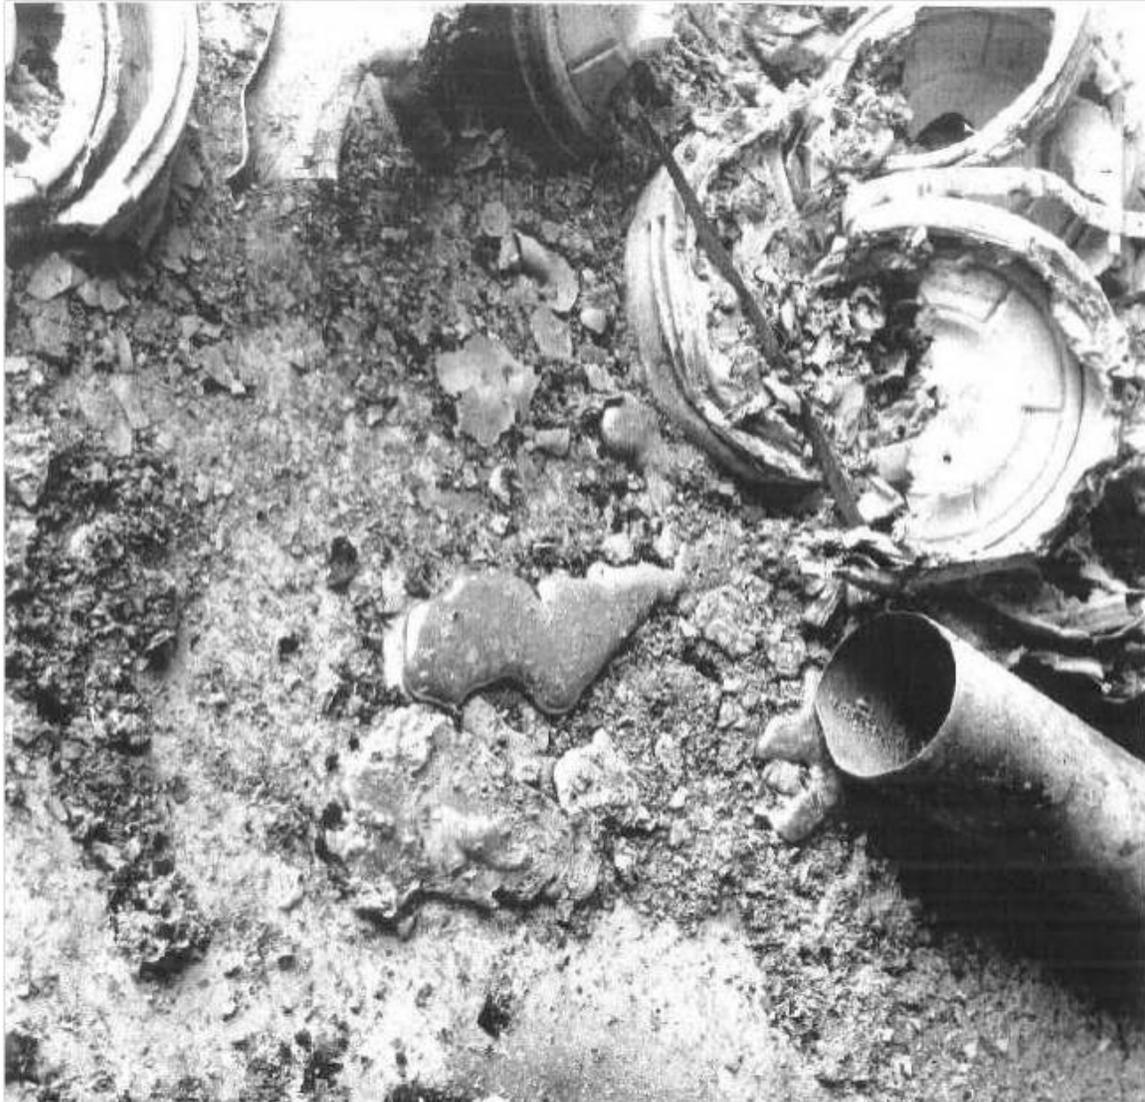
The most intense heat was at the front portion of the magazine as evidenced by slag that had been molten metal from the metal shipping containers (Figure 19). Since the shipping containers were aluminum, this indicates that the containers were exposed to temperatures of over 660°C (1,220°F) sufficiently long to cause melting.

FIGURE 19. Debris on Floor of Magazine Showing Slag That was Molten Aluminum.

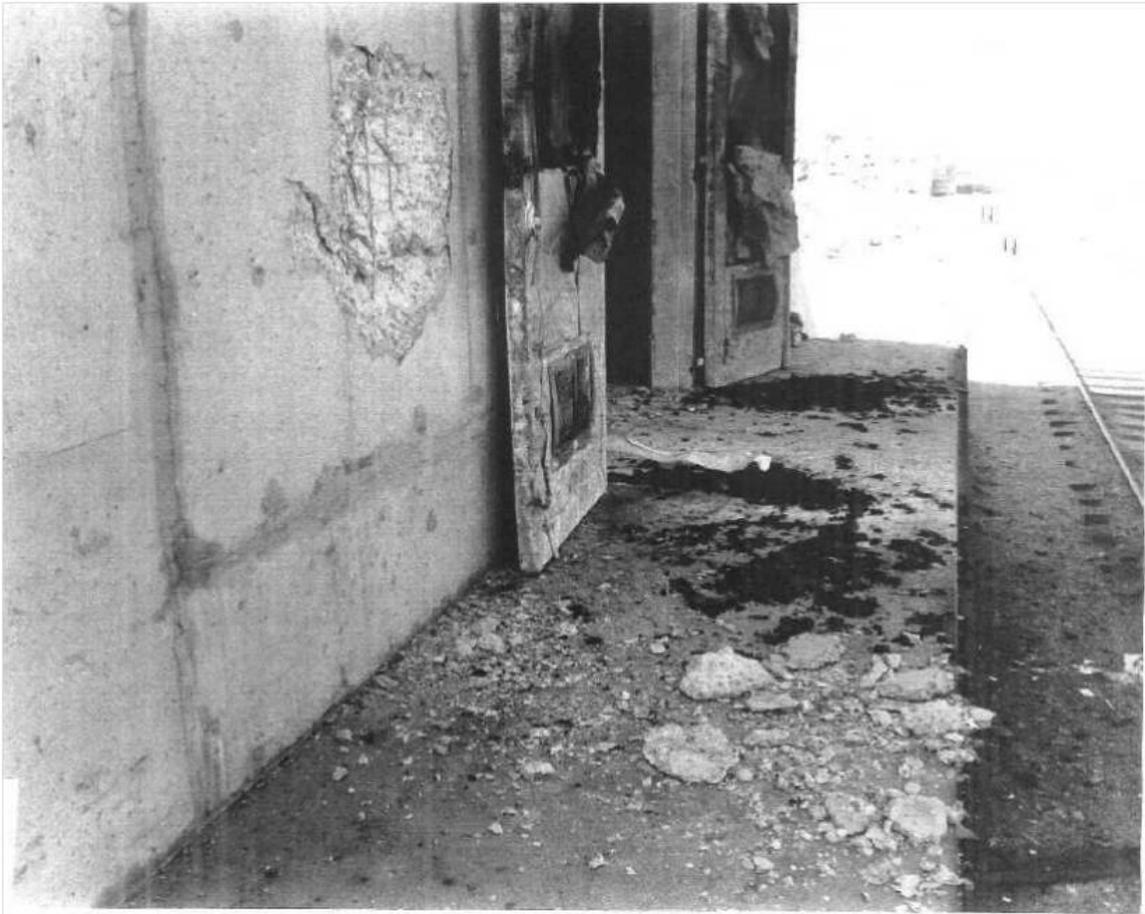
There was heavy smoke residue and spalling in various locations within the magazine. There was evidence that a 6-inch, 47-caliber case propelling charge impacted the front wall near a side wall. There was an indentation approximately 1-inch deep on the inside wall, and severe spalling on the outside of the wall opposite the impact that was about 2 feet by 2 feet and several inches deep (Figure 20). The steel rebar was exposed and concrete fragments were thrown across the entire width of the loading dock.

**FIGURE 20. Damage to Front of Head Wall of Magazine 116-14-E Caused by Impact of 6-Inch, 47-Caliber Case Propelling Charge That Impacted the Rear of the Head Wall (Inside the Magazine).**

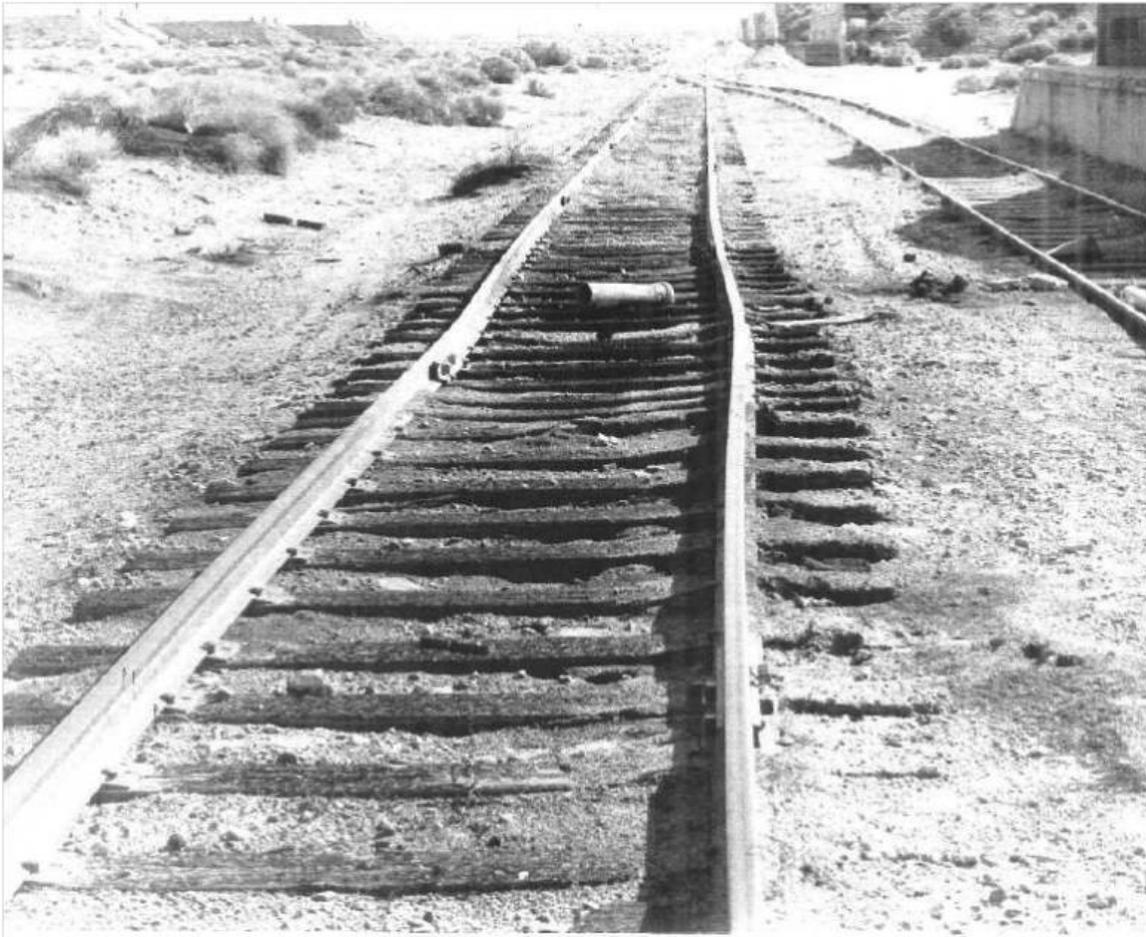
The railroad tracks directly in front of the magazine were damaged and numerous railroad ties were severely charred attesting to the intensity of the plume exiting the doors (Figure 21).

FIGURE 21. Damage to Rails and Charred Rail Ties in Front of Magazine 116-14-E.

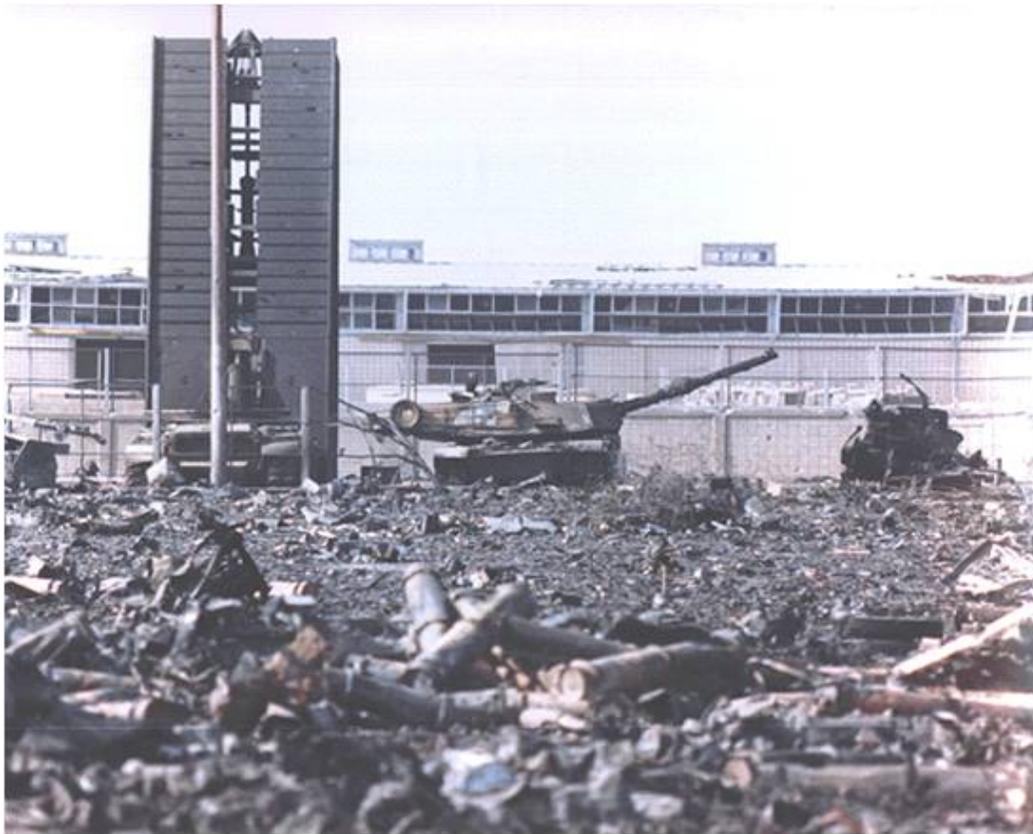
FIGURE 25. Aftermath of Doha Motor Pool Fire (View of Wash Rack Area) Showing Armor Hulks and Unexploded Explosive Ordnance (UXO).

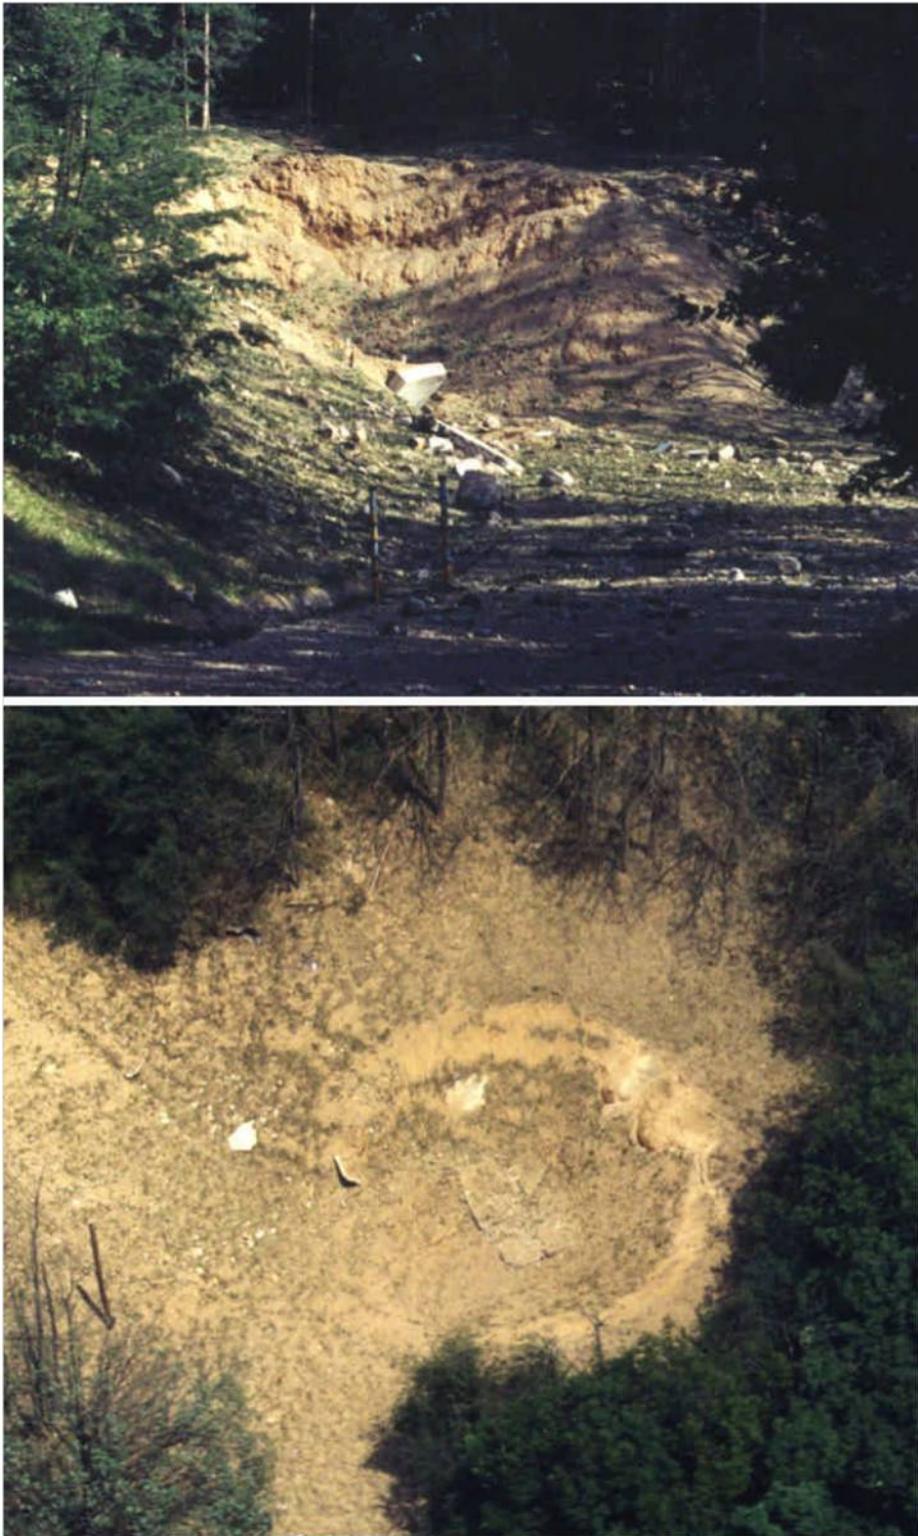
The explosions removed all of the earth covering the magazine and the structure down to the floor slab. The floor slab was broken into several pieces. Some of these pieces were driven several feet into the earth below their original location. Large portions of the floor slab were missing entirely. The average radius of the crater was 32.4 feet and no depth was given in the report.

FIGURE 30. Damage Around Where Magazine 355 Had Been Located.

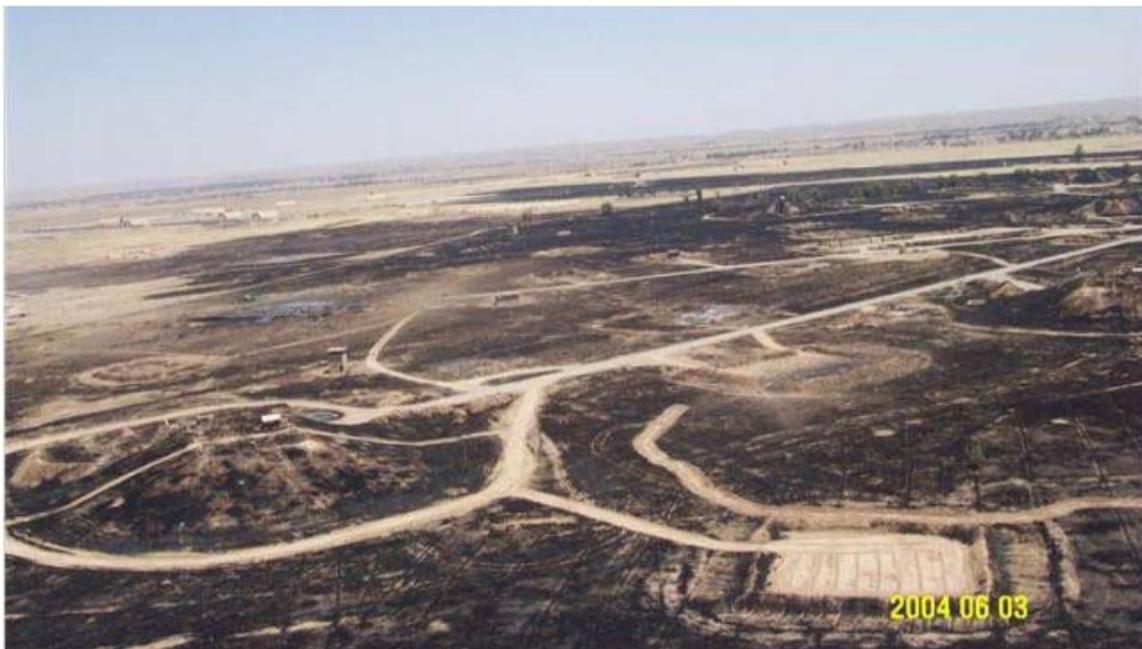
FIGURE 43. Damage to the Kirkuk Airbase After the Fire and Explosions of 2 June 2004.

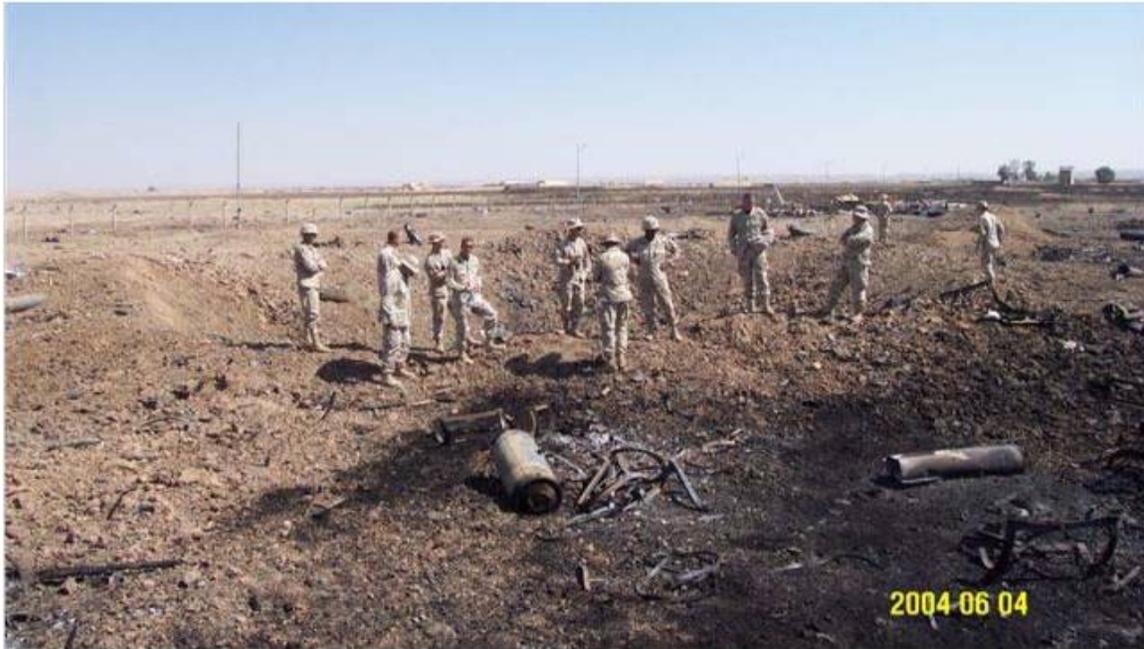
FIGURE 44. Crater Evidence of the Violence of Reactions Occurring at Kirkuk Airbase, 2 June 2004.

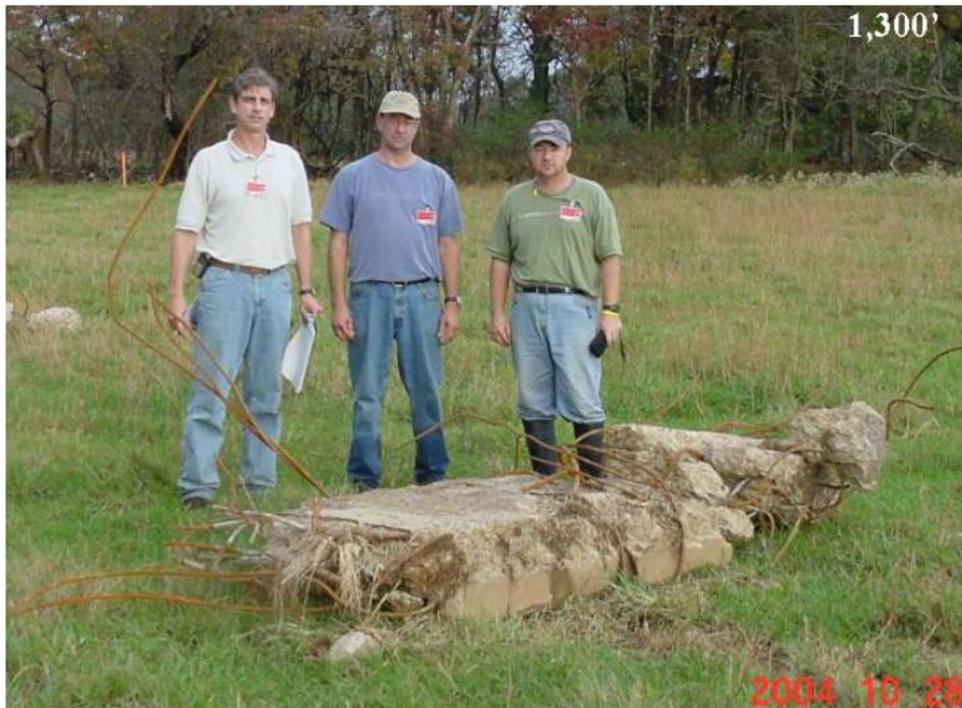
Some of the debris resulted from large fragments breaking up into smaller fragments on impact. There was also evidence of significant fragments traveling distances significantly greater than the 1,250-foot radius IBD arc (Figure 46). For example, there was significant damage to a tree located 2,100 feet in front of ECM-69, as shown in Figure 47 that presents photographs of the tree and the debris found at the base of the tree.

FIGURE 46. Large Fragment That Had Been Part of the Head Wall.  
It was found approximately 1,300 feet from the magazine.

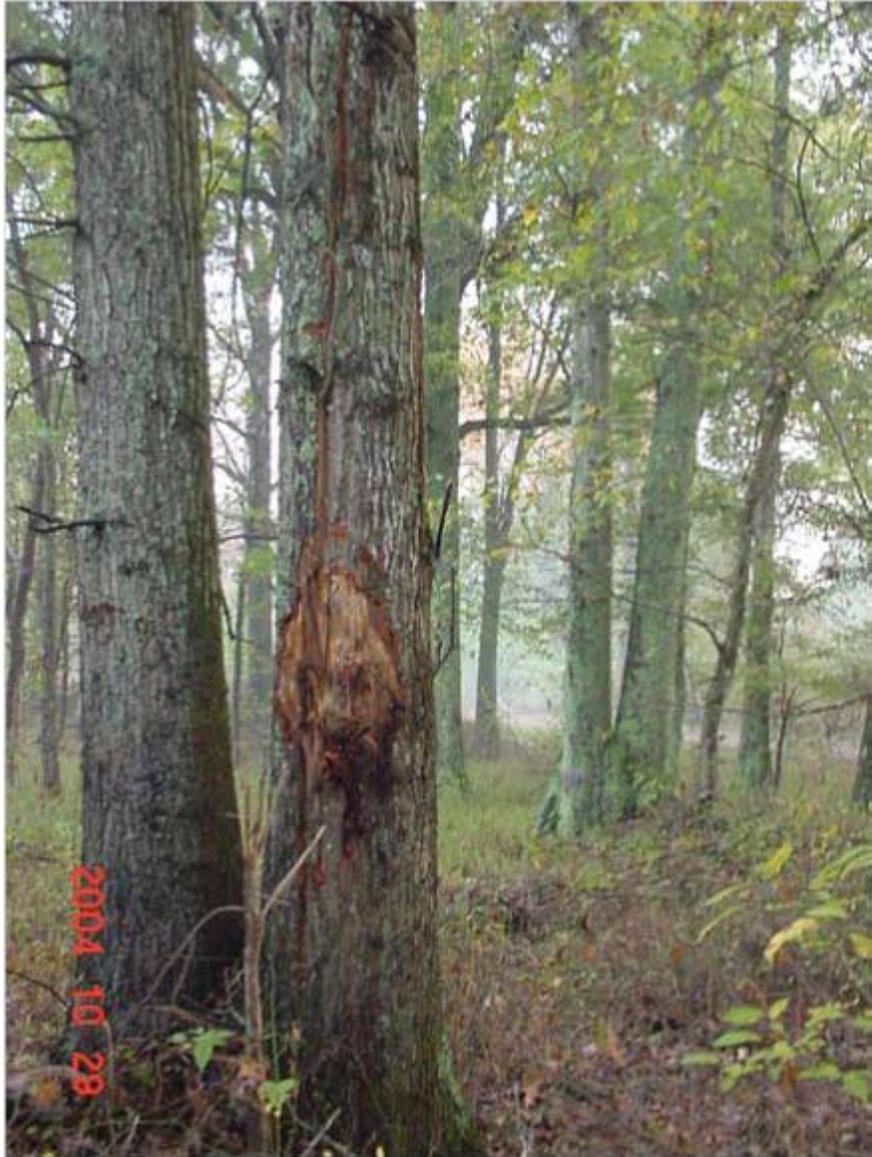
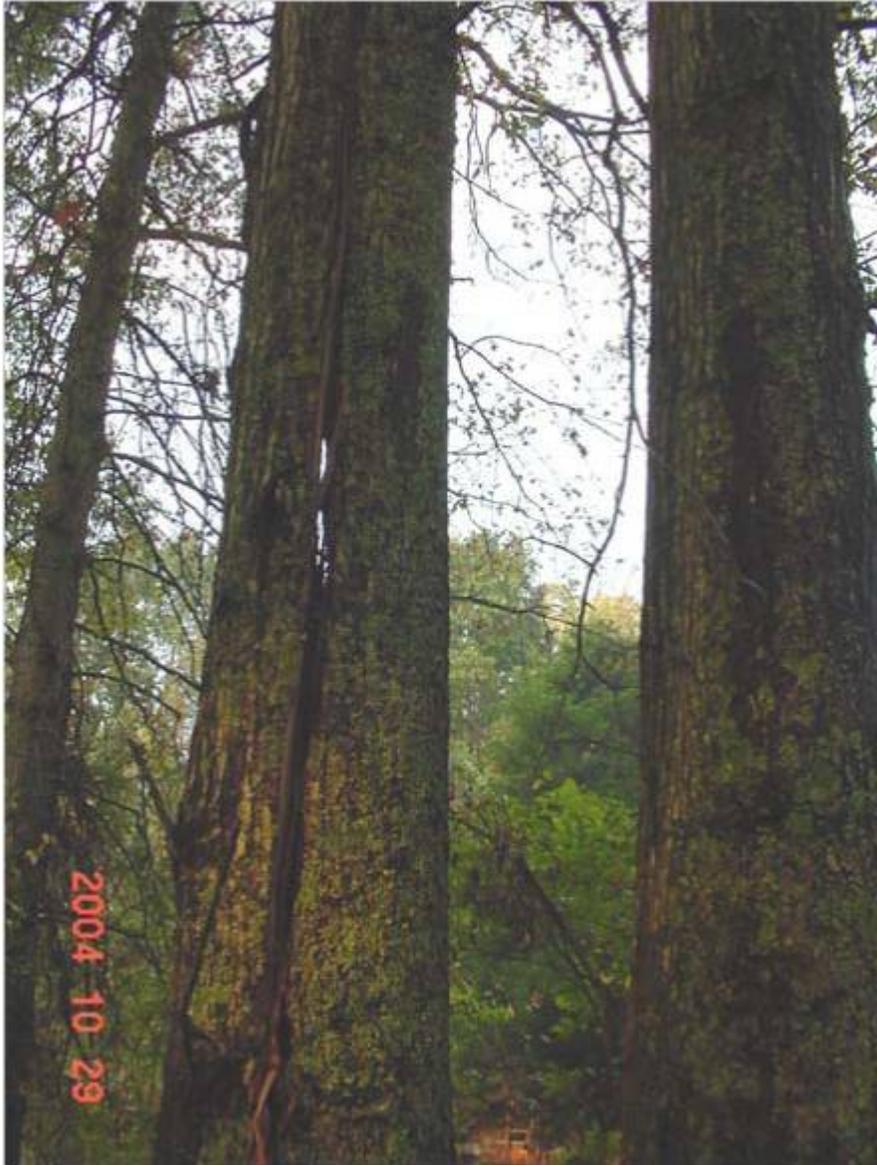
(a) Tree impacted by debris shown in (c).

FIGURE 47. Tree Impacted by Debris.

(b) Another view of the tree showing damage.

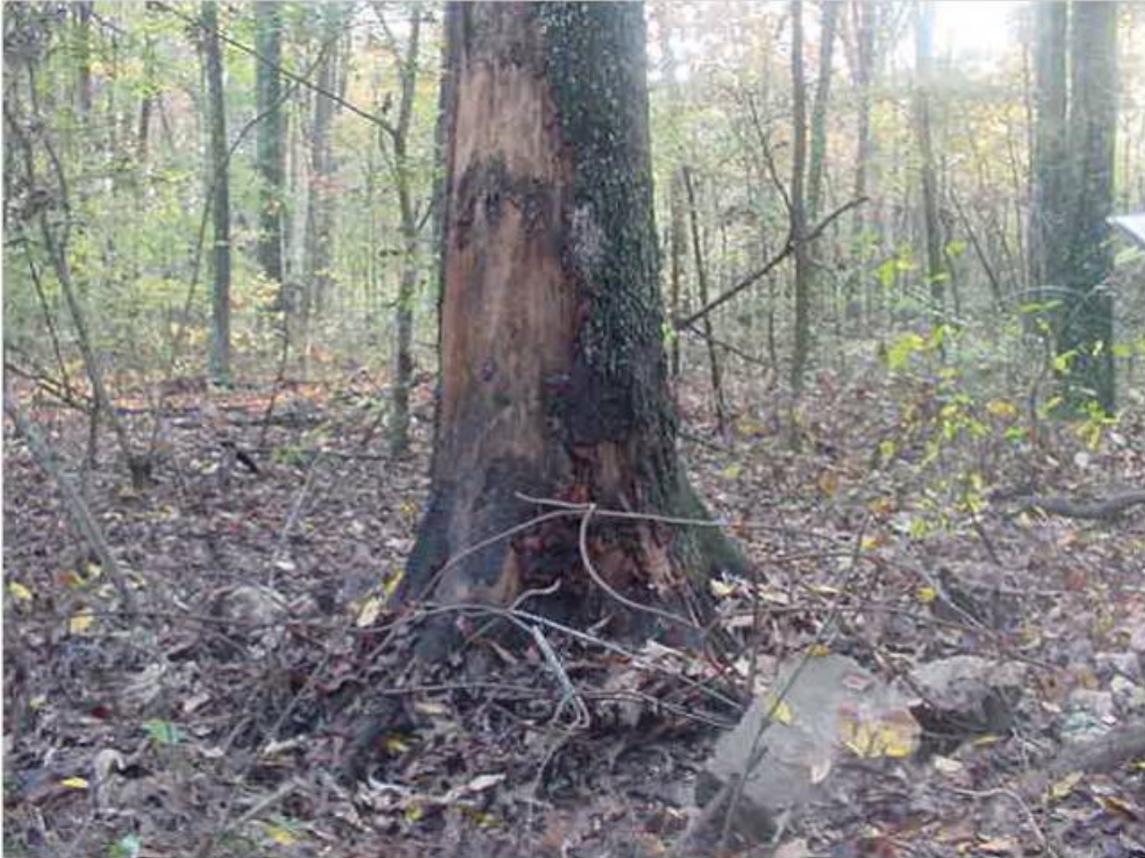
Other debris estimated to have been a 6- by 8-foot section from the head wall significantly damaged a tree 3,100 feet from ECM-69 shown in Figure 48. Obviously, this is well beyond the 1,250-foot IBD arc.

FIGURE 48. Tree Approximately 3,100 Feet From P-69 That was Impacted by an Estimated 6- by 8-Foot Section From the Head Wall of P-69.

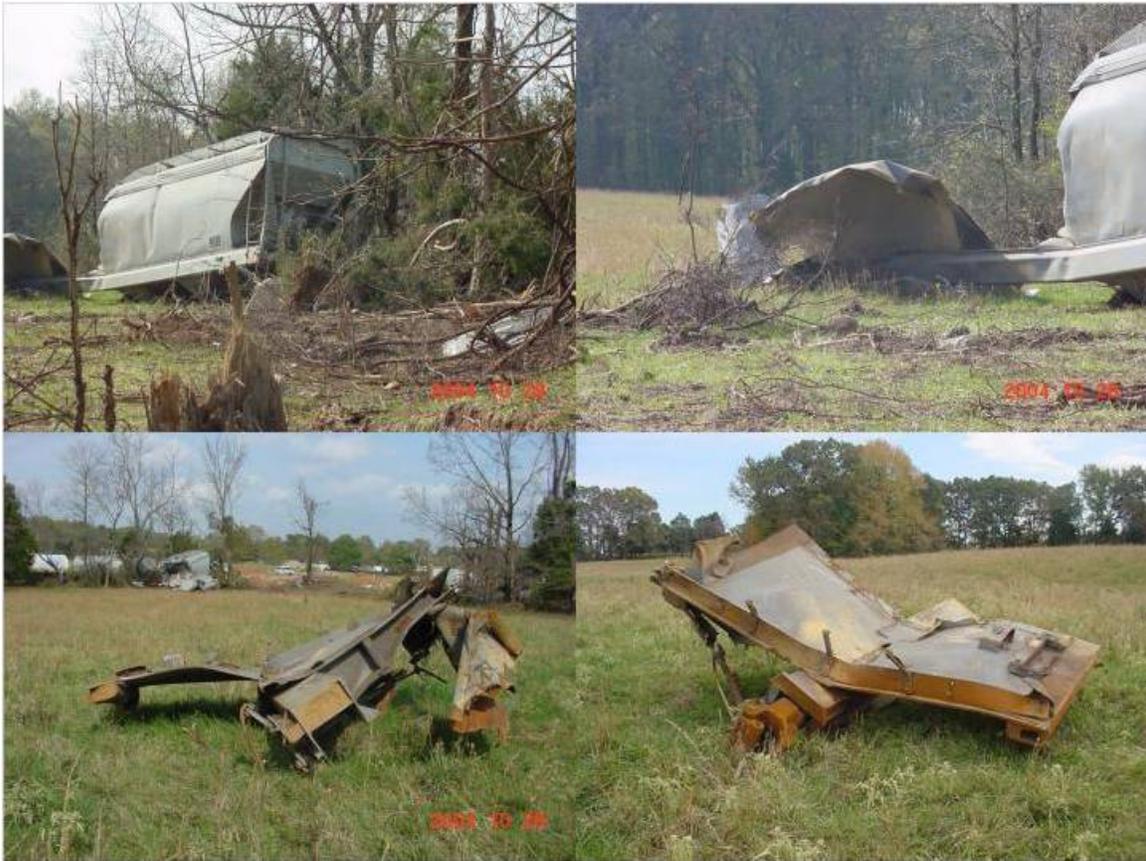
In addition to fragments from ECM-69, there was also damage to railcars. The railcar pictured in Figure 49 was located on the rail line that serviced ECM P-69. As shown in Figure 49, there was significant damage to the railcar and many large steel fragments were torn from it and projected long distances.

FIGURE 49. Railcar That Had Been Located on Rail Line That Serviced ECM P-69.

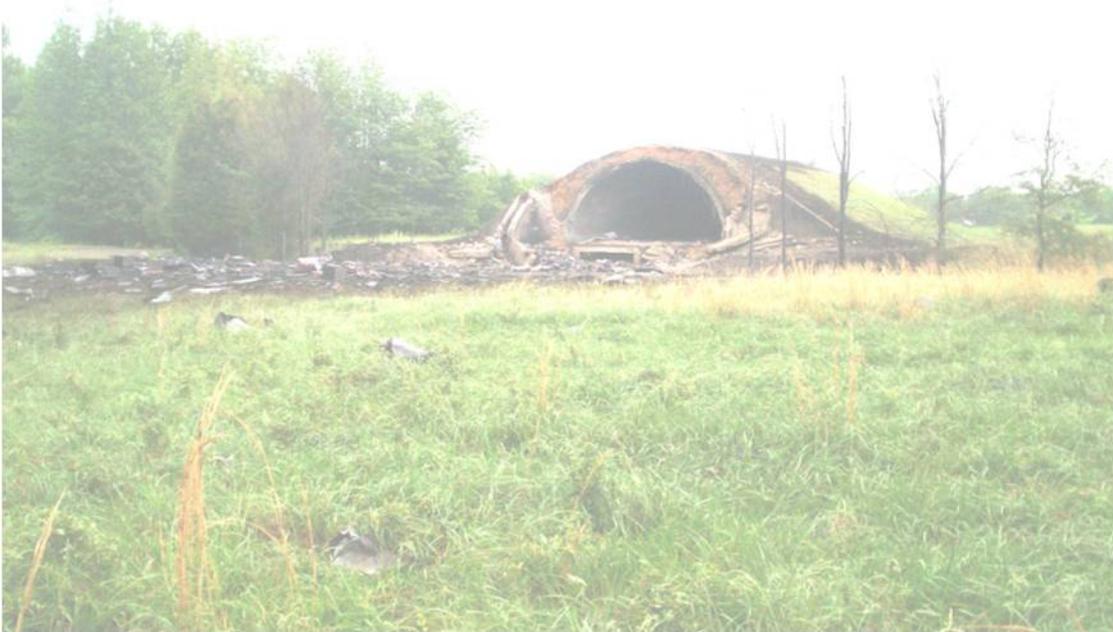
FIGURE 54. ECM With Head Wall Blown Out and Debris Scattered.

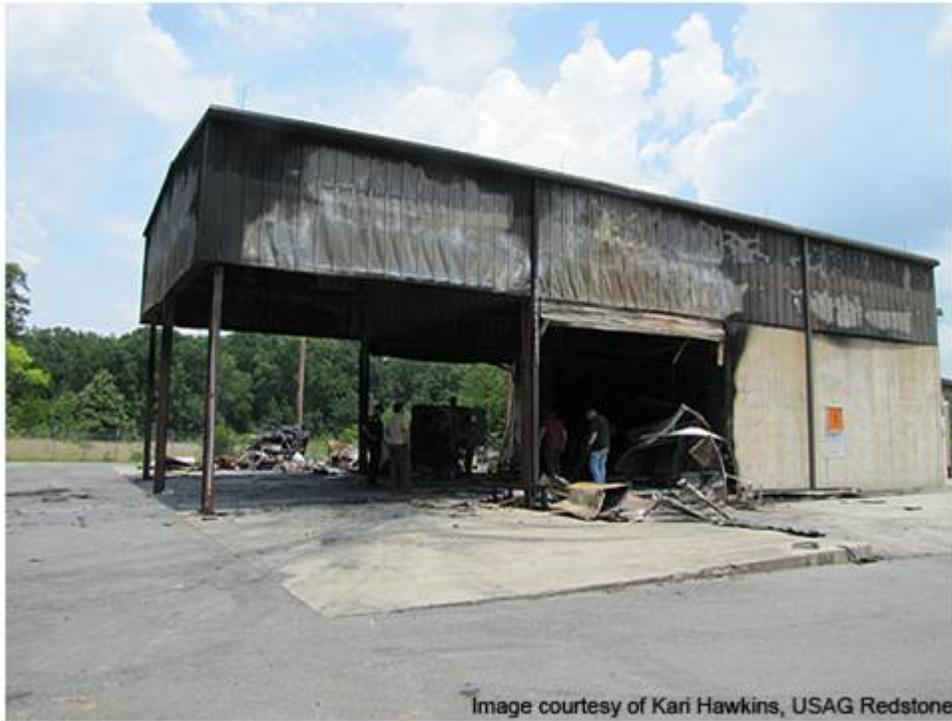
A fire broke out in Building 7298 in the Redstone Arsenal Test Center at 11:55 a.m. on 13 July 2010. No one was hurt and everyone was accounted for. Flames caused partial damage to the building but firefighters worked quickly to keep the damage from spreading. While the fire was contained, it was allowed to smolder until the next day. There were no explosions. The cause of the fire was unknown. On 15 July, it was reported that Redstone Test Center personnel were conducting a Hellfire missile test at the time the fire was reported. Figure 61 shows the damage from the fire to Building 7298.

FIGURE 61. Damage to Building 7298, Redstone Arsenal,  
Due to Fire on 13 July 2010.

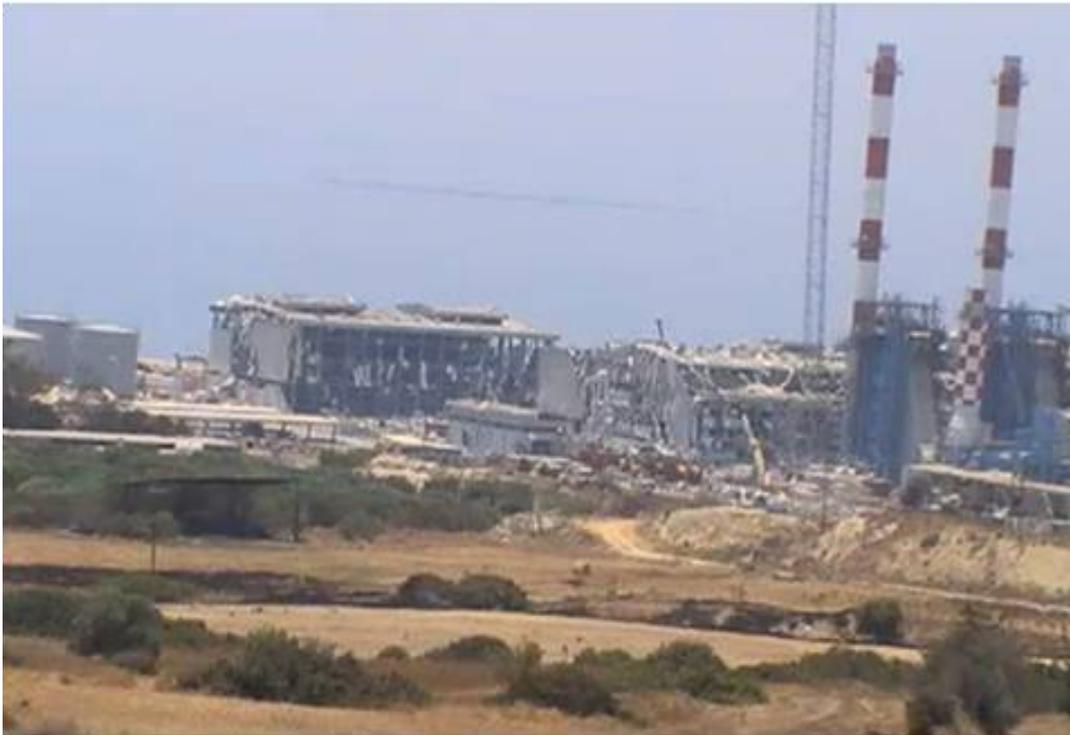
FIGURE 75. Damage to Vassilikou Power Plant.
