# **Realistic Safe-Separation Distance Determination for Mass Fire Hazards**

Thomas L. Boggs  
*New Directions Technology, Inc.*  
*Ridgecrest, CA 93555*

Kevin P. Ford  
*Energetics Research Division*  
*Weapons and Energetics Department*  
*Naval Air Warfare Center Weapons Division*  
*China Lake, CA 93555*

**MARCH 2013**

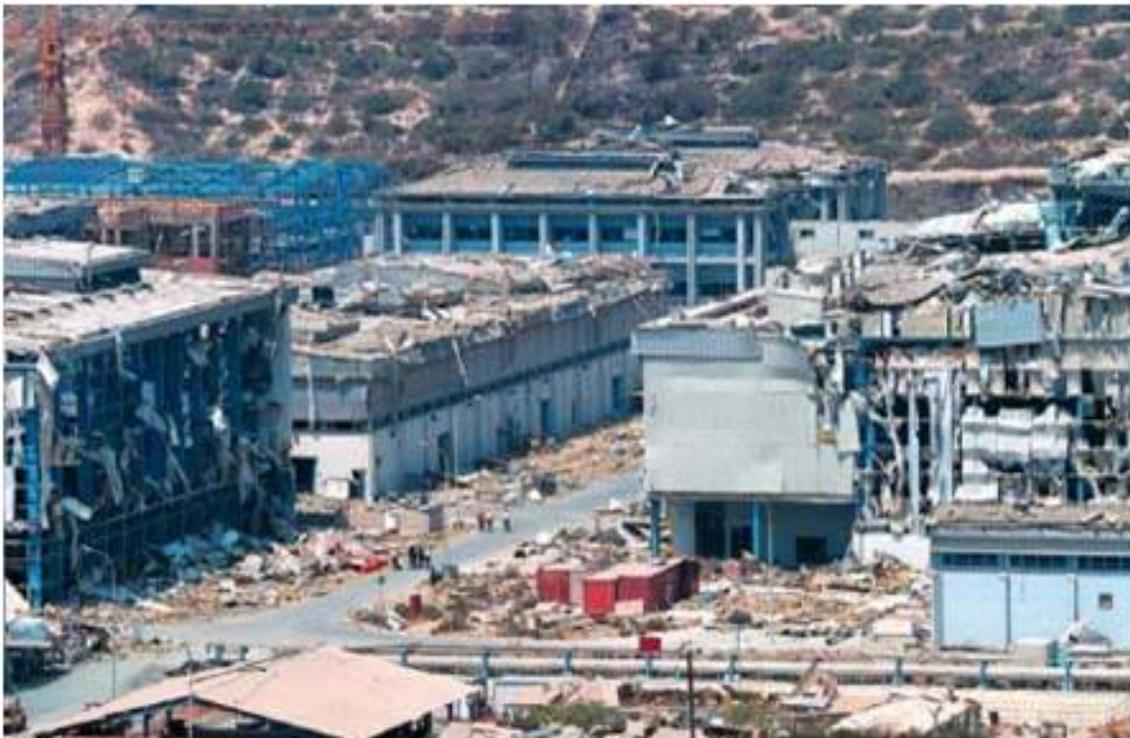
FIGURE 76. Damage to Vassilikou Power Plant.

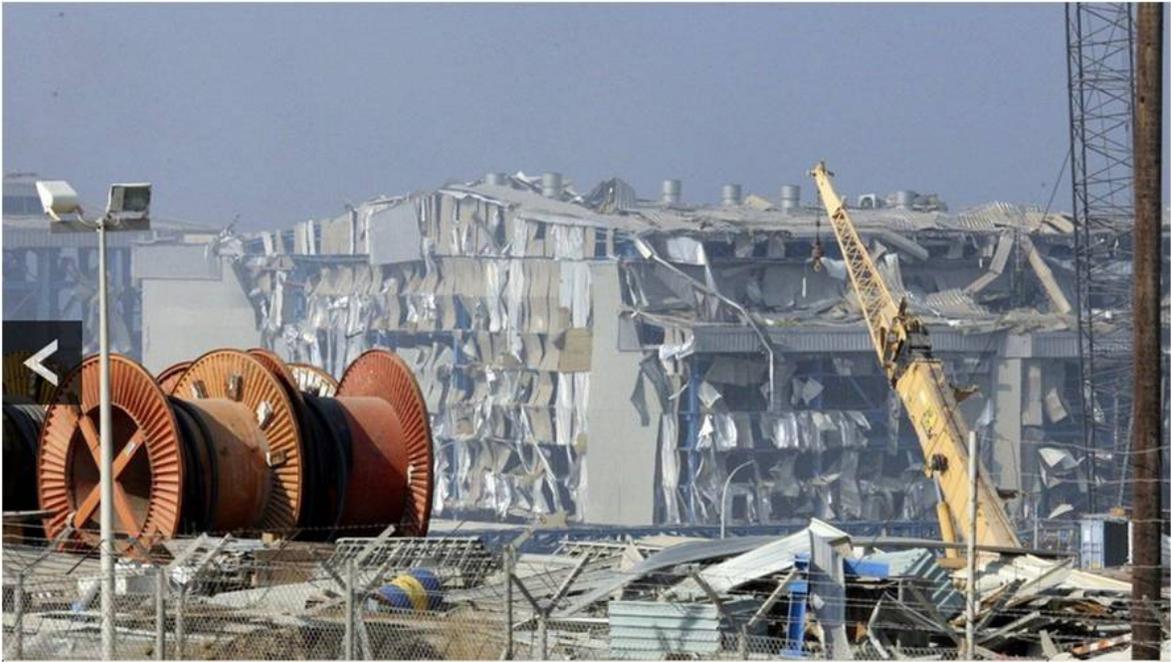
FIGURE 77. Damage to Vassilikou Power Plant.

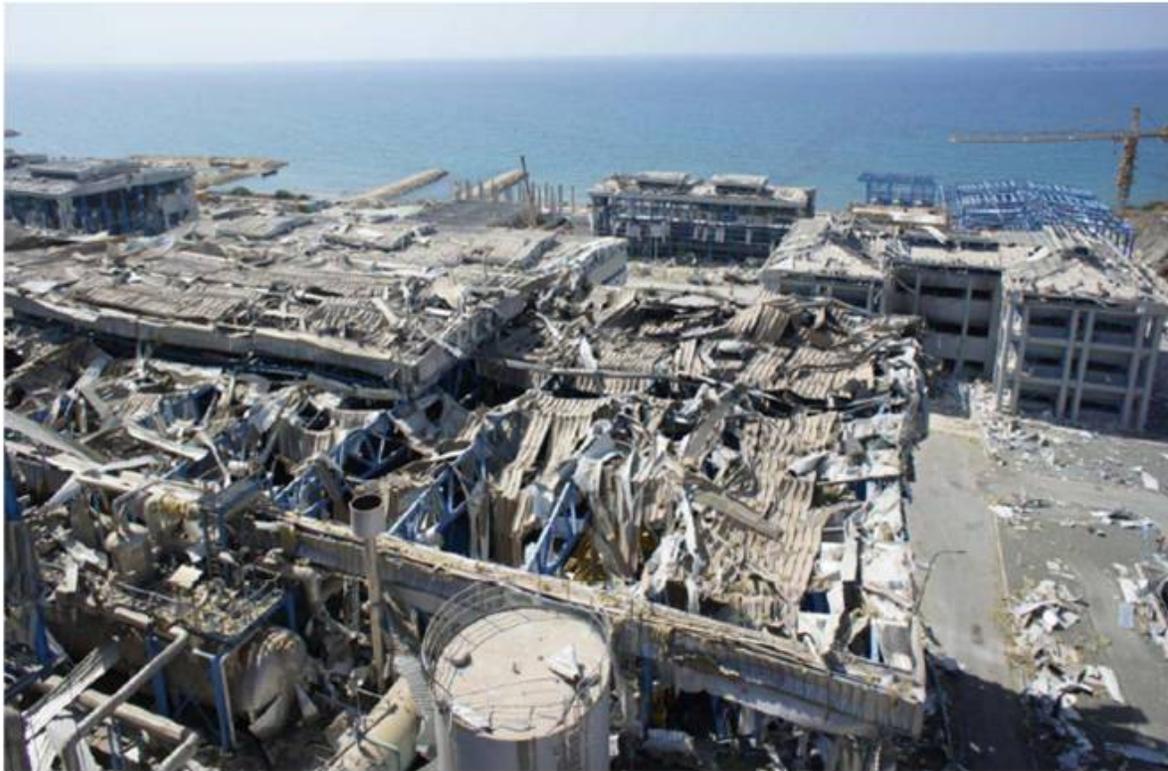
FIGURE 79. Damage to Vassilikou Power Plant.

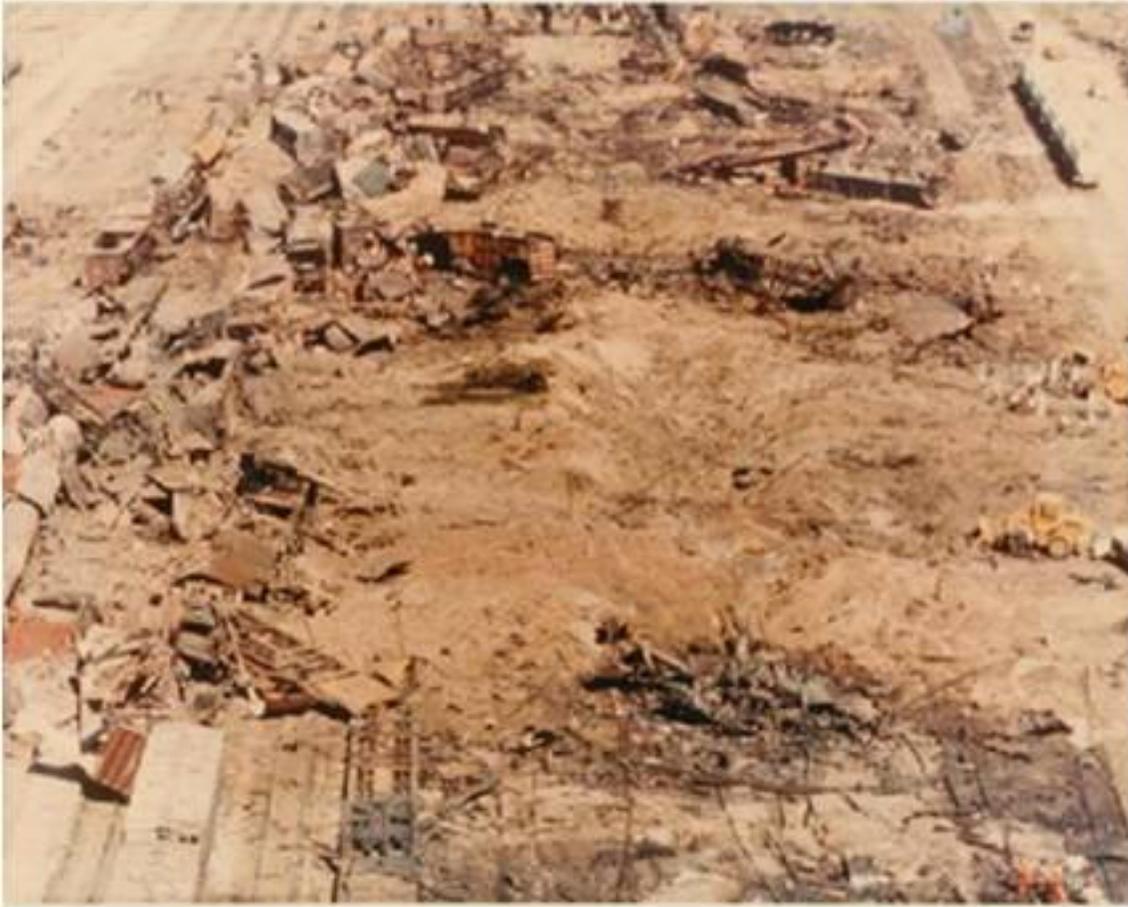
FIGURE 85. Aerial View Showing Damage at Roseville Railyards, 28 April 1973.

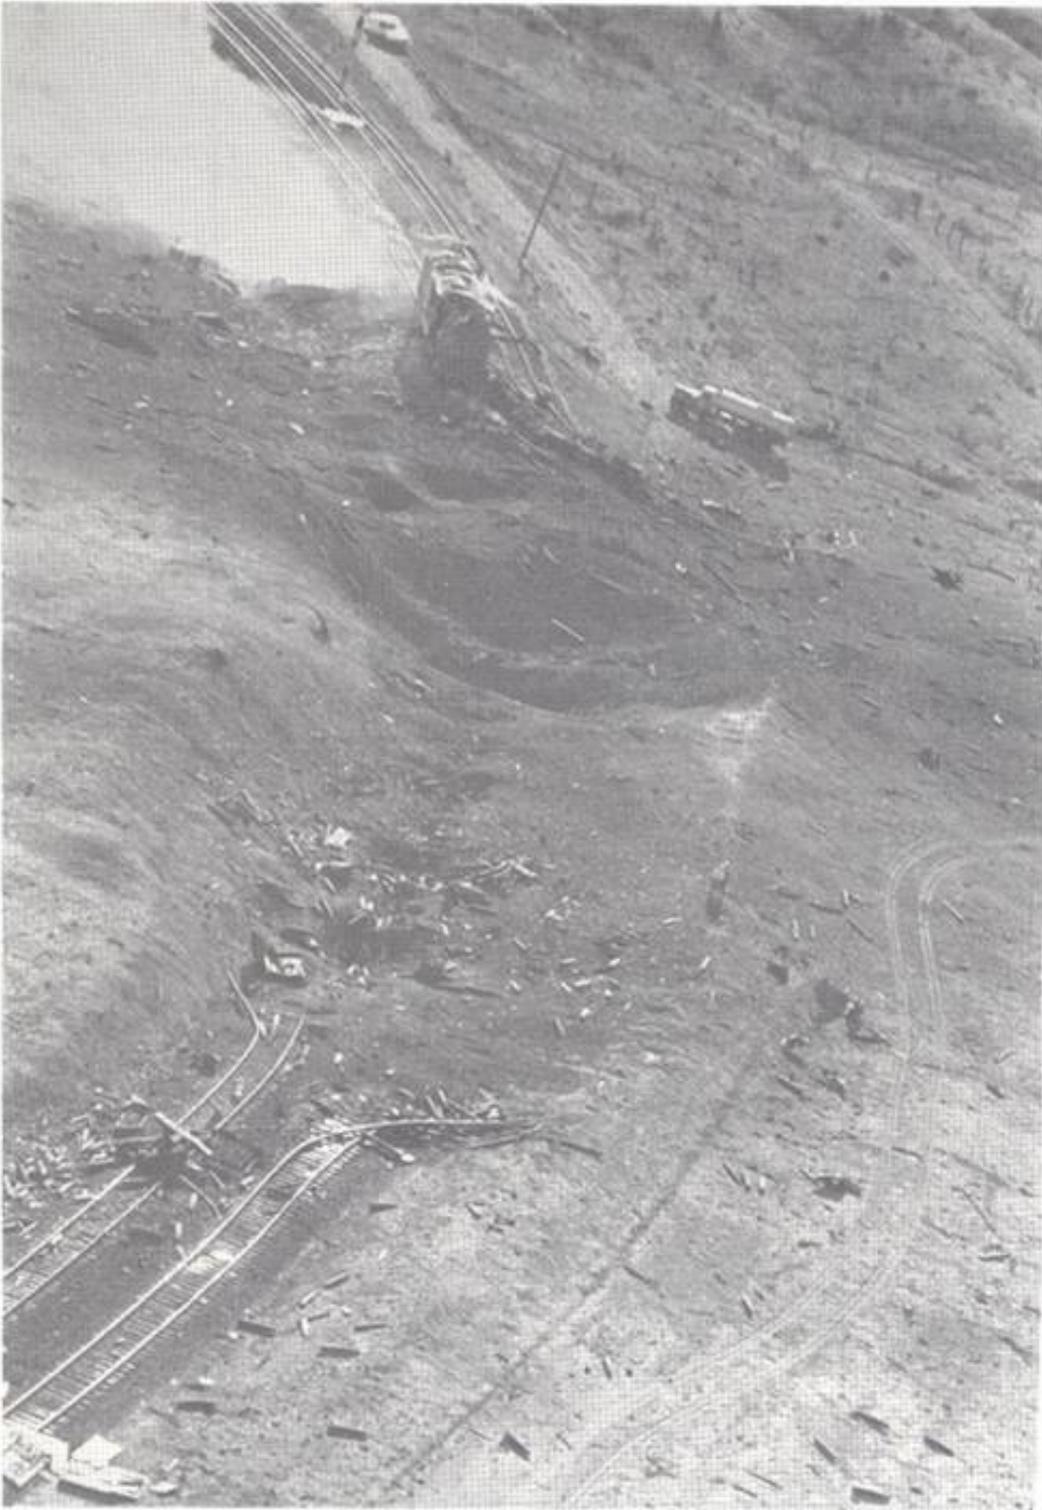
FIGURE 87. Aerial View Showing the Damage From the Accident Near Benson, Arizona, 24 May 1973.

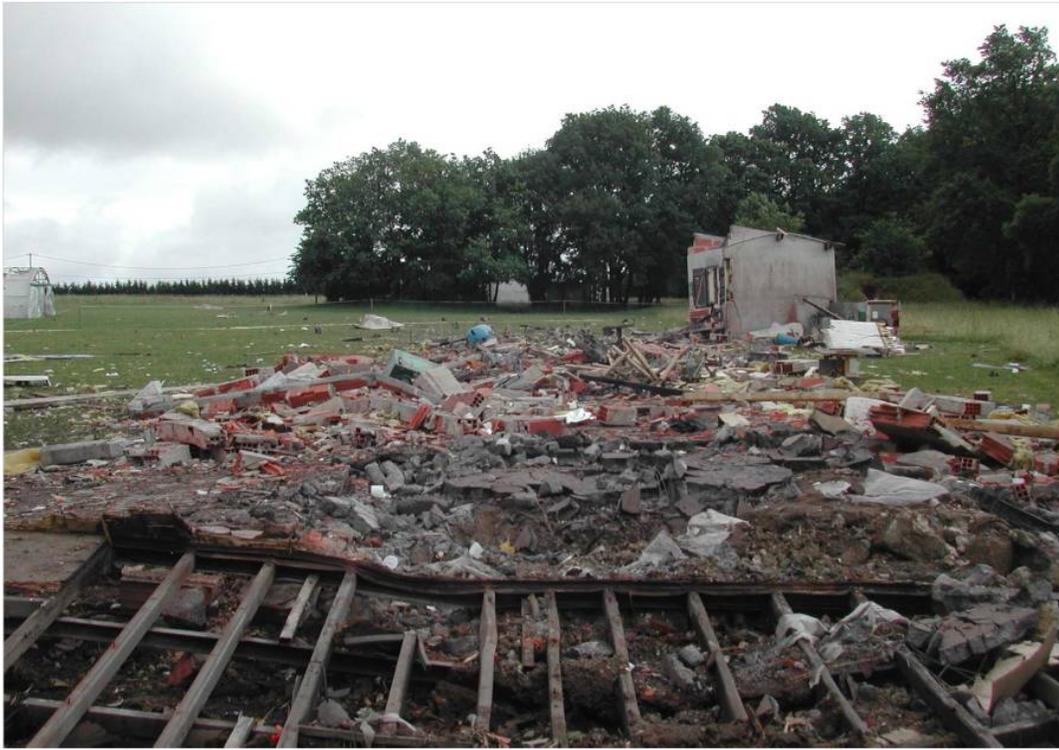
FIGURE 103. Remains of Building 9 After the Accident.

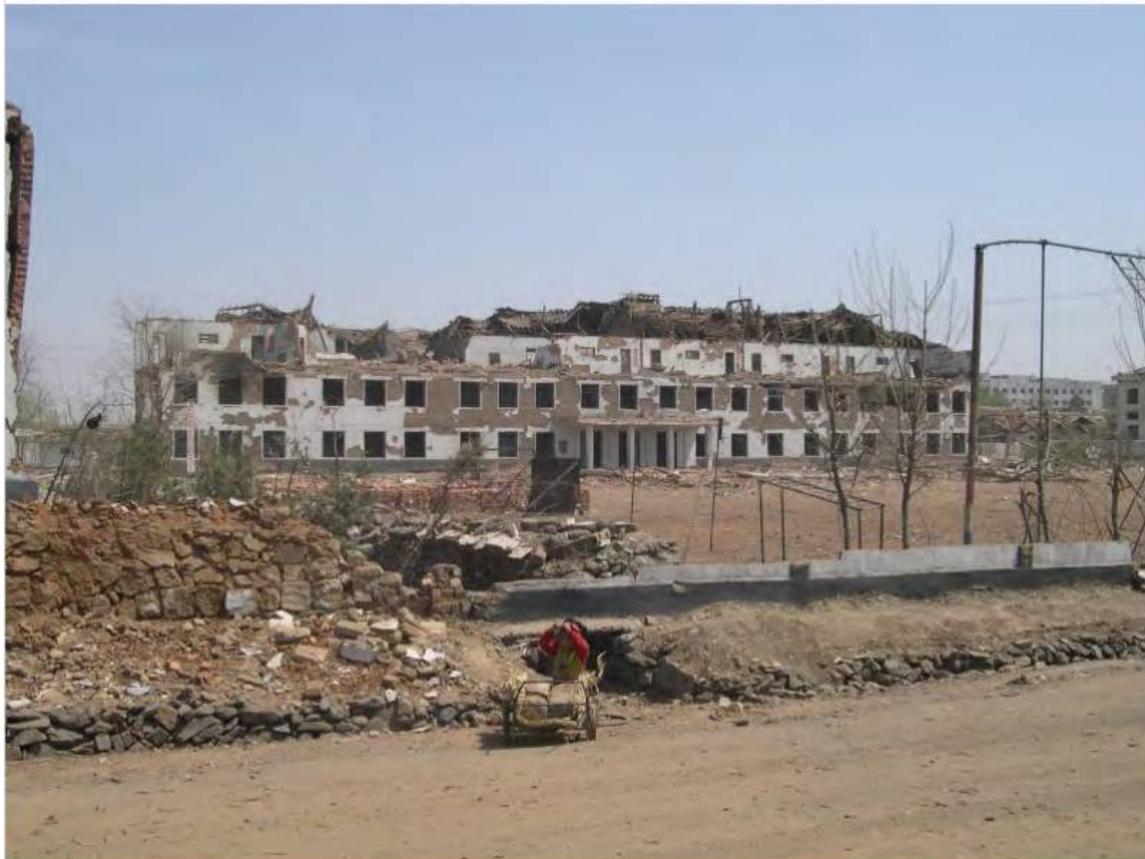
FIGURE 121. Damage to the Ryongchon Primary School.  
<http://www.cdc.gov/niosh/mining/pubs/pdfs/arorai.pdf>

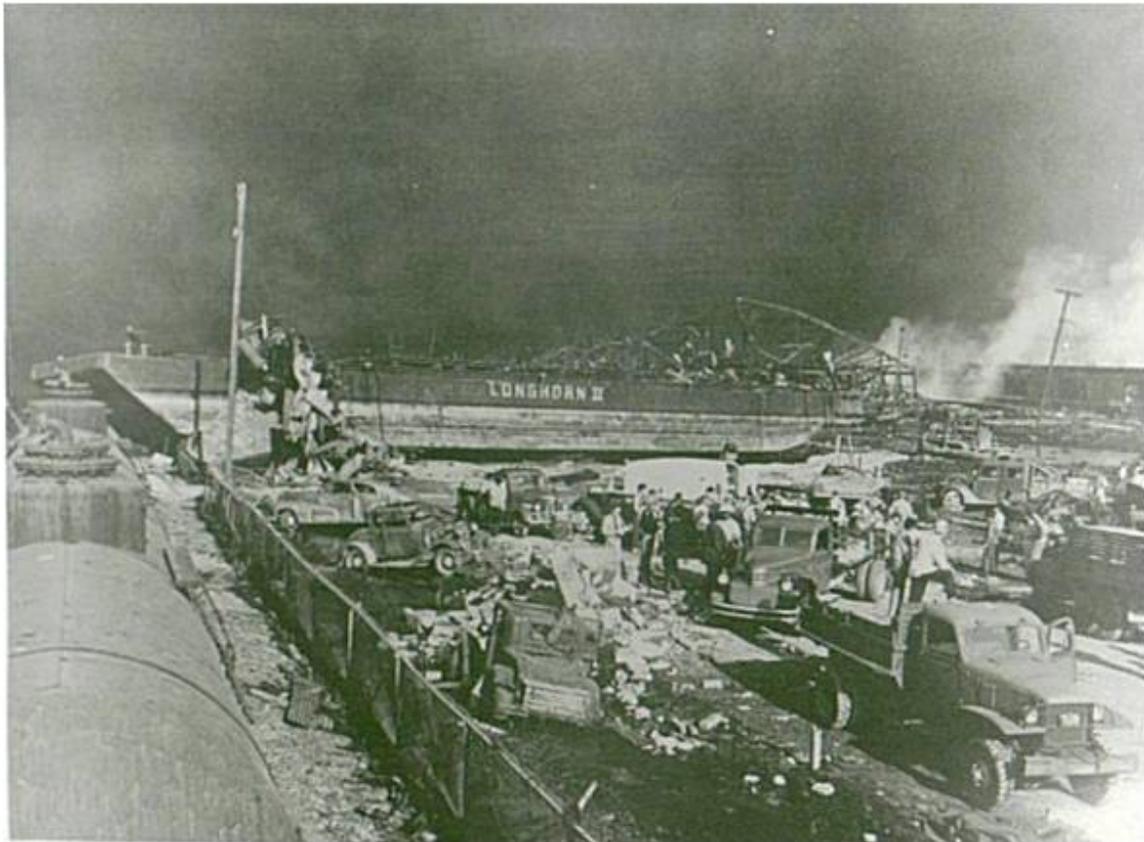
FIGURE 125. Barge *Longhorn II* was Picked up and Carried About 200 Feet Inland by the Tidal Wave Caused by the Blast Caused by the Explosion of the *Grandcamp*.

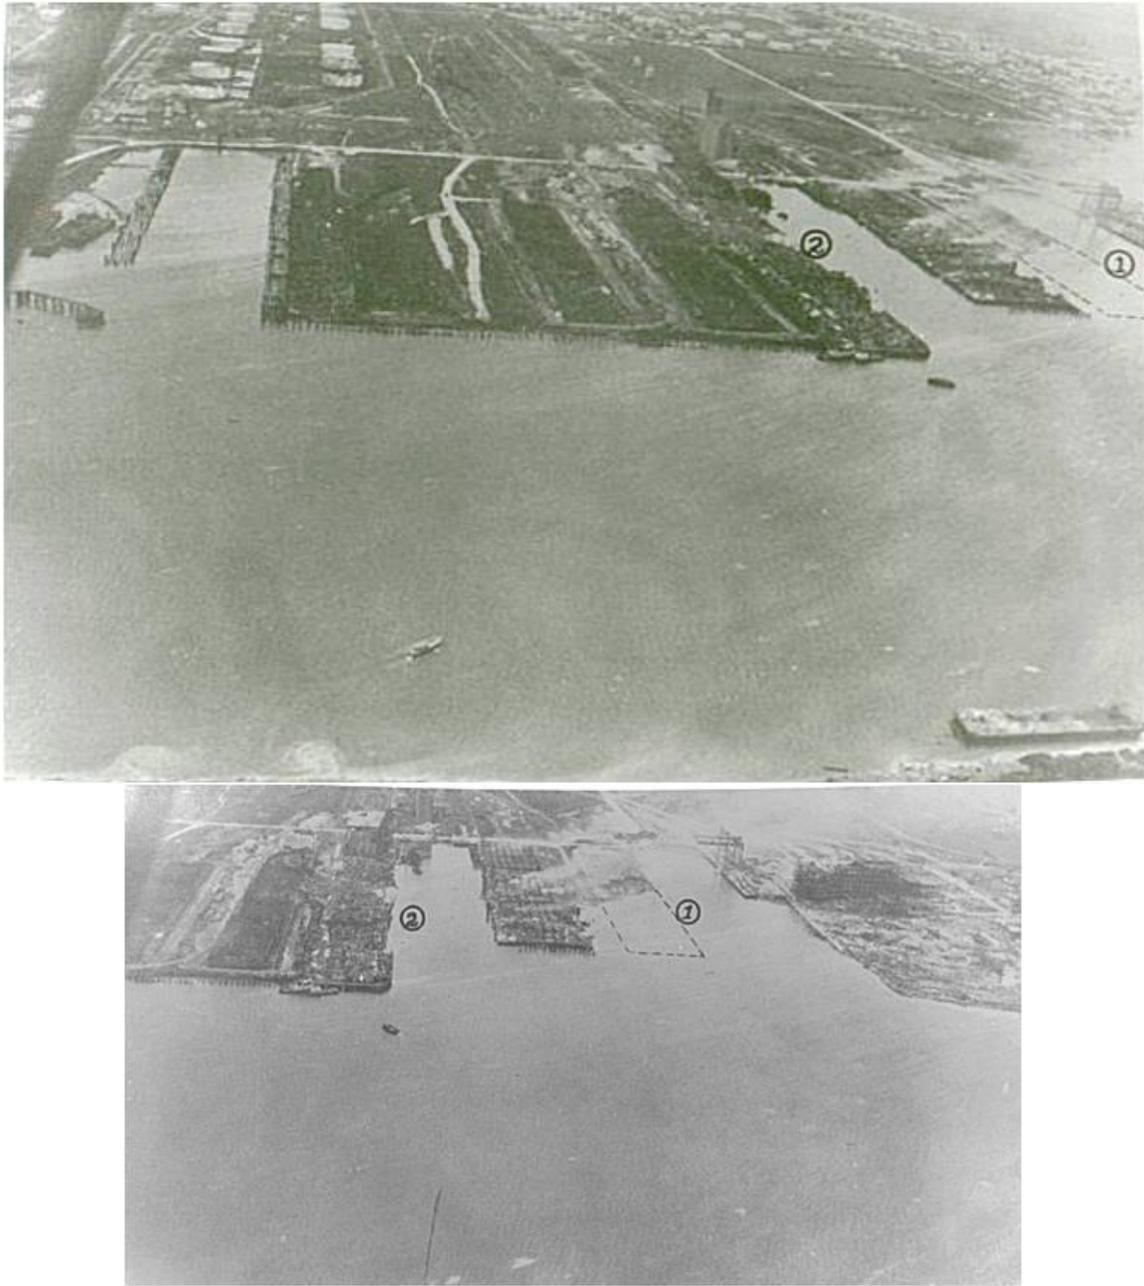
FIGURE 127. Texas City Port Area After the Disaster.

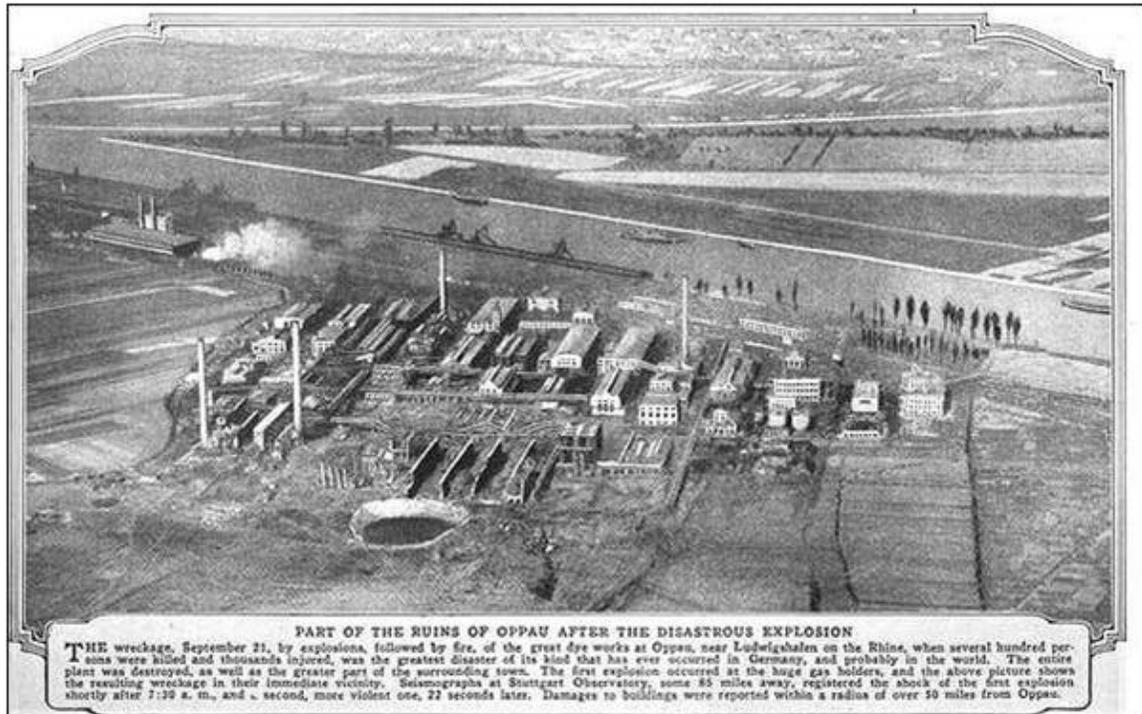
FIGURE 132. BASF Plant After the Explosion. The crater and extent of damage are apparent. This was from *Popular Mechanics Magazine* 1921.

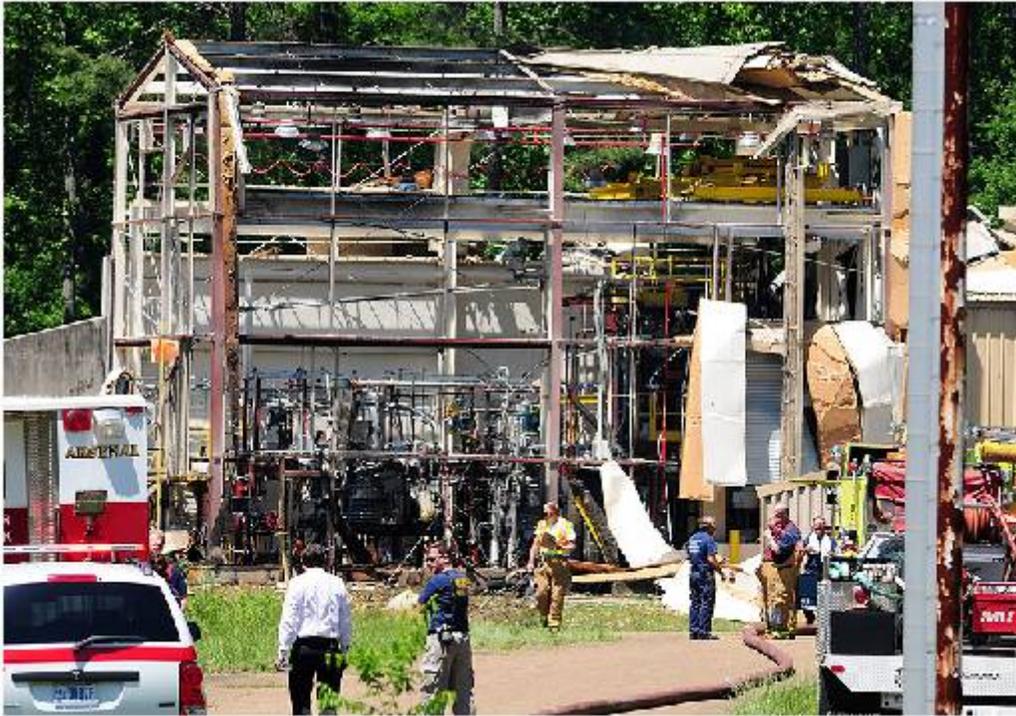
FIGURE 143. Damage to Building 7352, Redstone Arsenal From Explosion That Occurred 5 May 2010.

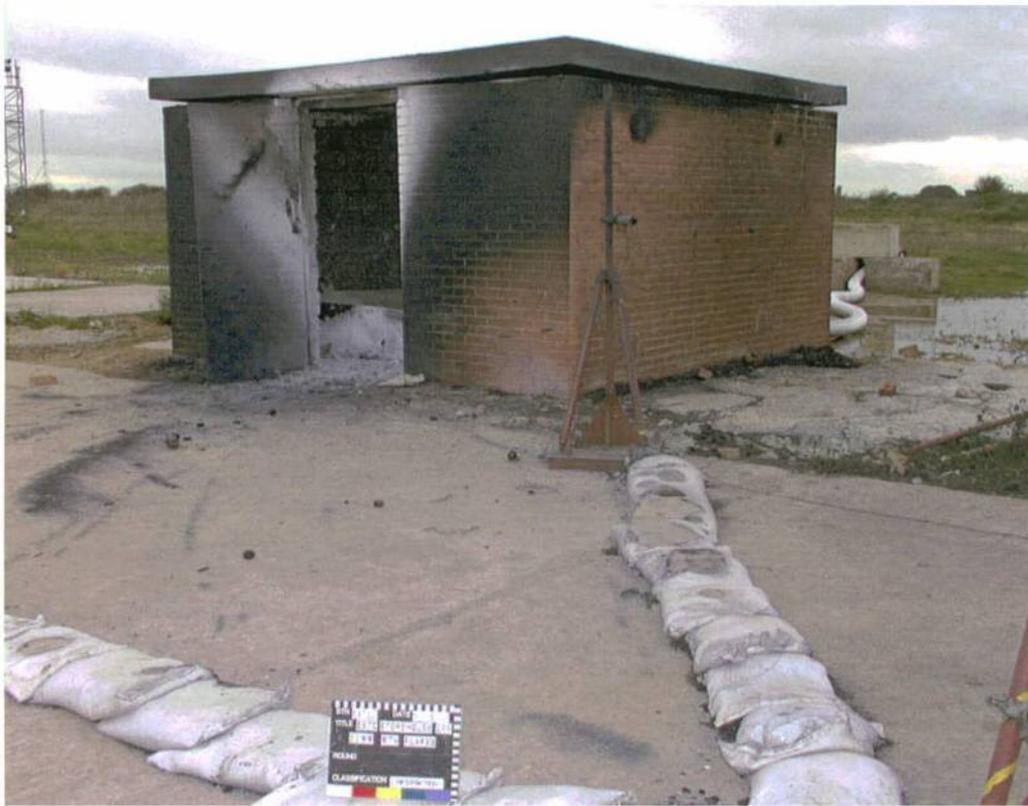
FIGURE 164. Storage Building After Test With 55-mm MTV Flares Subject to Standard Liquid Fuel Fire (Reference 50).

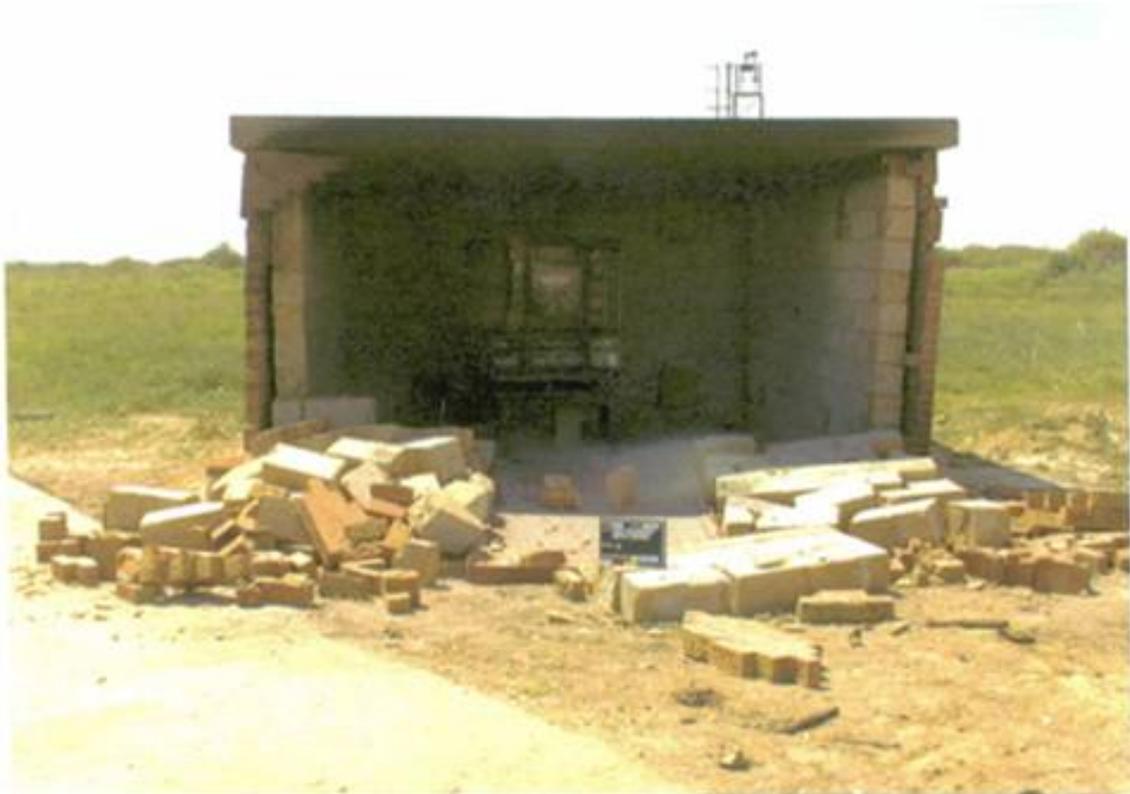
FIGURE 167. Effects of Functioning 120-mm Propelling Charges When Contained Within an Explosive Storehouse Structure, View of Front of Magazine (Reference 50).
