Investigation of the Corrosion Mechanism and Determination of the EMS Estimated Service Life at Site 81

February 2013

Final report

Prepared for U.S. Army Corps of Engineers
Europe District
CMR 410, Box 1, APO, AE 09049

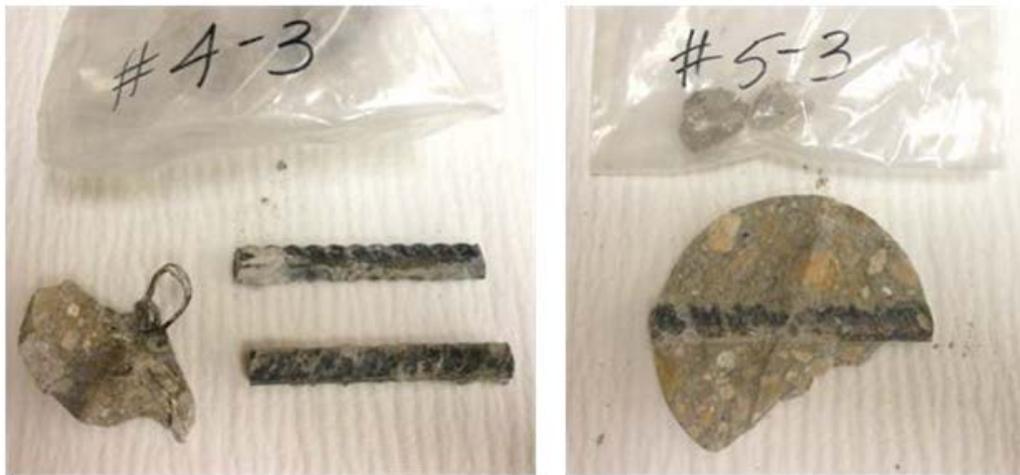
Results from acid-soluble chloride analysis are presented in Table 1 and Table 2 for each of the sixteen concrete cores at 0–1 in., 1–2 in., and 2–3 in. depths from the surface. Chloride content ranges from 0.097–2.068 lb/yd³. However, all but the topmost layer in sample #1 were below the threshold limit of 1 to 2 lbs/yd³ of concrete necessary to initiate corrosion. 11 of the 16 cores tested had no definable increase in chloride ion concentration from the 3 in. level up through the 2 in. level to the 1 in. depth. Because the GSL team had no knowledge of the configuration and location of concrete cores taken at Site 81, conclusions related to potential exposure conditions and chloride ingress trends could not be made. Reinforcing bars extracted from cores showed signs of minor corrosion (Figure 15); however, this condition most likely was due to atmospheric corrosion prior to or during original installation of the rebar. Corrosion of the reinforcing steel's exposed surface at the exterior of concrete cores was also noted; however, such corrosion likely occurred following the coring process when the steel was exposed to neutral pH water and oxygen.

Figure 15. Segments of reinforcing steel extracted at 2-3 in. depth from core sample #4 (left) and core sample #5 (right) with both showing minor surface corrosion.

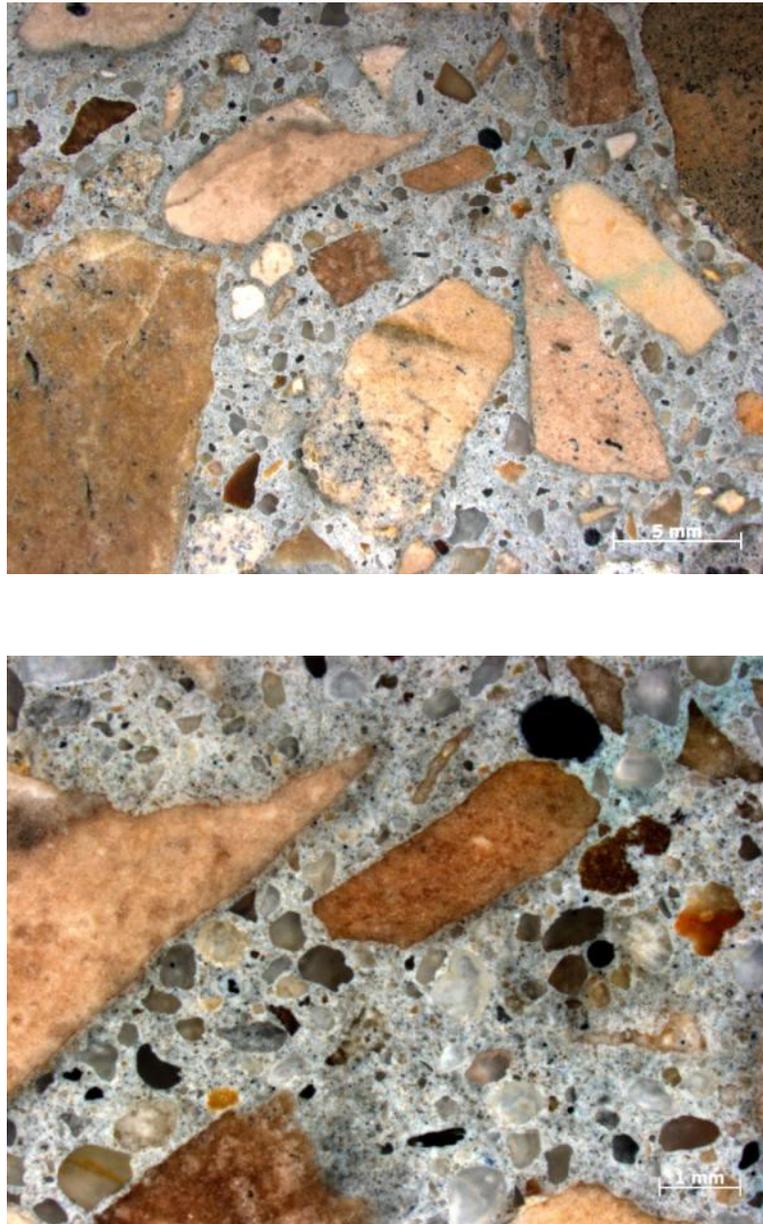
Figure 16. Photomicrographs of core sample #1 (5x above; 15x below).

Images of concrete from core sample #1 are shown in Figure 16. The concrete appears to be composed of an angular coarse and subangular-shaped fine aggregate of unknown composition. There appears to be very little air in the concrete. The concrete appears quite competent, with no visible cracks or signs of chemical reactions.

- Chlorides were found to be present in measureable quantities in each core analyzed, with contents ranging from 0.097–2.068 lb/yd³. Chloride contents in all but sample #1 were below the level of approximately 1–1.5 lb/yd³ of concrete necessary for initiation of corrosion of the embedded reinforcing steel. Further, Chloride contents generally did not decrease with depth from the surface. No corrosion was evident on reinforcing steel bars and fibers extracted from concrete cores during the crushing process.

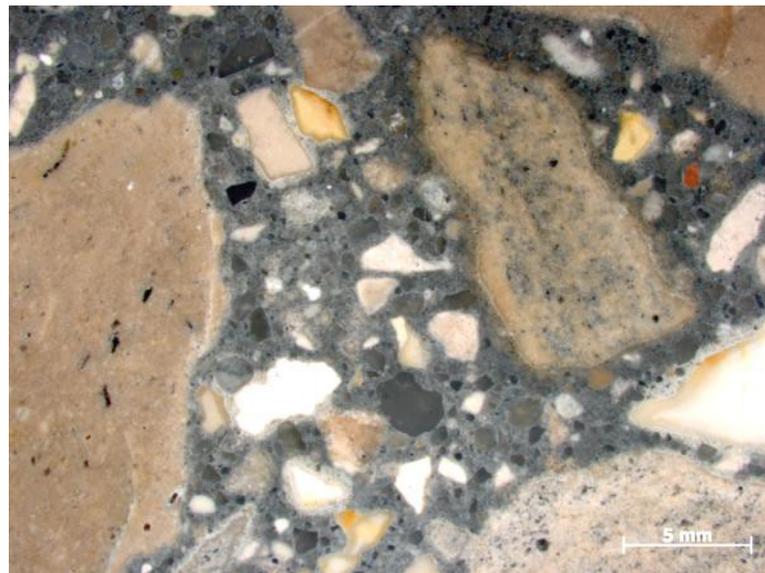
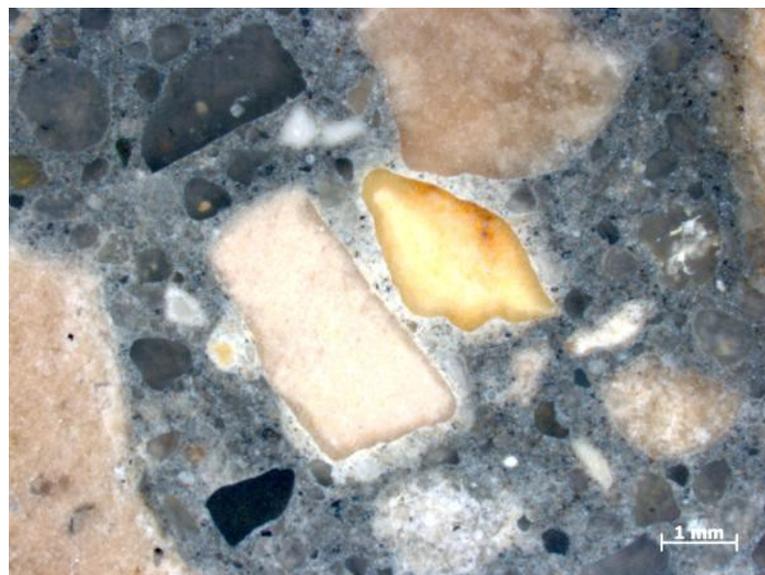
Figure 17. Photomicrographs of core sample #3 (5x above; 15x below).

Images of concrete from core sample #3 are shown in Figure 17. The concrete appears to be composed of an angular coarse and subangular-shaped fine aggregate of unknown composition. There appears to be very little air in the concrete. Although the concrete appears competent with no visible cracks, there are areas in the cement paste around selected aggregate particles that are lighter in color than the surrounding paste.

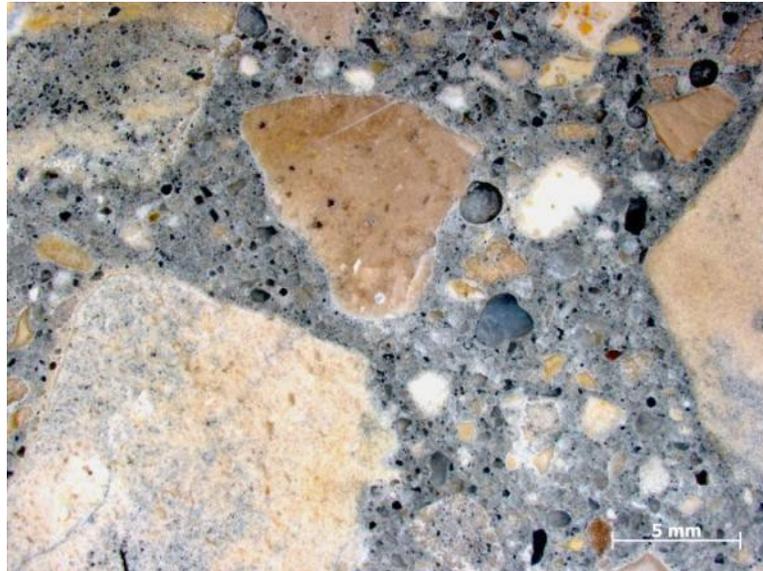
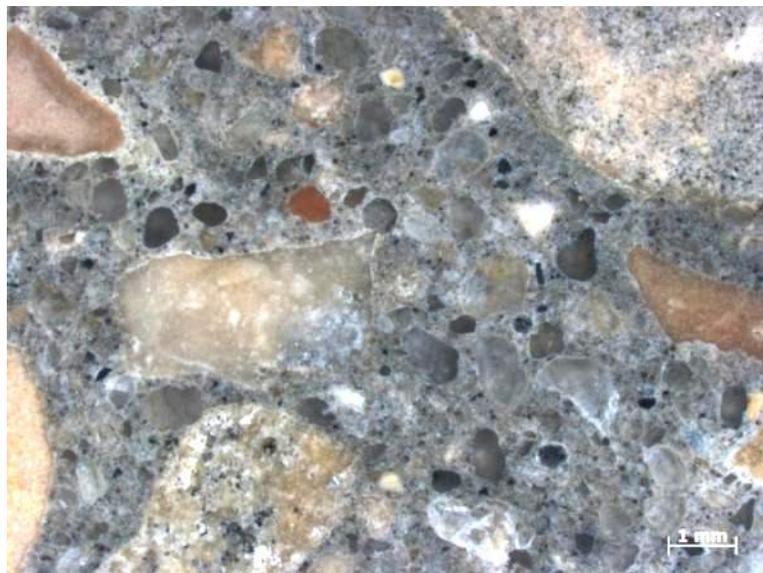
Figure 18. Photomicrographs of core sample #4 (5x above, 15x below).

Images of concrete from core sample #4 are shown in Figure 18. The concrete appears to be composed of an angular coarse and subangular-shaped fine aggregate of unknown composition. Some entrapped air is visible in the concrete. The concrete appears quite competent, with no visible cracks or signs of chemical reactions.

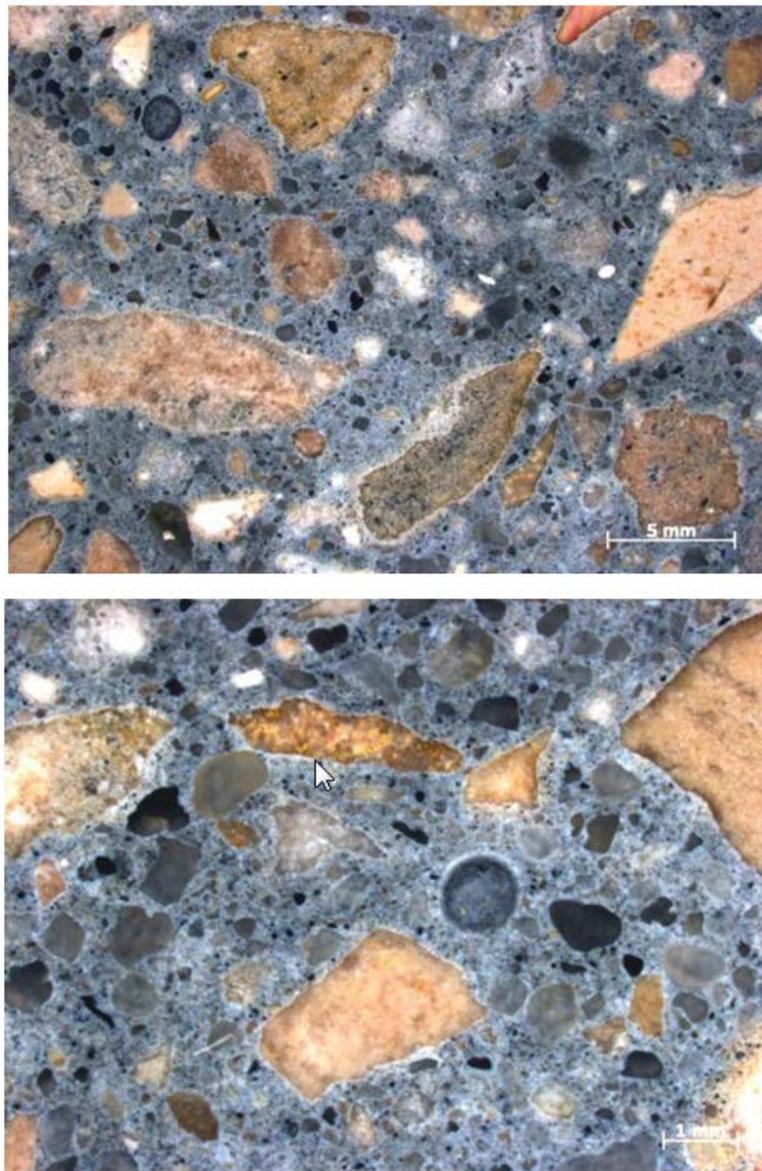
Figure 19. Photomicrographs of core sample #5 (5x above, 15x below).

Images of concrete from core sample #5 are shown in Figure 19. The concrete appears to be composed of an angular coarse and subangular-shaped fine aggregate of unknown composition. There appears to be very little air in the concrete. Although the concrete appears competent with no visible cracks, there are areas in the cement paste around selected aggregate particles that are lighter in color than the surrounding paste.

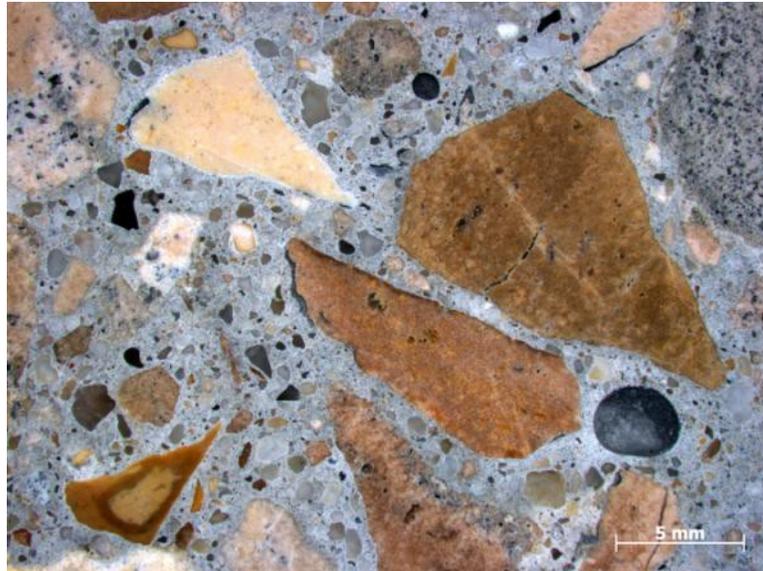
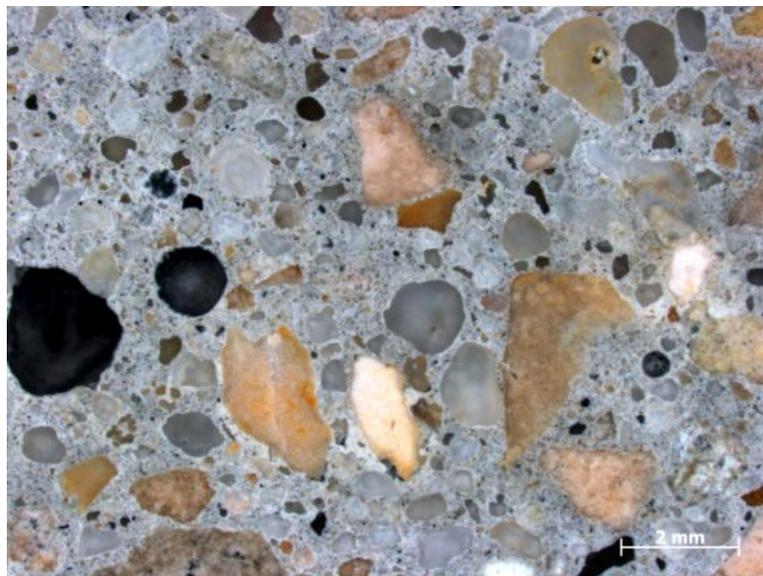
Figure 20. Photomicrographs of core sample #6 (5x above, 15x below).

Images of concrete from core sample #6 are shown in Figure 20. The concrete appears to be composed of an angular coarse and subangular-shaped fine aggregate of unknown composition. There appears to be very little air in the concrete. The concrete appears quite competent, with no visible cracks or signs of chemical reactions.

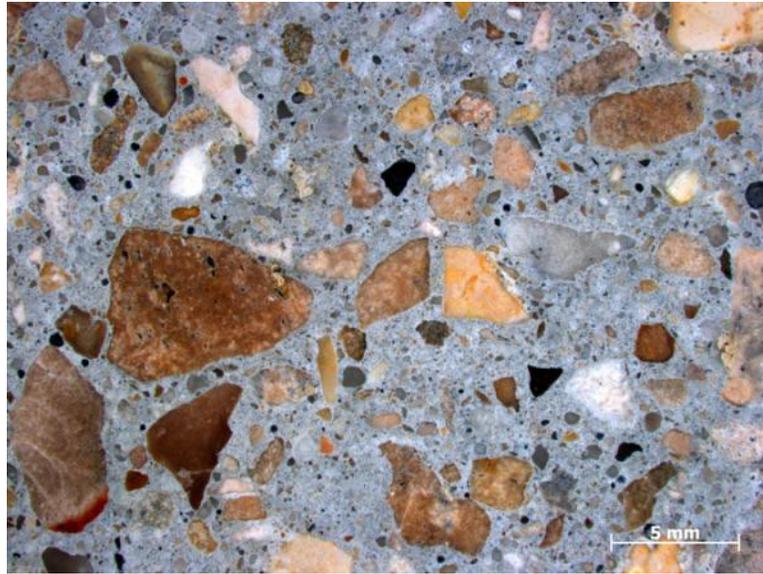
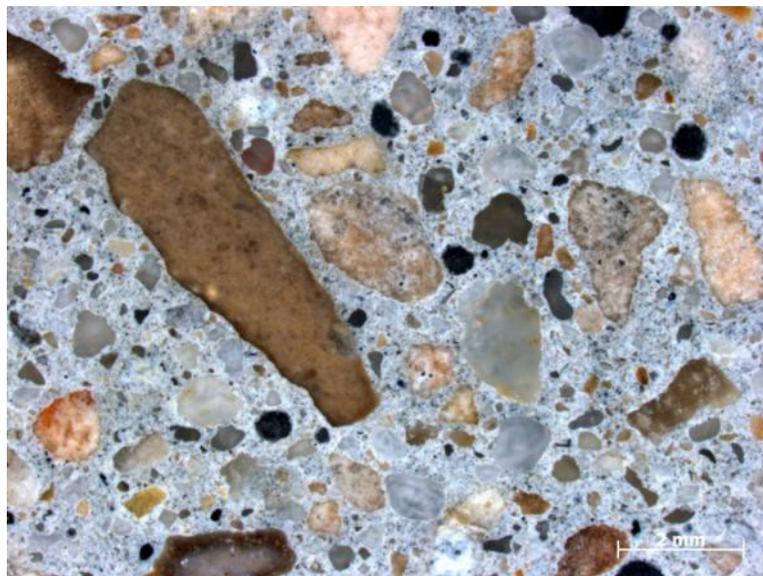
Figure 21. Photomicrographs of core sample #7 (5x above, 15x below).

Images of concrete from core sample #7 are shown in Figure 21. The concrete appears to be composed of an angular coarse and subangular-shaped fine aggregate of unknown composition. There appears to be very little air in the concrete. The concrete appears quite competent, with no visible cracks or signs of chemical reactions.

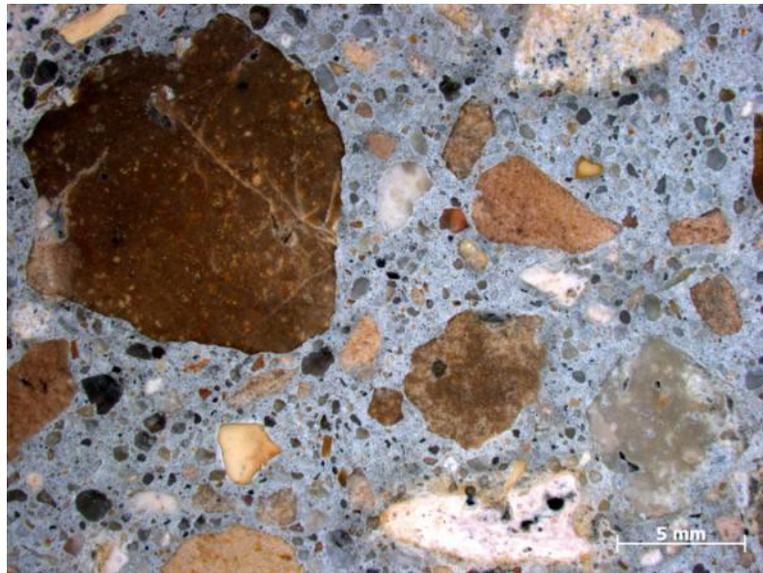
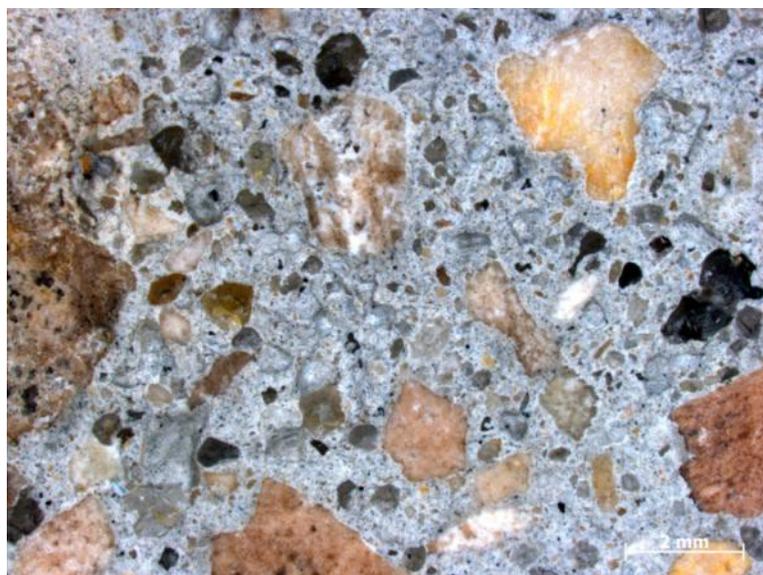
Figure 22. Photomicrographs of core sample #8 (5x above, 15x below).

Images of concrete from core sample #8 are shown in Figure 22. The concrete appears to be composed of an angular coarse and subangular-shaped fine aggregate of unknown composition. There appears to be very little air in the concrete. The concrete appears quite competent, with no visible cracks or signs of chemical reactions.

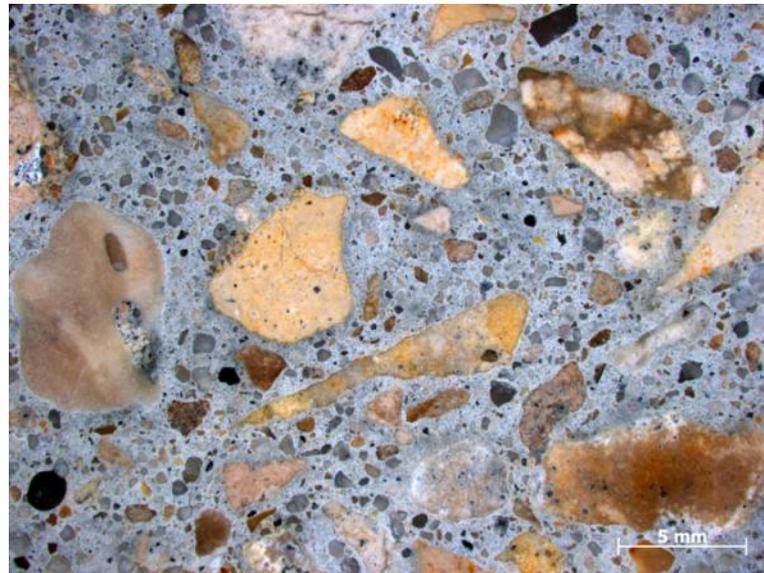
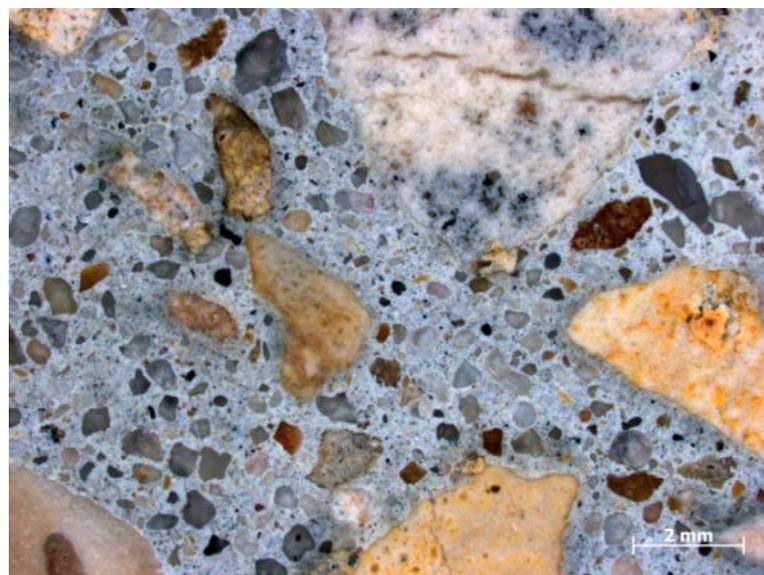
Figure 23. Photomicrographs of core sample #9 (5x above, 15x below).

Images of concrete from core sample #9 are shown in Figure 23. The concrete appears to be composed of an angular coarse and subangular-shaped fine aggregate of unknown composition. There appears to be very little air in the concrete. The concrete appears quite competent, with no visible cracks or signs of chemical reactions.

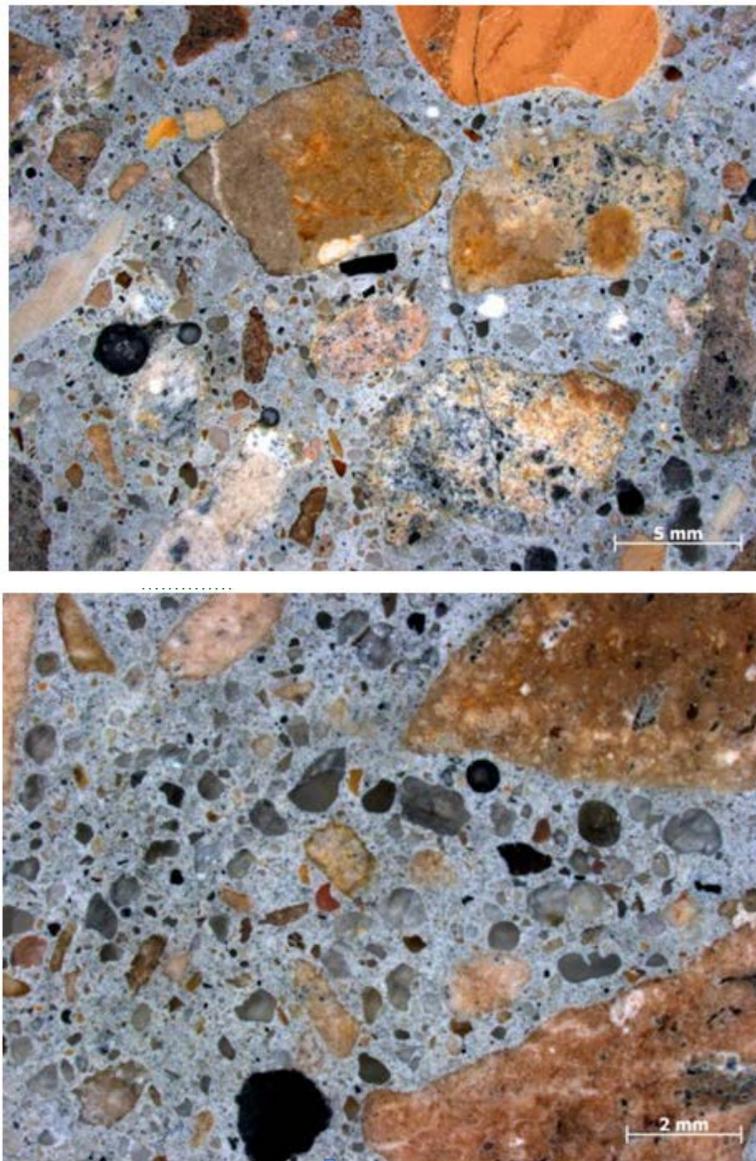
Figure 24. Photomicrographs of core sample #10 (5x above, 15x below).

Images from core sample #10 are shown in Figure 24. The concrete appears to be composed of an angular coarse and subangular-shaped fine aggregate of unknown composition. There appears to be very little air in the concrete. A large crack in the concrete starts at the upper right center and proceeds through an orange-colored aggregate that extends into the cement paste. There are no indications of any chemical reactions, which may indicate the damage is due to application of some structural load.

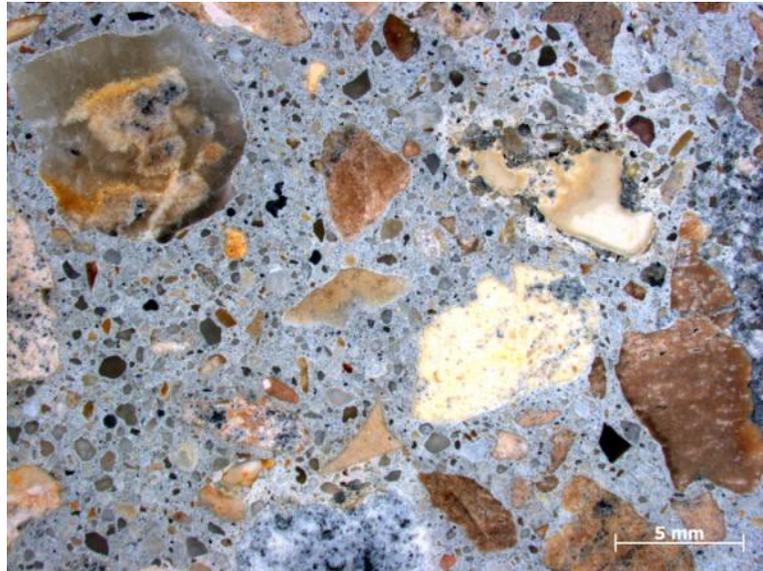
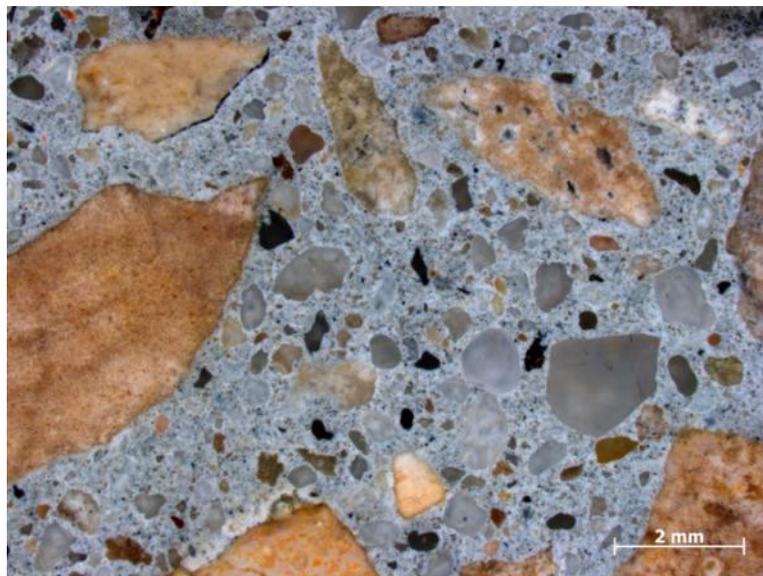
Figure 25. Photomicrographs of core sample #11 (5x above, 15x below).

Images of concrete from core sample #11 are shown in Figure 25. The concrete appears to be composed of an angular coarse and subangular-shaped fine aggregate of unknown composition. There appears to be very little air in the concrete. The concrete appears quite competent, with no visible cracks or signs of chemical reactions.

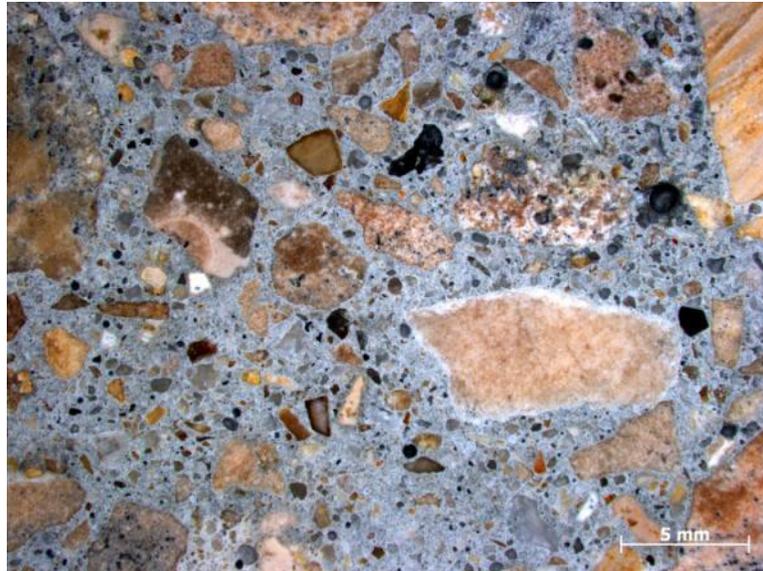
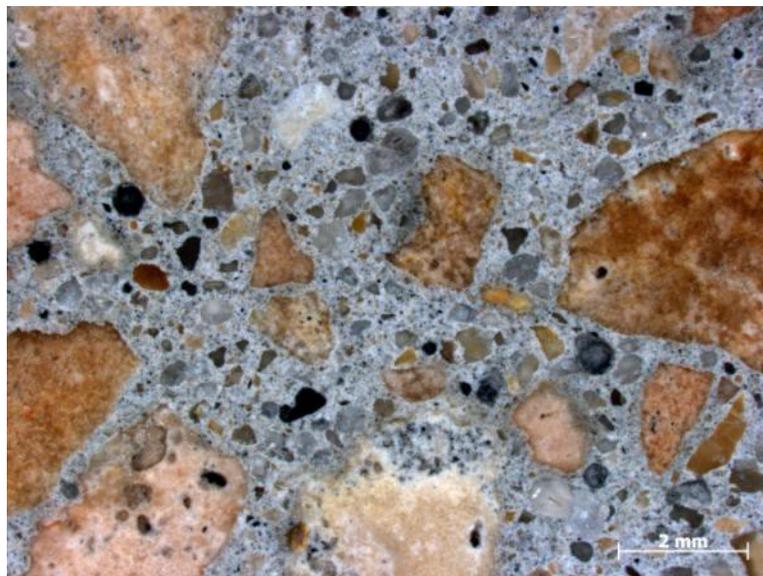
Figure 26. Photomicrographs of core sample #12 (5x above, 15x below).

Images of concrete from core sample #12 are shown in Figure 26. The concrete appears to be composed of an angular coarse and subangular-shaped fine aggregate of unknown composition. There appears to be very little air in the concrete. The concrete appears quite competent, with no visible cracks or signs of chemical reactions.

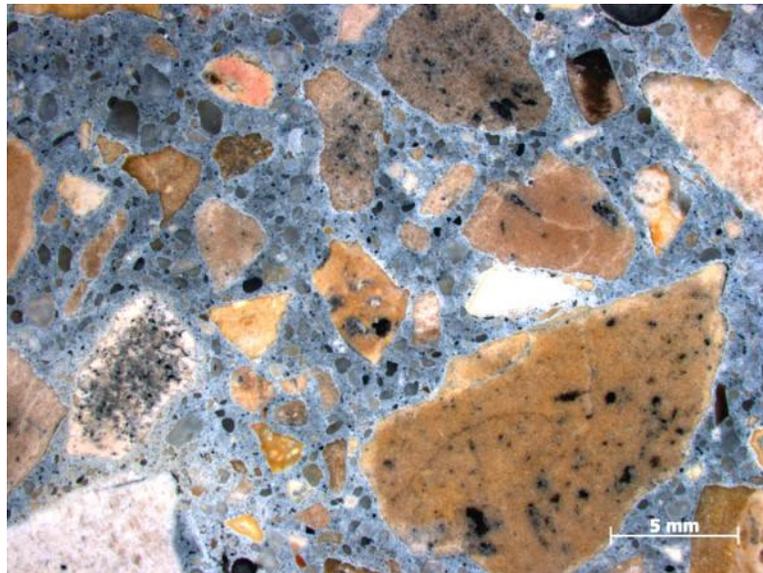
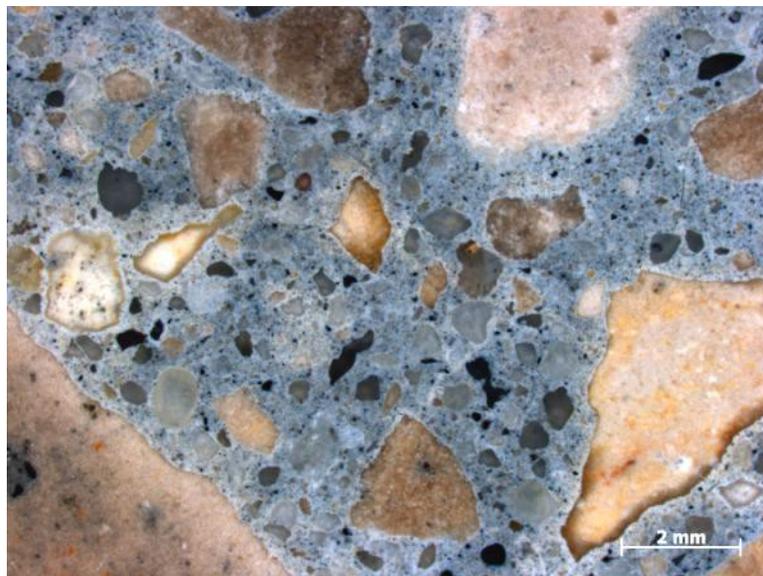
Figure 27. Photomicrographs of core sample #13 (5x above, 15x below).

Images of concrete from core sample #13 are shown in Figure 27. The concrete appears to be composed of an angular coarse and subangular-shaped fine aggregate of unknown composition. There appears to be very little air in the concrete. The concrete appears quite competent, with no visible cracks or signs of chemical reactions.

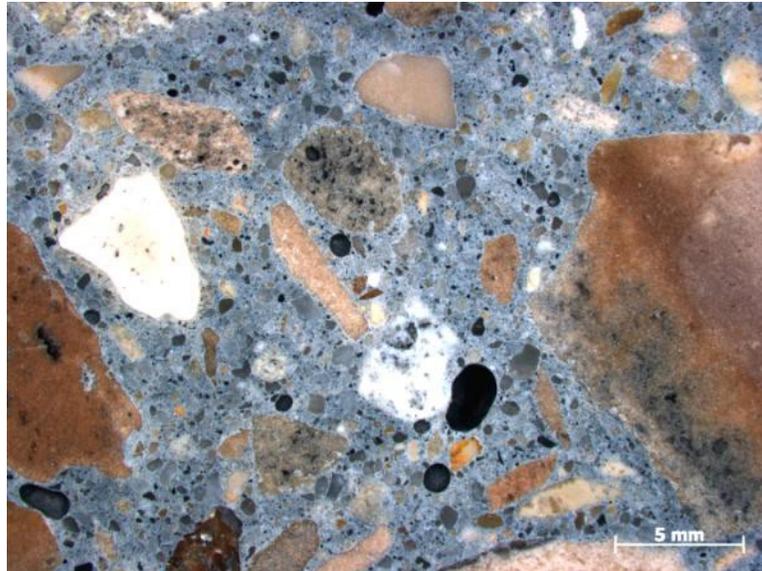
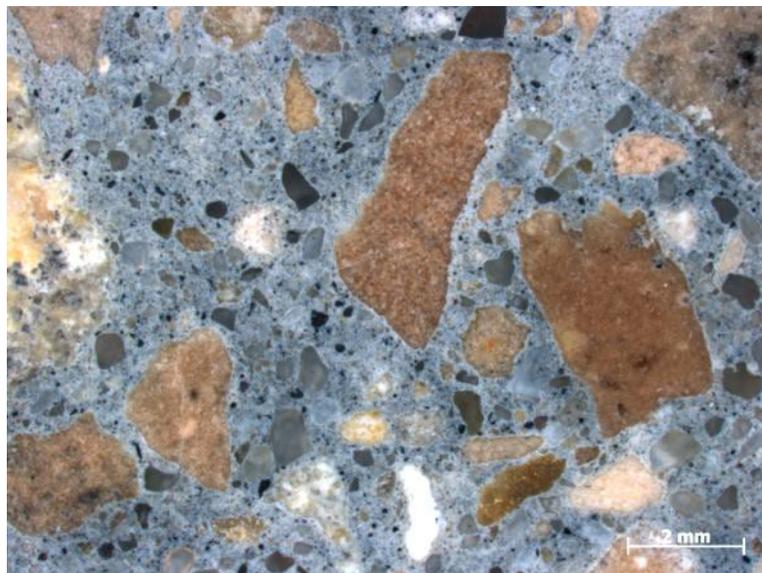
Figure 28. Photomicrographs of core sample #14 (5x above, 15x below).

Images of concrete from core sample #14 are shown in Figure 28. The concrete appears to be composed of an angular coarse and subangular-shaped fine aggregate of unknown composition. There appears to be very little air in the concrete. The concrete appears quite competent, with no visible cracks or signs of chemical reactions.

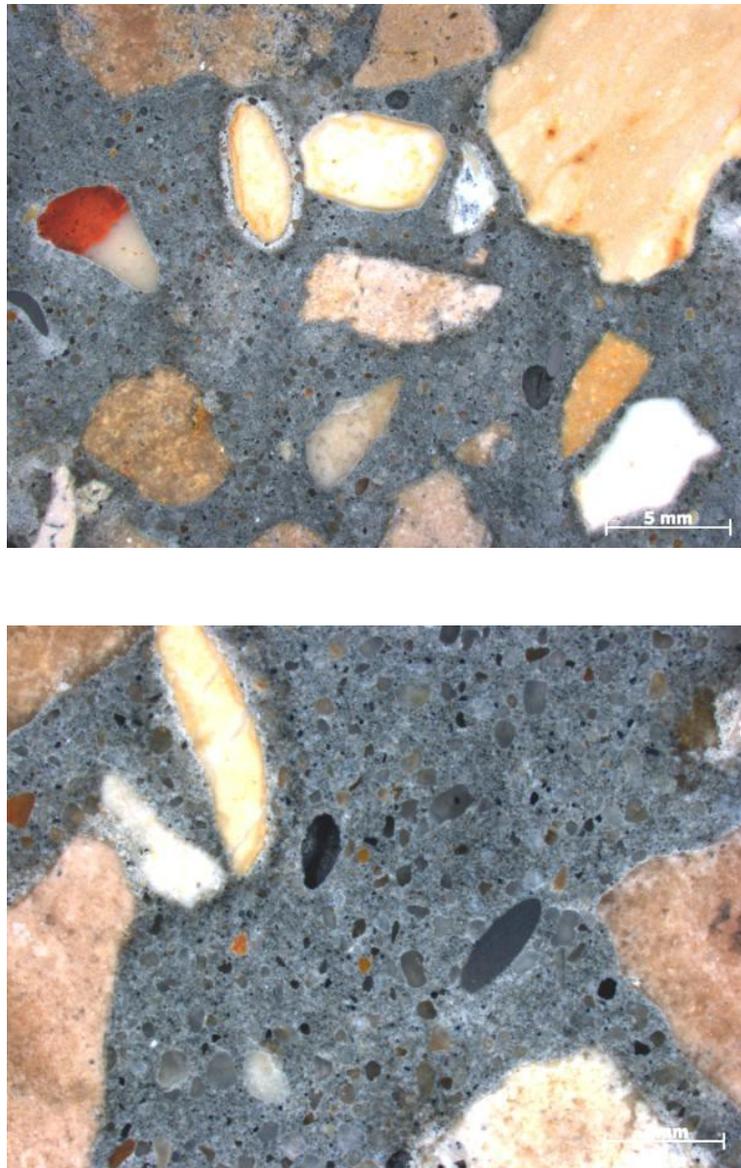
Figure 29. Photomicrographs of core sample #15 (5x above, 15x below).

Images of concrete from core sample #15 are shown in Figure 29. The concrete appears to be composed of an angular-to-rounded coarse and subangular-to-rounded shaped fine aggregate of unknown composition. Steel fibers are present in the concrete. There appears to be very little air in the concrete. Although the concrete appears competent with no visible cracks, there are areas in the cement paste around selected aggregate particles that are lighter in color than the surrounding paste.

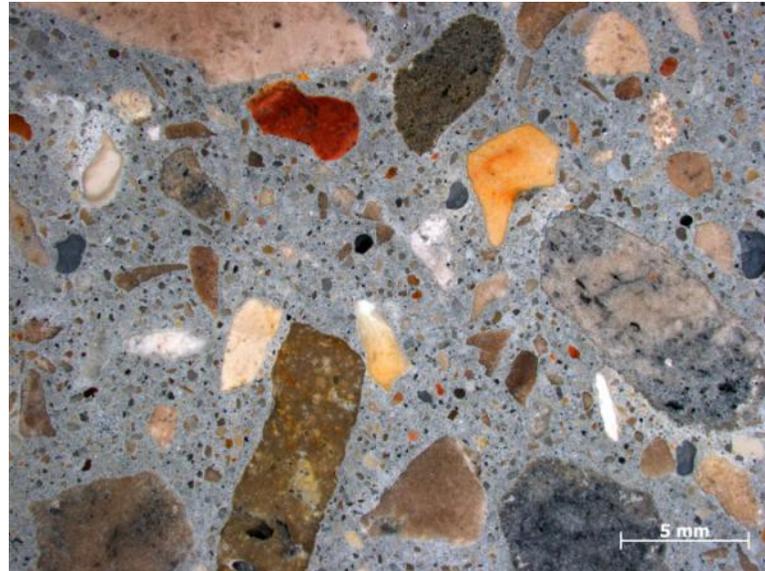
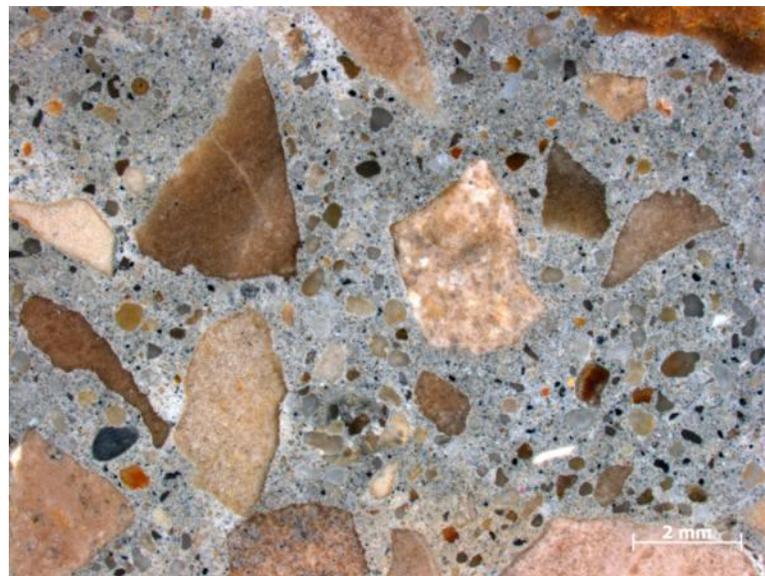
Figure 30. Photomicrographs of core sample #16 (5x above, 15x below).

Images of concrete from core sample #16 are shown in Figure 30. The concrete appears to be composed of an angular coarse and subangular-shaped fine aggregate of unknown composition. There appears to be very little air in the concrete. The concrete appears quite competent, with no visible cracks or signs of chemical reactions.

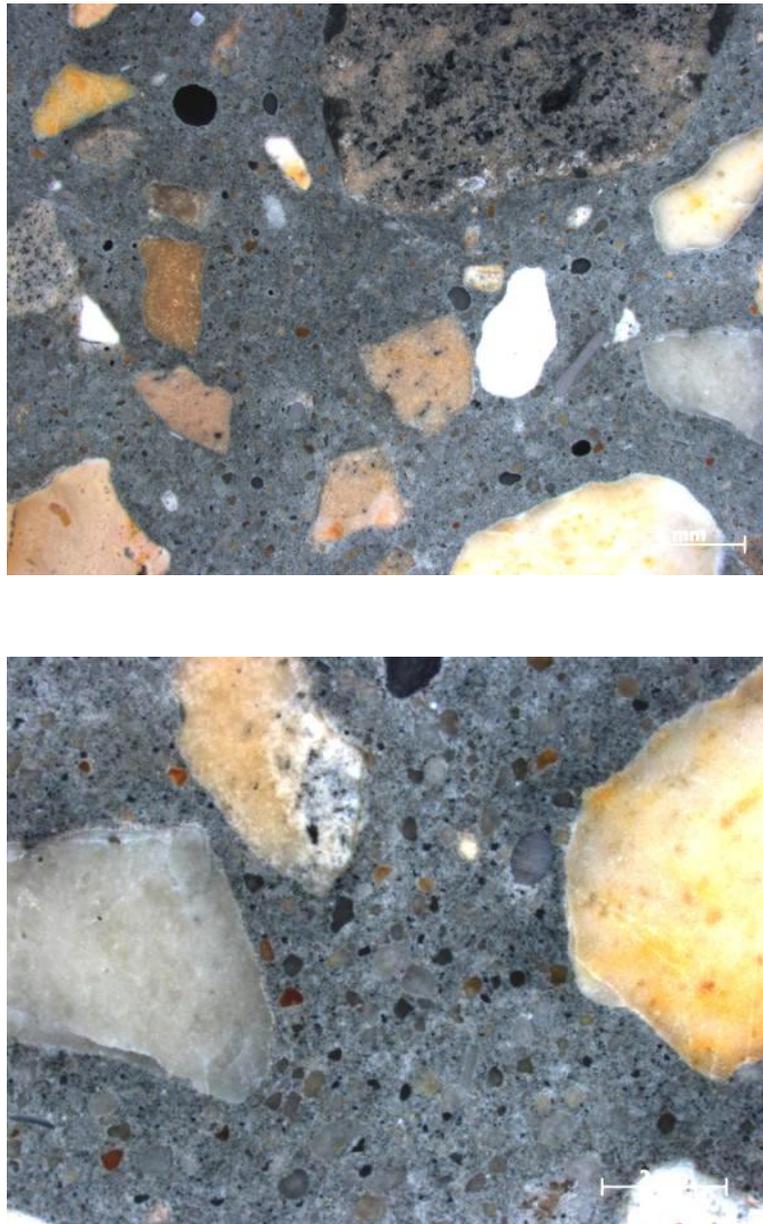
Figure 31. Photomicrographs of core sample #17 (5x above, 15x below).

Images of concrete from core sample #17 are shown in Figure 31. The concrete appears to be composed of an angular-to-subangular coarse and subangular-to-rounded shaped fine aggregate of unknown composition. Steel fibers are present in the concrete. There appears to be very little air in the concrete. The concrete appears quite competent, with no visible cracks or signs of chemical reactions.
