## SIO Shipyard Representative Bi-Weekly Progress Report

<b>SIO Shipyard Representative Bi-Weekly Progress Report</b>		
<b>Project: AGOR 28</b>	<b>Contract No.: N00014-12-C-0305</b>	<b>Shipyard: Dakota Creek Industries</b>
<b>Prepared by:</b> Paul D. Bueren Scripps Institution of Oceanography (SIO) 297 Rosecrans St. San Diego, CA 98106	<b>Date:</b> <b>22 November, 2013</b>	<b>Program Officer:</b> Robert (Tim) Schnoor Office of Naval Research 875 Randolph St ONR 321 Arlington, VA 22203-1995
<b>Distribution Statement A:</b> Approved for public release; distribution unlimited.		<b>Report No. A002.045</b>

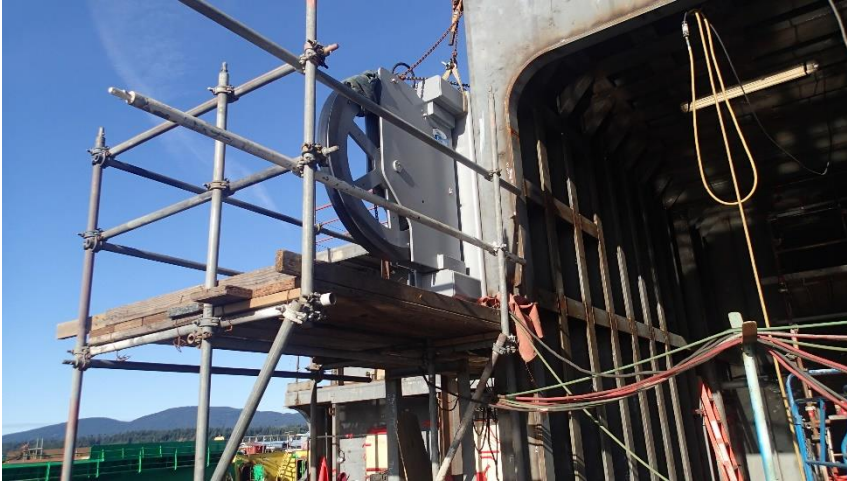
- Neil Armstrong Flag Block Deck Penetration – The penetration is being cut and the drawings are to be reviewed by ABS. The actual flag block is being mounted on the side of Armstrong’s Staging Bay.

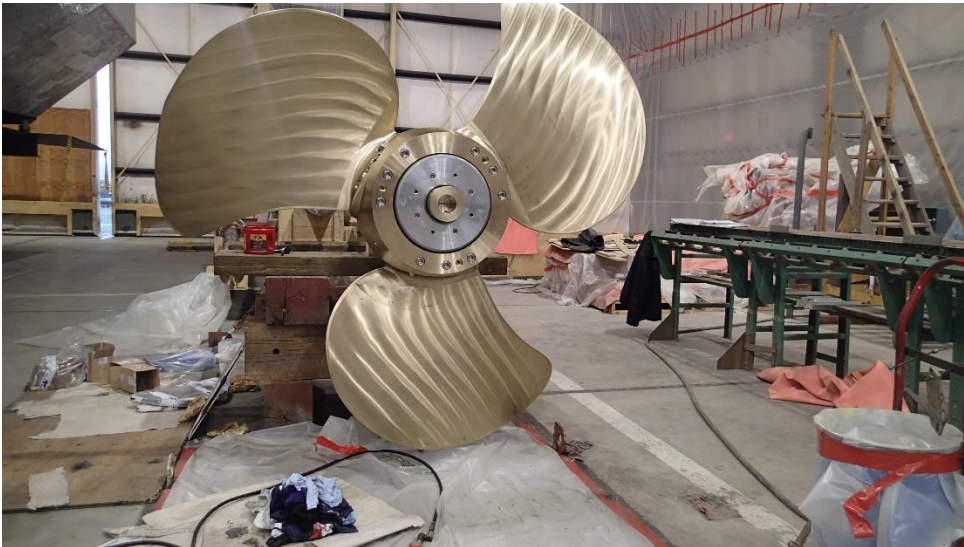
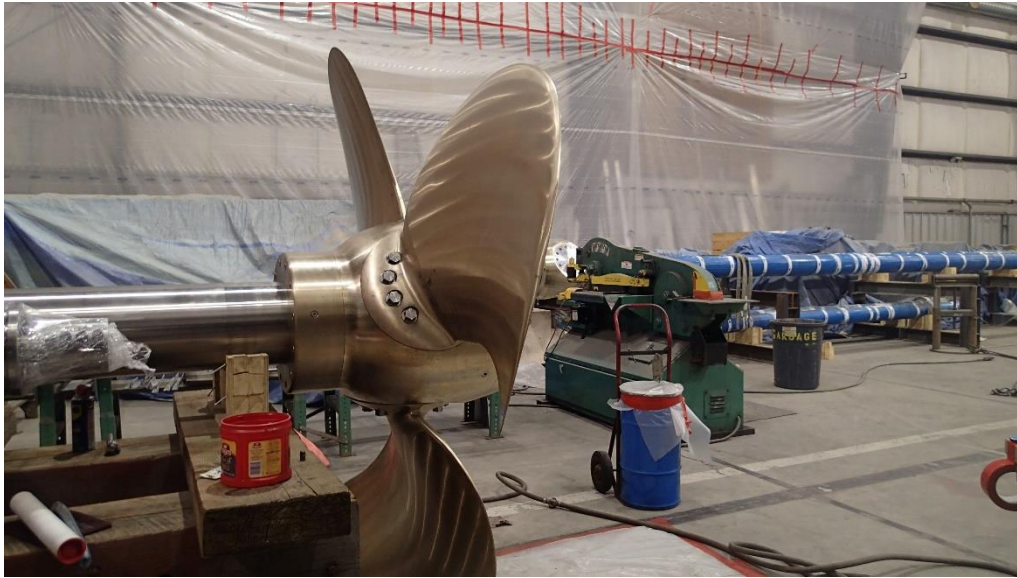
- Sally Ride Port Rudder – Inspected welds and pressure tested with ABS in attendance. No leaks found.
- Neil Armstrong CP Props – The man from Hundested was on site to install the blades to the hubs. The bolts were torqued, but the locking wire will remain off until after the pitch test has been done. 2.5-man days at a leisurely pace to do the work.

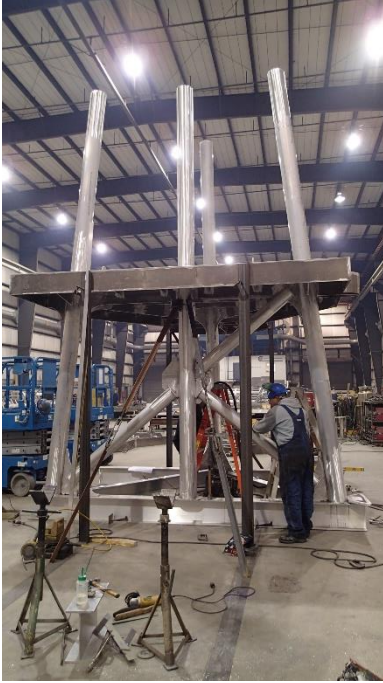
- Armstrong/Ride Main Mast– Fabrication of the masts for both ships continues, with the base for Neil Armstrong pictured below. Since this photo was taken several more large diagonals have been added to the lower structure. The remaining radar platforms for both ships are fabricated along with the upper masts sections.

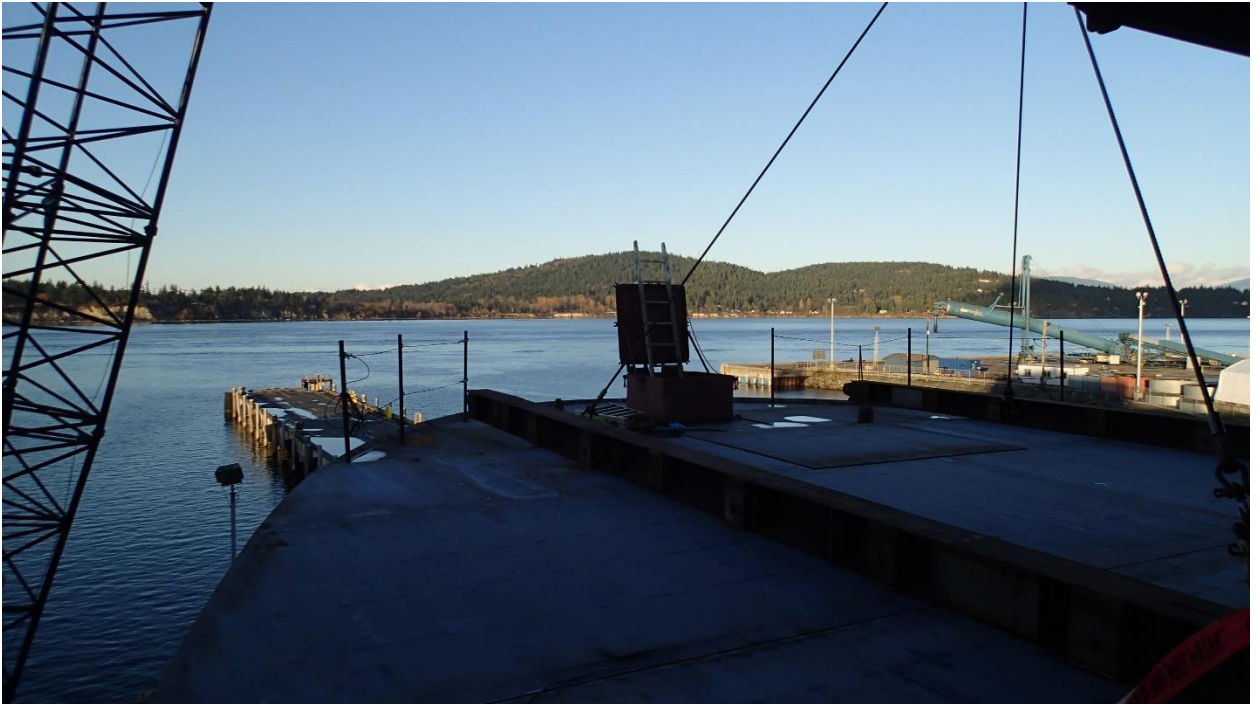
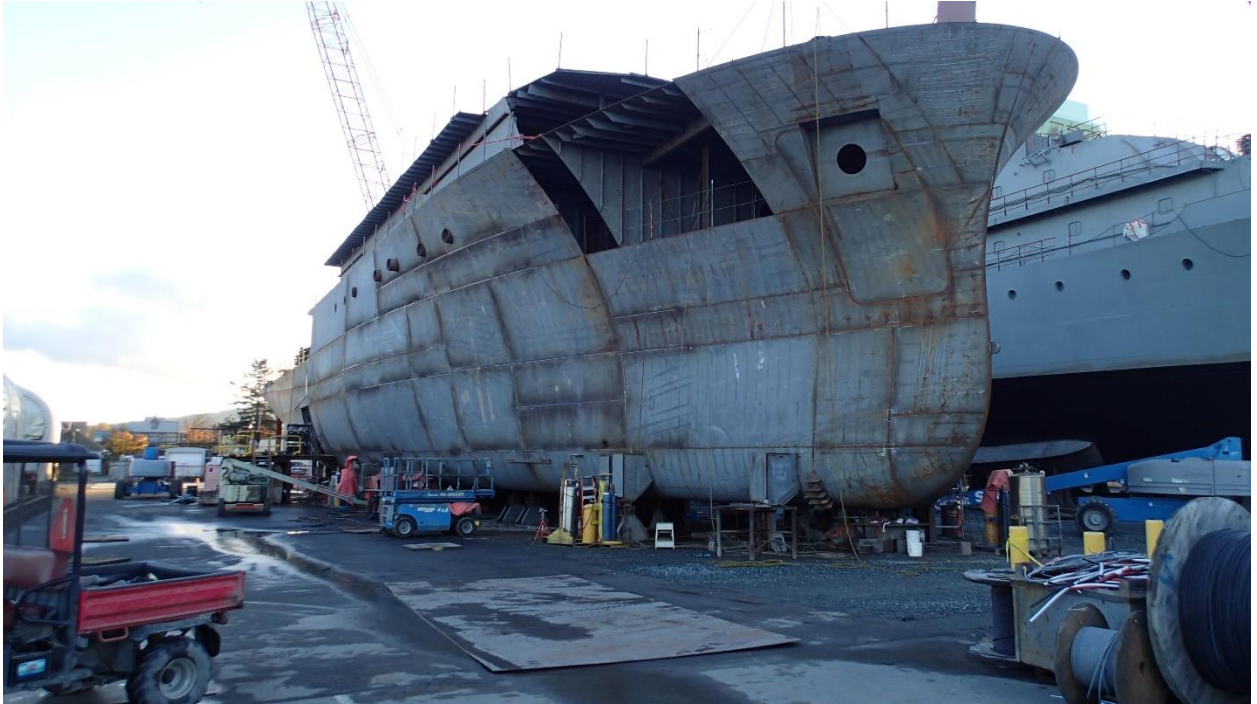
- Sally Ride Bow – The foc's'le deck was landed on the bow.
