SIGAR 14-31 Inspection Report

SALANG HOSPITAL: LACK OF WATER AND POWER SEVERELY LIMITS HOSPITAL SERVICES, AND MAJOR CONSTRUCTION DEFICIENCIES RAISE SAFETY CONCERNS

**JANUARY
2014**

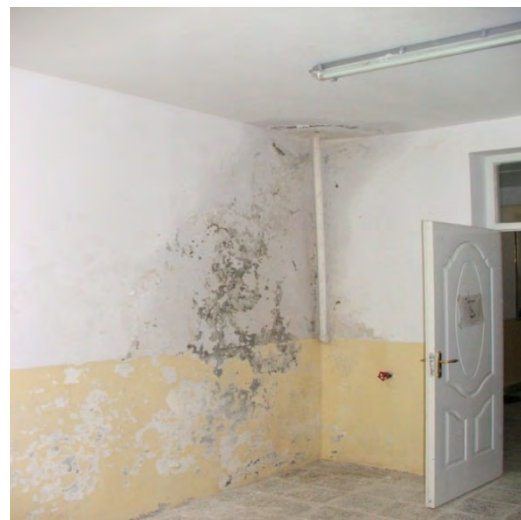
Photo 2 - Leaky Roof Damages Ceilings and Walls

- The hospital staff told us the hospital roof was leaking, causing mold and mildew on the ceiling and walls. Our inspection confirmed the presence of mold and mildew (see photo 2). The statement of work required that the concrete roof slab be hot-tarred to provide waterproofing prior to installing wooden trusses to support the corrugated metal roof. Photos contained in the contract files show that the hot-tarring was not done. Photos also show that the wooden trusses on top of the concrete slab roof were not covered with plywood and tar paper, as required. Our inspection confirmed these construction deficiencies.

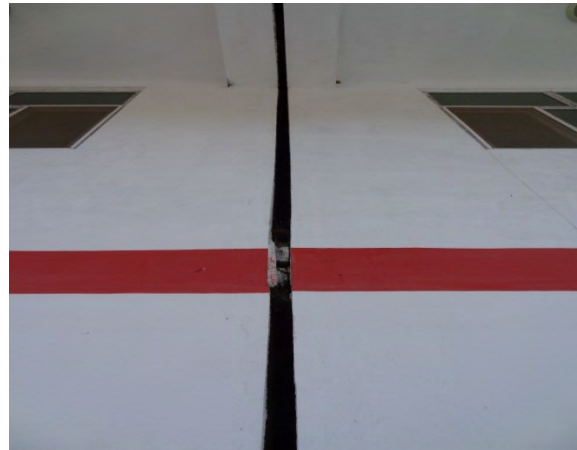
Photo 3 - Excessively Wide Expansion Joint

- First, we observed a vertical expansion joint that basically cuts the hospital structure in half (see photo 3). The gap is about 3 inches wide and has no concrete or reinforcing steel providing a connection across the joint. In essence, the hospital consists of two separate buildings under one corrugated metal roof. Due to missing design documents, we do not know whether the expansion joint was a

requirement. However, based on the industry standards⁶ for design, only very large or very long structures would normally have this type of an expansion joint. Our engineers believe that the existence of this 3-inch wide expansion joint and the fact that it is unreinforced makes the hospital highly susceptible to earthquake damage.

- 1. Identify the contracting officer(s) responsible for oversight of the Salang hospital construction activities and determine:**
 - (a) why the hospital was not built according to contract specifications and acceptable construction standards;**
 - (b) why required documents were not placed in the CIDNE database;**
 - (c) what disciplinary action, if any, should be taken against the contracting officer(s) who failed to provide required oversight.**
- 2. Perform a physical inspection of the building, including appropriate engineering tests and analyses, and, given its location in a high seismic activity zone, determine what corrections are required to ensure the structural integrity of the building.**

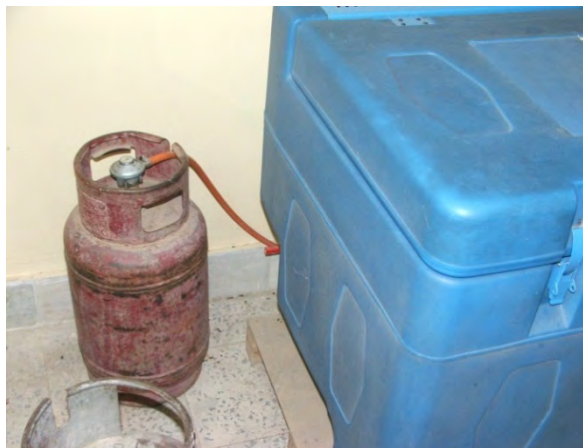
Photo 4 - Propane Supply for Refrigerator

Salang hospital is not providing many of the services it was intended to provide and is operating well below its capacity. As noted earlier, the hospital was designed to provide surgical and X-ray services, a pharmacy, and a laboratory, as well as pediatric, dental and mental health services. Although the hospital treats about 70 patients per day and is open 24 hours a day with staff available for night-time emergencies, it does not and cannot provide many of these intended services. For example, the doctors we spoke to on site confirmed they are not qualified surgeons, and the hospital does not have a functioning surgery unit. In addition, the X-ray machine is stored in a locked room and is not used because parts are missing and there is not enough electricity to operate it. The hospital staff also told us the ministry provides some medicine and vaccines, but without electricity it is hard to refrigerate them. As a "work around" measure, the hospital is using a propane-operated cooler for vaccine storage (see photo 4).

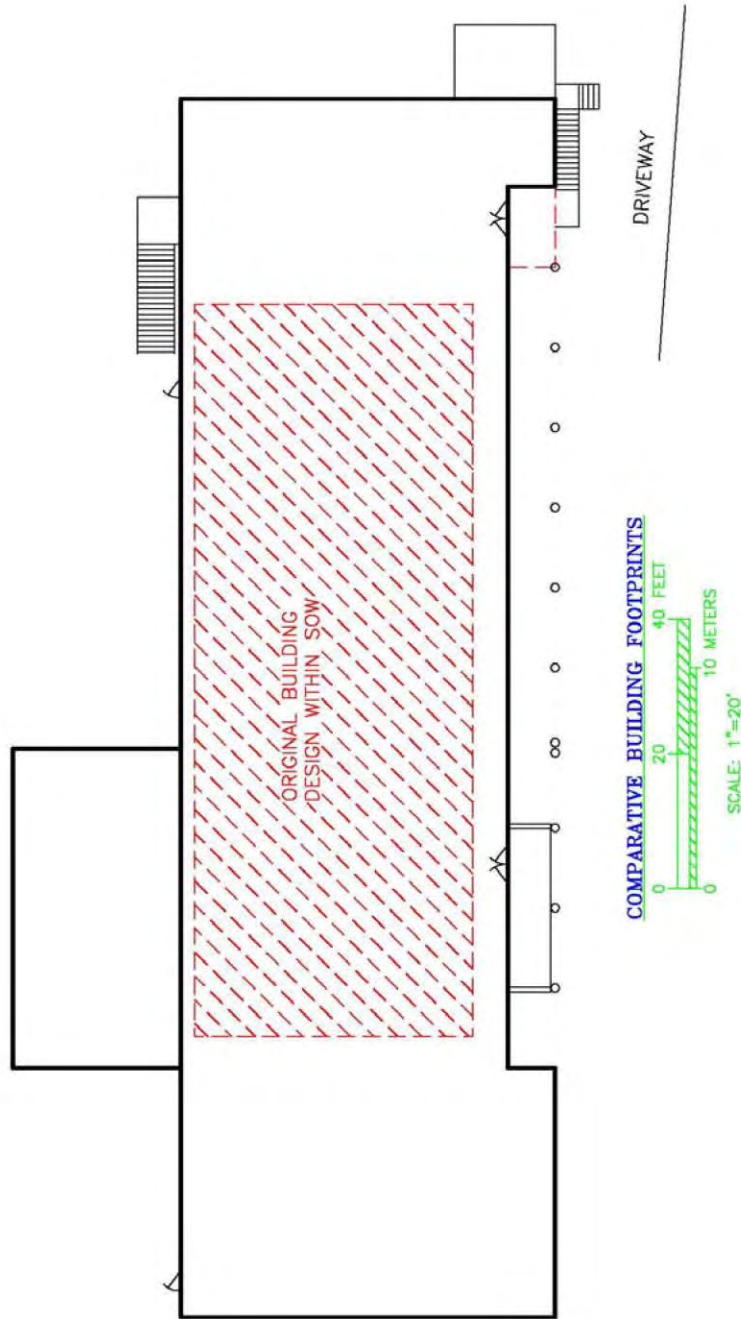
APPENDIX II - COMPARATIVE BUILDING FOOTPRINTS

- The original design drawings called for a one-story, 15-room hospital building; a one-story four-stall toilet facility; and a guard shack. However, we found that a two-story building had been built. It was an 18,300-square-foot structure, more than three times larger than the 5,300-square-foot building called for in the original design plans. We could not find any documentation showing that the Bagram Regional Contracting Center contracting officer had modified the contract to approve the two-story building, as was required under the contract.³ According to a Provincial Reconstruction Team record of a meeting with an Afghan Ministry of Public Health official, the Department of State member of the team stated that the Ministry and the provincial government approved the alternate design; however, no documentation exists to confirm that these officials approved the design. The State Department representative also noted that the alternate design was necessary because the hospital's irregularly shaped lot would not accommodate the design called for in the contract documents. However, it is unclear to us why the lot could not accommodate the hospital as originally designed, but could accommodate a facility that had a larger footprint than was called for under the contract. See Appendix II for a comparison of the originally-designed building's footprint and that of the building that was actually constructed.

Note: The outer black lines show the 9,150 square foot footprint of the 18,300 square foot two-story hospital building actually constructed by the contractor. The shaded red box within the black lines shows the relative size of the 5,300 square foot footprint that the Salang hospital would have occupied had it been constructed in accordance with the designs provided for in the contract. It remains a question as to why the lot was inappropriate for the 5,300 square foot building, but suitable for the 18,300 square foot building.
