## **An Investigation of Concrete Deterioration at South Florida Water Management District Structure S65E**

February 2014

Final report

Under Rapid Assessment of Concrete Deterioration at S65E

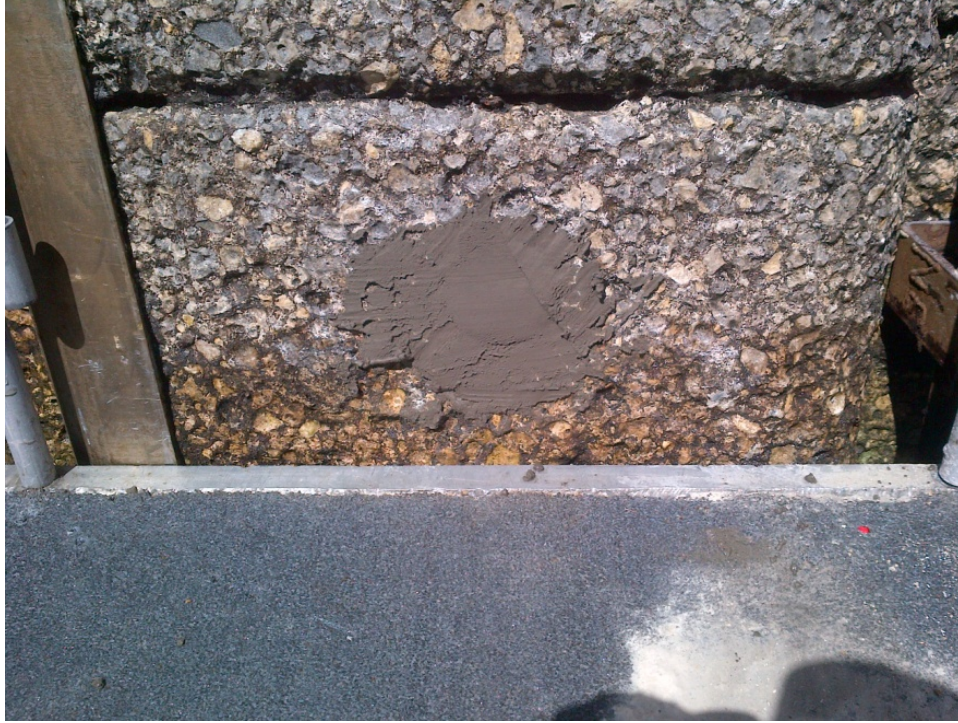
Concrete deterioration reported to ERDC by the Jacksonville District personnel focused on significant deterioration of the surface of the concrete. A photograph of typical concrete deterioration observed in an area where concrete cores were extracted is shown in Figure 2.

Figure 2. Typical concrete deterioration at location where concrete core was extracted.

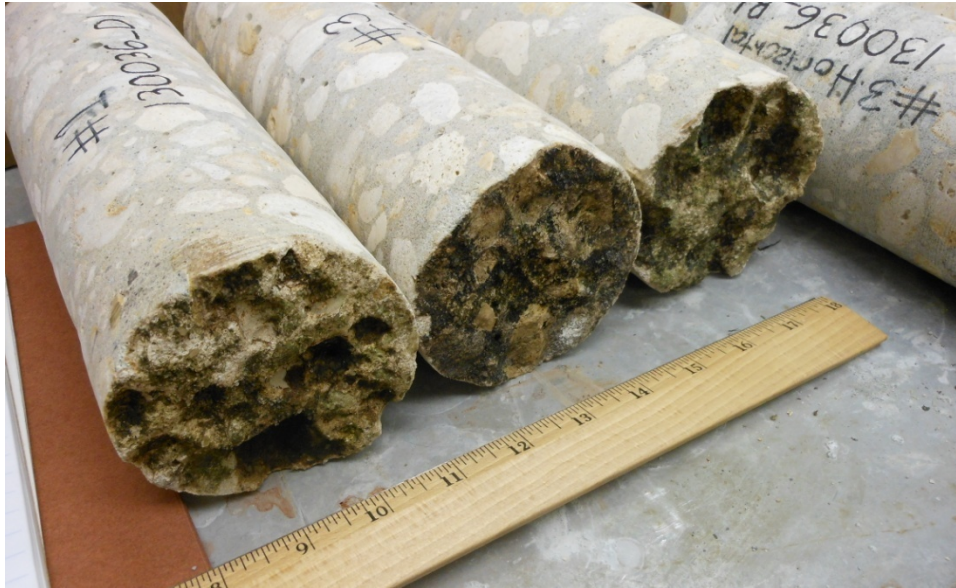
Figure 3. As-received concrete cores from deteriorated areas of S65E.

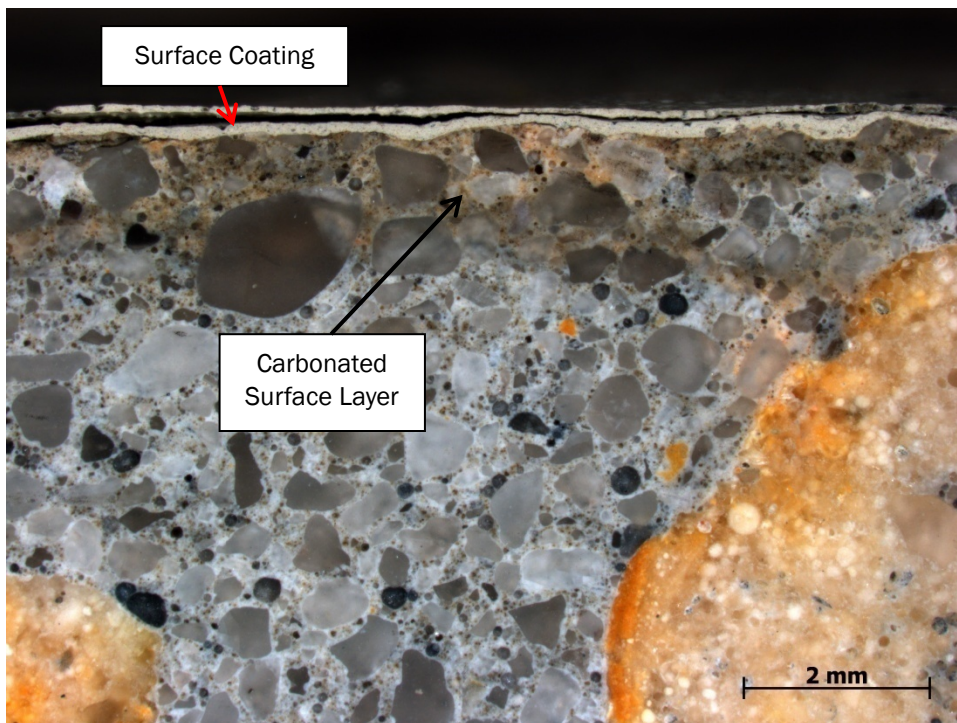
The condition of non-deteriorated concrete surfaces of as-received core 130036\_N1 was examined using stereomicroscopy. Figure 5 shows typical photomicrographs obtained from cross sections of the non-deteriorated surface concrete. Similar to the bulk concrete, the coarse aggregate was a Pleistocene limestone, and the fine aggregate was siliceous. The non-deteriorated surface was extremely planar and well finished. A surface paint/coating layer was also evident in the as-received cores. A layer of discoloration was observed to penetrate to a depth of approximately 1.5 to 2 mm from the surface. The discoloration is likely associated with carbonation of the surface concrete by slow reaction of  $\text{Ca}(\text{OH})_2$  present in the concrete with atmospheric  $\text{CO}_2$ . The presence of carbonation was confirmed with the use of the phenolphthalein pH indicator solution (see Figure 6). Other than the minimal carbonation observed, no other evidence of distress was observed in concrete from non-deteriorated areas of the structure.

Figure 5. Photomicrographs of typical concrete at surface of non-deteriorated areas of S65E.

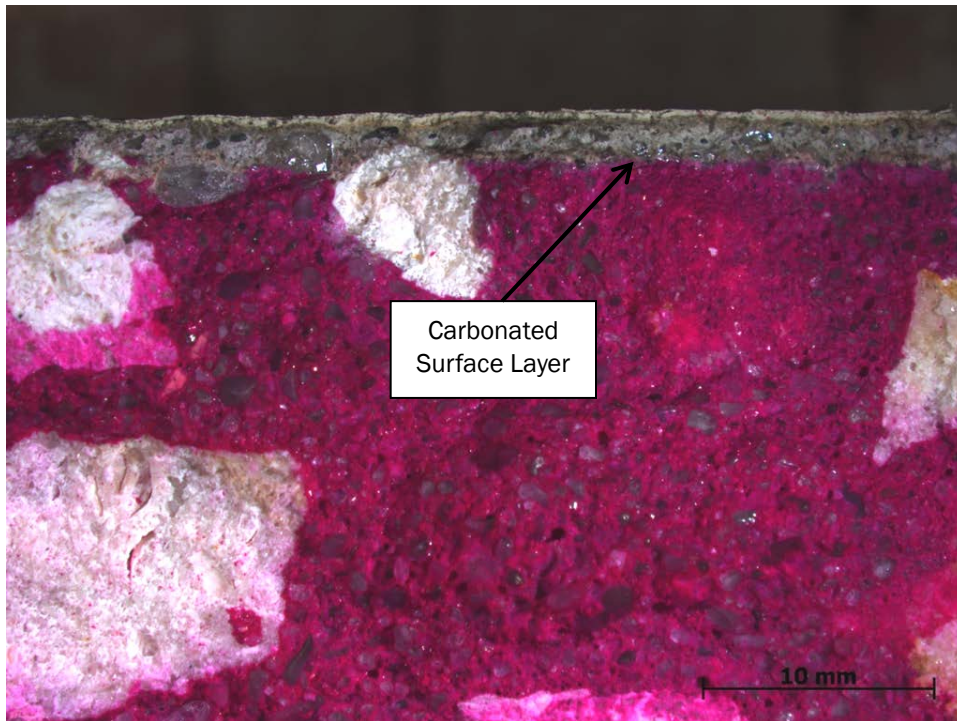
Figure 6. Surface of non-deteriorated concrete showing depth of carbonation using phenolphthalein pH indicator solution.

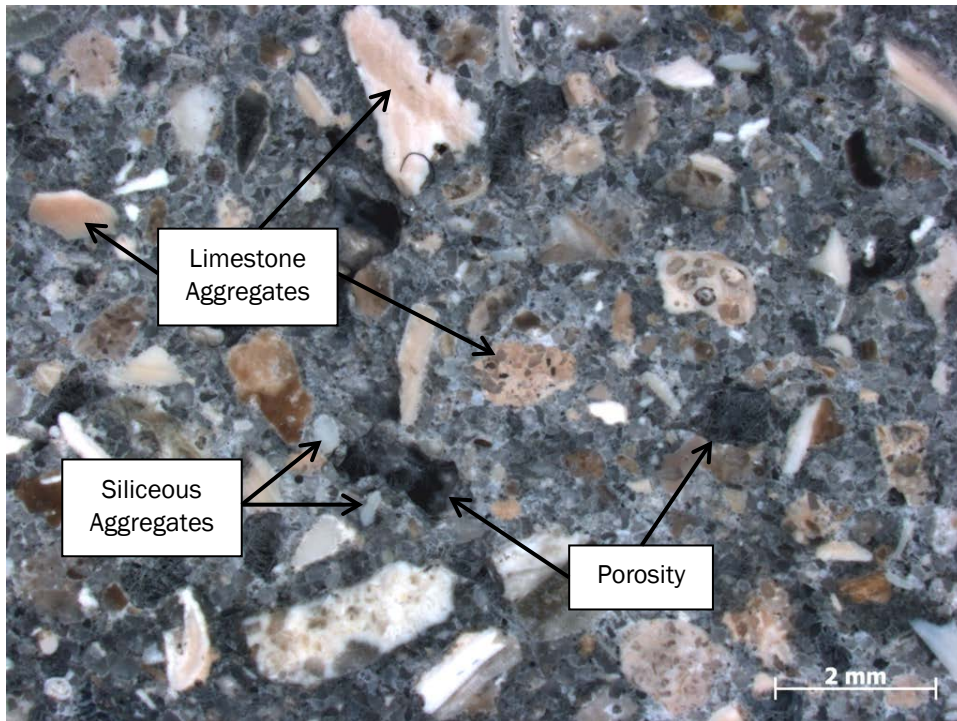
Concrete that was previously repaired due to deterioration of the original concrete at S65E was also examined. Figure 7 shows the typical microstructure observed in the shotcrete repair material. The shotcrete material contained a mixture of limestone and siliceous aggregates. The shotcrete was also found to be highly porous. The surface of the as-received repaired concrete had higher surface roughness than the original concrete examined from non-deteriorated areas of the structure (see Figure 8 of shotcrete surface vs. Figure 5 of original concrete surface). It is unclear whether this surface roughness is related to subsequent deterioration following application of the repair shotcrete or whether the initial finish of the shotcrete repair exhibited increased roughness.

Figure 7. Typical microstructure of shotcrete used for repair, which consisted of limestone and siliceous aggregates and significant porosity.

Regarding recommendations for the repair strategy, the shotcrete repair technique employed, while most simple, is likely not the most durable repair technique for wall rehabilitation, as it is more prone to cracking and delamination following application. Cast-in-place concrete, preplaced aggregate concrete, or retrofit with stay-in-place precast concrete panels are other options. Further information on lock wall rehabilitation can be obtained from the following:

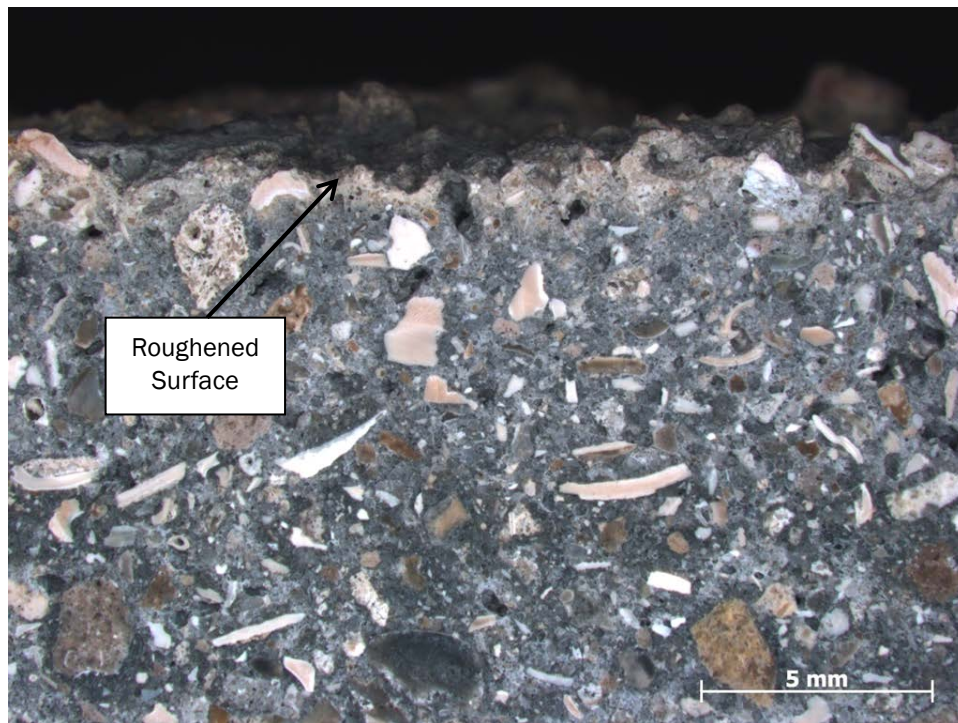
Figure 8. Photomicrograph of surface of shotcrete repair material showing high roughness.

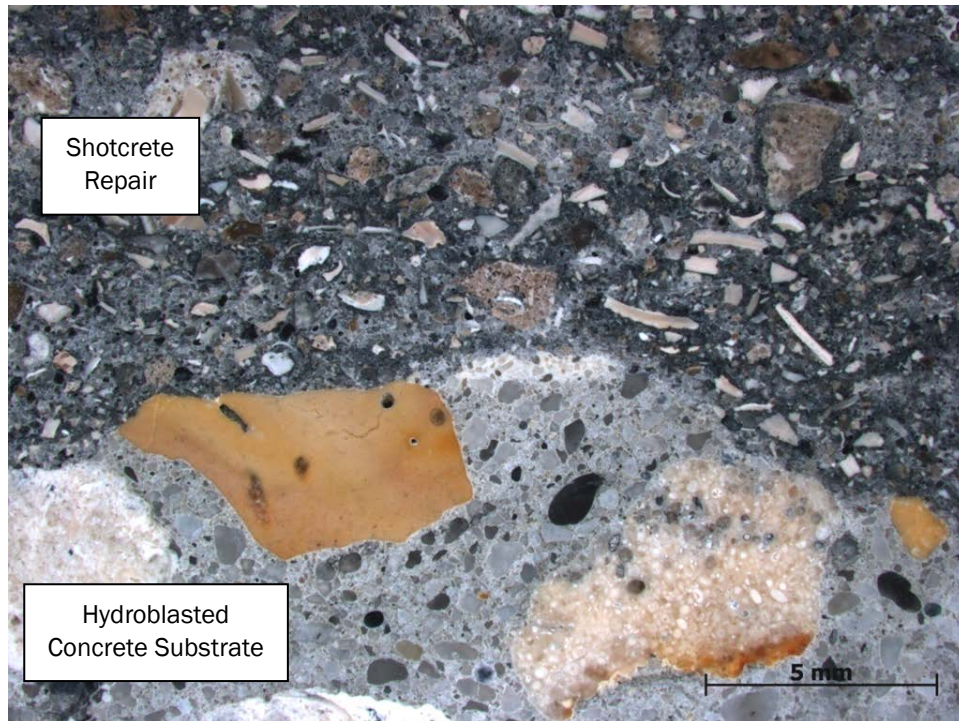
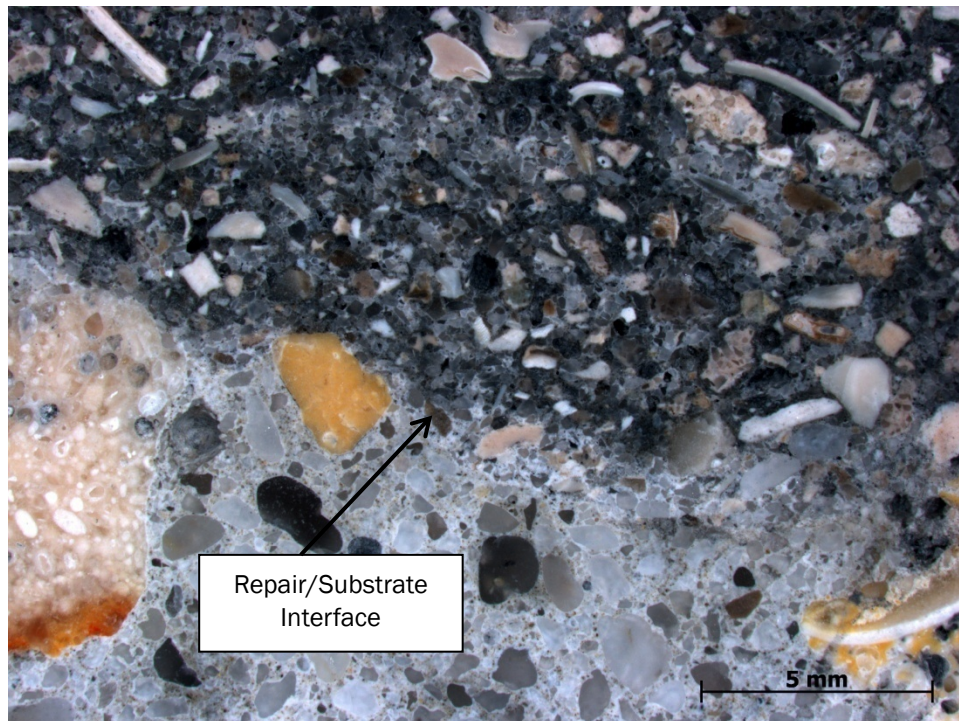
The interface between the shotcrete repair material and the original concrete substrate, which had damaged concrete removed by hydroblasting, was also examined. Figure 9 shows examples of the typical interface observed between original concrete and the shotcrete repair material. Overall, the interface between the shotcrete and the original concrete substrate appeared to be well bonded. However, sparse porosity and delaminations were observed at the interface, which corroborates the findings presented in a report provided to ERDC by Jacksonville District personnel.

Figure 9. Photomicrographs of typical interface between the shotcrete repair material and the original concrete substrate.

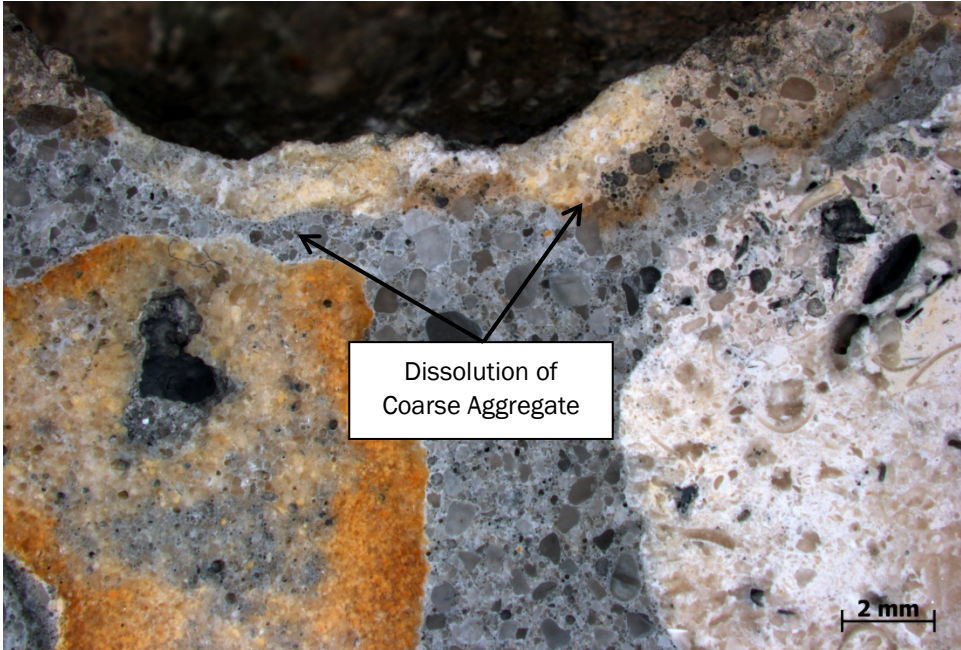
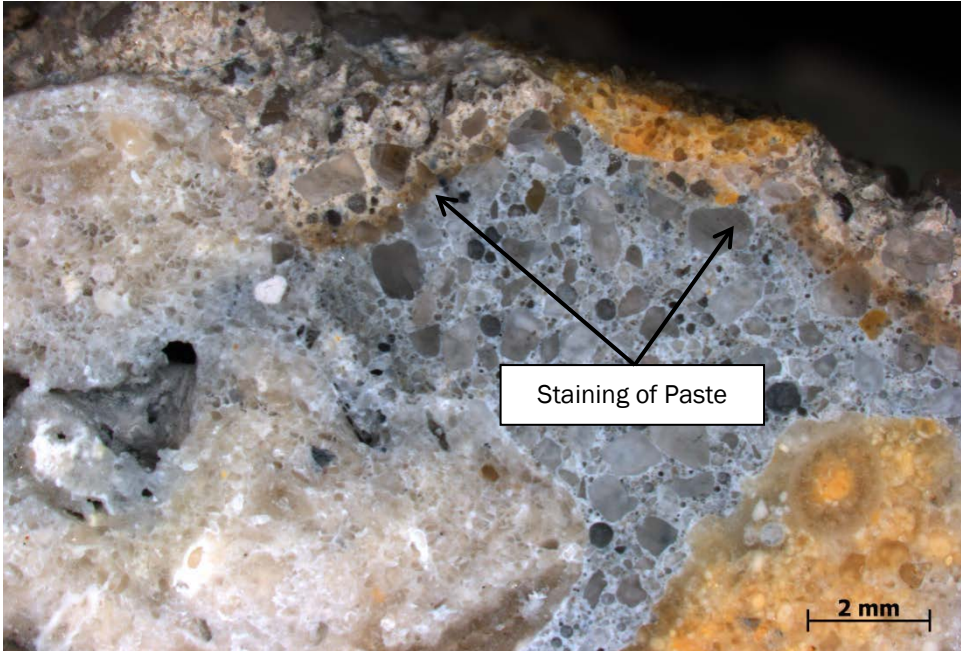
Deterioration in concrete from the dam had reached depths approaching 25 mm, which was approximately half of the cover depth observed over embedded reinforcing steel. Concrete from the lock chamber only exhibited deterioration to a depth of approximately 10 mm. It is hypothesized that the increased depth of deterioration in concrete from the dam may be related to the increased flow rates in the spillway when compared with flow velocities to which concrete surfaces in the lock chamber are exposed.

Figure 10. Photomicrographs of typical deterioration in concrete from dam piers.

Based on the results of this study, durability of the repair material (whether concrete, grout, or mortar) could likely be improved with the use of siliceous aggregates to minimize the deterioration observed in limestone aggregates in the existing concrete (note: biodeterioration mechanism must be validated). Efforts to minimize porosity/permeability (e.g., low w/cm, use of water-reducing admixtures, or addition of various supplementary

cementitious materials) and improve acid resistance (e.g., use of silica fume) would likely improve the durability of the repair material. The use of a high quality repair material that is durable will also serve to better protect the underlying concrete from subsequent deterioration.

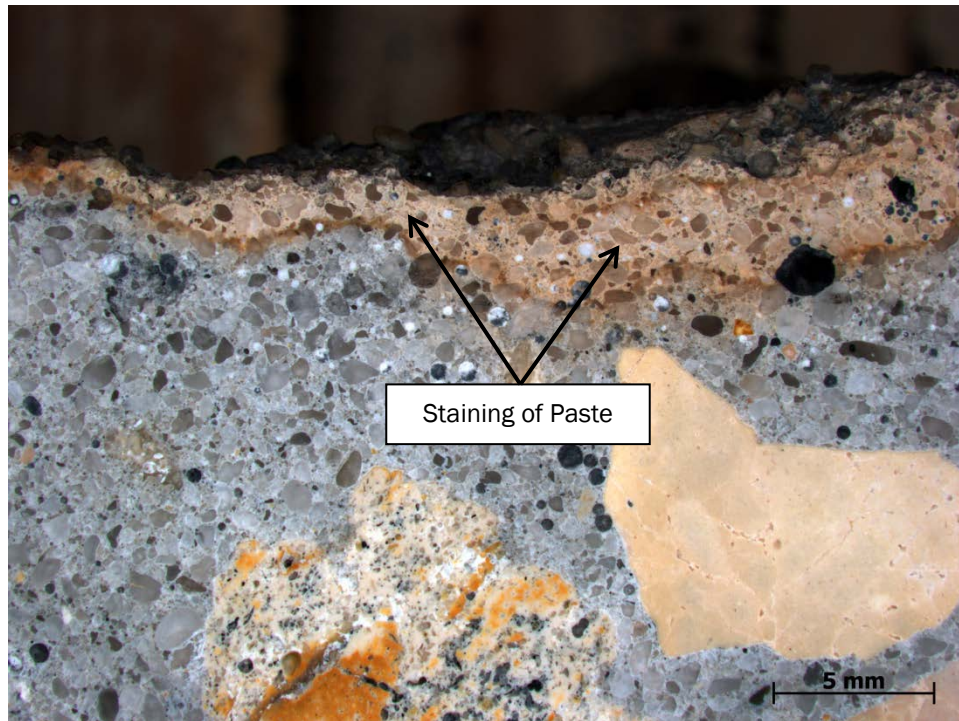
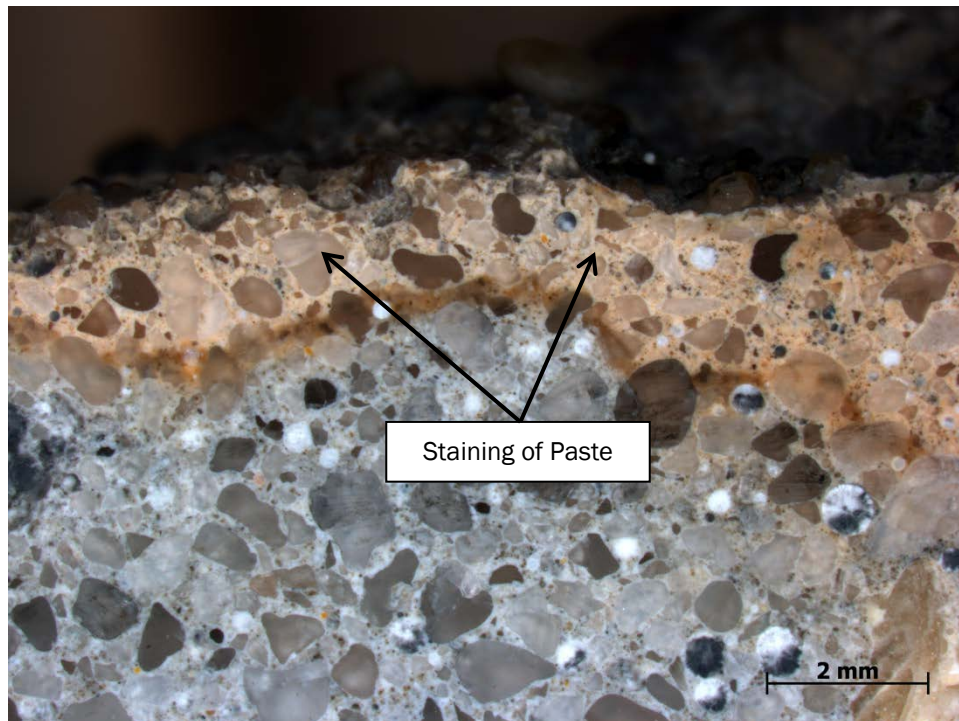
Figure 11. Photomicrographs of typical deterioration observed in concrete from lock chamber.

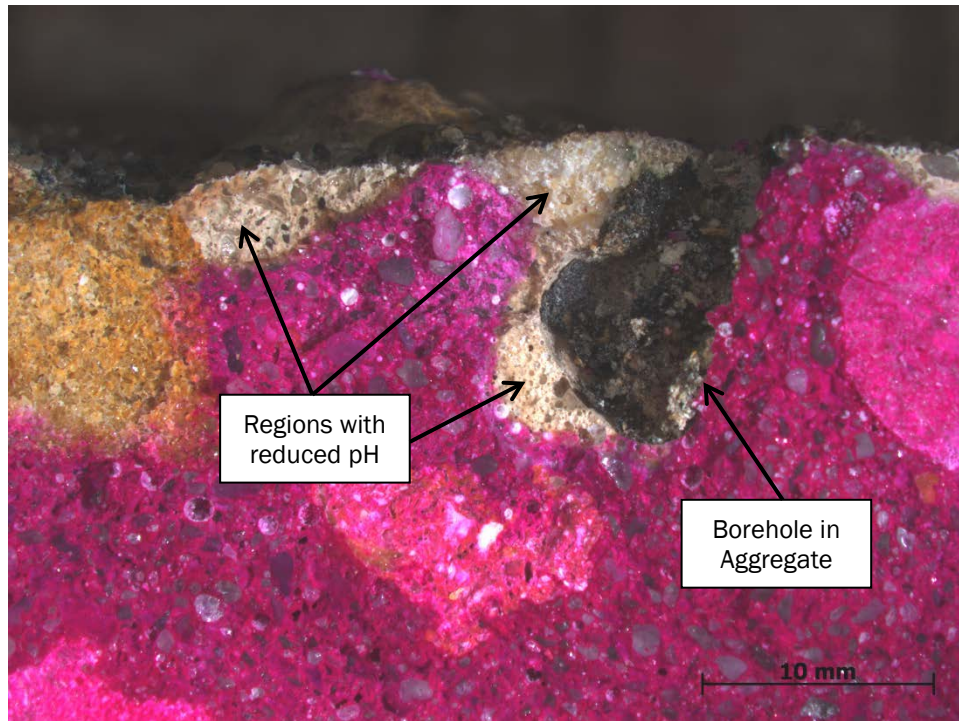
In concrete from the dam and the lock, a surface layer of discolored concrete that is likely associated with acidification/carbonation (see Figure 12) or other forms of distress causing the surface deterioration were observed. Reduction in pH also appeared to be correlated with staining and the location of significant surface damage of the concrete. A borehole was also observed in one of the coarse aggregates, which was associated with the acidification front (see Figure 12). The deterioration was observed to focus primarily on the Pleistocene limestone aggregates and to a lesser extent on the hydrated cement paste itself. High magnification imaging of the surface concrete showed that the siliceous fine aggregates were largely unaffected by the surface deterioration (see Figures 13 and 14).

Figure 12. Acidification/carbonation depth of surface concrete evidenced by pH indicator. A borehole likely caused by biodeterioration was also observed.

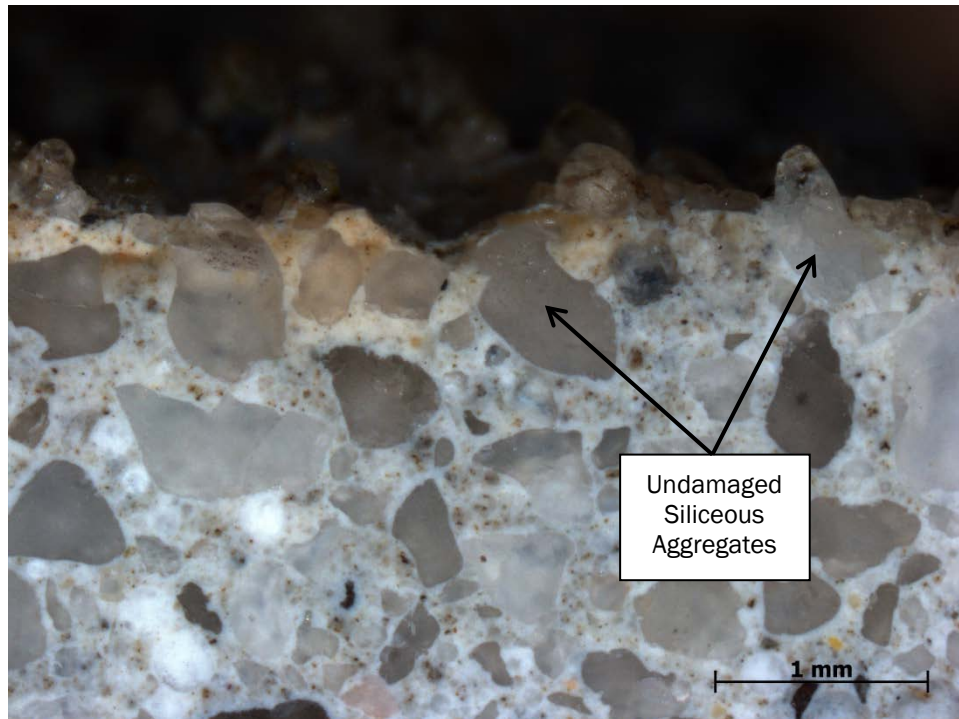
Figure 13. Photomicrograph of polished cross section of exposed concrete showing limited deterioration of siliceous fine aggregates when compared with limestone coarse aggregates and paste in exposed areas.

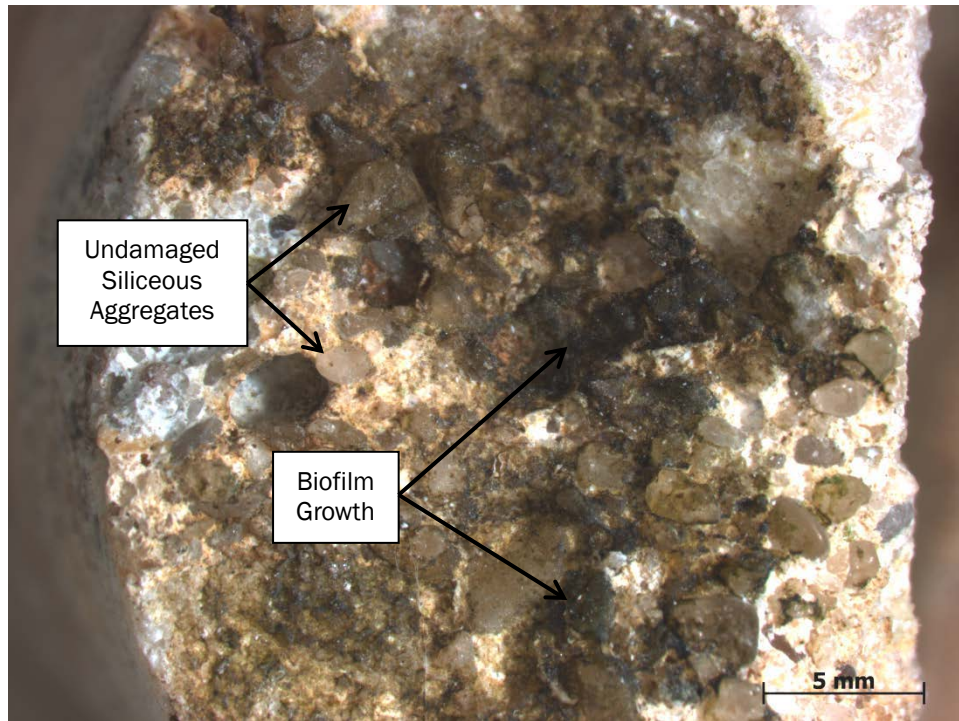
Figure 14. Photomicrograph of exposed surface of concrete showing biofilm growth and lack of damage to siliceous fine aggregates that remain exposed.

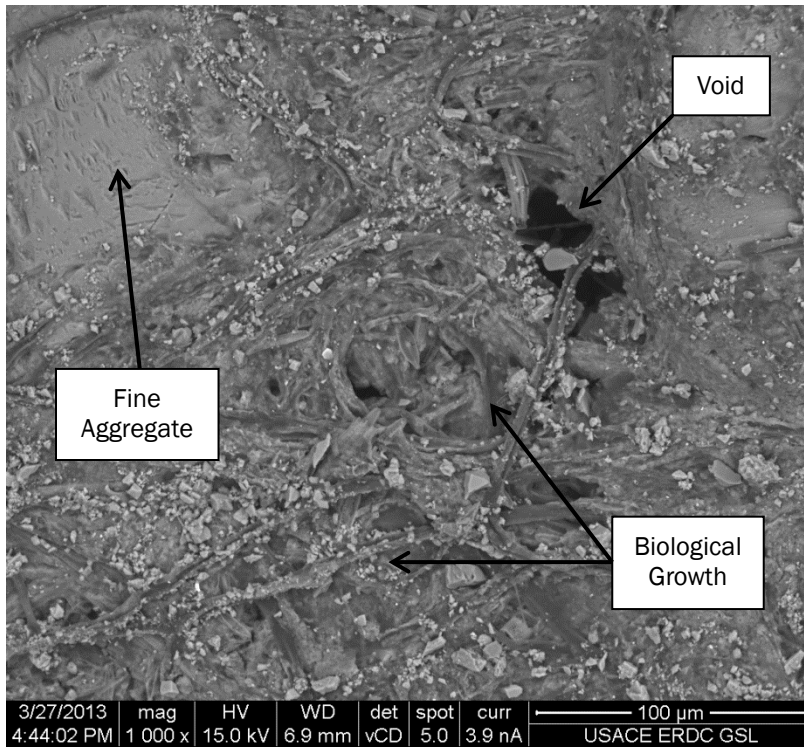
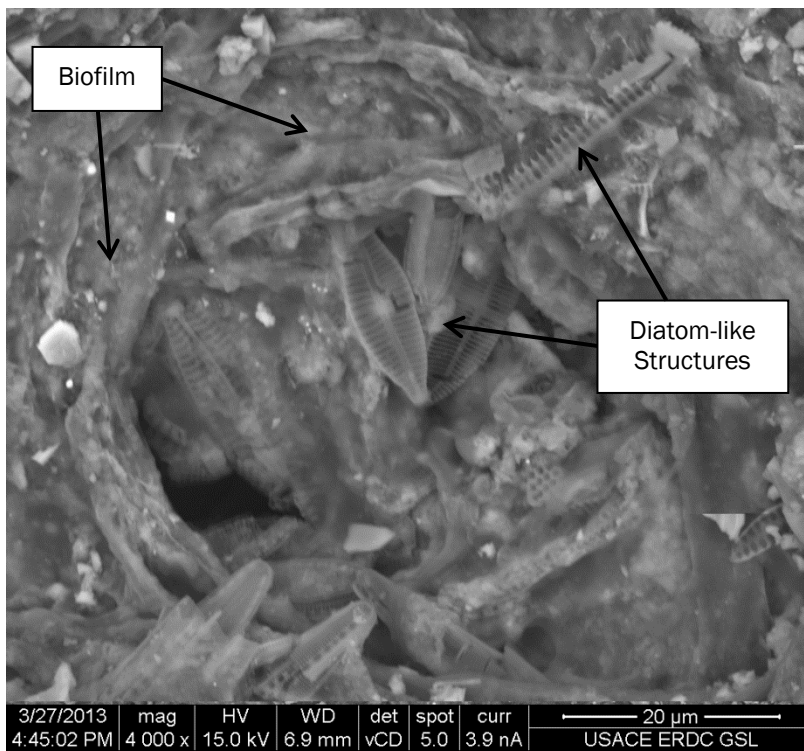
High-resolution imaging of deterioration at the surface of the concrete and also of the transition in deterioration from the surface to the inner bulk concrete was performed using scanning electron microscopy (SEM) of the as-received concrete surfaces and internal fracture surfaces. Typical SEM micrographs of the as-received surface of the deteriorated concrete are shown in Figure 17. The surface was highly populated by various biological species that were present primarily on the paste and limestone coarse aggregates. The biota appeared to consist of some type of bio-film along with diatom-like structures.

Figure 17. SEM micrographs of as-received deteriorated concrete surface showing biological growth present.

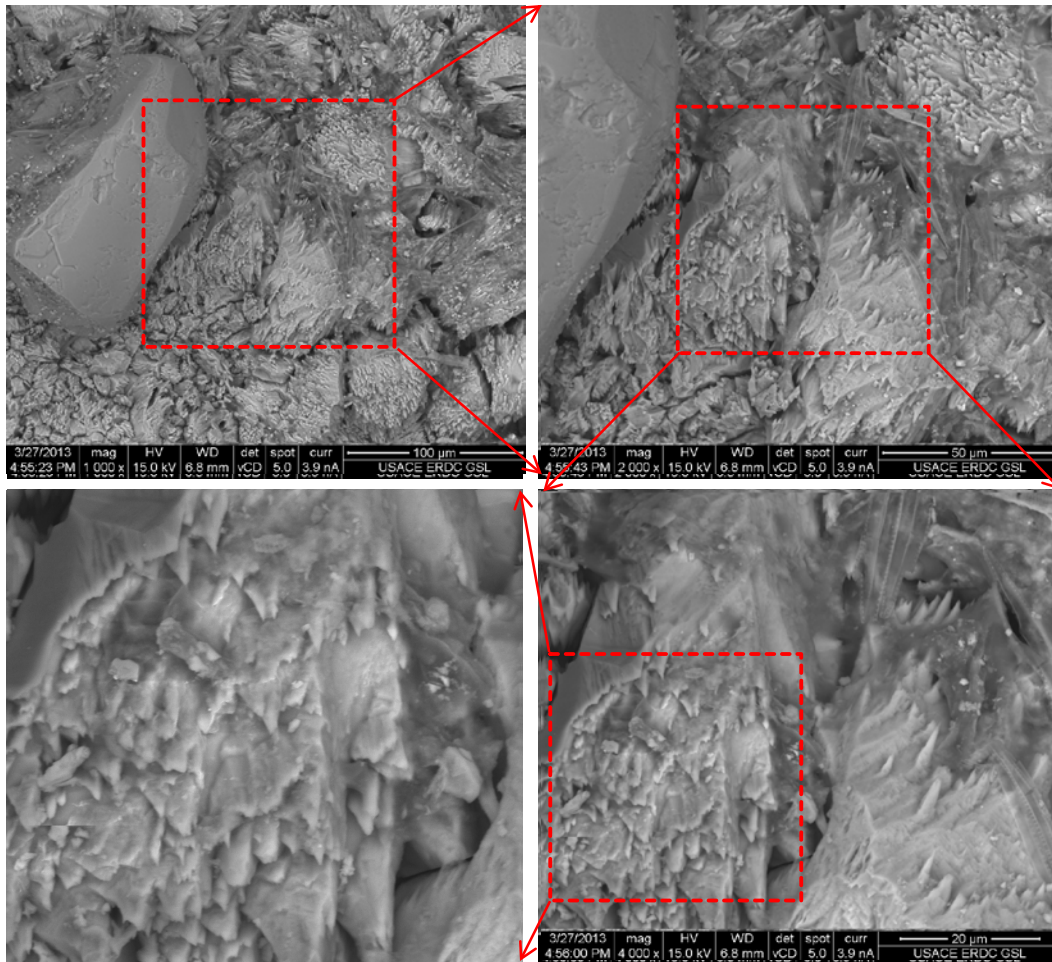
Further investigation of the surface showed a clear distinction between deterioration of limestone coarse aggregates and siliceous fine aggregates. Figure 18 shows an example of deterioration observed on the as-received concrete surface, with biological growth focused on paste and limestone aggregates; an unaffected fine aggregate; and apparent dissolution of an exposed portion of a limestone coarse aggregate. The dissolution of the limestone appeared to be correlated with the rhombohedral structure of calcite and changed with grain orientation in the coarse aggregate.

Figure 18. Progression in damage observed on as-received deteriorated concrete surface showing biological growth, unaffected siliceous fine aggregate, and dissolution of limestone coarse aggregate. Red boxes identify “zoomed in” areas in subsequent images.

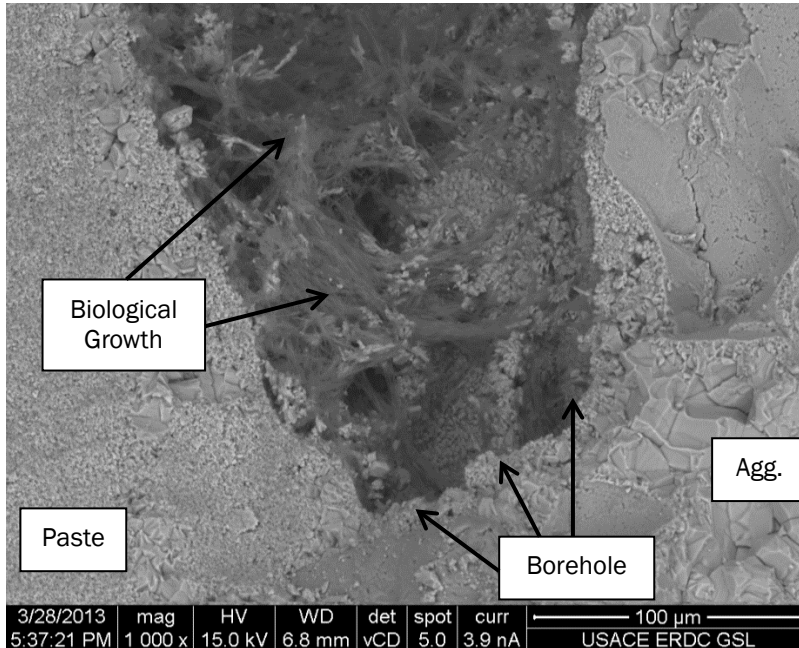
a. Deterioration and borehole observed on fracture surface.

Further examination of microcores extracted from the surface and split longitudinally was used to investigate damage from the surface in. Figure 19 shows examples of deterioration observed on the fracture surface and the transition between the surface deterioration and the non-deteriorated bulk concrete and unaffected aggregates. The inner bulk concrete appeared typical with no detectable other modes of deterioration (see Figure 20).

Figure 19. SEM micrographs of deterioration observed on fracture surface including borehole near exposed surface and transition between deteriorated and non-deteriorated limestone in Pleistocene limestone coarse aggregate.

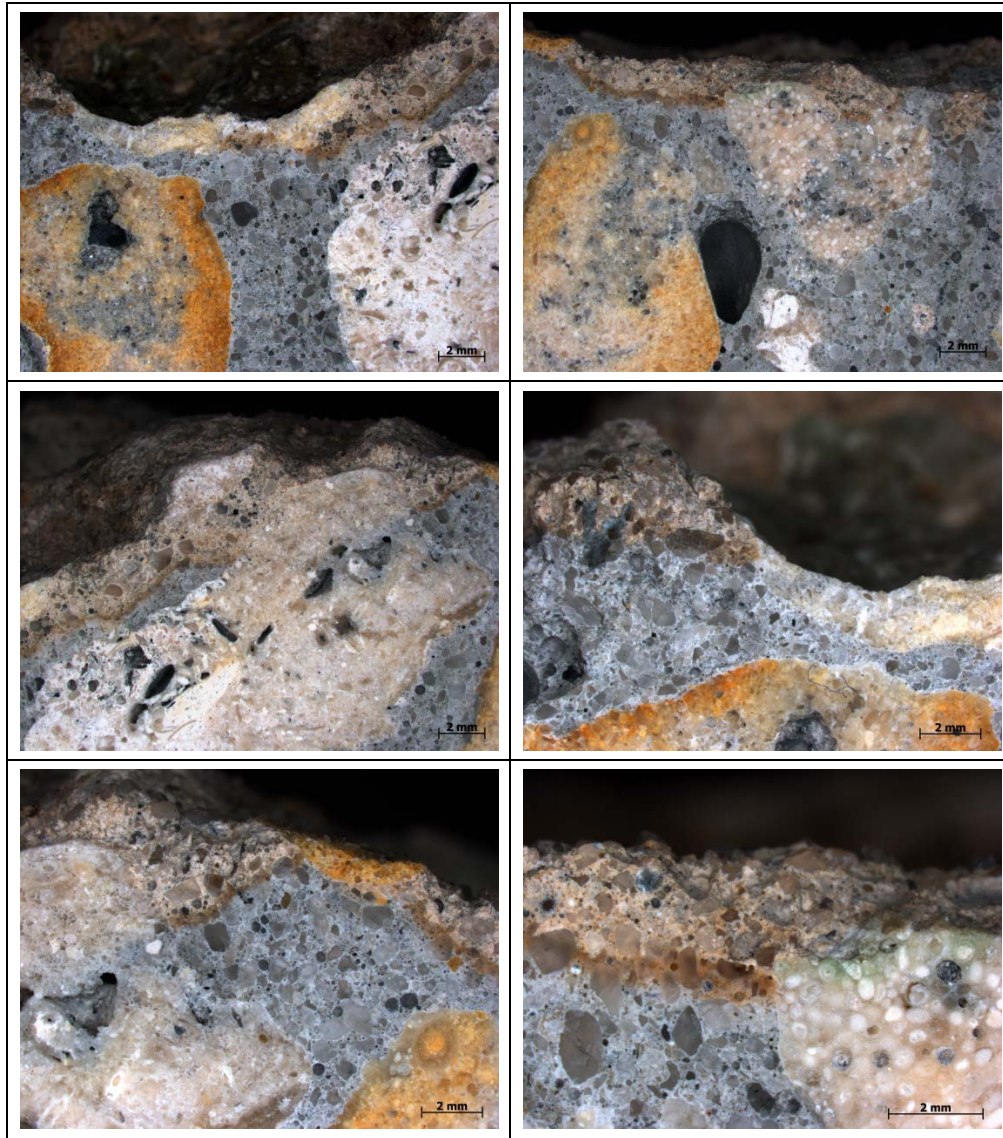
Figure A2. Supplemental photomicrographs of deteriorated concrete from core D2.

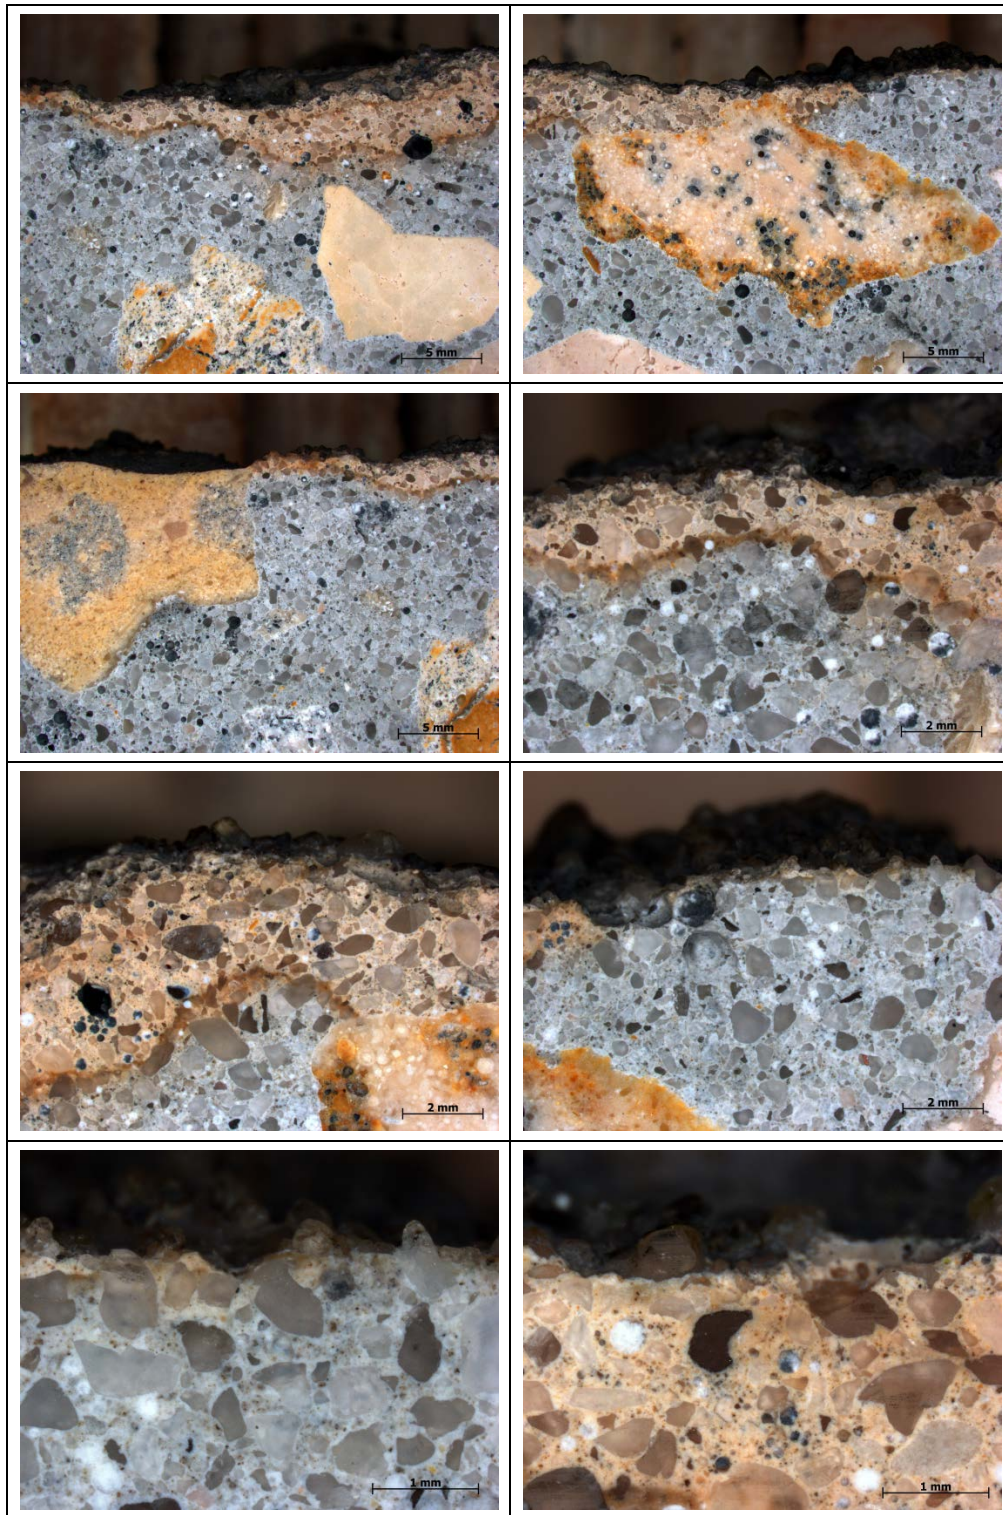
Figure A3. Supplemental photomicrographs of deteriorated concrete from core D3.

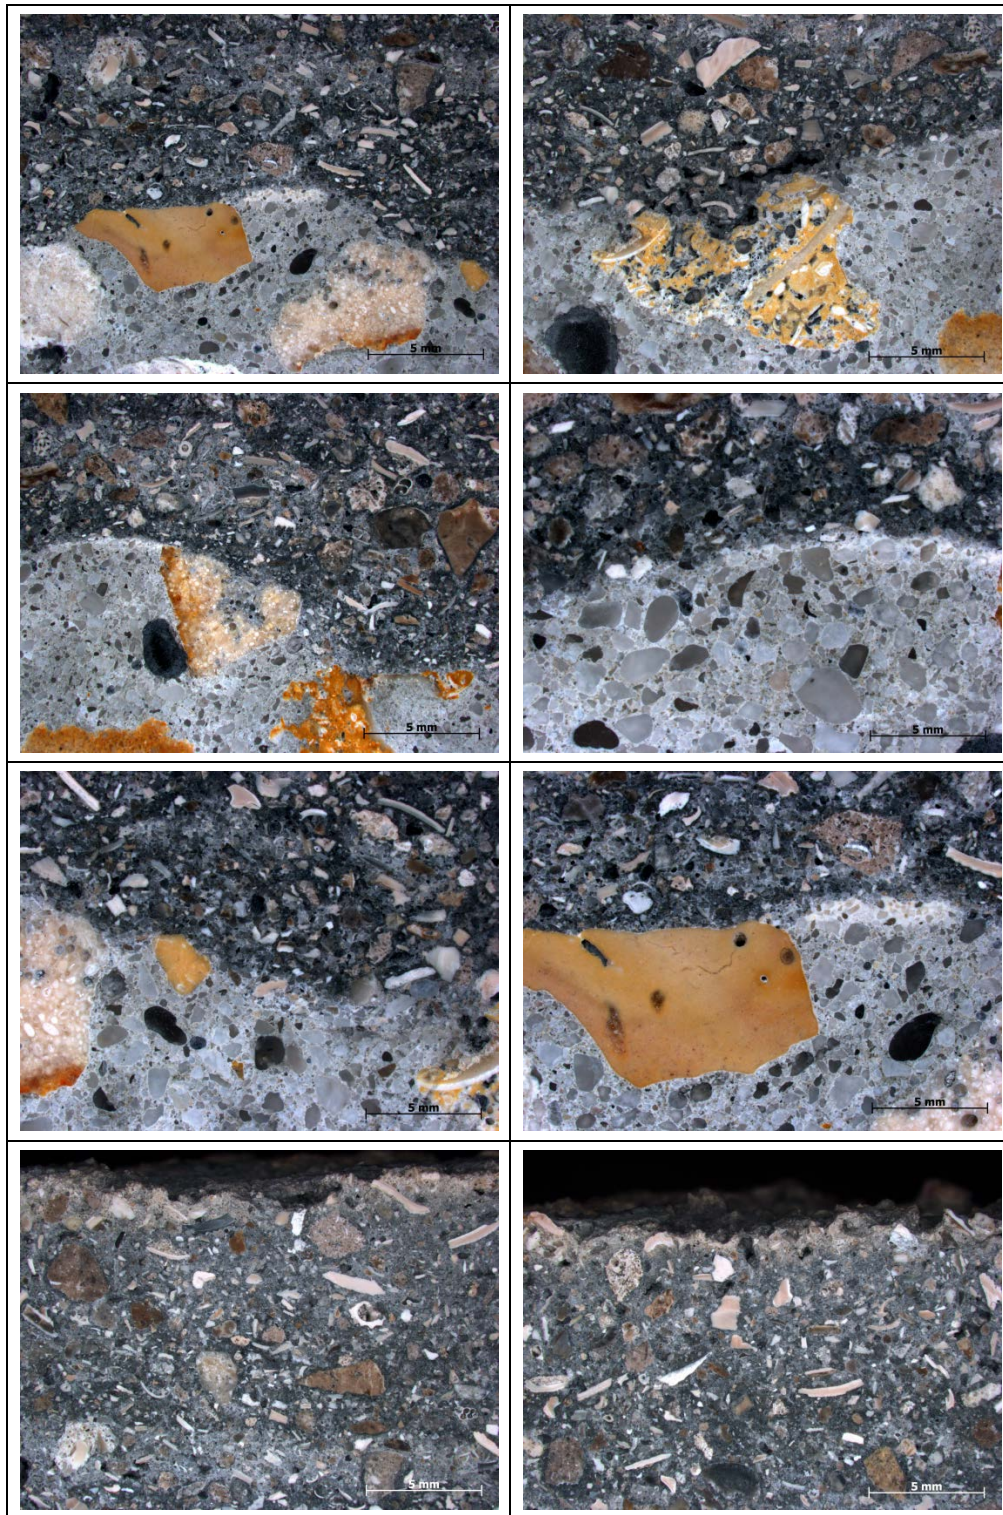
Figure A5. Supplemental photomicrographs of repaired concrete surface.

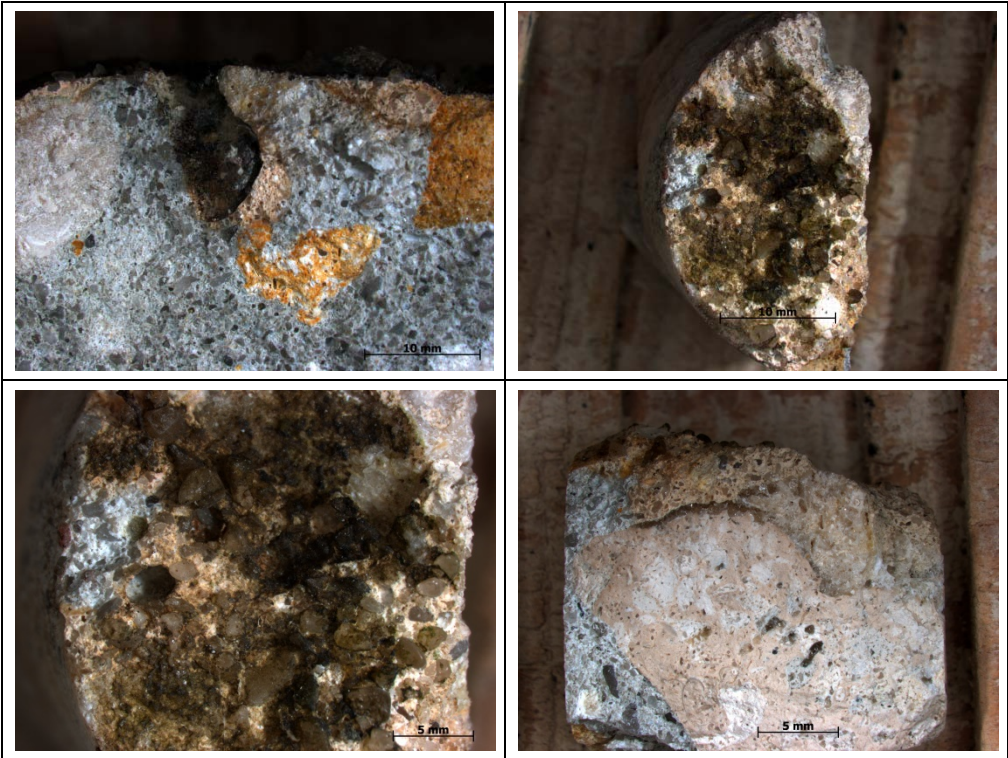
Figure A6. Supplemental photomicrographs of fractured sample of concrete, including deteriorated surface.

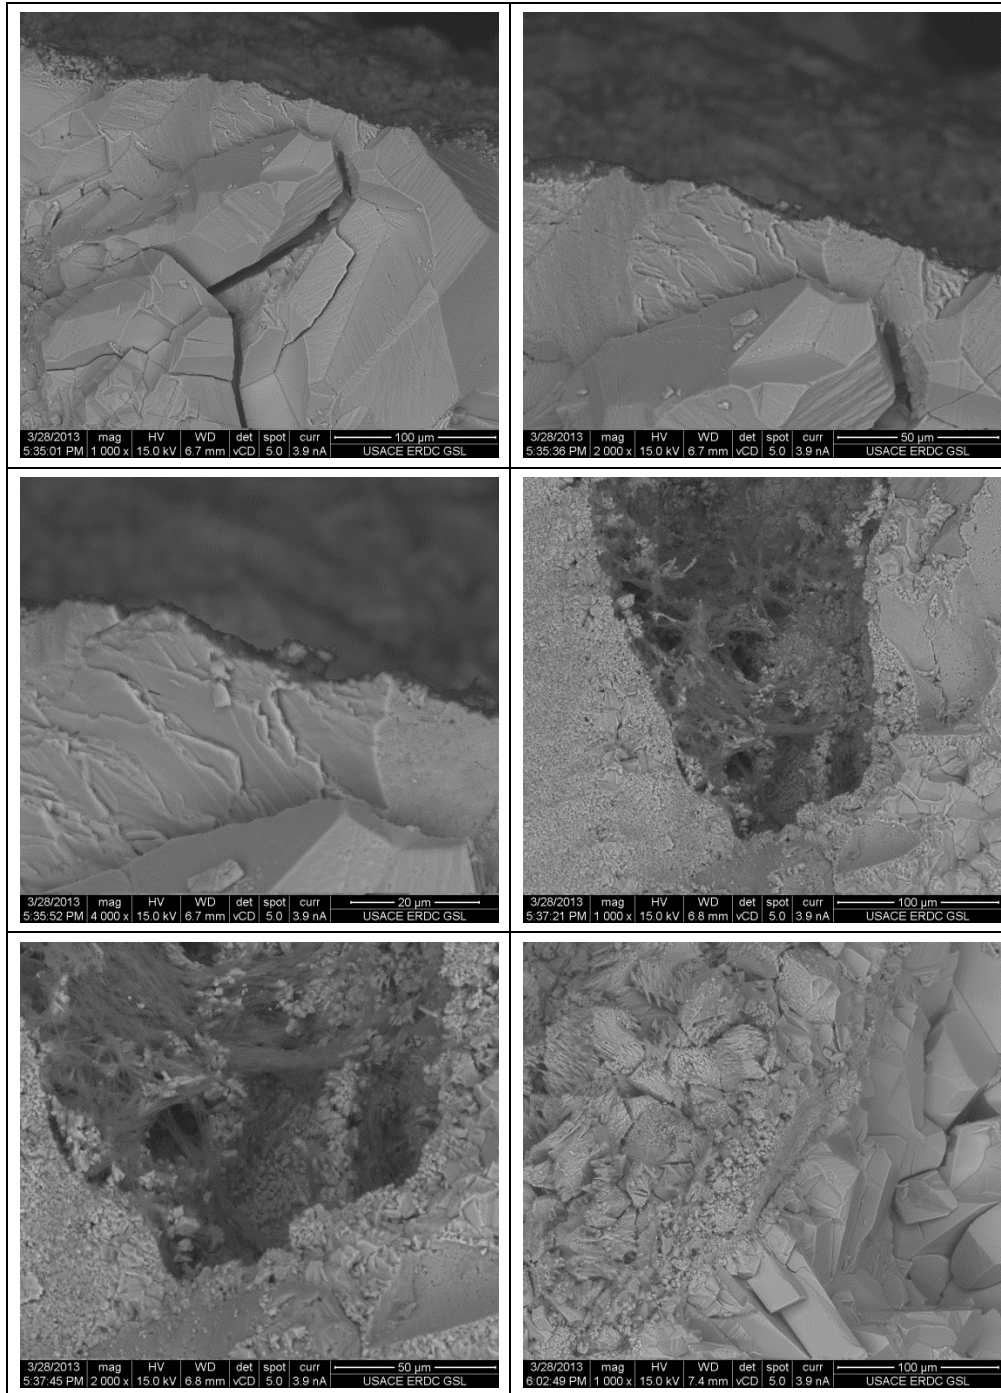
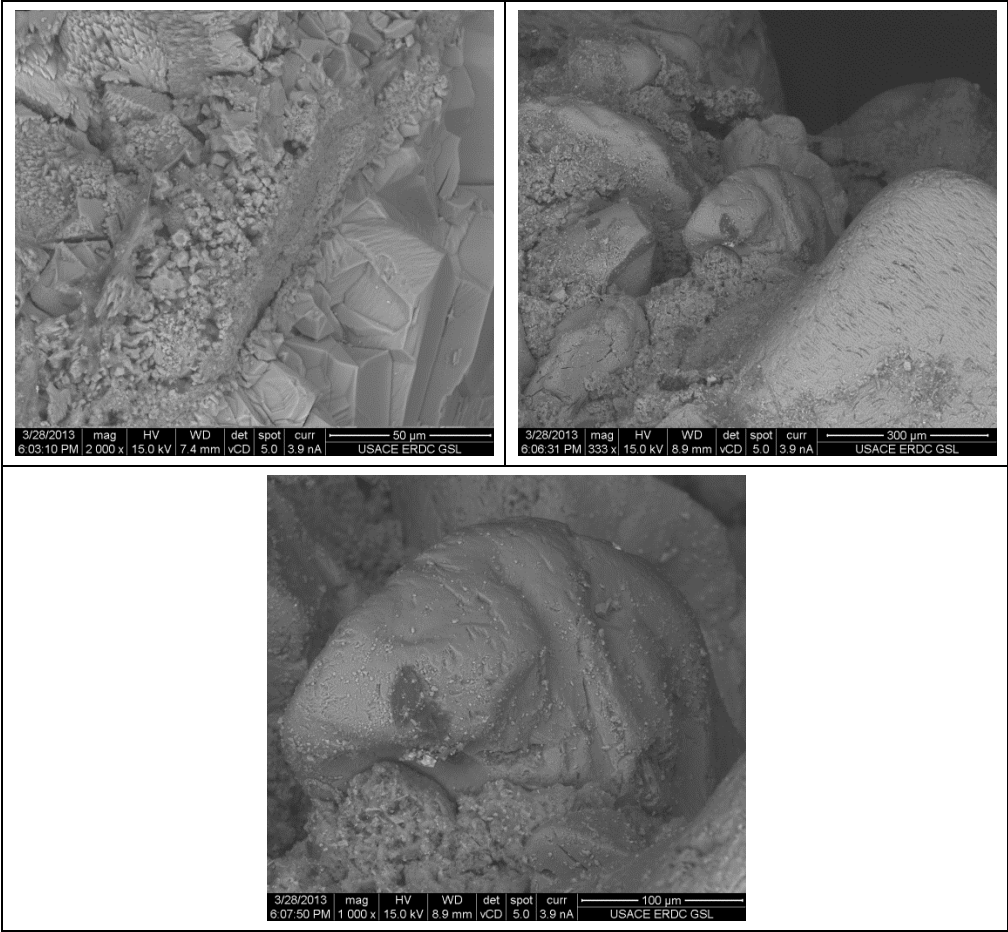
Figure B2. Supplemental SEM micrographs of fractured surface of deteriorated concrete.
