## **An Investigation of Concrete Deterioration at South Florida Water Management District Structure S65E**

February 2014

Final report

Under Rapid Assessment of Concrete Deterioration at S65E

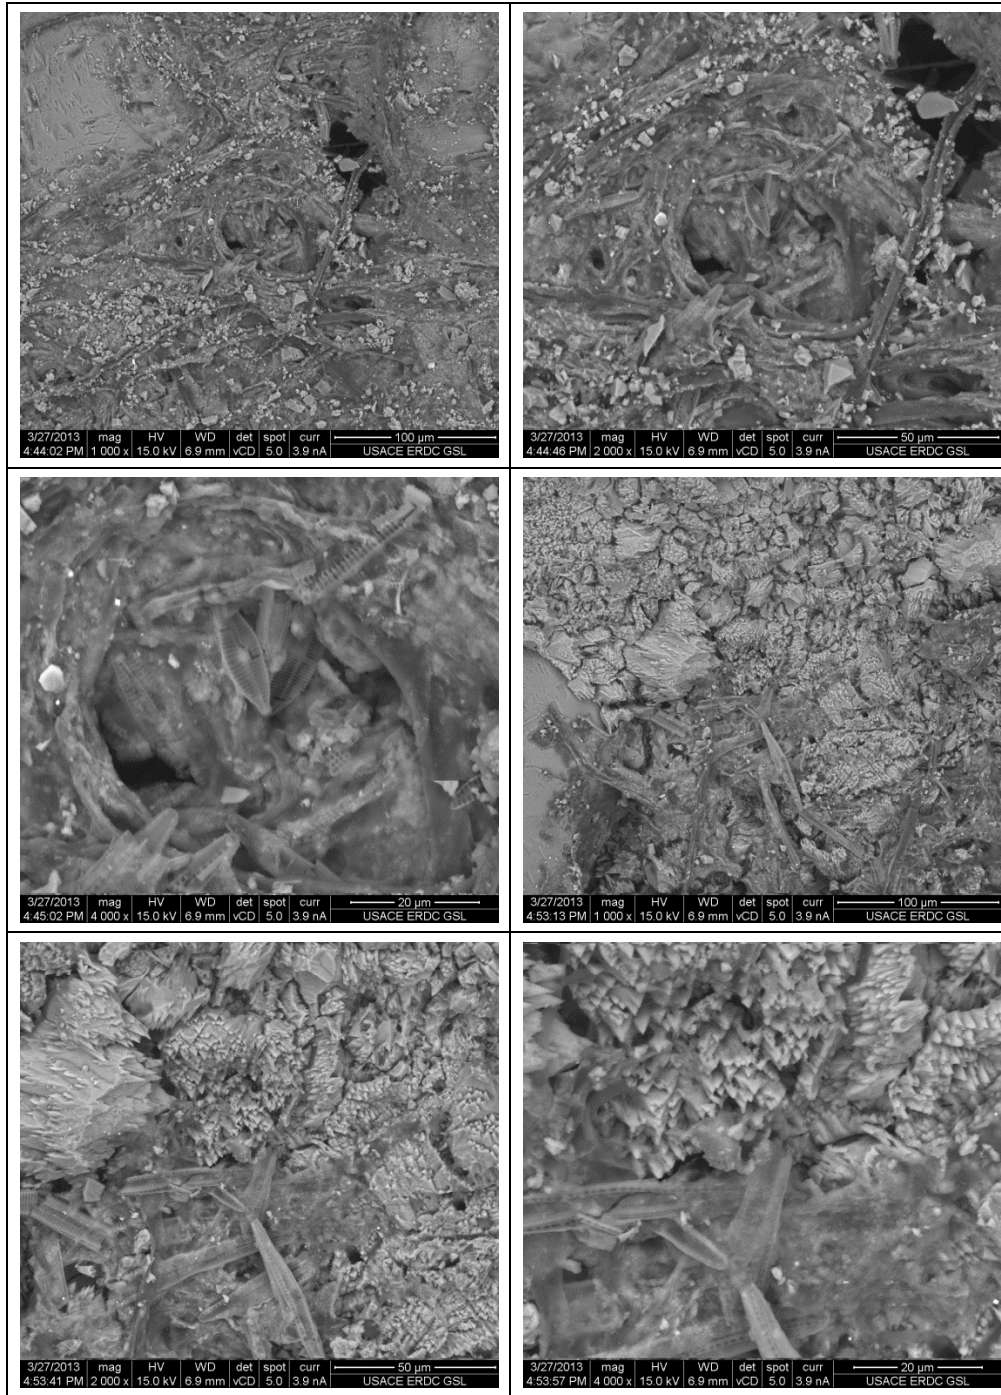
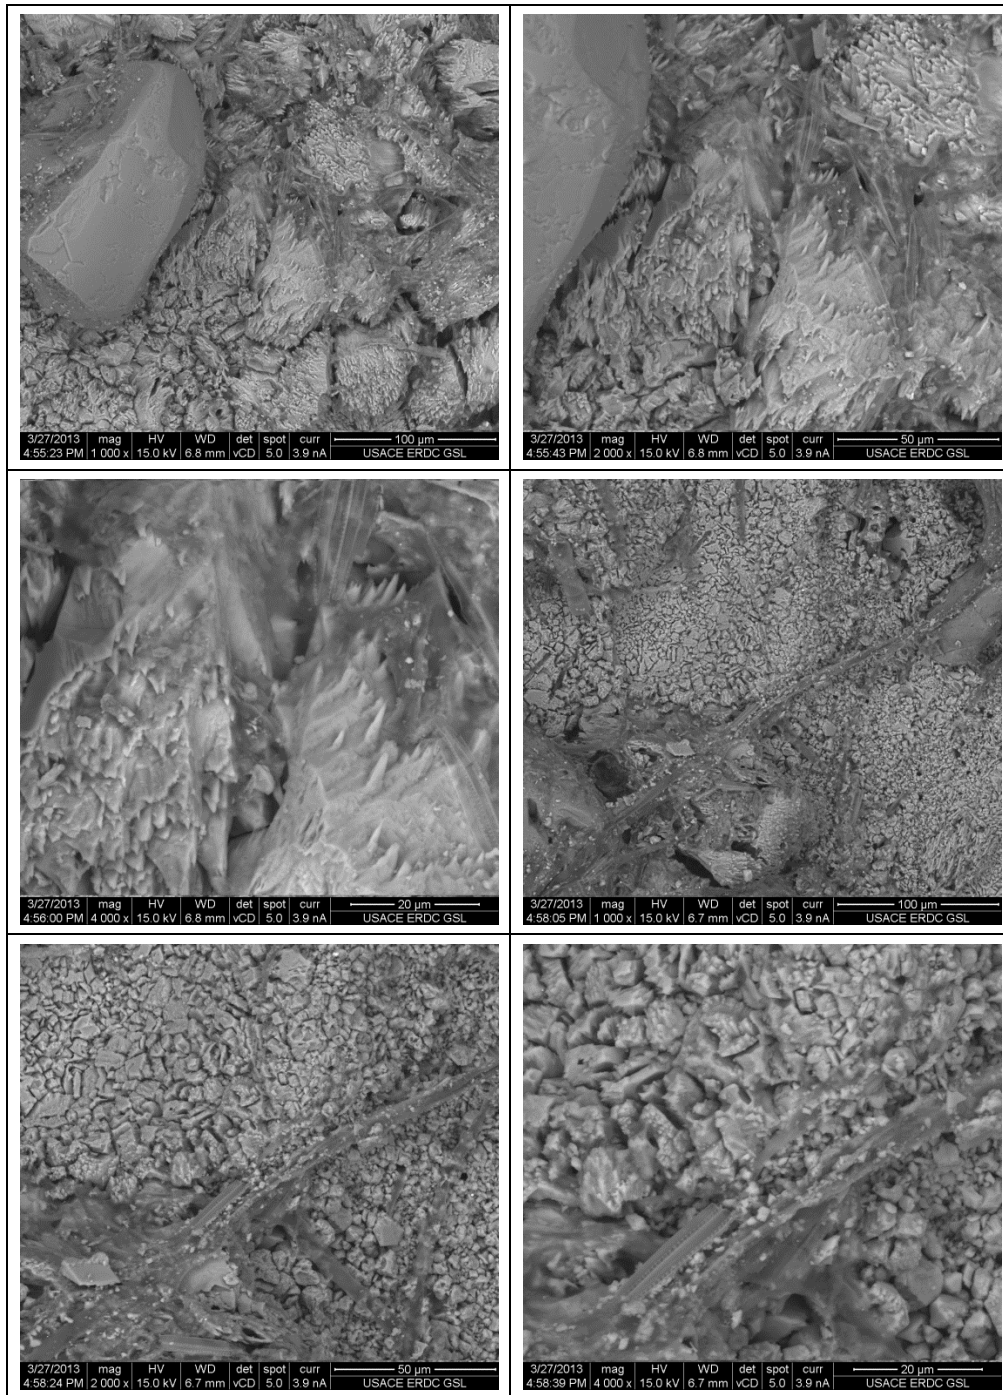
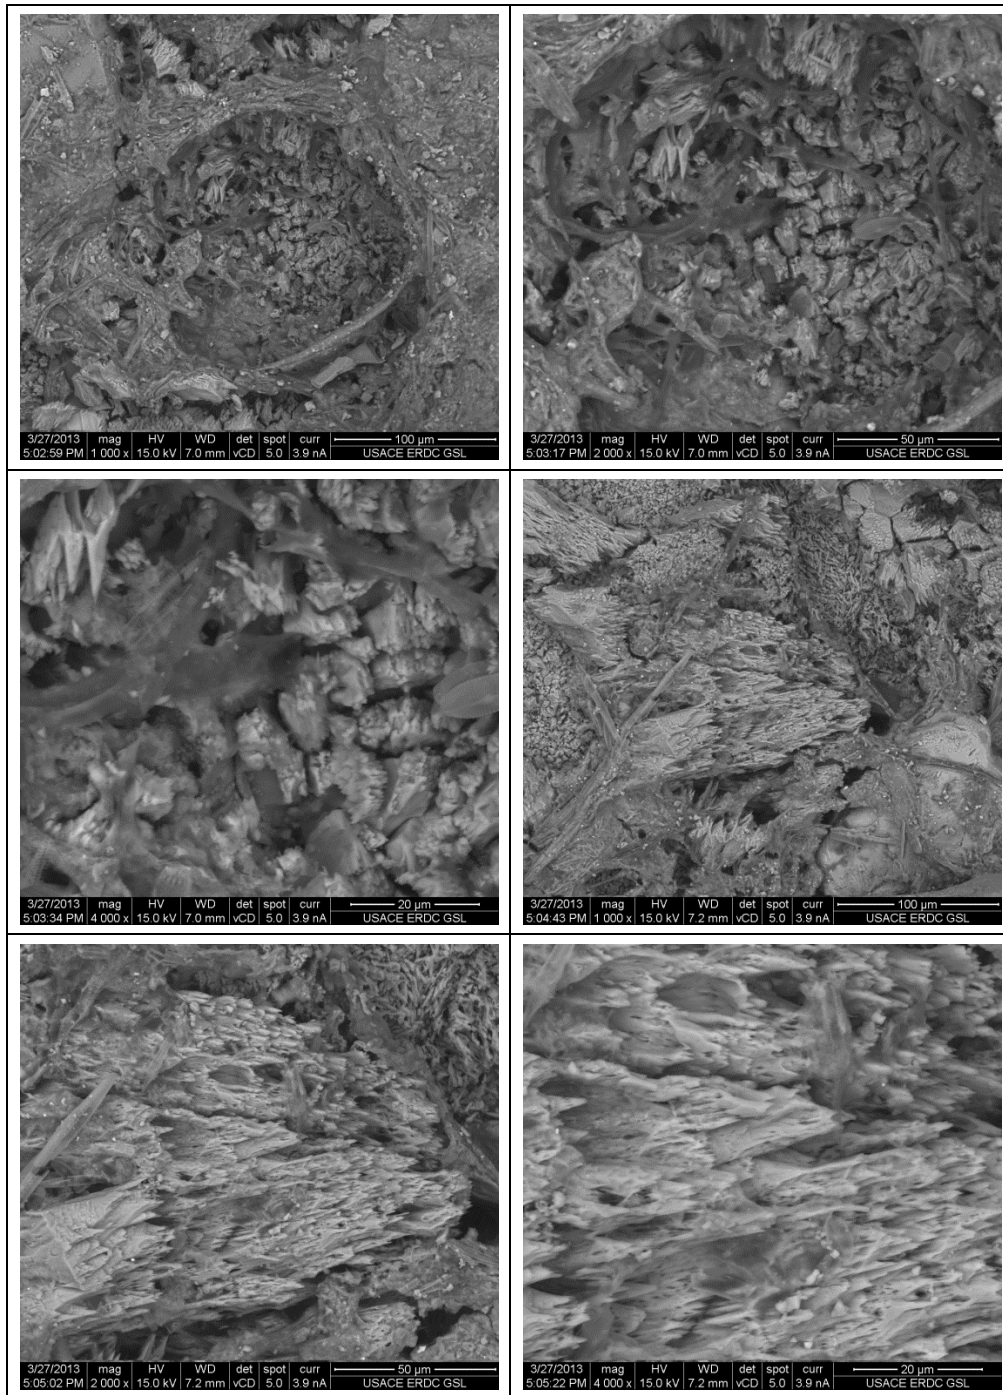
Figure B3. Supplemental SEM micrographs of exposed deteriorated concrete surface.
