| <b>4. TITLE AND SUBTITLE</b><br>FAILURE ANALYSIS OF HIGH PRESSURE TEST FACILITY CONTROL VALVES | | | | <b>5a. CONTRACT NUMBER</b><br>In-House | |

## FAILURE ANALYSIS OF HIGH PRESSURE TEST FACILITY CONTROL VALVES

P. M. Rice, M.S., P.E, M. Heitstuman, B.S.M.E., 1LT, USAF & J. Blanton, B.S.M.E., 2LT, USAF  
Air Force Research Laboratory, Aerospace Systems Directorate, Rocket Propulsion Division  
Edwards AFB, CA

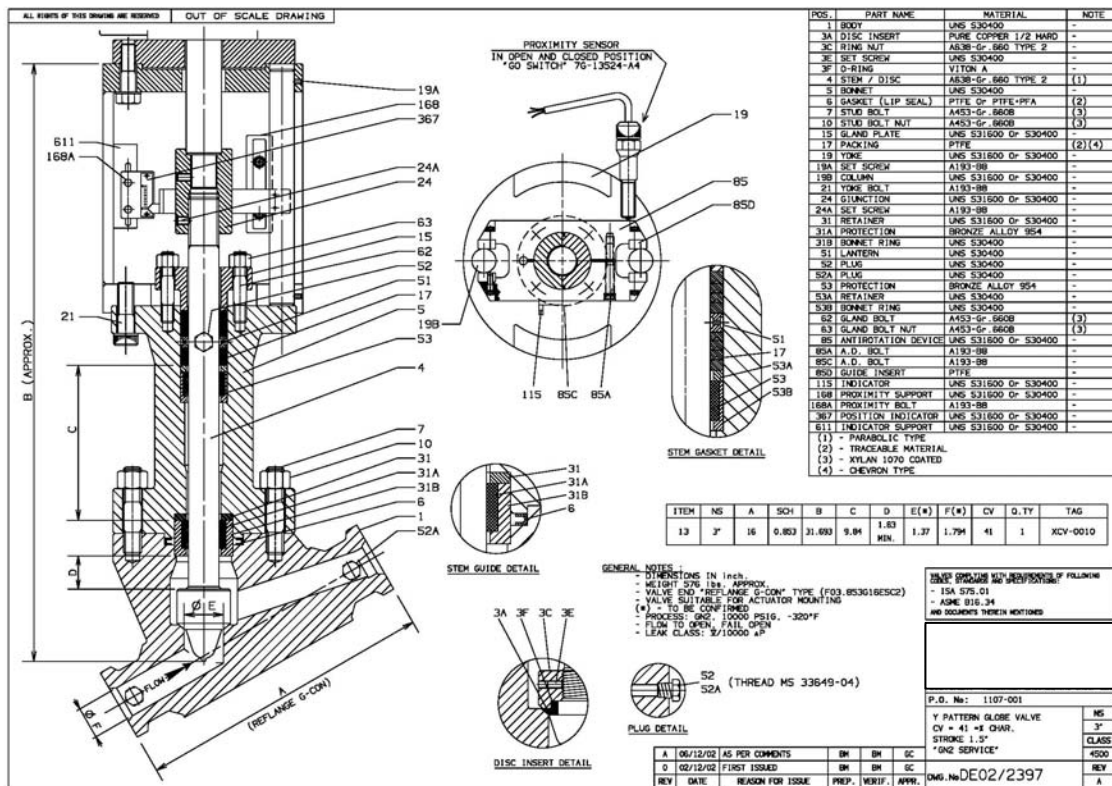
In **Figure 2**, we show the basic configuration of XCV-0010. The valve is a hydraulically actuated Y-pattern globe valve. The body of the valve is constructed from 304 stainless steel and the plug and stem are made from A286 Gr 660 Type 2 stainless steel. The plug is a three-piece design with a copper seat.

**Figure 2.** A cross sectional view of XCV-0010 shows the basic configuration of the valve. This configuration, consisting of a Y-pattern body, plug and stem, guides, and packing, is a common configuration for high-pressure globe valves, which has been used for over 60 years.

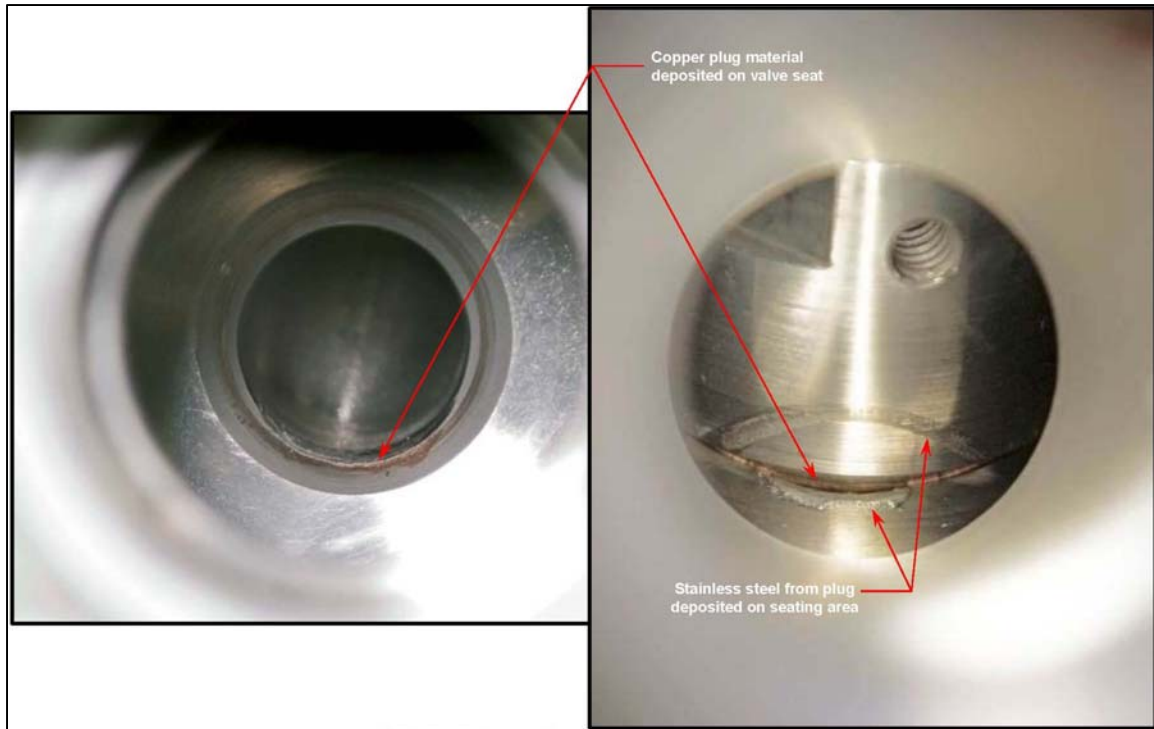
**Figure 5.** What you are looking at is the seating area of the valve body. Note that stainless steel in the seating area has been scrapped so hard that the plug contact area has rolled over where the plug contacted. Also, you can see where we found copper from the valve plug deposited on the valve seat.

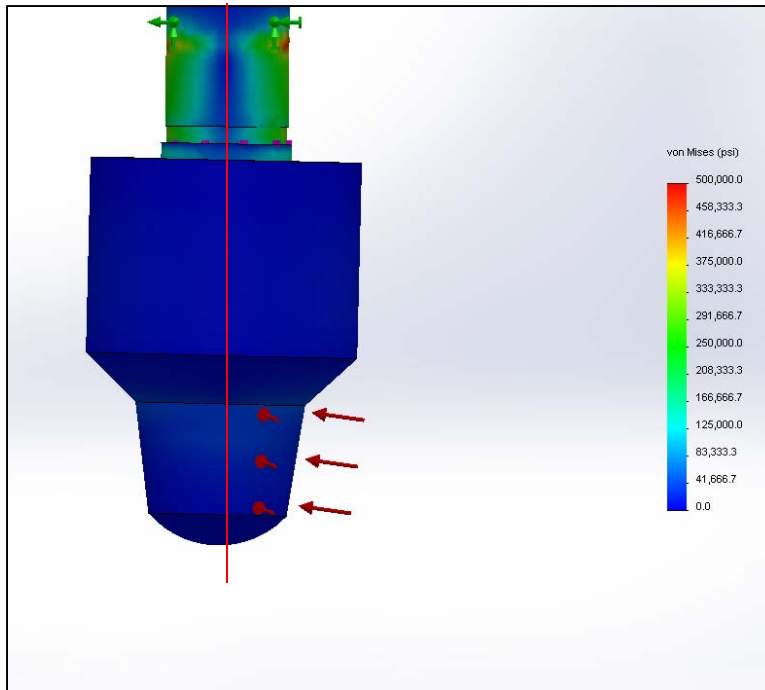
We constructed the models based on these constraints and assumptions in SolidWorks, and performed a series of finite element analysis studies. FEA studies were performed for both bending and buckling. The valve failed in bending by a large margin consistent with the postmortem examination of the valve. The analysis indicated that the factor of safety (FOS) in buckling was 8 (which means, the load required to make the stem fail is eight times larger than the axial load applied to the stem by the actuator in the closed valve position), so we decided that no further buckling analysis was warranted. The results are presented in and discussed with **Figures 6, 7, and 8.**

**Figure 6.** This graphic shows the output of the finite element solver displaying the maximum von Mises stress for the XCV-0010 stem/plug. Notice, as we stated in our assumptions, that the force of the pressure was placed orthogonal to the face of the plug, but to be conservative, only applied to the projection of the plug tip and not the whole wetted area of the plug (the large diameter portion). The results show that the maximum stress on the stem (487 ksi) occurs at the location of the cantilever support (guide bearing), and greatly exceeds the yield strength of the stem, resulting in permanent deformation. If you look carefully at the centerline, you will also notice slight bending of the stem. This is less than the real stem, but shows that even with this very conservative analysis, the stem would bend. If the maximum stress had not exceeded the material allowable, you would only see displacement on a greatly exaggerated (50x or greater) graphic (see next figure).

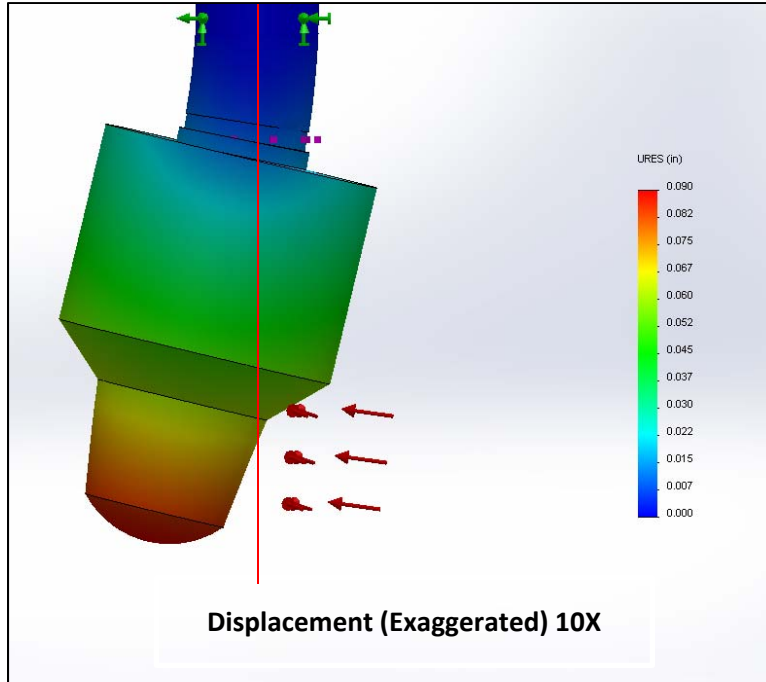
**Figure 7.** Seen here is the displacement exaggerated by 10 times to show the bending of the stem beginning at the location of the lower guide bearing. The maximum displacement according to the conservative model is approximately 0.09 inches. It doesn't seem like much, but permanent deformation of the stem on this magnitude indicates both an extreme overload, and in this case, certain interference between the plug and the valve seat.

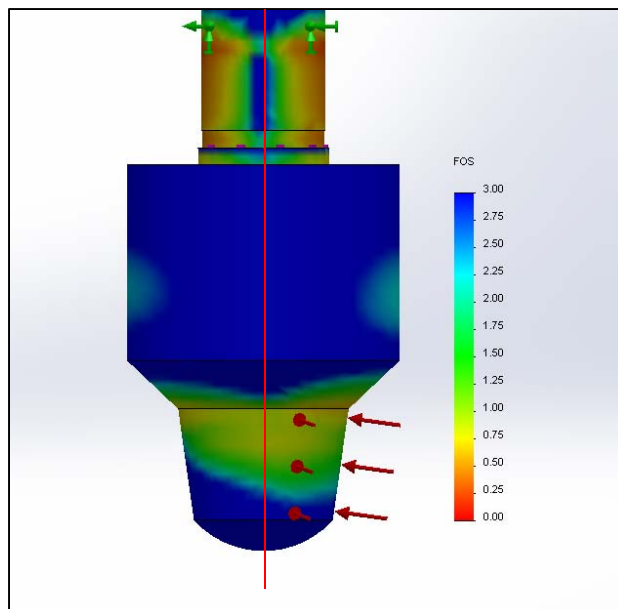
**Figure 8.** Here you can see the results of the finite element solver displaying the FOS for the XCV-0010 stem/plug. The results show that the FOS was less than one (1) in many areas of the structure with the minimum being 0.21. This means that permanent deformation occurred. No displacement is shown in this particular graphic.

The cause of the failure appears to be purely mechanical as there were no control system or operation errors that could be traced to the valve failures. Several obvious design flaws in the valve are considered to be major contributors to the failure of the valve. First, the large surface area projection of the plug into the flow stream subjects the stem and plug to an excessive load. Second, the distance from the stem guide bearing to the plug creates a long cantilever arm that promotes bending of the stem. This feature is not typical of other high pressure valves, which have guide bearings located much closer to the plug and have proven reliable in similar/identical environments. Third, the stem guide bearing tolerance was such that the stem was not well supported by the bearing, thus lending opportunity to produce greater displacements and higher stress concentrations on the valve stem. Finally, the ratio of the stem diameter to the plug diameter ( $d_{\text{stem}}/d_{\text{plug}}$ ) is low. This feature creates a higher stress concentration at the stem-plug interface.

To prevent this from occurring again in the as-built system, we found the location of all the installed valves that have a similar design by the same manufacturer. There were two additional valves identified on the installed system, and one installed on the test skid for the HCB program. We took the following steps to determine the extent of the problem and mitigate the program impact:

1. We verified the service requirements for each valve in order to determine whether they were susceptible to a similar type of failure.

2. We removed and replaced “high risk” valves where possible and tagged those valves to identify that they are not approved for future use in similar high-pressure applications.
3. We located out-of-service valves of the same design and identified them for non-use pending an engineering evaluation for proposed future service.

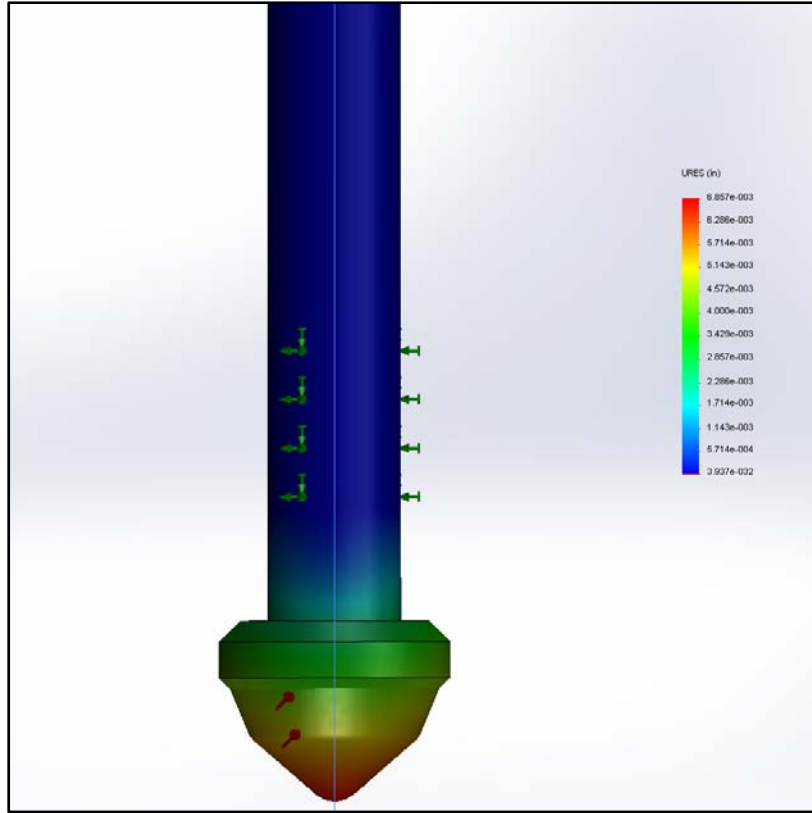
**Figure 10.** Seen here is the displacement results showing the maximum displacement is at least an order of magnitude less than XCV-0010, and would return to zero once the load is removed since no permanent yielding took place.
