FINAL REPORT

Ultrasonic Guided Wave Technology for Non-Invasive
Assessment of Corrosion-Induced Damage in Piping for Pollution
Prevention in DoD Fuel Storage Facilities

ESTCP Project WP-200819

AUGUST 2011

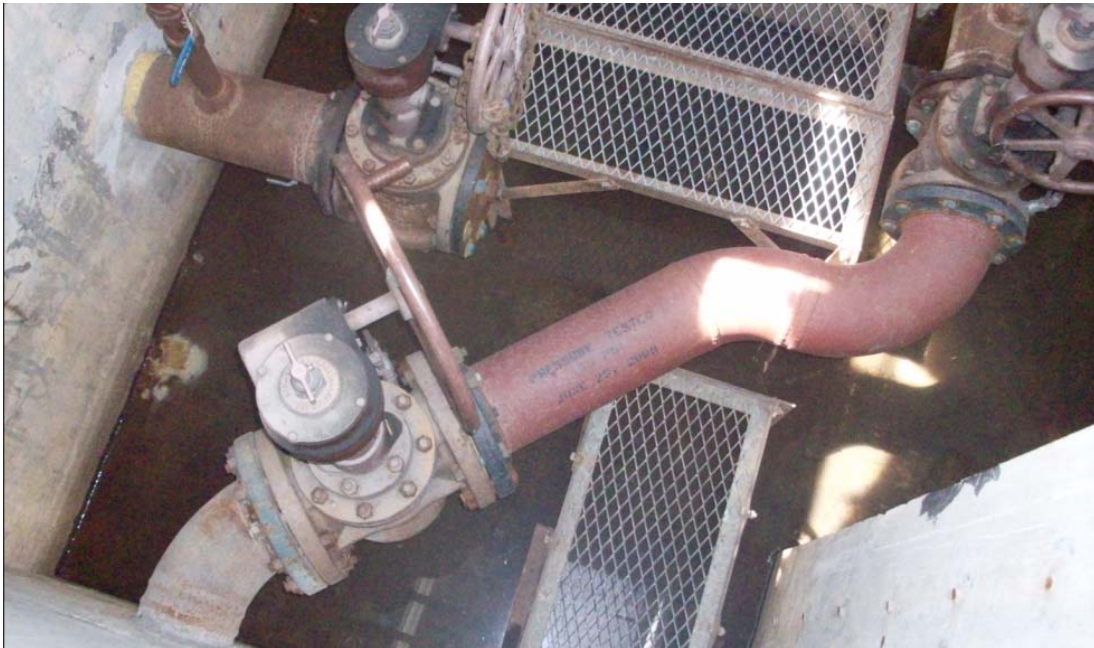
Figure 6. Pipeline accessories inside a valve pit. A section of the pipeline between Block 20 and Valve Pit 21 was replaced 4-years ago because of structural weakness as revealed by pressure testing. It has a mixture of 10 inch and 6 inch pipes connected through reducers and valves.

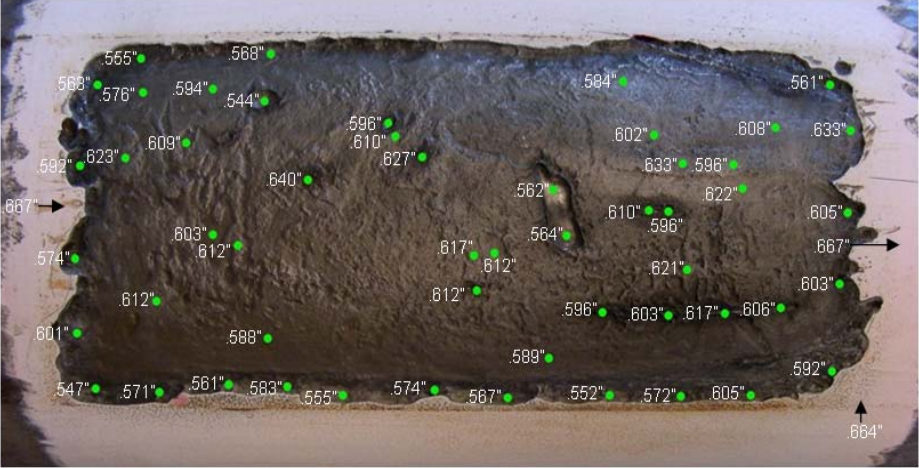
Figure 16. Annotated photograph of the Defect 1 corrosion area in Phase I.
 The numbers indicate micrometer readings at the green dot locations from which wall thickness loss was calculated.

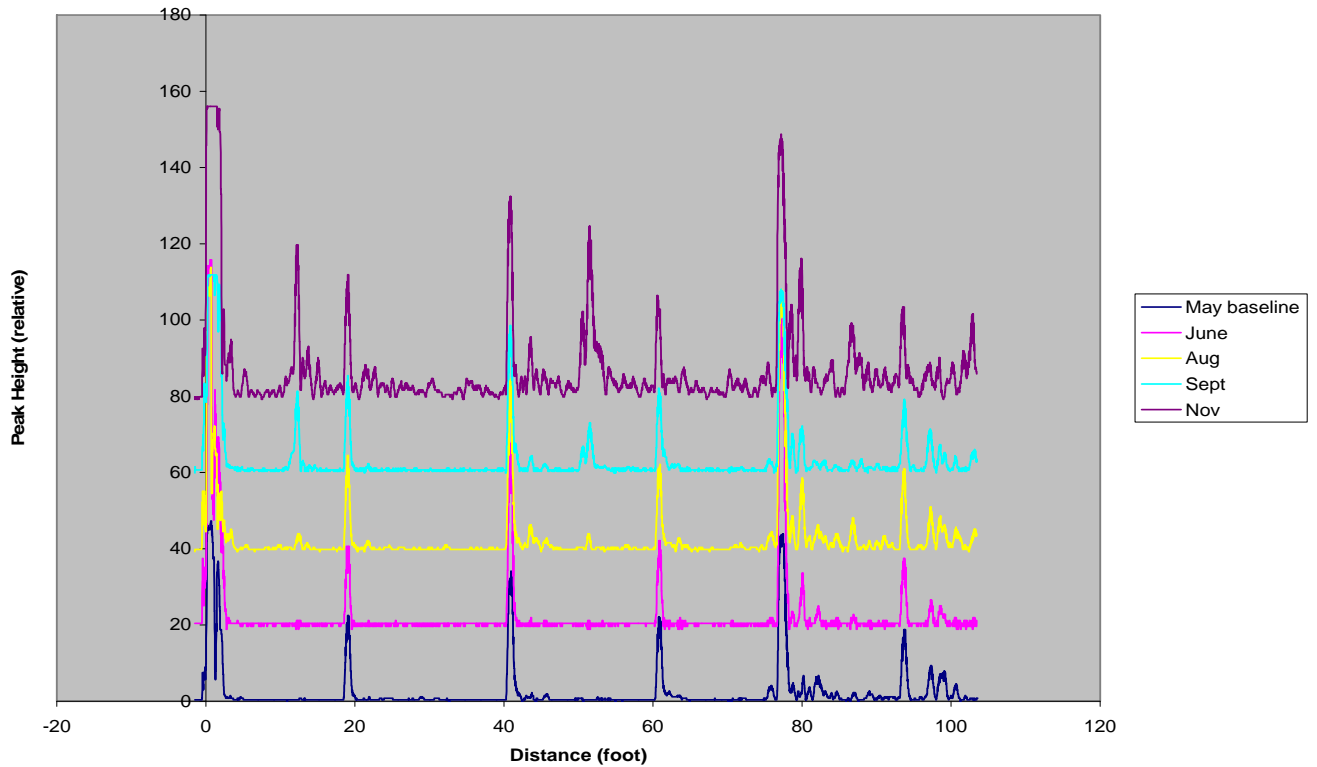
Shown in Figure 18 is the summary of the above-ground ultrasonic wave data over time as compared to the baseline with a systematic increase in defect peak height with successive stages of corrosion from a transducer placed at location 2. Waves from one transducer detect the presence of welds, elbows, and one or more defects in the guided wave propagation path. As expected, the signal height depends on the size of the defect, the distance between the transducer and the defect, and the number of welds in the wave propagation path. We note that the noise level increased in the later months as corrosion progressed, but was less than 0.1 of the weld signal height at about 80 feet.

Figure 18. Systematic increases in defect detection over time as compared to the baseline. Systematic increases in peak heights for growing Defects 1 and 2 sensed by transducer at location 2. Defect 1 was located at approximately 50 feet and Defect 2 was located at approximately 12 feet. The other large peaks, approximately 20 feet apart, are from the welds in the pipeline. The baseline signal (May 2008) is blue, the June signal is pink, the August signal is yellow, the September signal is light blue, and the November signal is purple. An offset of twenty units along the vertical axis has been added to each successive trace before plotting.

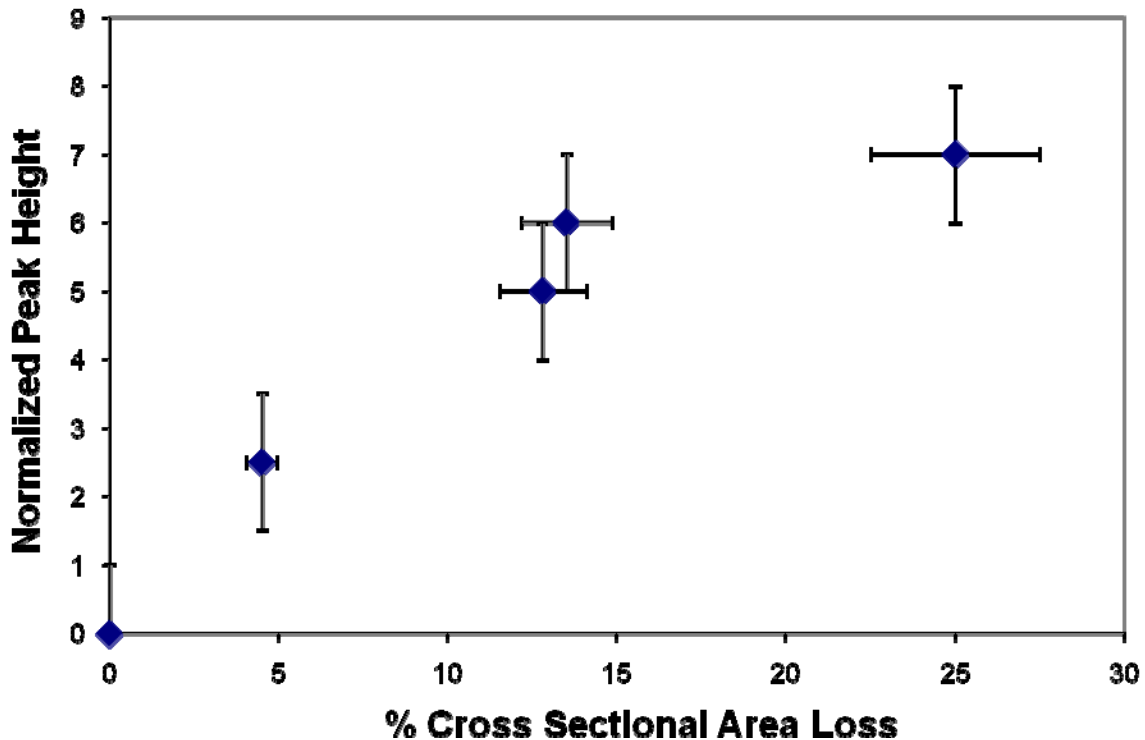
Figure 23. Plot of signal height against defect CSAL for defect W6 showing increased signal peak height for the weld signal as corrosion increased.

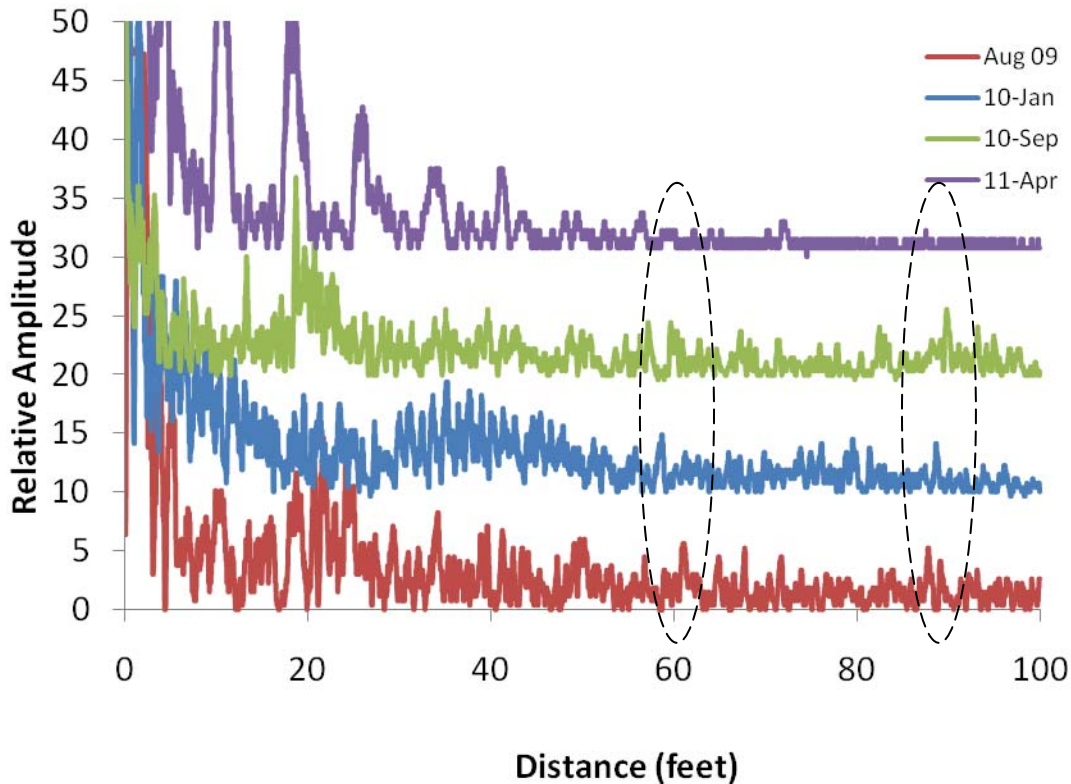
Shown in Figure 28 are traces obtained from the baseline through April 2011 for under-ground sensor #22532 with wave propagation from VP 21 towards BL 20.

Figure 28. Monitoring changes in data sets obtained at the baseline and successive months by underground sensor #22532.
An offset of ten units along the vertical axis has been added to each successive trace before plotting.

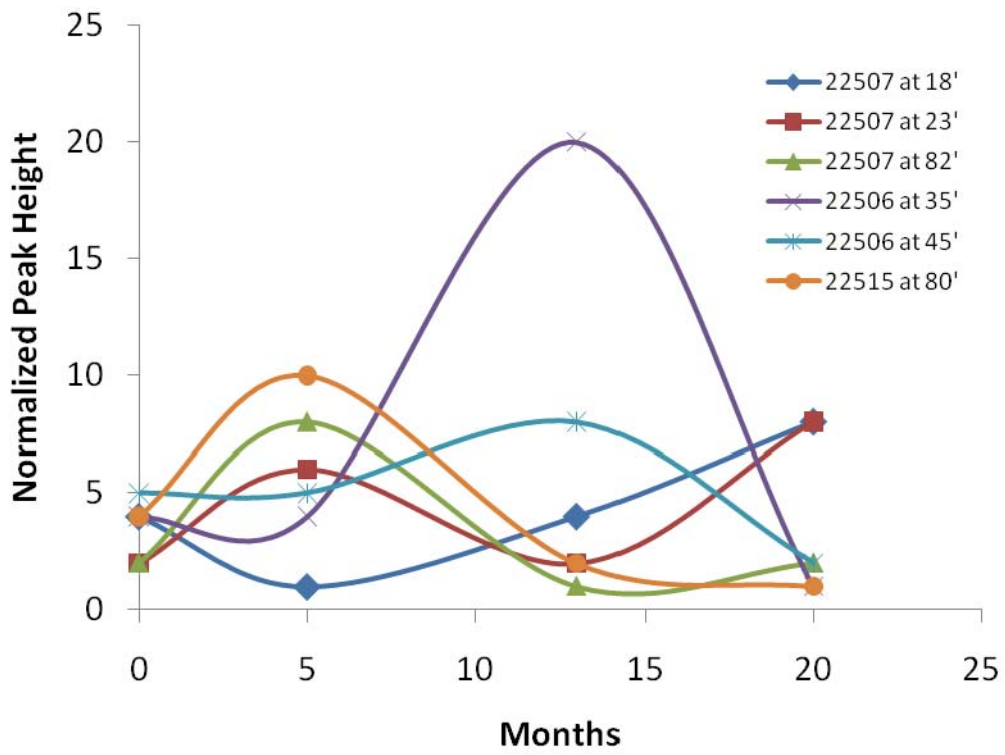
Figure 36. Changes in normalized peak height at suspected defect locations detected by three above-ground transducers.
 Typical signal noise was 2 vertical units.

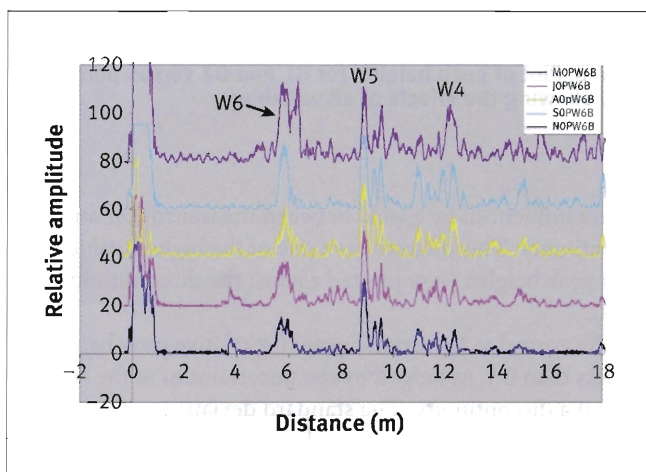
Figure 5. Data traces showing the increase in peak height and split peak features at W6 located approximately 5.5 m from the transducer placed at Location 0. An offset of 20 units along the vertical axis was added to each successive trace in this Figure.
