M1A1 Cannon Cradle Repair at Anniston Army Depot

Tony Pollard
Anniston Army Depot (ANAD)

Phillip F. Leyman
Army Research Laboratory (ARL)

13. SUPPLEMENTARY NOTES 24th Replacement of Hard Chrome Plating Program Review Meeting, July 20-21, 2004, Park City, UT. Sponsored by SERDP/ESTCP.

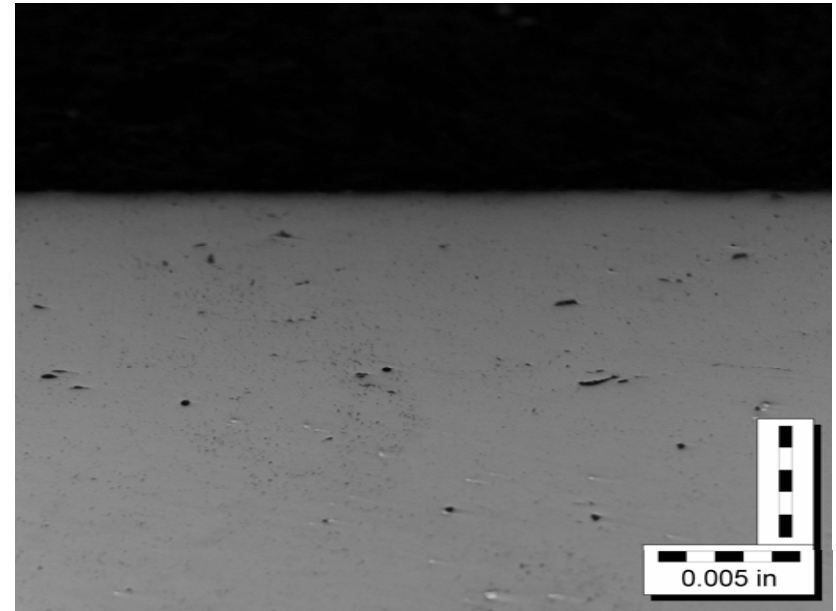
Micrograph of ESD applied Iconel 718
(.010" dimple)

- Pulse Rate – 400 Hz
- Capacitance – 30 mfd
- Voltage – 150 volts
- Step Rate – 340 Hz
- Swing – 3
- Rotate Increment – 3
- Direction – CW
- Interval – 6
- Argon Gas Atmosphere

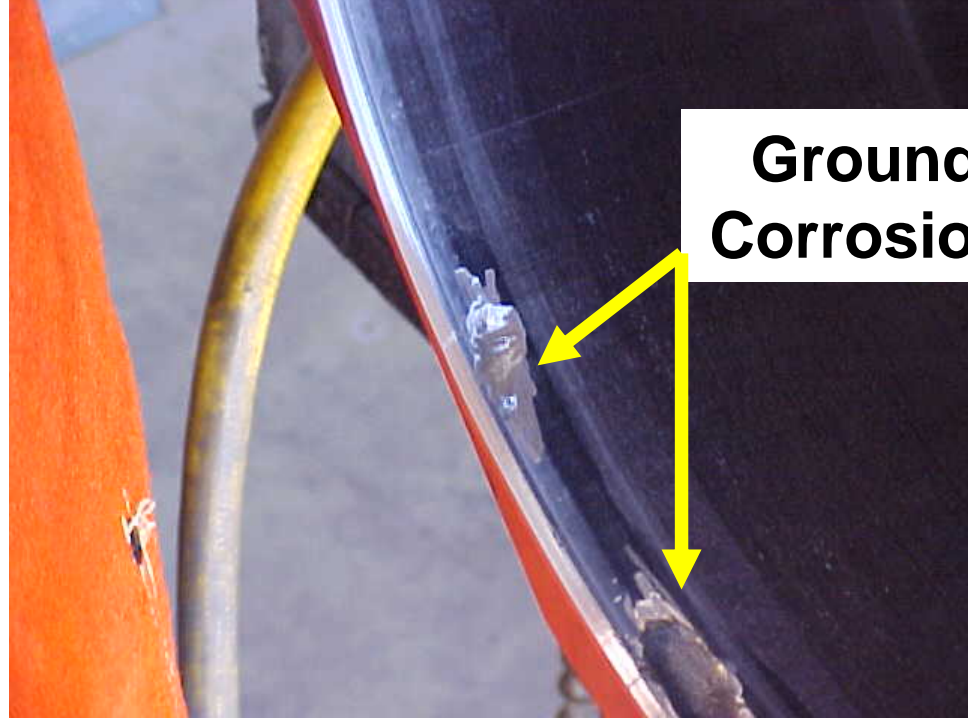
- Large corrosion pits 1/8" by 3/8" – 0.060" deep
- Build up pits with base material
- Base material - 4130 steel
- Repair material – Inconel 718

**Ground Out
Corrosion Pits**

- Clean cradle using vapor degreaser.
- Using hand-held grinder w/wire brush, remove corrosion from pit.
- Using hand-held grinder w/grinding tool, break the sharp edges of the pit.
- Using the ESD Equipment fill the pit to .005" - .010" above the parent material surface.
- Using ID grinder, grind ID to prepare for chroming.
- Chrome plate and finish grind.

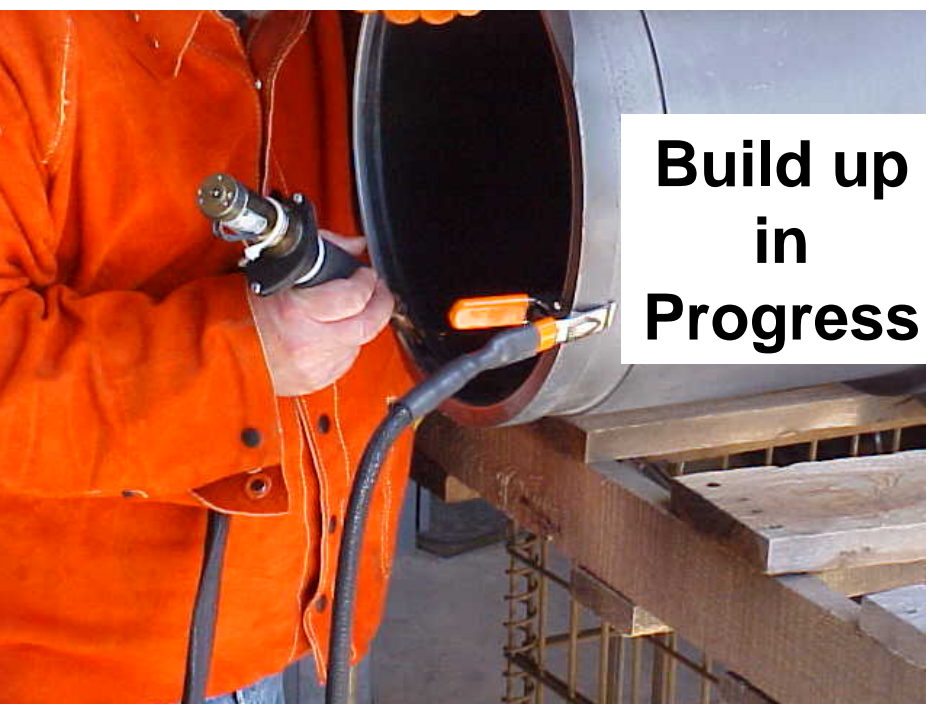
**Build up
in
Progress**

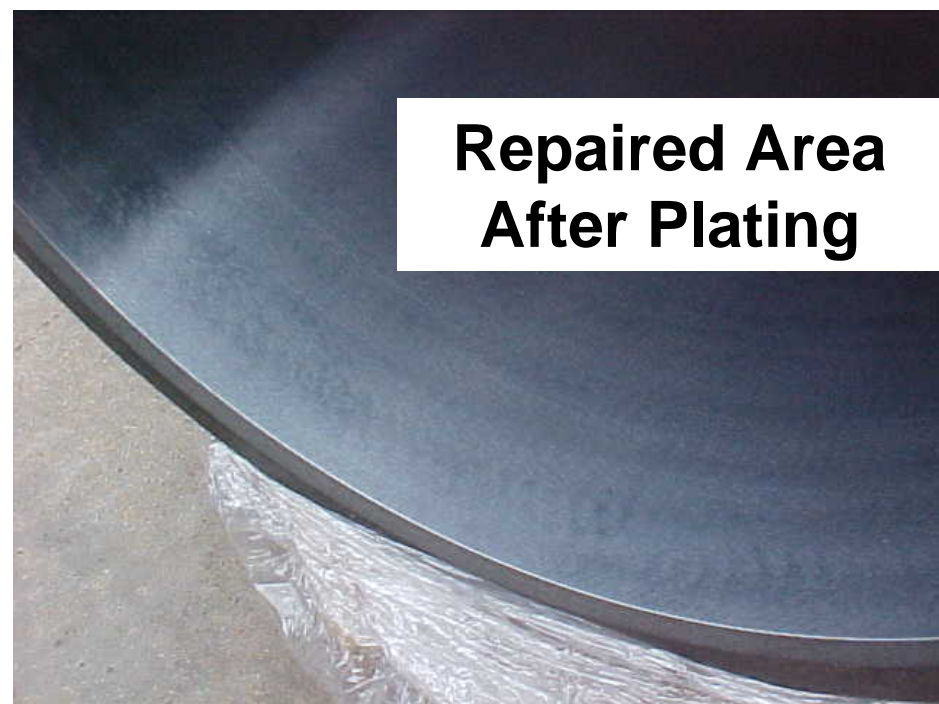
**Repaired Area
After Plating**
