ERDC/CERL TR-13-11

## **Architectural Survey of Pershing Elementary School, Fort Leonard Wood, Missouri**

August 2013

This document is an architectural survey of Building 6501, Pershing Elementary School, constructed in 1955 at Fort Leonard Wood, Missouri. This survey was initiated for a Section 106 process that satisfies Section 110 of the National Historic Preservation Act of 1966 as amended, and was used to determine the eligibility of the school for inclusion on the National Register of Historic Places (NRHP). This report determined that Pershing Elementary School is not eligible to the NRHP, since it is not individually significant and is not part of a larger historic district.

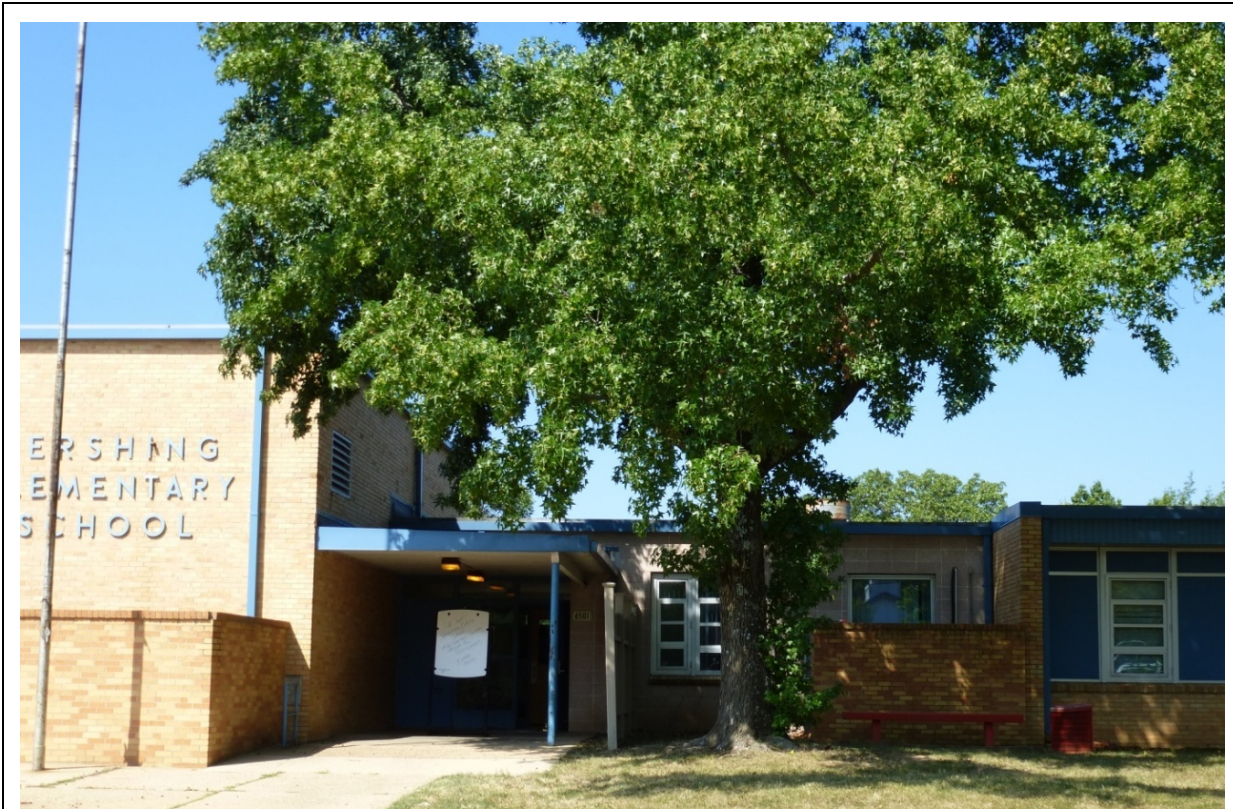
Photo 1. Main entrance on the east elevation (ERDC-CERL, 2012).

**East Elevation:** The east elevation faces Indiana Avenue. The main entry into the building is located in the left of center on the elevation and is defined by a recessed entry (photos 1 and 2). The entry consists of replacement metal doors, each with one narrow glass pane. A divided sidelight is located between the two doors and three fixed transoms stretch across the doors and sidelights (photo 2). The left side of the east elevation is where the double-height multi-purpose room is located (photo 3). The east elevation of the double-height wall has been modified with the removal of the original windows (photo 5). The four large window openings have been filled in with the same brick that is found on the exterior walls of the addition (photo 6). There is a set of replacement metal doors located on the far left side of the double-height wall (photo 8) and large letters spelling out “PERSHING ELEMENTARY SCHOOL” are placed on the brick exterior wall on the upper right corner of the double-height wall (photo 4). A newer air conditioning unit shielded by a brick screen wall addition is located below the lettering (photo 7). The far-left side of the east elevation is one-story in height (photo 9).

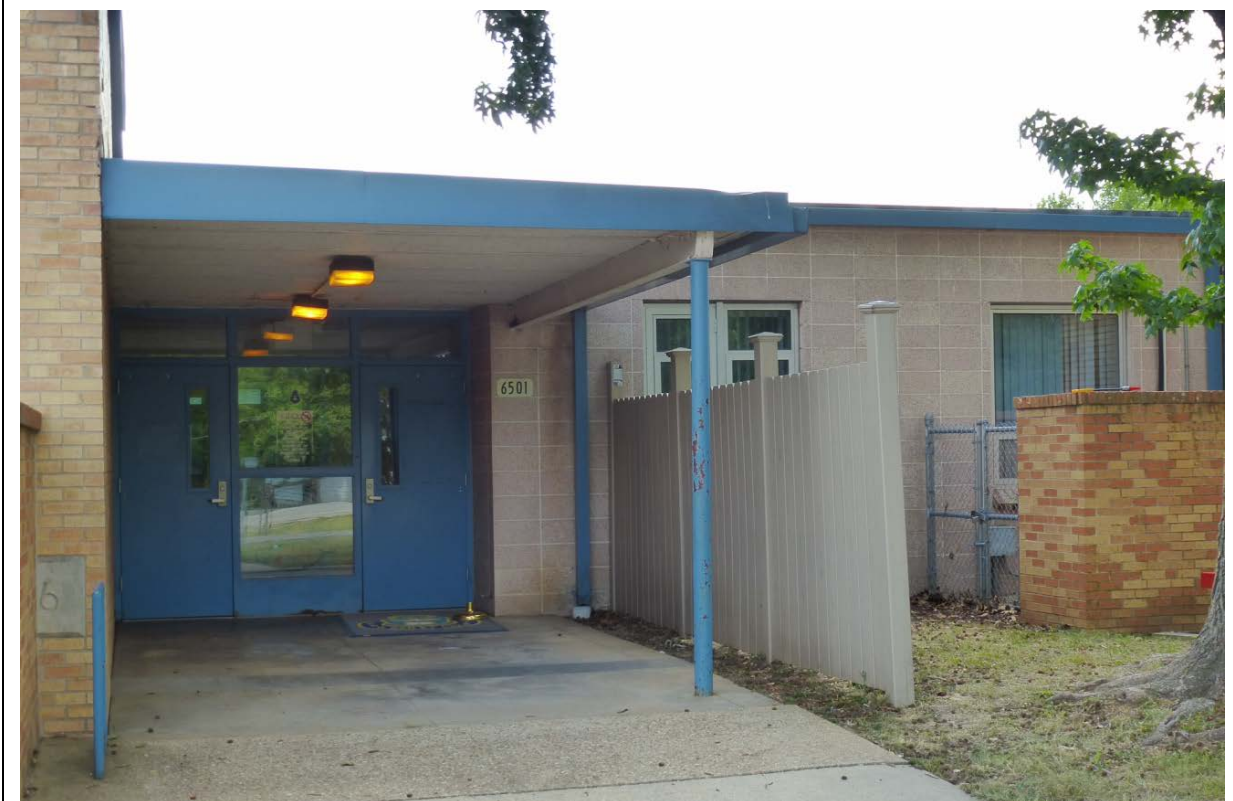
Photo 2. Replacement entry doors and sidelight of the main entry on the east elevation (ERDC-CERL, 2012).

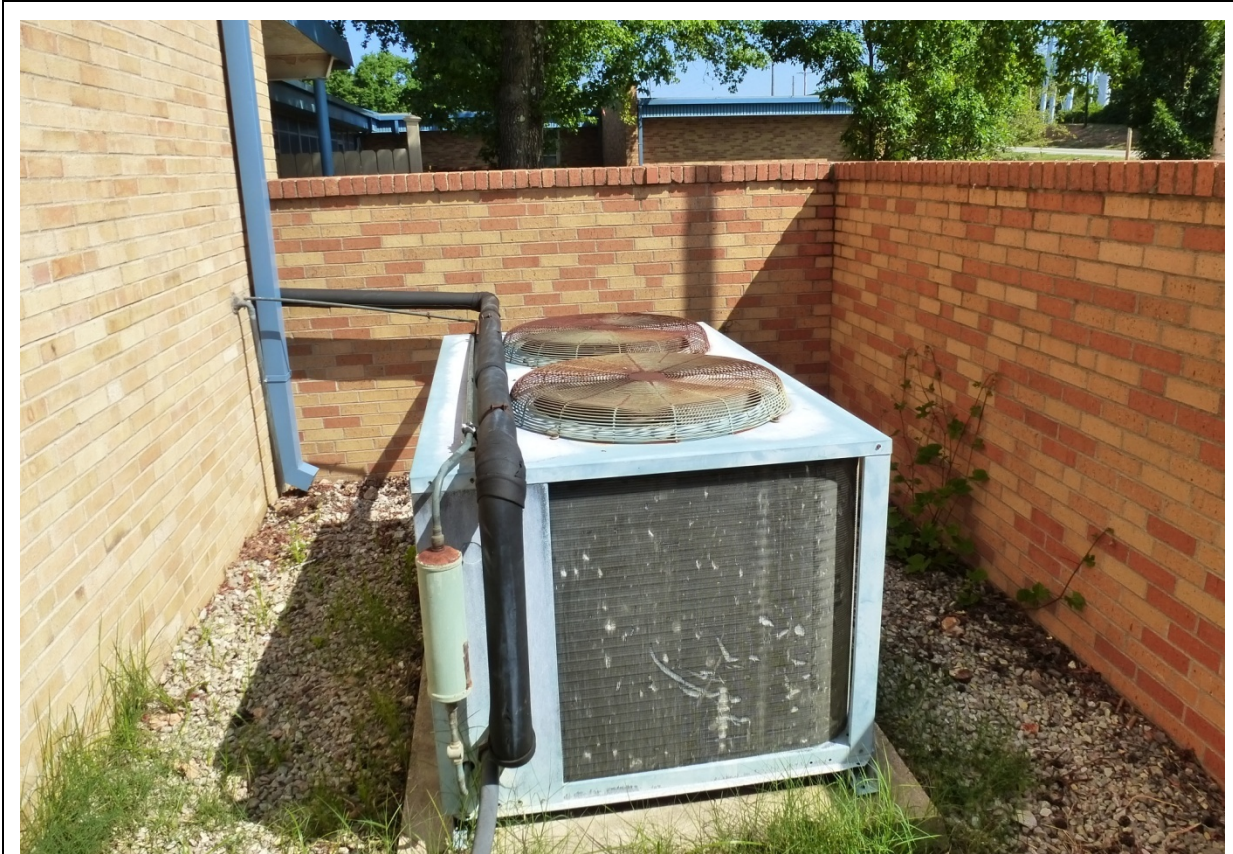
Photo 7. Air-conditioning unit addition with newer brick enclosure walls (ERDC-CERL, 2012).

The exterior of the building has been modified over the years, and the major alteration is the window pattern with the replacement of the original windows with the current windows, along with the modification of replacement doors and the construction of the two additions. The one-story exterior is dominated with walls of combination of porcelain enamel metal panels and bright aluminum windows. The windows have brick windowsills and rest on brick walls. The exterior of the classroom are defined with two four-pane awning-style windows and five panels (photo 18). There are several replacement light fixtures (photo 16) and only one original light fixture intact (photo 17). Most of the original “mudscrapers” used for shoes are intact near the entries (photo 24). Several air-conditioning units have been installed outside of each interior space. Brick screen walls have been constructed to hide the units (photo 7).

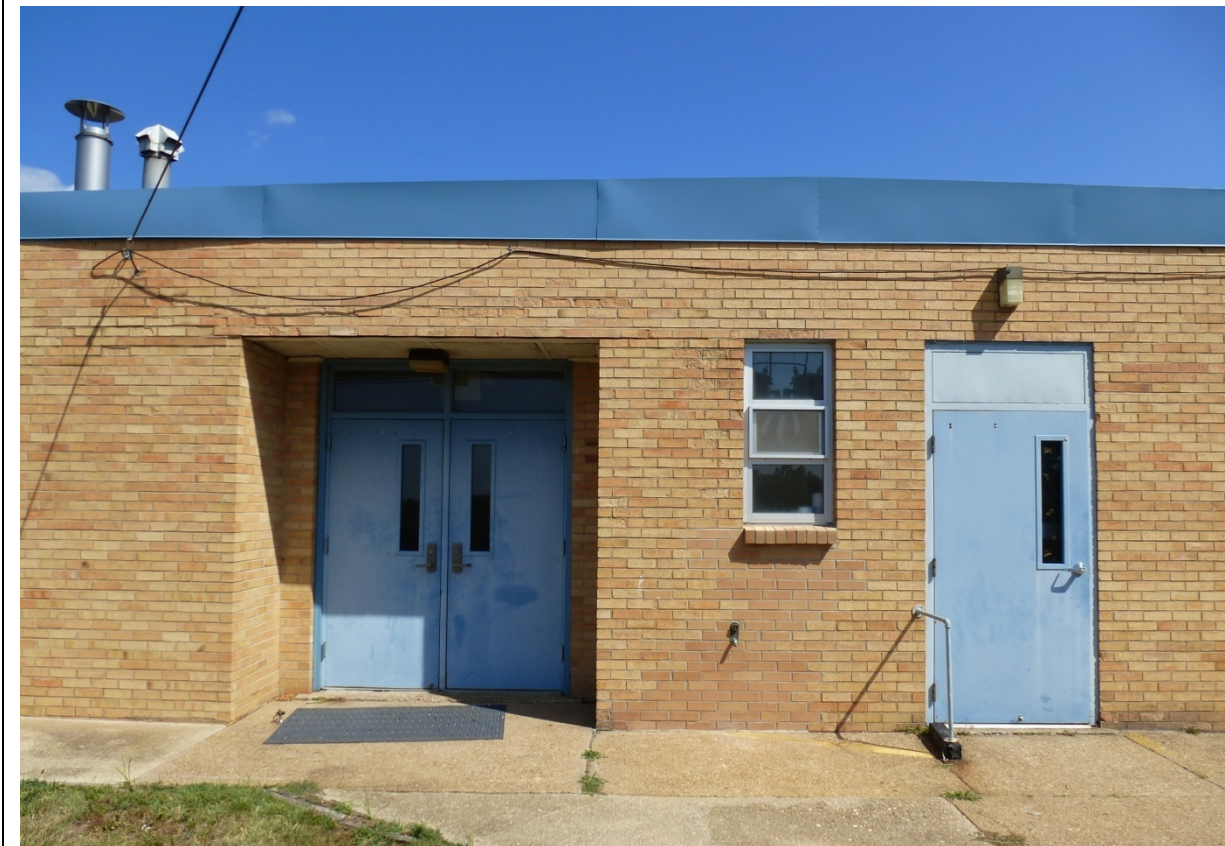
**Photo 10. Replacement entry doors and replacement window on the south elevation (ERDC-CERL, 2012).**

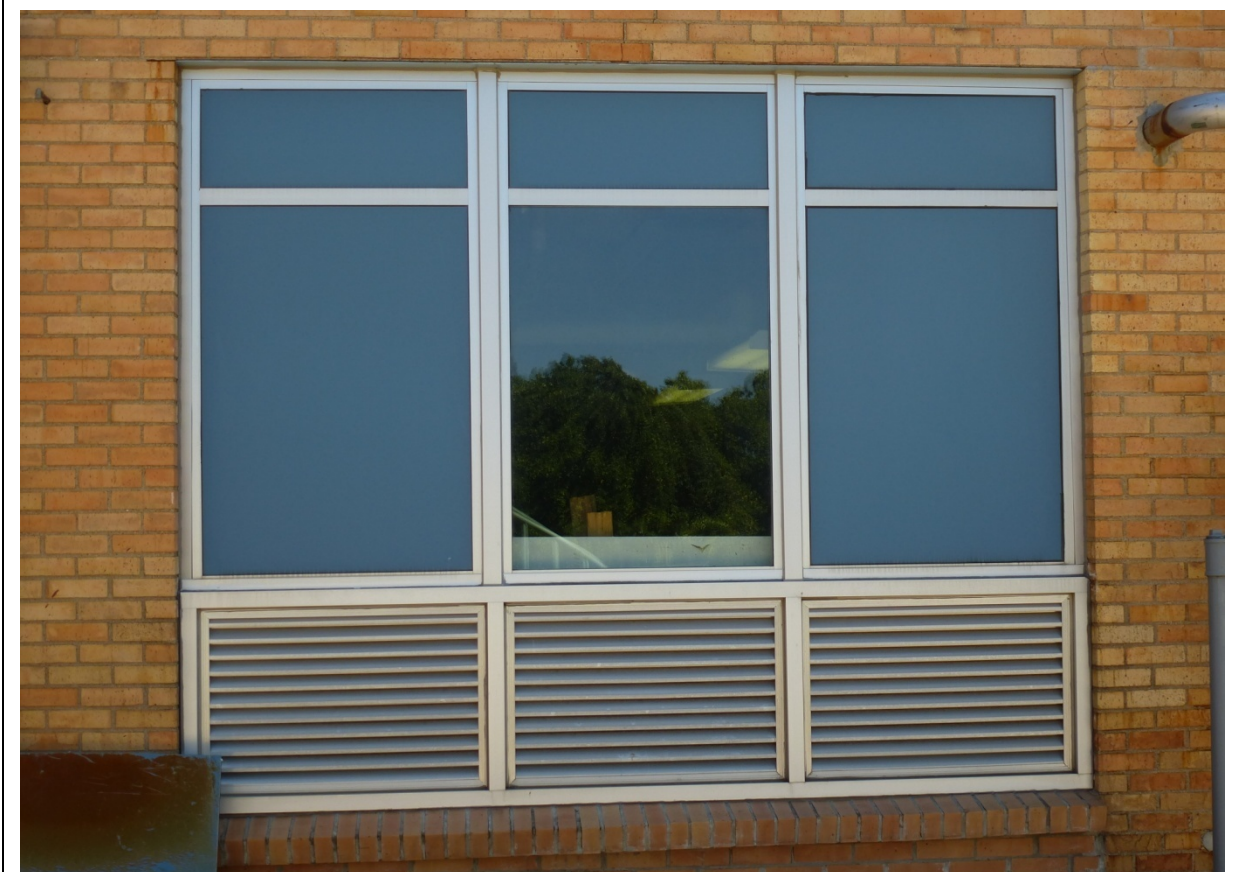
**Photo 14. Closeup of replacement bright aluminum windows with metal louvered vents and panel inserts on the west elevation of the boiler room (ERDC-CERL, 2012).**

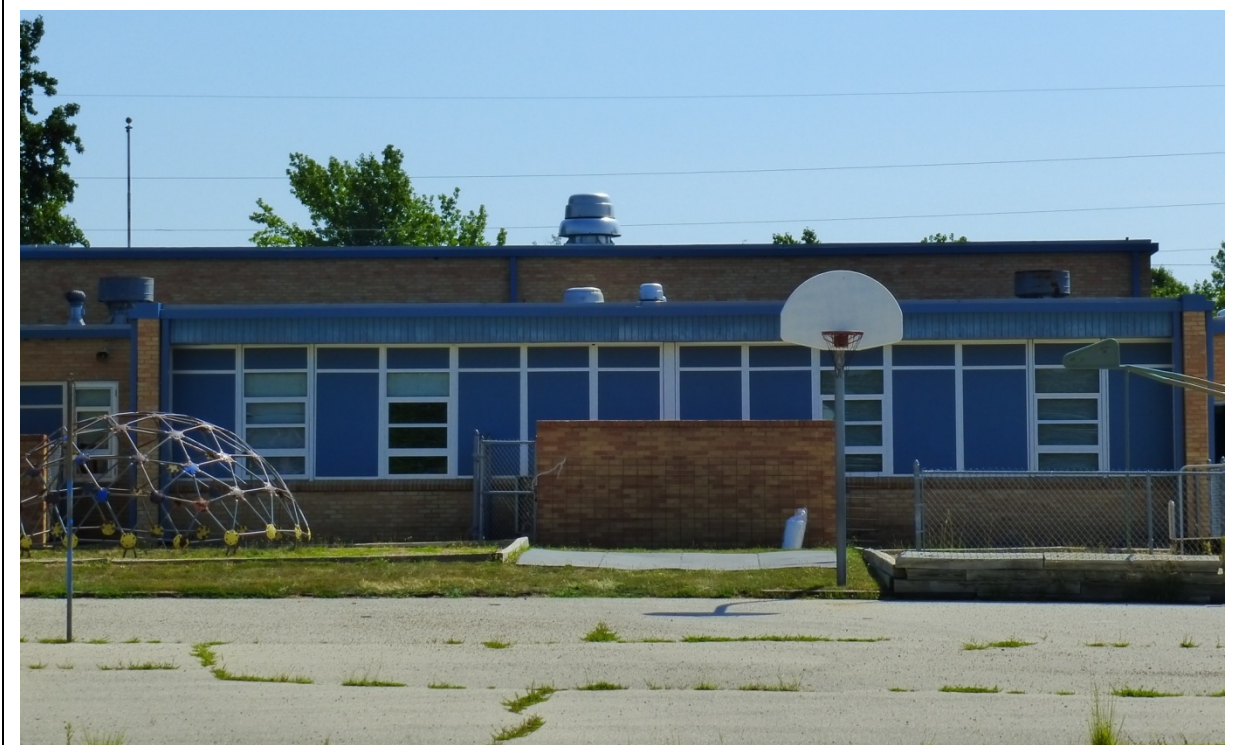
**Photo 18. Modified window pattern with replacement bright aluminum windows and panel inserts on the right side of the west elevation of the original school portion (ERDC-CERL, 2012).**

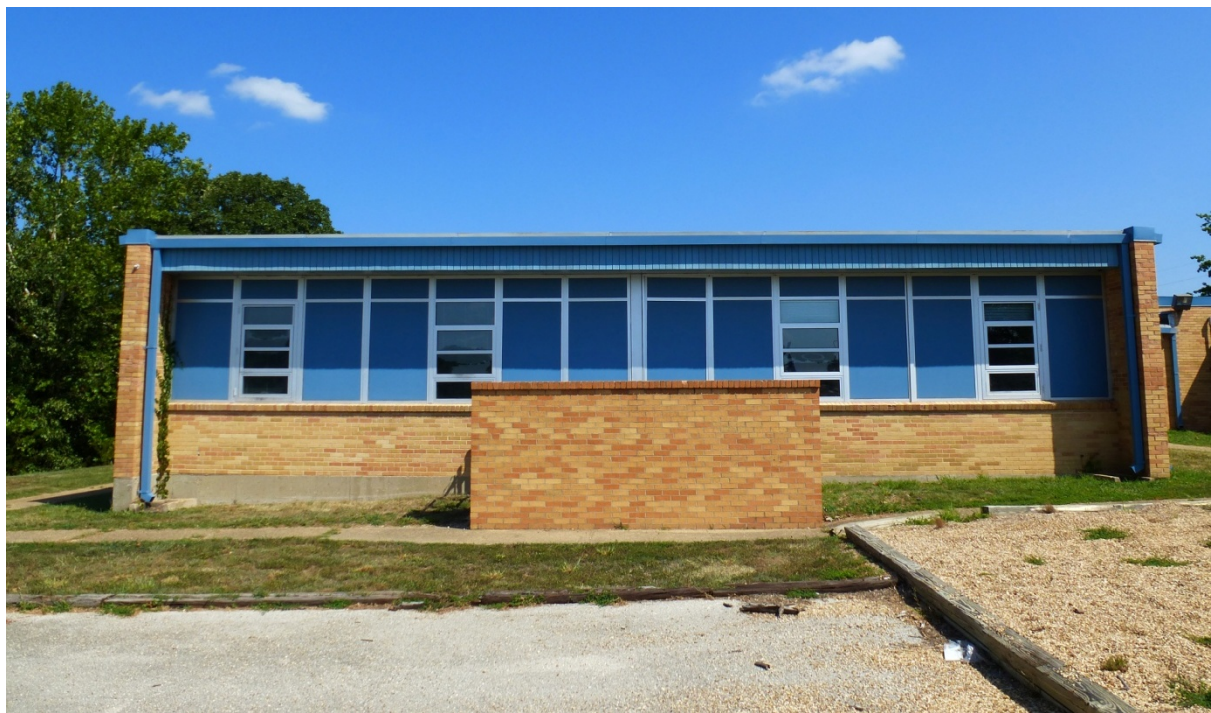
**Photo 32. South elevation with modified window pattern with replacement windows and panel inserts. Left side is 1984 addition and right side is 1957 addition (ERDC-CERL, 2012).**

**South Elevation:** The south elevation is divided into two-parts. The right side of the elevation projects forward. The right side is the original portion of the 1955 structure, while the left side is a combination of both 1957 and 1984 additions (photo 27). The right side consists of a replacement single entry door, a replacement bright aluminum three-pane window, and a set of replacement metal doors that are recessed in the brick wall (photos 9–12). Just to the left of this wall, the wall is slightly recessed and a single-entry replacement door is located there to provide access into a classroom space (photos 13 and 15). The middle section of the south elevation is recessed back from the right and left portions of the elevation (photo 27). The middle section is the 1957 addition. The middle section consists of another main entry into the building from the playground area. The entry has large divided-light fixed windows that are original to the 1957 construction, a set of replacement metal doors, and a flat roof canopy (photo 31). The far left side projects out from this entry and where two classrooms are located; however, the right classroom is the 1957 addition, while the left classroom is part of the 1984 addition (photo 32). Both classrooms are defined by the window/panel pattern.

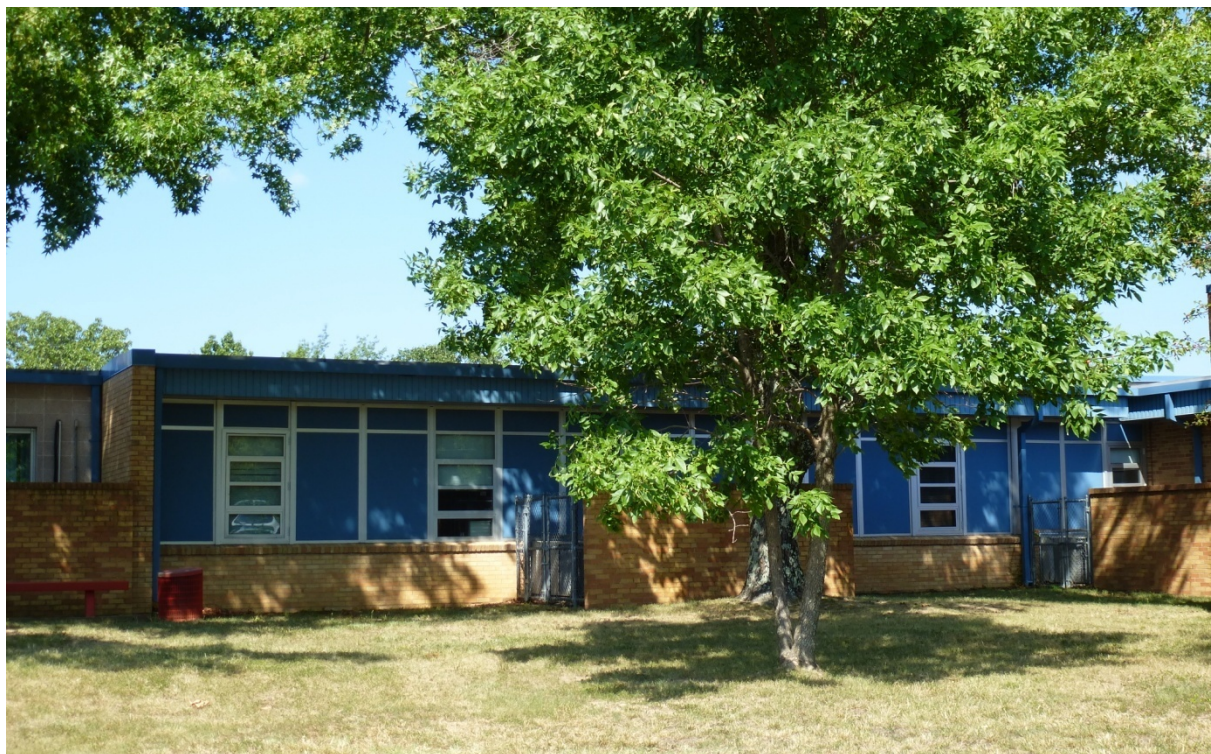
**Photo 48. East elevation of the original school building with modified window pattern of replacement bright aluminum windows and panel inserts (ERDC-CERL, 2012).**

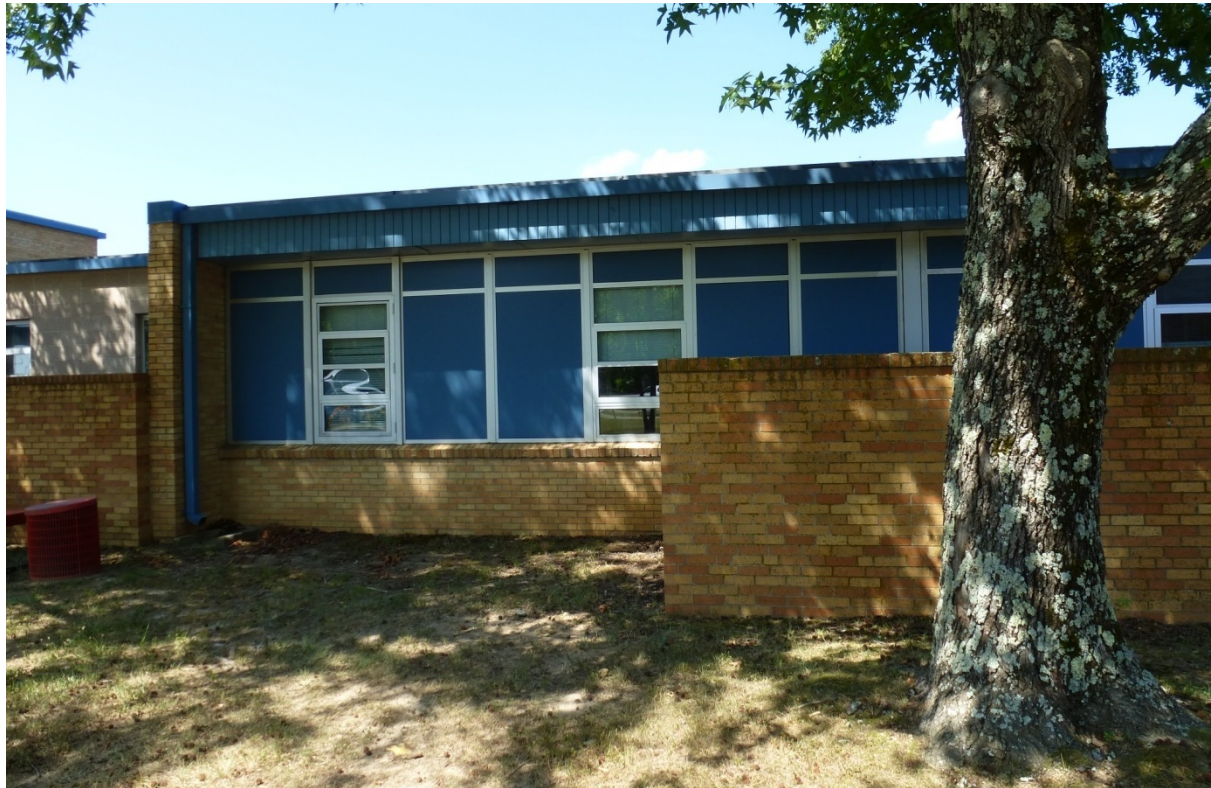
**Photo 49. East elevation of the original school building with modified window pattern of replacement bright aluminum windows and panel inserts (ERDC-CERL, 2012).**

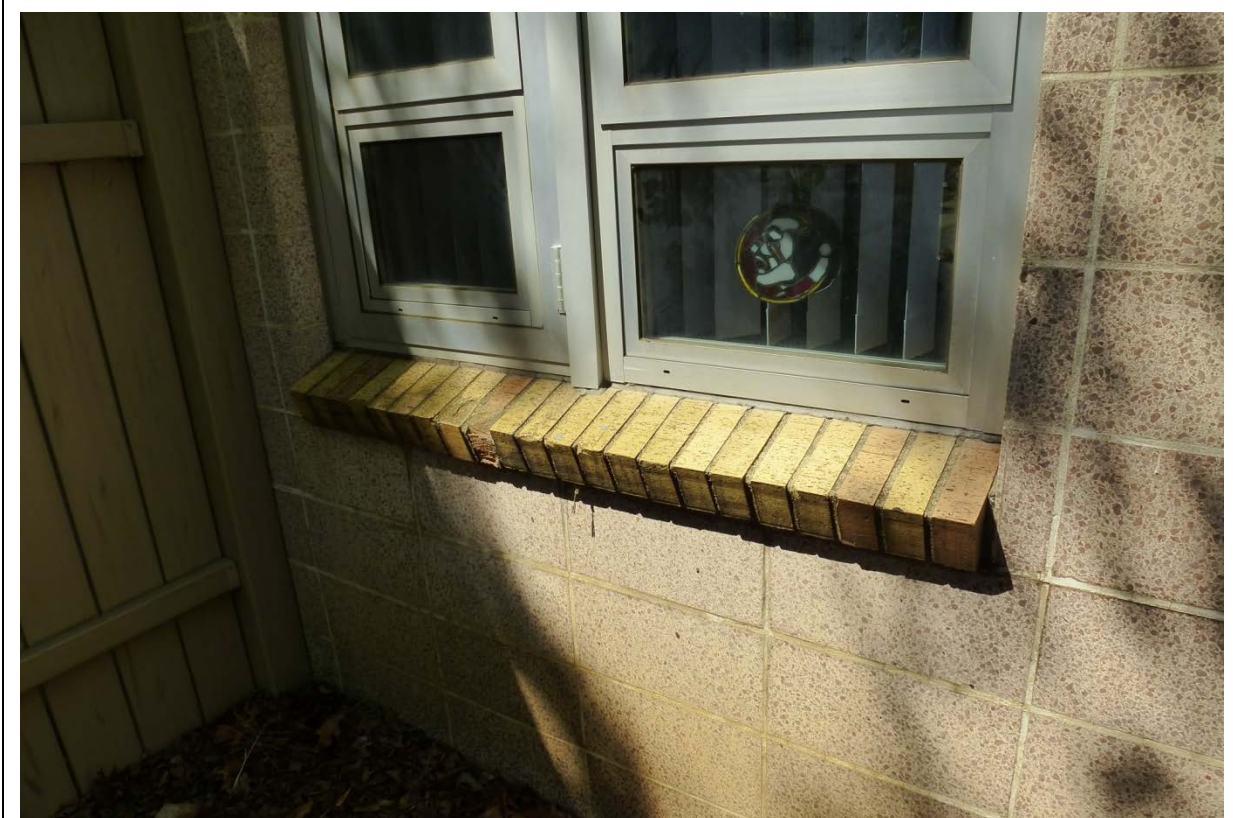
**Photo 52. Replacement window with original brick windowsill near the main entry on the east elevation (ERDC-CERL, 2012).**

On the right side of the main entry are two replacement windows with brick windowsills (photo 52). The windows are bright aluminum awning windows set into a wall of terrazzo faced block (photo 51). To the right of these two windows are two of the original classrooms. The original wall of windows have been removed and replaced with a combination of porcelain enamel metal panels and bright aluminum windows (photo 48). The portion of the east elevation that projects off the original brick exterior is the 1984 addition. The face brick is

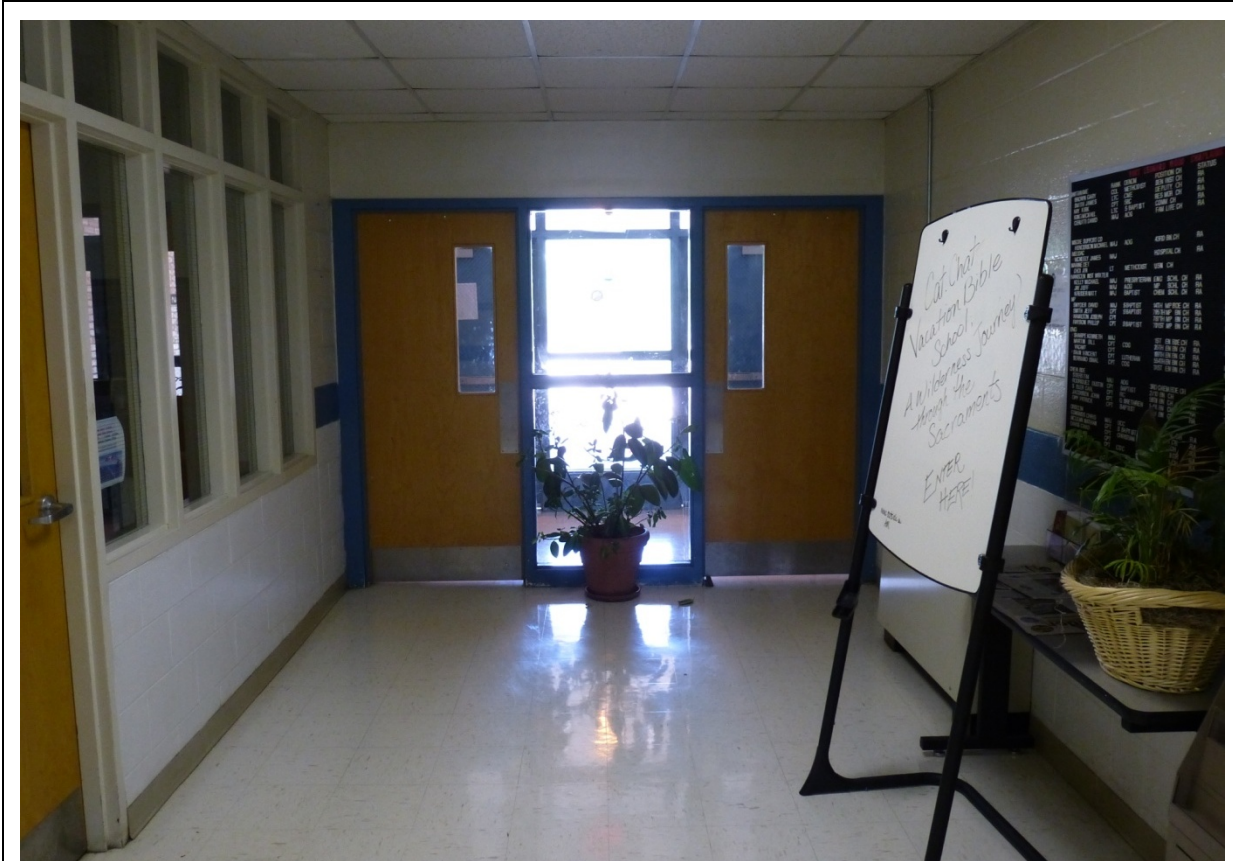
Photo 53. Looking toward the replacement vestibule doors on the east side of the building (original school) (ERDC-CERL, 2012).

**Vestibule on the east entry (This vestibule is part of the original design.):** The vestibule has two replacement wood doors, each with a narrow glass pane. A two-pane fixed sidelight is located in between the two doors (photo 53). The floor has been replaced and is currently covered with vinyl tiles. This vestibule is part of the original design.

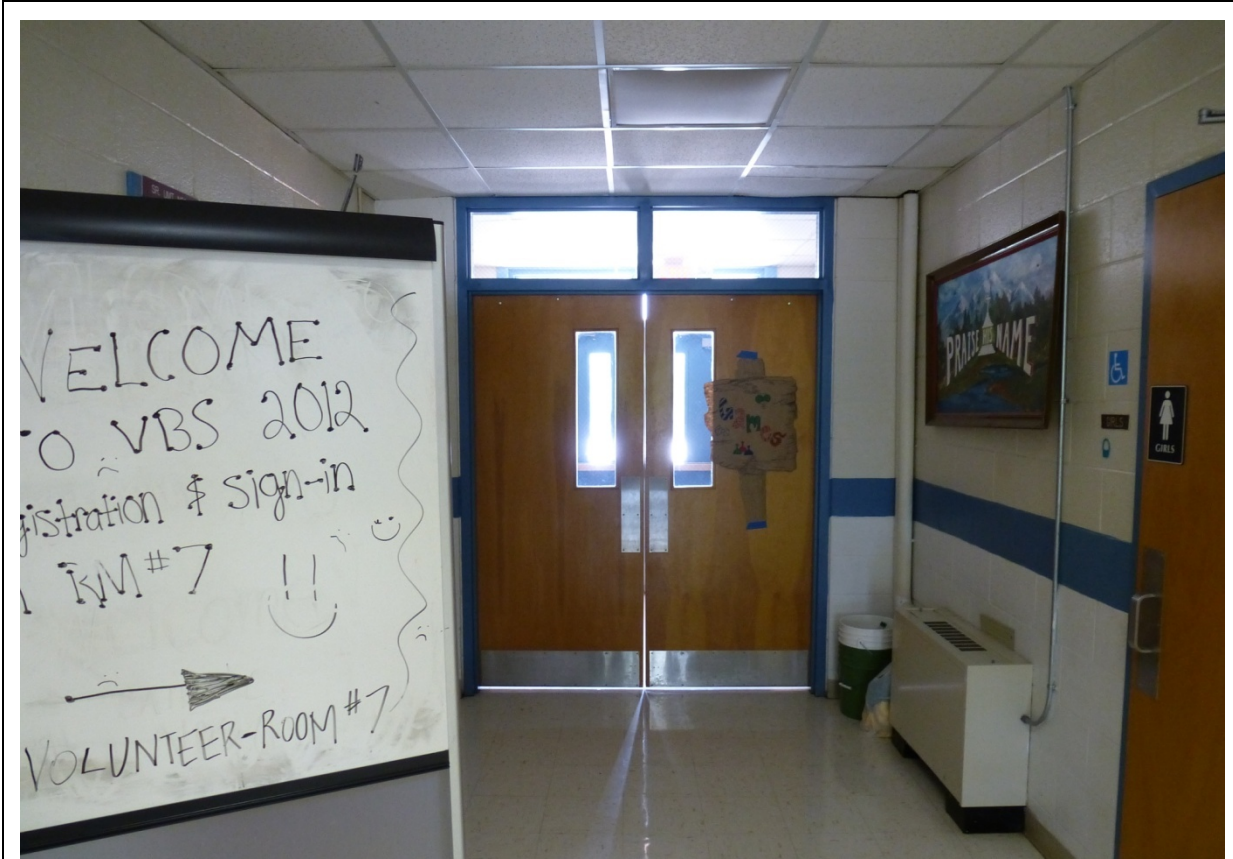
Photo 57. Looking toward replacement vestibule doors on the west side of the building (original school) (ERDC-CERL, 2012).

**Vestibule on the west entry (This vestibule is part of the original design.):** The vestibule has replacement two replacement wood doors each with a narrow glass pane. Two fixed transoms are located above the doors (photo 57). The floor has been replaced and is currently covered with vinyl tiles. This vestibule is part of the original design.

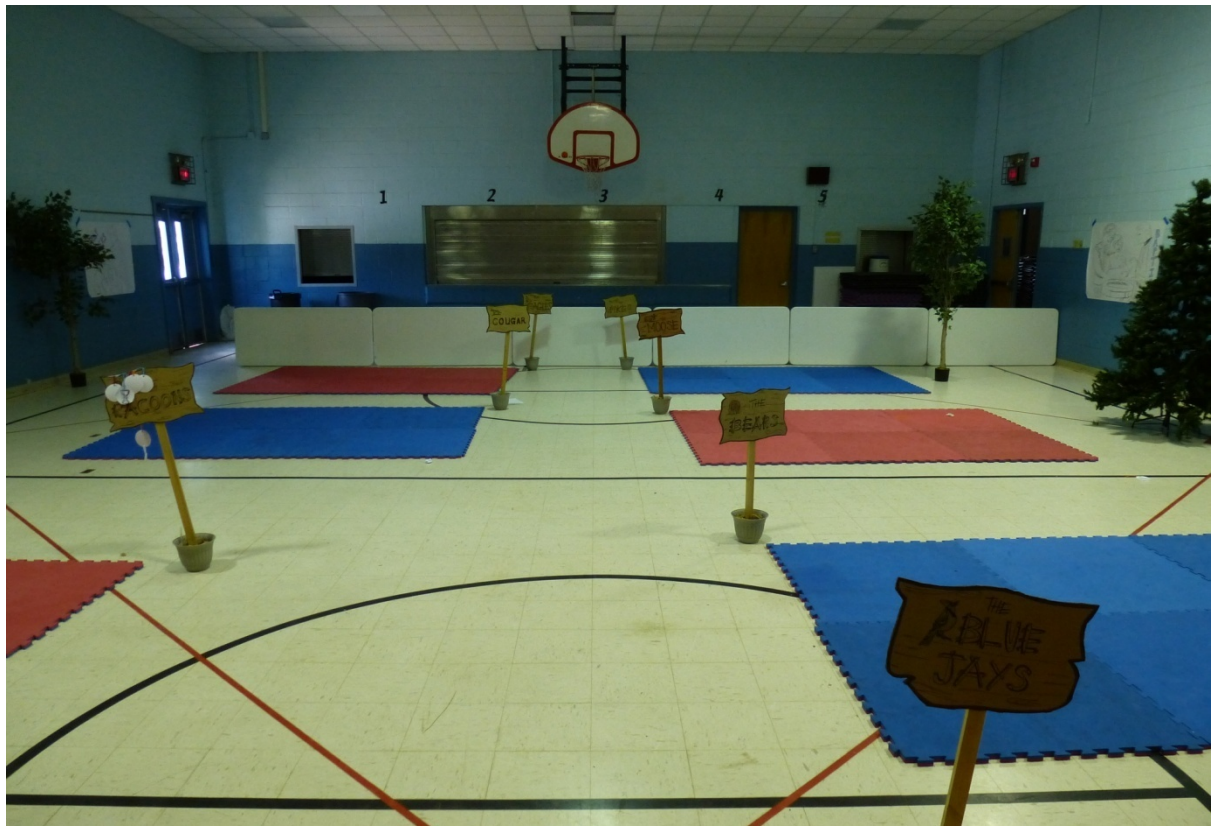
Photo 65. Looking south in the multi-purpose room with replacement flooring and acoustic drop-tile ceiling (original school) (ERDC-CERL, 2012).

**Multi-purpose room:** The multi-purpose room is a large double-height space. Most of the space has been modified with new flooring, replacement light fixtures, an acoustical drop-tile ceiling, and replacement wood doors (photos 65 and 74). Two sets of replacement wood doors provide access into the multi-purpose room from the corridor (photo 60), while a set of replacement metal doors, located on the east wall provide access to the outside.

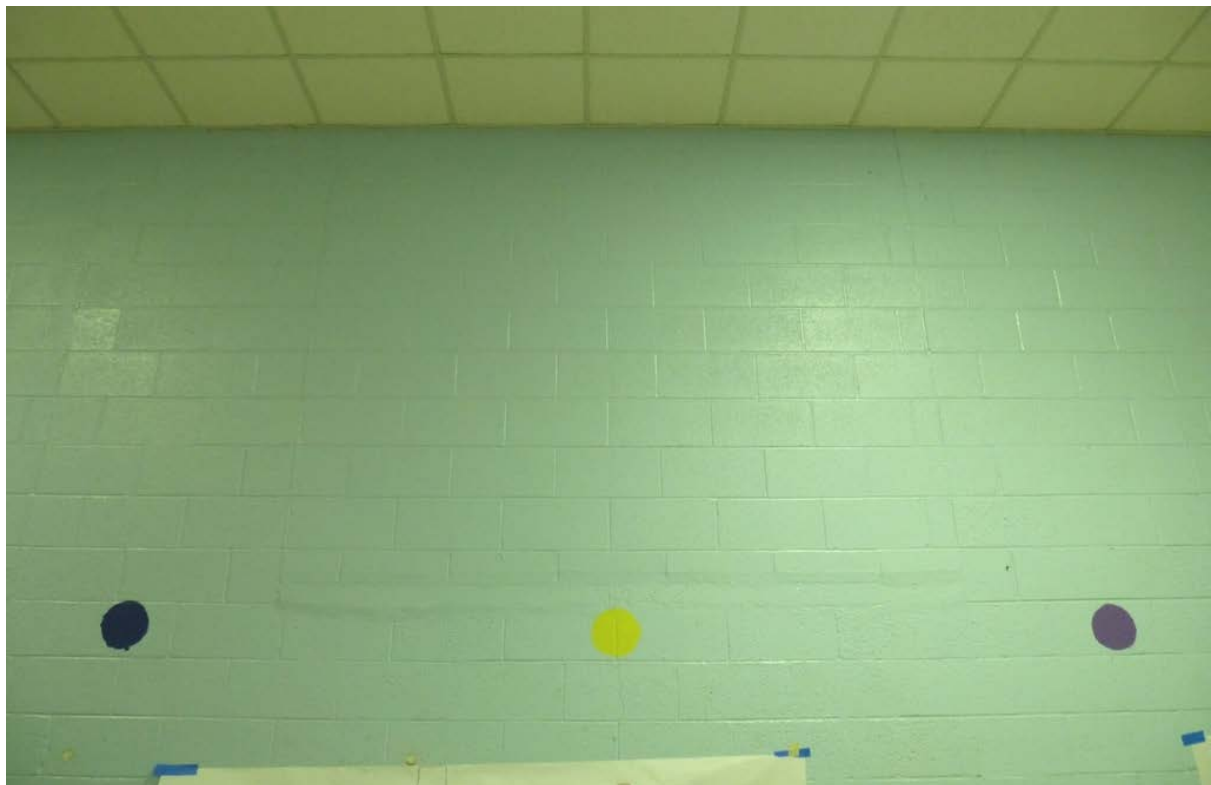
Photo 66. Looking toward east wall in multi-purpose room where the original windows were removed and the openings filled with concrete block (original school) (ERDC-CERL, 2012).

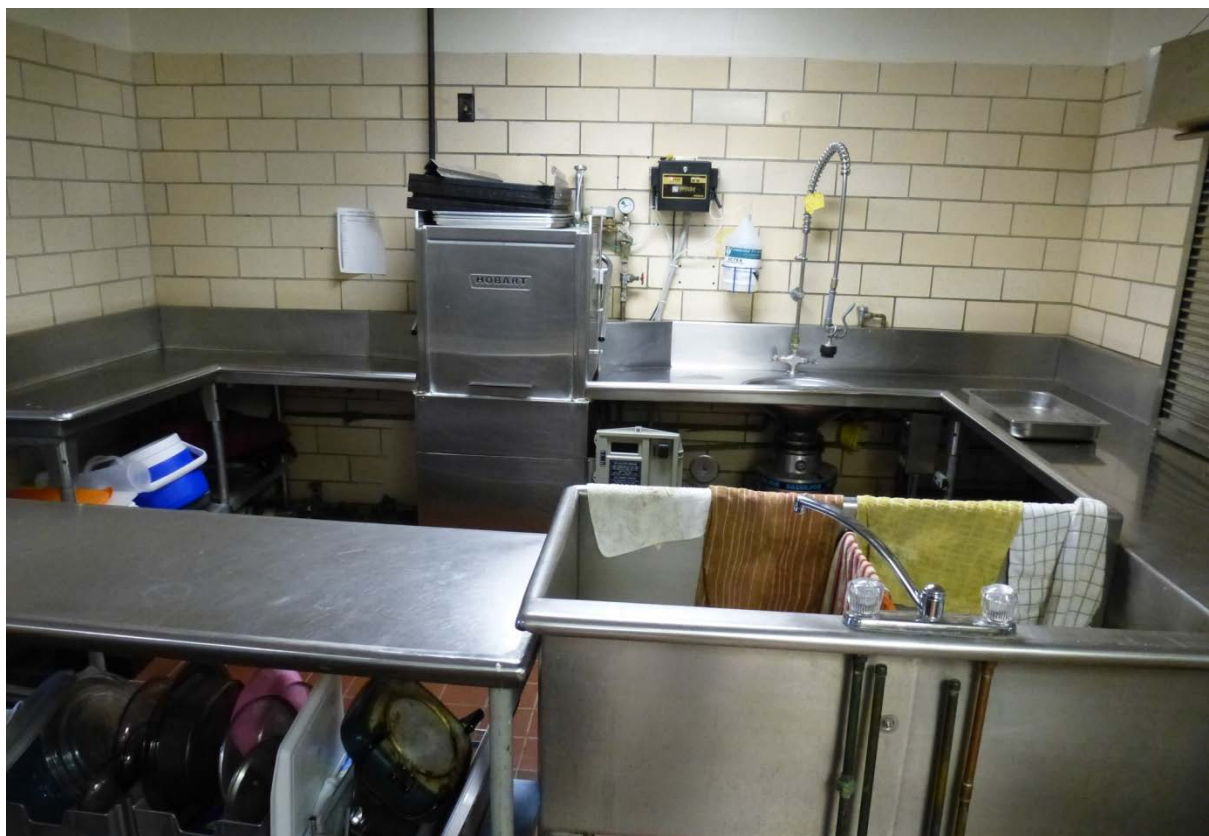
Photo 70. Kitchen with original glazed-tile floor and sanitary tile walls (original school) (ERDC-CERL, 2012).

**Kitchen:** The kitchen is located on the south end of the multi-purpose room. The space of the kitchen is intact, along with the original red tiled floor and glazed-tile floor (photo 70). The kitchen has concrete block walls, a red clay tile floor, and an acoustical tile drop ceiling. There are newer stainless steel sinks, countertops, and appliances (photo 71). A large window opening is located on the wall that divides the kitchen from the multi-purpose room. The opening has a bright aluminum roll-door that can be opened so that the space can be used as a serving line (photo 68). A small storage area is located on the east side of the kitchen. A small “pass-through” window is located in this room (photos 67 and 72). A small toilet room is located in the southwest corner of the kitchen. The toilet room has a replacement door, red tile floor, a sink, and a toilet (photo 73).

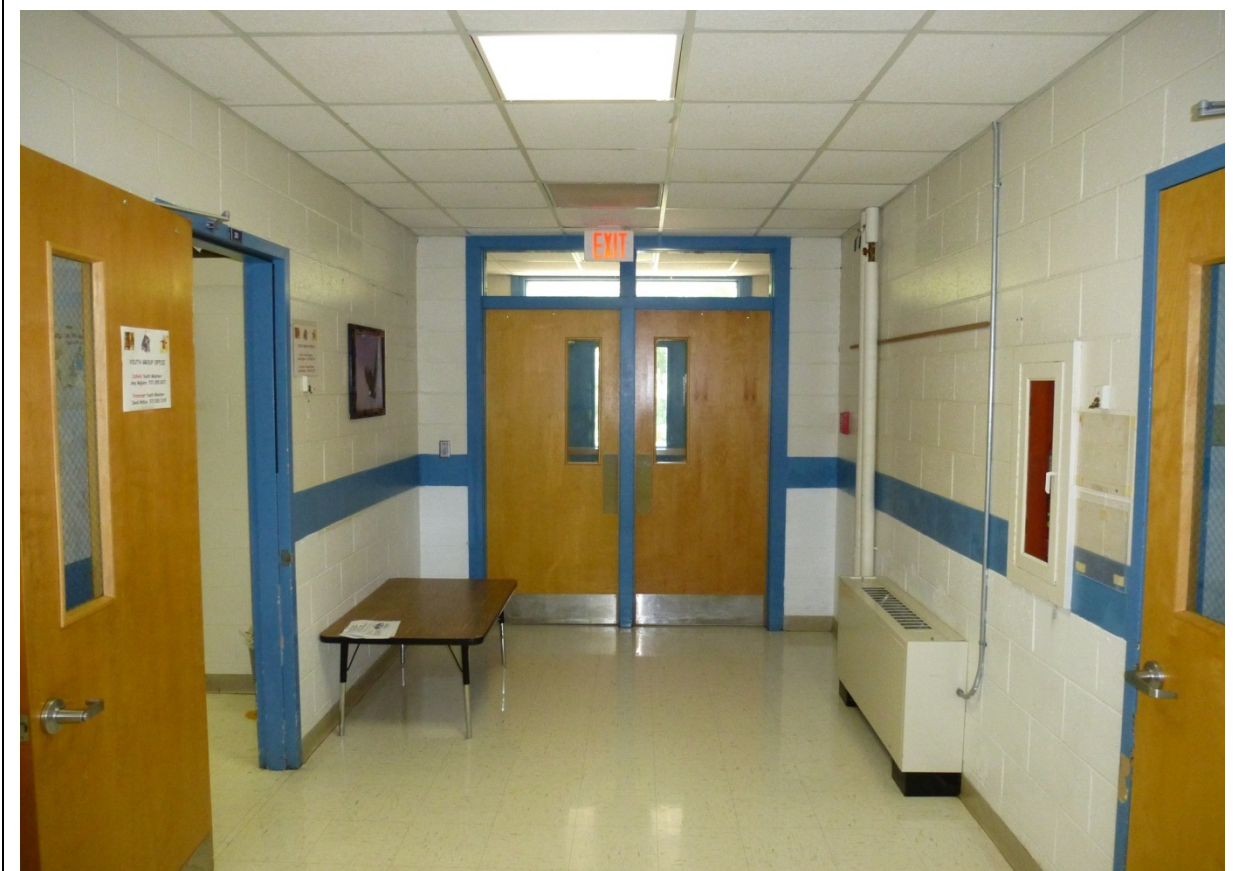
Photo 111. Replacement vestibule doors at the north end of the 1984 addition (ERDC-CERL, 2012).

**Vestibule on the north entry (This vestibule is part of the 1957 addition.):** The vestibule has two replacement wood doors, each with a narrow glass pane. Two fixed transoms are located above the doors (photo 111). The floor has been replaced and is currently covered with vinyl tiles.

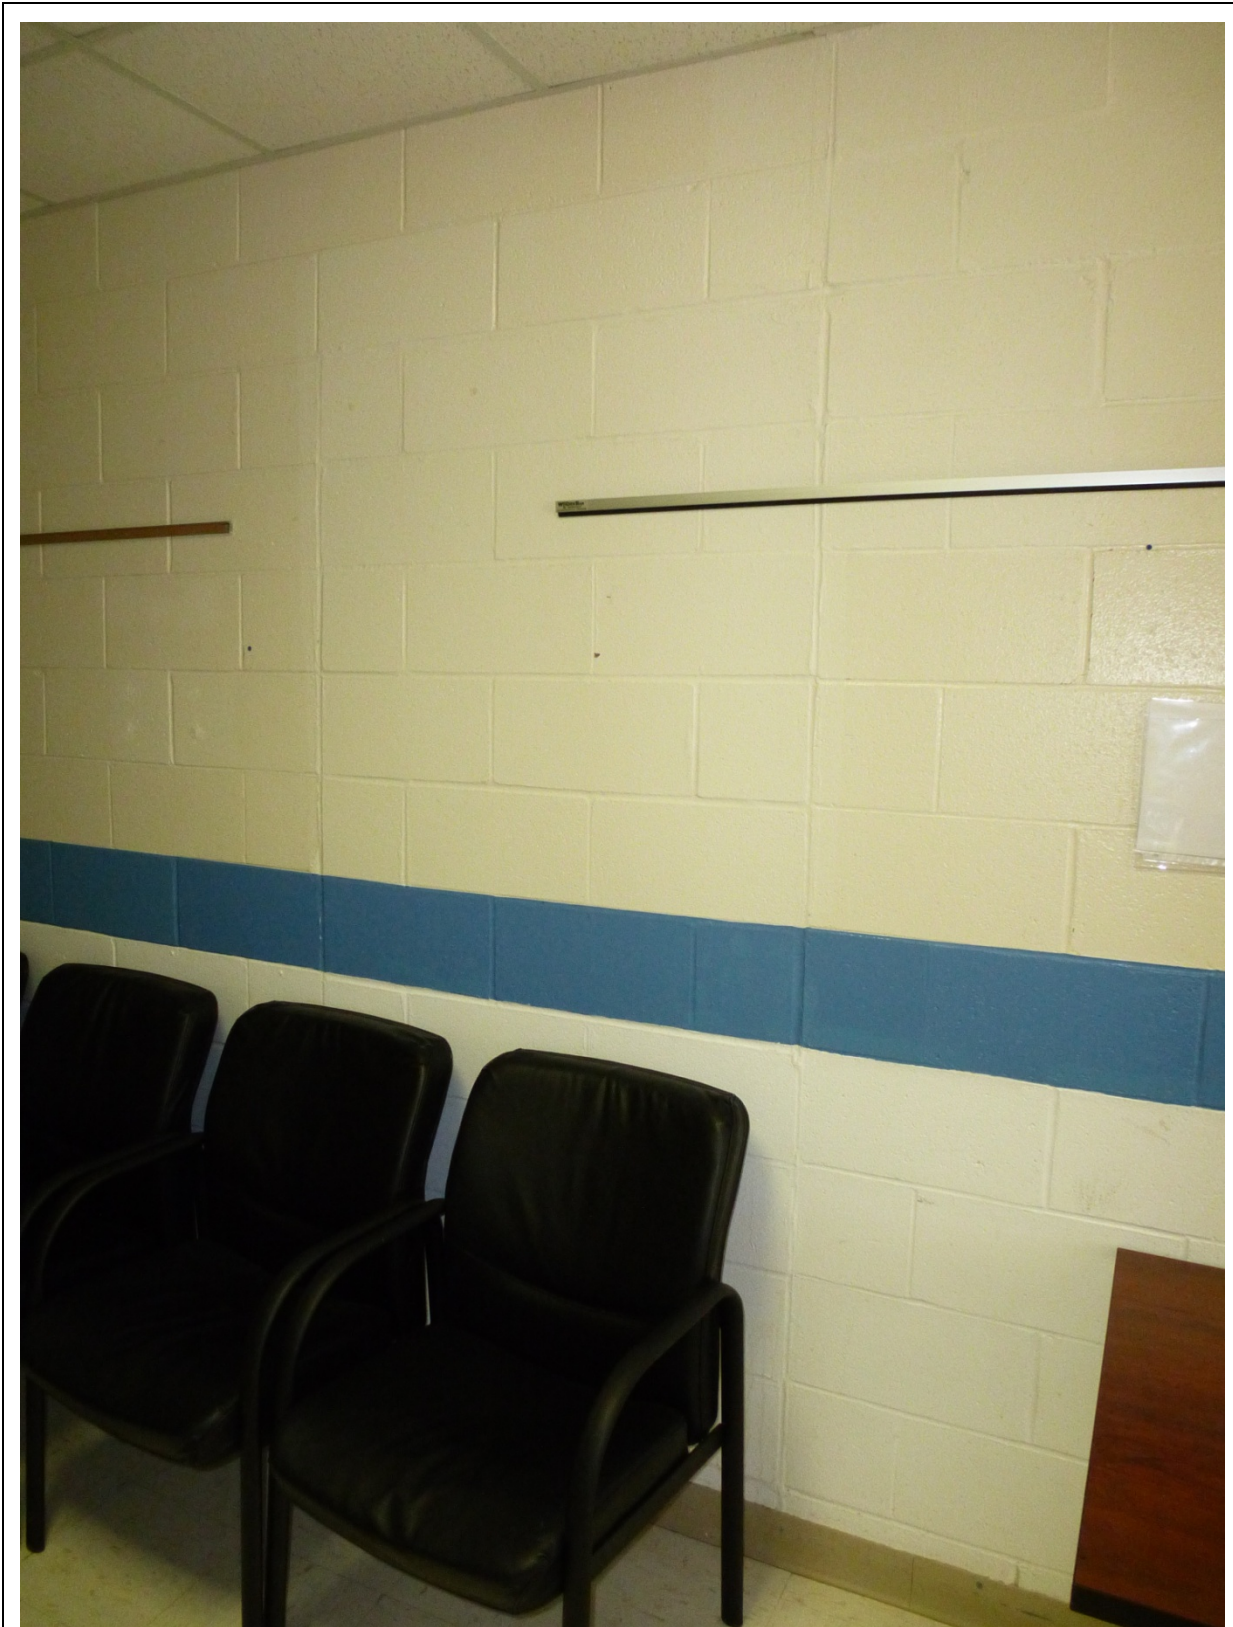
**Photo 129. Close-up of modified door opening leading to a classroom on the south side of the 1957 west-wing addition (ERDC-CERL, 2012).**

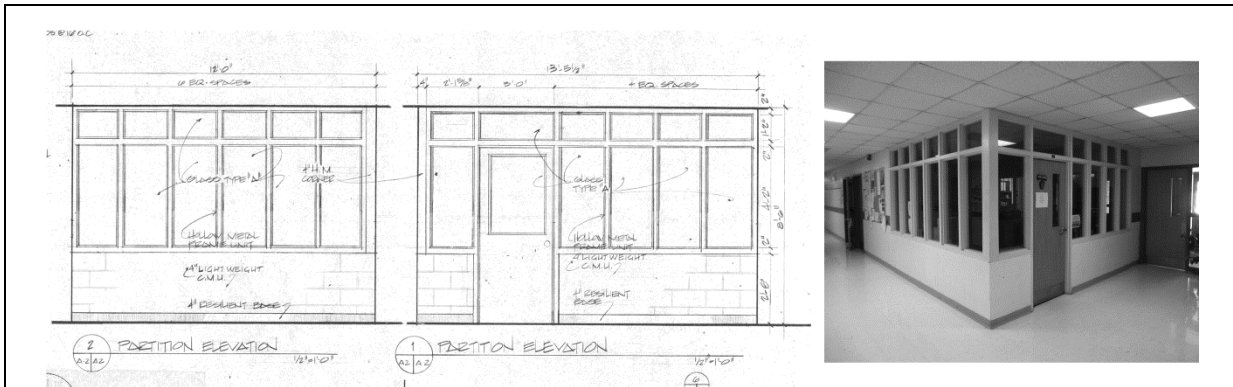
Interior office: 1984 addition drawing on the left compared to the current enclosure of the open office space near the main entry on the east elevation.
