*Airfield Damage Repair Modernization Program*

## **AM2 3-4 Alternate Lay Pattern Evaluation**

Timothy W. Rushing, Lyan Garcia, Jeb S. Tingle,  
Paul G. Allison, and Craig A. Rutland

September 2014

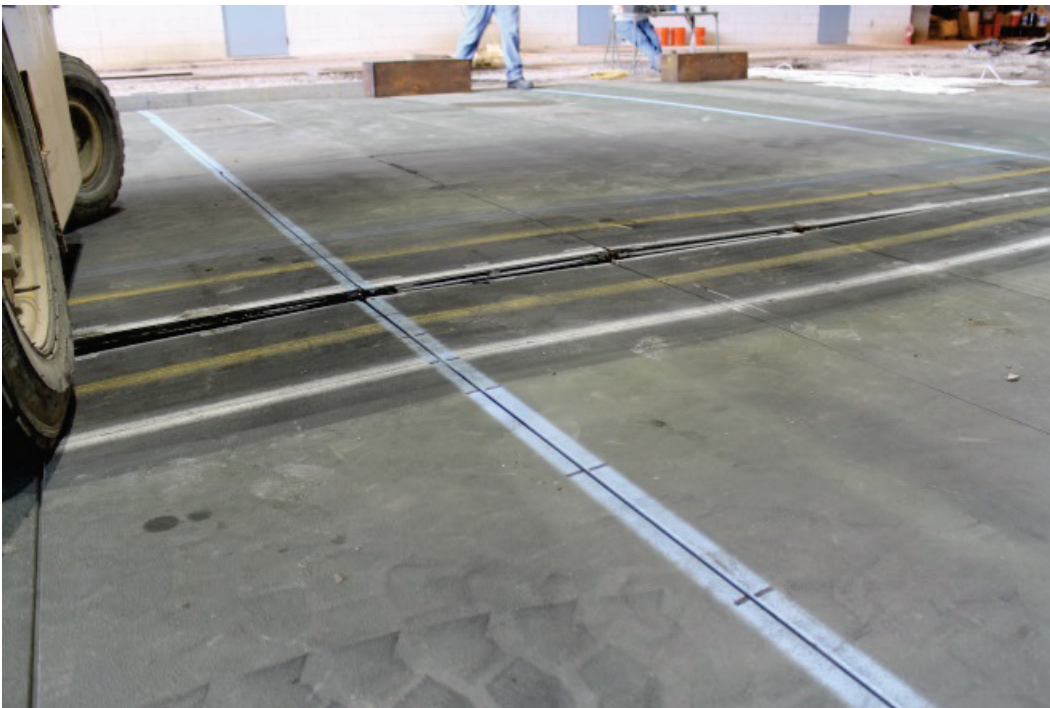
Figure 33 shows the successive panel failures along the centerline with a forklift parked on the surface. At this point in the test, four 12-ft panels and two 6-ft panels had failed, equaling 12% of the test item. Therefore, the test item failed due to mat breakage, and trafficking was terminated to prevent instability of the load cart and damage to the aircraft tire.

Figure 33. Six successive panel rail failures where joints were continuous.

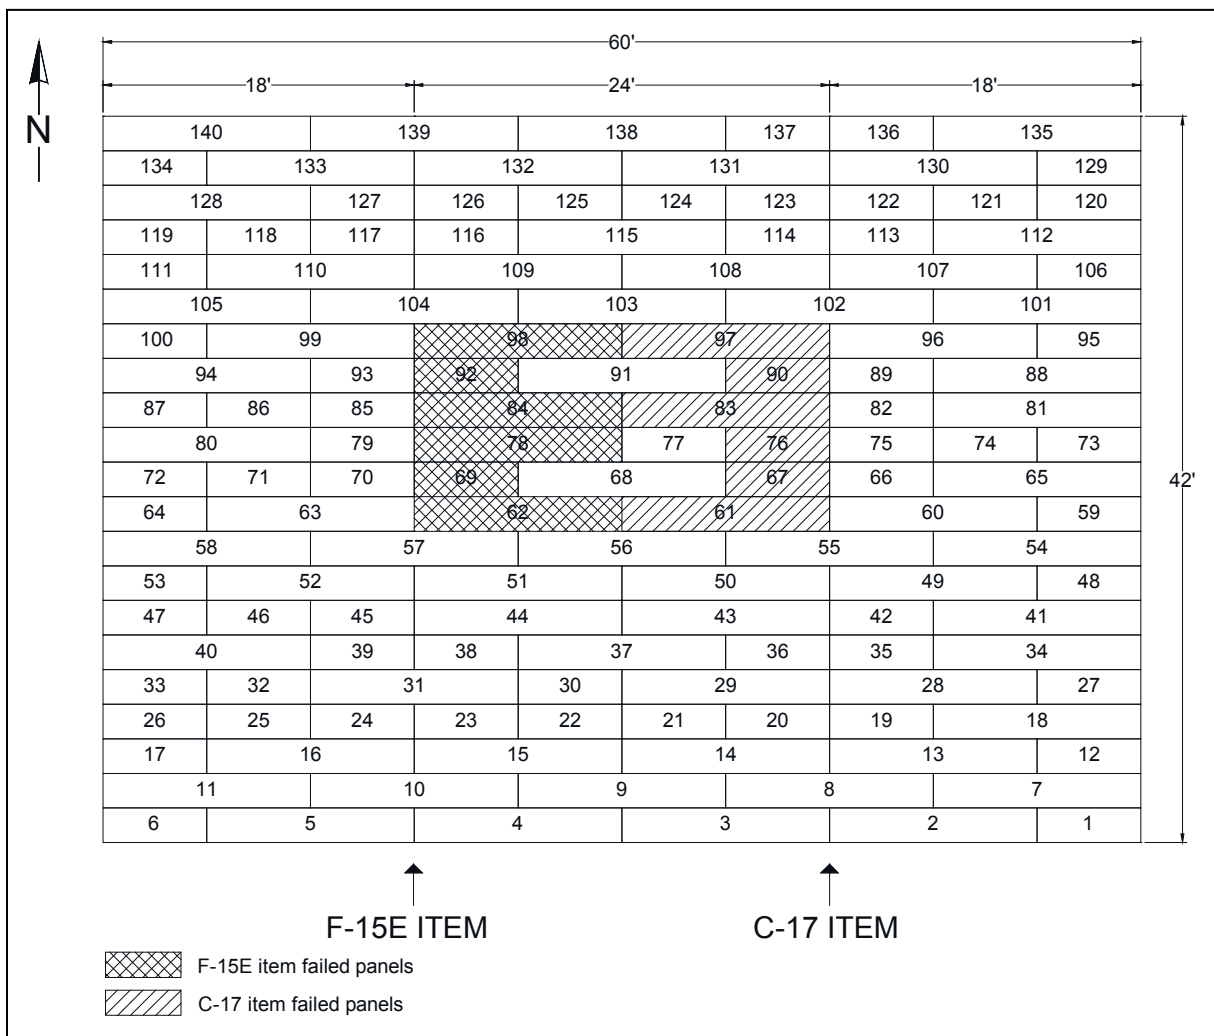
When the panels were removed after trafficking was completed, no significant additional damage was noted that could not be observed from the surface. Table 7 gives a summary of mat distresses, permanent surface deformation, and failures on the mat surface at various pass levels for the F-15E item. Figure 34 shows the layout of failed panels for the F-15E item after trafficking concluded.

Figure 34. Layout of failed panels in the F-15E and C-17 items.

Upon removal of the panels from the test section, the lower overlap of Panel 97 was also broken, and the panel was failed. The only other damage was a small corner curl in the southwest corner of Panel 96. The non-instrumented panels, 14, 20, 29, 36, 43, and 50, installed in a similar arrangement as the failed panels were not damaged. Table 8 gives a summary of mat distresses, permanent surface deformation, and failures on the mat surface at various pass levels for the C-17 item. Figure 34 shows the layout of failed panels for the C-17 item after trafficking concluded.

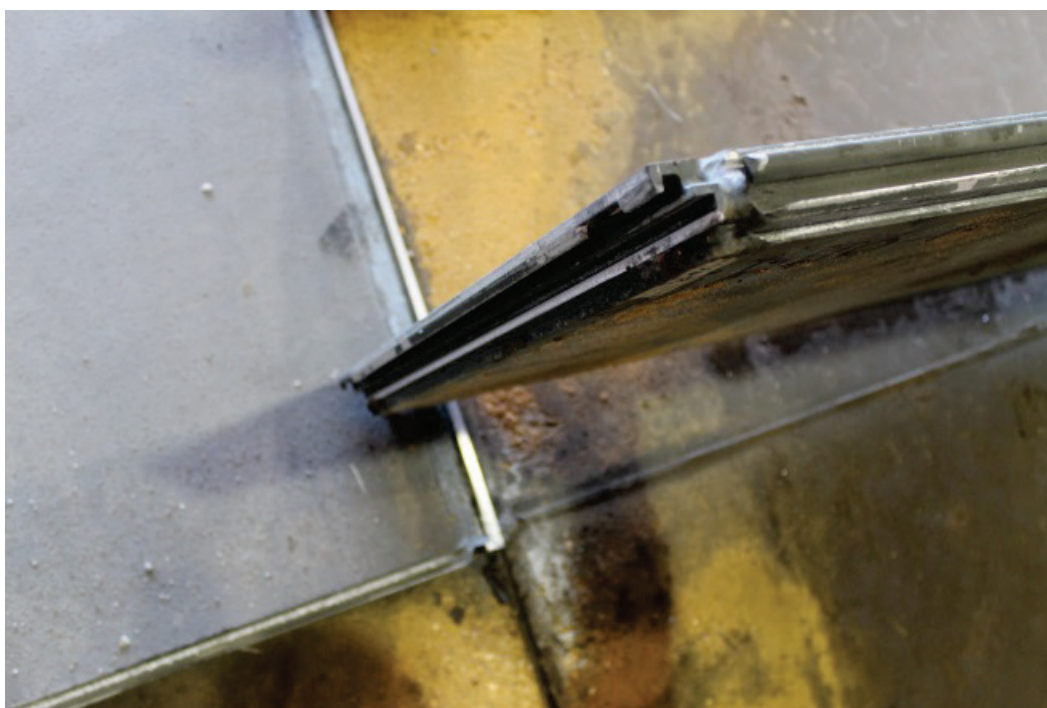
Trafficking of the C-17 test item over a subgrade with a CBR of 6 began on May 13, 2013. Instrumented panels began to fail quickly along the area with six continuous longitudinal joints. After 28 passes, the lower overlap

Figure 35. Typical broken lower overlap rail on C-17 item.

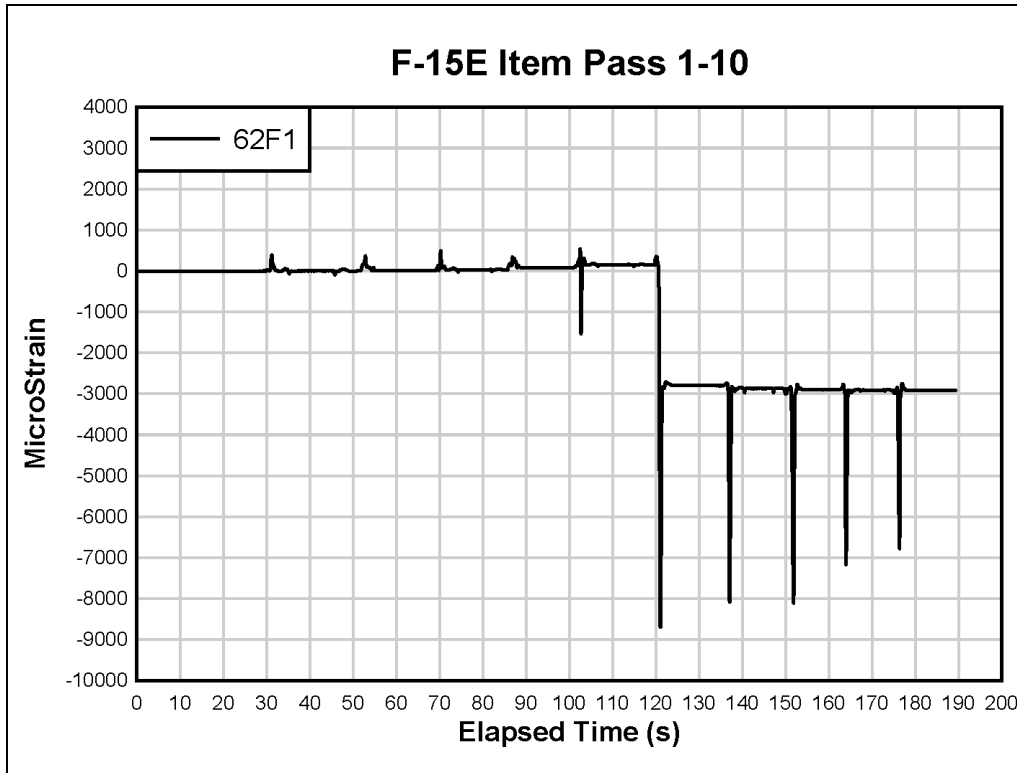
Figure 49. Strain gauge data for F-15E item, SG 62F1, passes 1-10.

side of the joint on pass six, where there is a baseline shift indicating permanent deformation and large compressive strains. The changing magnitude of the peaks was caused by the wander pattern used to simulate a normal distribution of traffic over the test section. The higher peaks indicate that the load cart was located directly above, or adjacent to, the strain gauge.

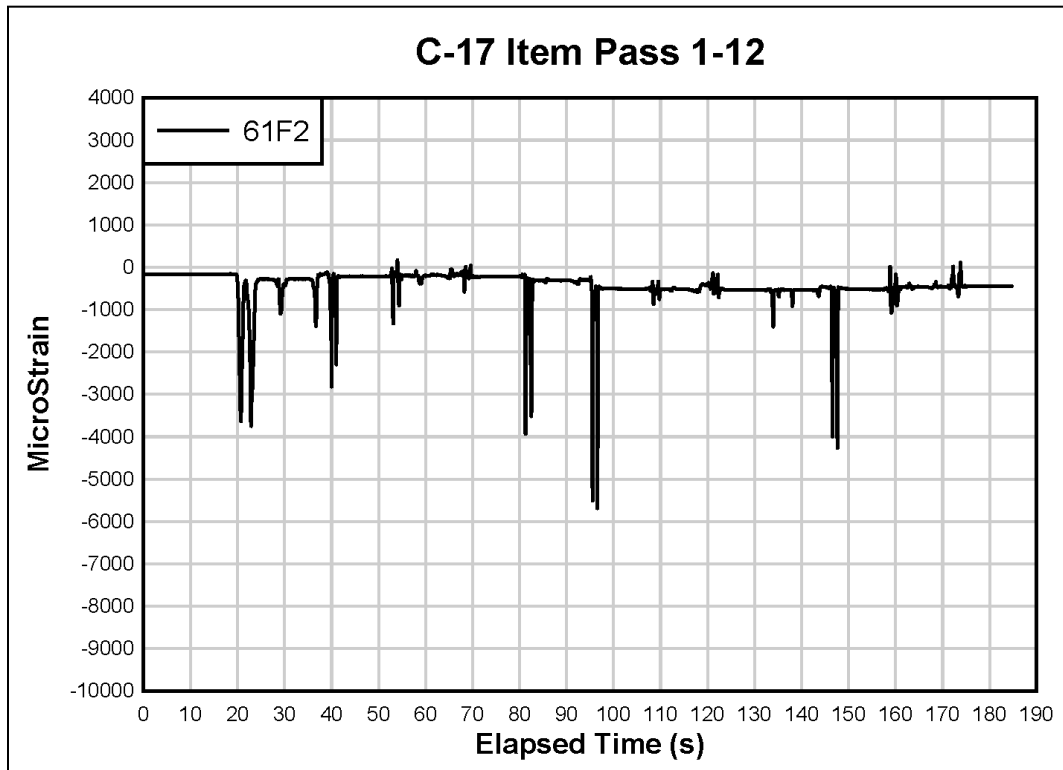
Figure 50. Strain gauge data for C-17 item, SG 61F2, passes 1-12.

Figure 50 represents raw data collected for the first 12 passes of the 6-wheeled C-17 load cart from a strain gauge mounted on the lower overlap of Panel 61 (third panel to fail). Each pass is indicated by two large peaks and one small peak, representing the two main axles of the C-17 and the drive axle of the scraper engine used to pull the simulator, respectively. The strain values generally show higher compressive strains for the first six passes when the vehicle was on the east side of the joint, and then the values tended to decrease when the vehicle moved to the west side of the joint. This reaction is exactly opposite of the effect shown in Figure 49 but is expected, since the opposing panel joints are represented. As described for Figure 49, the magnitudes of the peaks also indicate the wander pattern used in the test, but it is not as obvious, since six load wheels are being applied instead of one.
