Matthew Jones House

Historic Maintenance and Repair Manual

Adam D. Smith and Sunny E. Adams

August 2014

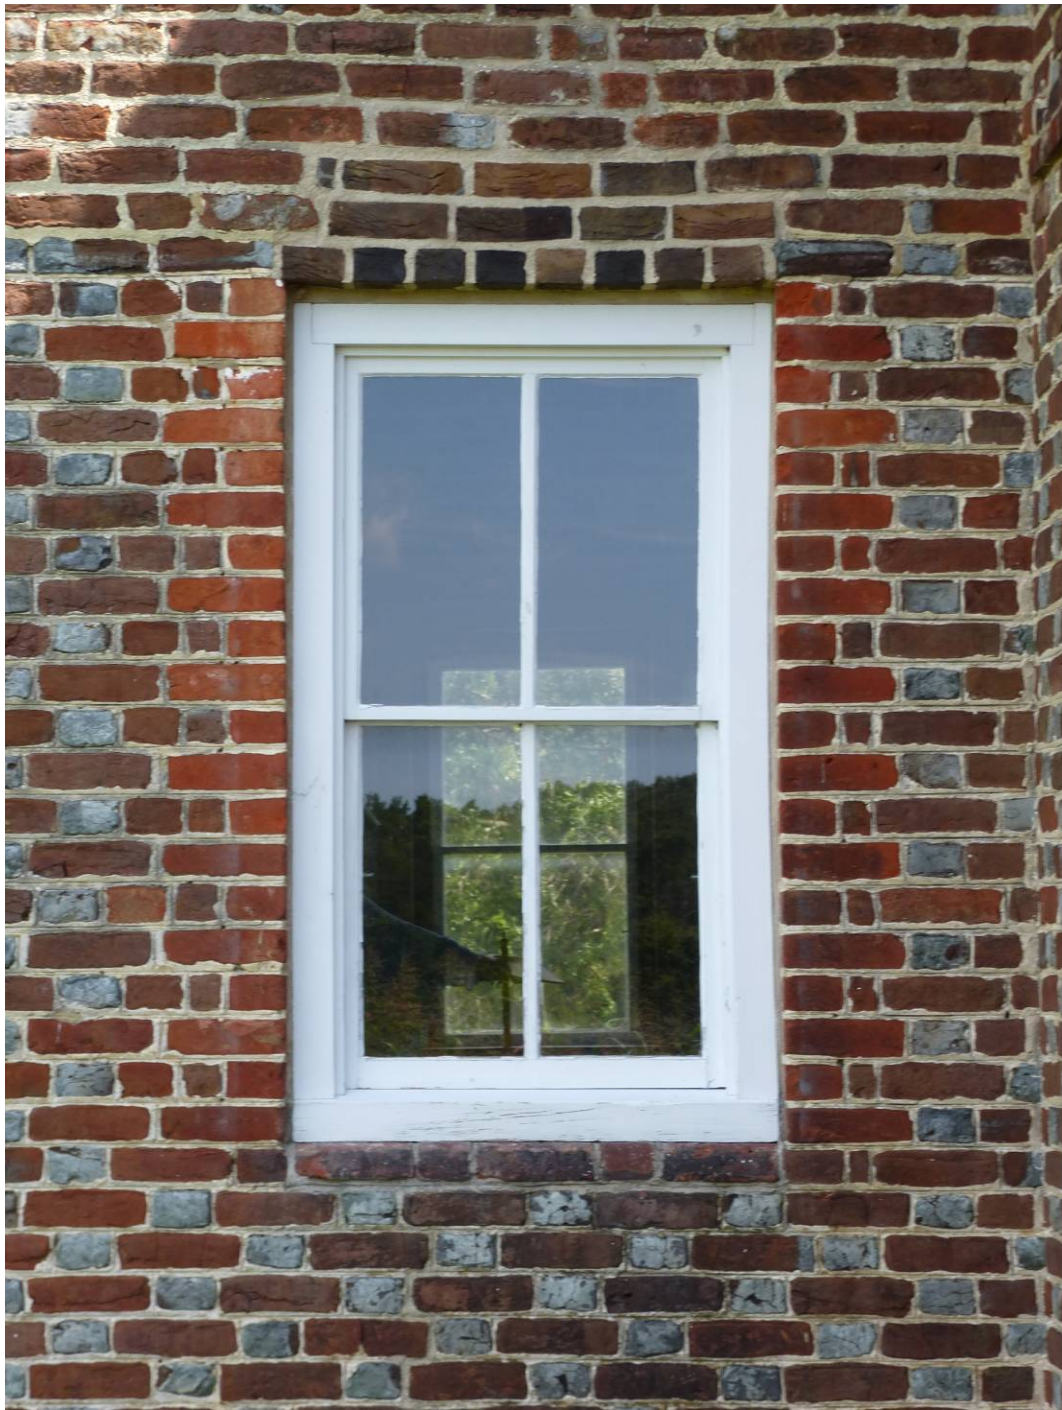
Figure 33. Wood windows on the first floor of the Matthew Jones House need to be replaced with more appropriate Period II windows (ERDC-CERL, 2012).

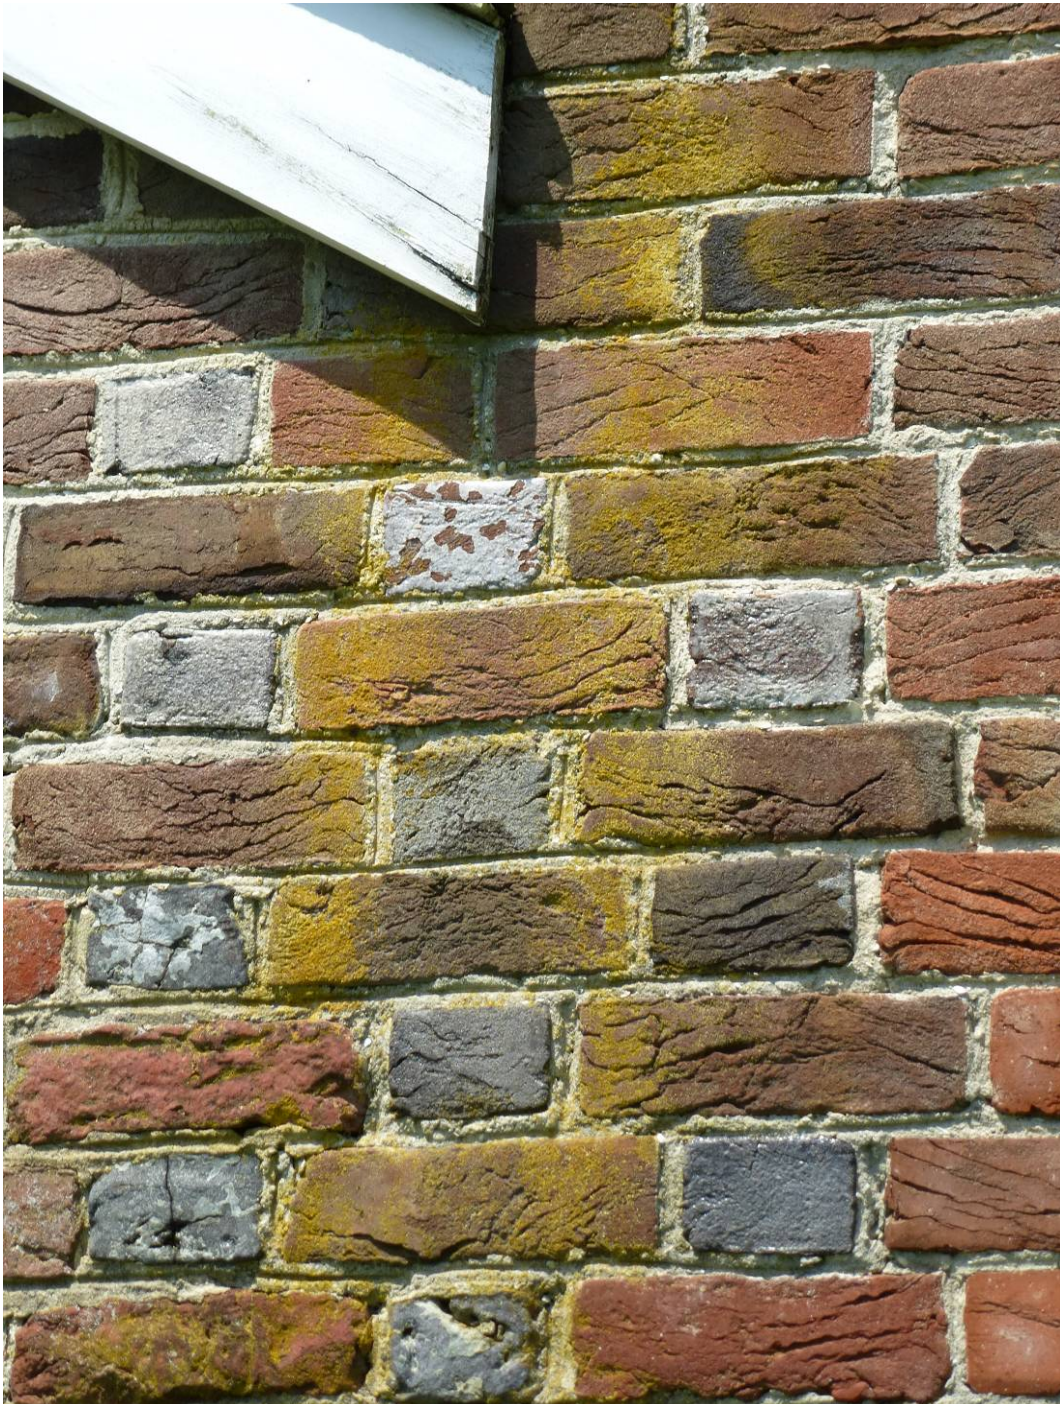
Figure 58. Growth and stains on the brickwork caused by water being shed from wood roof member (ERDC-CERL, 2012).

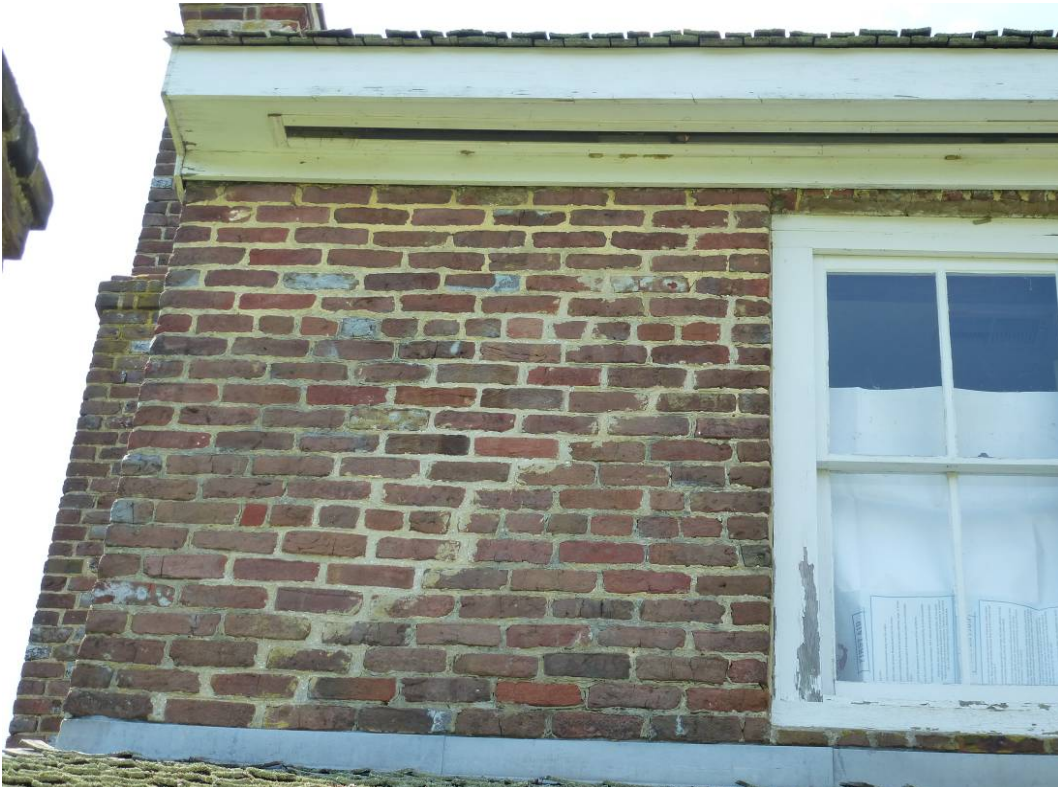
Figure 62. Replacement mortar used on the second floor on the northeast elevation (ERDC-CERL, 2012).

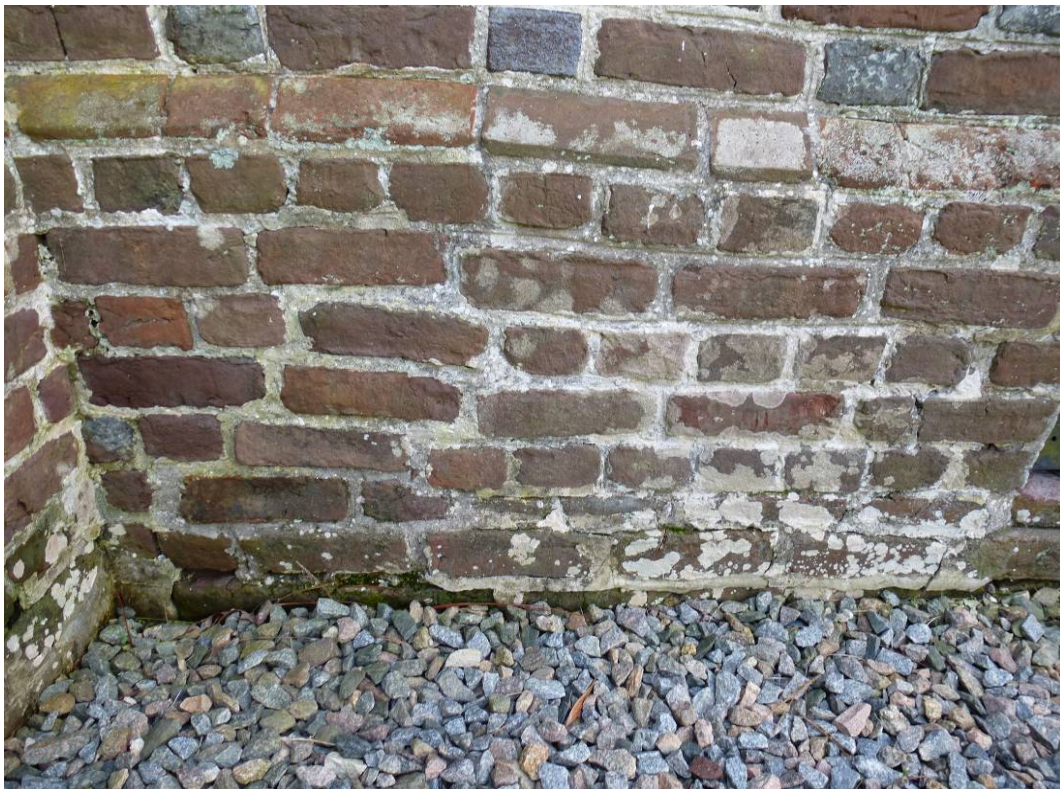
Figure 78. Lichen growth and efflorescence on the water table caused by rain water shedding from roof and splashing back onto the brickwork (ERDC-CERL, 2012).

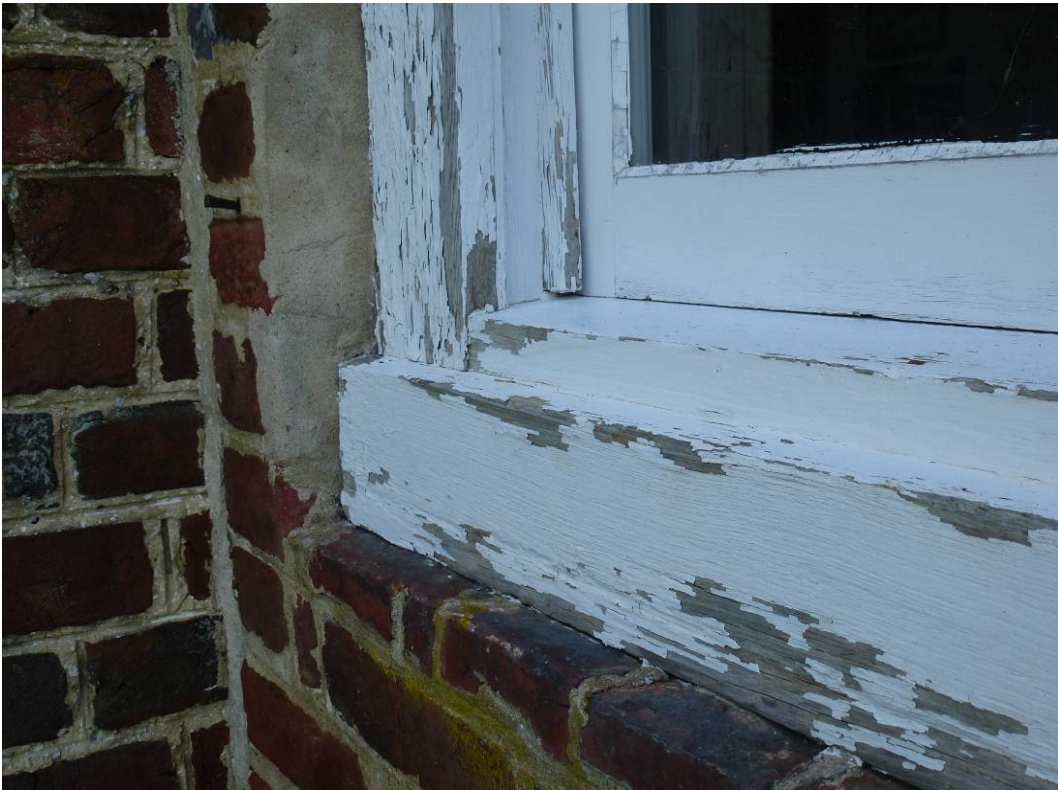
Figure 115. Deterioration of paint on wood window frame and sash (ERDC-CERL, 2012).

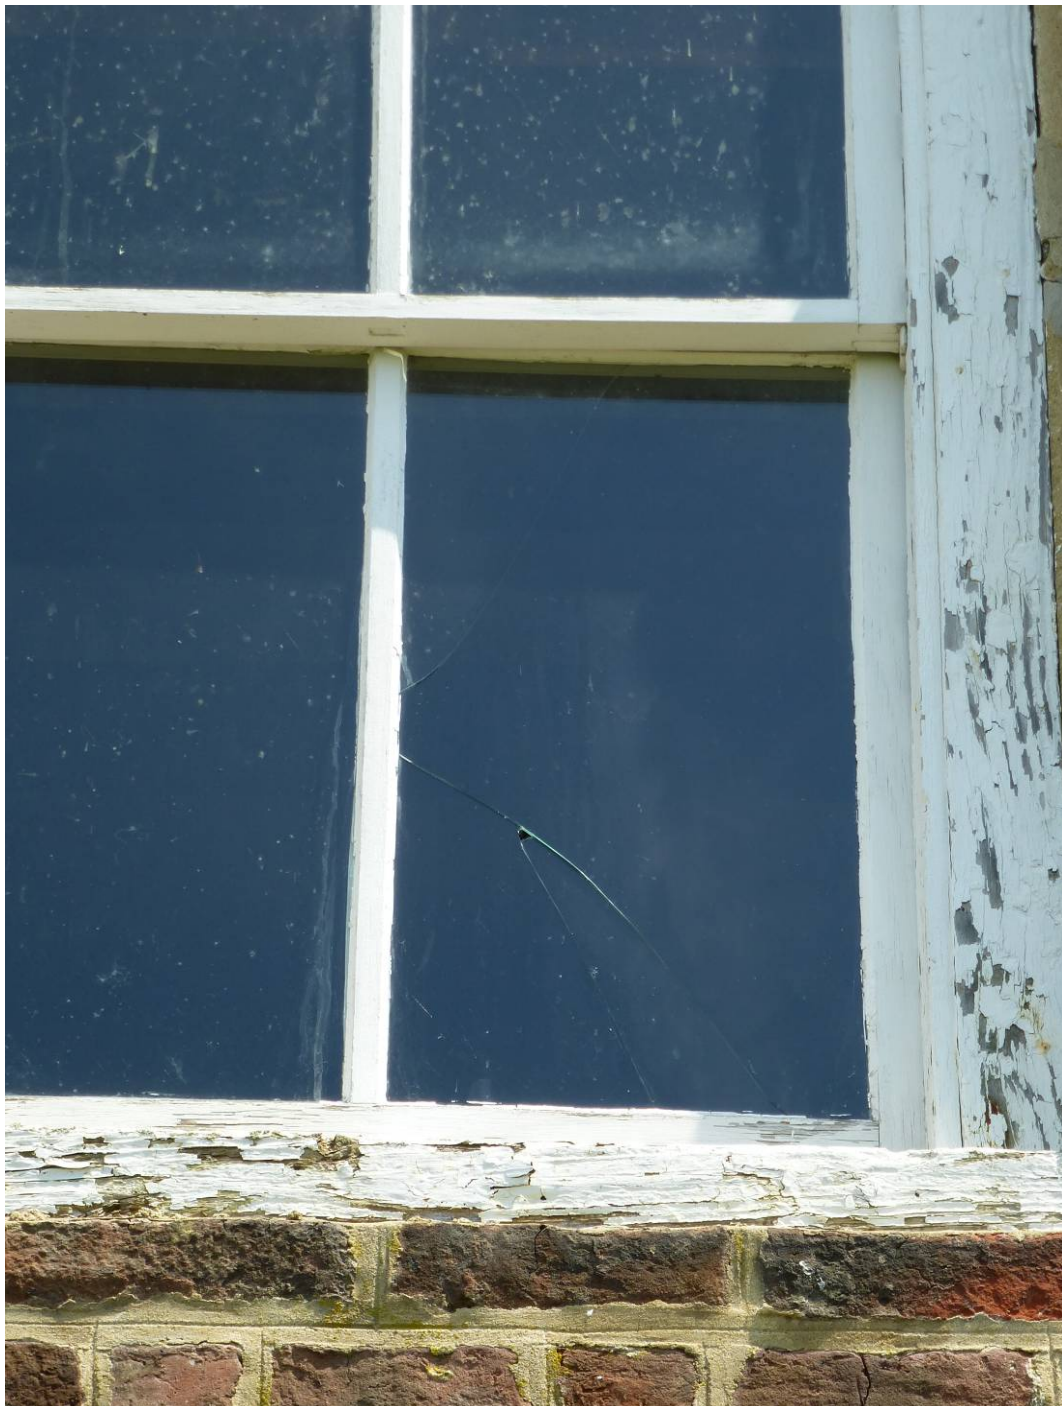
Figure 118. Cracked window pane that even has a hole in it that lets elements into the building (ERDC-CERL, 2012).

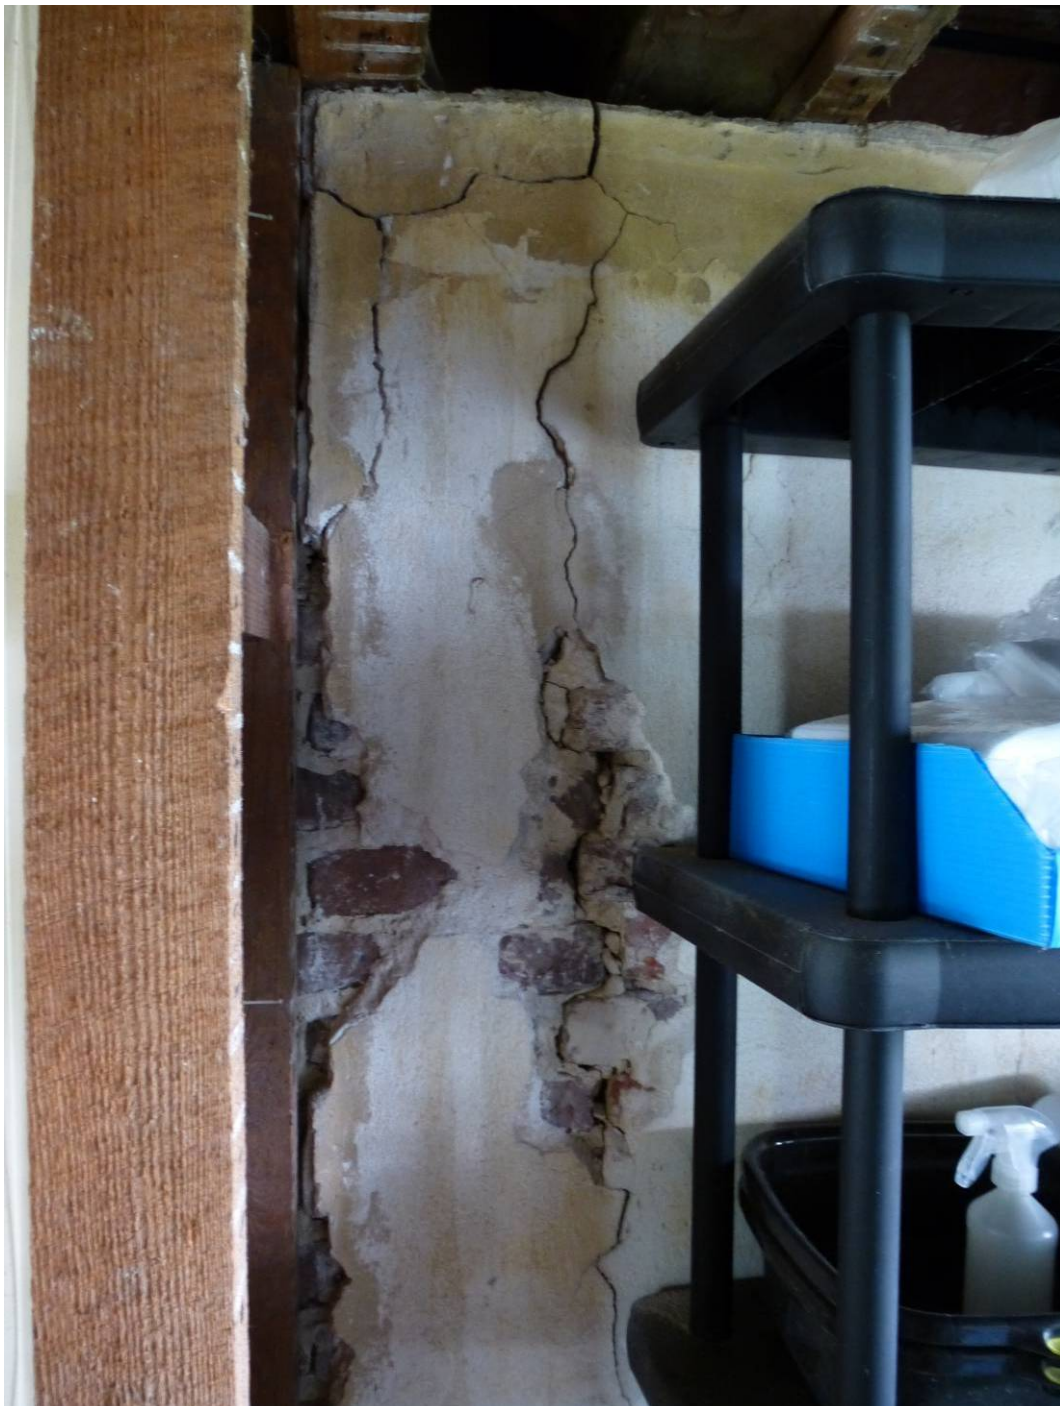
Figure 154. Second-floor southeast wall of porch tower is showing signs of cracking in both plaster lath and brick exterior wall (ERDC-CERL, 2012).

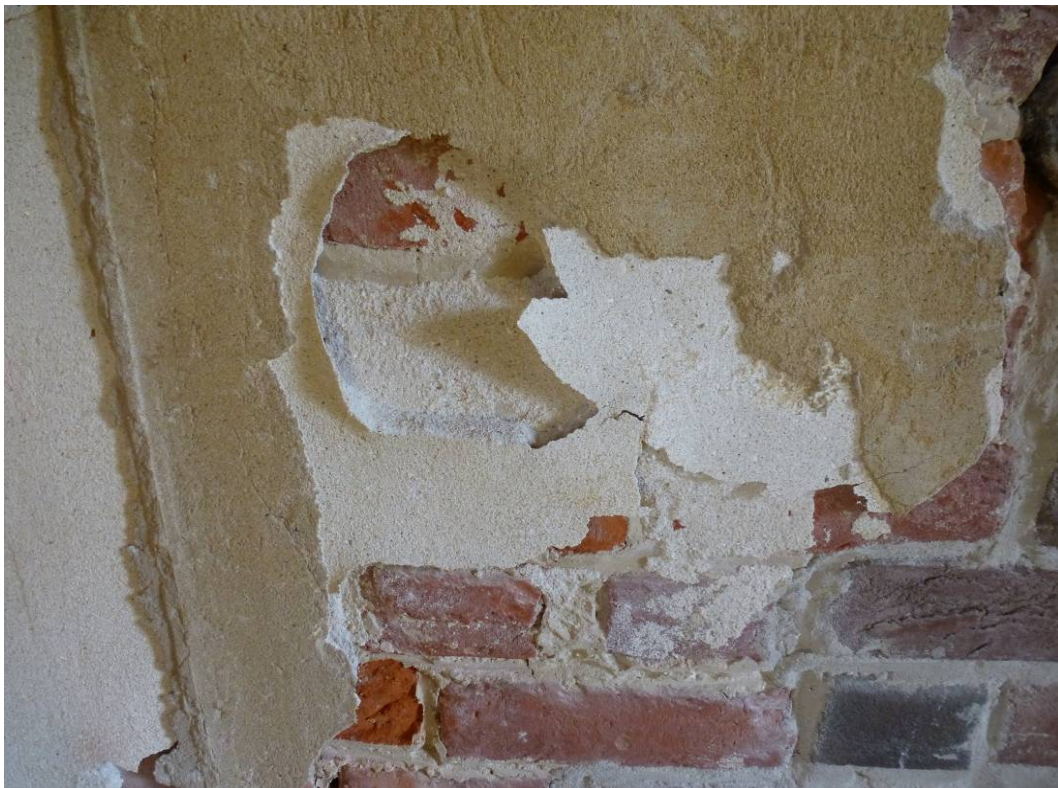
Figure 189. Plaster has fallen off the top half of the brick wall (ERDC-CERL, 2012).

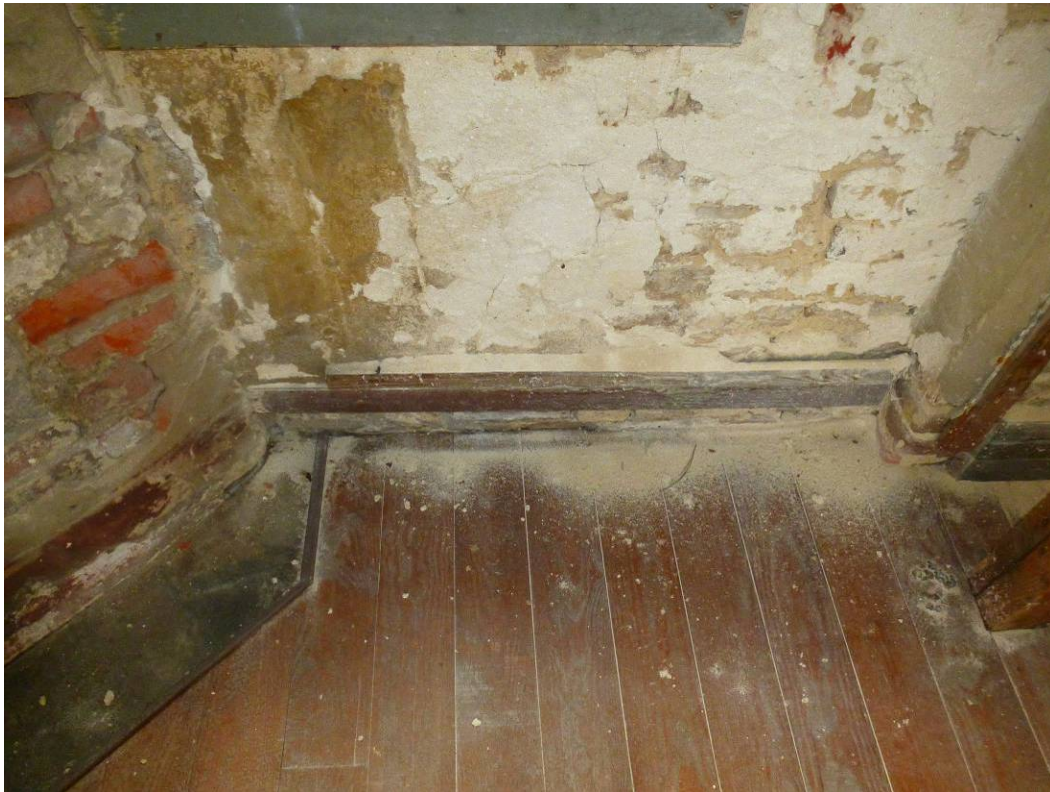
Figure 193. Plaster and brick dust pile around the steel rod enforcement in the upper stair passage on the northeast wall (ERDC-CERL, 2012).

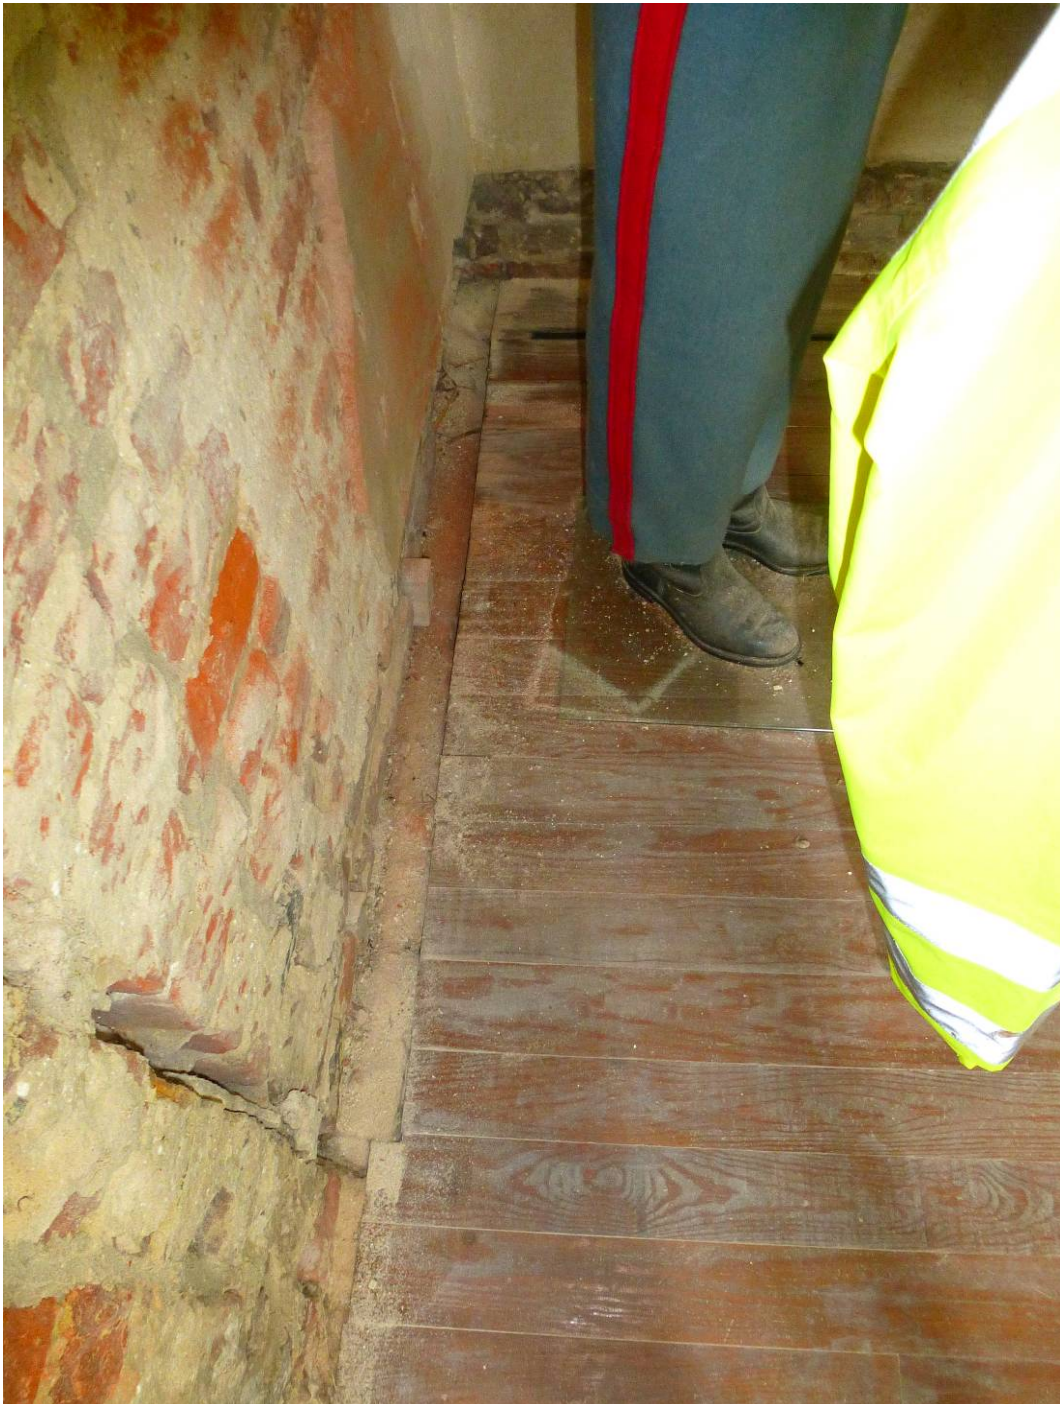
Figure 200. A newer HVAC vent has been cut in narrow slits in various places in the wood floor. The moisture from the HVAC system is damaging the floorboards (ERDC-CERL, 2012).
