TECHNICAL REPORT REMR-CO-3

**CASE HISTORIES OF CORPS BREAKWATER
AND JETTY STRUCTURES**

Report 2

SOUTH ATLANTIC DIVISION

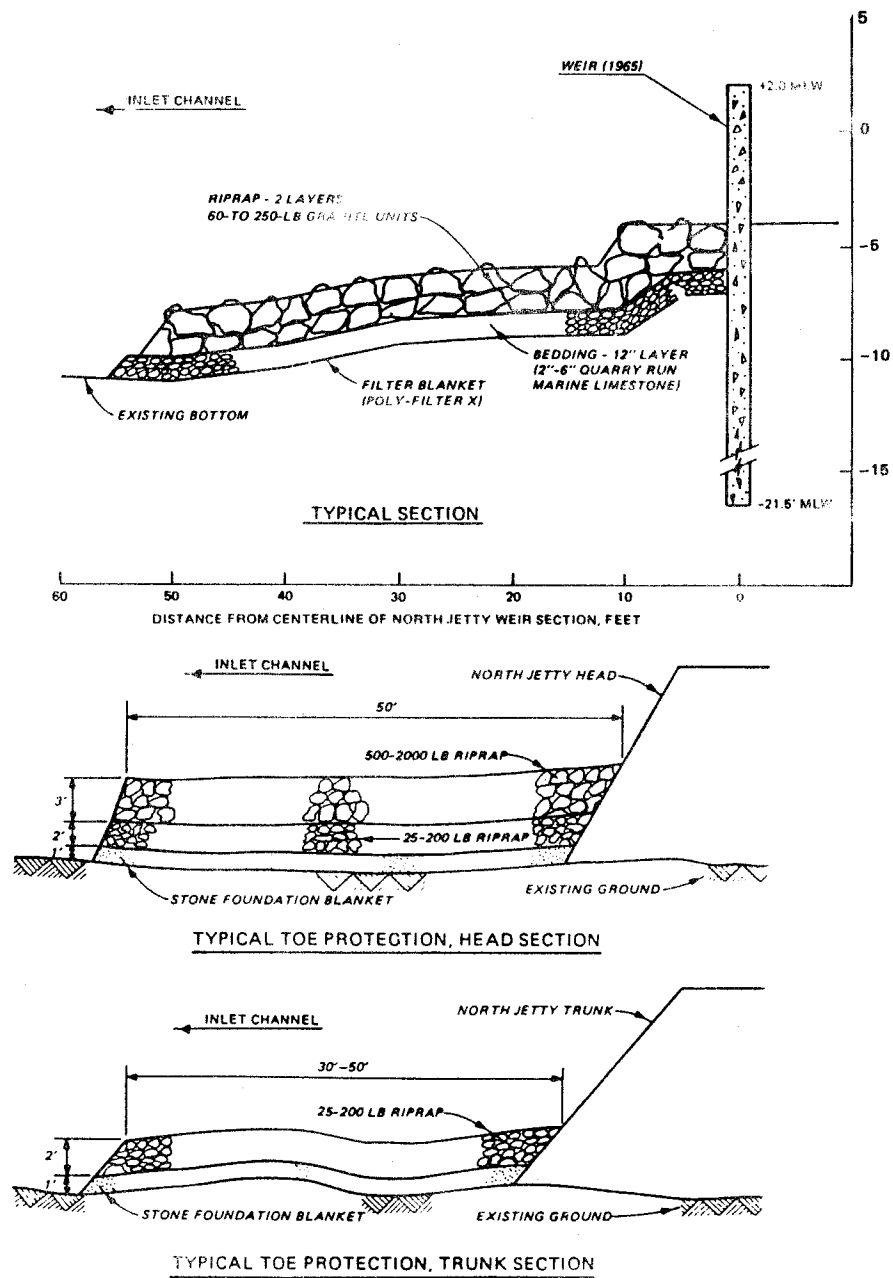
Figure 12. North jetty toe protection
Masonboro Inlet

1973- 1974	Toe protection (Figure 12) was placed along the channel side of the 1,100-ft weir section because of continued movement of the navigation channel and the costs involved should a catastrophic failure occur (loss of sheet-pile sections resulting from scour and undermining). The toe apron was to be 50 ft wide with a 1-ft-thick foundation blanket of 2- to 6-in. stone overlain with a 2.5-ft layer of 25- to 250-lb riprap. Total cost of the repair was \$248,800.
1978- 1980	Construction of the south jetty, built of quarry stone and concrete sheet pile to a length of 3,450 ft, began in July 1978 and was completed in August 1980. A bathymetric survey taken in 1978 showed the channel to be extremely close to the north jetty with water depths up to -25 ft mlw along the rubble-mound section and -12 ft mlw along the weir jetty section. Model tests of the south jetty alignment and geometry, conducted at the US Army Engineer

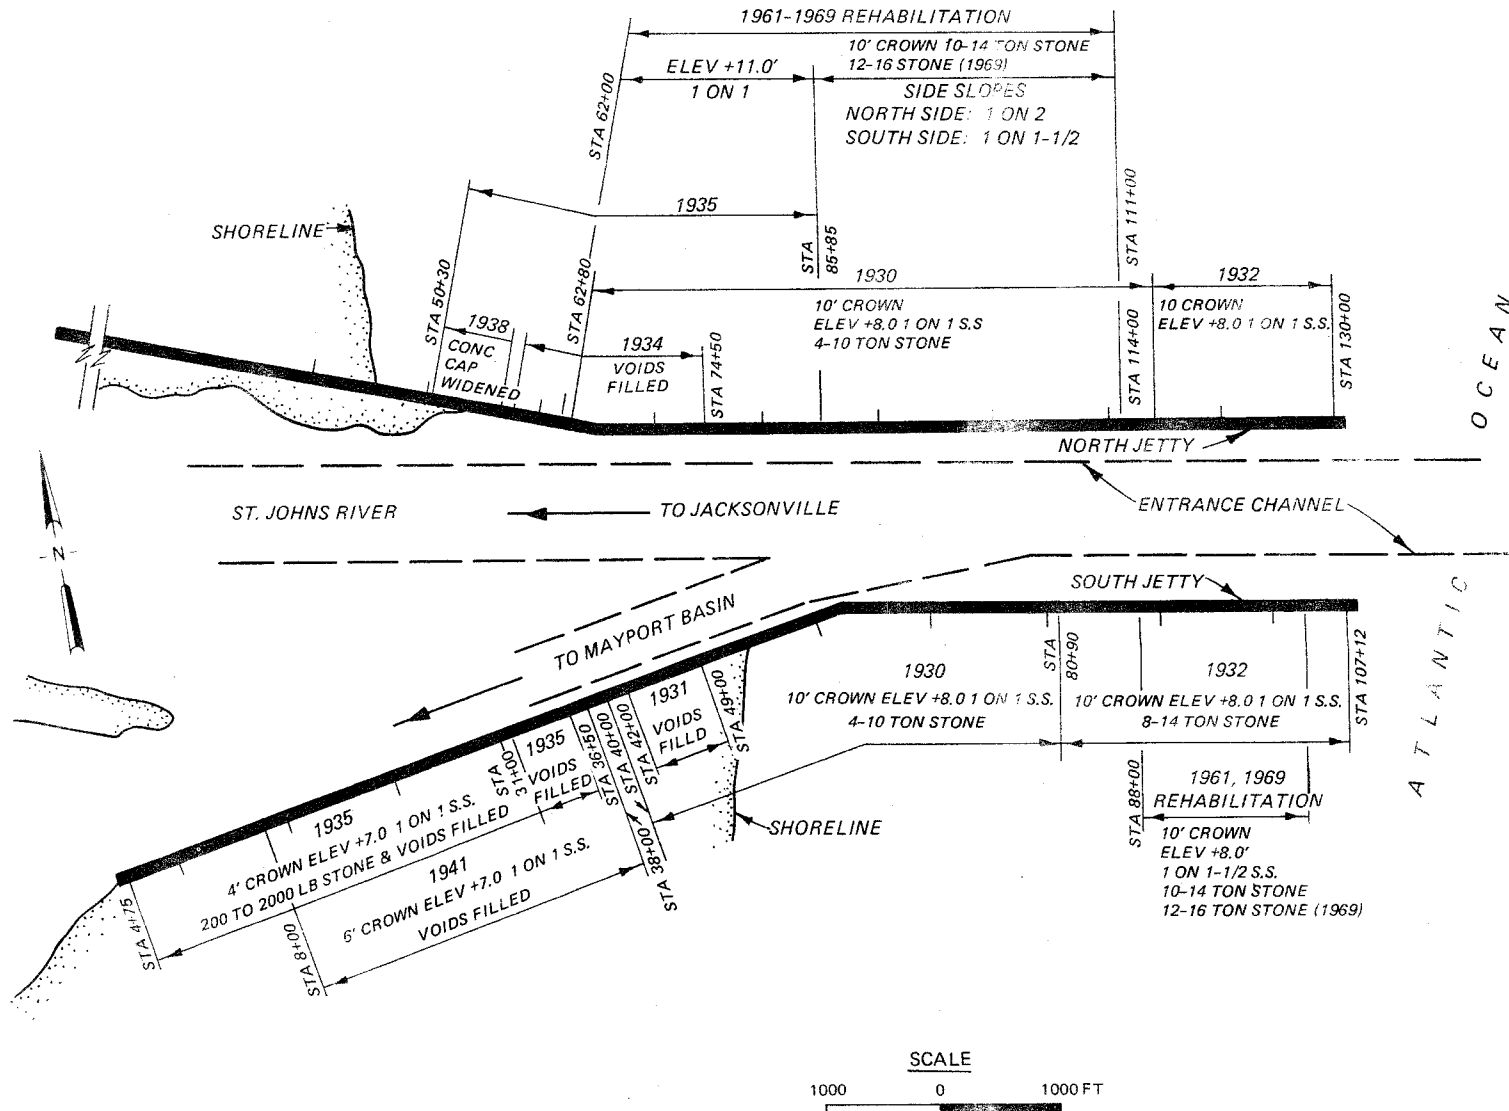
Figure 24. Plan view of cumulative repairs to Jacksonville jetties from 1930 to 1969

1930	Repairs were made between sta 62+80 and 114+00 of the north jetty with 29,700 tons of granite stone (Figure 24). Nine gaps with an average height of +4 to +5 ft mlw were raised to +8 ft mlw. The crest elevations on the outer 500 ft of the jetty were from -5 to -15 ft mlw. The south jetty was repaired between sta 40+00 and 80+90 with 26,600 tons of granite (Figure 25). Twenty major gaps with average heights of +3 to +5 ft mlw were raised to +8 ft mlw. The crest elevations on the outer 700 ft of the jetty were from +3 to -10 ft mlw. The stone size was from 4 to 10 tons with an average size of 6 to 8 tons. The crown width was 10 ft, and the side slopes were 1V:1H. Cost of the repairs totaled \$228,000.
1931- 1932	Voids below +4 ft mlw on the ocean side of the south jetty were filled with 25- to 100-lb granite stone to stop the flow of sand through the structure, and 3,450 tons of stone were placed between sta 36+50 and 54+00 (Figure 25). A 110-ft-long groin (crest elevation +7 ft mlw) constructed of 550 tons of stone was placed at sta 44+56 on the ocean side of the south jetty to stop the flow of water along the jetty. Later, a head section on the groin was constructed using 245 tons of granite and 50 cu yd of oyster shell. Total cost of the groin was \$15,300. The seaward ends of the jetties were repaired (Figure 24), the north between sta 114+00 and 128+60 and the south between sta 88+00 and 106+30. Storm waves had, over time, lowered both jetties and created gaps, necessitating the repairs. Gaps (low points) on the jetties ranged from +3 to +4 ft mlw. The outer 500 ft of the north jetty ranged from -5 to -20 ft mlw, and the outer 700 ft of the south jetty ranged from +3 to -12 ft mlw. The armor stone ranged from 8 to 14 tons, and the design section consisted of a 10-ft crest width at +8 ft mlw and 1V:1H side slopes.

Date(s)	Construction and Rehabilitation History
1931- 1932 (Cont)	49,500 and 51,200 tons of stone were placed on the north and south jetties, respectively. The cost of the seaward repairs totaled \$376,000.
1934	Voids on the ocean side of the north jetty were filled with 25- to 100-lb of granite stone to arrest the flow of sand through the structure, and 4,800 tons of stone were placed between sta 57+50 and 74+50 at a cost of \$21,300 (Figure 24). A monolithic concrete cap ranging in width from 2 to 8 ft was constructed along the centerline of the north jetty between sta 50+30 and 85+85. The crown elevation ranged between +11 and +13 ft mlw. A total of 3,780 cu yd of concrete was placed on the structure at a cost of \$58,000 (Figure 24).
1935	Elevations on the north jetty varied from +6 to +14 ft mlw and on the south jetty varied from 0 to +14 ft mlw. Repairs were made to the inner portion of the south jetty, filling void spaces from sta -4+75 to 31+00 using 200 to 2,000-lb stone. From sta 31+00 to 36+50 the voids were filled between 0.0 and 4.0 ft mlw with smaller stone (less than 200 lb). This section was repaired using a 4-ft-crown width at an elevation of +7 ft mlw and 1V:1H side slopes (Figure 24).

1938	The north jetty concrete cap was widened from the existing 2-ft section to a width of 6 ft between sta 50+30 and 56+60 (Figure 24).
1940- 1941	Repairs were made to the south jetty between sta 8+00 and 38+00 (Figure 24). Granite stone of 1 to 3 tons and 3 to 6 tons was placed on the inner 1,200 ft and outer 1,800 ft, respectively. Void filling stone of 50 to 150 lb was placed throughout the repair section. The design called for a 6-ft crown width at +7 ft mlw with 1V:1H side slopes. Sand overlying the jetty was to be removed before stone placement. Small stone was removed between 33+00 and 38+00 as required to allow placing of the cover stone to the design section with the removed stone subsequently used to fill voids. 21,800 tons of 1- to 6-ton stone and 4,800 tons of 50- to 150-lb stone were placed at a cost \$105,000.
1961	Rehabilitation made to the seaward end of the south jetty between sta 88+00 and 102+70 and the north jetty between sta 62+00 and 11+100 (Figure 24). Areas of deterioration from settlement and dislodgement of stone had occurred at the ocean ends and along landward portions of both jetties. Also, several portions of the north jetty concrete cap had been broken and displaced from the crown along with some of the underlying support stone. The major causes of settlement seemed to be slope flattening and the possibility of wave

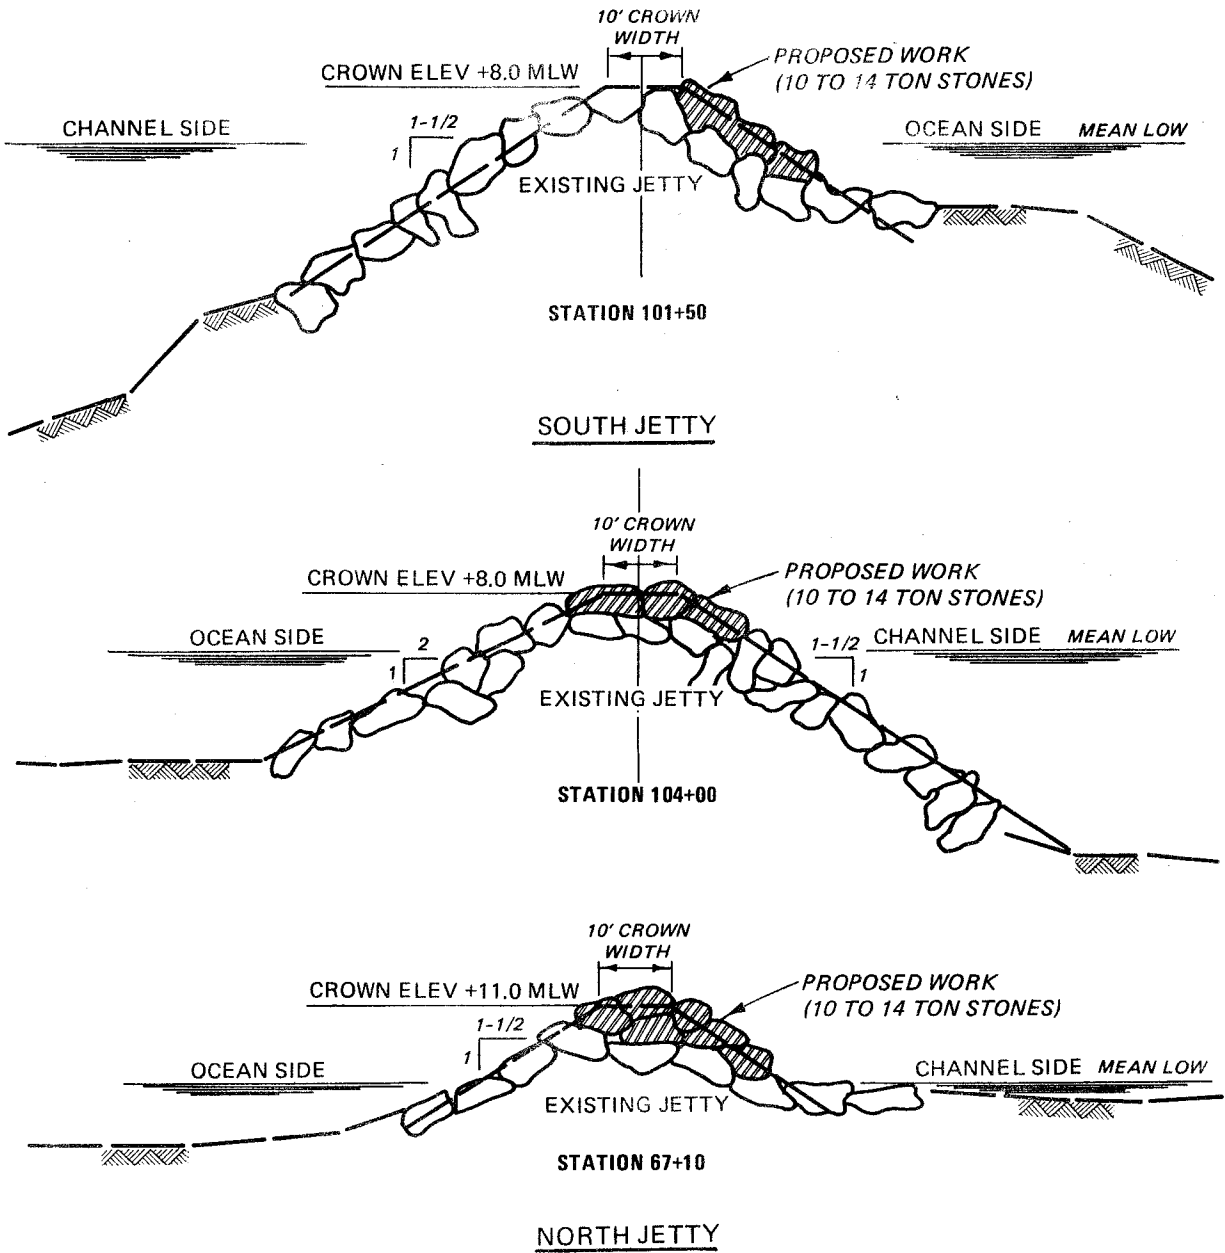
Figure 25. Typical 1961 repairs to Jacksonville jetties

Date(s)	Construction and Rehabilitation History
1961 (Cont)	<p>action causing increased consolidation. Repairs were made to bring the structure back up to previous designs but with larger stone. The design called for 10- to 14-ton granite stone and a crown width of 10 ft for all repair sections (Figure 25). On the concrete cap section of the north jetty, between 62+00 and 85+88, the crown elevation was to be +11 ft mlw, and the side slopes were 1V:1.5H. The remainder of the jetty repairs were to have a +8 ft mlw crown elevation and 1V:1.5H side slopes (with the exception of the north jetty ocean-side slope which was 1V:2H). The design was based on a 14- to 15-ft wave height and Hudson's stability equation. Cost of the rehabilitation with 5,500 tons of stone was \$54,600.</p>
1969	<p>Rehabilitation of jetties was carried out on approximately the same section as the 1961 repairs (Figure 25). Except for the use of 12- to 16-ton stone, the design sections were identical to those of 1961. The north jetty from sta 50+45 to 85+80 was built up to +11 ft mlw with 1V:1.5H side slopes and from sta 85+80 to 122+80 was built up to +8 ft mlw with 1V:2H and 1V:1.5H side slopes on the ocean and channel sides, respectively. The south jetty from sta 85+90 to 103+20 was built up to +8 ft mlw with 1V:1.5H side slopes. The crown width on all sections was 10 ft. Dislocation and consolidation of cover stone overlying smaller stone (below mlw) was thought to be the cause of jetty deterioration. The low areas to be repaired were wide which provided a good base to place new stone. Wave heights of 14 and 15 ft and Hudson's stability equation were used, similar to those in the 1961 design. A total of 21,500 tons of stone was placed at a cost of \$398,000. Inner areas of the jetties were not rehabilitated although in need of some repairs.</p>

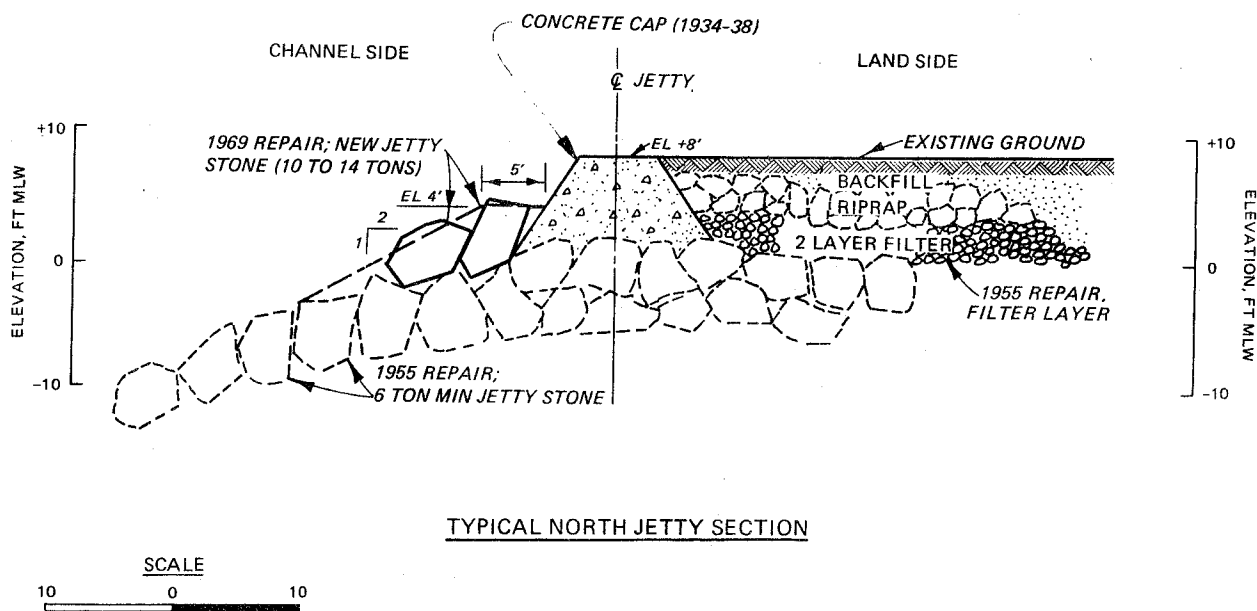
Figure 34. Palm Beach north jetty repairs of 1955 and 1969

1950	In January 1950 repairs to the north jetty consisted of (a) placing a filter blanket of 1/4- to 6-in. stone along 200 ft of its shore-side landward junction (to impede sand motion) and (b) placing existing and additional 500- to 2,000-lb armor stone at the revetment/jetty cap interface (30-ft section). In March 1950 repair of the south jetty consisted of placing 2- to 10-ton armor stone as needed. Total cost of the repairs to the south jetty (26,000 tons of stone placed) and revetment was \$227,000. (The jetty portion was roughly 90 percent of the total.) In August 1950 an underwater survey of the asphalt-filled north jetty showed some deterioration on the channel side; otherwise, it continued to function properly.
1955	Repairs were made to the north jetty from the existing shoreline to the landward end of the concrete cap (500 ft). A total of 1,300 tons of 6-ton minimum capstone was placed on the channel side of the repair section. Filter layers were placed on the shoreward side of the cap as follows (Figure 34): (a) 2-ft-thick lower layer of 3- to 6-in. stone placed above, and shoreward of, new/existing armor stone, (b) overlayed with 9 in. of 0.1- to 0.4-in. material, and (c) covered by a layer of 500- to 4,000-lb riprap stone. Total cost of the repairs was \$51,000.

Date(s)	Construction and Rehabilitation History
1967- 1968	The harbor was deepened to 35 ft. Federal support of the sand transfer plant ended.
1969	Rehabilitation of the 550-ft seaward section of the north jetty was made with 10- to 14-ton capstone on 1V:2H-side slopes (Figure 34). A total of 2,000 tons of armor stone was placed at a cost of \$83,000. A design wave height of 15 ft and a 14-sec wave period were used to select the capstone size.
1985	Present plans call for repairs to 1,300 ft of the south jetty. The jetty would be made impervious to sand motion via injection of silicate grout on the shoreward 800 ft and via a rubble filter on the seaward 500 ft. For slope protection, 5- to 10-ton stone were placed on 200 ft of the channel side (near shoreward end). The design wave height of 12.7 ft (obtained using the method outlined in Seelig and Ahrens (1980) used to compute size of cover stone to provide protection of the filter layer on the seaward end of repair). Cover stone will be 8 to 14 tons with an underlayer of 800- to 2,400-lb stone and 3- to 6-in. filter stone. The estimated first cost is \$2.2 million.

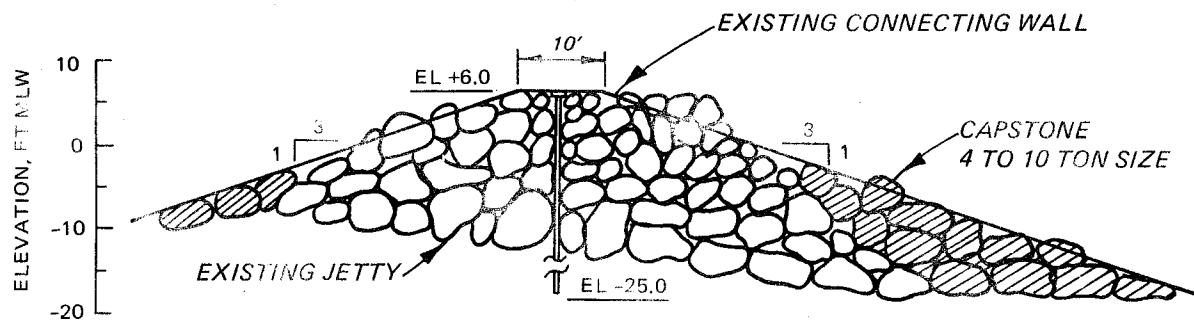
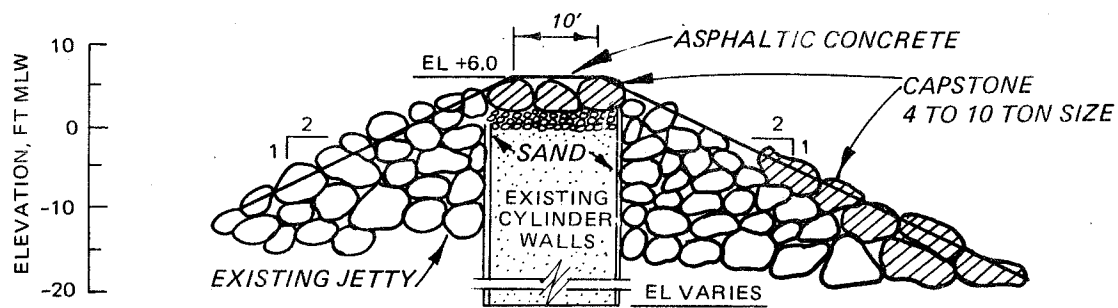
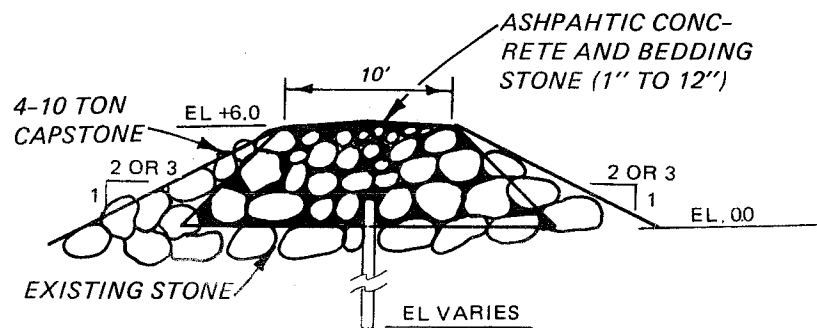
Figure 40. Typical 1969 jetty repair sections as Casey's Pass

1978	<p>Repair to jetties consisted of resetting stone and adding 6- to 12-ton stone (75 percent > 10 ton) on the outer 200 ft of the jetties and 2- to 6-ton stone on the next 450 ft of the jetties as needed to solidify the structure.</p>
1985	<p>The jetties are in good condition except for their head sections which are in need of some repair.</p>

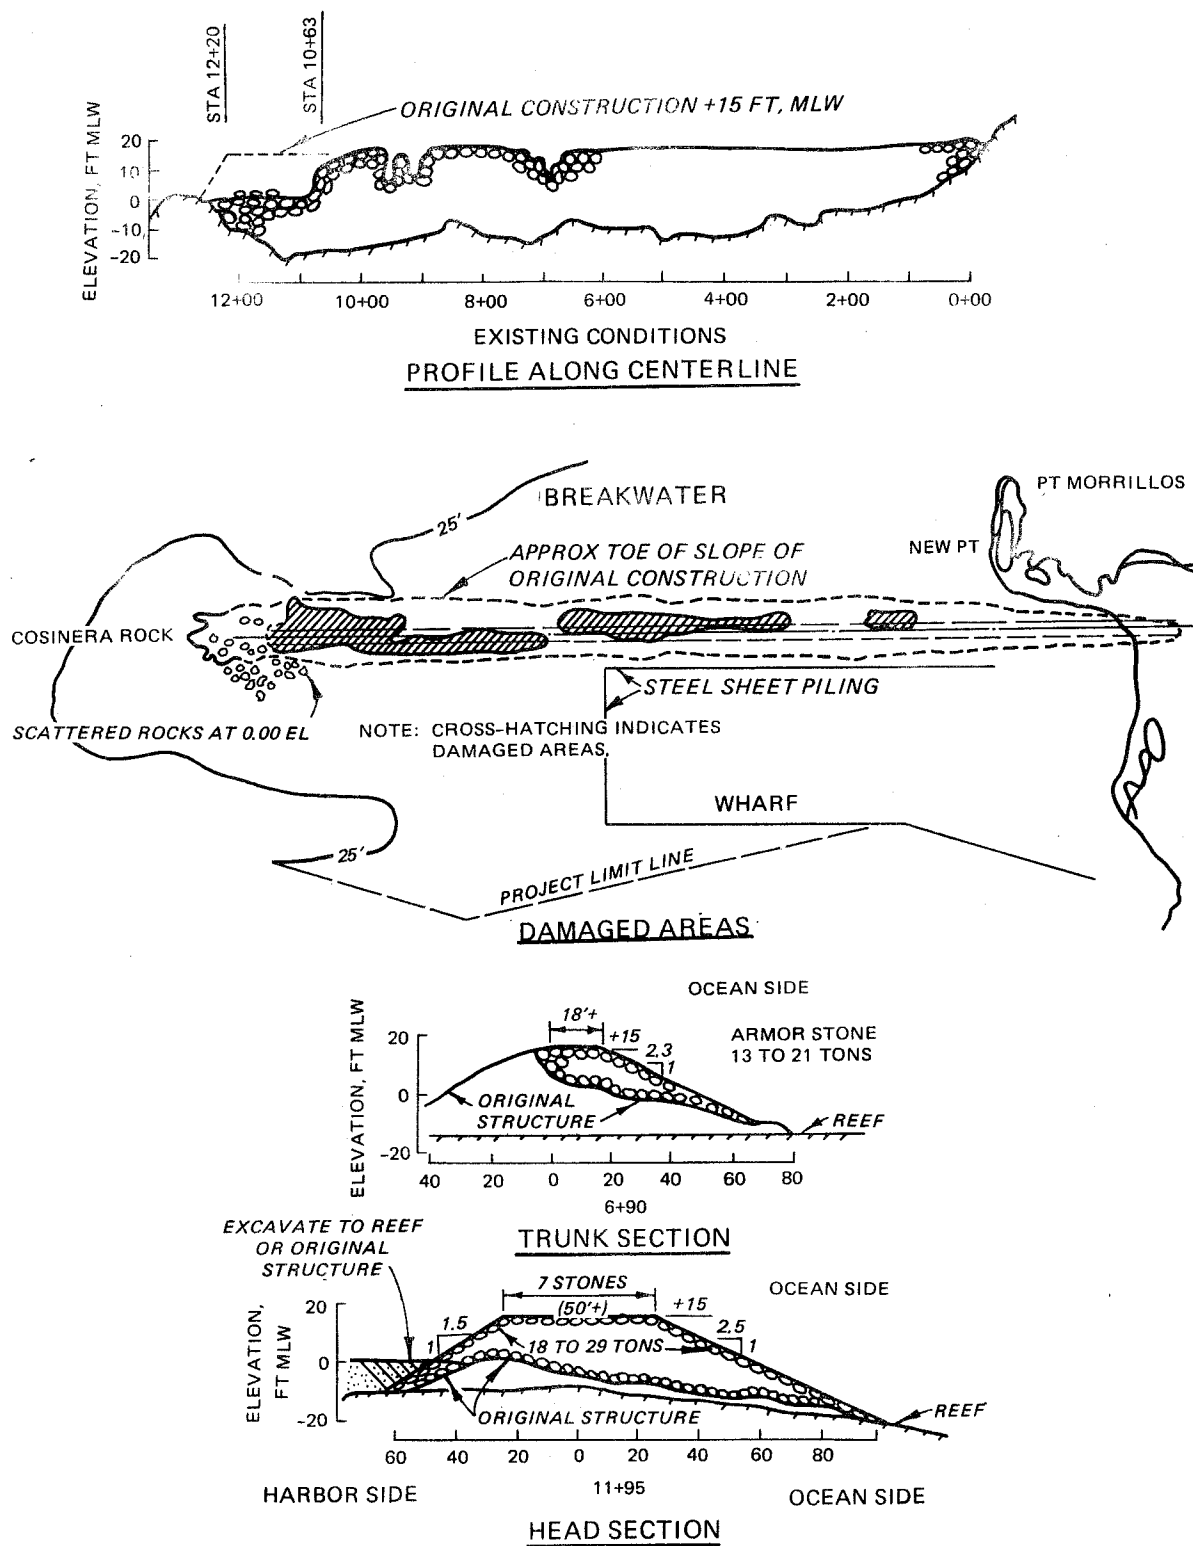
Figure 42. Arecibo Harbor existing damage prior to 1984 repairs and typical repair sections

Date(s)	Construction and Rehabilitation History
1984 (Cont)	WIS 20-year wave hindcast study (Corson, et al. 1982) together with a wave shoaling model (Seelig and Ahrens 1980) and a stability equation presented by the Danish Hydraulic Institute (Gravesen et al. 1979) in addition to SPM (1984) procedures.
1985	The structure is in excellent condition.
